Brush Creek Geomorphic Assessment to Address Fish Passage Barriers

Location: Brush Creek is located within the Wenatchee National Forest north of Lake Wenatchee. Brush Creek is a tributary stream to the Chiwawa River that may support threatened and endangered chinook salmon, steelhead trout, and bull trout. The site is on U.S. Forest Service ownership in Section 33, Township 28 North, 17 East, W. M.

Existing Structures: The culvert for the USFS 6306 Road crossing of Brush Creek is undersized and poses a fish passage barrier. The site is located approximately 0.75 miles above the confluence with the Chiwawa River at about River Mile 12.5. The site will require a new drainage structure.

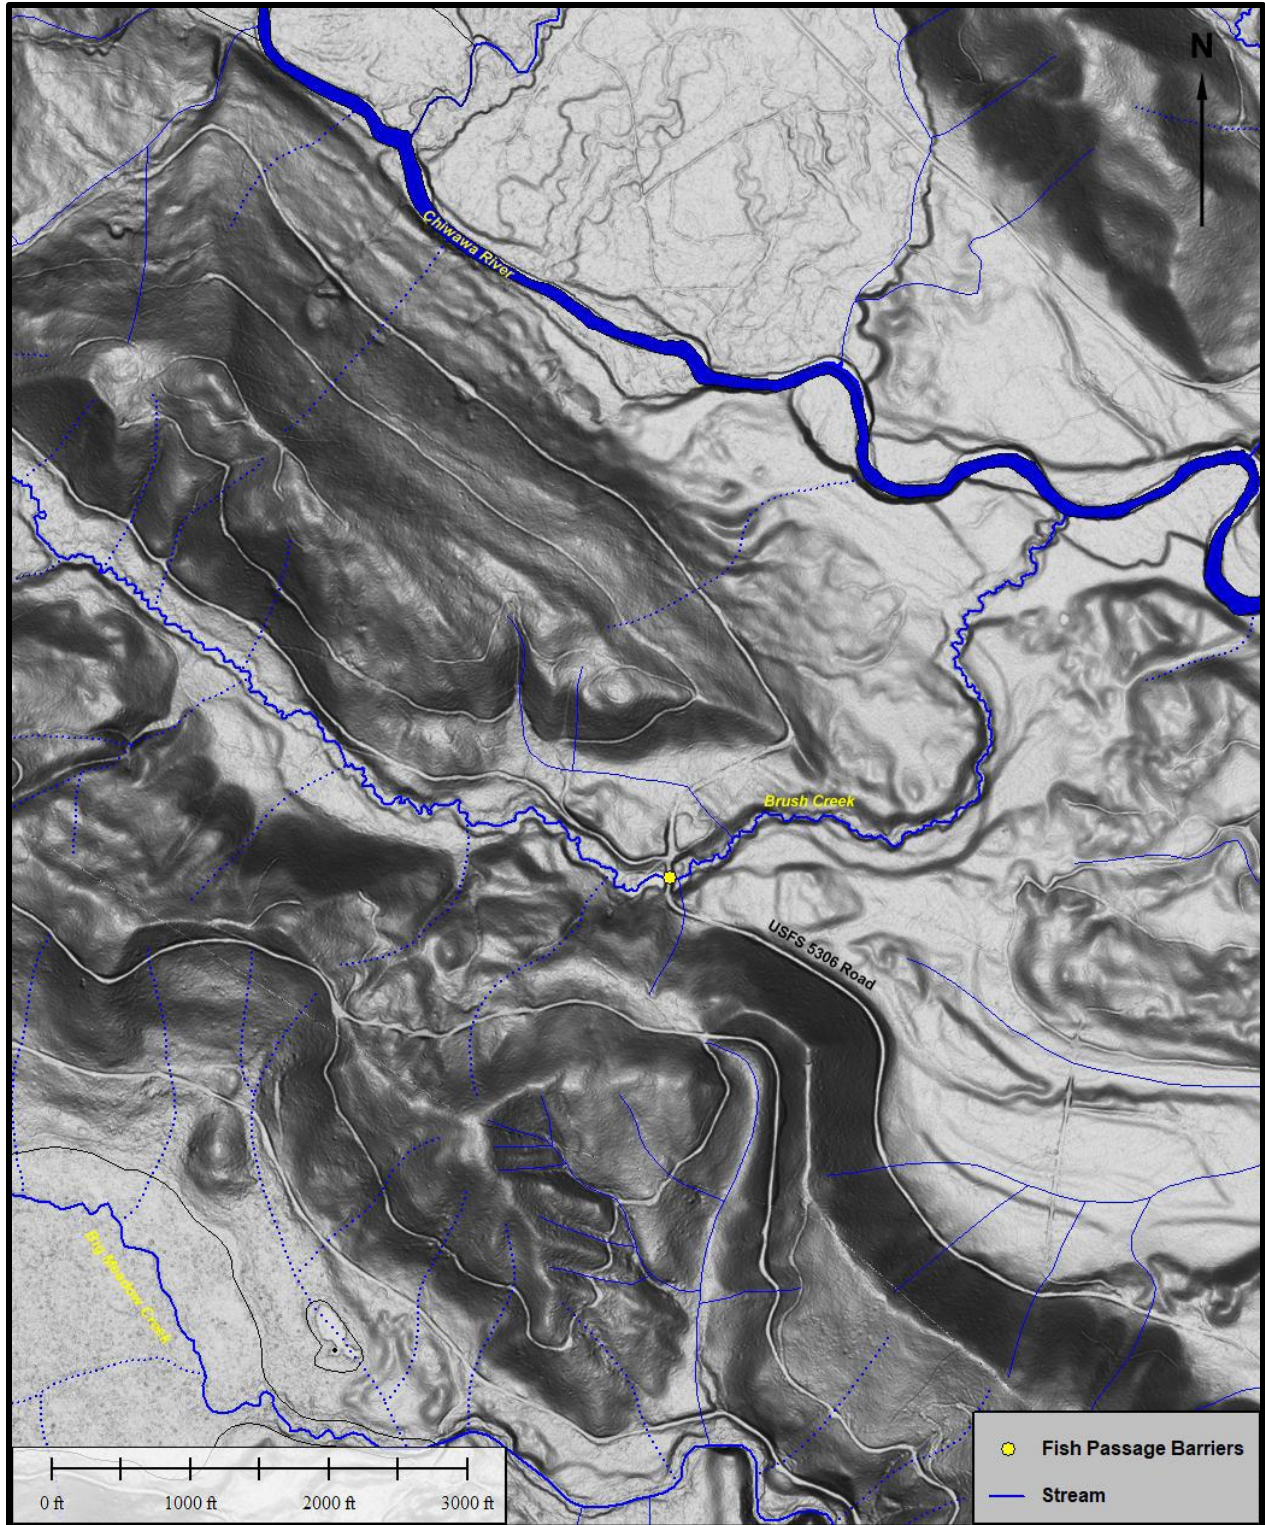
Interpretation: The proposed passage barrier correction work is located on moderate gradient slopes composed of unconsolidated alluvial and glacial outwash deposits that can have variable properties across the landscape. Unconsolidated materials on steeper slope gradients can be subject to erosion hazards and slope stability issues.

Figure 1. Shaded relief LiDAR map of the lower Brush Creek project area.

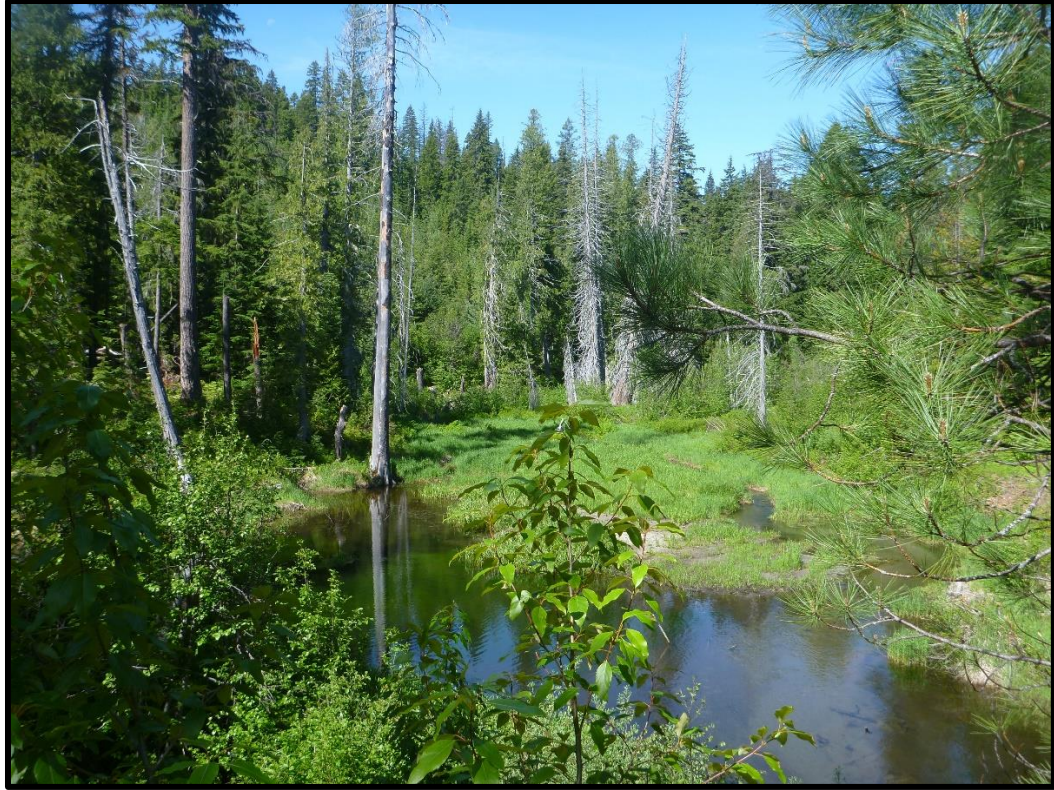
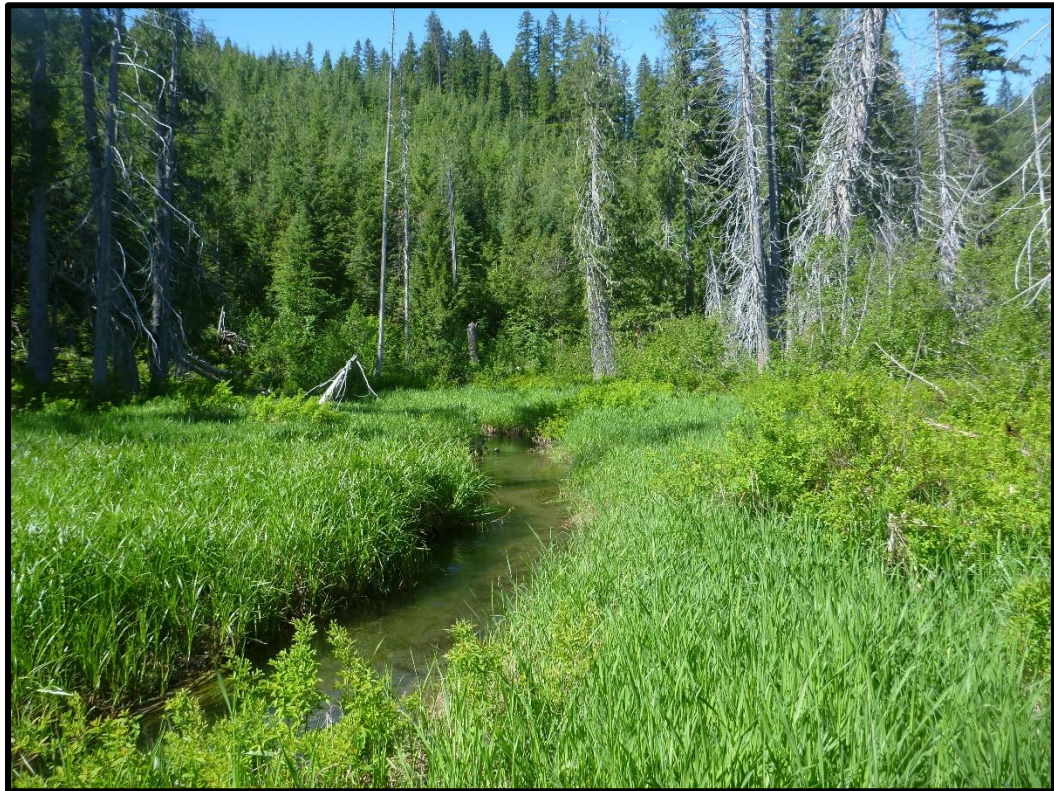
The vegetation around the beaver pond immediately upslope of the Brush Creek road crossing consists primarily of sedges (*Carex* spp.), reed canary grass (*Phalaris arundinacea*), hardhack (*Spirea* spp.), willow (*Salix* spp.), and alder (*Alnus* spp.) (Figure 2). The riparian vegetation in the valley bottom upstream and downstream of the beaver pond is comprised of a dense thicket of mountain alder (*Alnus incana*), sitka alder (*Alnus sinuata*), Douglas maple (*Acer glabrum*), willow (*Salix* spp.), and red-osier dogwood (*Cornus stolonifera*), with a few young black cottonwood (*Populus trichocarpa*) as well (Figure 3). A diverse stand of conifer trees is present in the uplands, including western red cedar (*Thuja plicata*), grand fir (*Abies grandis*), Douglas-fir (*Pseudotsuga menziesii*), mountain hemlock (*Tsuga mertensiana*), Pacific silver fir (*Abies amabilis*), and ponderosa pine (*Pinus ponderosa*). Much of the valley bottom and adjacent uplands show signs of past logging, with older stumps in the understory.

Interpretation: The riparian vegetation communities immediately adjacent to the Brush Creek road crossing have been impacted by the beaver pond and past riparian logging. In addition, invasive, non-native, reed canary grass has become established in the beaver pond area. The riparian zone within the valley bottom is dominated by hardwoods, such as alder and Douglas maple, while the uplands have a maturing stand of conifers trees. The dense thicket of trees and shrubs help to stabilize the stream banks and maintain cool water temperatures. The conifer trees in the uplands are unlikely to contribute much large woody debris to the stream channel due to their significant distance from the stream channel.

Figure 2. Typical conditions along Brush Creek immediately above the 6306 Road crossing.

Interpretation: Riparian logging and water impoundment from a beaver dam have significantly altered the vegetation community around the road crossing site. The beaver dam at the inlet to the road crossing appears to be a significant design issue for the crossing structure.

Interpretation: The Choralmont and Chiwaukum soil types have a high volcanic ash content and along with the glacial sediments can be subject to erosion, particularly following disturbance or compaction. Erosion control measures, such as slash placement, hay bales, or silt fences, will be needed to prevent sediment generated during ground-disturbing activities from reaching surface waters.

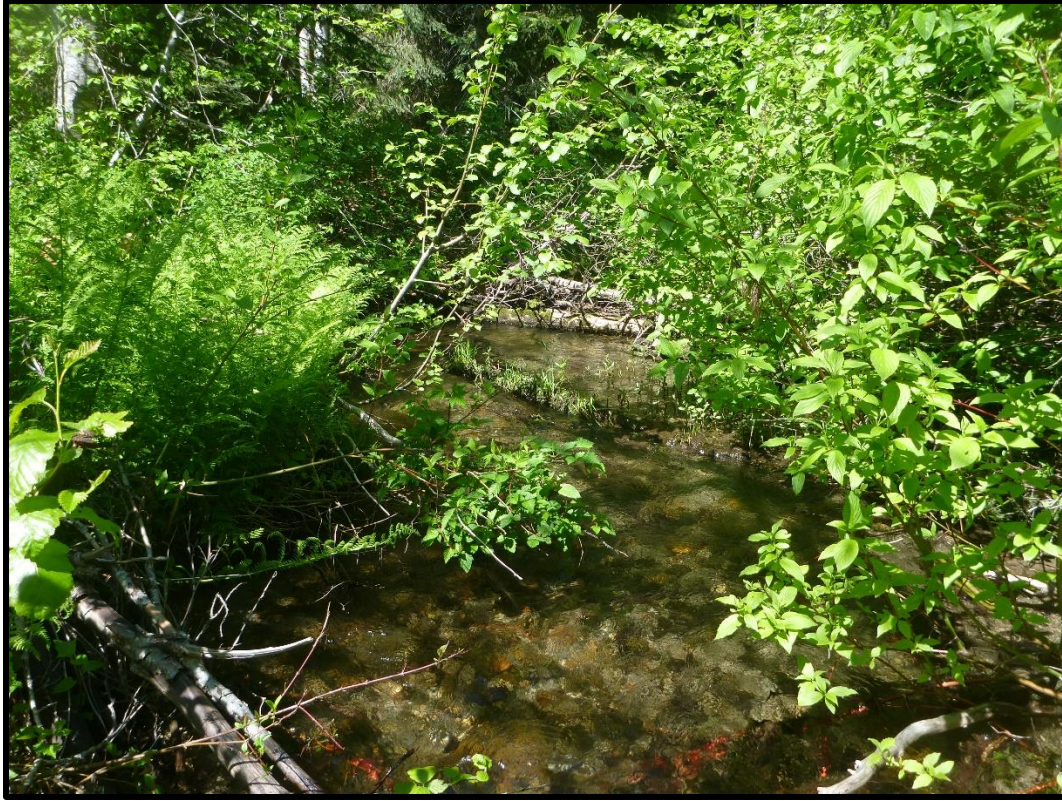
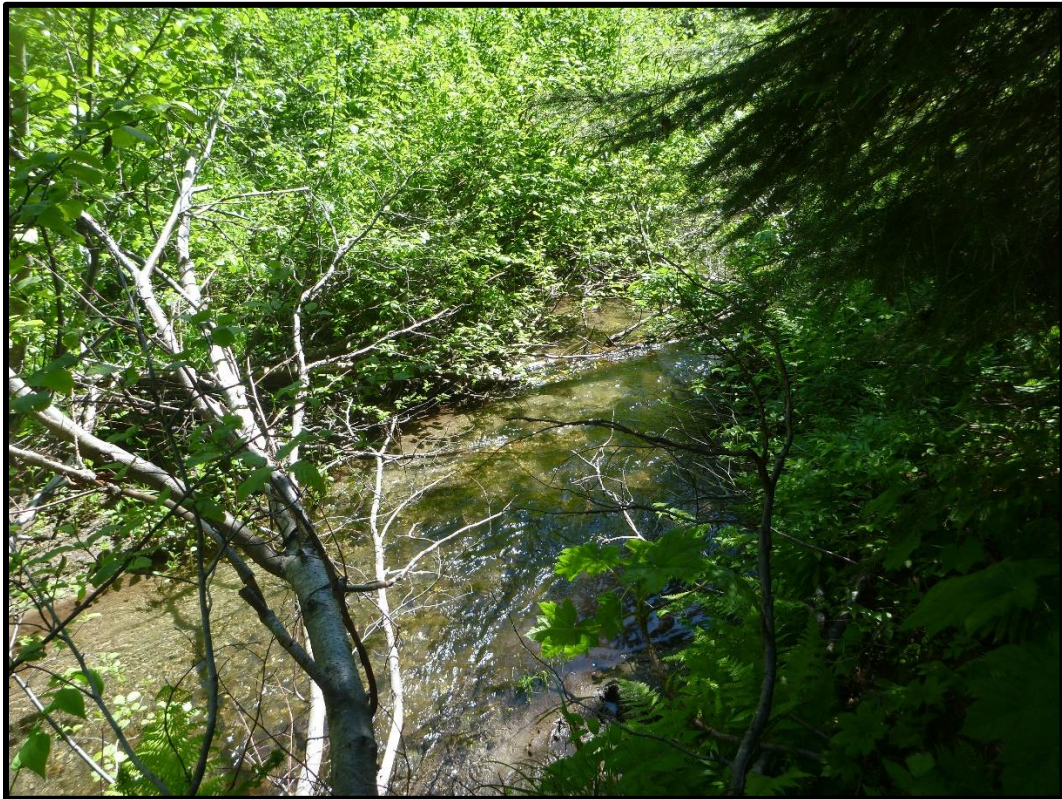
Figure 3. Typical conditions along Brush Creek above the influence of the beaver pond.

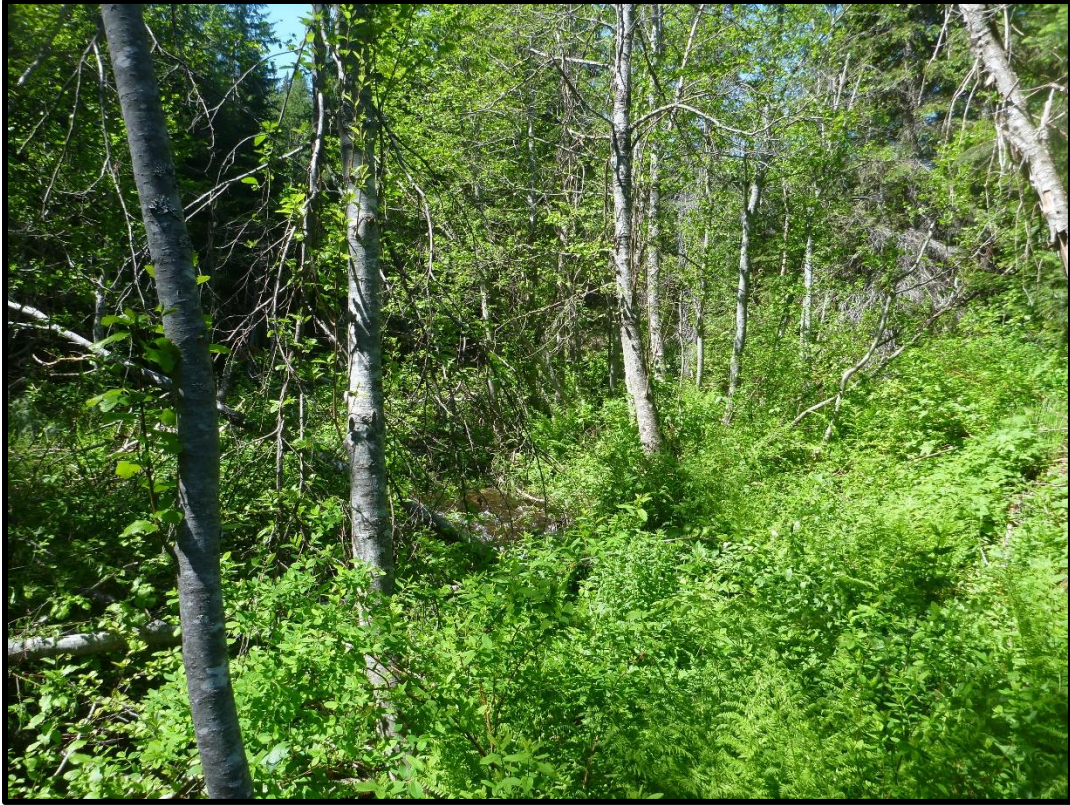
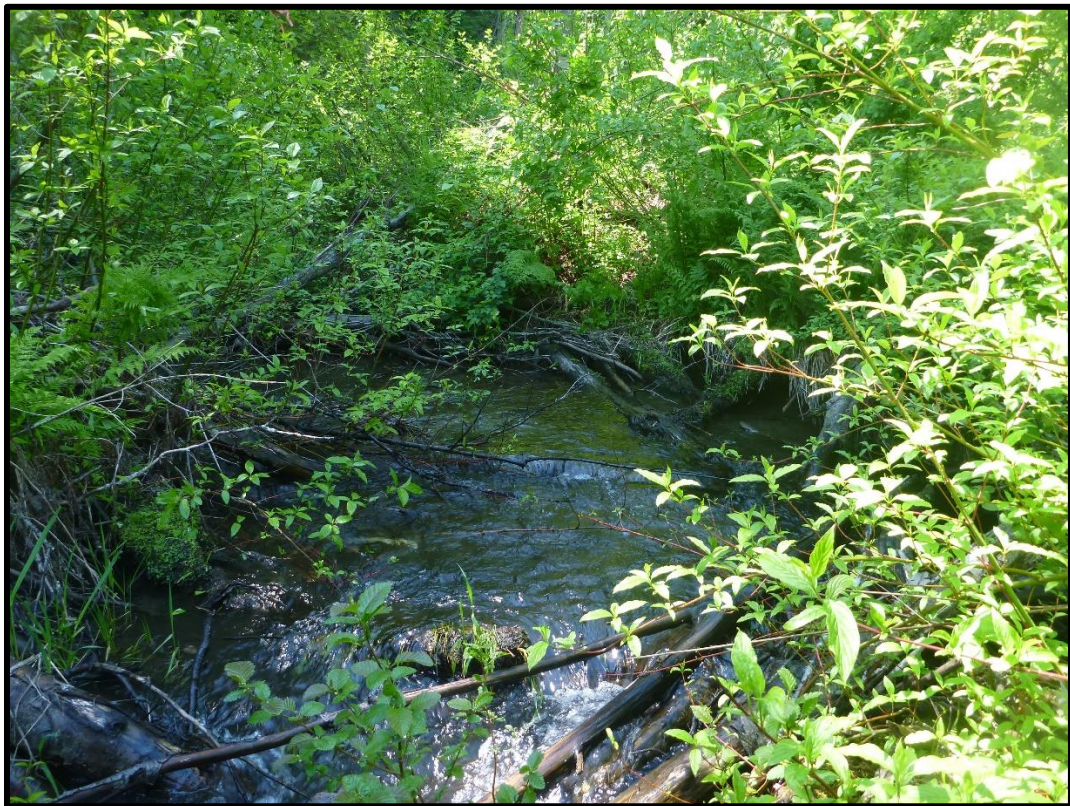
Figure 4. Typical conditions along Brush Creek below the 6306 Road crossing.

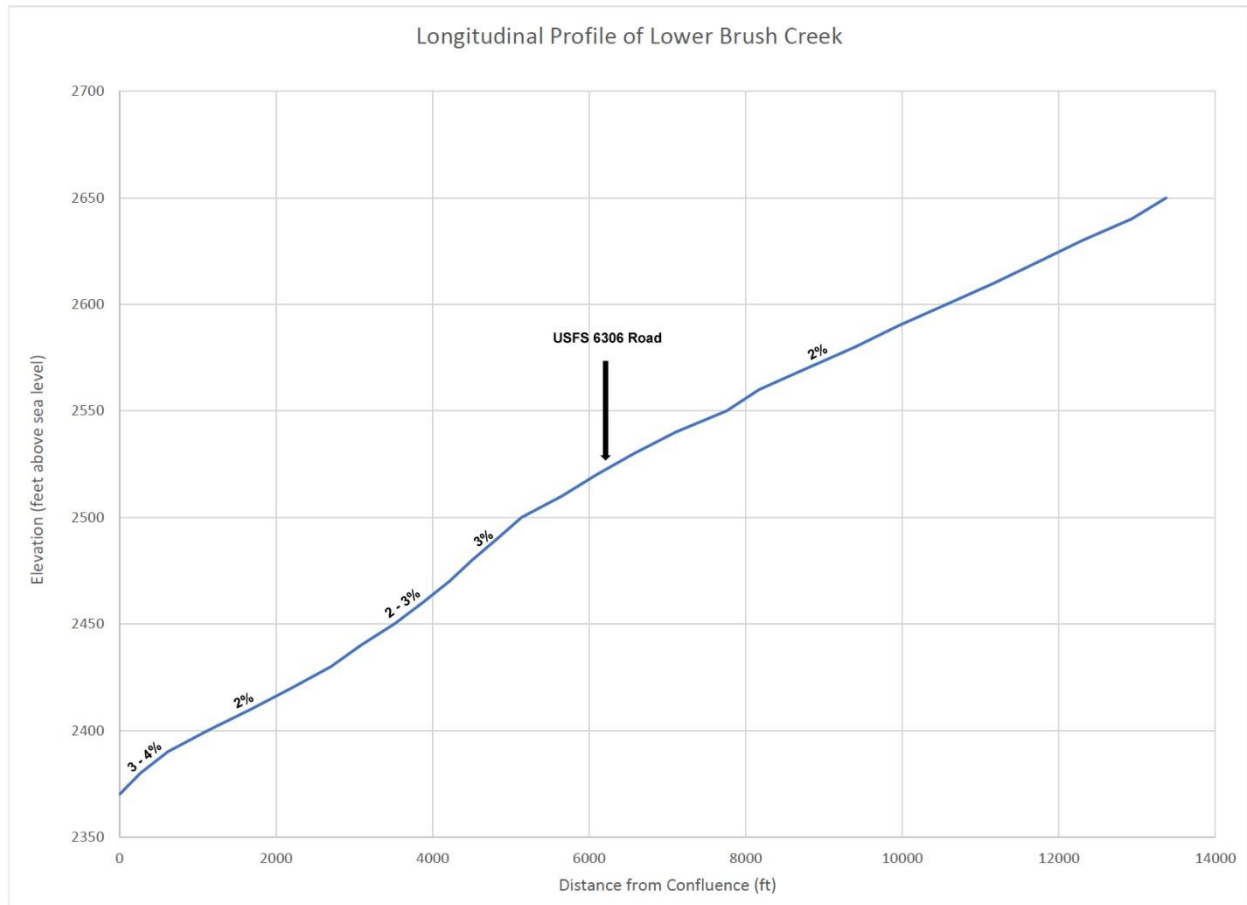
The stream channel above the USFS 6306 Road crossing is consistently around 2 percent gradient for more than 1.5 miles (Figure 5). The reach below the 6306 Road crossing generally ranges from 2 to 3 percent gradient, except for a reach of 4 percent gradient above its confluence with the Chiwawa River.

Figure 5. Longitudinal profile of lower Brush Creek above its confluence with the Chiwawa River.

Interpretation: The lower reach of Brush Creek at the road crossing is a C4/C5 Rosgen stream type that primarily has a plane-bed/forced pool-riffle channel form. Modest amounts of woody debris in the channel help to store sediment and create pools. The primary consideration for grade control will be the persistence of the beaver dam and potential changes in bed elevations and channel gradient once the beaver dam is breached and the stream begins to erode the accumulated deposits. Grade control measures may be needed at the 6306 Road crossing due to the large accumulation of sediment behind the beaver dam and the potential for future head-cutting of the stream channel and downstream sediment aggradation following culvert replacement.
