Appendix C
BEAVER CREEK CORRECTION ANALYSIS FORM

Project Name: **Beaver Creek Culvert Replacement**

Date: **March 31, 2021**

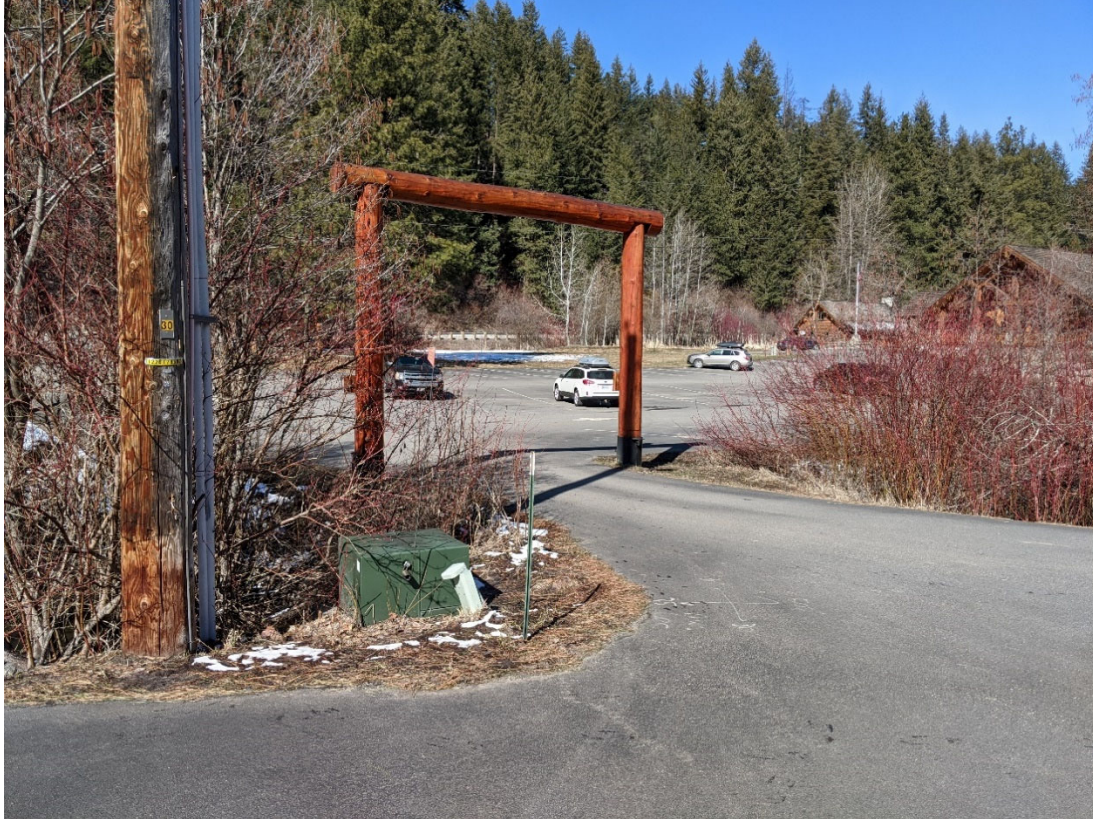
Road Description/Condition (mainline, spur road, driveway/access): **Private driveway (asphalt) connecting parking lot (west side) to access road for other buildings on the property (east side) which splits after crossing the creek. Road drops longitudinally approximately 3 ft across the existing culvert (see Photo 1).**

Photo 1. Looking west across existing culvert crossing.

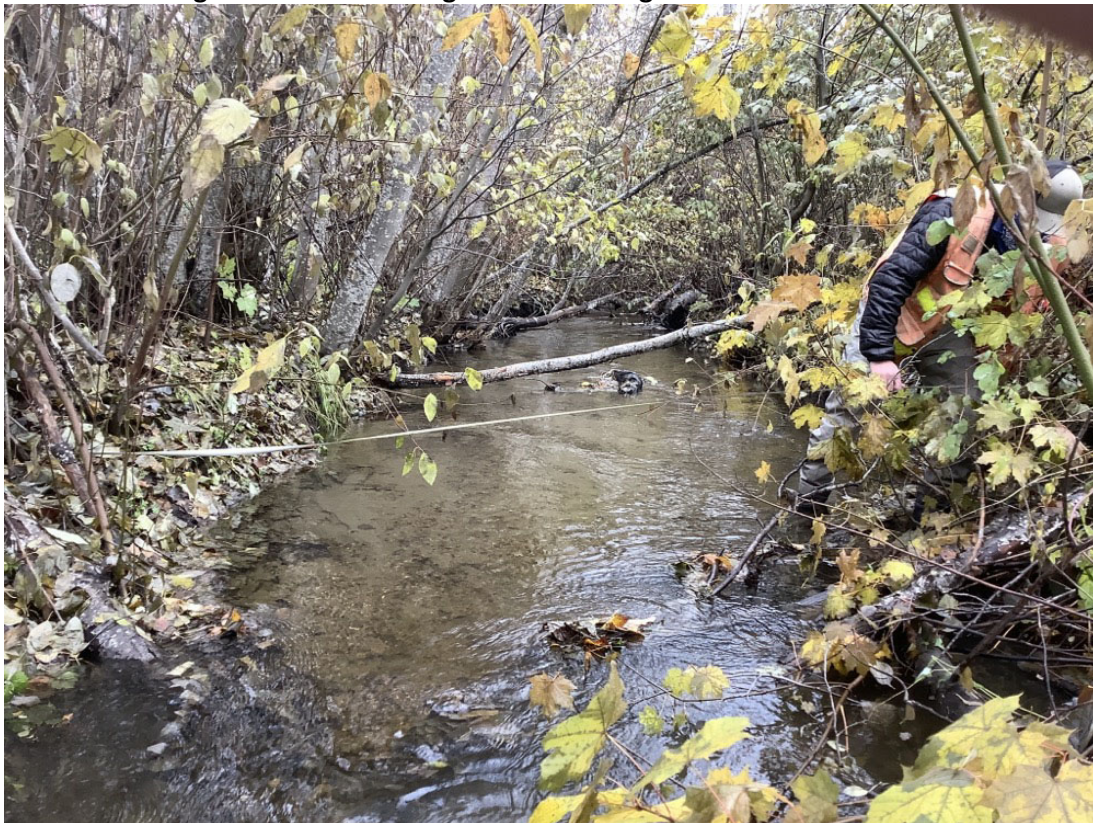
Photo 2. Steep, well-defined and vegetated banks typical of channel in project reach.

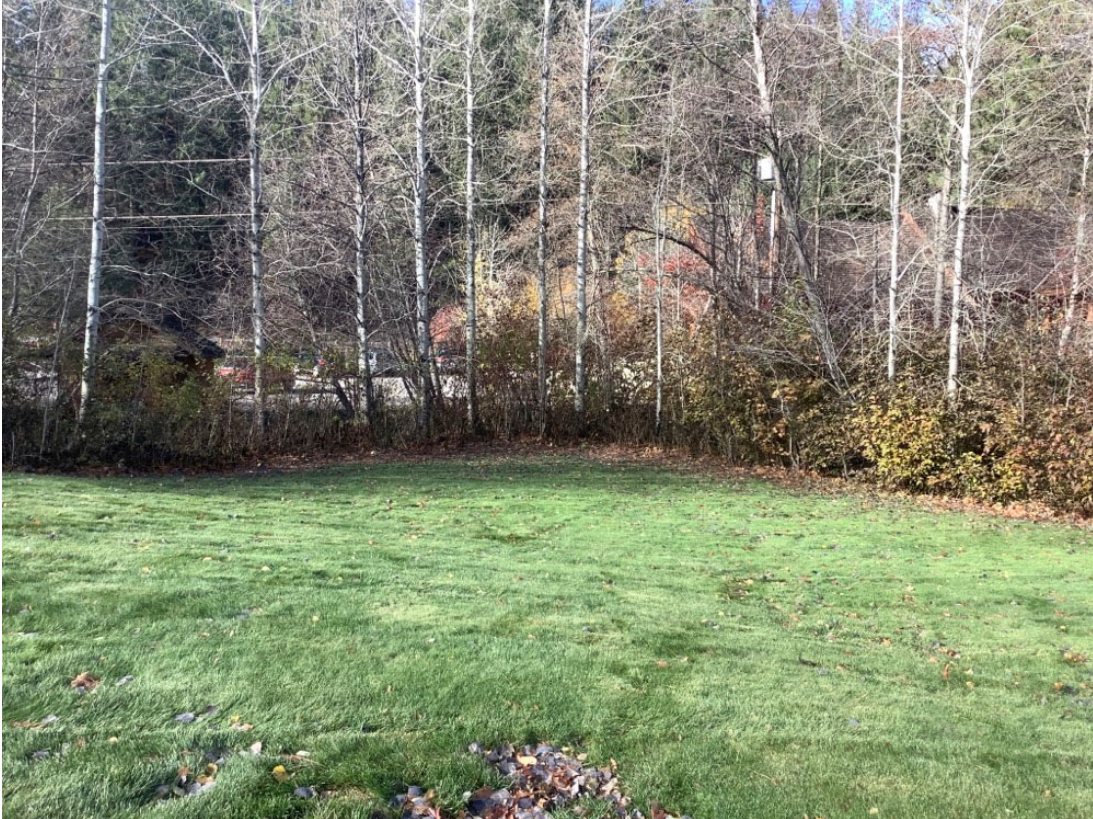
Photo 3. Narrow riparian corridor upstream of existing culvert.

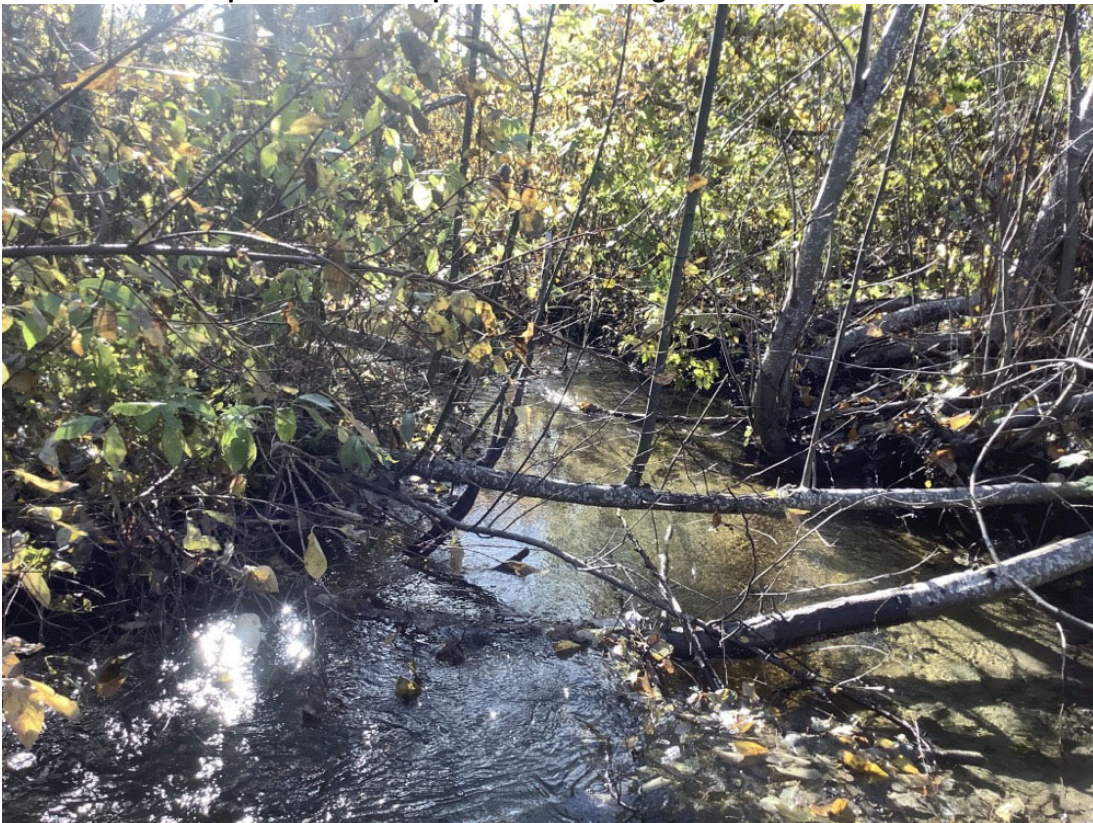
Photo 4. Small woody material present in channel upstream of culvert.

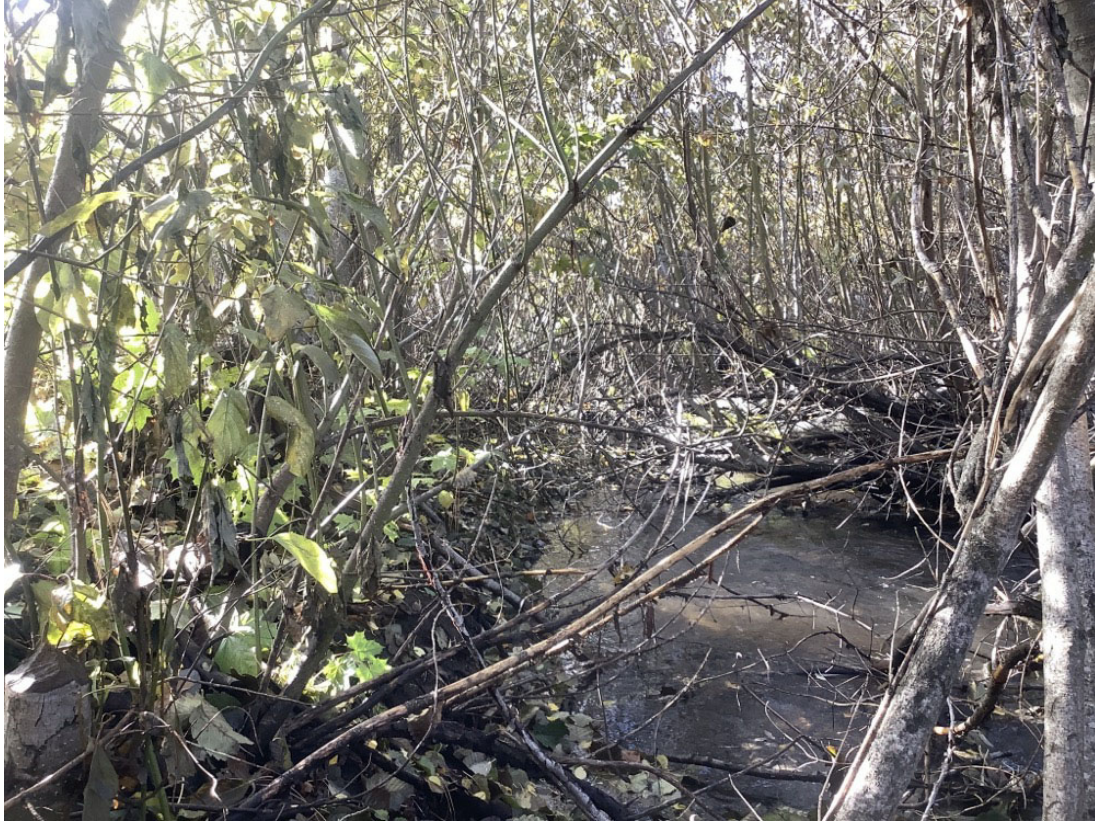
Additional Downstream Information, Habitat Description, Other Site Conditions or Concerns: **Downstream of the culvert, the channel is heavily vegetated with riparian shrubs and small trees (see photo 5). Channel geometry including width and bank heights are generally consistent with upstream channel geometry. Approximately 40 feet downstream of the existing culvert outlet the channel enters a wide meander, turning toward river right and then back toward river left over a length of approximately 3 bankfull widths. The meander downstream of the culvert has an active floodplain with an obvious high flow channel cutting across the floodplain bar near the left side of the ravine. Small woody material in the channel immediately downstream of the high flow channel inlet likely directs some portion of flow during regular high flows (1- to 2-year events) into the high flow channel (see photo 6). Slope and sediment composition downstream of the culvert are similar to conditions upstream of the culvert. The gradual slope extends downstream of the Chiwawa Loop Road crossing before gradient increases again for the lowest 0.2 RM of Beaver Creek upstream of the confluence with the Wenatchee River (see Figure 1).**

Photo 5. Riparian conditions downstream of existing culvert.

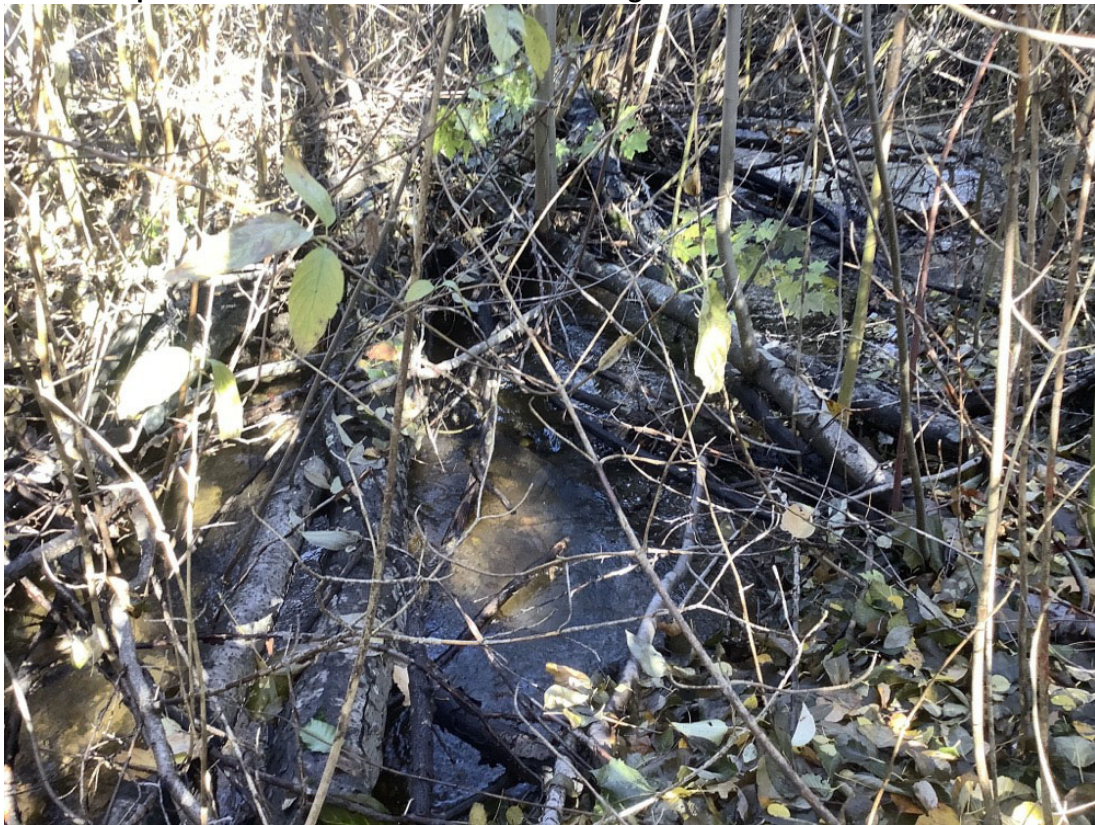
Photo 6. Small woody material downstream of existing culvert.

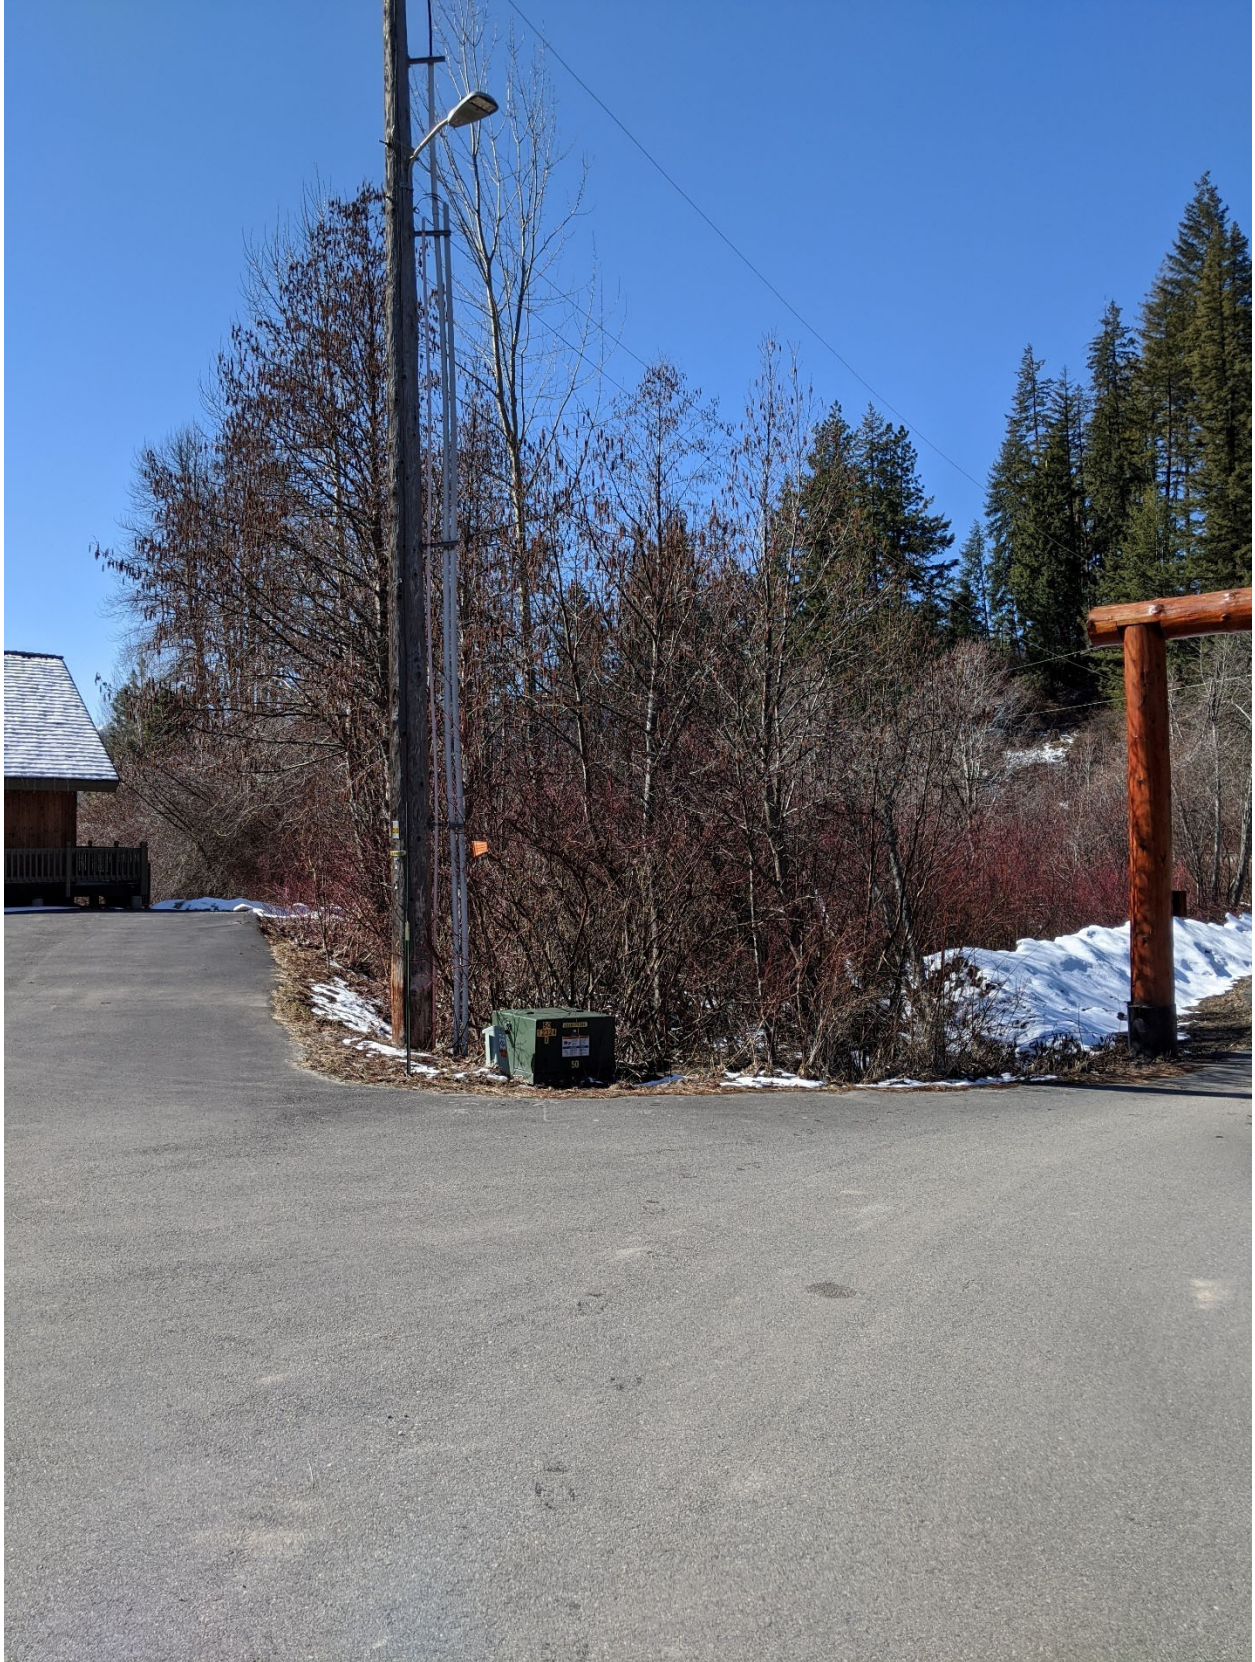
Downstream of the culvert several utilities are present which will require at least temporary relocation during construction. Several overhead utility lines cross the creek downstream of the existing culvert and tie into a nearby junction box before continuing in multiple directions underground. A utility locate conducted prior to site survey indicated that buried power and phone lines are present on the east side of the existing culvert; based on discussions with the landowner it is likely that a buried domestic water line and a buried phone line are present on the west side of the creek and cross toward the east at the existing culvert; neither buried line was identified on the utility locate. The landowner also suggested that a fiber line exists overhead, crossing the creek overhead before joining the nearby junction box and continuing underground in an unknown direction; the presence of the fiber line has not been confirmed. The utility pole and associated junction box (see photo 7) will at a minimum require temporary relocation to

accommodate construction; if the buried water and phone lines do in fact exist, the design will have to incorporate a means of allowing the utility lines to cross the creek.

Photo 7. Looking downstream at utility pole and associated junction box near the existing culvert.

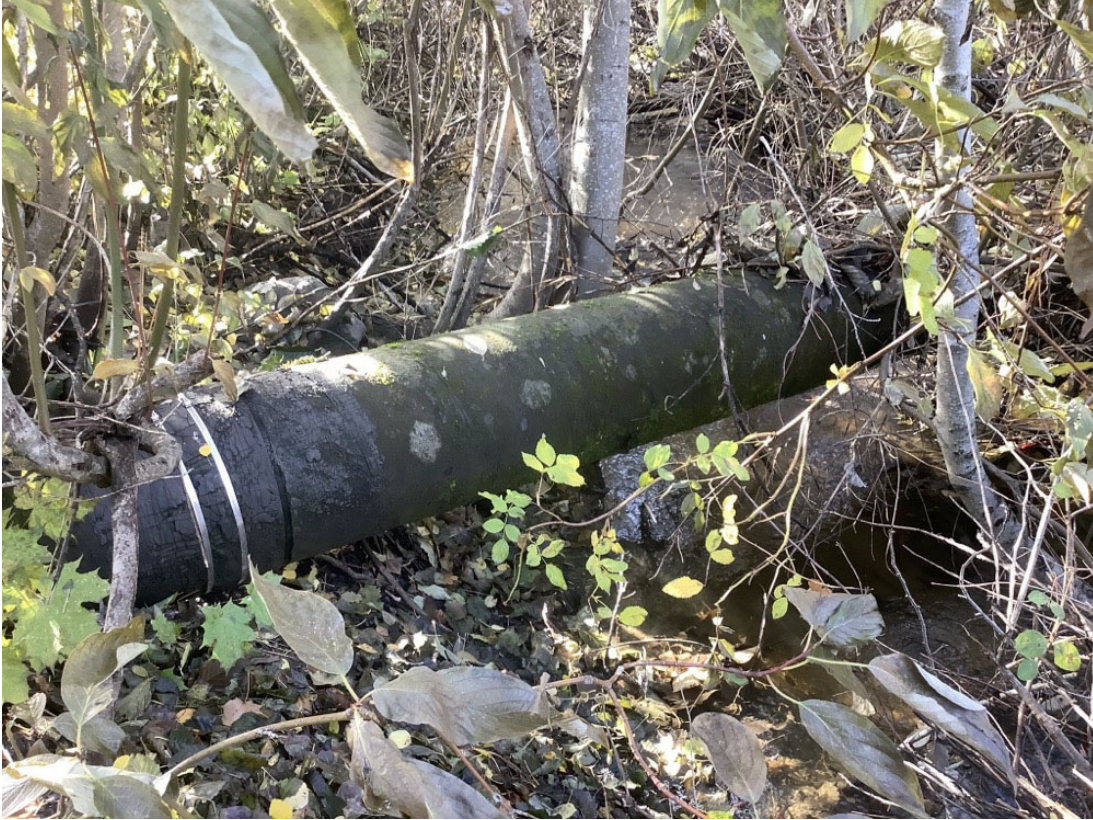
Approximately 8 ft downstream of the existing culvert outlet an 18" diameter irrigation pipe crosses the creek channel. The pipe crosses the channel above ground and is exposed to natural elements; a protective covering is included on the pipe through the exposed crossing. The irrigation pipe is owned and operated by the Wenatchee-Chiwawa Irrigation District (WCID). The pipe conveys irrigation water from west of the creek across the creek to the east side of the creek (see photo 8). This pipe will likely be within the limits of earthwork for the replacement structure; at a minimum, this pipe will require special care while conducting earthwork and at worst the pipe may require temporary removal and replacement during construction if work cannot be conducted with the pipe in its current location; if required this work will be coordinated with WCID.

Photo 8. Existing irrigation pipe which crosses Beaver Creek above channel downstream of existing culvert.
