MEMORANDUM

From: Mike Brunfelt, LG and Mike McAllister PE – Interfluve

Date: December 31, 2022

Re: Cub Creek 2 Fire: Chewuch River Watershed and Fish Habitat Impact Summary

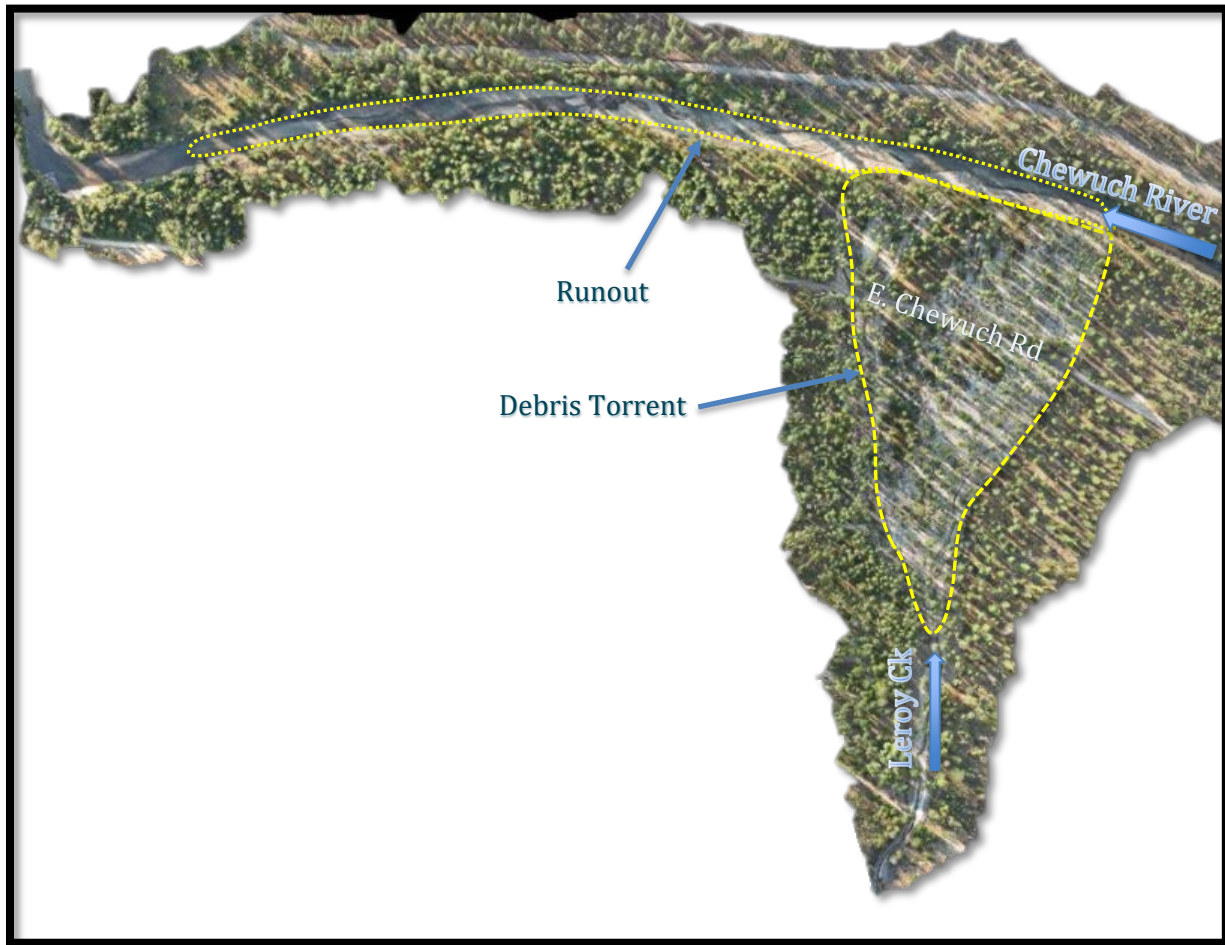
Following the fire and USFS post-fire analysis, debris torrent formation began to be observed in the watershed. Three debris torrents from steep tributary streams were observed in the summer of 2022. The timing and precipitation event that triggered them is unknown and their impacts to the Chewuch River were varied due to size and runout lengths. Two of the debris flows were relatively small. However, one debris torrent initiated in Leroy Creek was large enough to significantly impact the Chewuch River by depositing a large volume of fine sediment in the channel (Figures 3, 4 and 5). Indeed, the USFS post-burn analysis and USGS debris flow modeling predicted that Leroy Creek was high risk for debris flows, so 2022 debris flows events appear to be consistent with both general research on post-fire debris flow timing and USGS debris flow risk modeling.

Figure 3. Orthomosaic aerial photo showing the Leroy Creek debris torrent runout and sediment impacts to the Chewuch River. Drone flight completed October 2022.

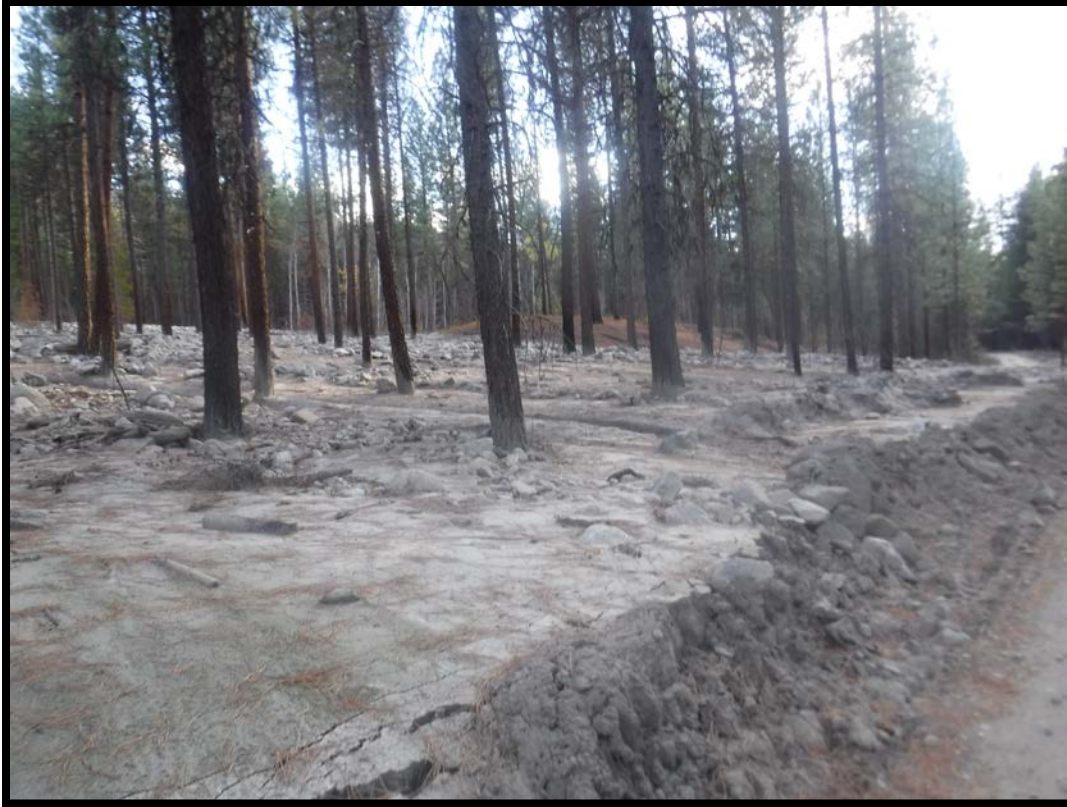
Figure 4. Leroy Creek debris flow runout taken along the East Chewuch Road.

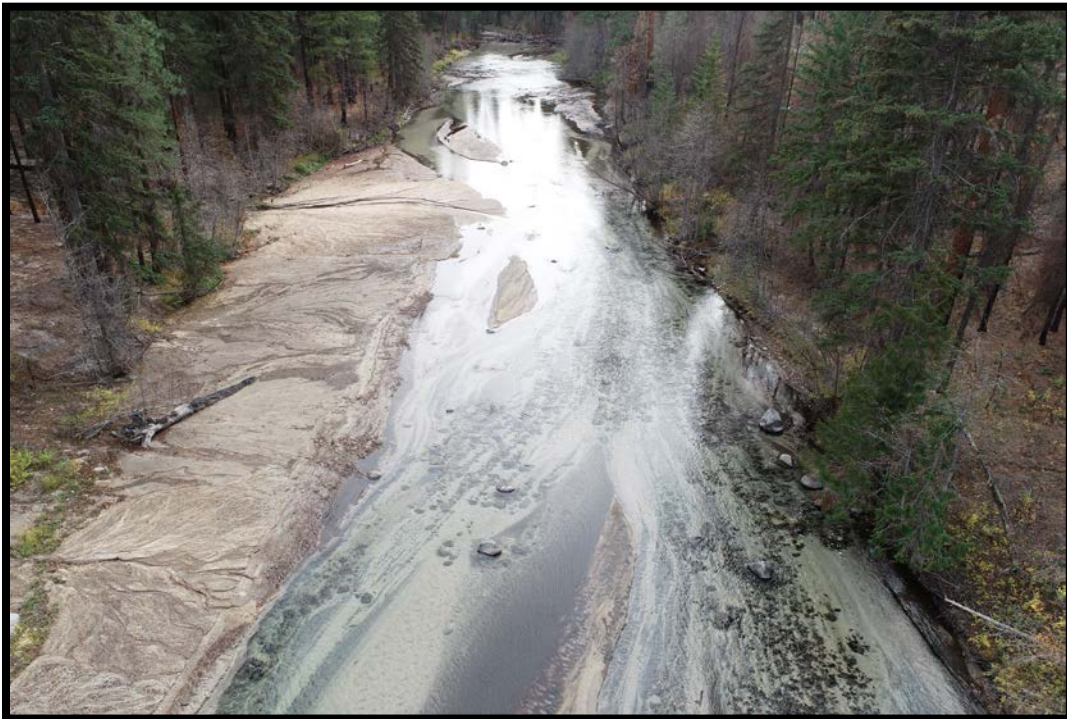
Figure 5. Elevated sediment load and Leroy Creek debris flow runout (left bank).

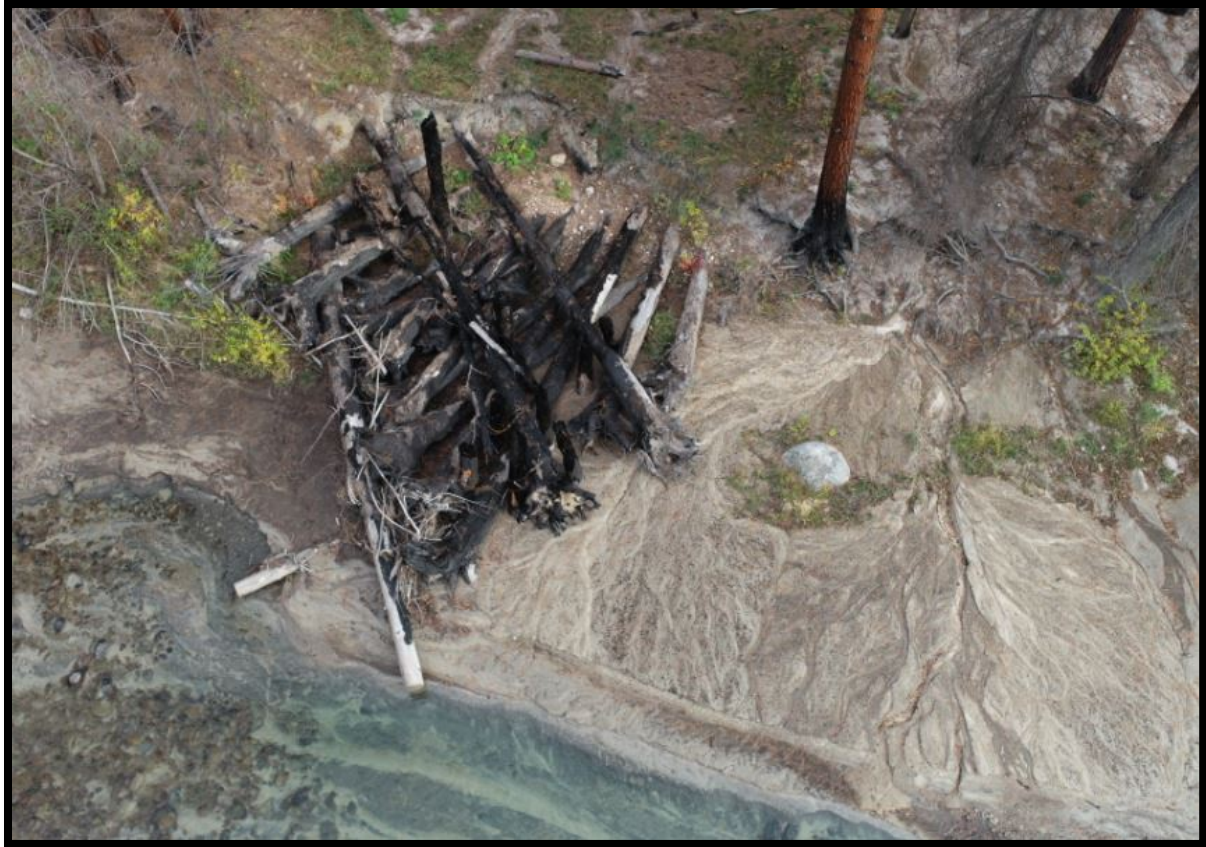
None of the structures was entirely consumed by fire and several structures retain the original habitat functions. However, all burned structures now have reduced stability due to compromised vertical piles and reduction in wood diameters. Most structures, though damaged, will continue to collect wood and provide habitat, but individual or groups of logs may become loose or broken during large flooding.

Although mainstem wood structures could be buried, it is likely that over time they will be naturally re-scoured as the burned areas recover and sediment loads return to pre-fire levels. Therefore, habitat loss due to mainstem channel filling and pool volume loss near large wood habitat may be temporary. To date, there has been only one example of a buried large wood structure near the Leroy debris torrent runout (Figure 6). However, other downstream project sites might experience similar impacts as sediment from existing and future debris torrents moves through the system.

Figure 6. Photo showing typical mainstem large wood structure burn and post fire burial from 2022 Leroy Creek debris flow.

Direct repair is an option for some of the direct and indirect effects of the Cub Creek 2 fire. As it relates to burned mainstem jams, additional wood loading could be completed with a helicopter to increase vertical ballast, stability and complexity. In all cases, burned wood structures could be made to equal or exceed stability and habitat function of their pre-fire condition.

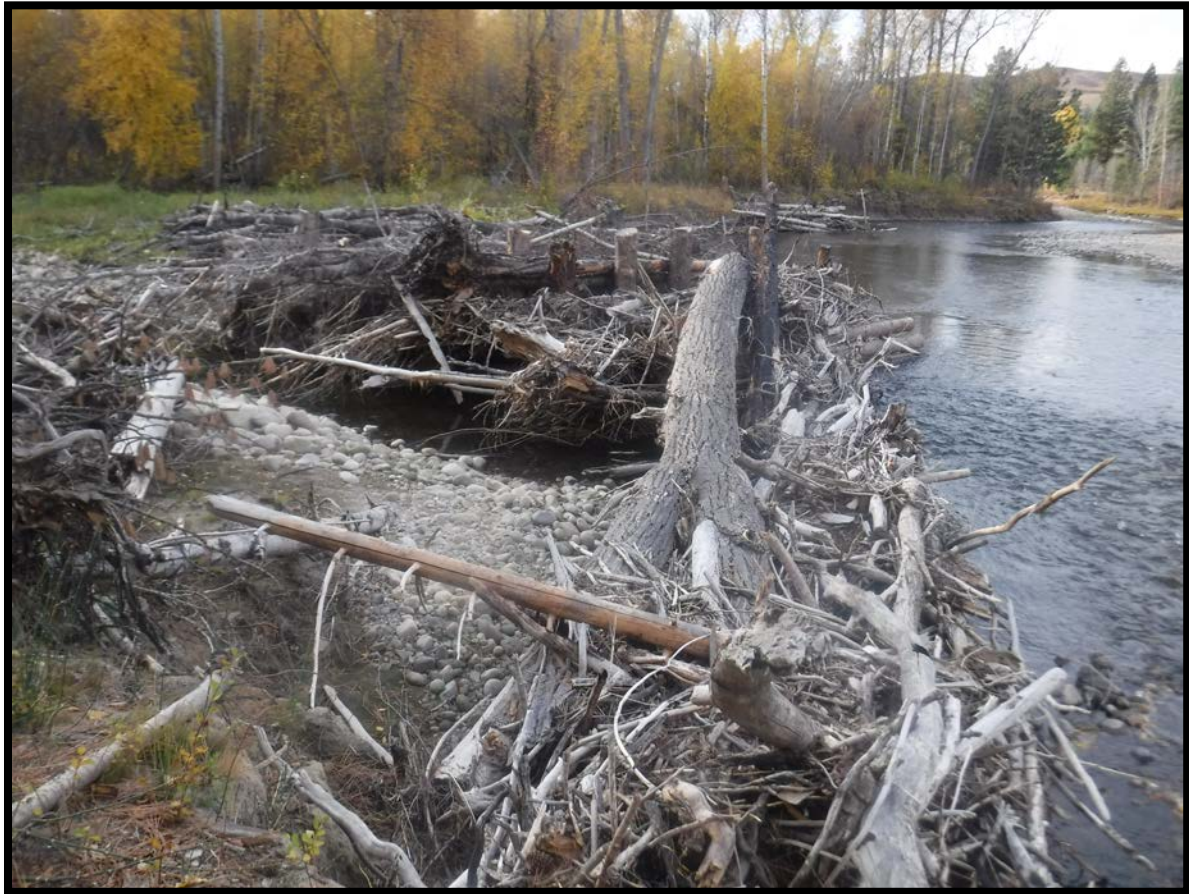
There has already been documented post-fire debris plugging a newly constructed side channel near RM 4.2 (Figure 7), which is far downstream of the burn area. In the future it is possible that debris and

sediment deposition will remain problematic until fine sediment load and debris returns to pre-fire levels.

Figure 7. Fire debris deposits within the 2021 Chewuch RM 4.2 project side channel inlet.

Side channel projects that become buried could be excavated using heavy equipment to maintain sediment transport in the side channels, until watershed sediment loads drop to pre-fire levels. Another way to meet the same objective would be to increase the large wood adjacent to created side channel projects at risk of filling. This method increases, mainstem roughness and complexity while also forcing more flows into side channels to increase sediment transport and habitat. This type of mitigation would lift habitat conditions to a level that is greater than the original projects by restoring large wood density in the mainstem while maintain side channel performance. On the Chewuch River there are two places where this could be done. The first is near RM 15 and the second is near RM 13. Both of these are pre-

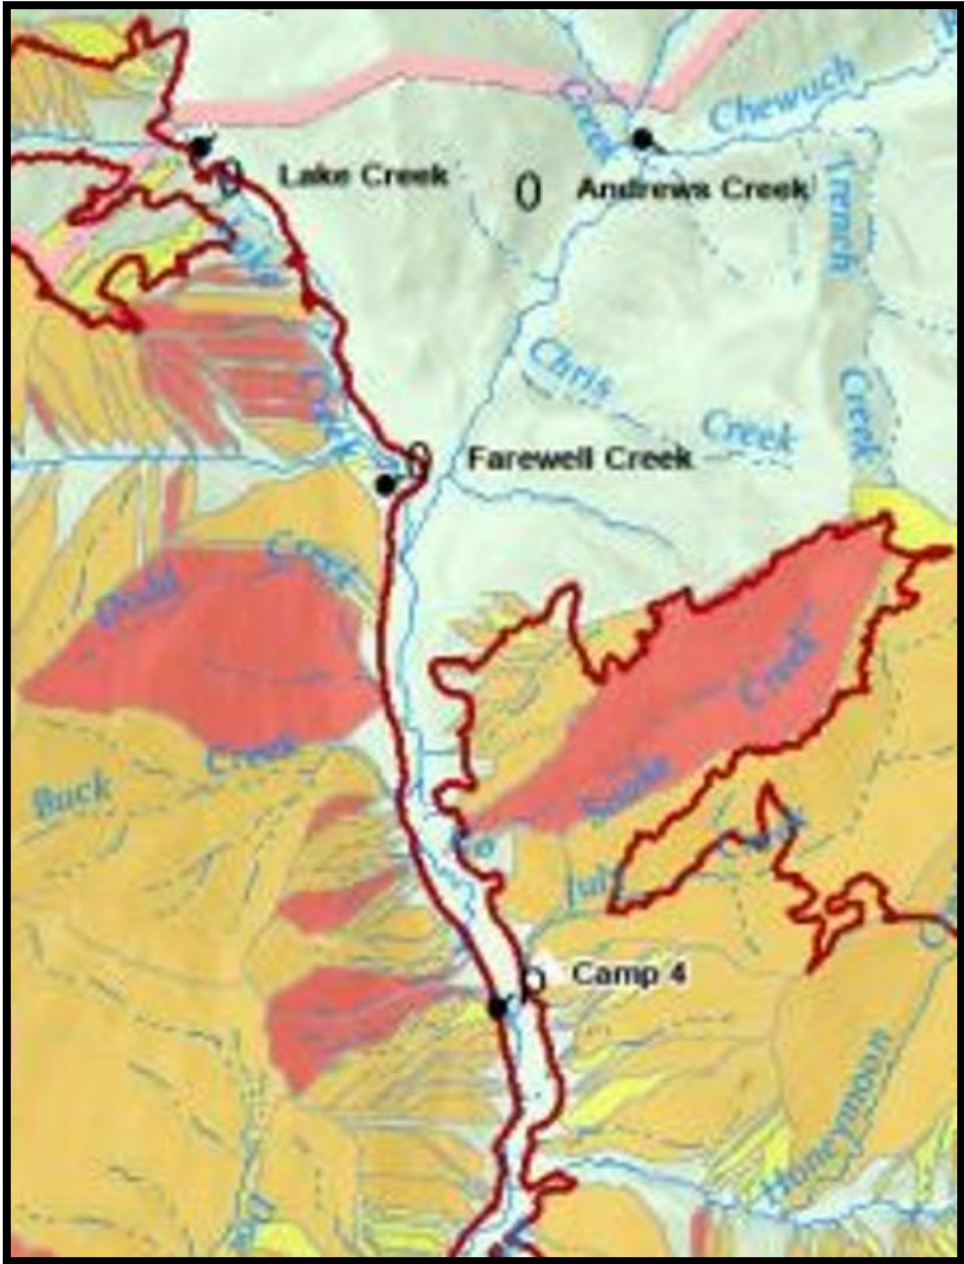
Due to proximity to recent severe burns, conceptual project areas that should be delayed due to potential debris torrent risk and elevated sediment loads are Chewuch River RM 19 – 23.5 (Lake Creek Confluence), Lake Creek, Twenty Mile Creek, and Boulder Creek. Several of these conceptual project areas could be re-evaluated for viability and implementation after 2023.

Conceptual project areas on the Chewuch River between RM 23.5 to 26 have no risk because they were upstream of the Cub Creek 2 burn and were unaffected by the fire or its aftereffects. Projects in these areas could be implemented at any time with no post-fire risk of debris torrent and elevated sediment load.

Figure 8. Post fire debris flow risk within Chewuch RM 19-26 conceptual project designs.

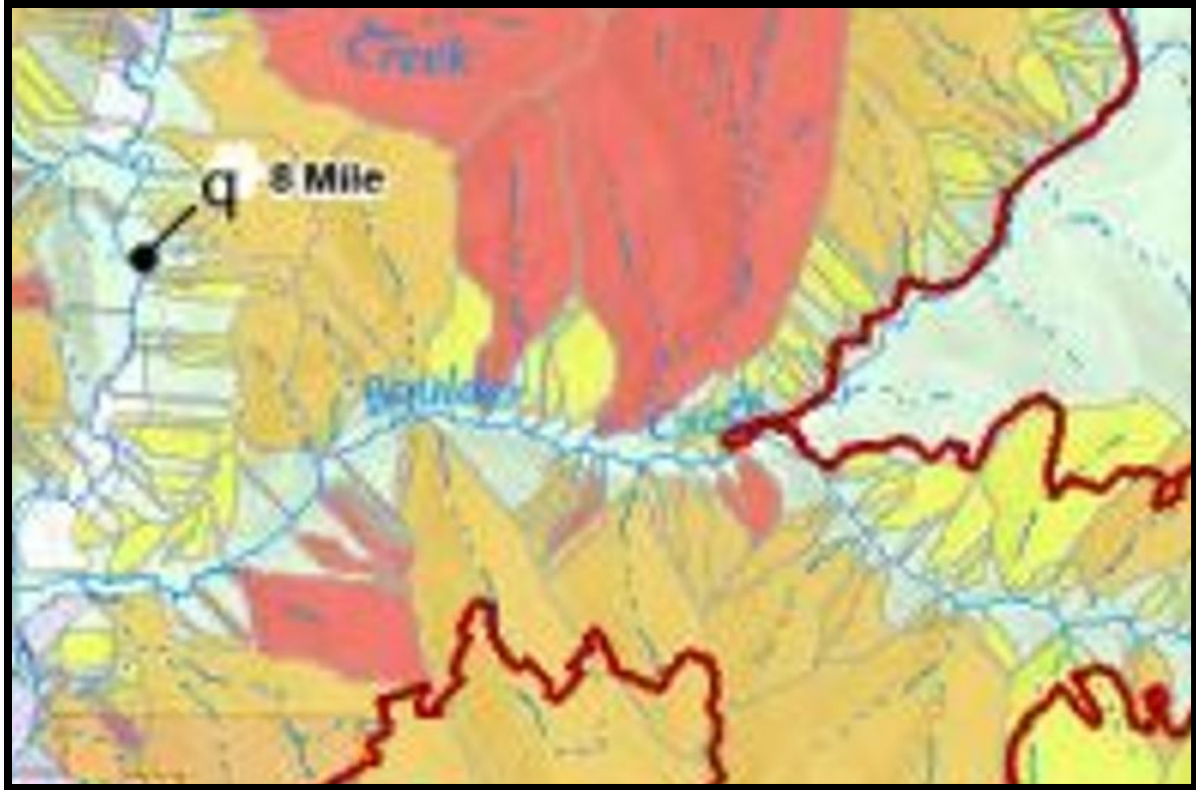
Figure 9. Debris flow risk in Boulder Creek that is included in the Chewuch 10-26 conceptual project designs.
