Lower & Middle Nason Creek Reach Assessment & Restoration Strategy Update *Final Report*

JANUARY 2026

PREPARED FOR
Yakama Nation Fisheries

PREPARED BY
Inter-Fluve

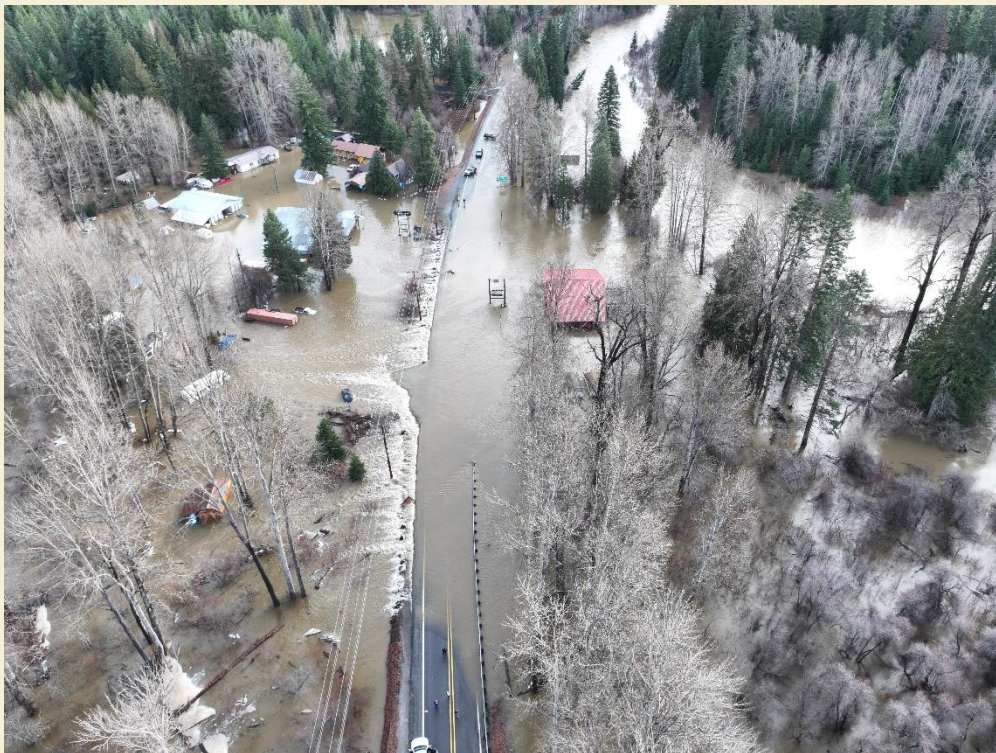
Figure 1. Flooding within the Nason Creek confluence area, view looking south, showing water over State Route 207. Note that this area is also influenced by flows in the Wenatchee River. Drone imagery from Yakama Nation, December 11, 2025.

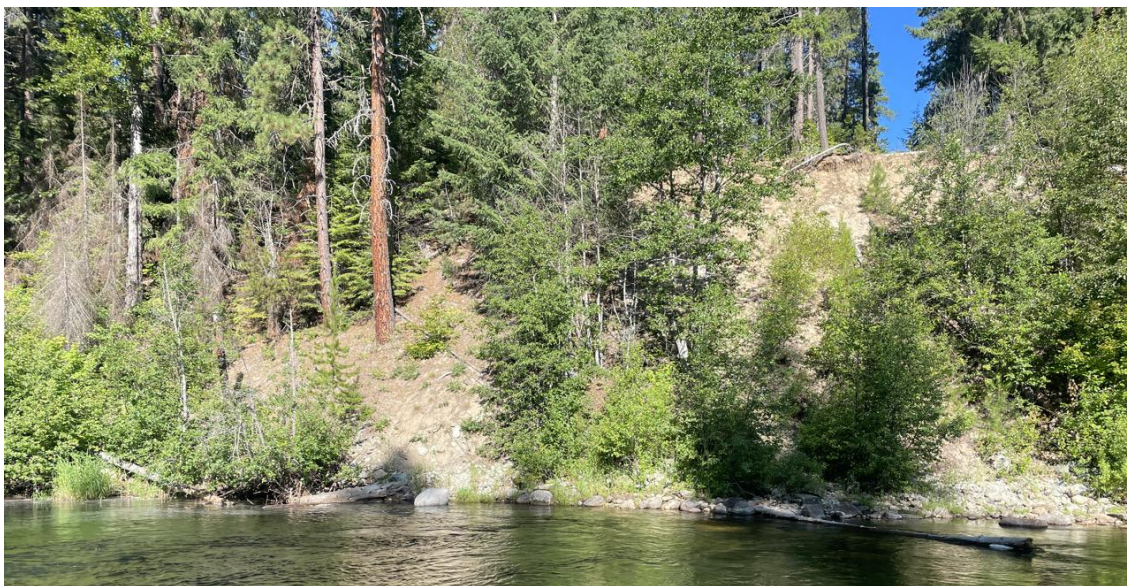
Figure 27. View toward river-left bank near RM 1.05 where material is being recruited from glacial deposits.

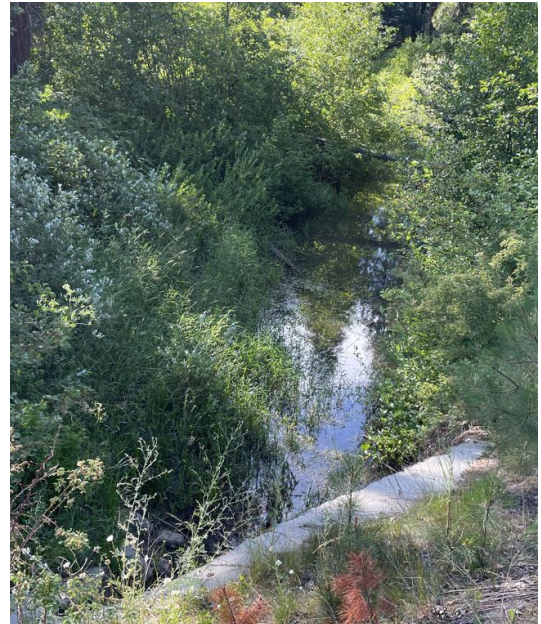
Figure 39. View toward the river from State Route 207 at the outlet of the reconnected channel near RM 1.15.

In 2009, the disconnected main channel segment in Reach 2 was reconnected as a side-channel with culverts placed under State Route 207 (Chelan County project). Culverts were placed at the upstream (RM 1.3) and downstream (RM 1.15) ends to provide fish passage. Survey of the culverts was not performed during the field survey although standing water was observed on both sides of both culverts, even though the side-channel did not have any discernable flow (Figure 39).

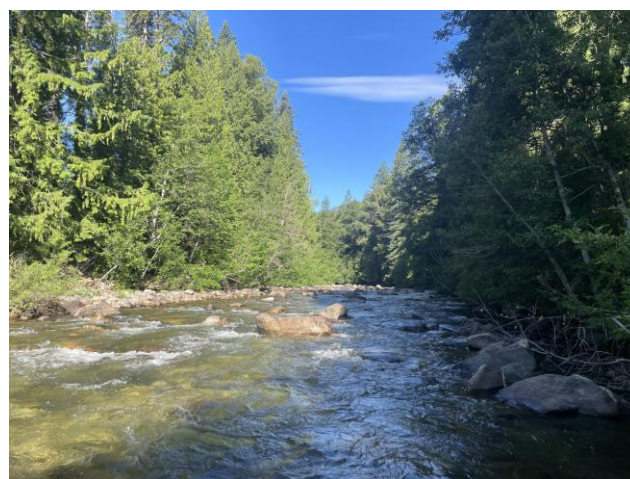
Figure 68. View downstream near RM 5.3 at steep uniform boulder-bed channel segment typical of this section of Reach 6 (Inter-Fluve photo July 2025).

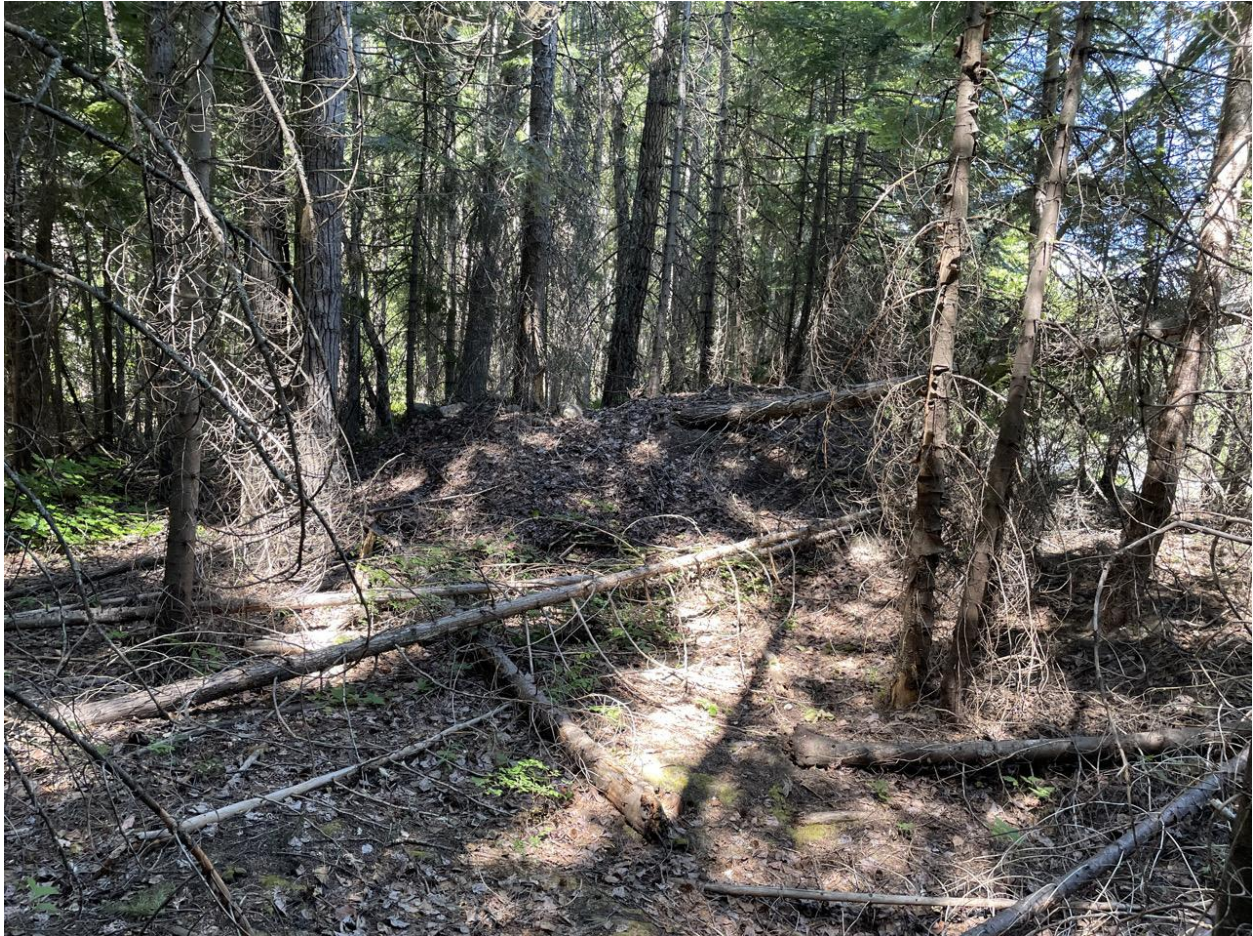
Figure 73. Floodplain fill mounds in river-right floodplain near RM 4.75.

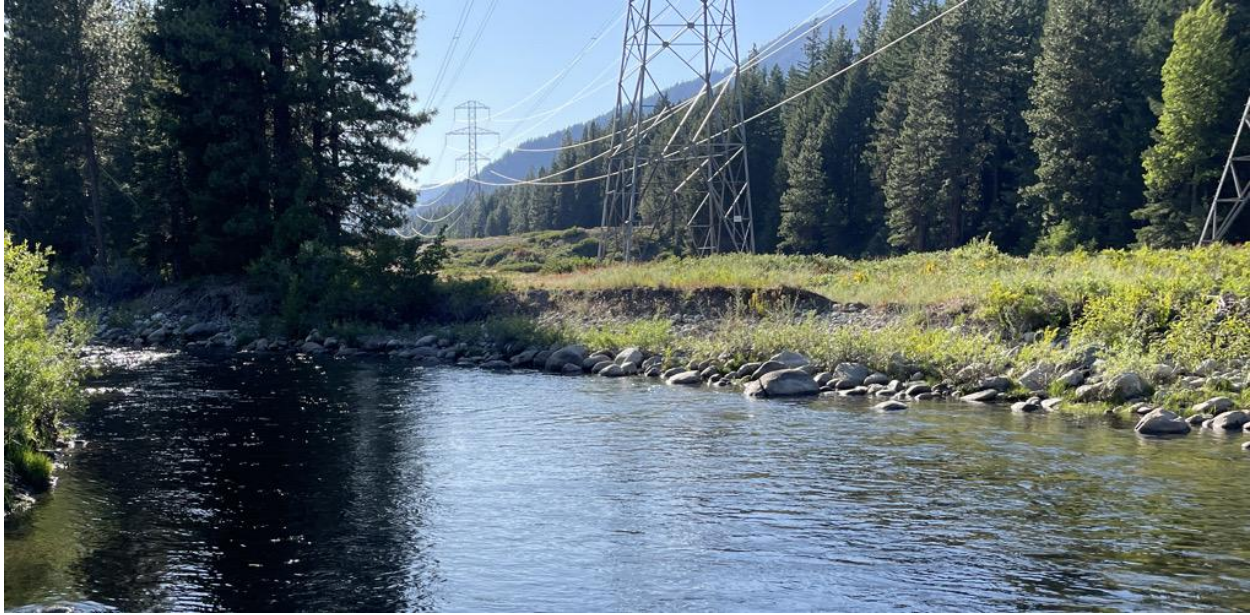
Figure 74. View upstream near RM 5.95 showing bank erosion on river-left bank.

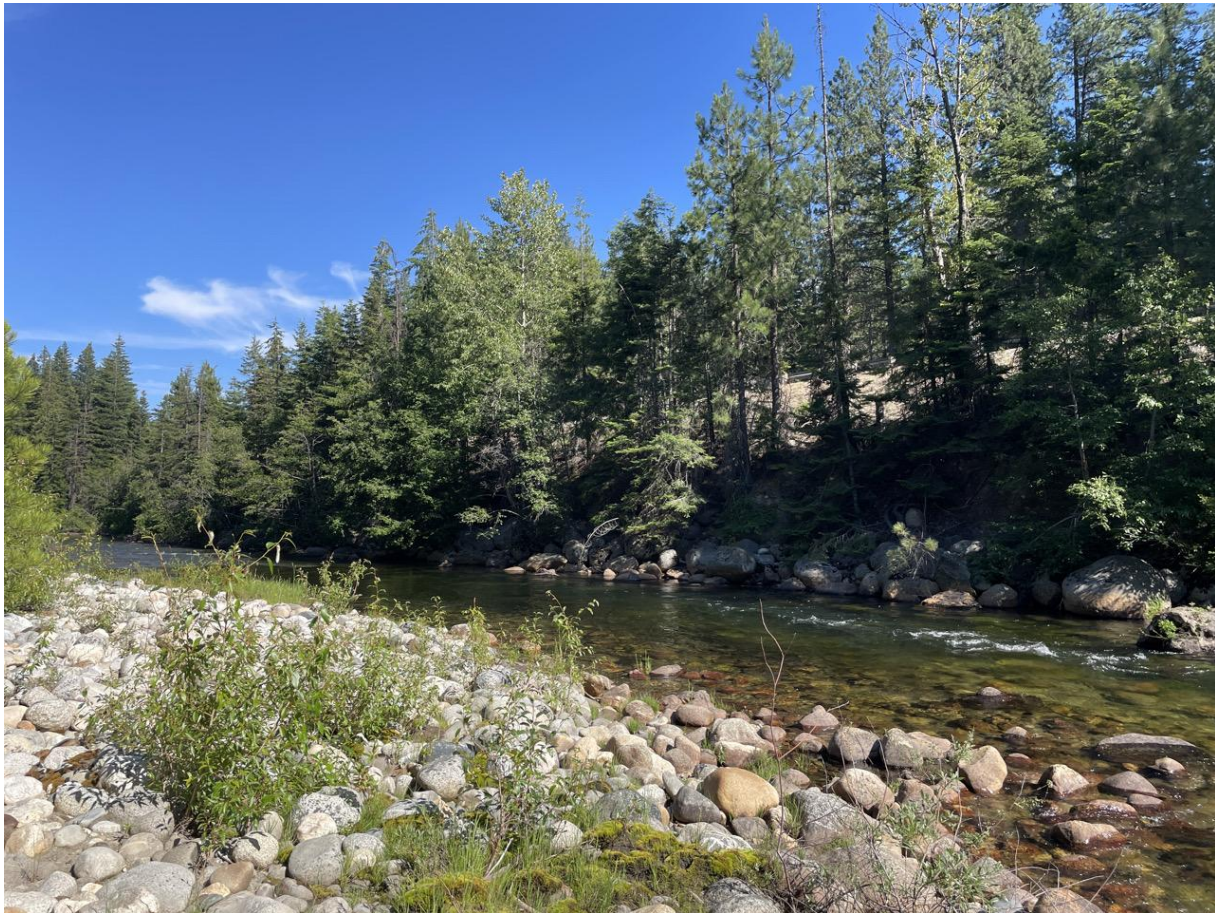
Figure 91. View downstream at riprap along the road fill on river-right near RM 6.9.

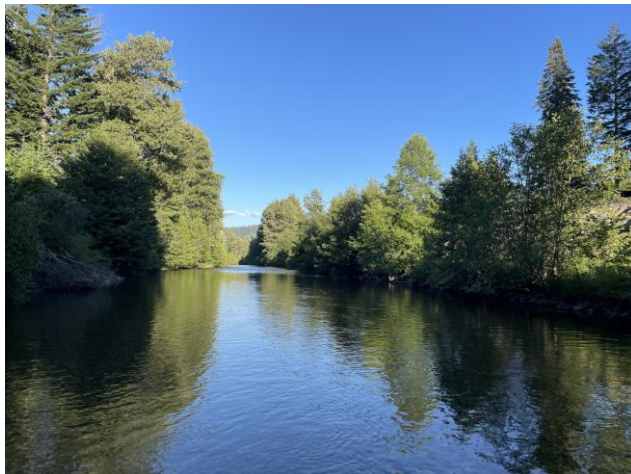
Figure 111. View downstream near RM 10.6 showing typical simplified conditions in straightened reach long railroad embankment (right side of photo) (Inter-Fluve photo June 2025).

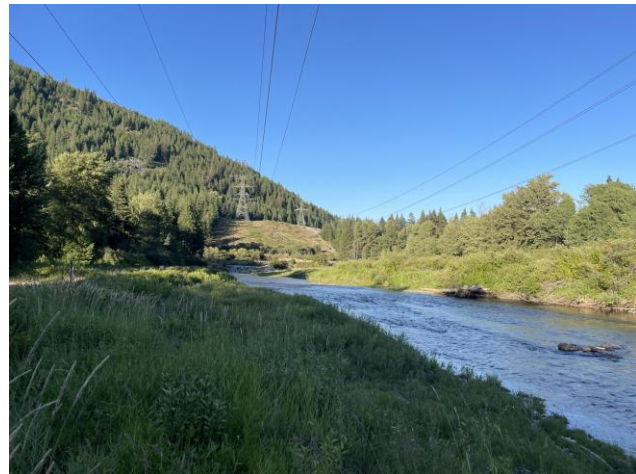
Figure 112. View downstream near RM 10.2 showing highly impacted channel and riparian conditions within the BPA powerline corridor (Inter-Fluve photo June 2025).

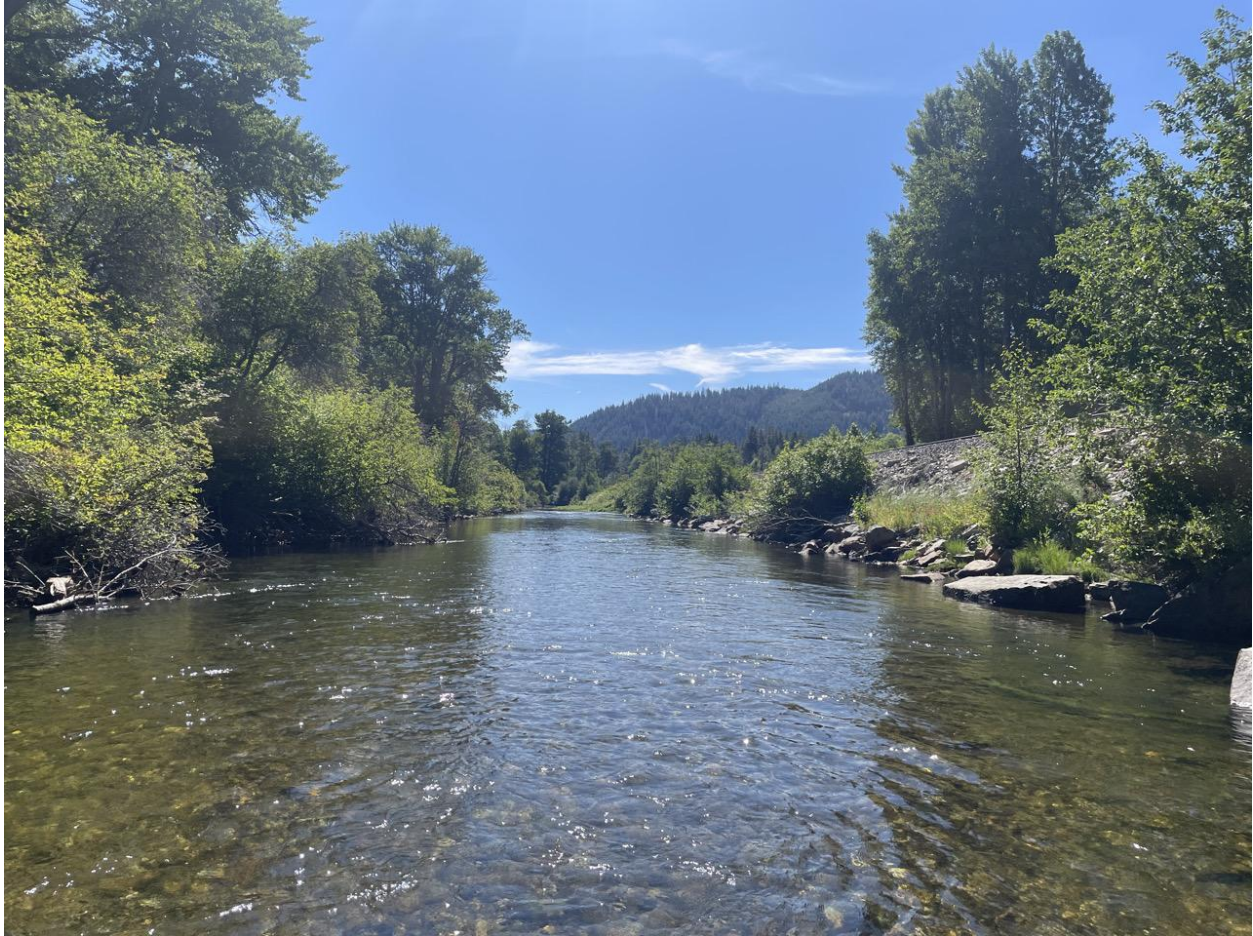
Figure 113. View downstream near RM 9.4 showing straightened section along railroad embankment (right side) (Inter-Fluve photo July 2025).

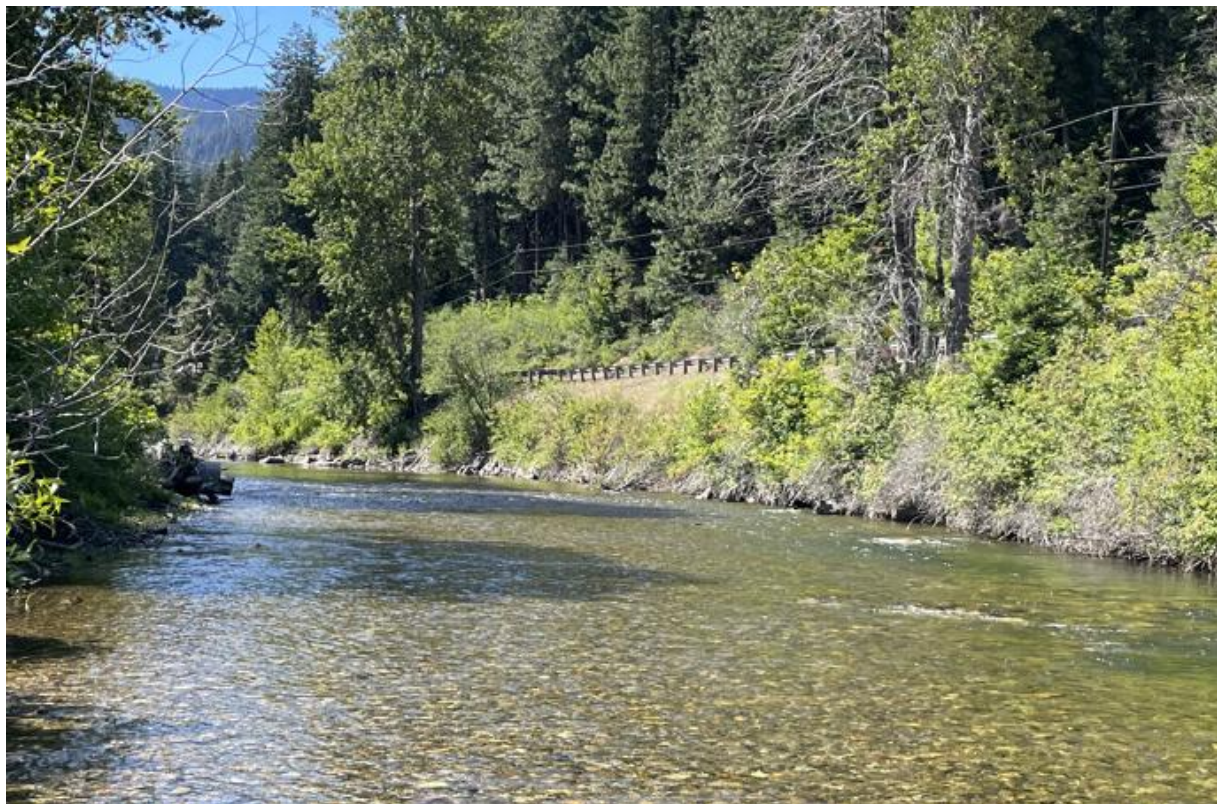
Figure 148. View upstream near RM 12 .1 showing nearly non-existent riparian buffer along Highway 2.
