NASON CREEK HABITAT ASSESSMENT
From the Bend at RM 4.6 to the Railroad Bridge Crossing at RM 14.2

Survey Dates:
September 17 to 19, 2007 AND September 24 and 25, 2007

Prepared by Dave Hopkins and Cameron Thomas
Okanogan-Wenatchee National Forest
October 15, 2007

NASON CREEK HABITAT SURVEY REPORT
RM 4.6 to RM 14.2
September 2007

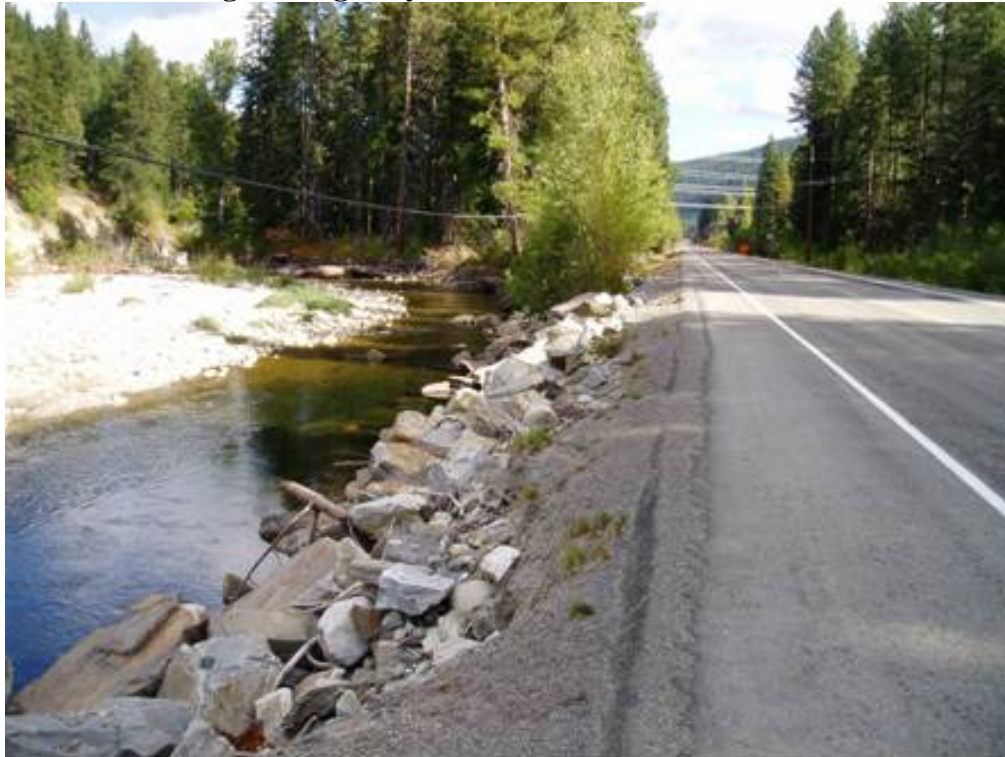
Nason Creek alongside Highway 2 in Reach 1

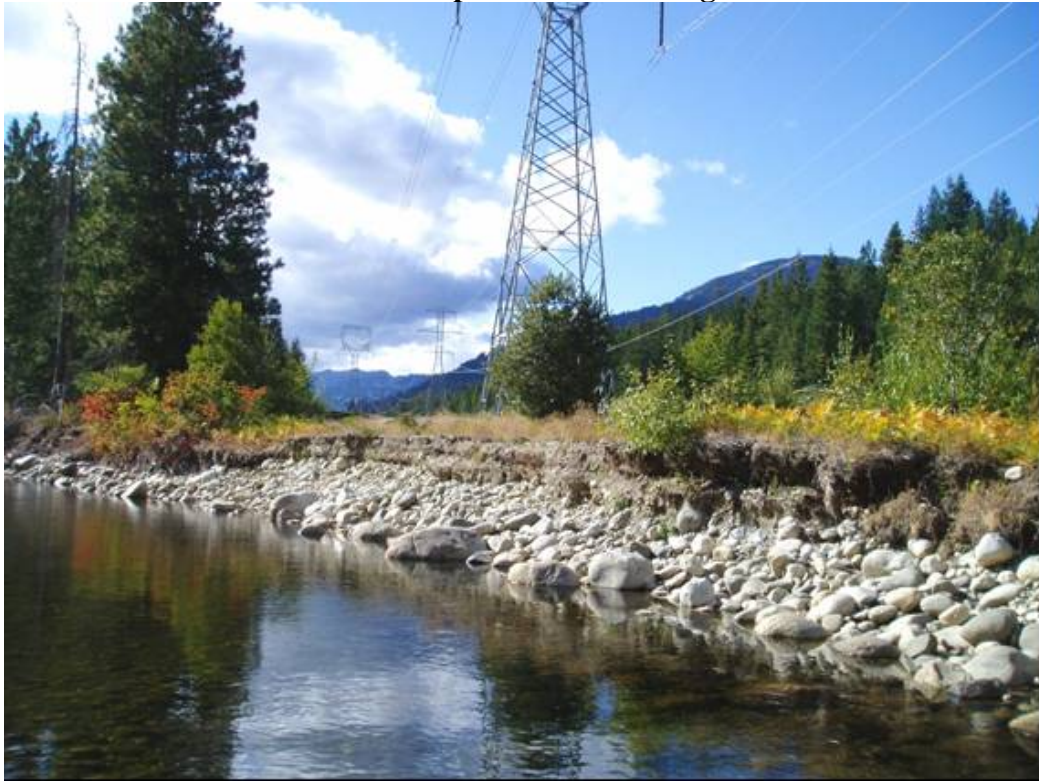
●**Bank Erosion:** About 7% of the banks are actively eroding in the reach. While about half of the erosion appears to be naturally occurring, the remaining erosion is caused by the removal of vegetation for the construction/maintenance of power line corridors, private property development (home construction, and from the constriction of the channel due to the road.

Bank erosion from power line crossing at RM 6.2

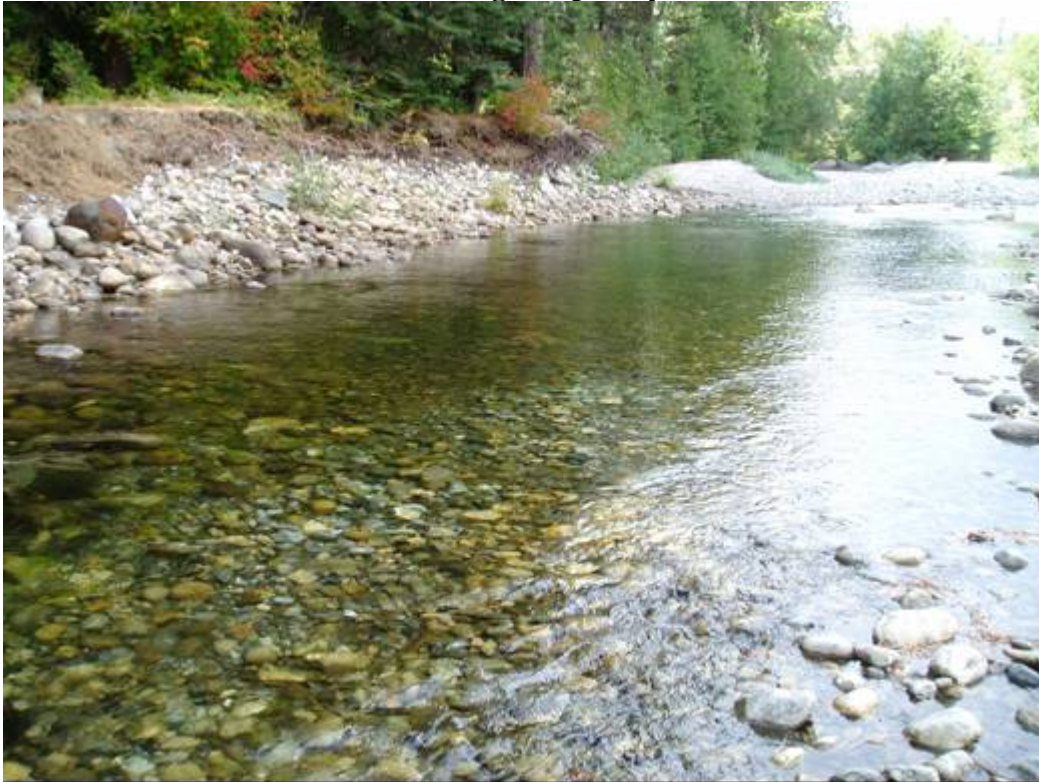
●**Pool Habitat:** The number of pools per mile is low, with about eight pools per mile counted in the reach. Although some deep pool habitat exists in the reach, pools generally do not have cover and lack complexity. A total of nine pools greater than five feet deep were observed in the reach (two per mile). The number of five foot deep pools per mile is less than half of the deep pools observed above RM 9.4, due mainly to the lower amount of wood in the channel below RM 9.4.

Pool habitat lacking complexity in Reach 1

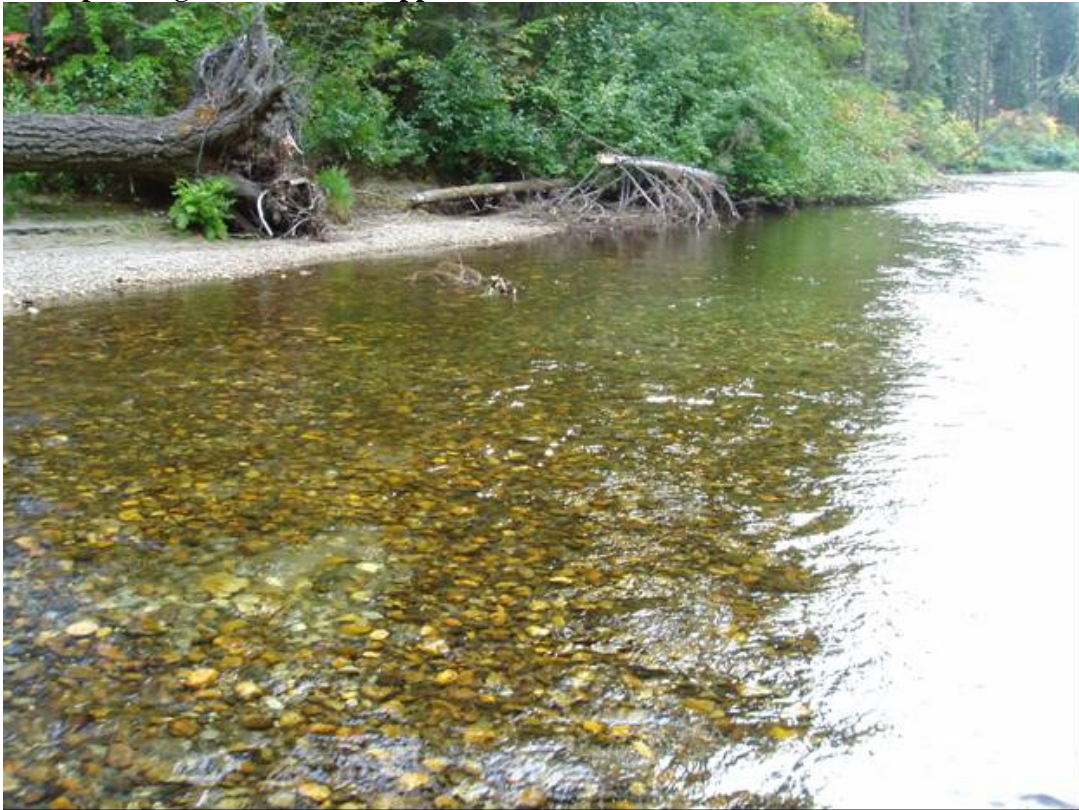
●**Fish Spawning Habitat:** Excellent fish spawning habitat is found in the gravel-dominated upper half of this reach. A total of 12 spring Chinook salmon redds were observed in the reach, all in the upper half of the reach. The redds were located above a bedrock constriction in the middle of the reach. Upwelling in the area of the bedrock may make this area attractive to spawning salmon. The 21.6 redds per mile was by far the highest number of redds per mile in the surveyed segment of Nason Creek. Pools greater than 450' long and about 4.5' deep are found at the upper and lower end of the spawning area.

Spawning Habitat in the Upper Half of Reach 2

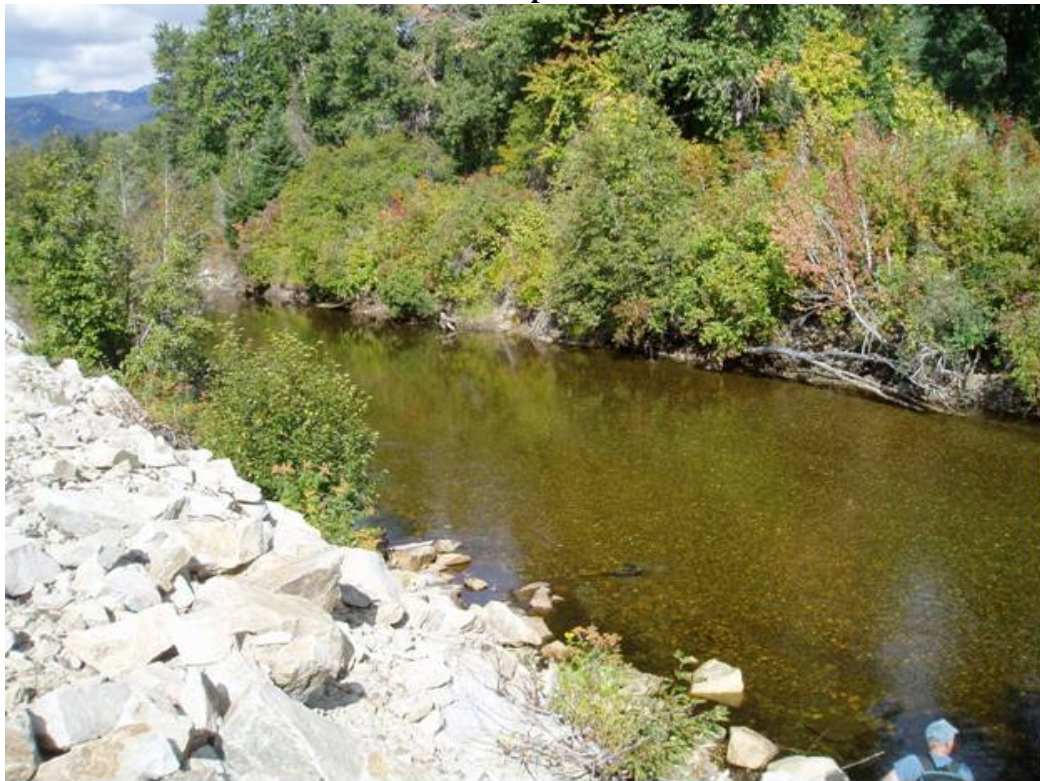
Nason Creek from top of Railroad Grade

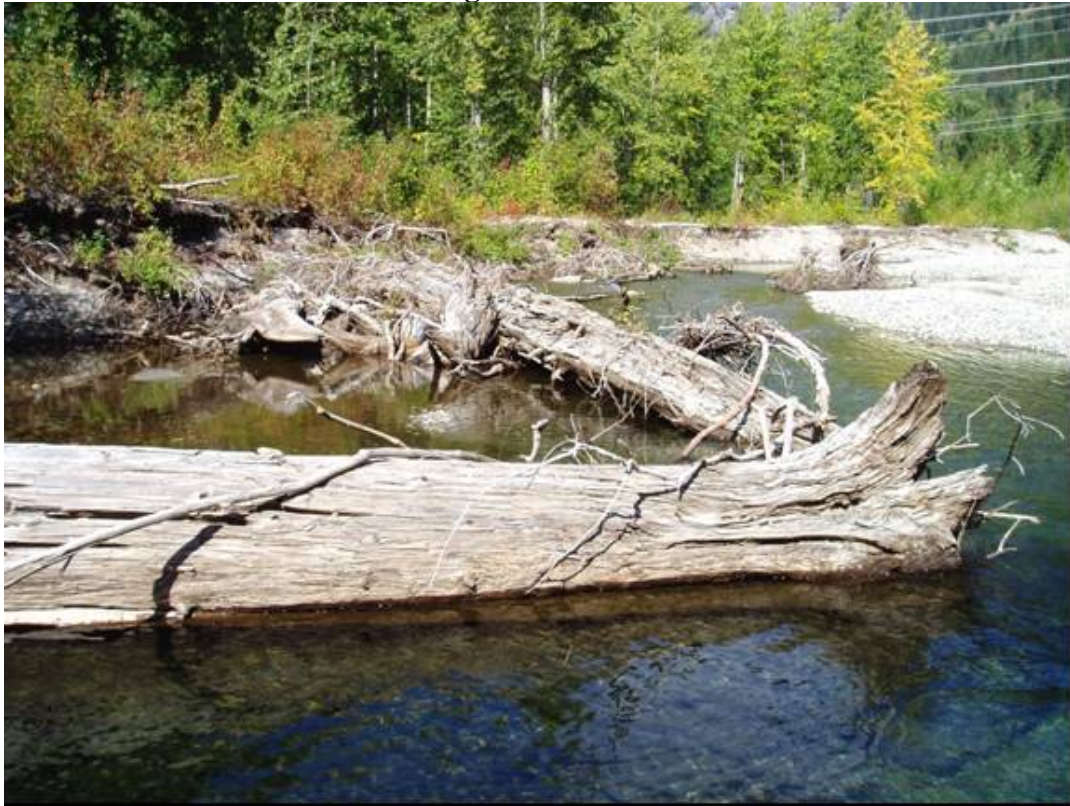
Cabled Logs in Pool at RM 10.3

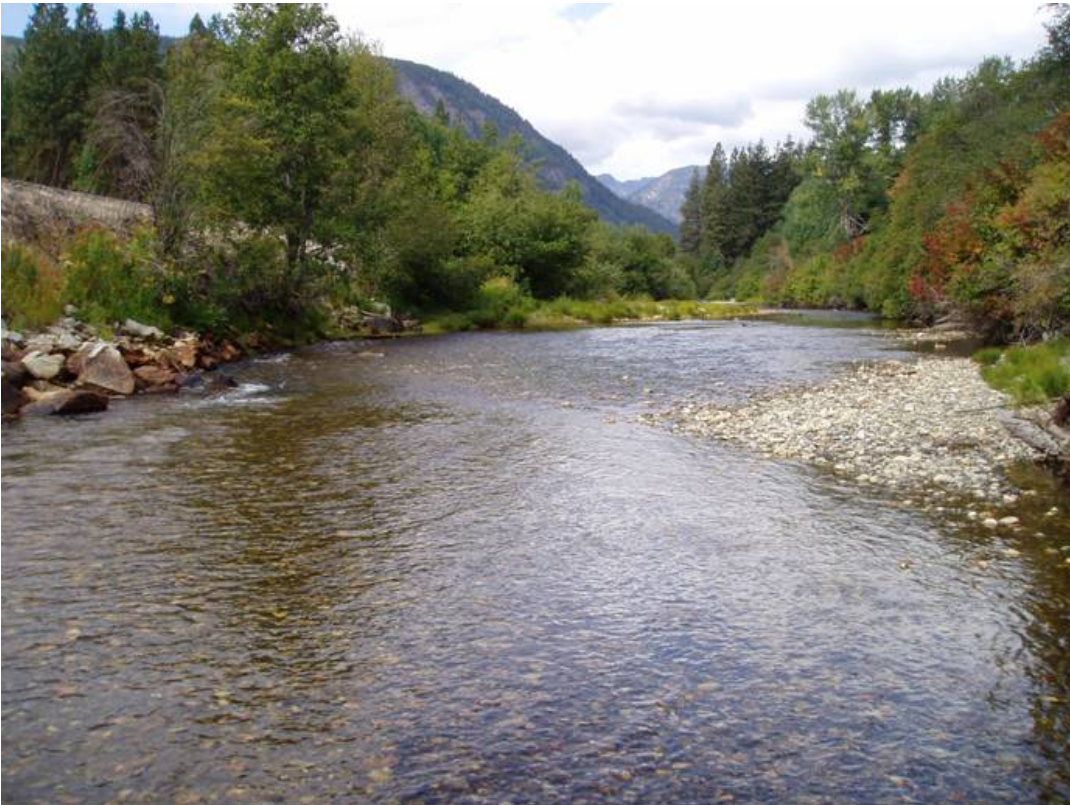
●**Riffle Habitat:** About 29% of the total habitat area consisted of riffles and runs. Hiding cover in the riffles was poor as there was almost no large wood, the channel bottom was uniform and there was little overhead cover above the stream surface. The average thalweg depth in the riffles was about a foot deep, and considered adequate for fish migration.

Riffle Habitat in Reach 3

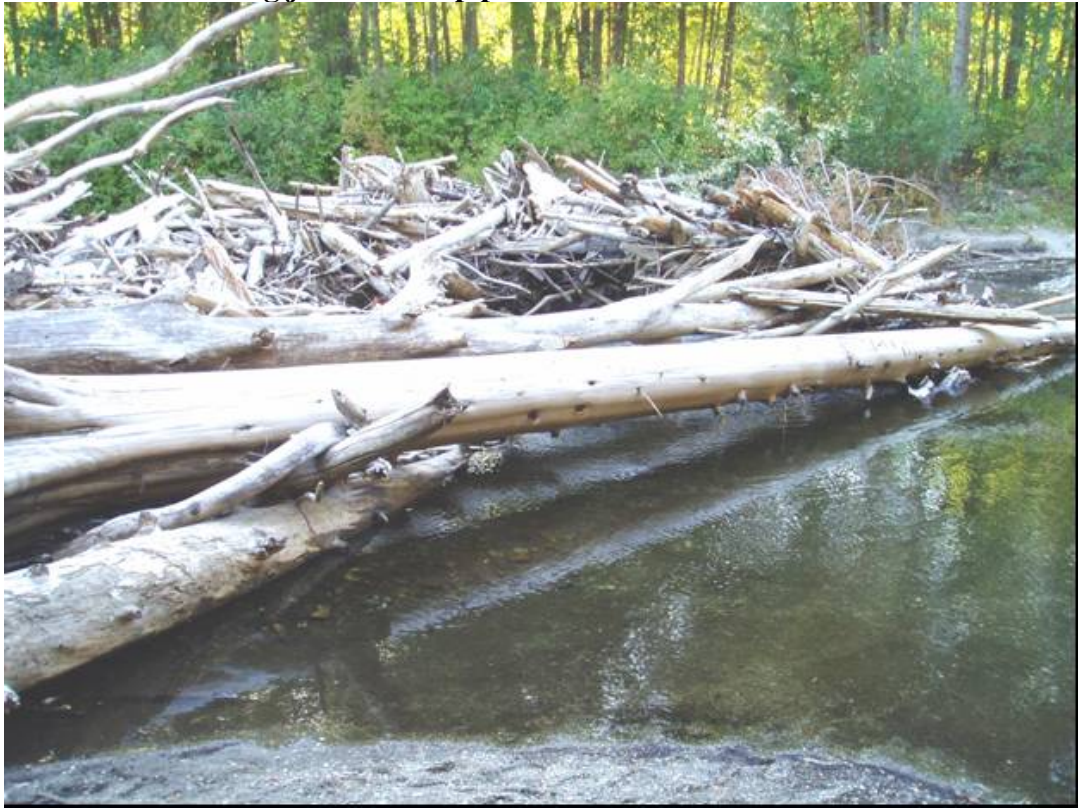
Log jam and deep pool habitat in Reach 4

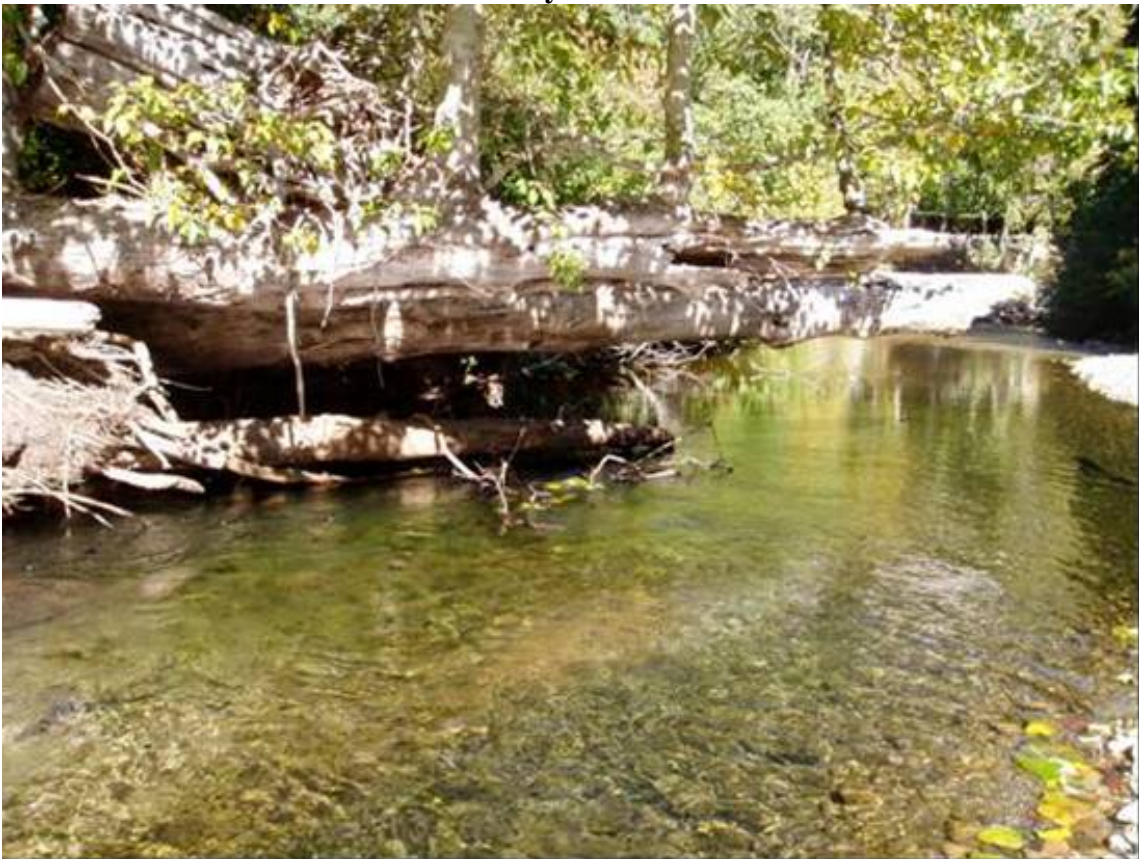
Pool formed by wood in Reach 4

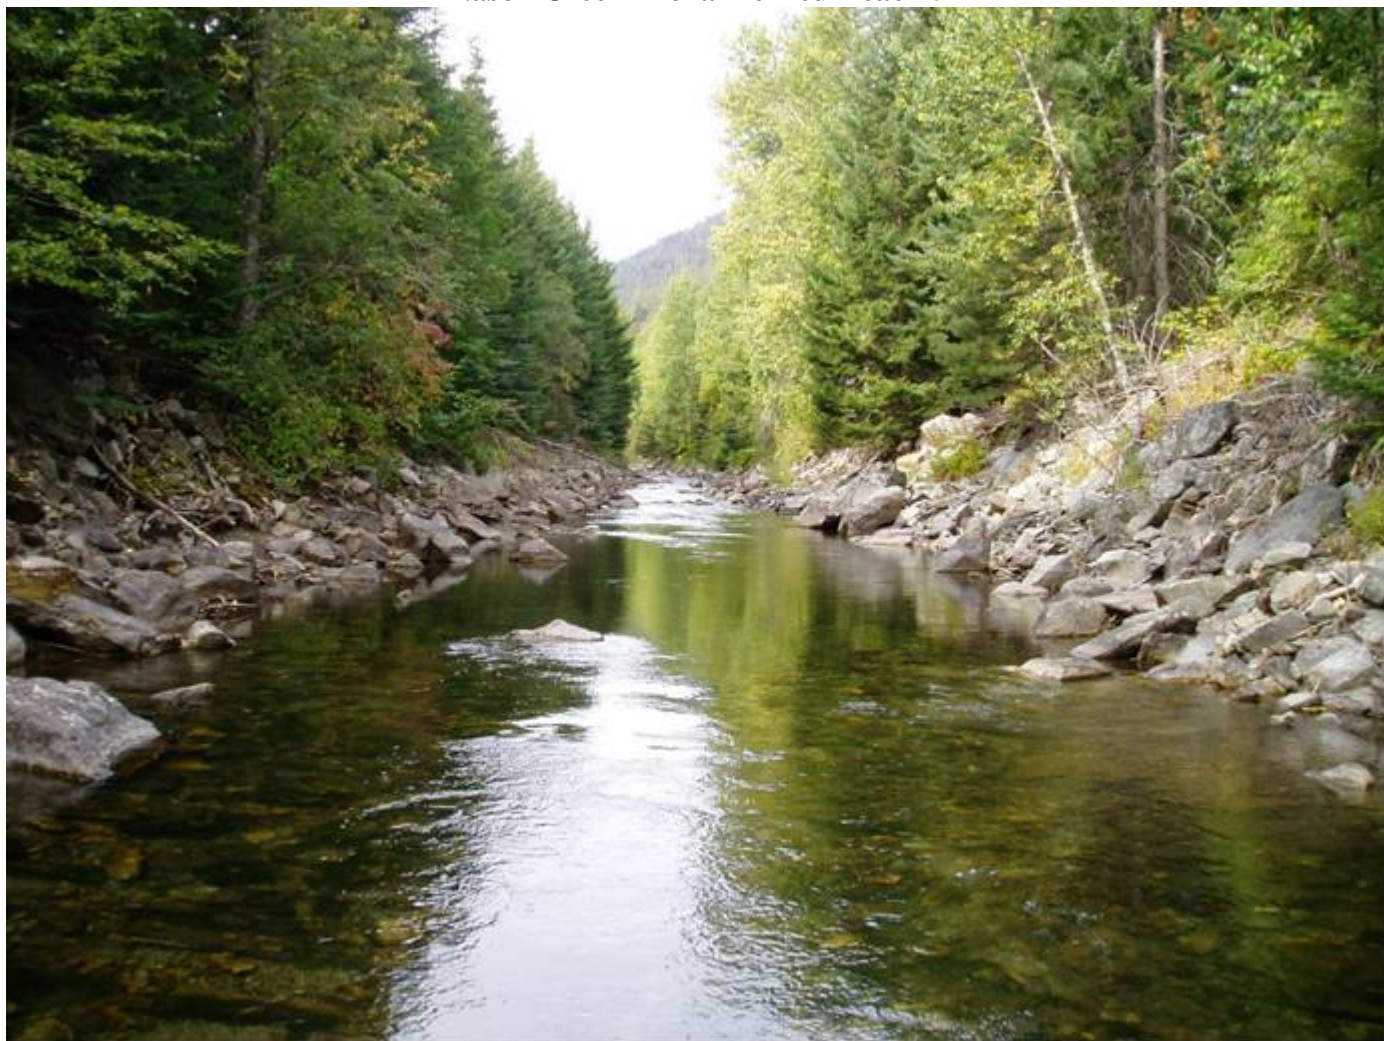
●**Reach Description:** This 0.8 mile reach is a straight, channeled segment of the stream comprised mainly of riffles and one ¼ mile long pool. This segment of the creek was moved from its original stream bed during construction of the railroad in the 1940s. The right bank consists of the railroad bed and the left bank has been rip-rapped to protect power lines. Both banks of Nason Creek have been cut off from its floodplain.

Nason Creek in channelized Reach 5
