Appendix A

REI Analysis Details

Upper Chewuch Habitat Assessment
Restoration Concepts - Map 1, Chewuch Reach 10a
 Relative elevation is derived as the difference between bare earth elevations and a reference plane representing the low flow water surface. Topographic data source: 2015 Okanogan lidar data. Other data: USGS NHD (1:24,000) edited so flowline represents main channel of each stream, US Forest Service Roads, Google Earth Air Photos (2017).

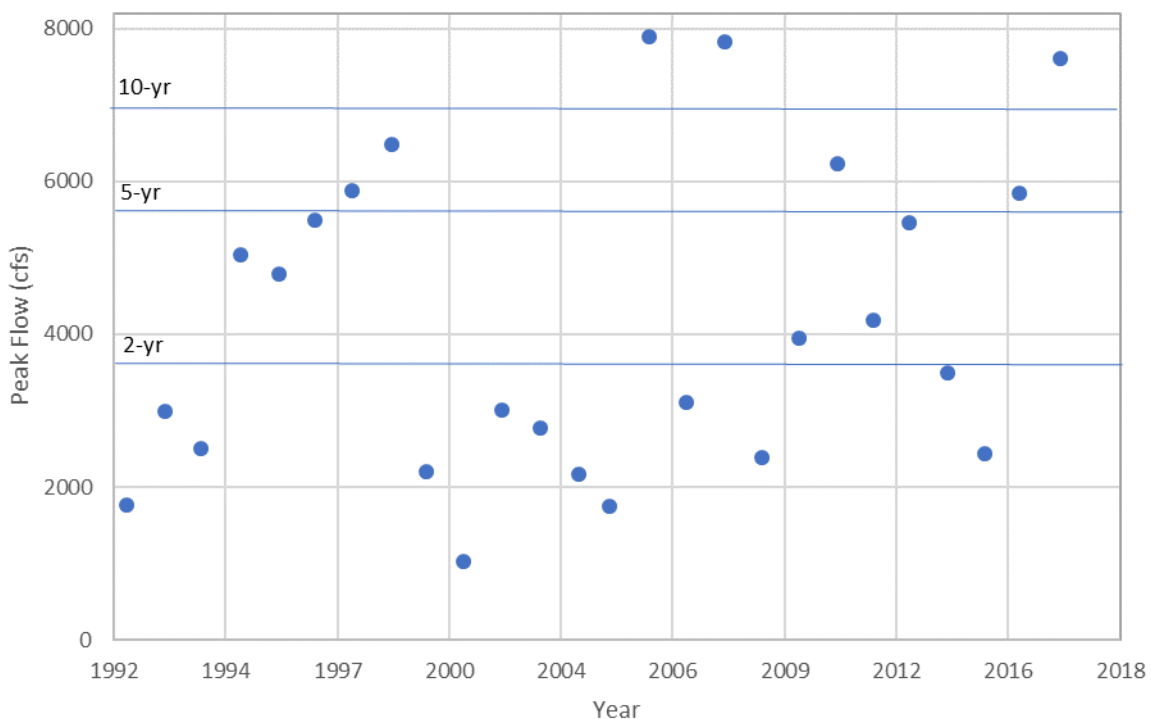
Figure 1. Peak flows for the Chewuch River from USGS gage 12448000 with 2, 5, and 10 year flows indicated in solid blue lines.

A large portion of the Chewuch Watershed has burned in fires since 2001. The loss of vegetation from these widespread fires has the potential to affect the hydrology of the watershed, leading to more intense and frequent peak flow events (Shakesby and Doerr 2006). In the Chewuch, there is some evidence of a potential shift in peak flow magnitude since the mid 2000's. In a 12-year span since 2005 there have been 3 peak flows in exceedance of the 10-year flow recurrence, and five peak flows in exceedance of the 5-year flow recurrence (Figure 1). Given the short period of record for the gage data and variability of peak flows in the period of record (1992-2017), this trend does not appear to be statistically significant but does point towards a potential trend and merits being tracked into the future. With large fires continuing to occur on a nearly annual basis in the Chewuch watershed, there is a chance that fire effects on hydrology will become more pronounced or at least continue to the point where there is a statistically significant shift. However, vegetation recovery from fires may offset the future impacts depending on the rate of recovery and the scale of new fires. Recovery time from fire effects to peak flows varies, but can take up to several decades (Shakesby and Doerr 2006).

A shifting hydrologic regime due to climate change puts the Chewuch Watershed at risk to potential adverse effects from changing flow patterns, combined with the reduced capacity for moisture on the landscape due to recent widespread fire activity (Beechie et al. 2013). Open ground and areas where fire has removed vegetation have higher run-off rates than heavily vegetated soils. As the climate changes we expect earlier peak flows, reduced summer flows, higher peak flows from decreased snow pack and more precipitation falling as rain rather than snow (Gaines et al 2012). While the Chewuch Watershed currently has a snowmelt driven hydrograph and peak flows, it is expected that it will become a transition, mixture of rain and snowmelt driven, watershed by 2100 (Mantua et al 2010). These conditions will lead to high flow occurring in

different times of year than historically, and potentially larger flow events that cause more redd scour, bank erosion, and habitat degradation.

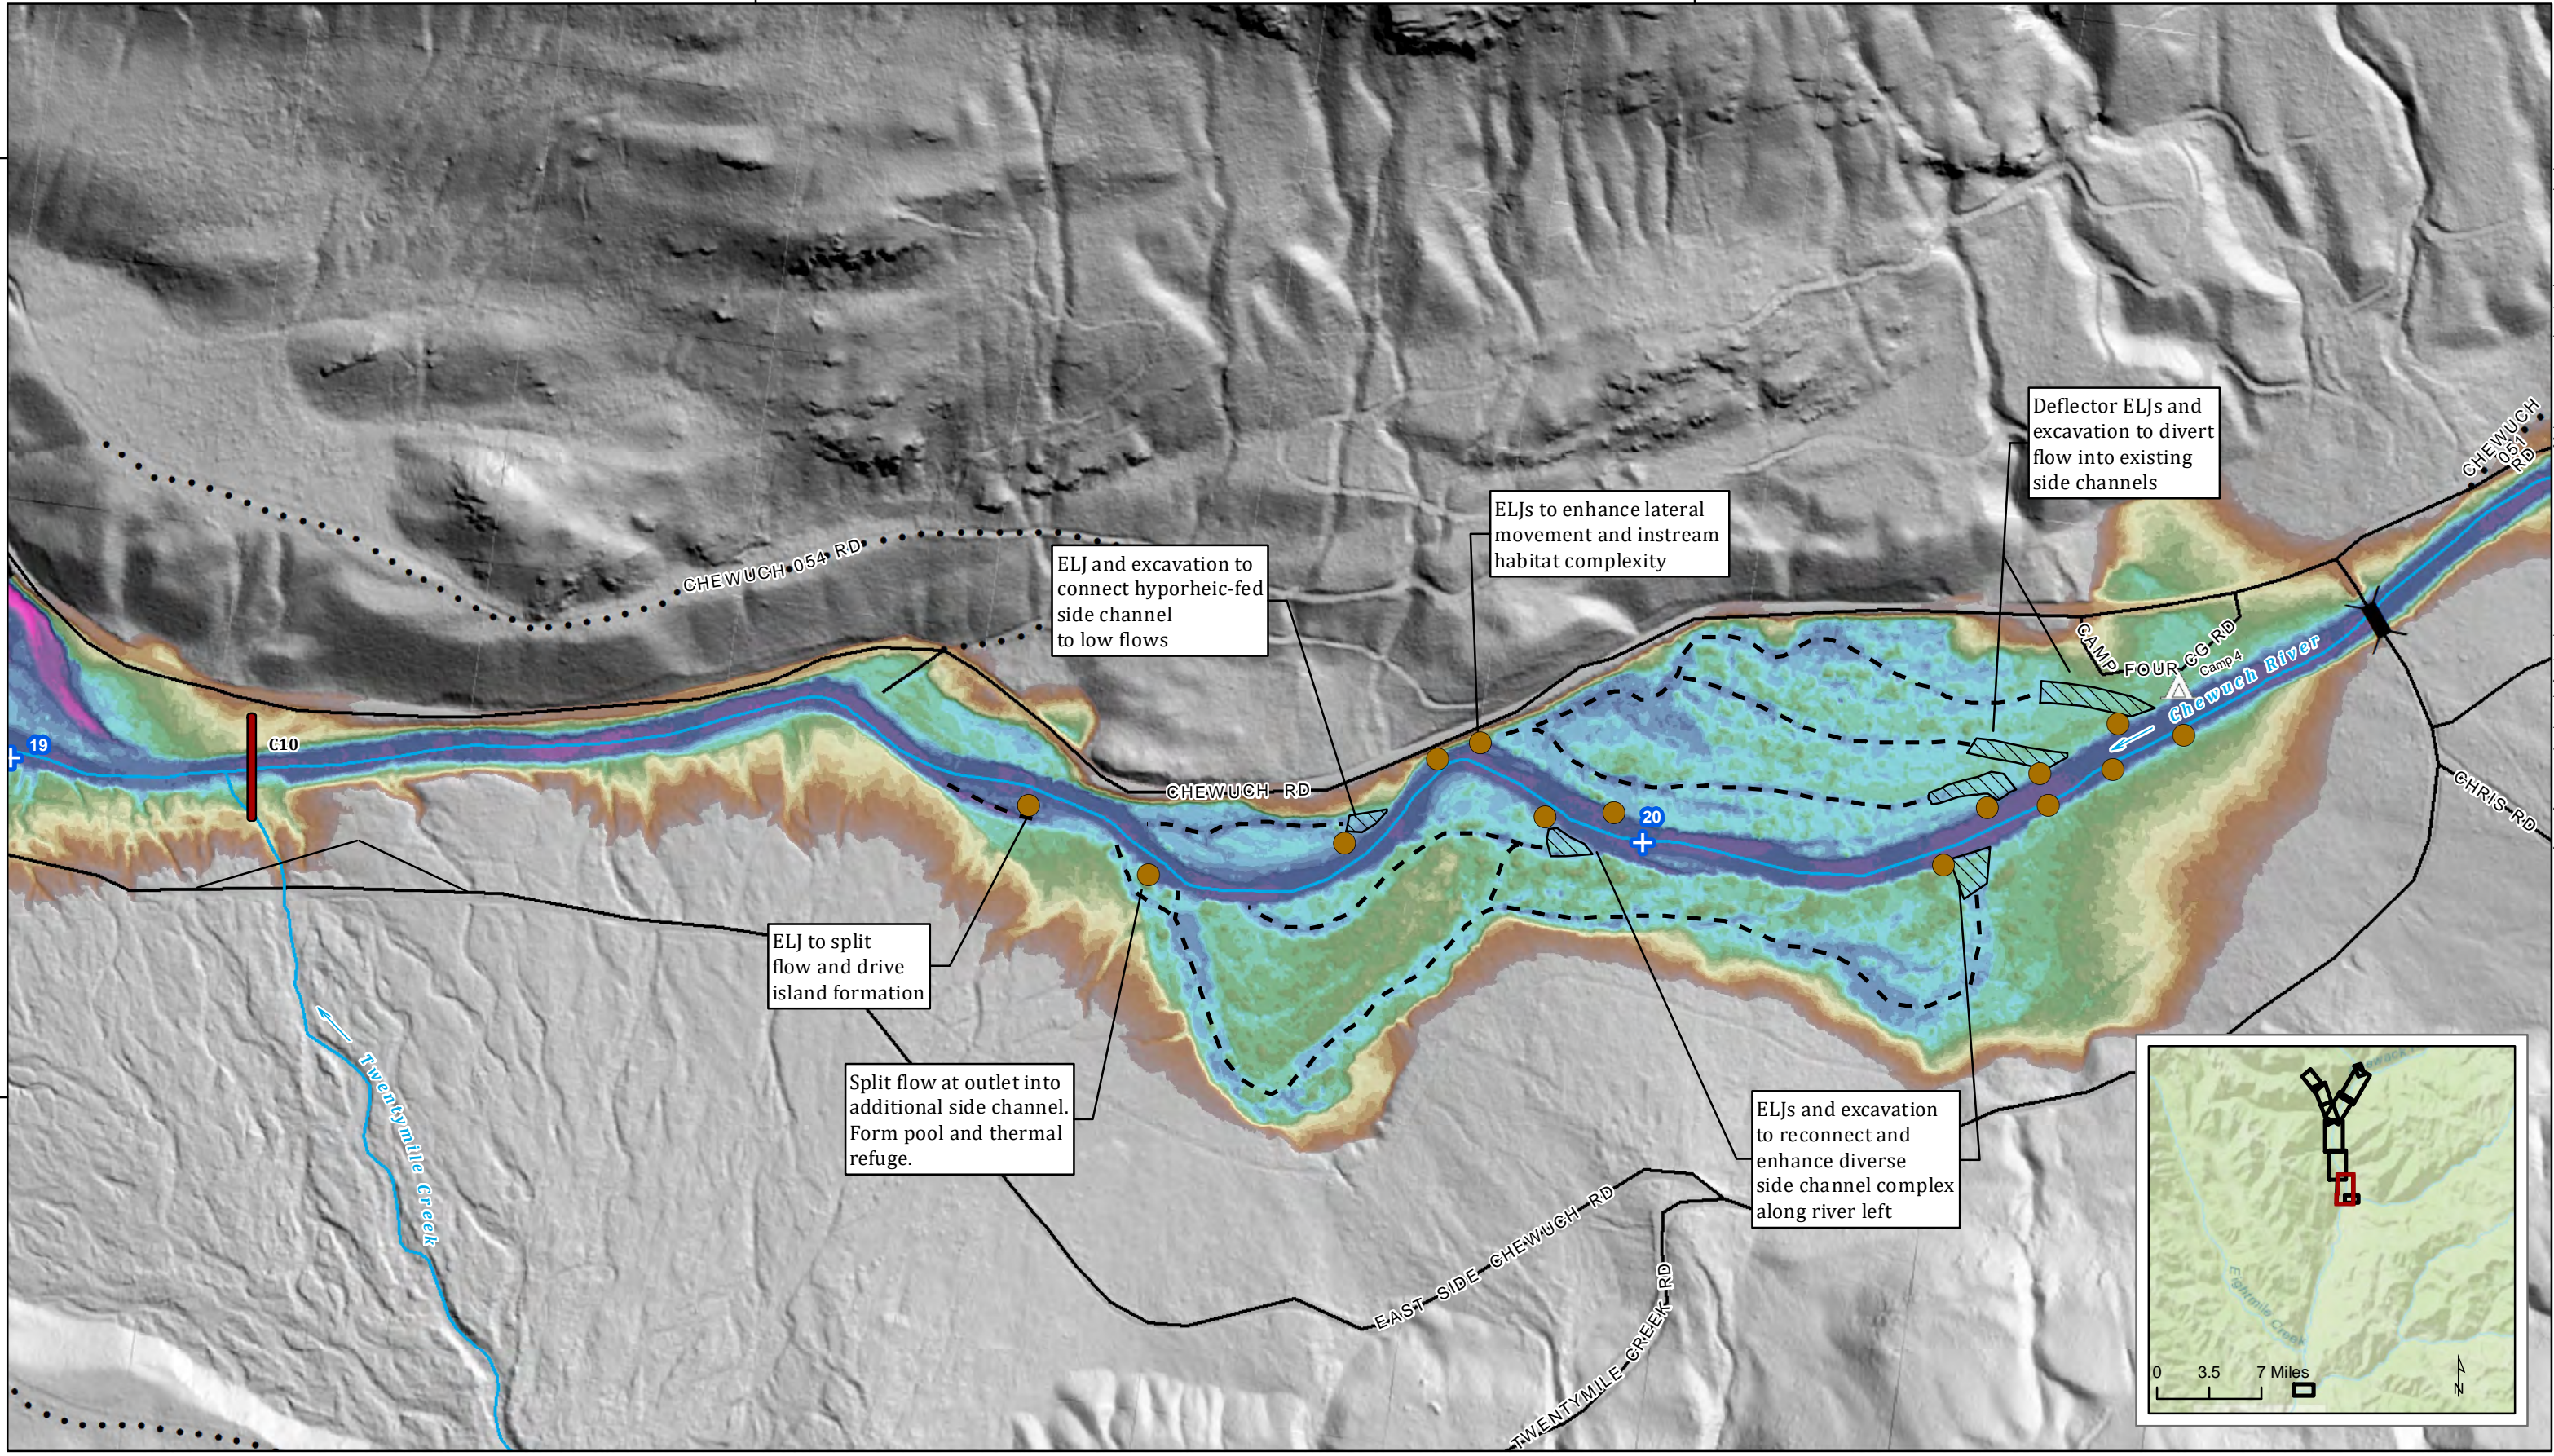
Large wood condition in Chewuch C10 is unacceptable. Overall the wood density in this reach at 25.7 pieces/mile is well below the adequately functioning threshold, and the majority of that wood is in the side channel. Moreover, there is very little mainstem wood, with only 60 pieces in mainstem over the 2.9 mile reach. Only 26 pieces in the mainstem are greater than 12 in diameter and 35 ft long, coming out to a density 9 pieces/mile, well below the threshold for adequate or at risk conditions. The majority of the large wood is located in the No Snake side channel, where habitat quality, including large wood is good condition. The mainstem is in an unacceptable condition. There is recruitment potential, but limited existing structure to retain recruited wood.

ELJ to split flow and drive island formation

Split flow at outlet into additional side channel. Form pool and thermal refuge.

ELJs and excavation to reconnect and enhance diverse side channel complex along river left

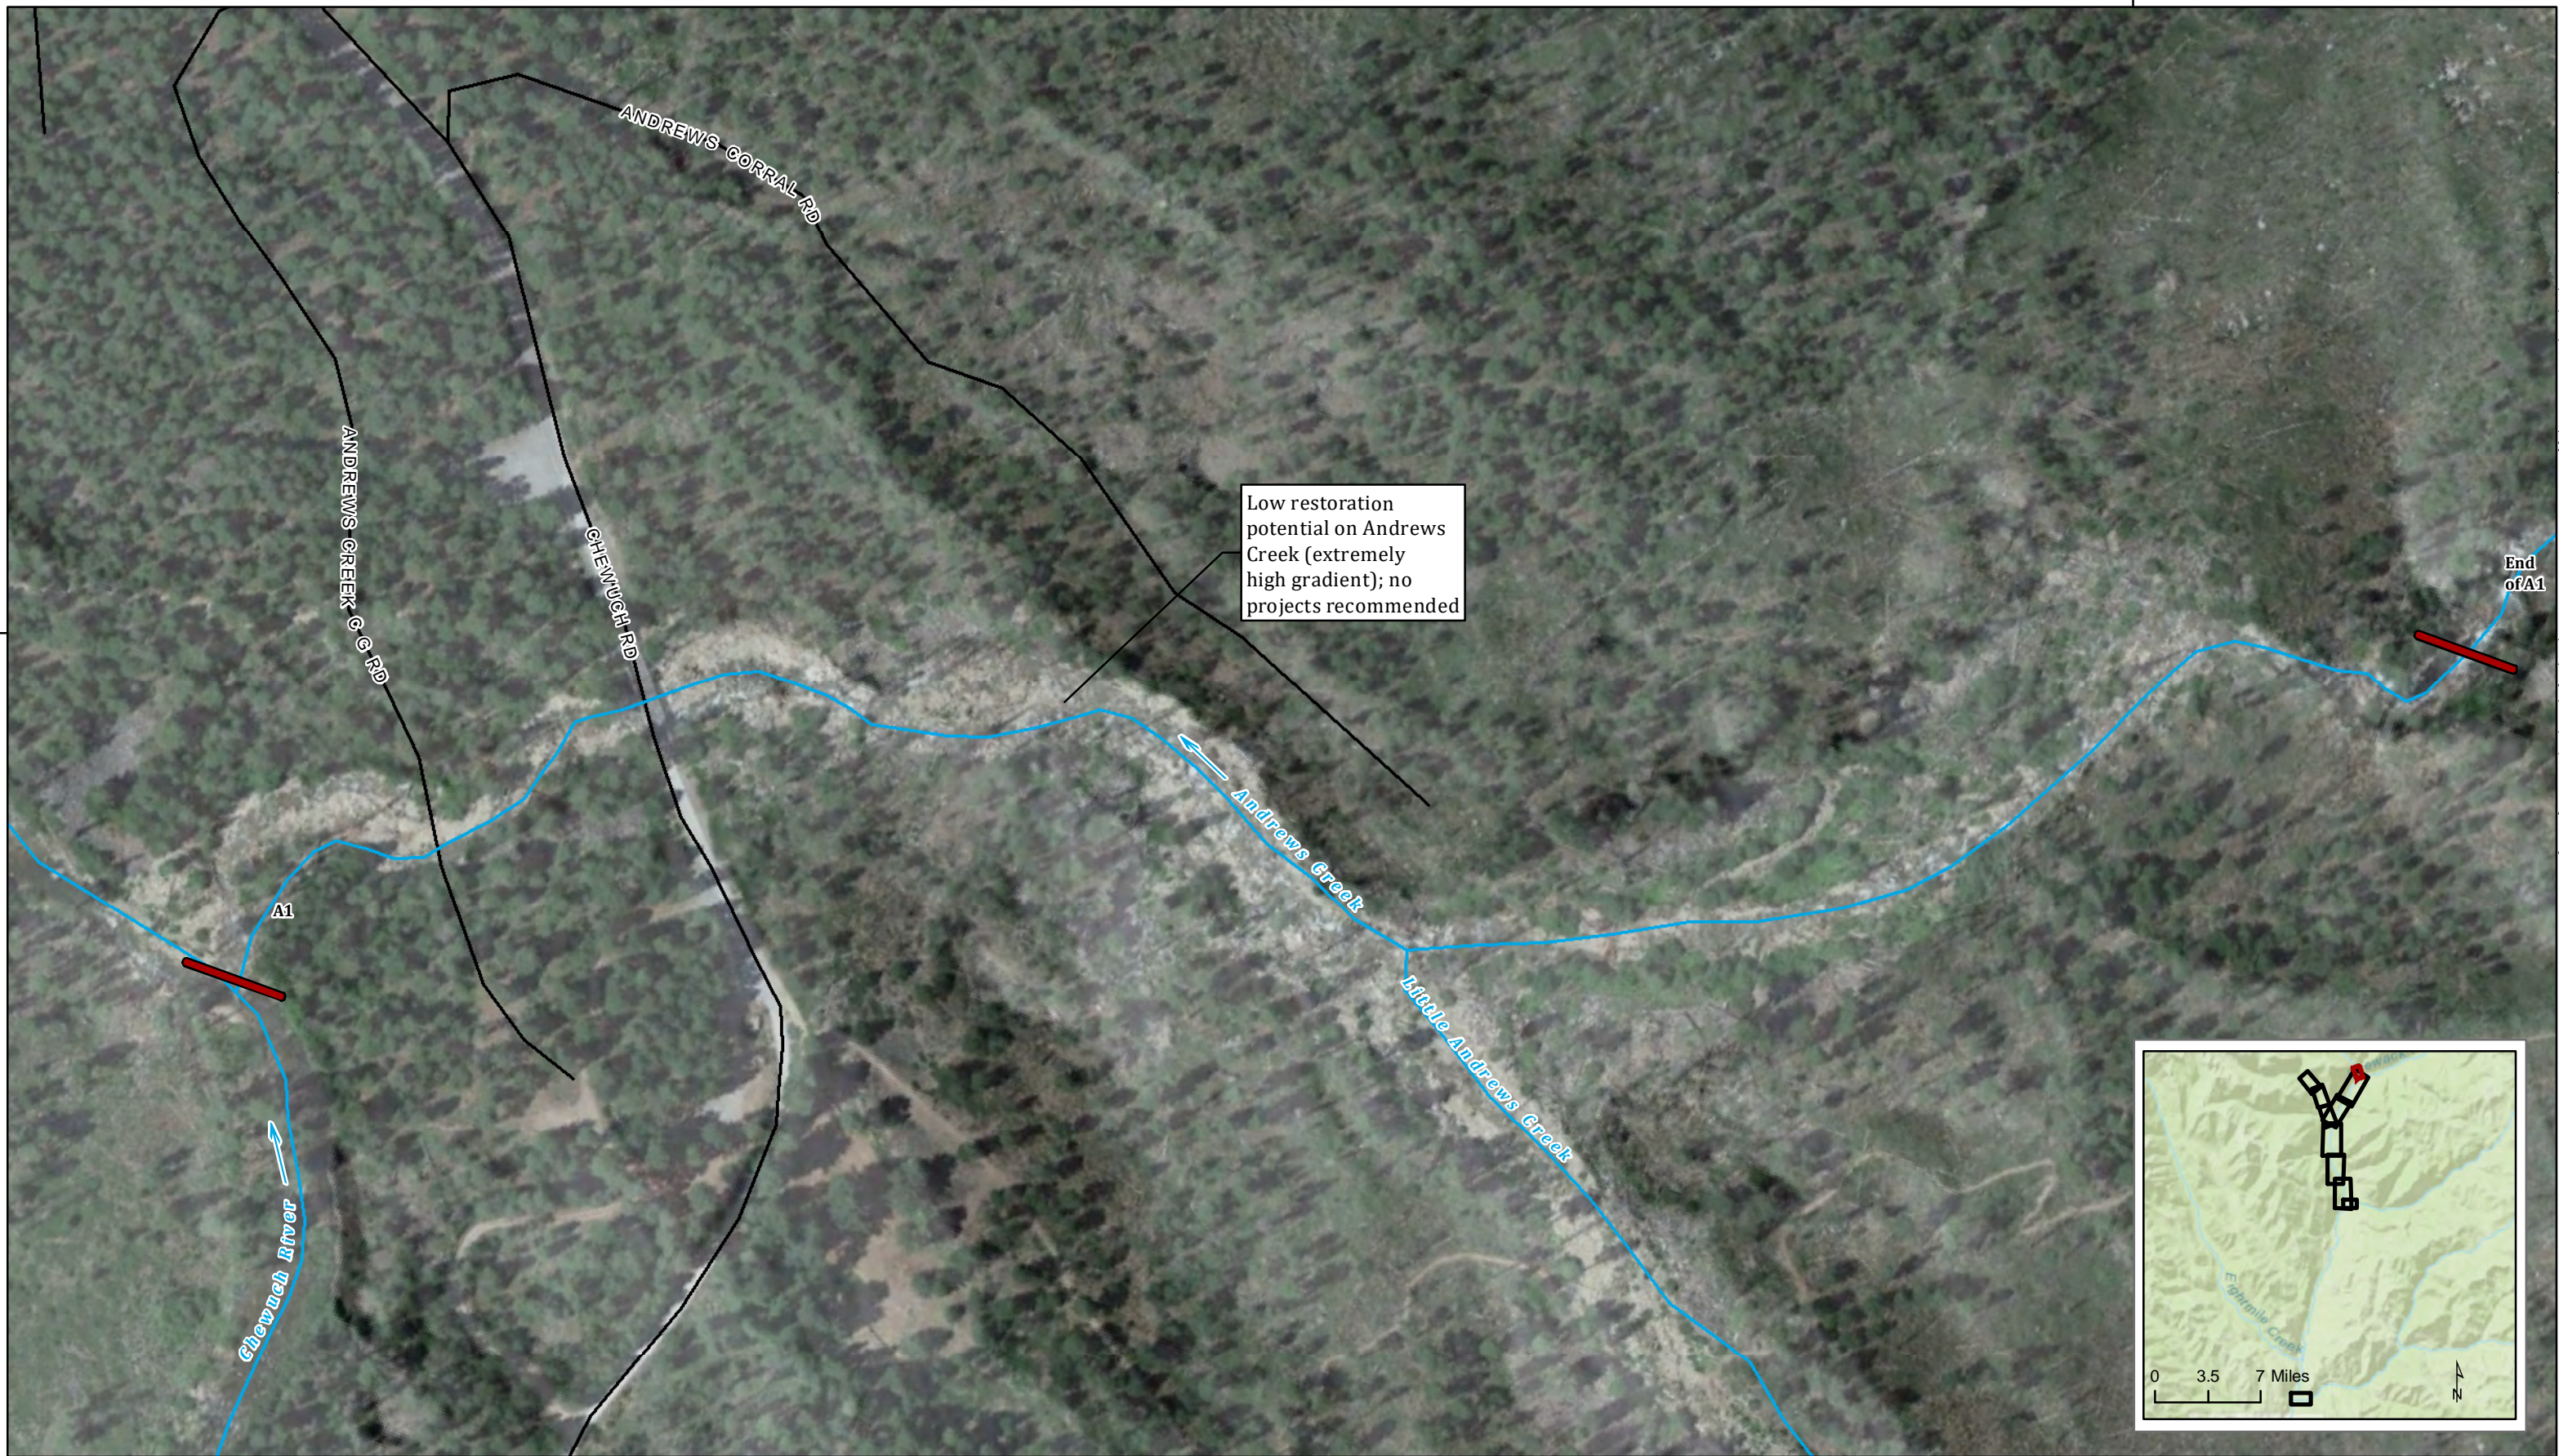
Upper Chewuch Habitat Assessment
Restoration Concepts - Map 6, Andrews Creek
 Topographic data source: 2015 Okanogan lidar data. Other data: USGS NHD (1:24,000) edited so flowline represents main channel of each stream, US Forest Service Roads, Google Earth Air Photos (2017).

Low restoration potential on Andrews Creek (extremely high gradient); no projects recommended
