## Appendix A | Stream Habitat Assessment

Habitat Inventory Survey: *August 1st – September 1st, 2024*

White River RM 0 - RM 16.17

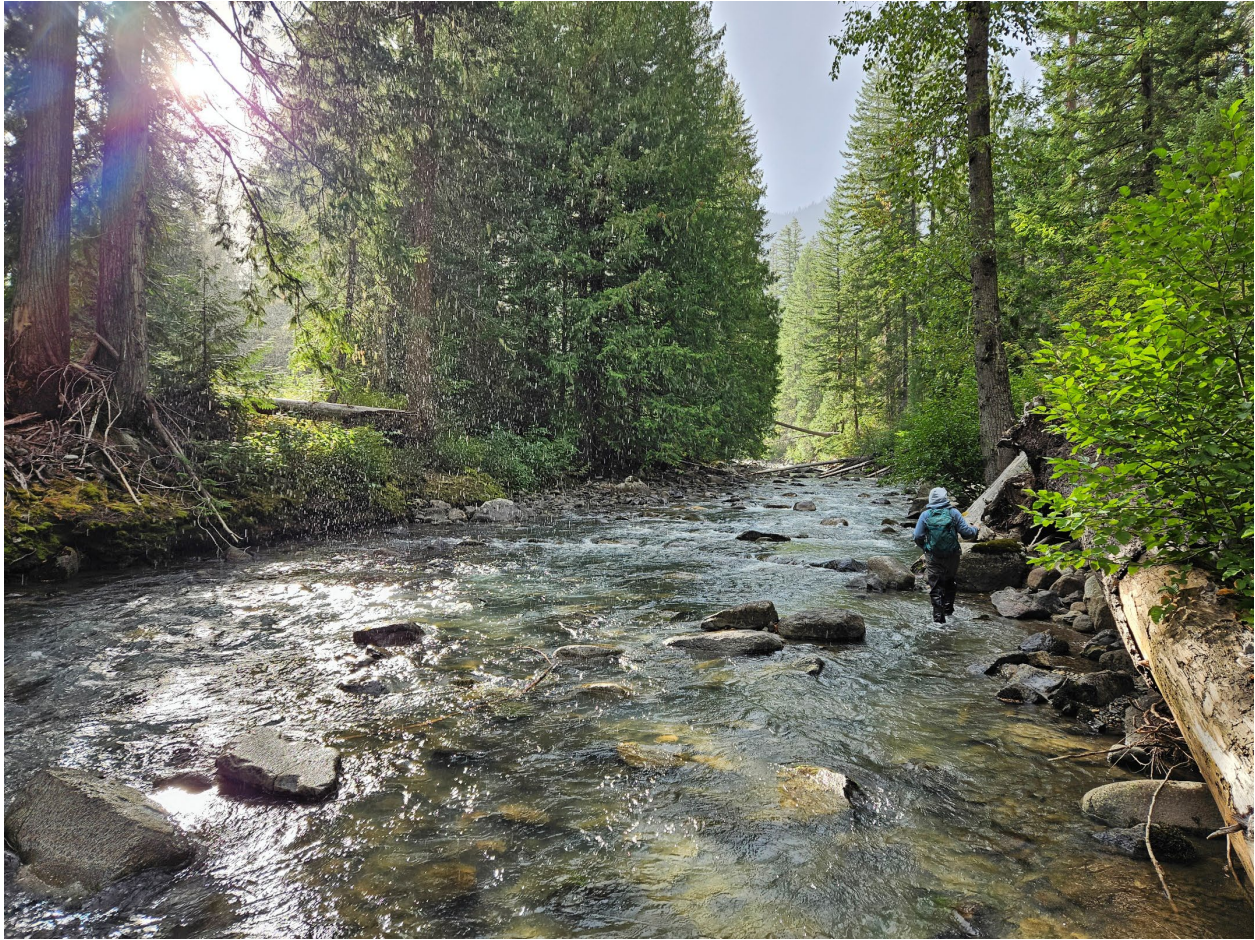
*Figure 4. One of the side channels in Reach 9, located downstream of the Panther Creek confluence.*

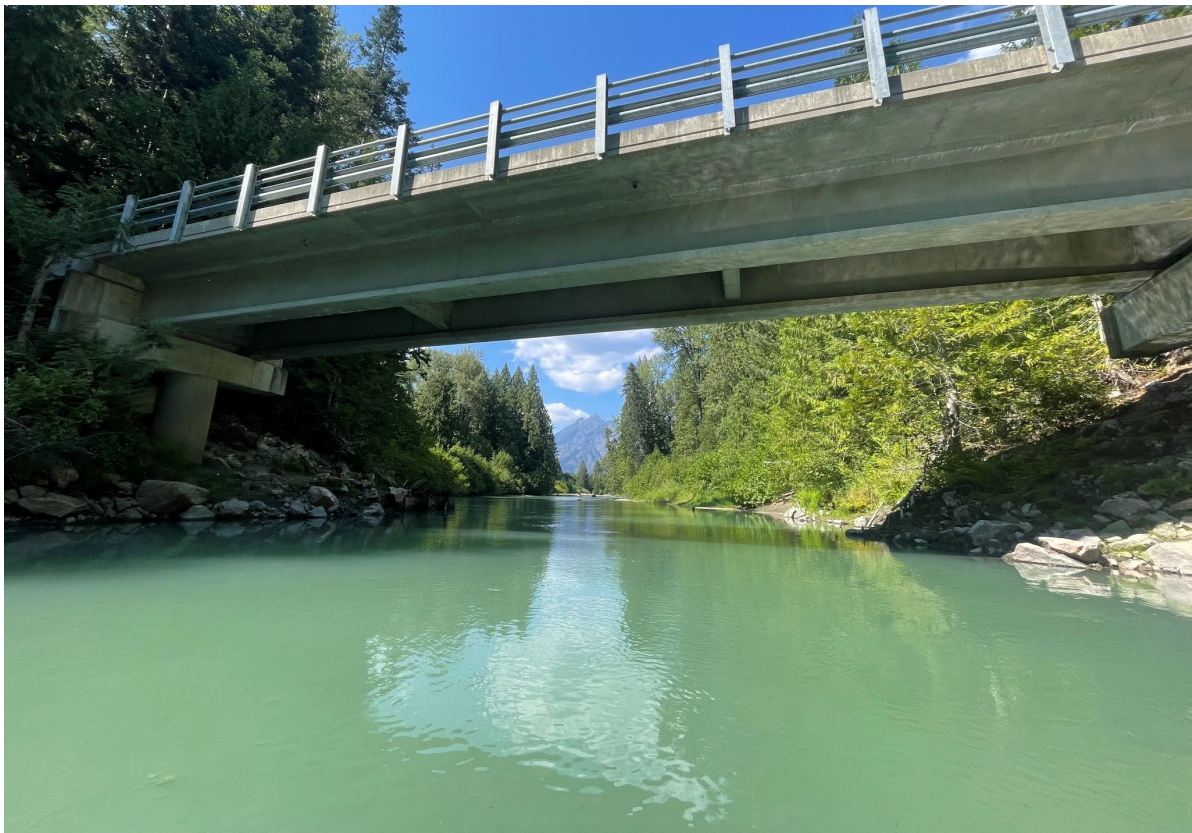
White River Reach 5 and the Napeequa River Reach 1 had the highest percentages of unstable banks, with 10% and 9% (respectively) of their total bank lengths having anthropogenically-caused bank instability. The river-left bank in White River Reach 5 abuts a privately-owned property with a large clear-cut parcel (RM 7.7-8.25), which field crews attributed to the localized erosion in that area, as well as residential building on river-right with rip rap protecting it (RM 9.4). The downstream end of Reach 5 is locked into place by the Sear Creek Road bridge near RM 7, which also had bank armoring. The downstream section (RM 0-0.9) of Napeequa River Reach 1 snaked through a neighborhood on the river-left side and Tall Timber Ranch, a privately owned retreat center, on river-right. Development and modification to the riparian area/channel banks, including access routes from neighborhoods into the channel, caused bank instability in the reach. Riprap was observed in some locations.

**Figure 8. Photo of riprap protecting the Sears Creek Bridge around RM 7 (at the break of Reach 4 and Reach 5) on the mainstem of the White River.**

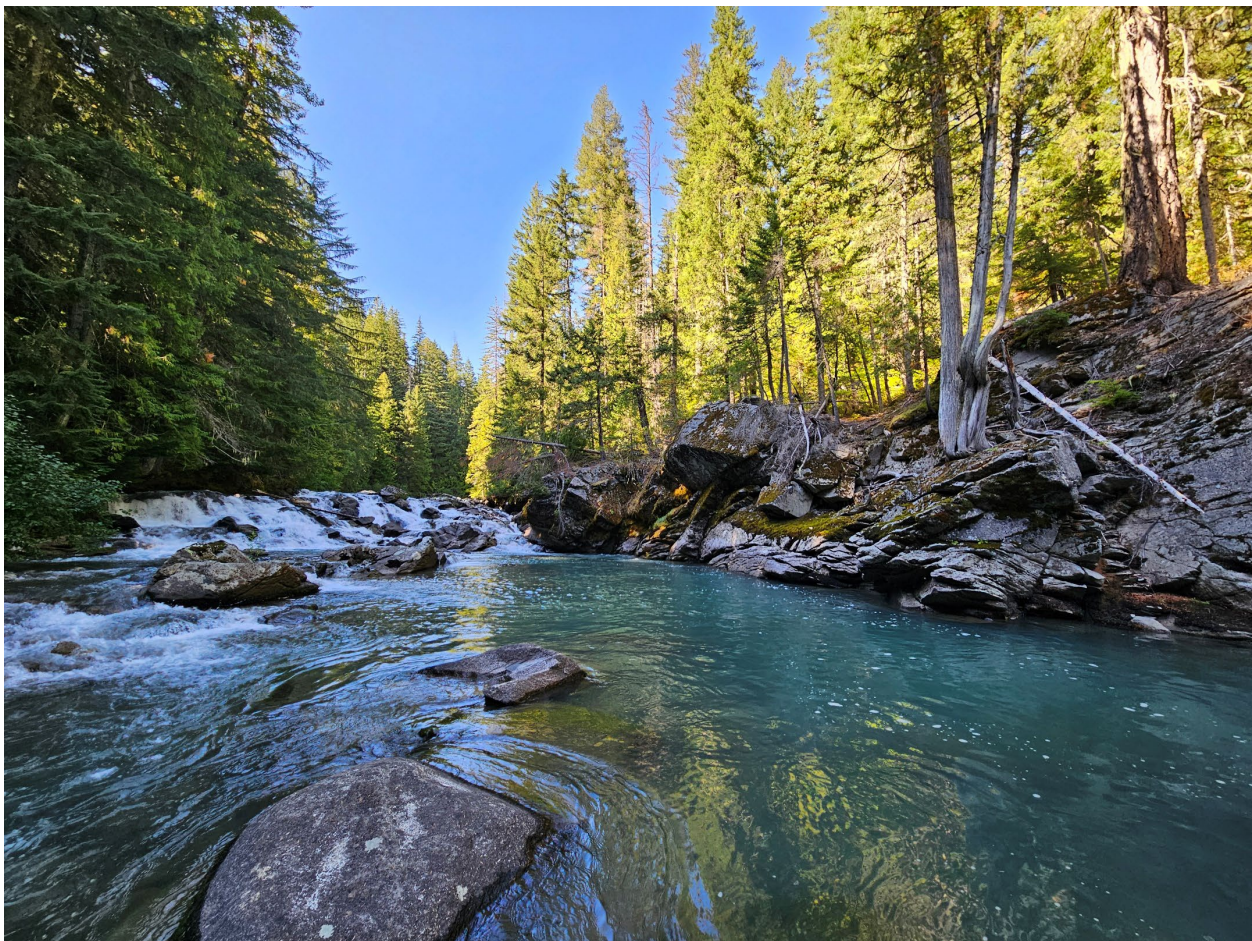
No anthropogenic fish passage barriers were observed in the mainstem channel or in either of the tributaries. White River Falls at RM 16.17 on the mainstem is a fish passage barrier, but was outside the study area extent (the base of the falls formed the upstream boundary of the study area). The lower White River falls (near RM 16.09) is understood to be a natural partial fish passage impediment, but not a full

*Figure 9. An example of the natural fish passage impediments on the White River survey. This is the lower falls at White River falls, where the habitat survey stopped.*

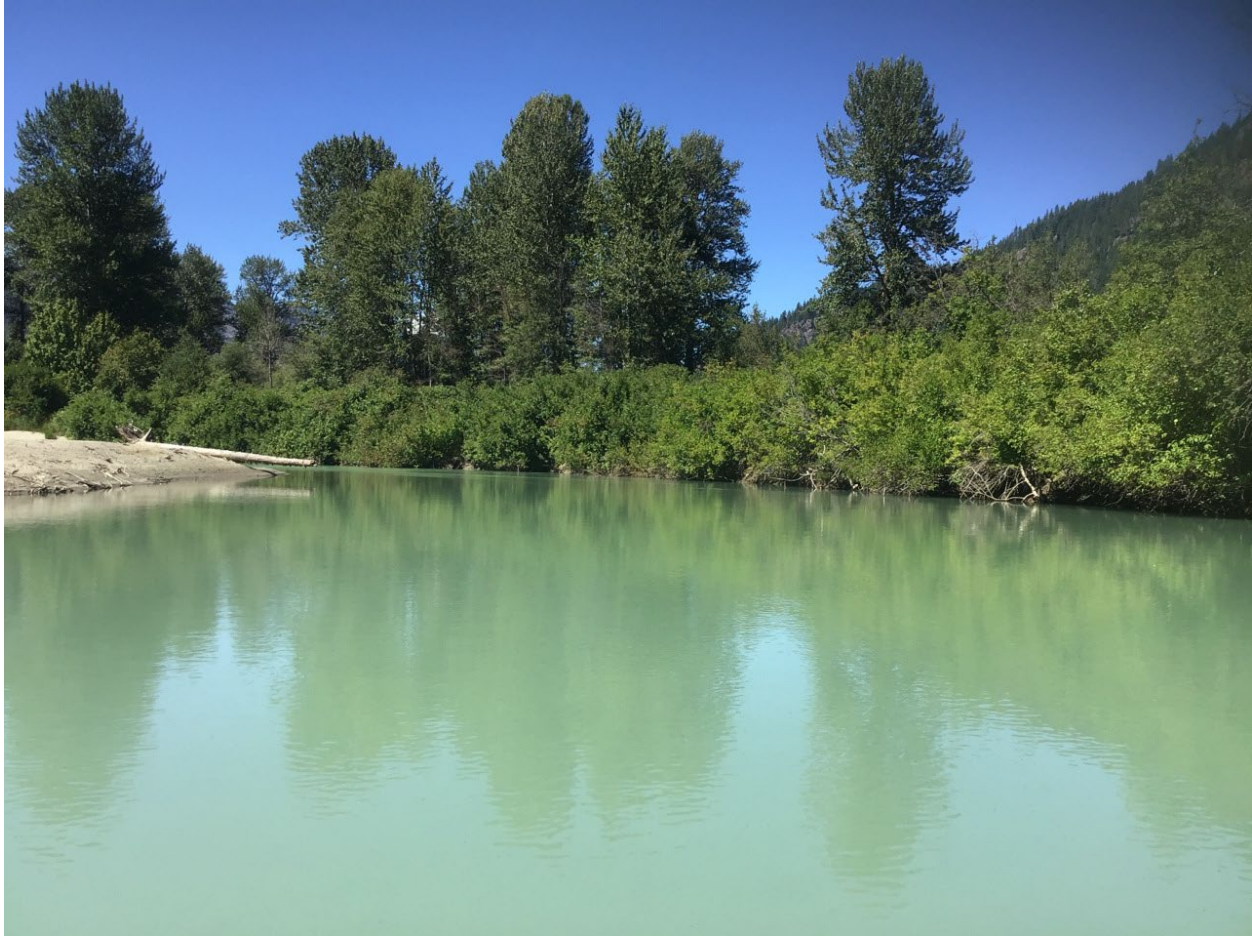
**Figure 14. Representative photo of Reach 1. Habitat units dominated by pools.**

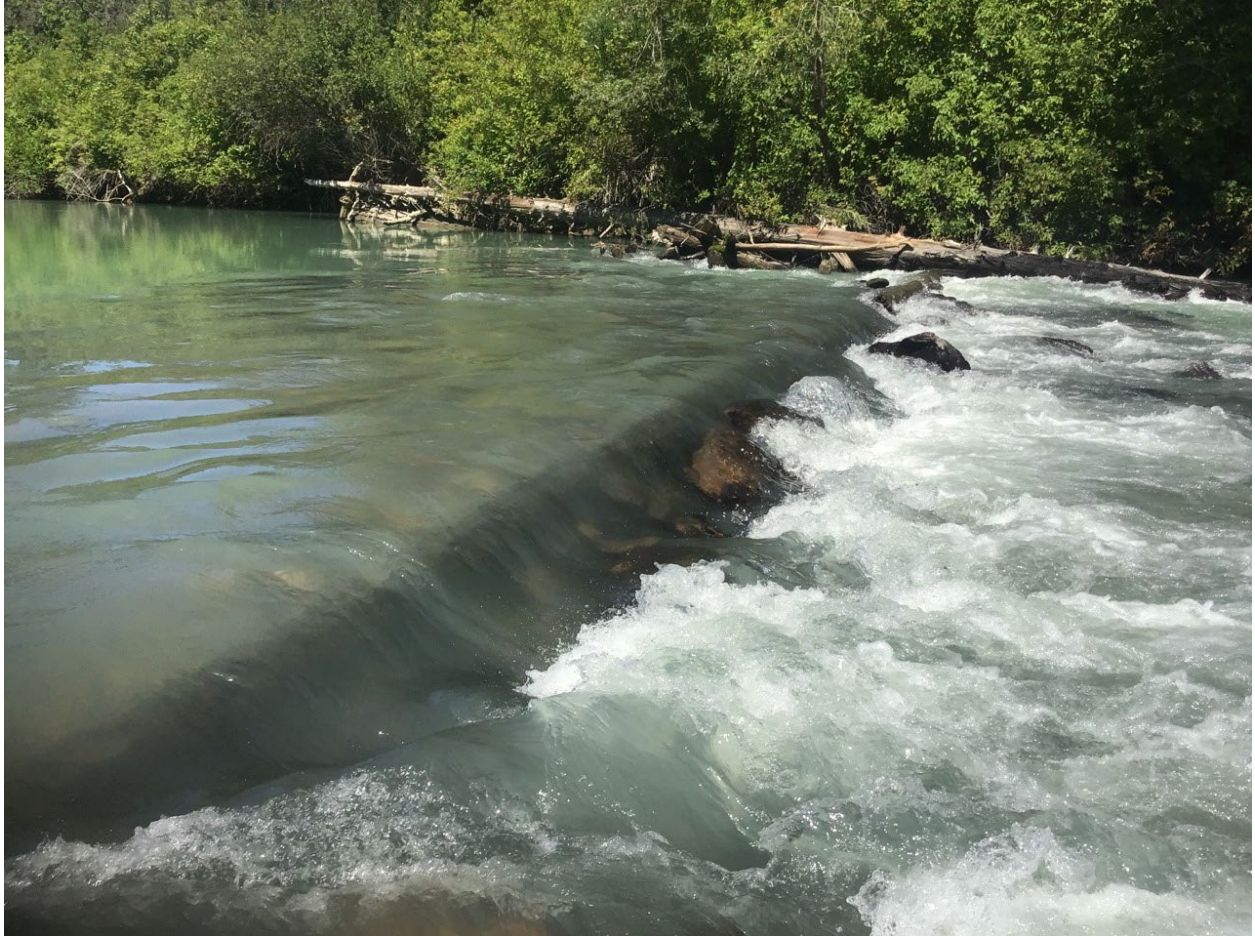
Reach 1 is two miles long and is almost entirely (99.7%) pool habitat (Figure 17), largely due to the backwater effect of Lake Wenatchee in the reach. There is a channel spanning weir (Figure 15) located near RM 1.65 that makes up 0.3% of the reach habitat by area. The weir spans the entire width of the White River channel, and likely is not a full fish passage barrier except at very low flows, which may create a hydraulic drop at the structure that is difficult for smaller/juvenile fish to navigate. No side channels were present. There is a small amount of residential land use in the upstream river-left floodplain of the reach and the Little Wenatchee Road bridge crosses the White River at RM 2.0, coinciding with the end of the reach. The upstream portion of the channel in Reach 1 is incised, primarily from the Little Wenatchee Road bridge. Reach 1 has the lowest gradient of all the reaches at 0.02%.

***Figure 15. Channel spanning weir in Reach 1 near RM 1.65.***

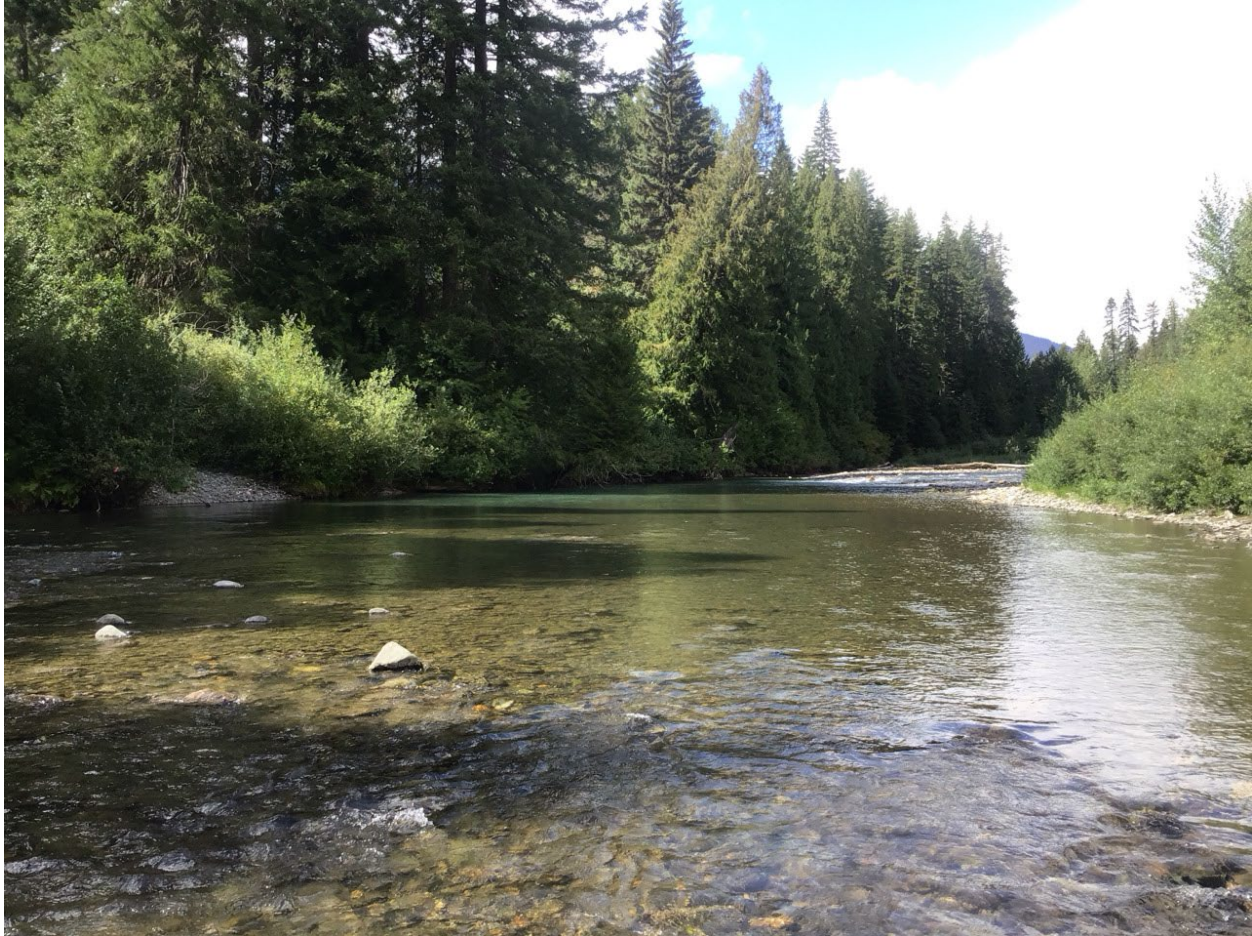
**Figure 71. Representative photo of Reach 8. The primary habitat type was pool, with increased amount of fast water compared to downstream reaches.**

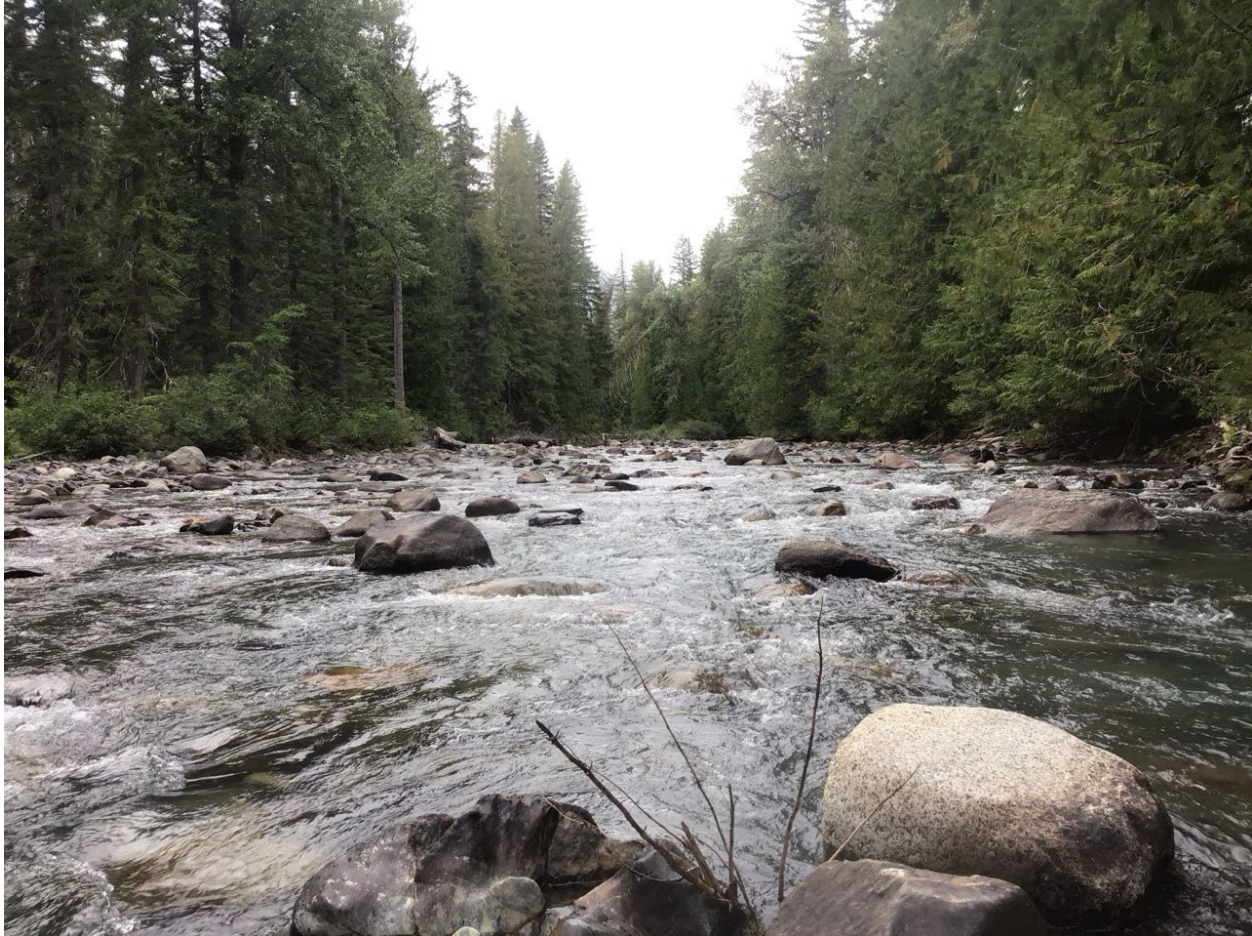
**Figure 79.** Representative photo of Reach 9. Riffles made up the majority of the channel units in Reach 9.

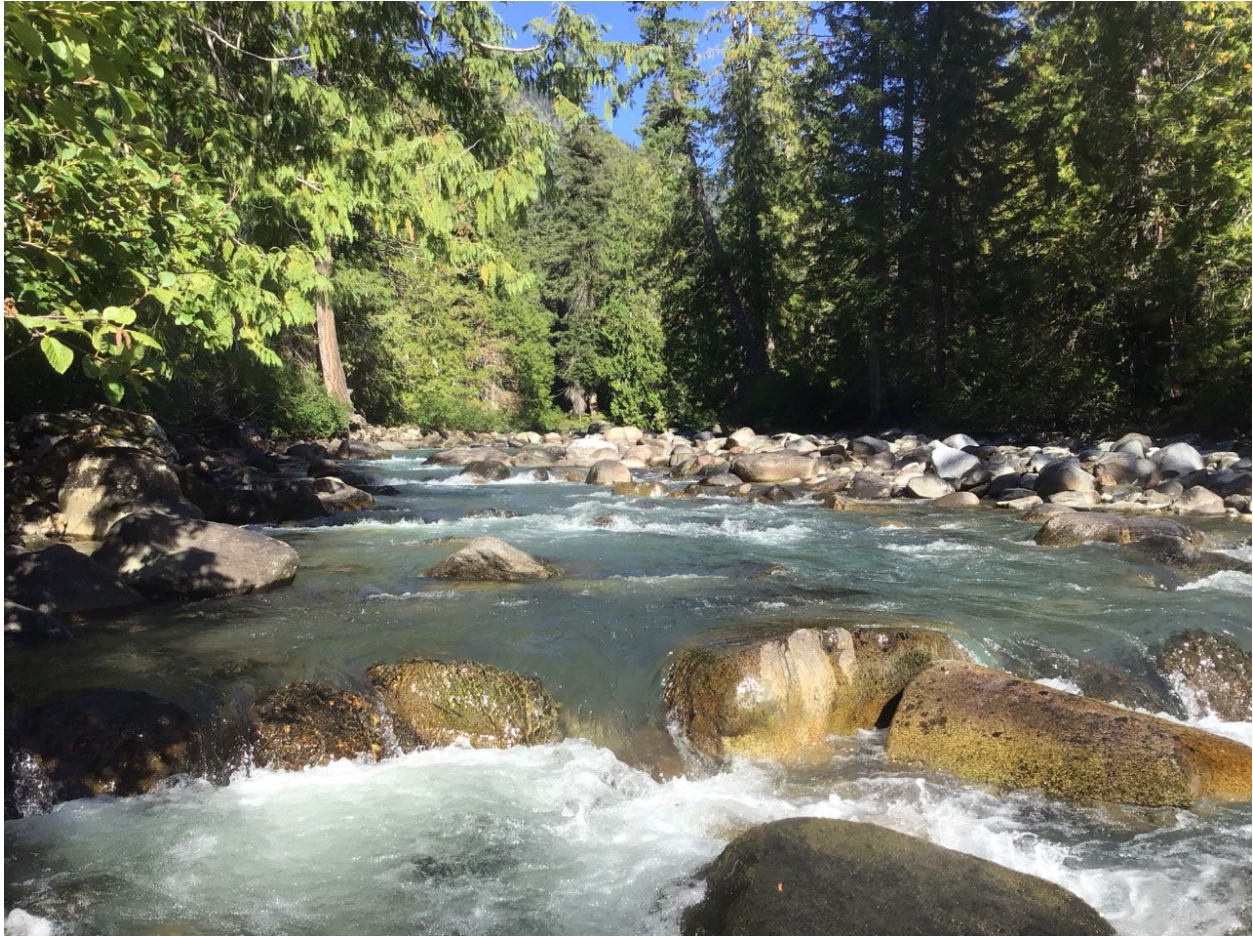
**Figure 87. Representative photo of Reach 10. The primary habitat type is riffle.**
