Pole Creek Geomorphic Assessment to Address Fish Passage Barriers

Existing Structures: The culvert for the USFS 6305-111 Road crossing of Pole Creek is undersized and poses a fish passage barrier. The site is located approximately 1,500 feet above its confluence with Big Meadow Creek. The road crossing has a relatively large fill and will require a new drainage structure.

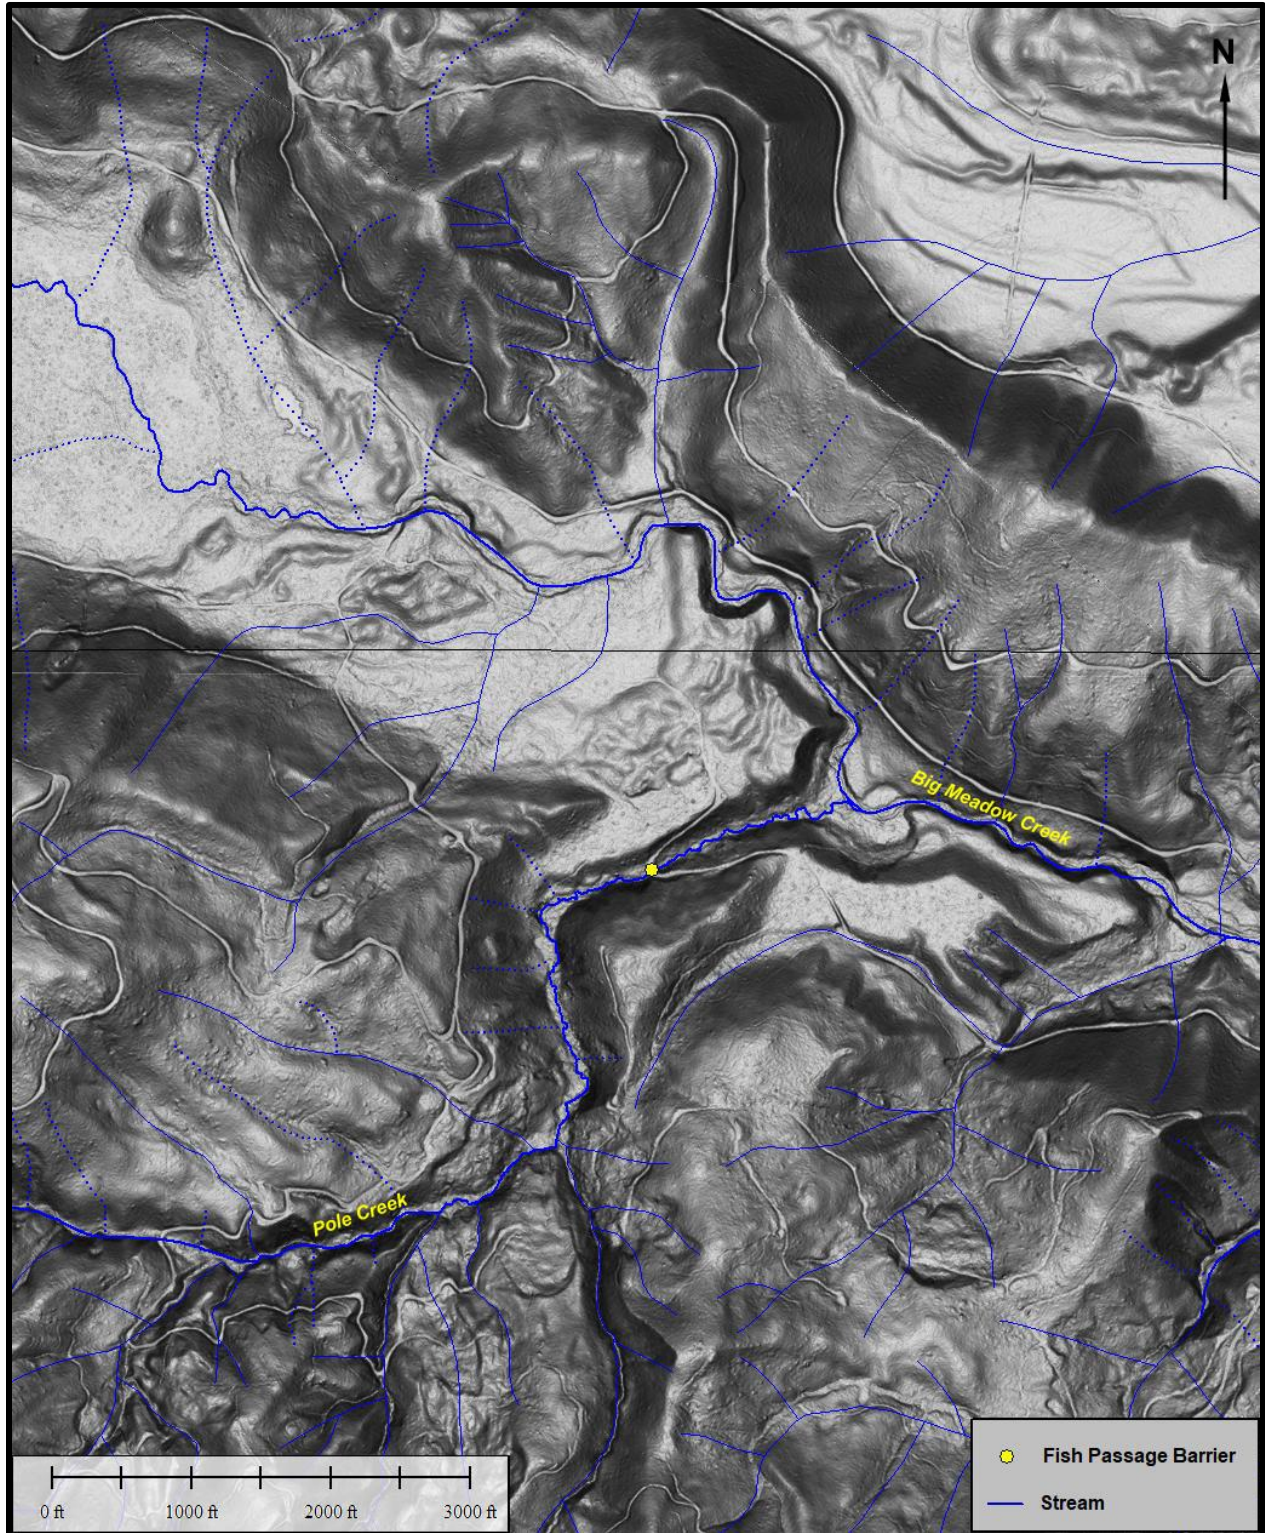
Figure 1. Shaded relief map of the lower Pole Creek project area.

Shaded relief derived from 2015 Chelan County LiDAR digital elevation models

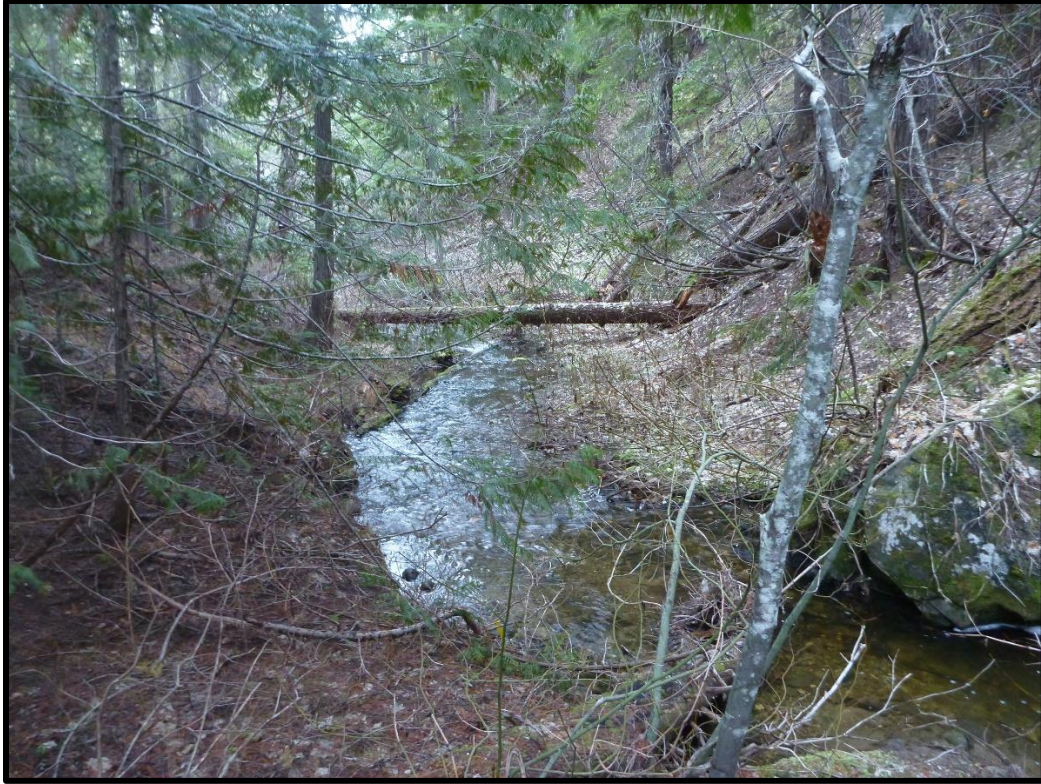
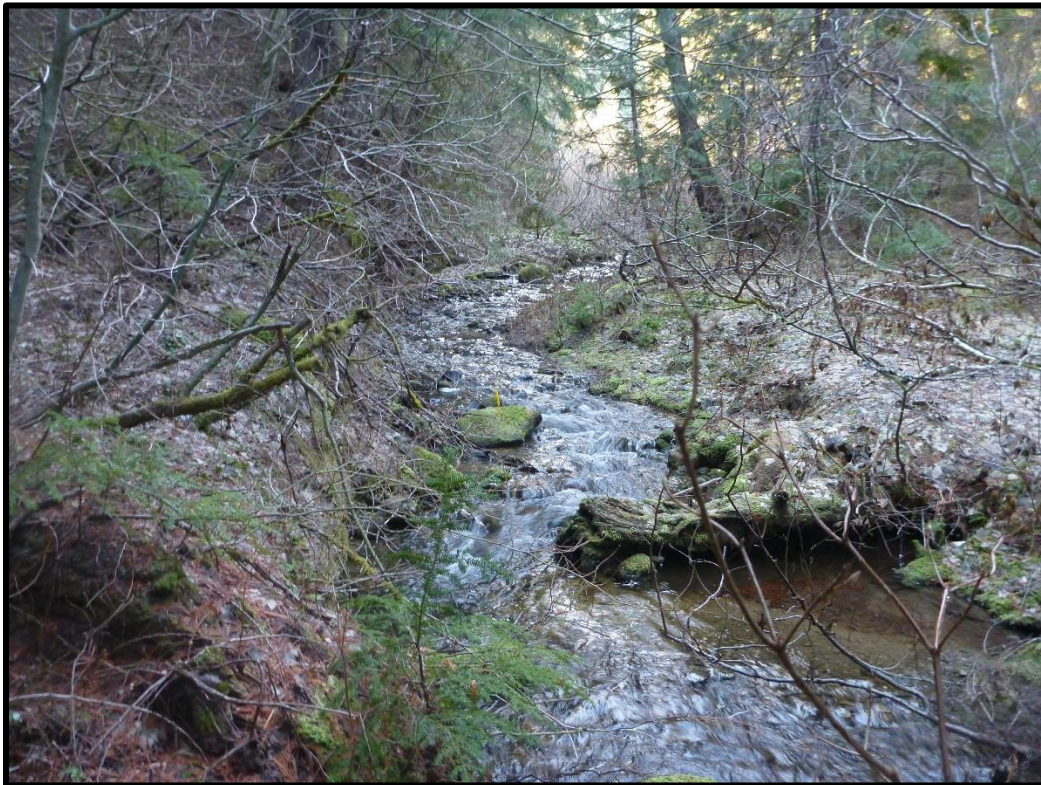
Figure 3. Typical conditions along Pole Creek above the USFS 6305-111 Road crossing.

The riparian area along Pole Creek has a diverse set of conifer species including mature mountain hemlock (*Tsuga mertensiana*), western red cedar (*Thuja plicata*), grand fir (*Abies grandis*), Douglas-fir (*Pseudotsuga menziesii*), and Pacific silver fir (*Abies amabilis*). Other tree and shrub species include black cottonwood (*Populus trichocarpa*), mountain alder (*Alnus incana*), sitka alder (*Alnus sinuata*), Douglas maple (*Acer glabrum*), and red-osier dogwood (*Cornus stolonifera*). The riparian area along the upper Pole Creek crossing consists largely of mature trees (Figure 3).

Interpretation: The riparian vegetation communities immediately adjacent to the Pole Creek road crossing are relatively undisturbed, with mature trees lining much of the channel length. The deeply rooted trees and shrubs in the understory help to stabilize the stream banks and maintain cool water temperatures. The mature forest stand will also provide a long-term source of large woody debris to the stream channel.

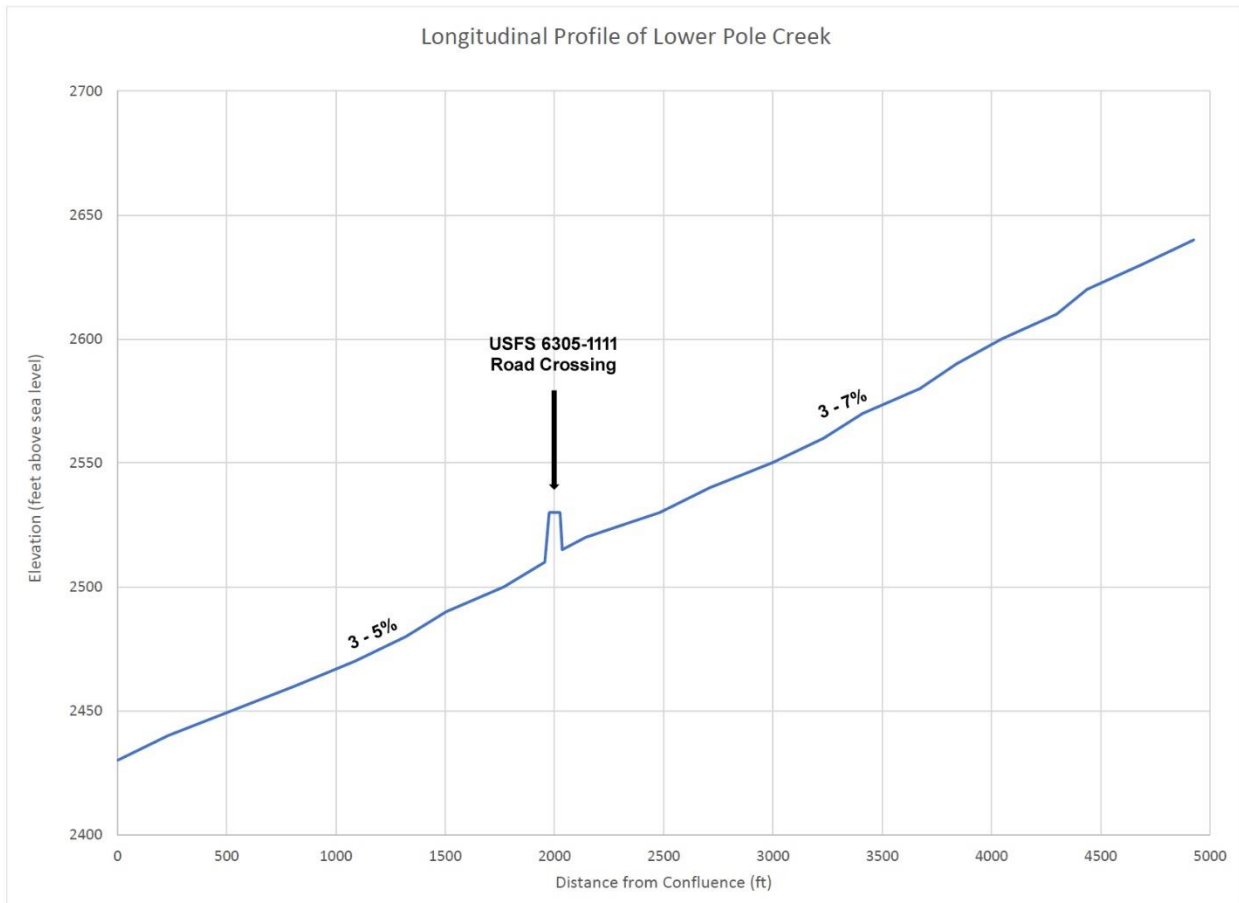
Figure 4. Longitudinal profile of lower Pole Creek above its confluence with Big Meadow Creek.

The stream channel above the USFS 6305-111 Road crossing generally ranges from 4 to 7 percent gradient, except for a short reach immediately above the crossing with a 3 percent channel gradient (Figure 4). The reach below the road crossing averages 4.5 percent gradient and then drops to 3 percent gradient as it reaches the Big Meadow Creek confluence. This entire stream reach is confined by glacial outwash terraces and Chumstick Formation sedimentary bedrock.

Interpretation: The lower reach of Pole Creek at the USFS 6305-111 Road crossing is an A3 Rosgen stream type that has a step-pool and plane-bed channel form. Low to moderate amounts of large wood are present in the channel that help to store sediment and create pools. No significant changes are expected in channel location or sediment supply at the road crossing. Minor grade control measures may be needed due to the large pool at the culvert outlet and the lower gradient channel caused by sediment storage above the culvert inlet. Otherwise, the channel gradient on either side of the crossing is similar and has a low potential for significant head-cutting following culvert replacement.
