# Washington Department of Fish and Wildlife

## Level A Culvert Assessment Report

Site ID: <b>040016</b>	Stream: <b>Beaver Cr</b>	WRIA: <b>45.0751</b>	
Latitude: <b>47.766919723</b>	Tributary To: <b>Wenatchee R</b>	Fish Use Potential: <b>Yes</b>	
Longitude: <b>-120.65282193</b>

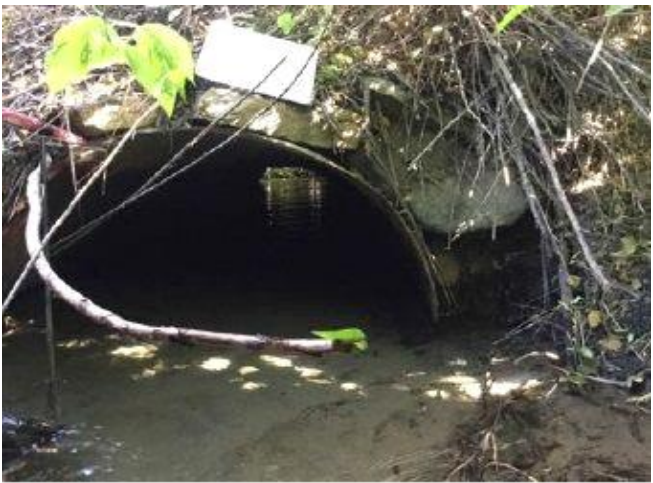
Culvert Details							Level A Parameters						
ID	Shape	Material	Span	Rise	Length	WDIC	Apron	WSDrop	Location	Countersunk	Backwater	Slope (%)	Sediment
1.1	SQSH	CST	1.43	0.91	10.10	0.20	NO	0.00		Yes	No	-0.52

<b>Channel Description</b>	
Toe Width (m):	<input type="text" value="2.7"/>
Average Width (m):	<input type="text" value="3.70"/>
Culvert/Stream Width Ratio:	<input type="text" value="0.39"/>
<b>Plunge Pool</b>	
Length (m):	<input type="text" value="0.00"/>
Max Depth (m):	<input type="text" value="-99.99"/>
OHW Width (m):	<input type="text" value="-999.99"/>
<b>Road</b>	
Fill Depth (m):	<input type="text" value="2.00"/>

<b>Assessment Results</b>			
Tidal Influence:	<input type="text"/>	Tidegate Present:	<input type="text" value="No"/>
Barrier:	<input type="text" value="Yes"/>	Passability (%):	<input type="text" value="67"/>
Reason:	<input type="text" value="Velocity"/>	Fishway Present:	<input type="text" value="No"/>
		Method:	<input type="text" value="Level B"/>
		Recheck:	<input type="text"/>

<b>Comments</b>
[LvlB-Barrett,12/12/2017,FishXing. Depth Crit N/A. Qfp = 0.77 cms]
