Fish Passage & Diversion Screening Inventory Database Report Cover Sheet

Level A Culvert Assessment Report

Site ID: 603923	Stream: Eagle Cr	WRIA: 45.0404	
Latitude: 47.62729444	Tributary To: Chumstick Cr	Fish Use Potential: Yes	
Longitude: -120.63583333

**WDFW Fish Passage and Diversion Screening Inventory Database
Image Report - Active**

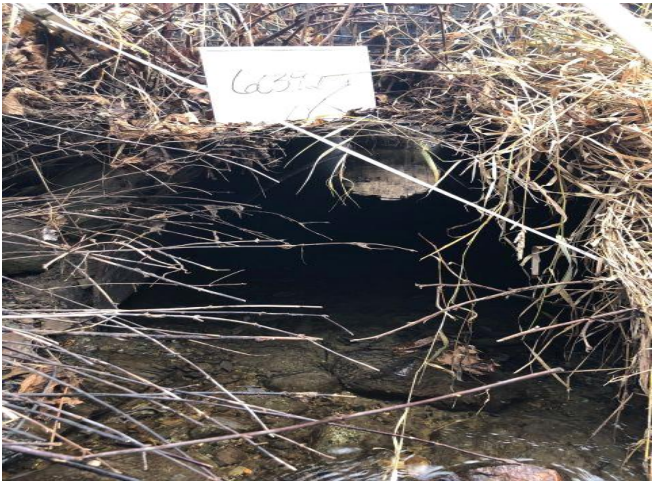
Culvert Details						Level A Parameters							
ID	Shape	Material	Span	Rise	Length	WDIC	Apron	WSDrop	Location	Countersunk	Backwater	Slope (%)	Sediment
1.1	RND	SST	1.13	1.19	7.20	0.21	NO	0.00		No	No	2.50

Assessment Results			
Tidal Influence:	<input type="text"/>	Tidegate Present:	<input type="text" value="No"/>
Barrier:	<input type="text" value="Yes"/>	Passability (%):	<input type="text" value="33"/>
Reason:	<input type="text" value="Slope"/>	Fishway Present:	<input type="text" value="No"/>
		Method:	<input type="text" value="Level A"/>
		Recheck:	<input type="text"/>

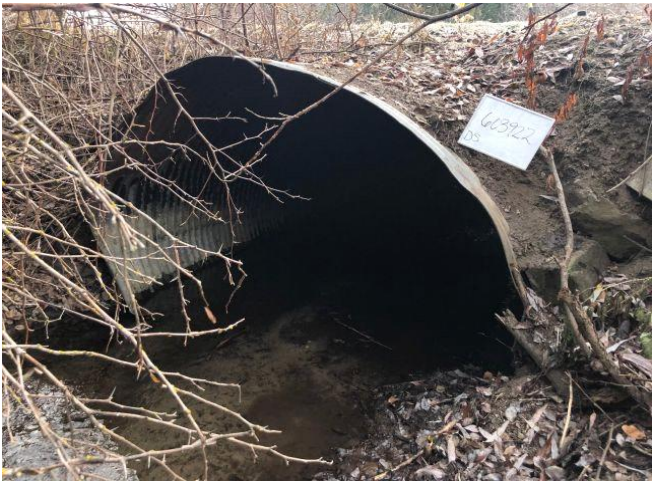
Culvert Details						Level A Parameters							
ID	Shape	Material	Span	Rise	Length	WDIC	Apron	WSDrop	Location	Countersunk	Backwater	Slope (%)	Sediment
1.1	RND	CST	2.20	2.20	11.70	0.31	NO	0.00		Yes	No	0.25	Yes

Assessment Results		Tidal Influence:	<input type="text" value="No"/>	Tidegate Present:	<input type="text" value="No"/>
Barrier:	<input type="text" value="Yes"/>	Passability (%):	<input type="text" value="67"/>	Method:	<input type="text" value="Level B"/>
Reason:	<input type="text" value="Velocity"/>	Fishway Present:	<input type="text" value="No"/>	Recheck:	<input type="text"/>

[LvIB,Barrett,FishXing,4/8/2021. Depth Crit = NA. Qfp = 2.06 cms]. Note: check for upstream diversions or impoundments which may influence high fish passage flows.

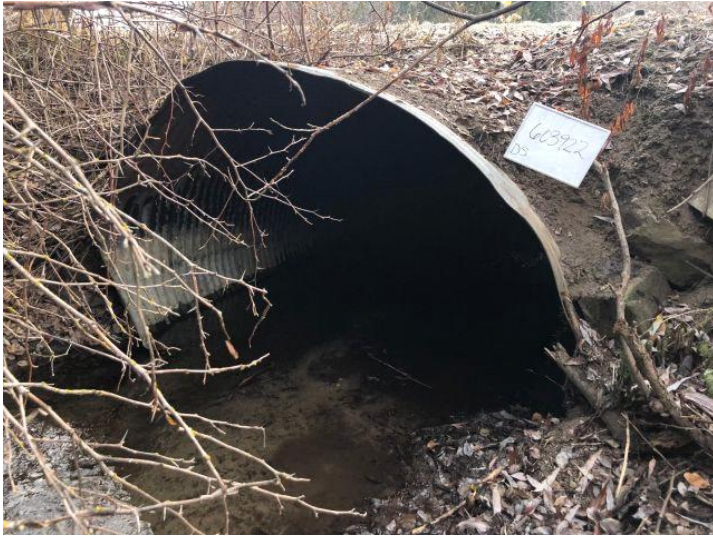
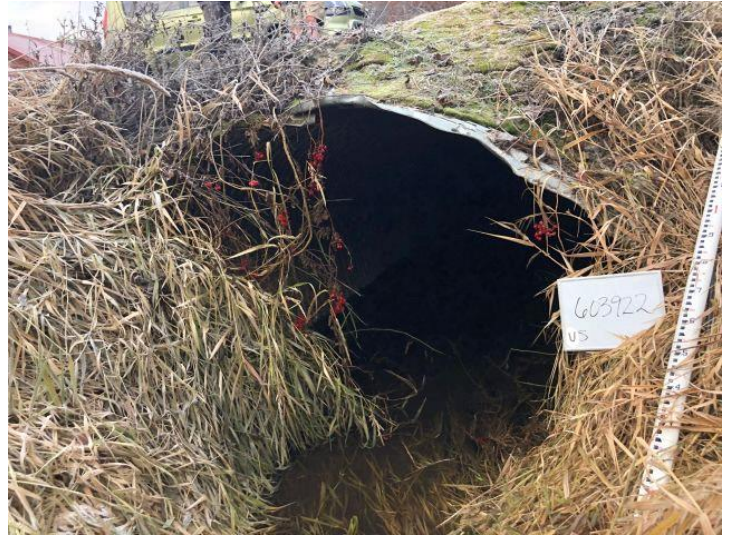
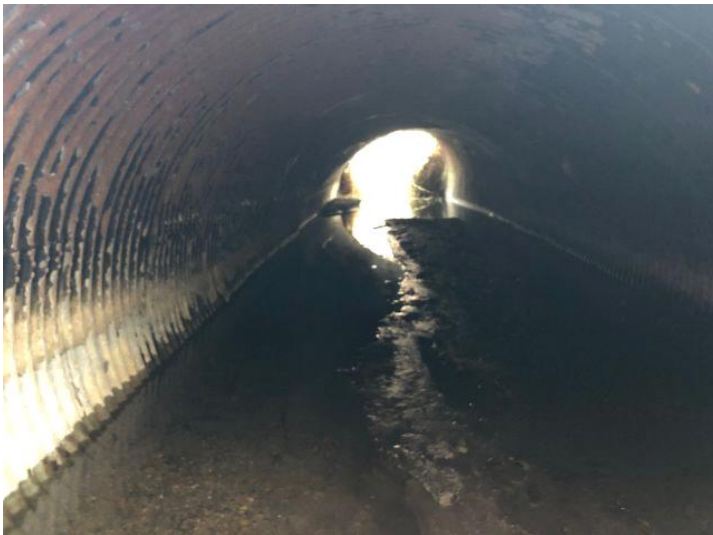
Site ID: 603922	Stream: Eagle Cr	WRIA: 45.0404
Latitude: 47.62675833	Tributary To: Chumstick Cr	Fish Use Potential: Yes
Longitude: -120.6369444

Steep driveway going to crossing - shared between private owners. Site overgrown with heavy reed canary grass.

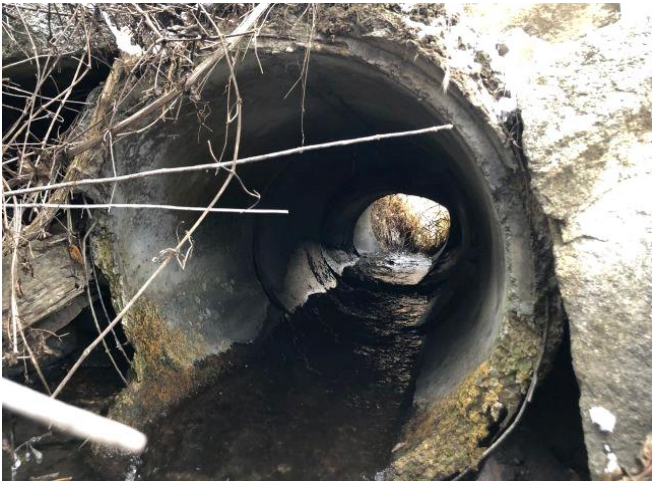
Assessment Results			
Tidal Influence:	<input type="text"/>	Tidegate Present:	<input type="text" value="No"/>
Barrier:	<input type="text" value="Yes"/>	Passability (%):	<input type="text" value="33"/>
Reason:	<input type="text" value="Slope"/>	Fishway Present:	<input type="text" value="No"/>
		Method:	<input type="text" value="Level A"/>
		Recheck:	<input type="text"/>

Comments
 Additional small water surface drops in interior. Damaged on inside, broken in four sections - no seams are connected.

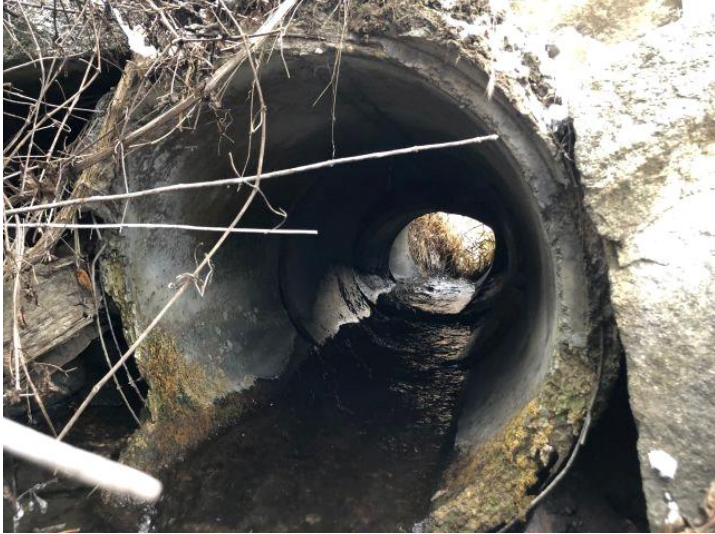
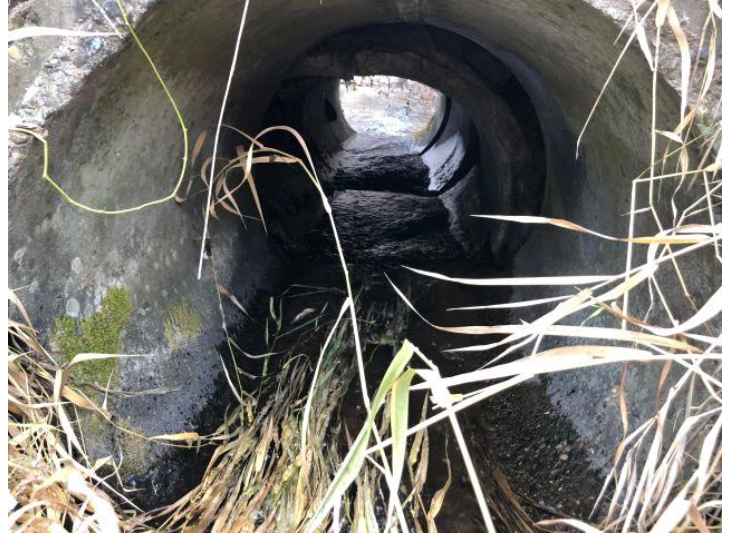
Heavy reed canary grass upstream.

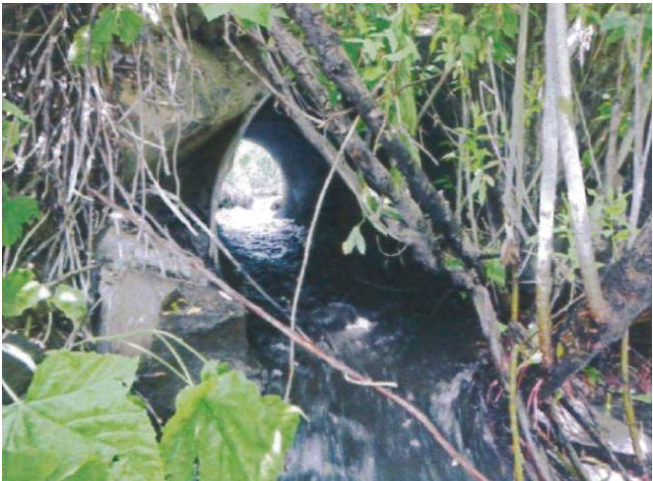
Assessment Results			
Tidal Influence:	<input type="text"/>	Tidegate Present:	<input type="text" value="No"/>
Barrier:	<input type="text" value="Yes"/>	Passability (%):	<input type="text" value="33"/>
Reason:	<input type="text" value="Slope"/>	Fishway Present:	<input type="text" value="No"/>
		Method:	<input type="text" value="Level A"/>
		Recheck:	<input type="text"/>

Comments
 Overflow culvert located on left bank. No substrate in pipe - signs of high velocity flows.
