Methow River

Assessment of the Twisp to Carlton
Reach

January 2017, Final

Prepared for Cascade Columbia Fisheries Enhancement Group
Project Name Methow River
 Assessment of the Twisp to Carlton Reach
Project Number E316005900
Project Manager Jon Ambrose
Date January 2017, Final

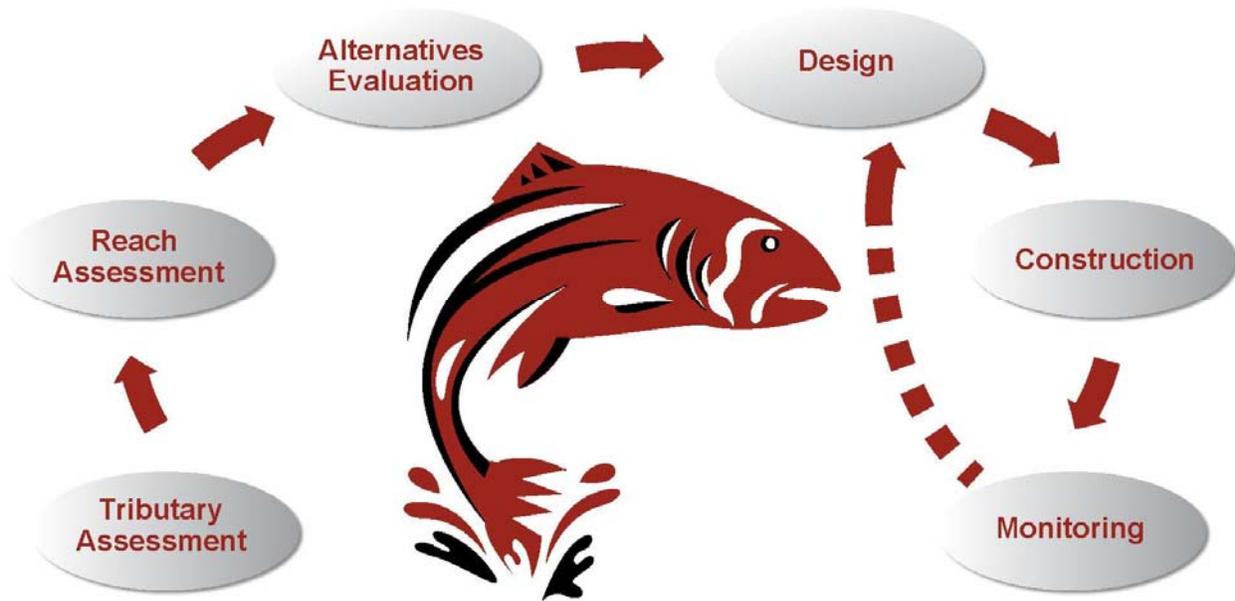
Figure 1-1 Bureau of Reclamation (2011) flow chart showing the reach assessment in the context of habitat restoration design, implementation, and monitoring.

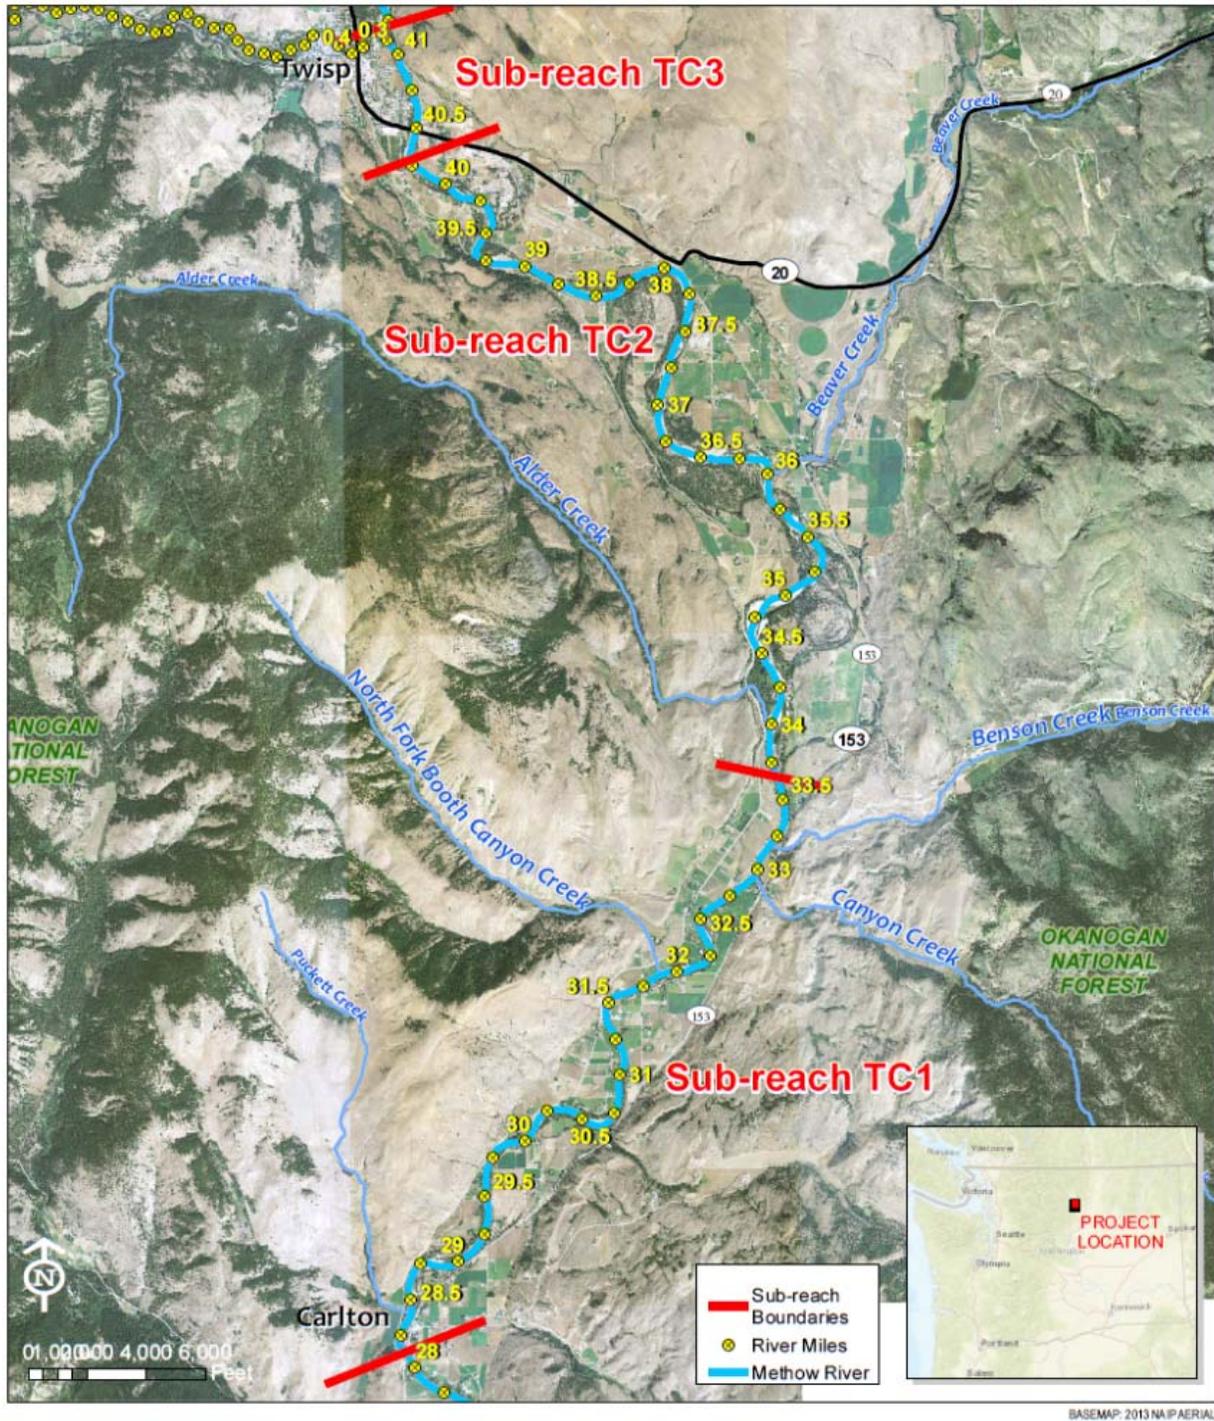
Figure 2-1 Twisp to Carlton Assessment Reach. Sub-reach boundaries are as follows: TC1 [RM 28.1–33.7], TC2 [RM 33.7–40.3], and TC3 [RM 40.3–41.3].

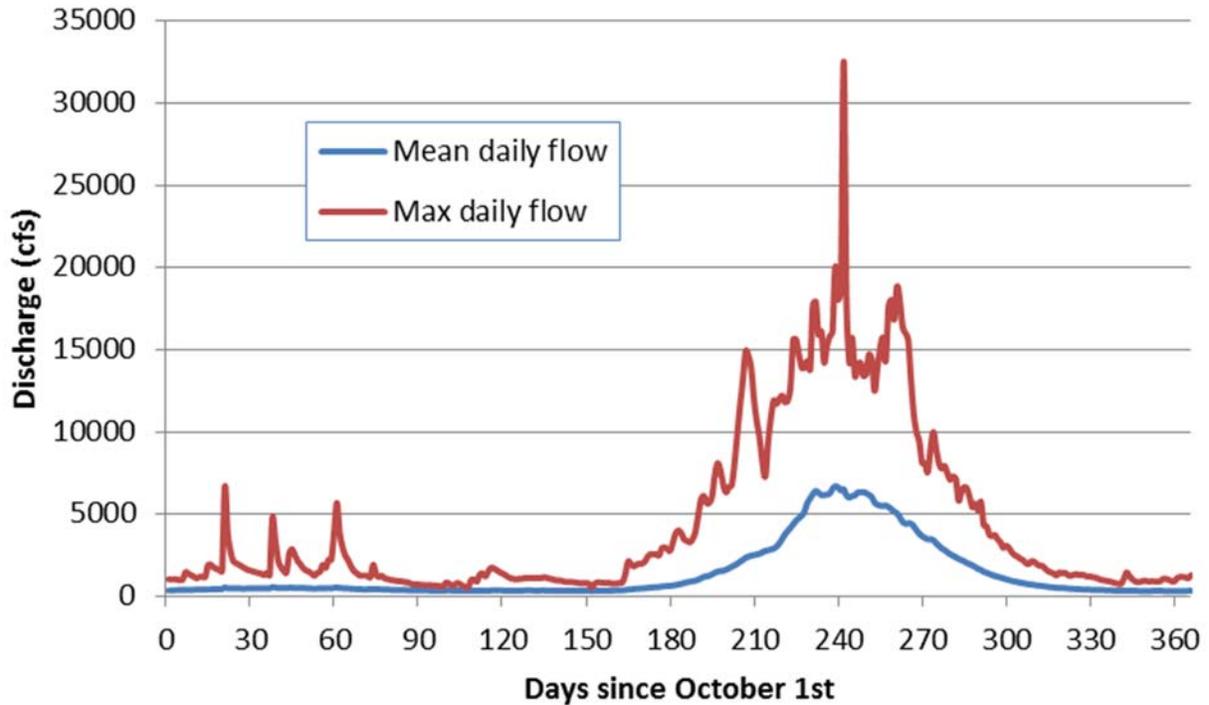
Figure 3-1 Mean and maximum daily flows of the Methow River at USGS gage 12449500, just downstream of the Twisp River confluence.

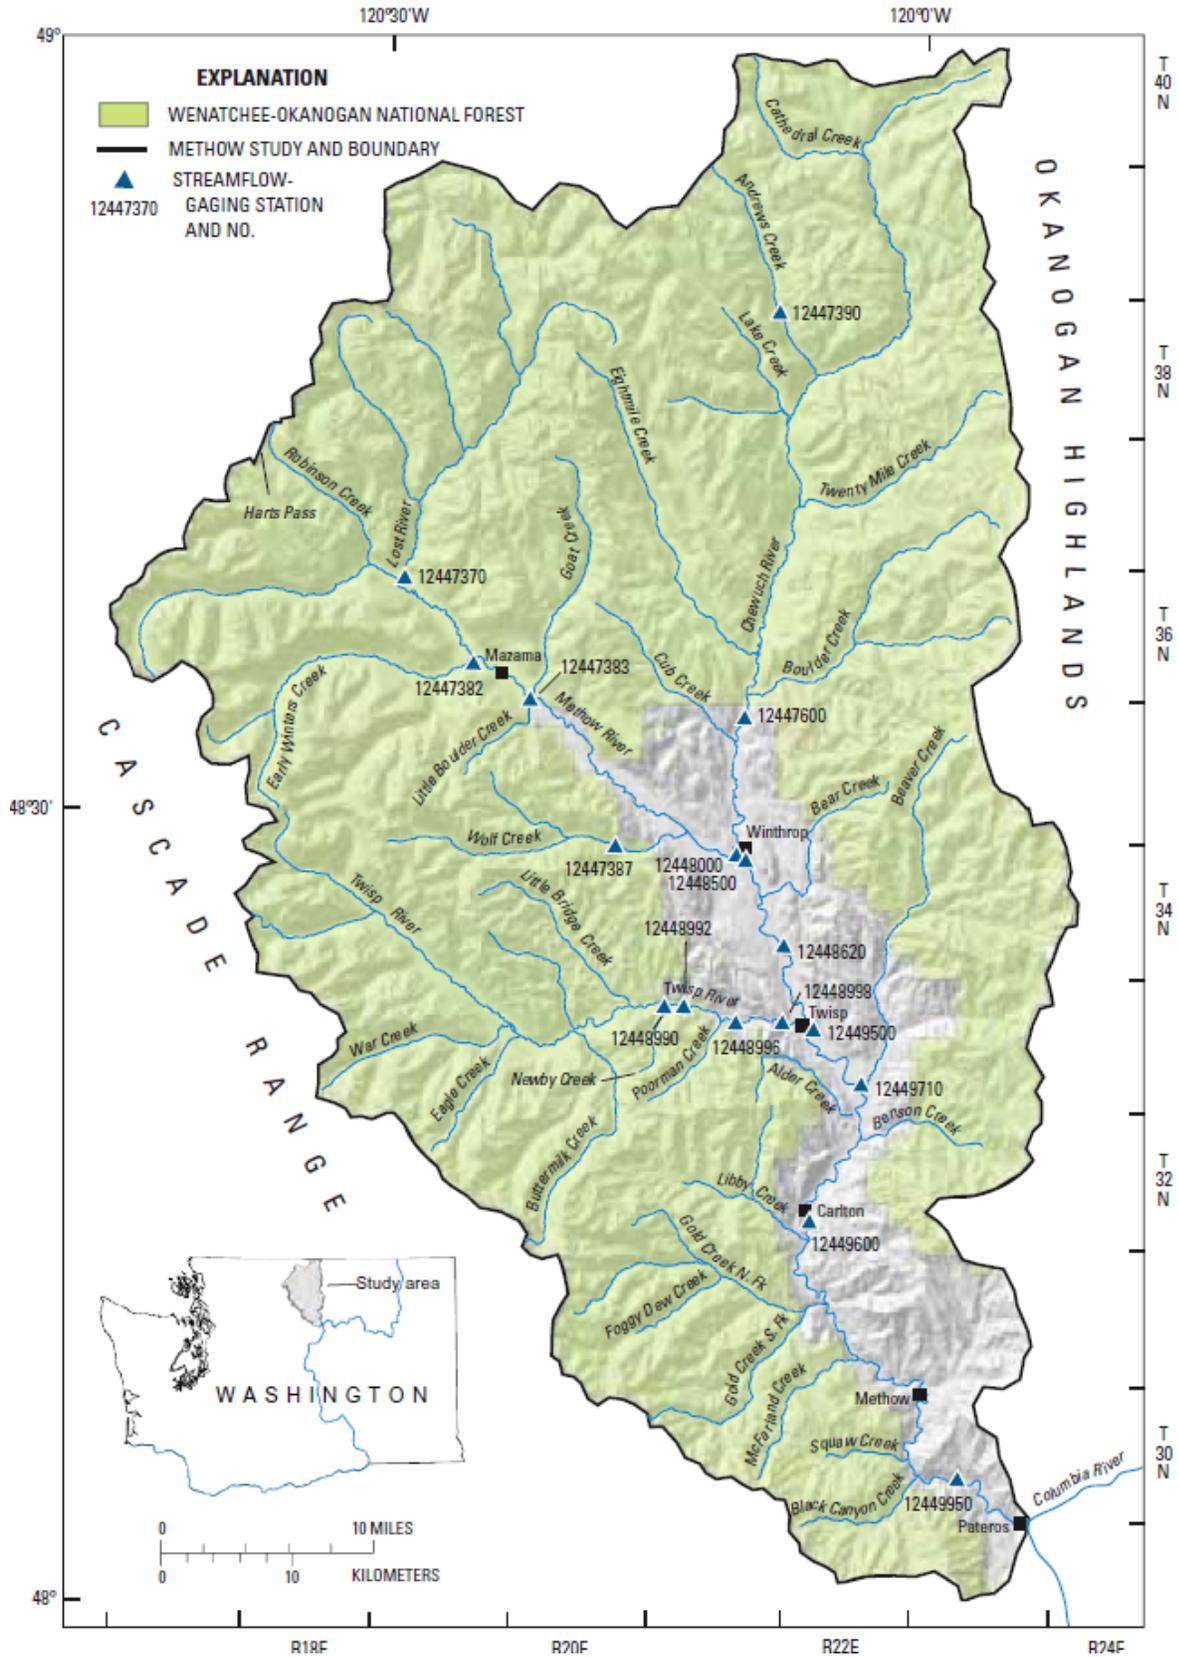
Figure 3-2 Methow Subbasin drainage and stream gage locations map (Konrad et al. 2003).

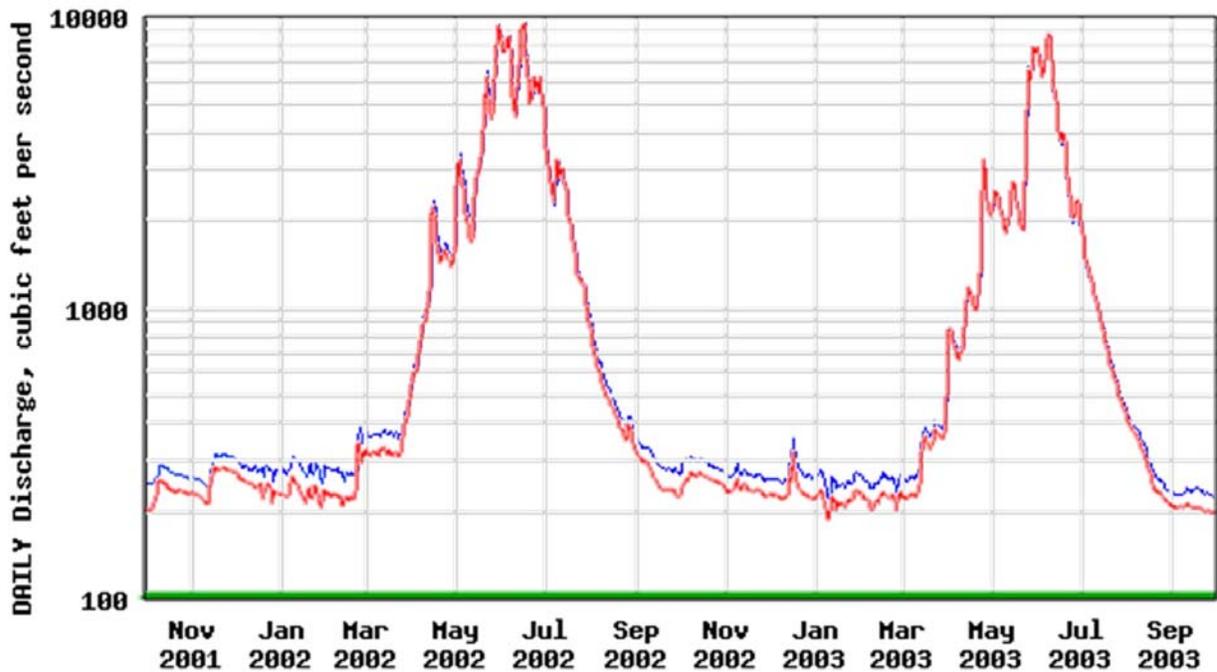
Figure 3-3 Comparison of USGS gage records for the Methow River at Twisp (12449500, in red) and Carlton (12449760, in blue).

During low-flow conditions, the Methow River experiences gains and losses in flow to groundwater (Konrad et al. 2003). The gaining and losing sections are best characterized by the sub-reaches between the major tributary inputs. These three groundwater reaches extend from Twisp to Beaver Creek (including all of TC3 and the upper portion of TC2), Beaver Creek to Benson Creek (lower portion of TC2), and Benson Creek to Carlton (TC1). The reach from Twisp to Beaver Creek consistently gained flow from groundwater inputs during the evaluation period of Konrad et al. (2003). The middle groundwater reach from Beaver to Benson Creek is a transient reach, with losses to groundwater or no change in flow during fall low flows, and flow gains during winter months. The lower reach consistently saw modest gains in flow (a large portion of which were within measurement error).

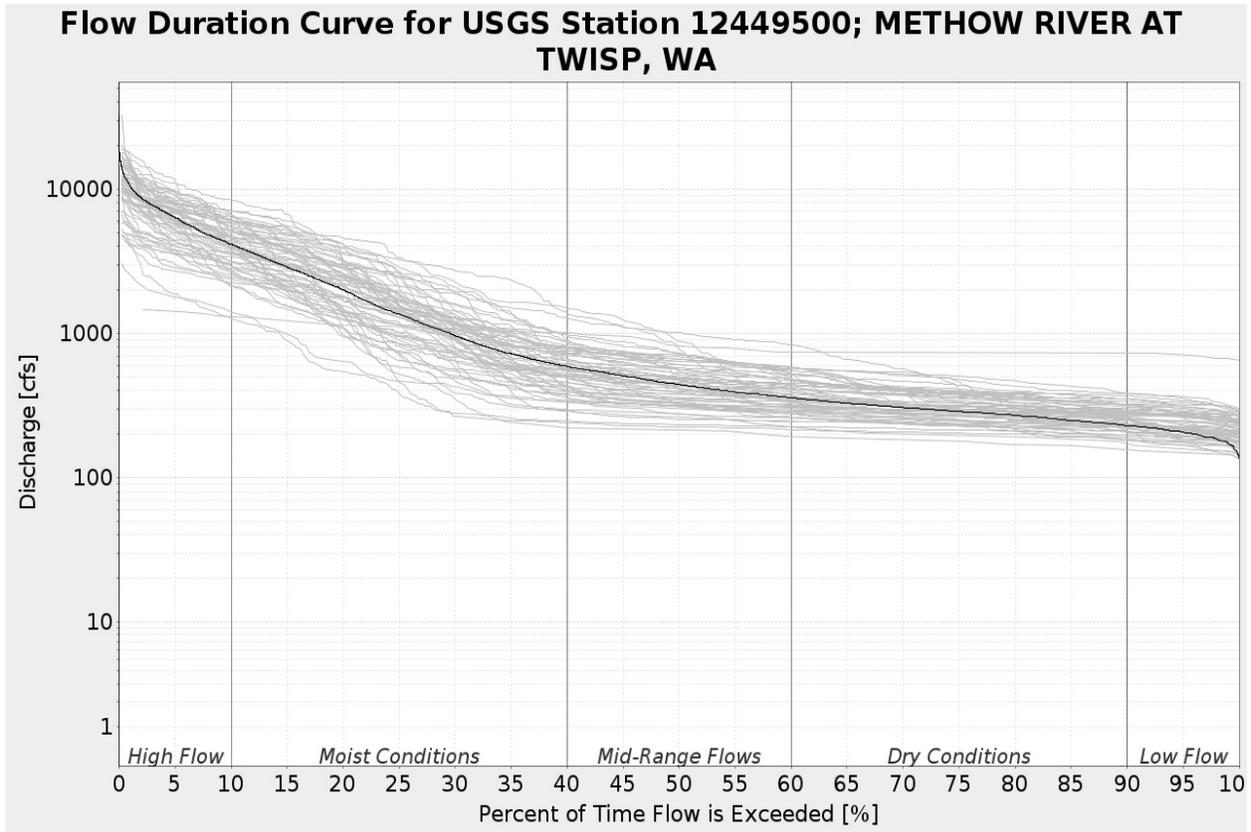
Figure 3-4 Aggregate flow-duration curve for the Methow River at the head of the Twisp to Carlton reach.

Note: The solid line is the median flow-duration curve for the 95 years of record; gray lines are plots of each individual year and show variability from year to year (plotted from www.erams.com).

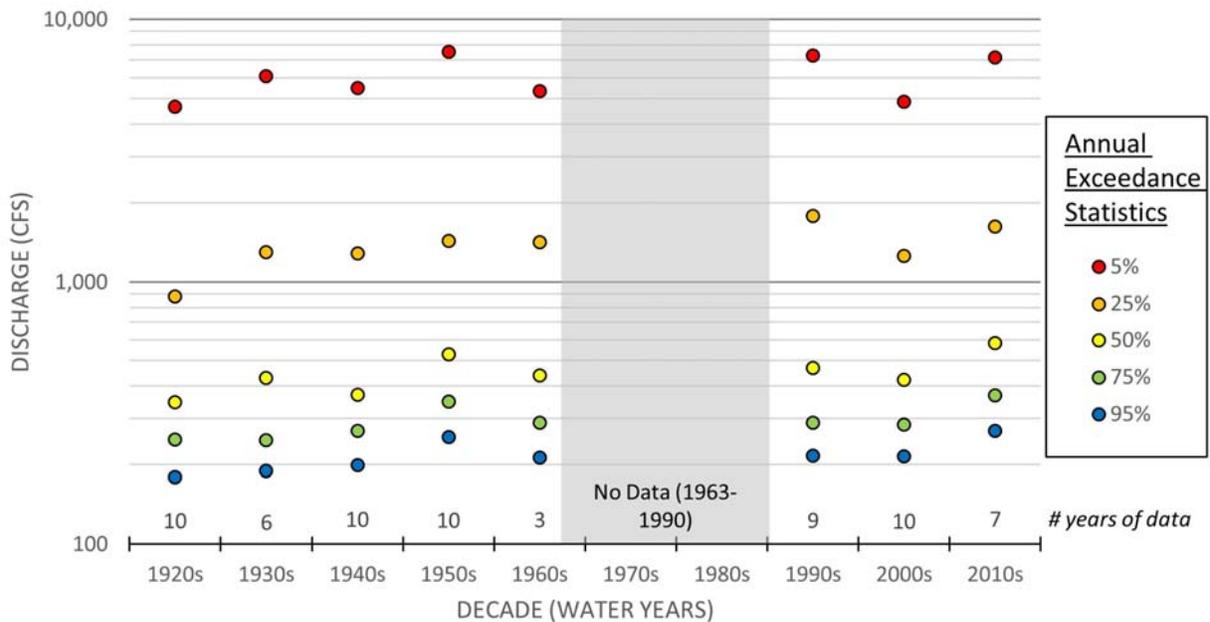
Figure 3-5 Annual exceedance statistics by decade for the flow record at Twisp (USGS gage 12449500).

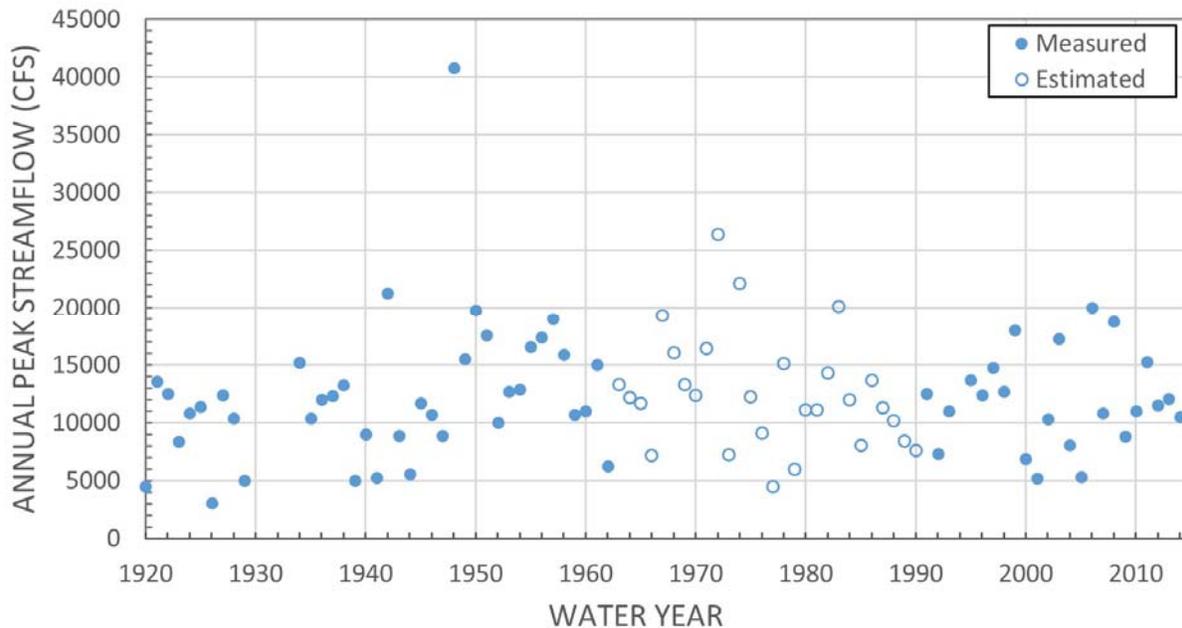
Figure 3-6 Historical peak flows for the stream gage at Twisp.

Note: Flow estimates (1963–1990) used a regression equation developed in this Assessment for the overlapping peak flow records of the Methow River gages at Twisp (12449500) and Pateros (12449950), which is $Q_{\text{Twisp}} = 0.88 Q_{\text{Pateros}} + 982$ ($R^2 = 0.97$).

Annual peaks (Figure 3-6) reflect the relatively uniform snowmelt-dominated hydrologic regime from year to year, with nearly all annual peaks within a factor of two above or below the 2-year discharge of about 11,100 cfs. The most noteworthy exception is the flood of 1948, which had a maximum discharge of about 40,000 cfs, which is far above the statistical confidence limits for the projected 100-year flood (Figure 3-7). The second exception is the flood of 1972. Despite these exceptions, the overall consistency of this record suggests that restoration actions intended to promote the reactivation of floodplain areas and side channels on an annual or biannual basis will not normally need to withstand flows many times greater than about 20,000 cfs, a condition of general uniformity that is not necessarily experienced in other parts of Washington state (or elsewhere).

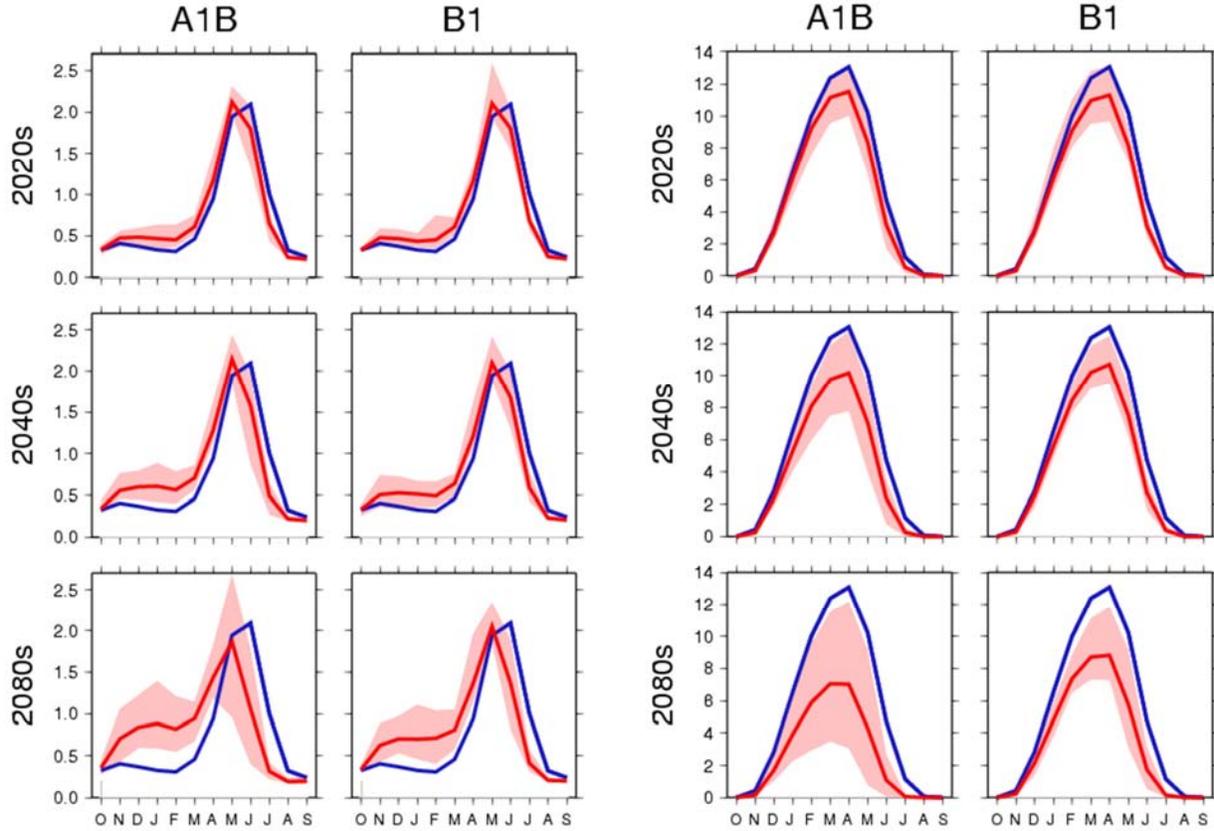
Figure 3-8 Projections of future hydrographs (“combined flow”) and SWE under two emissions scenarios, for the 2020s, 2040s, and 2080s.

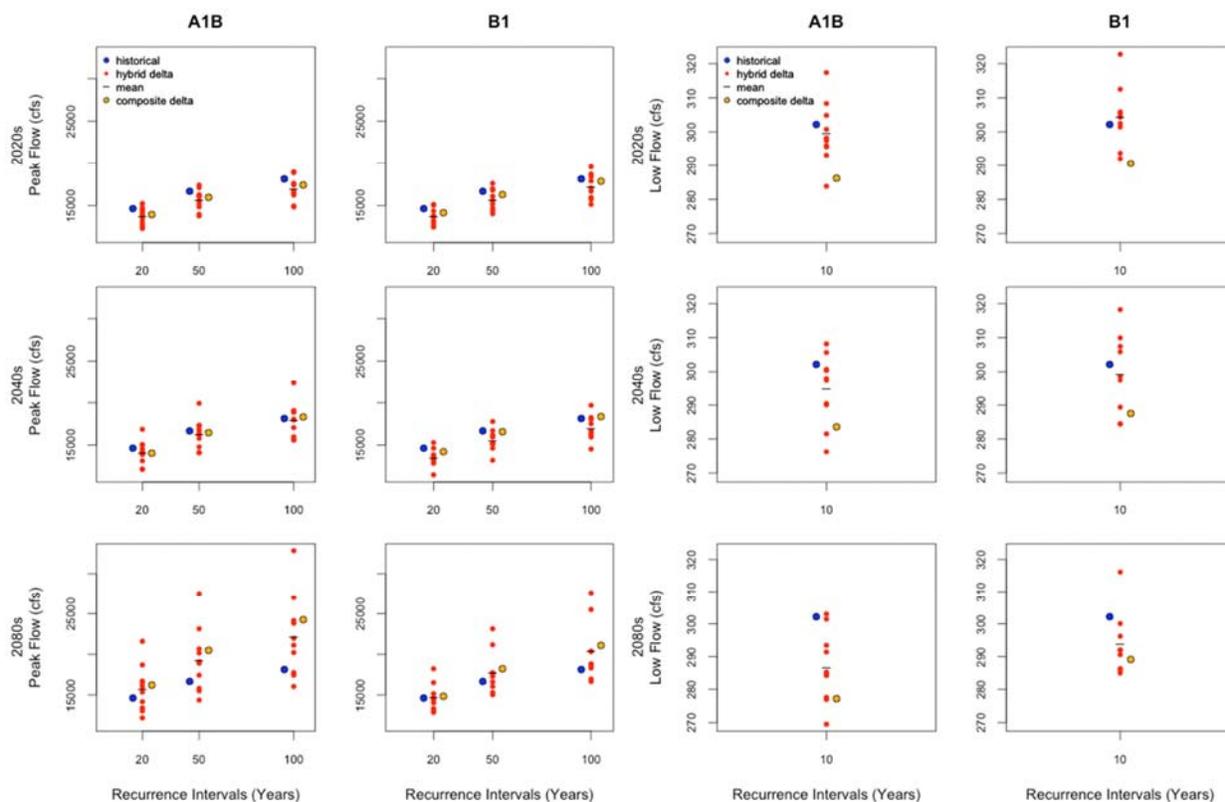
Figure 3-9 Projections of future peak and low flows under two emissions scenarios, for the 2020s, 2040s, and 2080s.

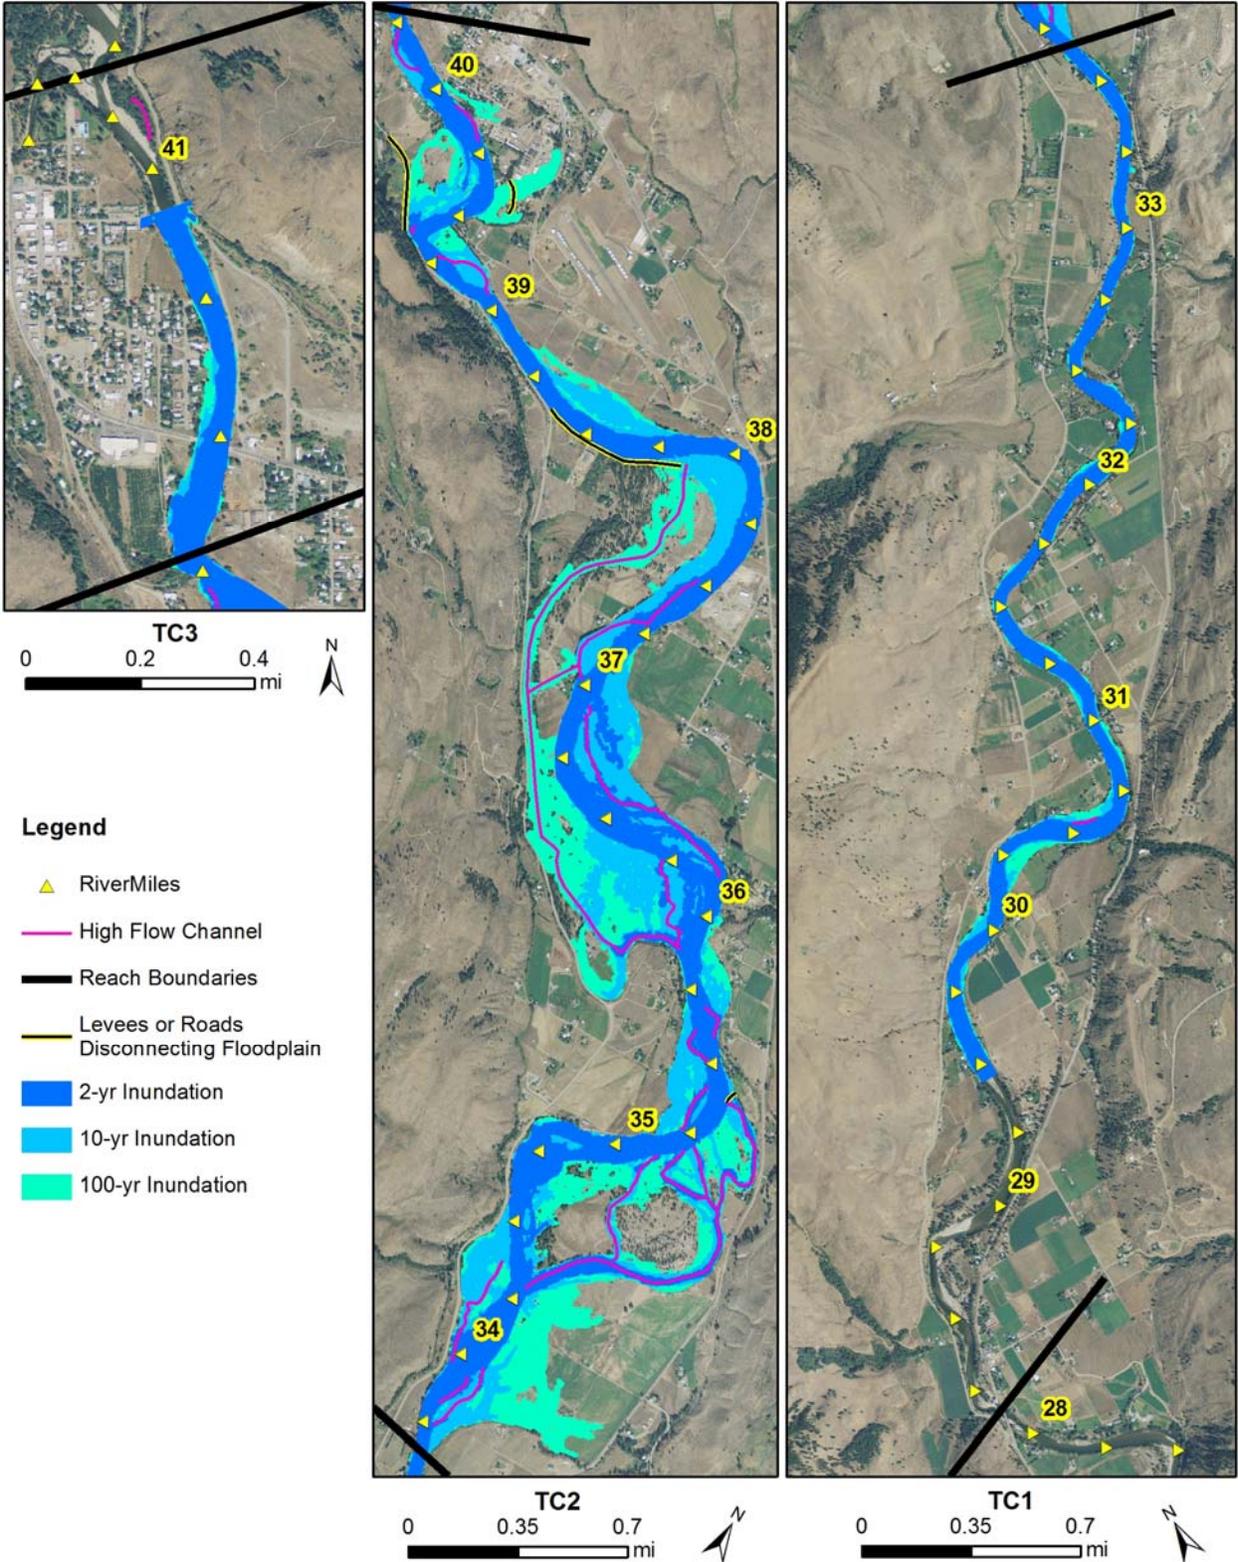
Figure 3-10 Modeled flood inundation along the sub-reaches (Reclamation 2014).

The hydraulic modeling results help to map flood inundation patterns and activation of the existing network of ephemeral floodplain channels. Figure 3-10 shows floodplain inundation patterns by sub-reach, as well as mapped human constraints on inundation within the natural floodplain. Disconnected floodplain areas are concentrated within TC2, where about 5,000 feet of levee/road actively limit floodplain inundation. TC1 and TC3 are naturally confined, and therefore have no features disconnecting flooding, despite their extensive bank hardening (discussed Section 3.4.3 above).

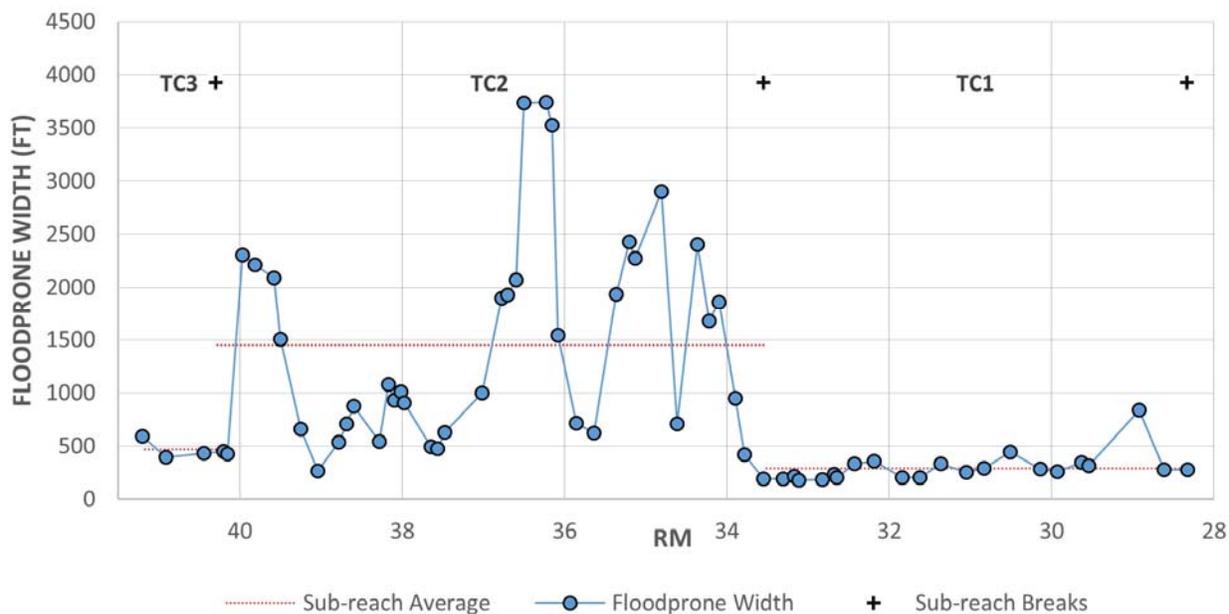
Figure 3-12 Floodprone width along the Assessment Reach.

The Twisp to Carlton reach runs along a highly variable valley morphology shaped by glaciation and subsequent fluvial incision. Using floodplain width as a metric, the channel runs through a floodplain of varying width along the Assessment Reach (Figure 3-12). In the uppermost sub-reach (TC3), the channel is confined by a combination of bedrock and inactive river and glacial terraces, and has a straight planform. TC2 has the widest floodplain of the three sub-reaches, but also contains much variation. Three fully unconfined sections are distributed within the reach, including the “Red Shirt Mill” section from RM 40.0 to 39.3, the “Beaver Ponds” section from RM 38.4 to 35.8, and the “Silver Side Channel” section from RM 35.5 to 33.7. These three sub-sections were respectively referred to as M2c, M2b, and M2a in the *Methow River Geomorphic Assessment* (Reclamation 2008) (and are TC2c, TC2b, and TC2a here) and have the greatest diversity in floodplain landforms, with abundant high-flow and abandoned channels. These floodplain channels in part have resulted from historical channel migration, but also are a product of the multi-threaded, anabranching channel likely present before European settlement. Currently the TC2 channel is single-thread with a sinuosity of 1.33. In the intervening sections of narrow floodplain in TC2, the channel again comes into contact with bedrock valley walls and the glacio-fluvial terraces present in sub-reach TC3. TC1 is almost entirely confined by the glacio-fluvial terraces, with localized zones of inset floodplain typically no wider than the bankfull channel.

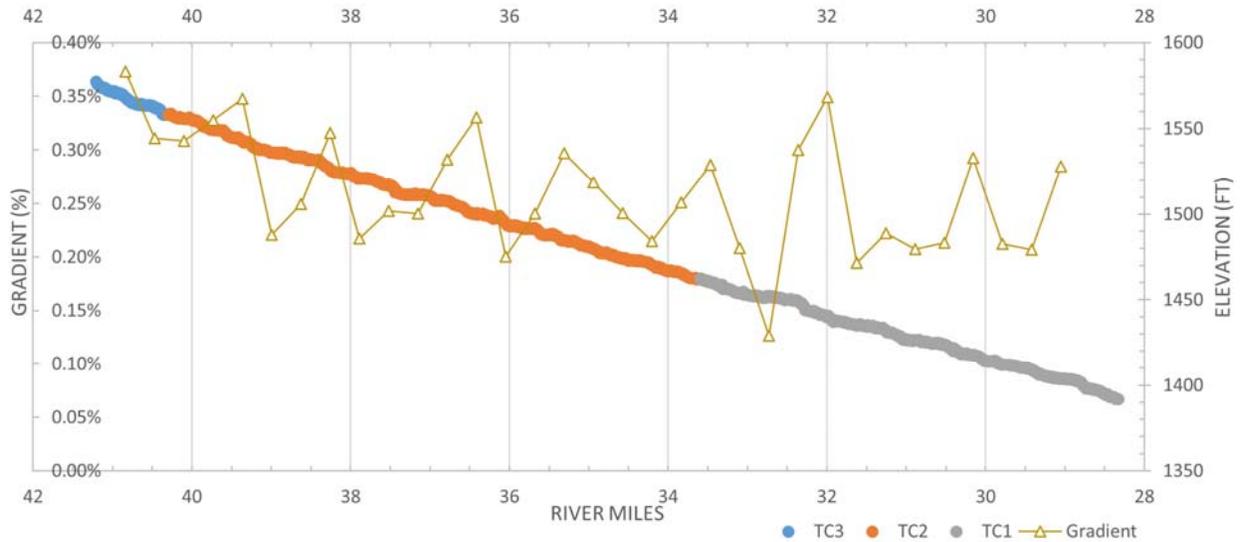
Figure 3-13 Longitudinal profile of the Assessment Reach.

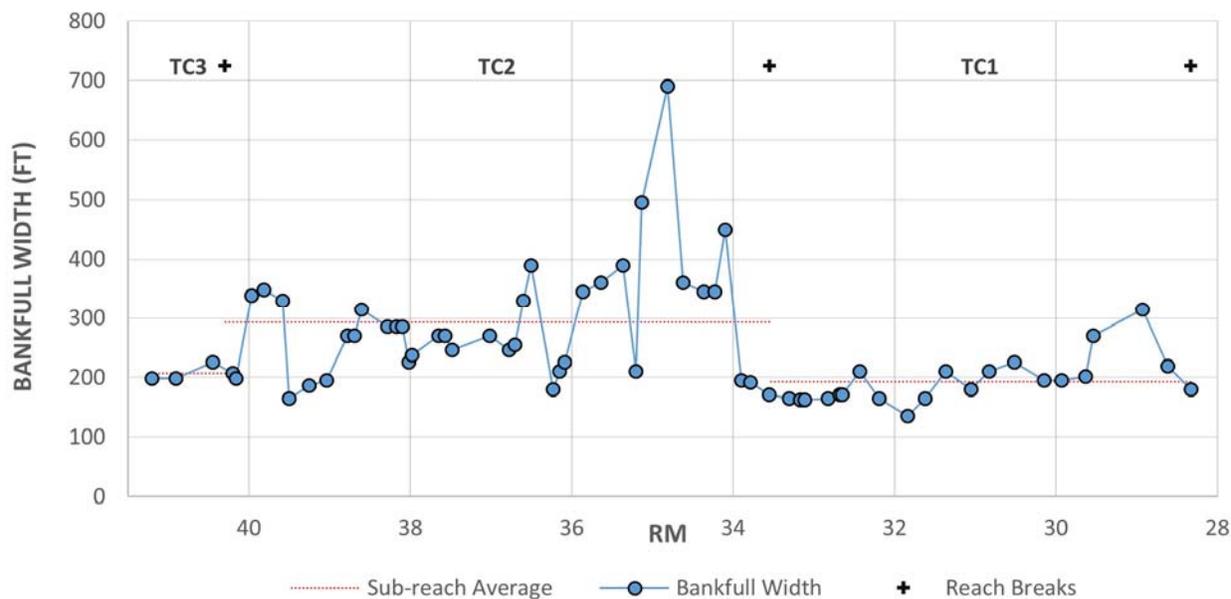
Figure 3-14 Bankfull width along the Assessment Reach.

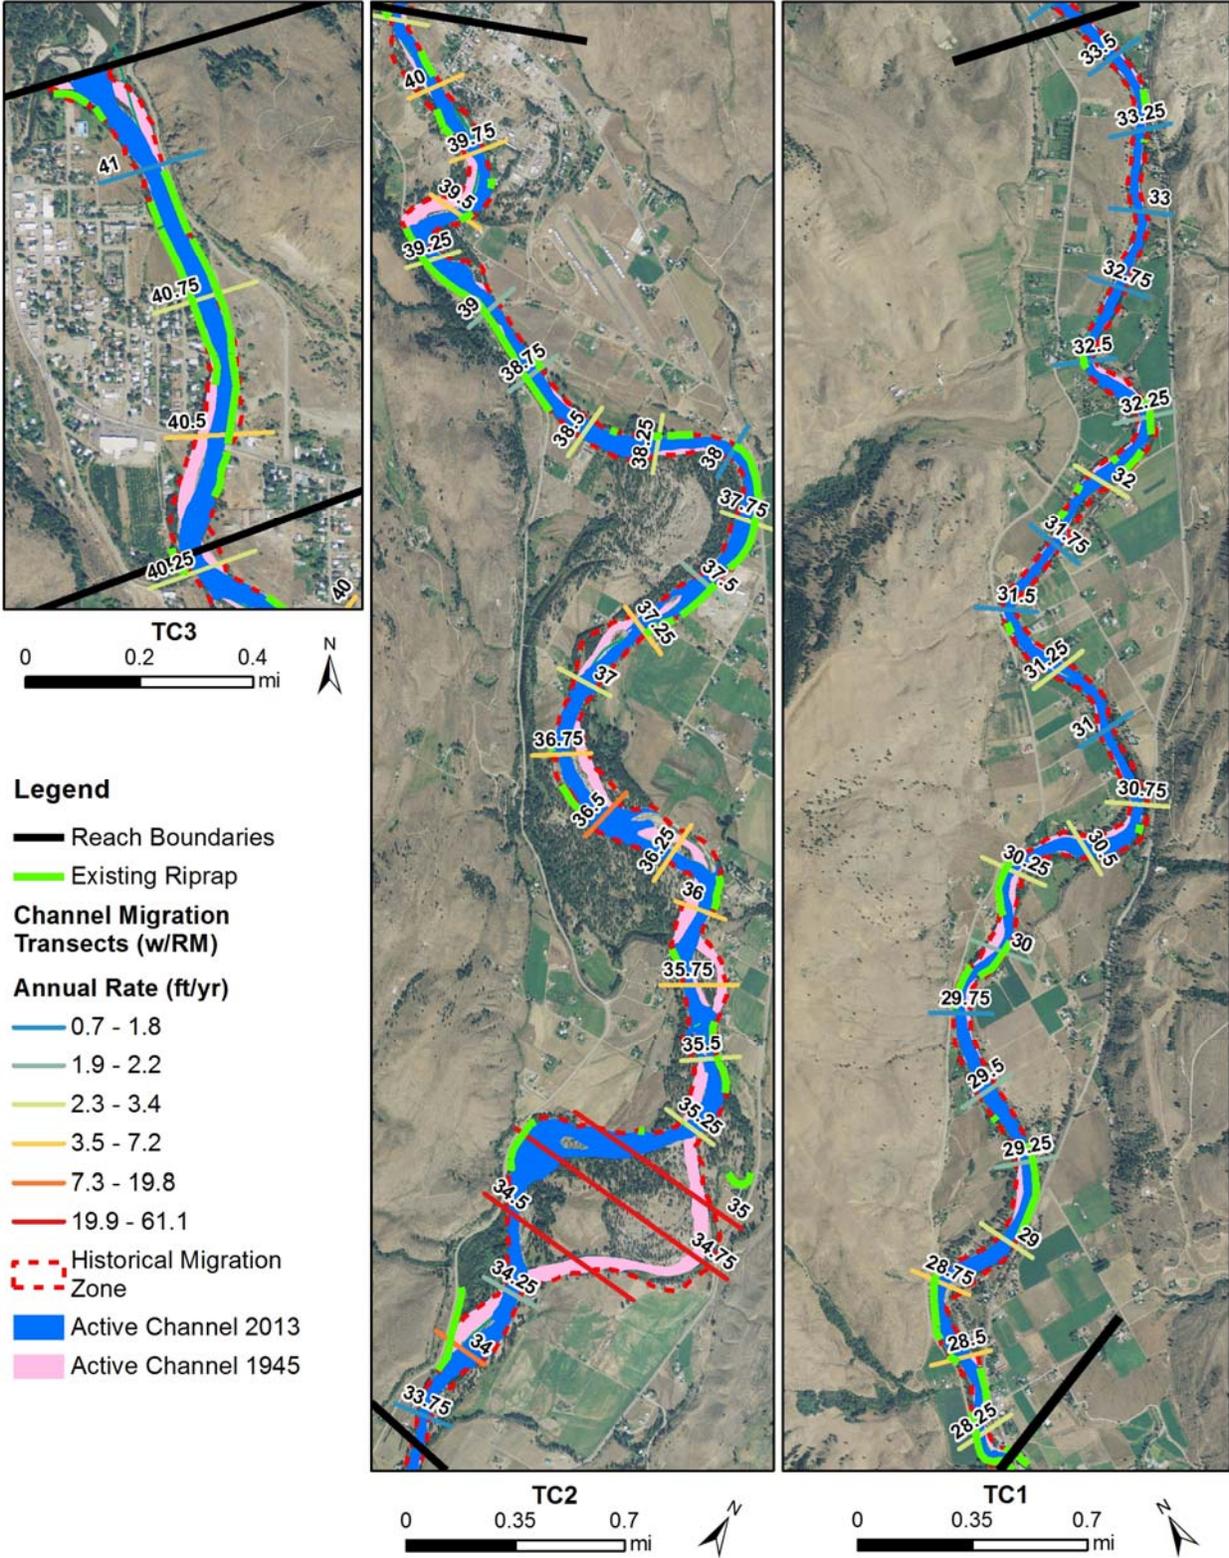
Figure 3-15 Map showing channel migration measurement transects and average annual rates along the each sub-reach (average rates for period of record).

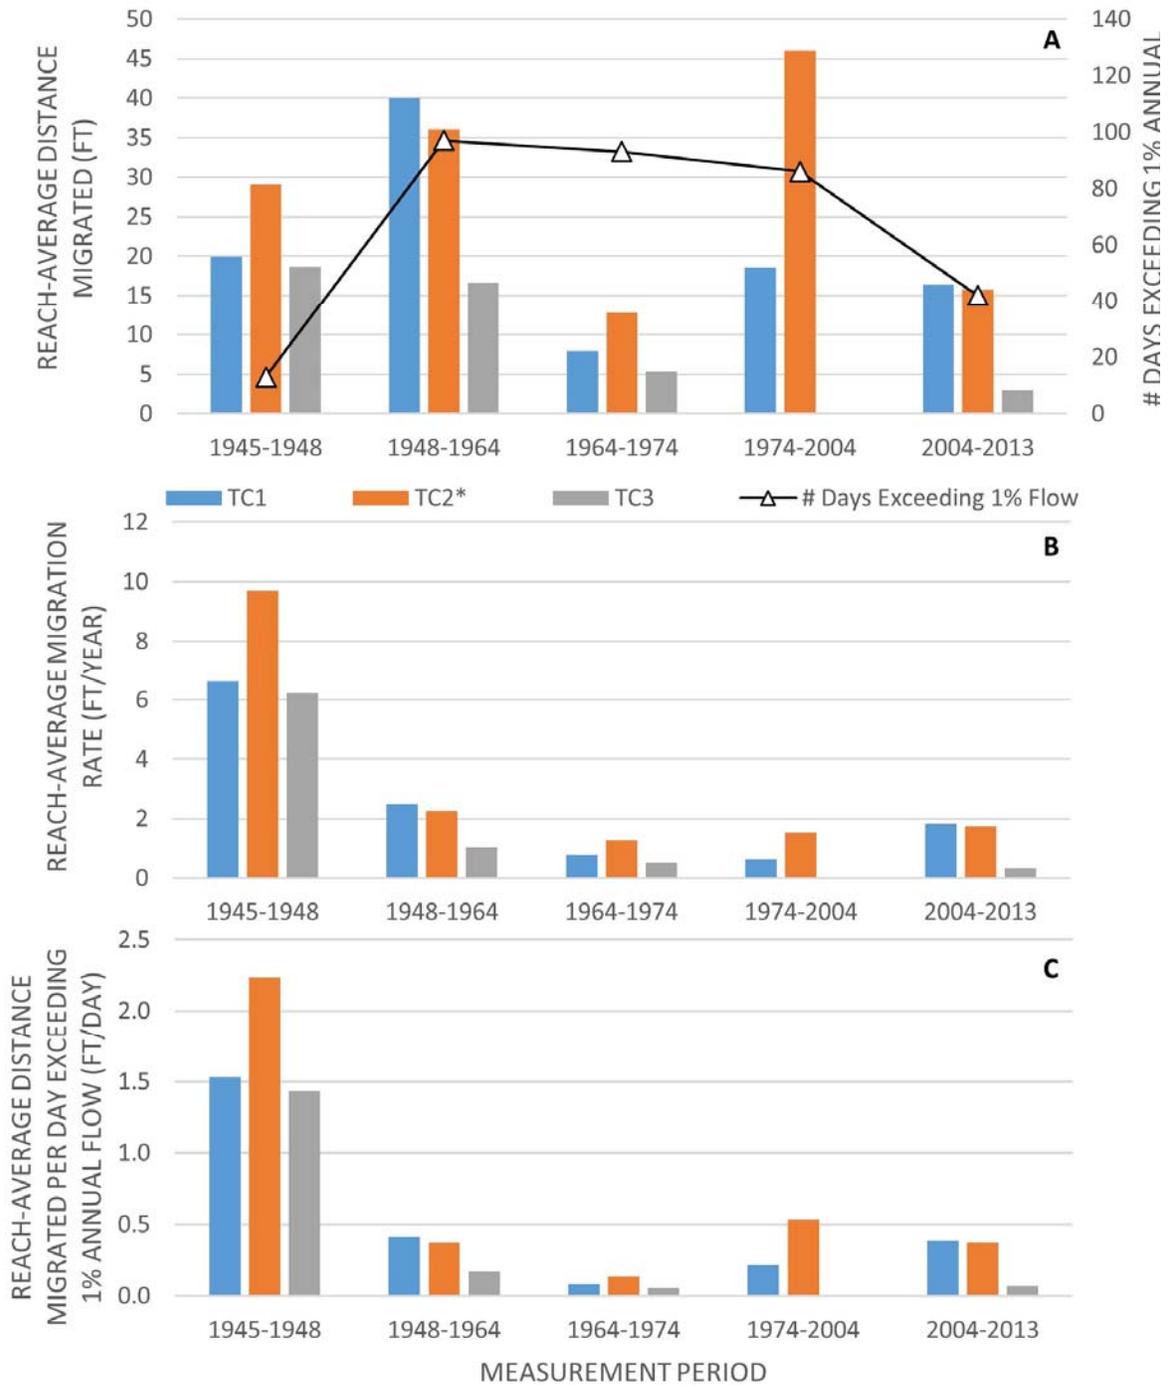
Figure 3-16 Temporal summary of channel migration on a sub-reach basis.

Note: Chart A shows distance migrated for each measurement period and the number of days in each period exceeding 1% annual flow as a measure of total duration of flood flows experienced in each period. Chart B shows annual migration rates. Chart C shows rates of migration (ft/day) relative to each day when flow exceeded the 1% annual discharge. * TC2 calculations excluded transects coinciding with the Silver Side Channel avulsion (RMs 34.5–35.0).

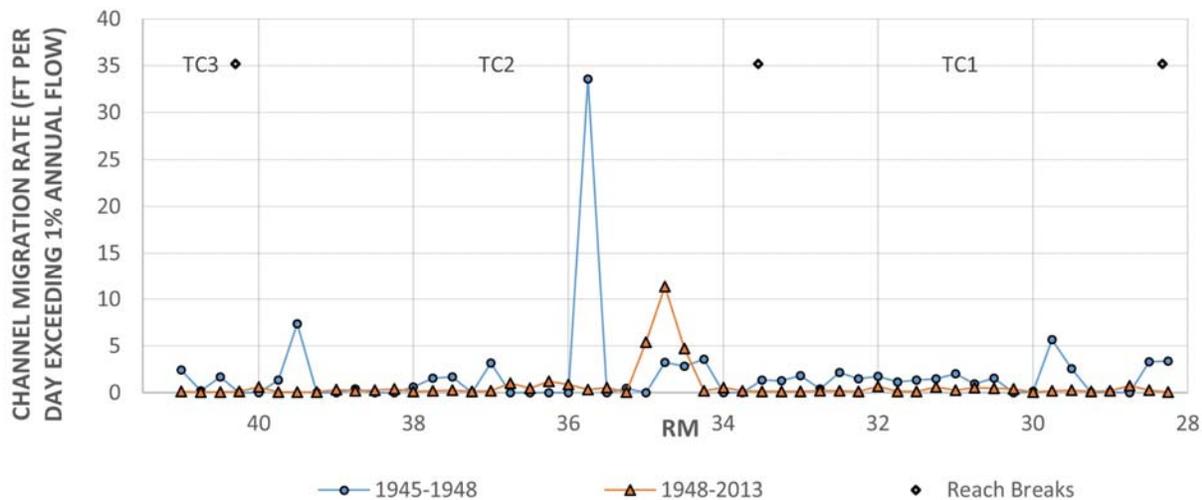
Figure 3-17 Longitudinal channel migration rates (relative to flows exceeding the 1% annual flow) for two measurement periods.

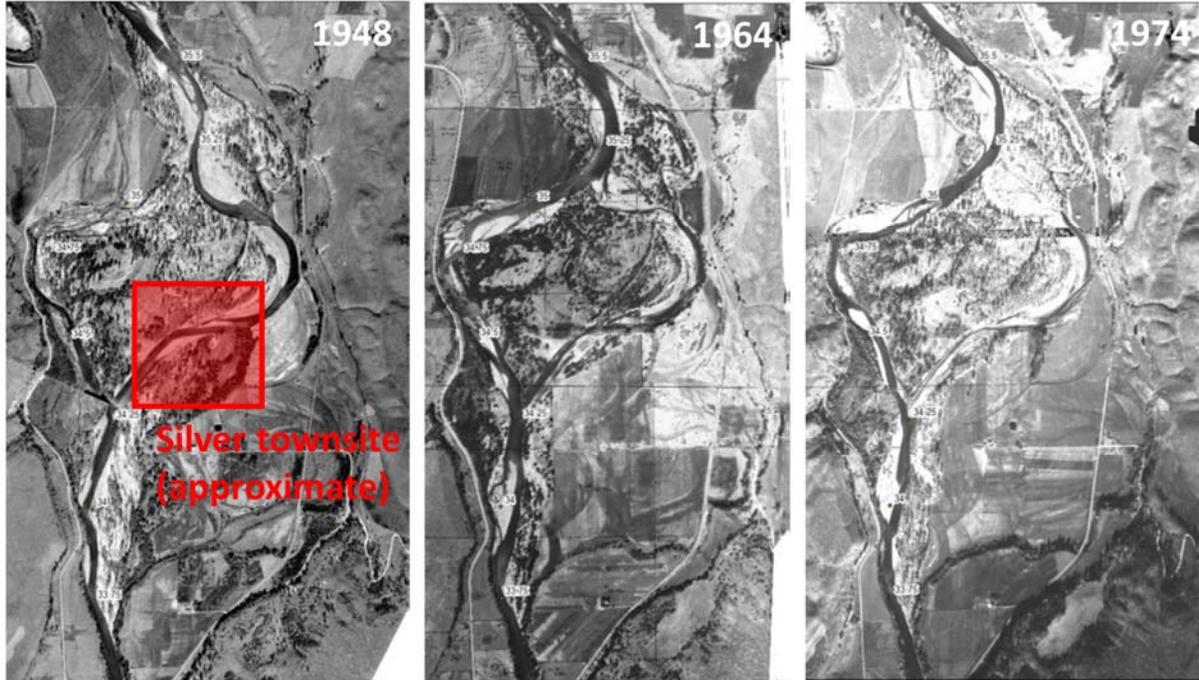
Figure 3-18 Channel migration and avulsion at the Silver townsite from 1948–1974.

The above history demonstrates the style of avulsion activity in this particularly active segment of sub-reach TC2. Of particular note is the abrupt avulsion (1894) relative to the gradual avulsion occurring the 1940s and 1950s, and the recurrence of such events, suggesting a possibility of similar events in the future.

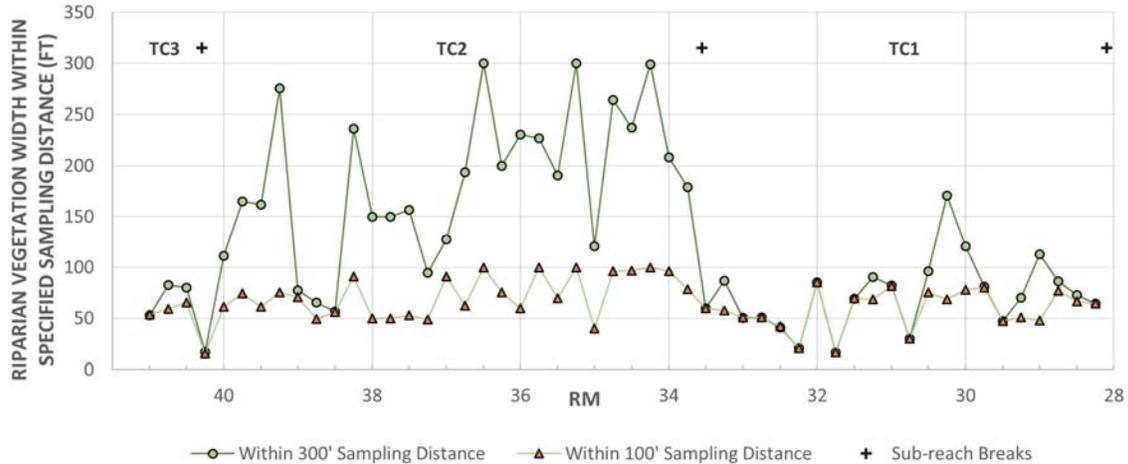
Figure 3-19 Widths of riparian vegetation as measured using 100-foot and 300-foot sampling buffers.

Using riparian vegetation mapping from the Methow In-Channel Habitat Restoration Plan (Reclamation 2008), riparian widths were measured within 100-foot and 300-foot wide sampling transects spaced every 0.25 RM. Within each buffer distance, the average percent canopy cover was measured. These canopy cover percentages were then converted to non-contiguous riparian widths by multiplying canopy cover percent by buffer width. Figure 3-19 shows these riparian width measurements longitudinally along the Assessment Reach, with sub-reach averages reported in Table 3-11. In general, riparian buffers are most degraded in TC1 and TC3. While floodplain development is significant in TC2, some significant patches of vegetation are present.
