Methow River

Assessment of the Twisp to Carlton
Reach

January 2017, Final

Prepared for Cascade Columbia Fisheries Enhancement Group
Project Name Methow River
 Assessment of the Twisp to Carlton Reach
Project Number E316005900
Project Manager Jon Ambrose
Date January 2017, Final

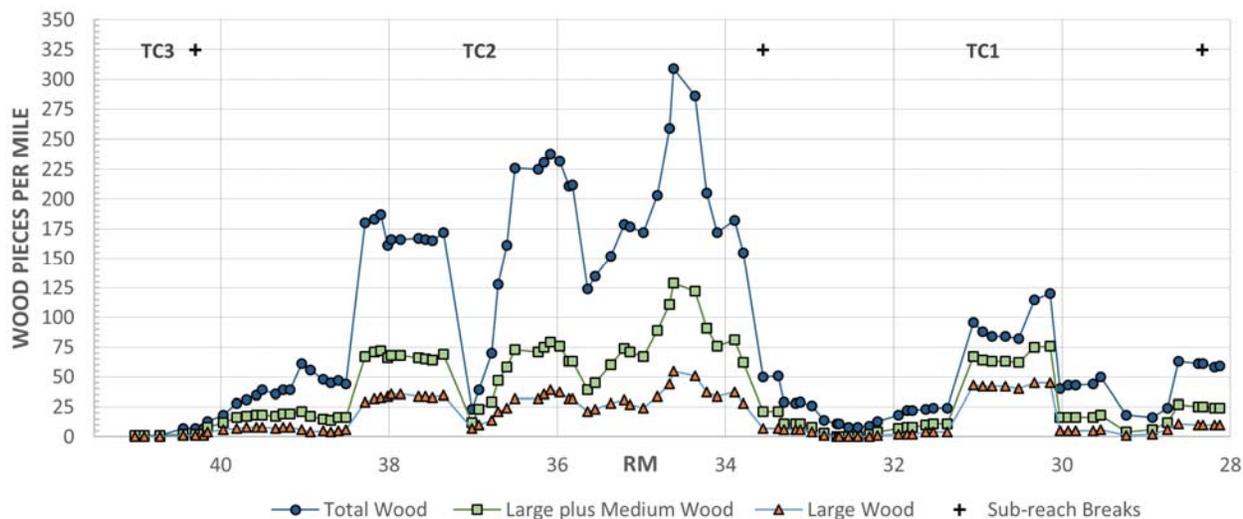
Figure 3-20 Wood pieces per mile along the Assessment Reach (moving sums based on 2016 habitat survey).

Figure 3-20 and Table 3-12 show the woody debris survey results for the Assessment Reach, in terms of pieces per mile. Figure 3-20 shows a moving sum of wood pieces over a mile of channel. The greatest frequency and abundance of large wood is present in TC2, with an average of 23 pieces per mile. TC1 has a moderate amount of wood (11 LWD pieces per mile), and TC3 is essentially devoid of wood.

The frequency data presented Figure 3-20 and Table 3-12 to some degree inflate the magnitude of habitat benefits from wood along the Assessment Reach. A vast majority of observed wood was just within the bankfull channel (i.e., near the banks) and thus mostly out of contact with the low-flow channel. Log jams near the channel margins result in habitat benefit, but in general their direct habitat benefits (e.g., cover) for salmonids are infrequent (only occurring during near-bankfull and greater flows). The benefits of these logs jams near channel banks are primarily physical, and secondarily habitat. For instance, jams on the channel margins have the benefit of dissipating flood energy and diverting flood flows onto the floodplain, as has happened in response to a large log jam on river right near RM 35.6 (see Figure 3-21), which has maintained a high-flow channel and stabilized a vegetated island that began forming around the year 2000 (and now functions as beneficial habitat). One of the few locations where woody debris jams interact with the low-flow channel is at RM 38.4 (see Figure 3-21), where a series of flow splits around a series of large log jams provides edge habitat.

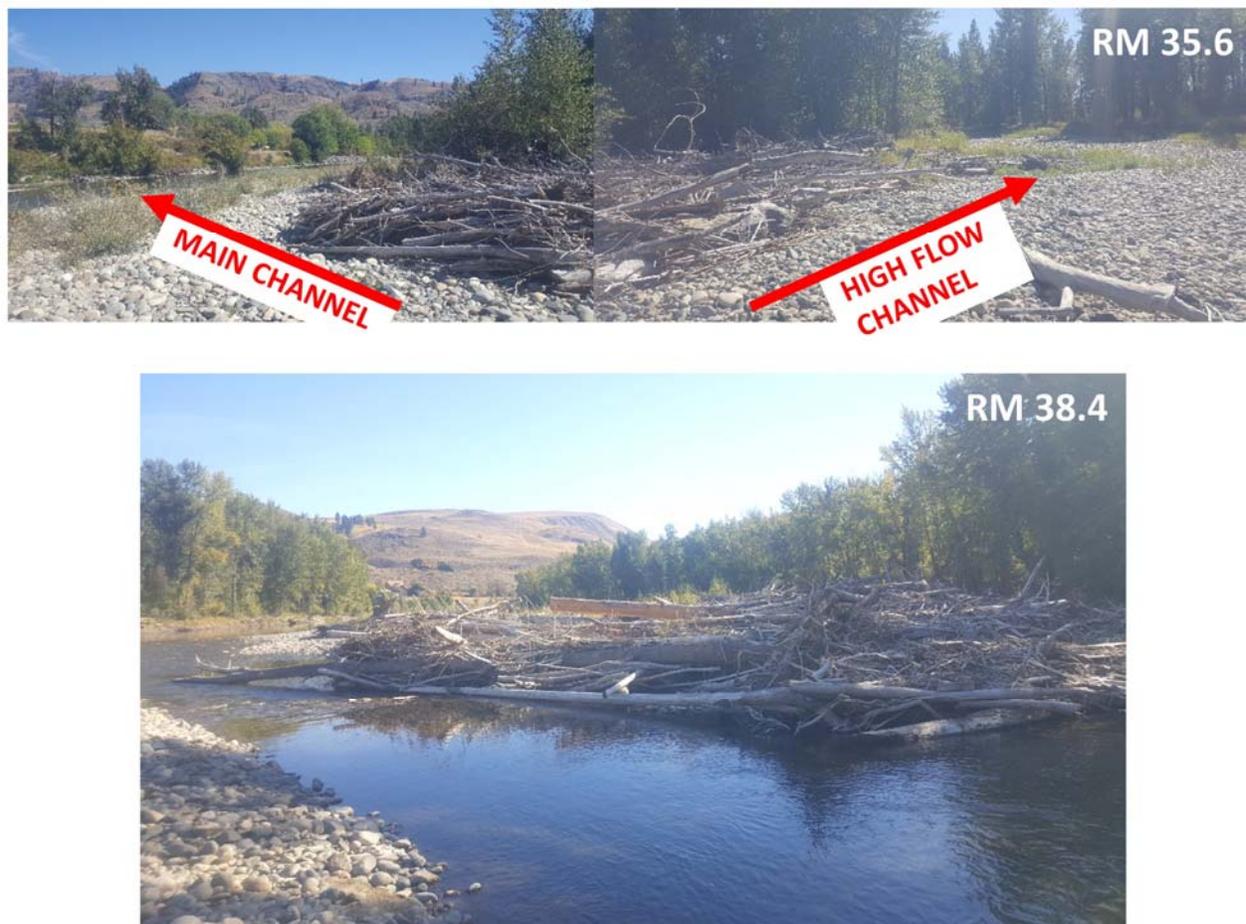
Figure 3-21 Photos showing geomorphic and habitat effects of localized log jams present in the Assessment Reach.

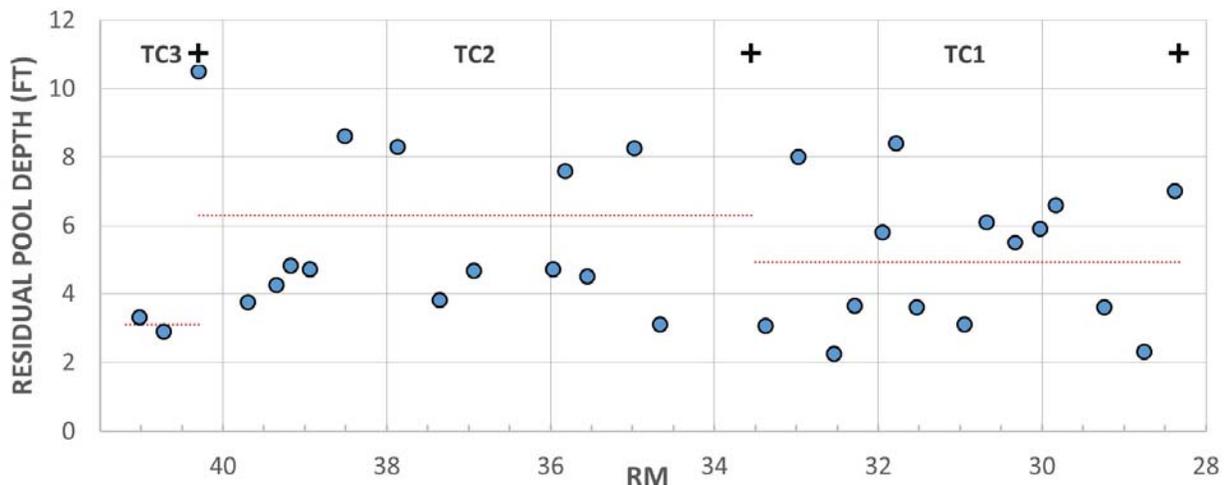
Figure 3-22 Residual pool depths measured along the Assessment Reach.

Pool frequency ranges from 2.2 to 3.3 pools per mile along the Assessment Reach. Since the inventory mapped units with a minimum length equaling that of the wetted width, pool frequency statistics include larger area pools and exclude smaller area pools typically associated with log jams. However, as noted in the LWD discussion above, few logjams are located near the low-flow channel, and consequently few pools associated with LWD jams were present. Residual pool depths—calculated as the maximum wetted depths minus pool crest depths surveyed in 2016—have no apparent longitudinal trend along the Assessment Reach (Figure 3-22) and are greatest on average in TC2. The deeper pools generally were adjacent to bedrock exposures, boulder-rich glacial deposits, or riprap. Shallower pools tended to be in strictly alluvial channels lacking the above forcing agents.

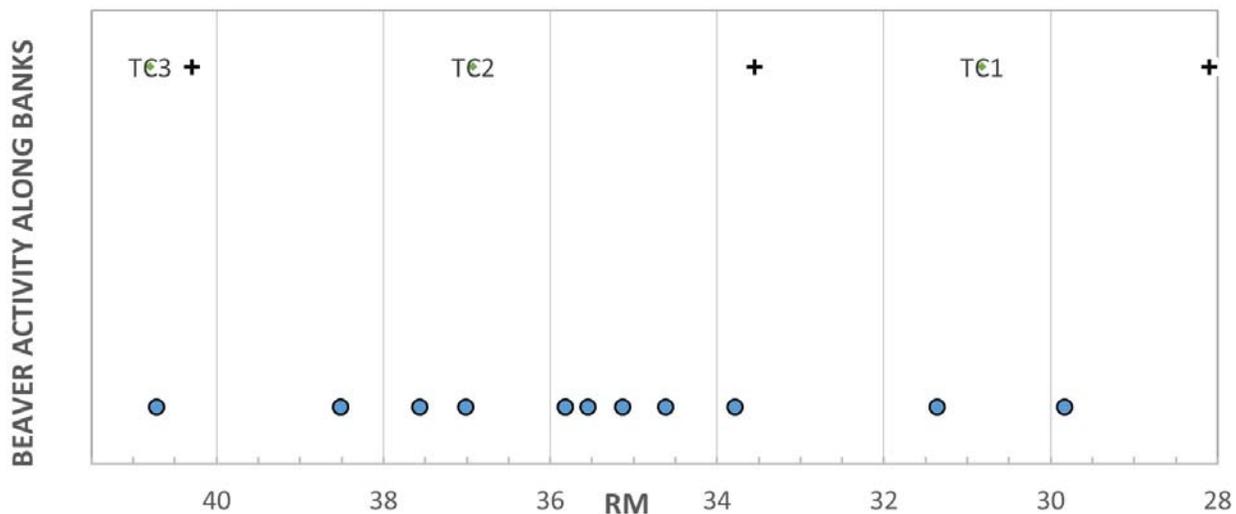
Figure 3-23 Locations of observed beaver activity along the Assessment Reach.

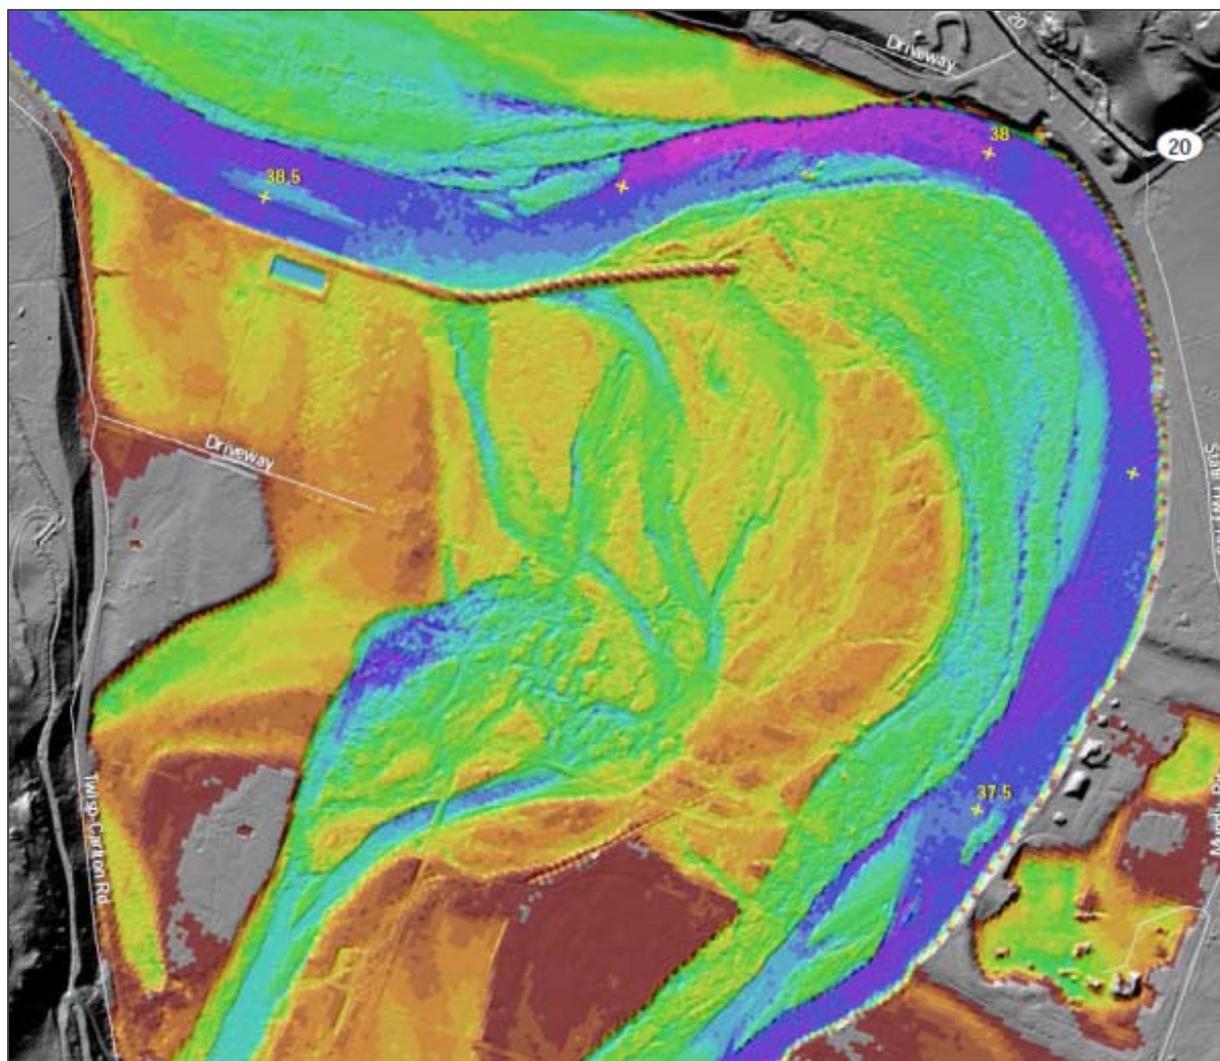
Figure 4-1 Extracted HAWS imagery (Appendix A) for the upper part of the Beaver Pond section of TC2.

In both the Red Shirt Mill and Beaver Pond sections, the primary flow paths have been largely unchanged throughout the history of recorded channel positions, but secondary and overflow channels, particularly associated with secondary channel positions in the 1940s, are still prominently expressed in the floodplain topography. Both the main and secondary channels are flanked by recently active fluvial surfaces; they are slightly too high to experience regular inundation or reworking by annual floods but, based on vegetation ages, are products of fluvial activity over the past century. An excellent example of these recent surfaces is provided by the Height Above Water Surface (HAWS) mapping of the upper half of the Beaver Pond section (Figure 4-1), which clearly highlights the active point bar of the modern channel (blues and turquoise on Figure 4-1 just east of the channel at RM 37.75) from the higher, but still fluvially modified, terrace immediately west (shaded in greens, yellows, and browns). The recently active side channel behind (i.e., west of) this bar complex is also well displayed, with elevations locally lower than those of the main channel. Also clearly displayed in this imagery is the narrow west-to-east-trending levee, which separates the main channel from its side channels on the right bank at RMs 38.4 to 38.2.

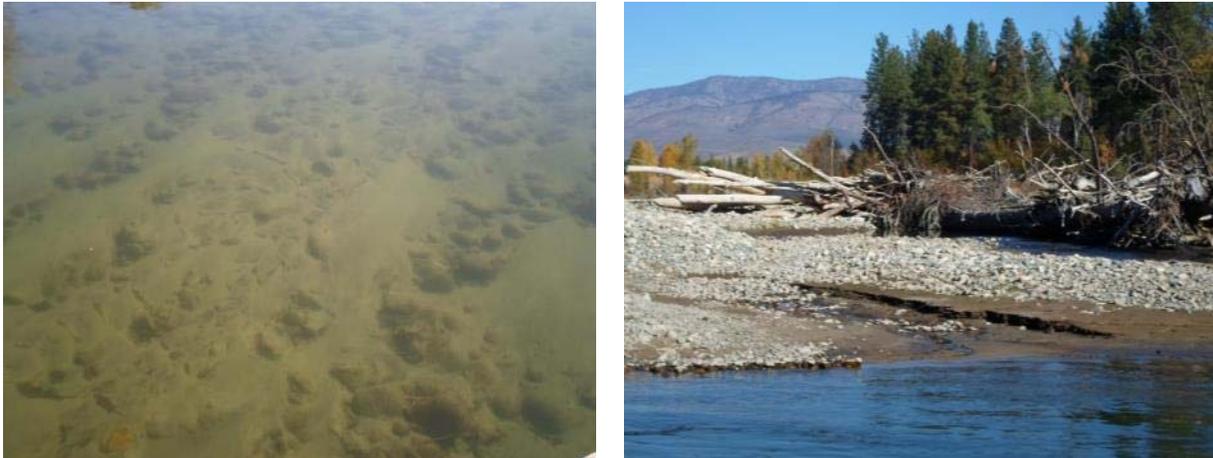
Figure 4-2 Fine sand and silt on the bed of the Methow River at RM 35.5, about 0.5 mile downstream of the confluence with Beaver Creek, in October 2014 (left).

Through TC2, the drainage area of the Methow River increases by about 125 mi² (a 9 percent increase). Nearly all of this (112 mi²) is from the addition of Beaver Creek, a steeply sloping left-bank tributary that reaches as high as 7,360 feet at its watershed divide. Much of the Beaver Creek watershed was burned during the Carlton Complex Fire of July 2014, which will increase the hydrologic contribution of this tributary to the mainstem for several years post-fire. Hydrophobic soils that resulted from the severity of the fires have contributed substantially to the runoff potential and contributed to soil erosion via overland flows associated with multiple fall and winter storm events (Burned Area Emergency Response [BAER] 2014). This channel was also a substantial source of fine sediment during the rainstorm of August 2014, with heavy (but likely only temporary) accumulations of fine sediment blanketing much of the bed of the river over 0.5 mile downstream of the confluence (Figure 4-2).

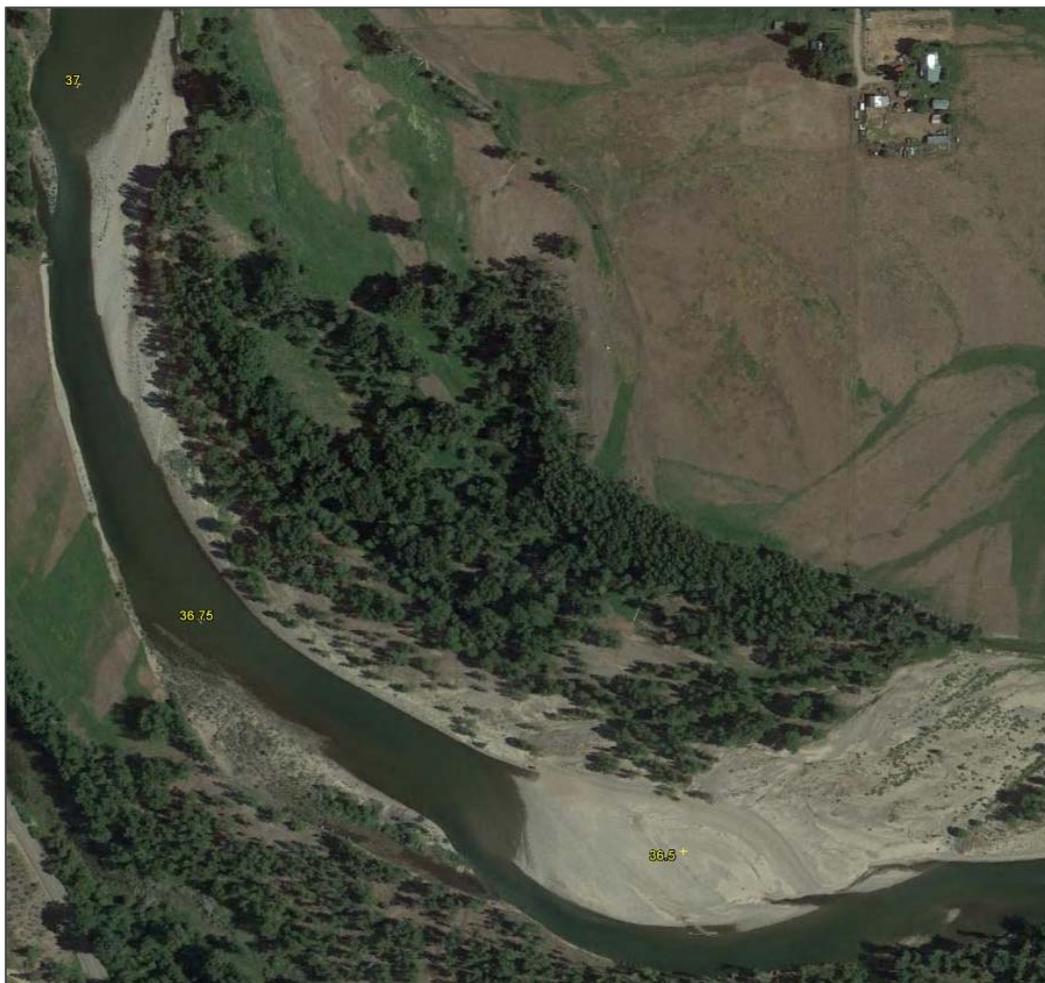
Figure 4-3 Aerial view of the point bar at RM 36.8, displaying the development of a floodplain forest on the active fluvial surface on the inside bend (flow from top [north] to bottom).

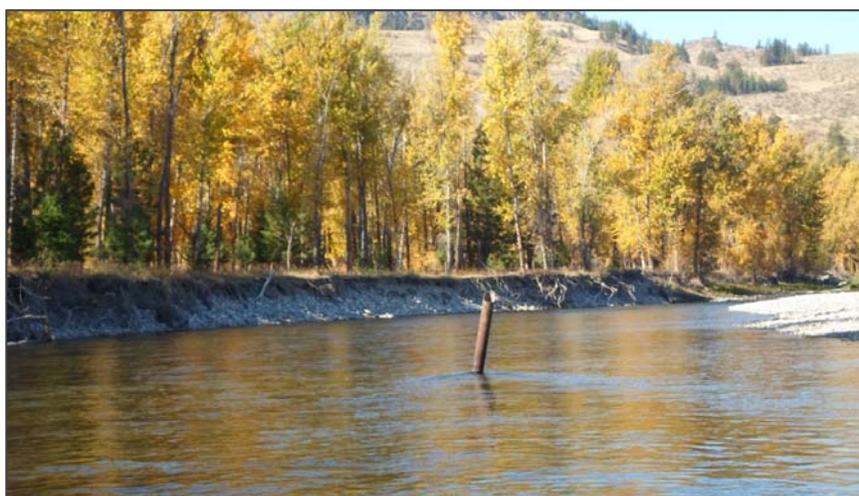
Figure 4-4 RM 36.5, looking upstream.

Bank armoring is widespread in this sub-reach, although it also includes the greatest percentage of armoring mapped in 2008 that has since been eroded away by the river (Figure 4-4). Most prominent of the human alterations affecting river processes in the entire Twisp to Carlton reach is the right-bank levee at RM 38.3, whose eastern 1,000 feet block access of the river to an extensive side channel complex that constitutes the Beaver Ponds section. Sections of riprap line both banks of the channel between the Red Shirt Mill and Beaver Ponds sections (RM 38.8), a mile on the outside bend from RM 38.2 to 37.2 to protect State Highway 20 and adjacent property, and scattered armoring through the Silver Side Channel section, including armor of a stable bedrock face at RM 34.75 and nearly a mile of right-bank riprap beginning at RM 34.2 and continuing into the next sub-reach. Most of this armoring supports high-bank property and infrastructure on the upper, inactive fluvial surface, but in several locations the riprap is clearly limiting channel migration and floodwater occupation of recently active channels and floodplain surfaces. These areas are highlighted in the identification of potential projects, below.

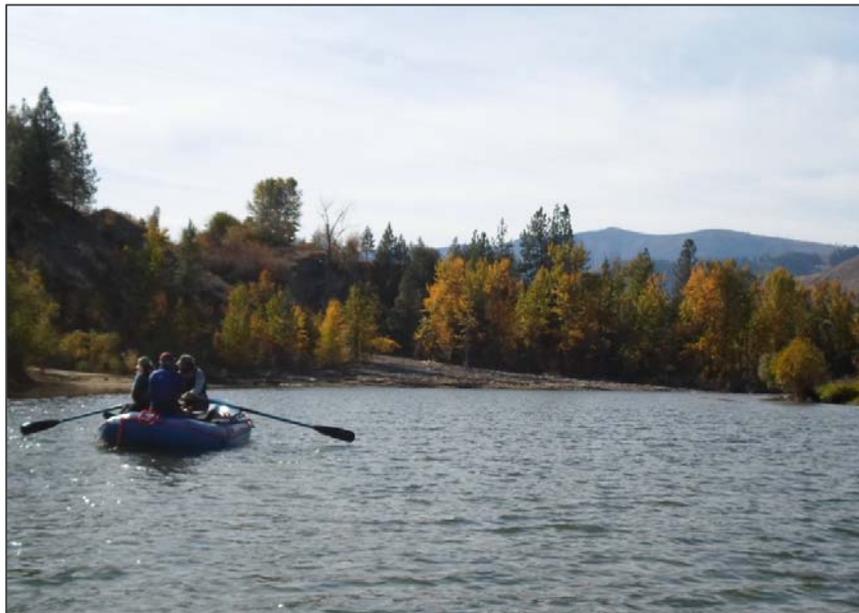
Figure 4-5 View of the alluvial fan at RM 30.65, extending from the left bank across more than half of the active channel width, which was deposited during the August 21 rainstorm.

Sediment inputs from tributaries provide some localized complexity along the sub-reach. Two small left-bank alluvial fans deposited from tributaries, Benson Creek (RM 33.2) and Canyon Creek (RM 32.9), do not appear to have materially affected the long-term location of the river; however, a more extensive right-bank fan at RM 32.2, emerging from the intermittent drainage of Booth Canyon, has likely determined the lateral position of the river for over 0.25 mile both upstream and downstream. An alluvial fan complex draining the bedrock hills west of the river from RMs 31.2 to 29.8 does not appear to have extended far out onto the intervening fluvial terraces; but across the river at RM 30.65, an unnamed drainage emerging from Leecher Canyon produced one of the most prominent deposits of sediment into the Middle Methow River resulting from the August 21, 2014, rainstorm (Figure 4-5), a consequence of draining a watershed largely burned during the Carlton Complex Fire. Given its position at the outside of a very long-lived bend of the Methow River, it is surely a short-lived feature of the active channel, but it does reflect the episodic nature of sediment delivery into this system where lateral channel migration is minimal and fire-and-flood sequences are not uncommon.

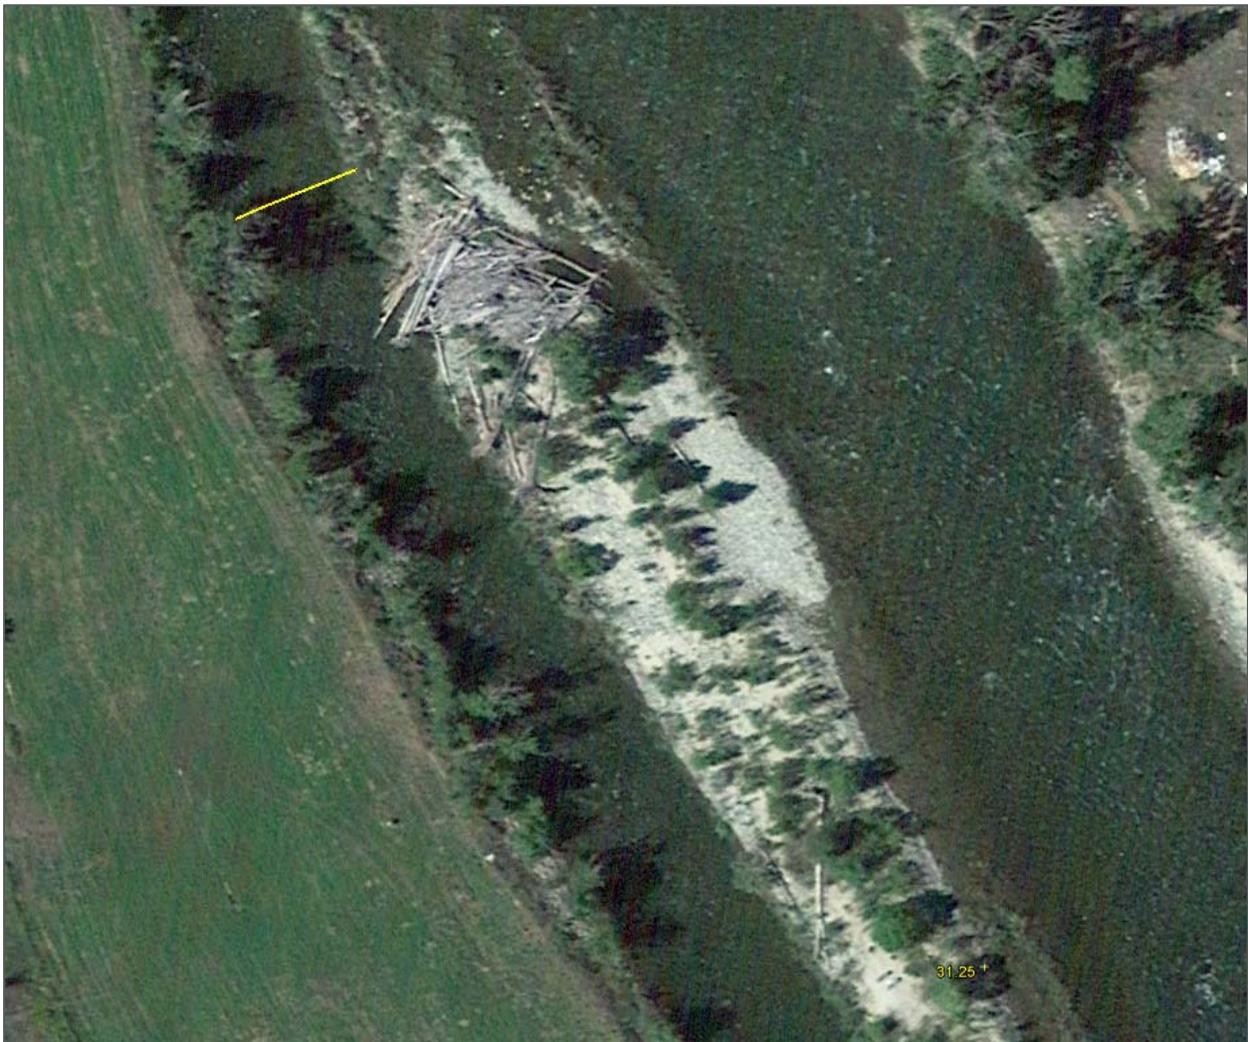
Figure 4-6 Aerial view of the log jam at RM 31.3, taken July 2013 (from Google Earth).

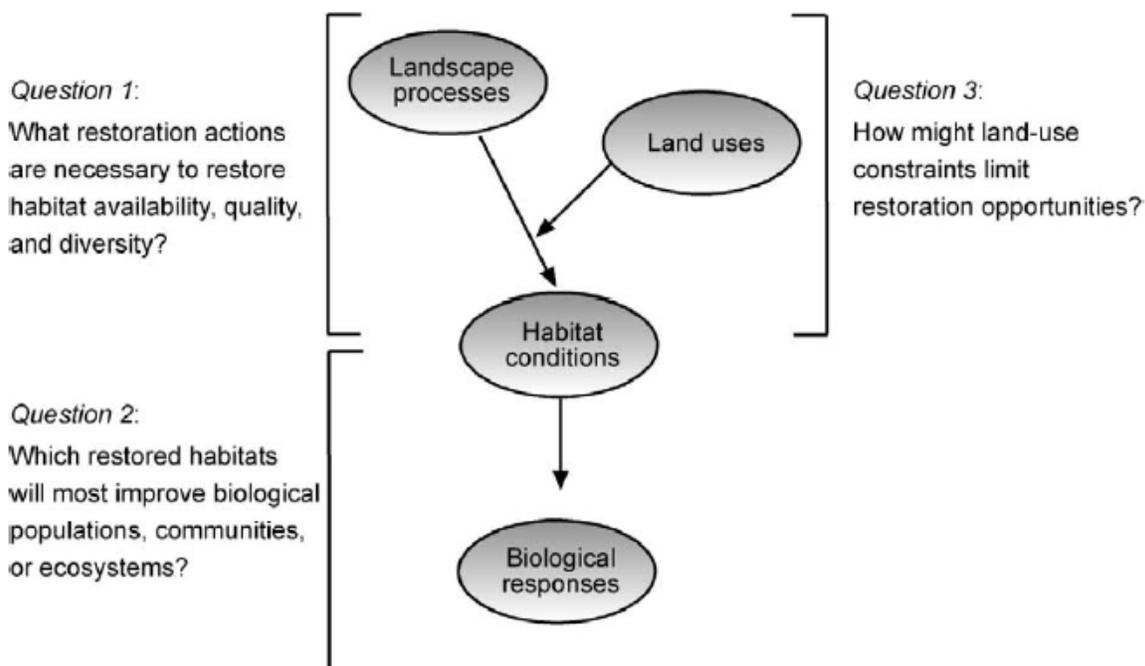
Figure 5-1 Conceptual Framework (Beechie et al. 2008).

This Reach Assessment and prioritization focuses on the conceptual linkages identified by Beechie et al. (2008) to identify actions at a landscape scale that can effect a positive biological response for listed species (Figure 5-1). Habitat actions identified within the Assessment Reach focus on improving riparian habitat conditions, increasing off-channel habitat (side channel reconnection and floodplain restoration), increasing habitat diversity, and/or improving bed and channel form. These actions, in part or collectively, are expected to increase steelhead, spring Chinook, and bull trout juvenile overwinter survival, increase pre-smolt foraging opportunities by increasing hydraulic habitat complexity, and provide additional adult holding and migratory habitat, and spawning success (UCSRB 2007).
