TECHNICAL MEMO (DRAFT)

DATE:	April 17, 2025
TO:	Cascadia Conservation District
FROM:	Lichen: Nick Legg, LG, Dominique Shore RSI: Gabe Williams, PE
PROJECT:	Roaring Creek Restoration Project
SUBJECT:	Conceptual Design - Alternatives Selection

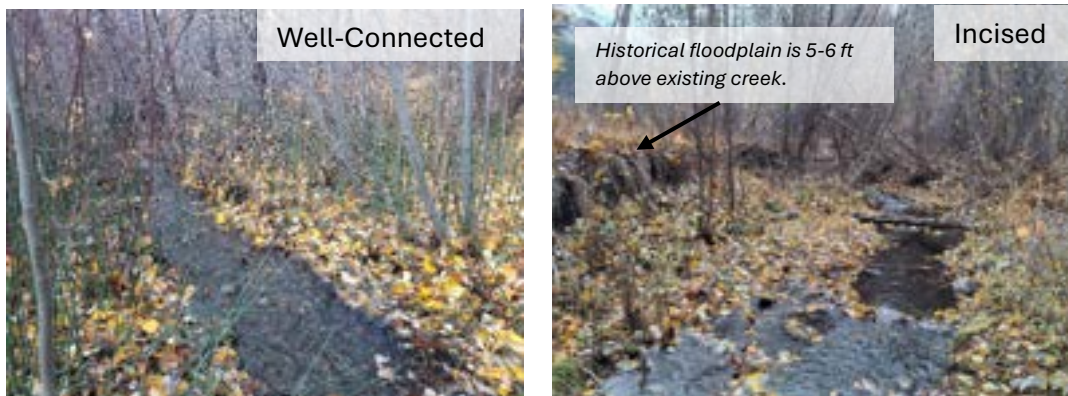
FIGURE 2. PHOTOS OF AN ISOLATED SEGMENT OF WELL-CONNECTED FLOODPLAIN (LEFT), AND THE MORE PERVASIVE INCISED CONDITIONS (RIGHT).

- A network of relict side channels within the historical floodplain surface
- Active beaver use in localized segments of the site, and immediately upstream
- A single isolated segment of well-connected floodplain as shown in Figures 1 and 2. This floodplain segment has multiple threads, dense riparian vegetation indicative of near-surface groundwater, and beaver use.

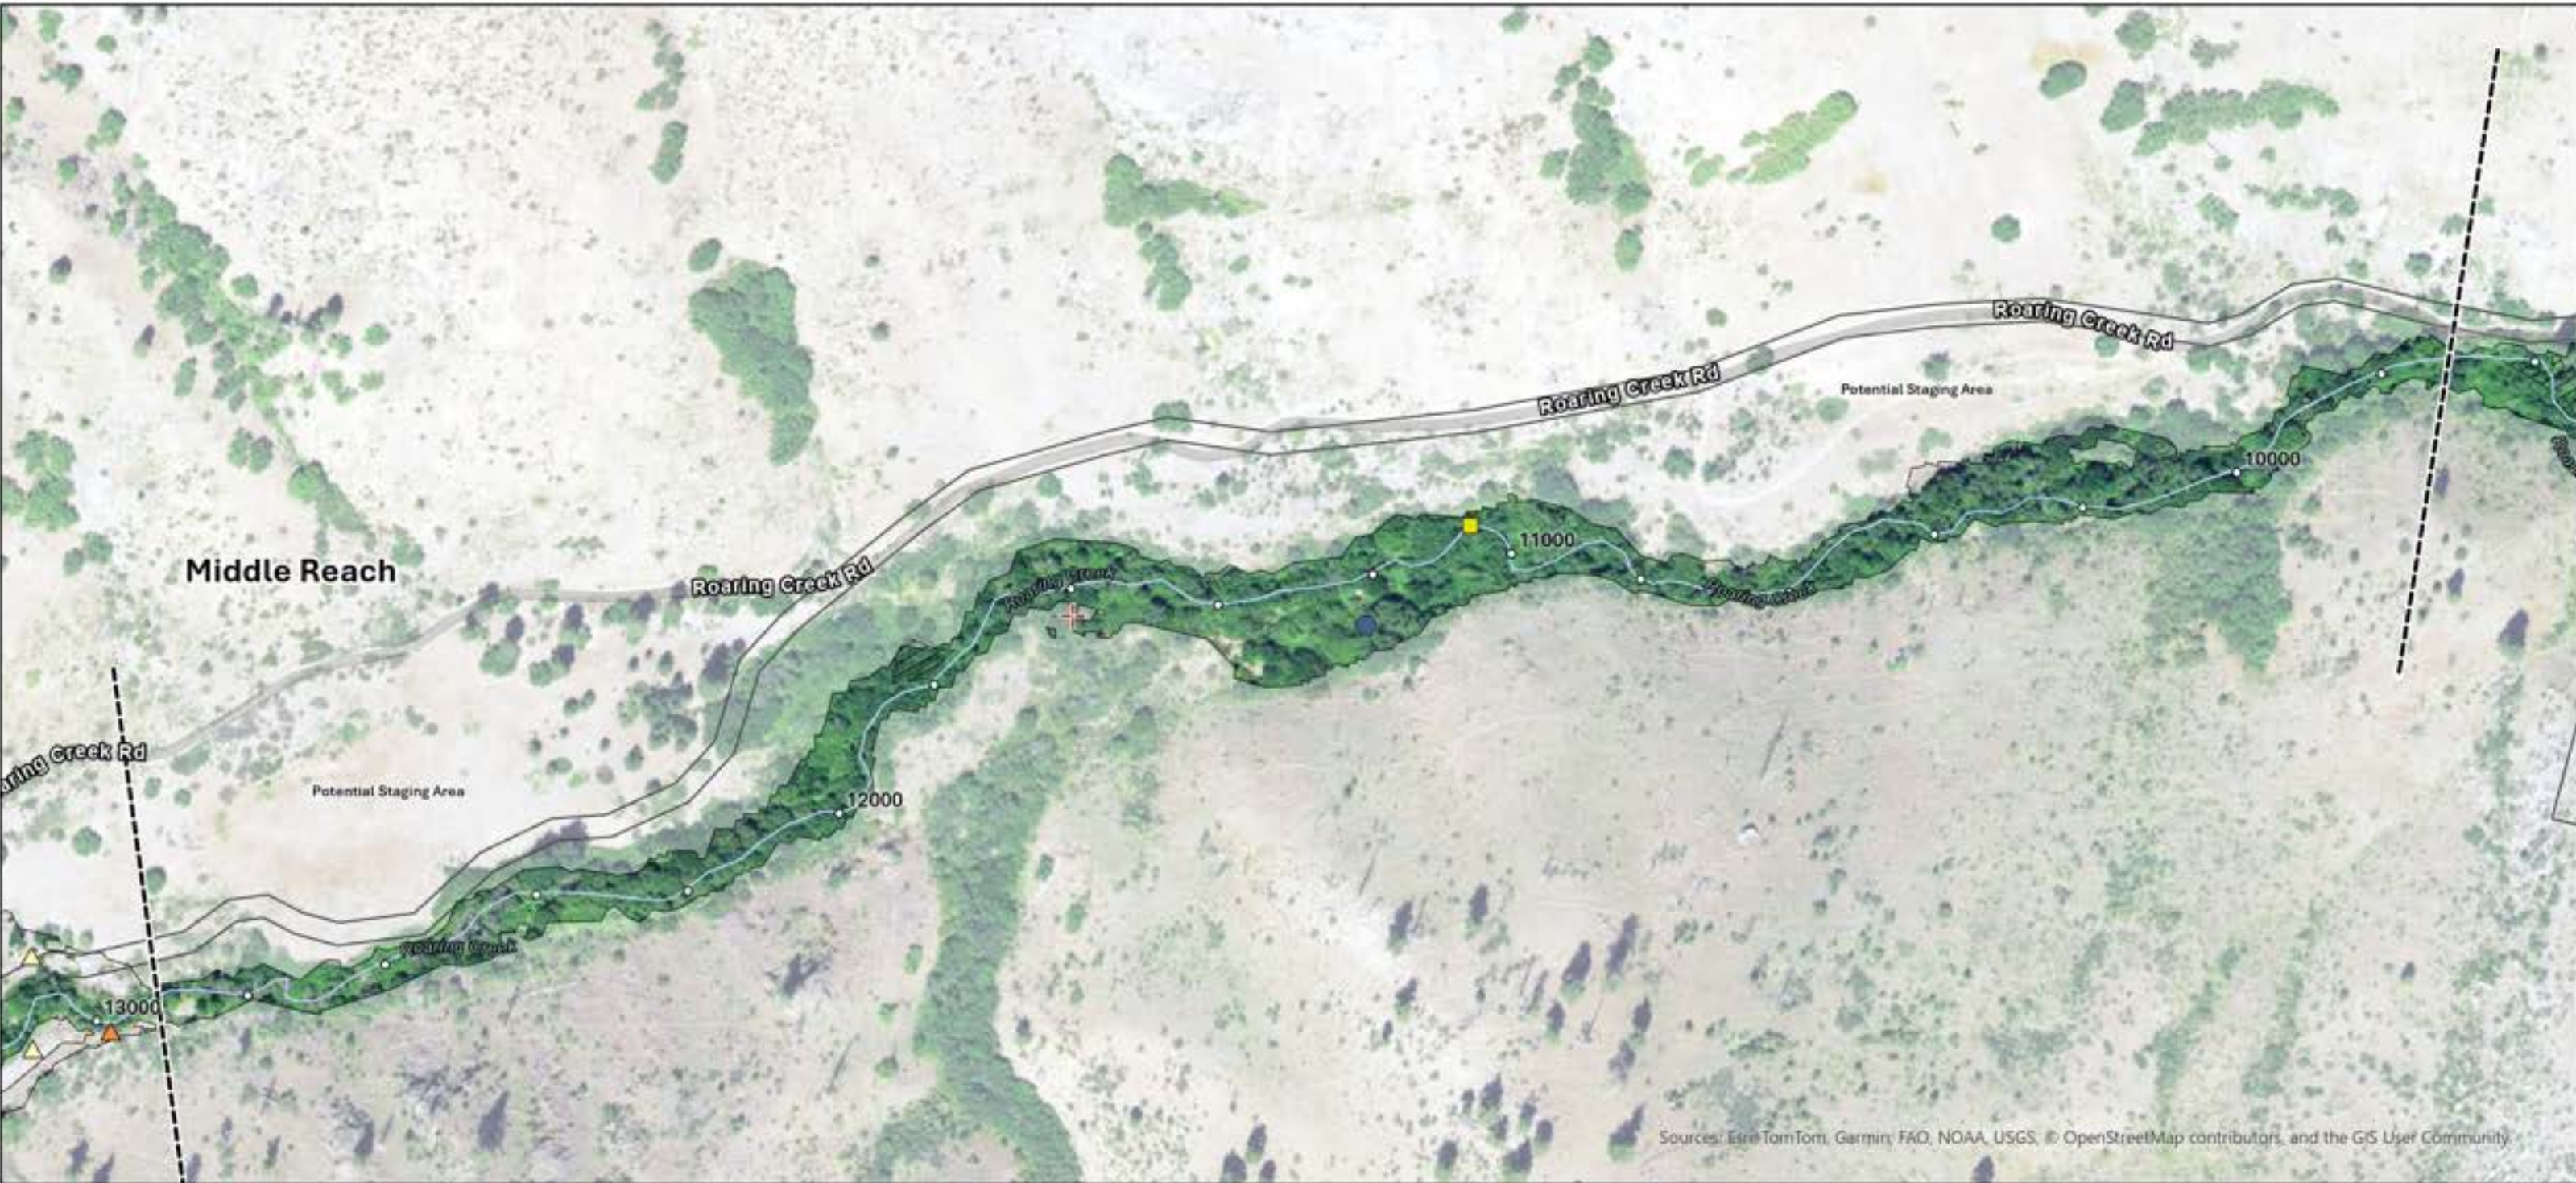
Existing Conditions Map (Aerial) Roaring Creek Floodplain Restoration Design

- Roaring Creek
- Station (ft)
- Tax Parcels (approx.)
- - - Reach Boundaries
- Historic Valley Bottom (approx.)
- Observed Wetland
- ▨ Observed Wetlands
- ✖ Headcut
- Monitoring**
- + Hobo Logger
- + Streamflow Gage
- Complexity Features**
- Beaver Dam Analogs
- Beaver Dam

- Depth to Gravel (in)**
- △ Gravel at Surface
 - ▲ 0 - 5
 - ▲ 5 - 15
 - ▲ 15 - 36
 - ▲ No gravel observed in soil pit

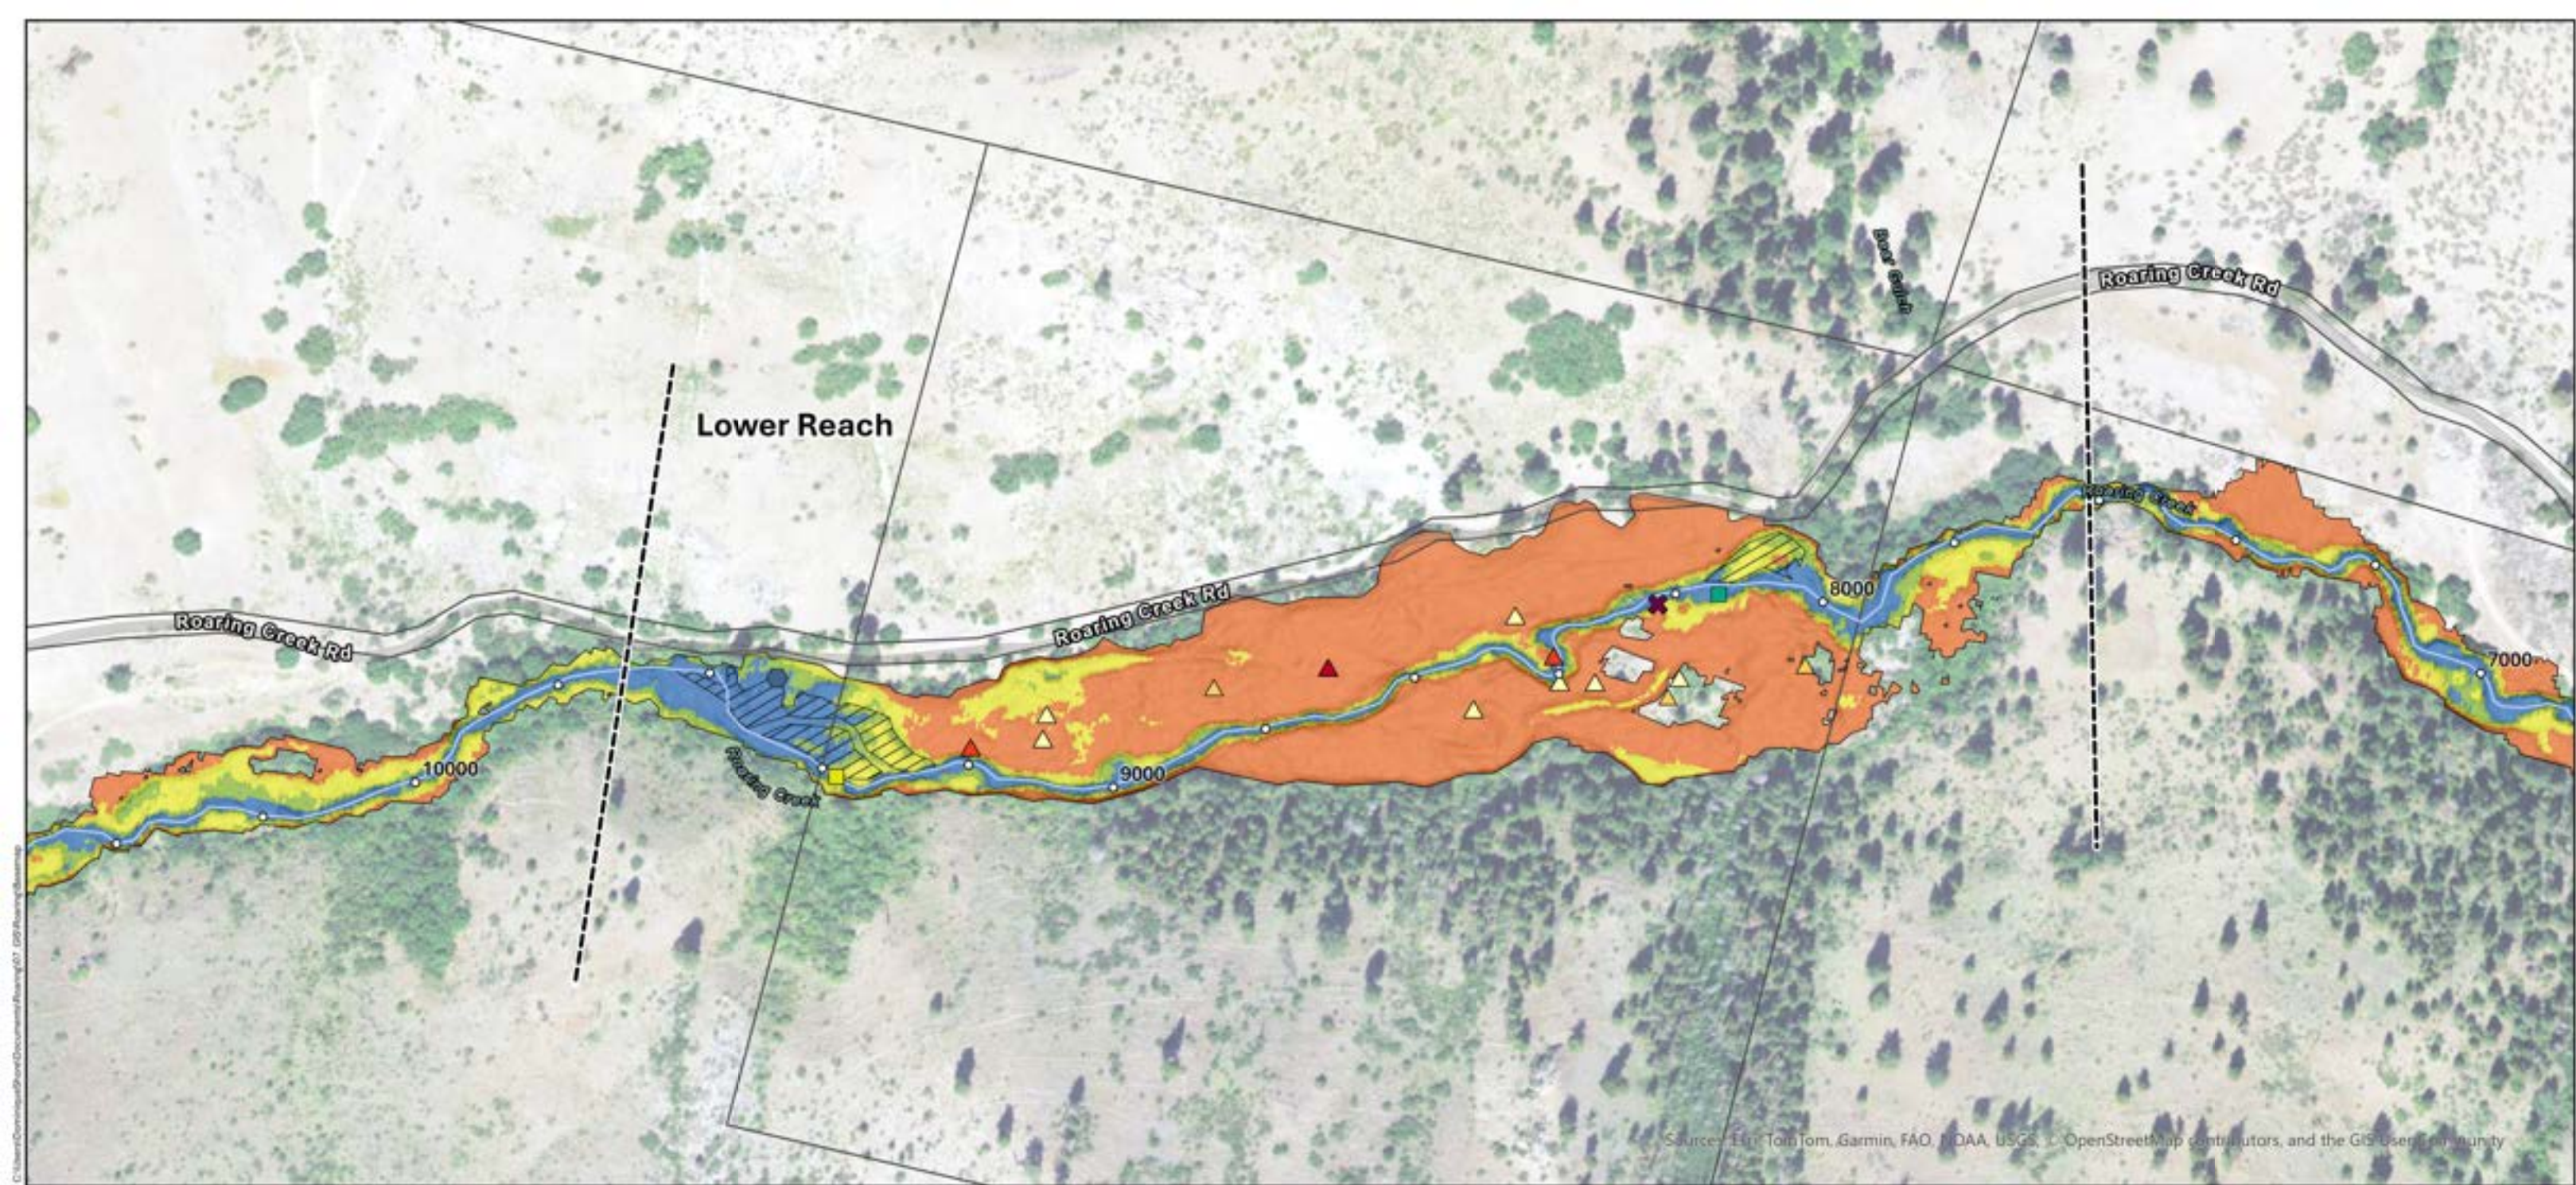
Existing Conditions Map (HAWS)

* Classified landscape zones based on relative elevation model (REM) tied to the streambed centerline elevation. The REM used for landscape classification was developed using topobathymetric LIDAR collected by NV5 Geospatial on behalf of WA Department of Natural Resources (2022).

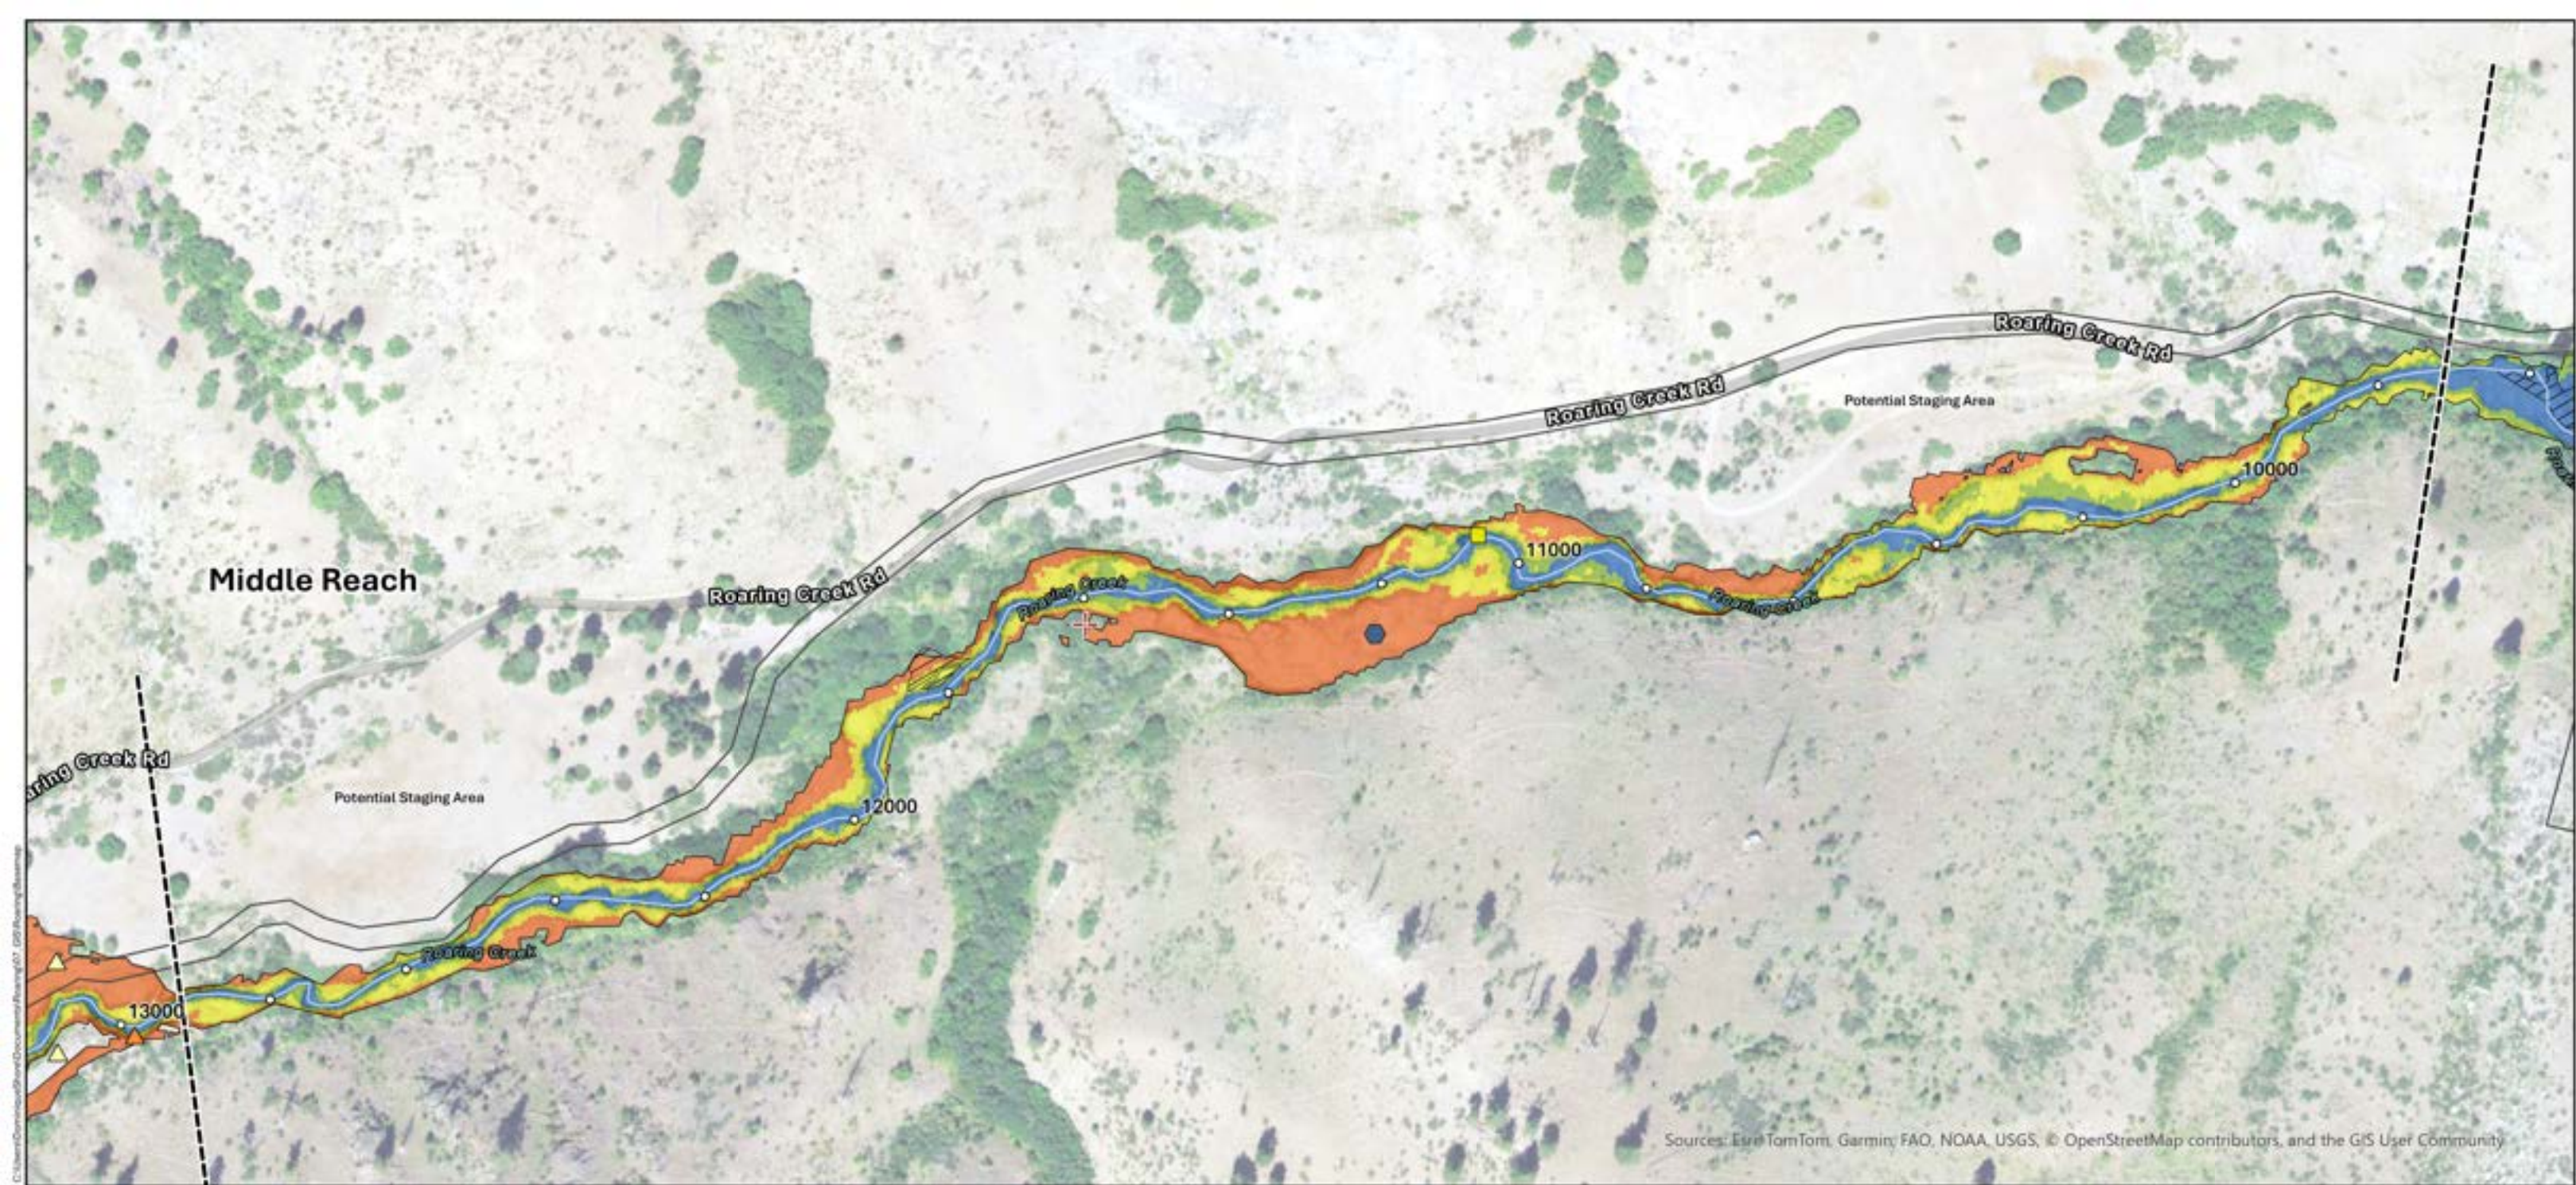
Existing Conditions Map (HAWS)

* Classified landscape zones based on relative elevation model (REM) tied to the streambed centerline elevation. The REM used for landscape classification was developed using topobathymetric LIDAR collected by NV5 Geospatial on behalf of WA Department of Natural Resources (2022).

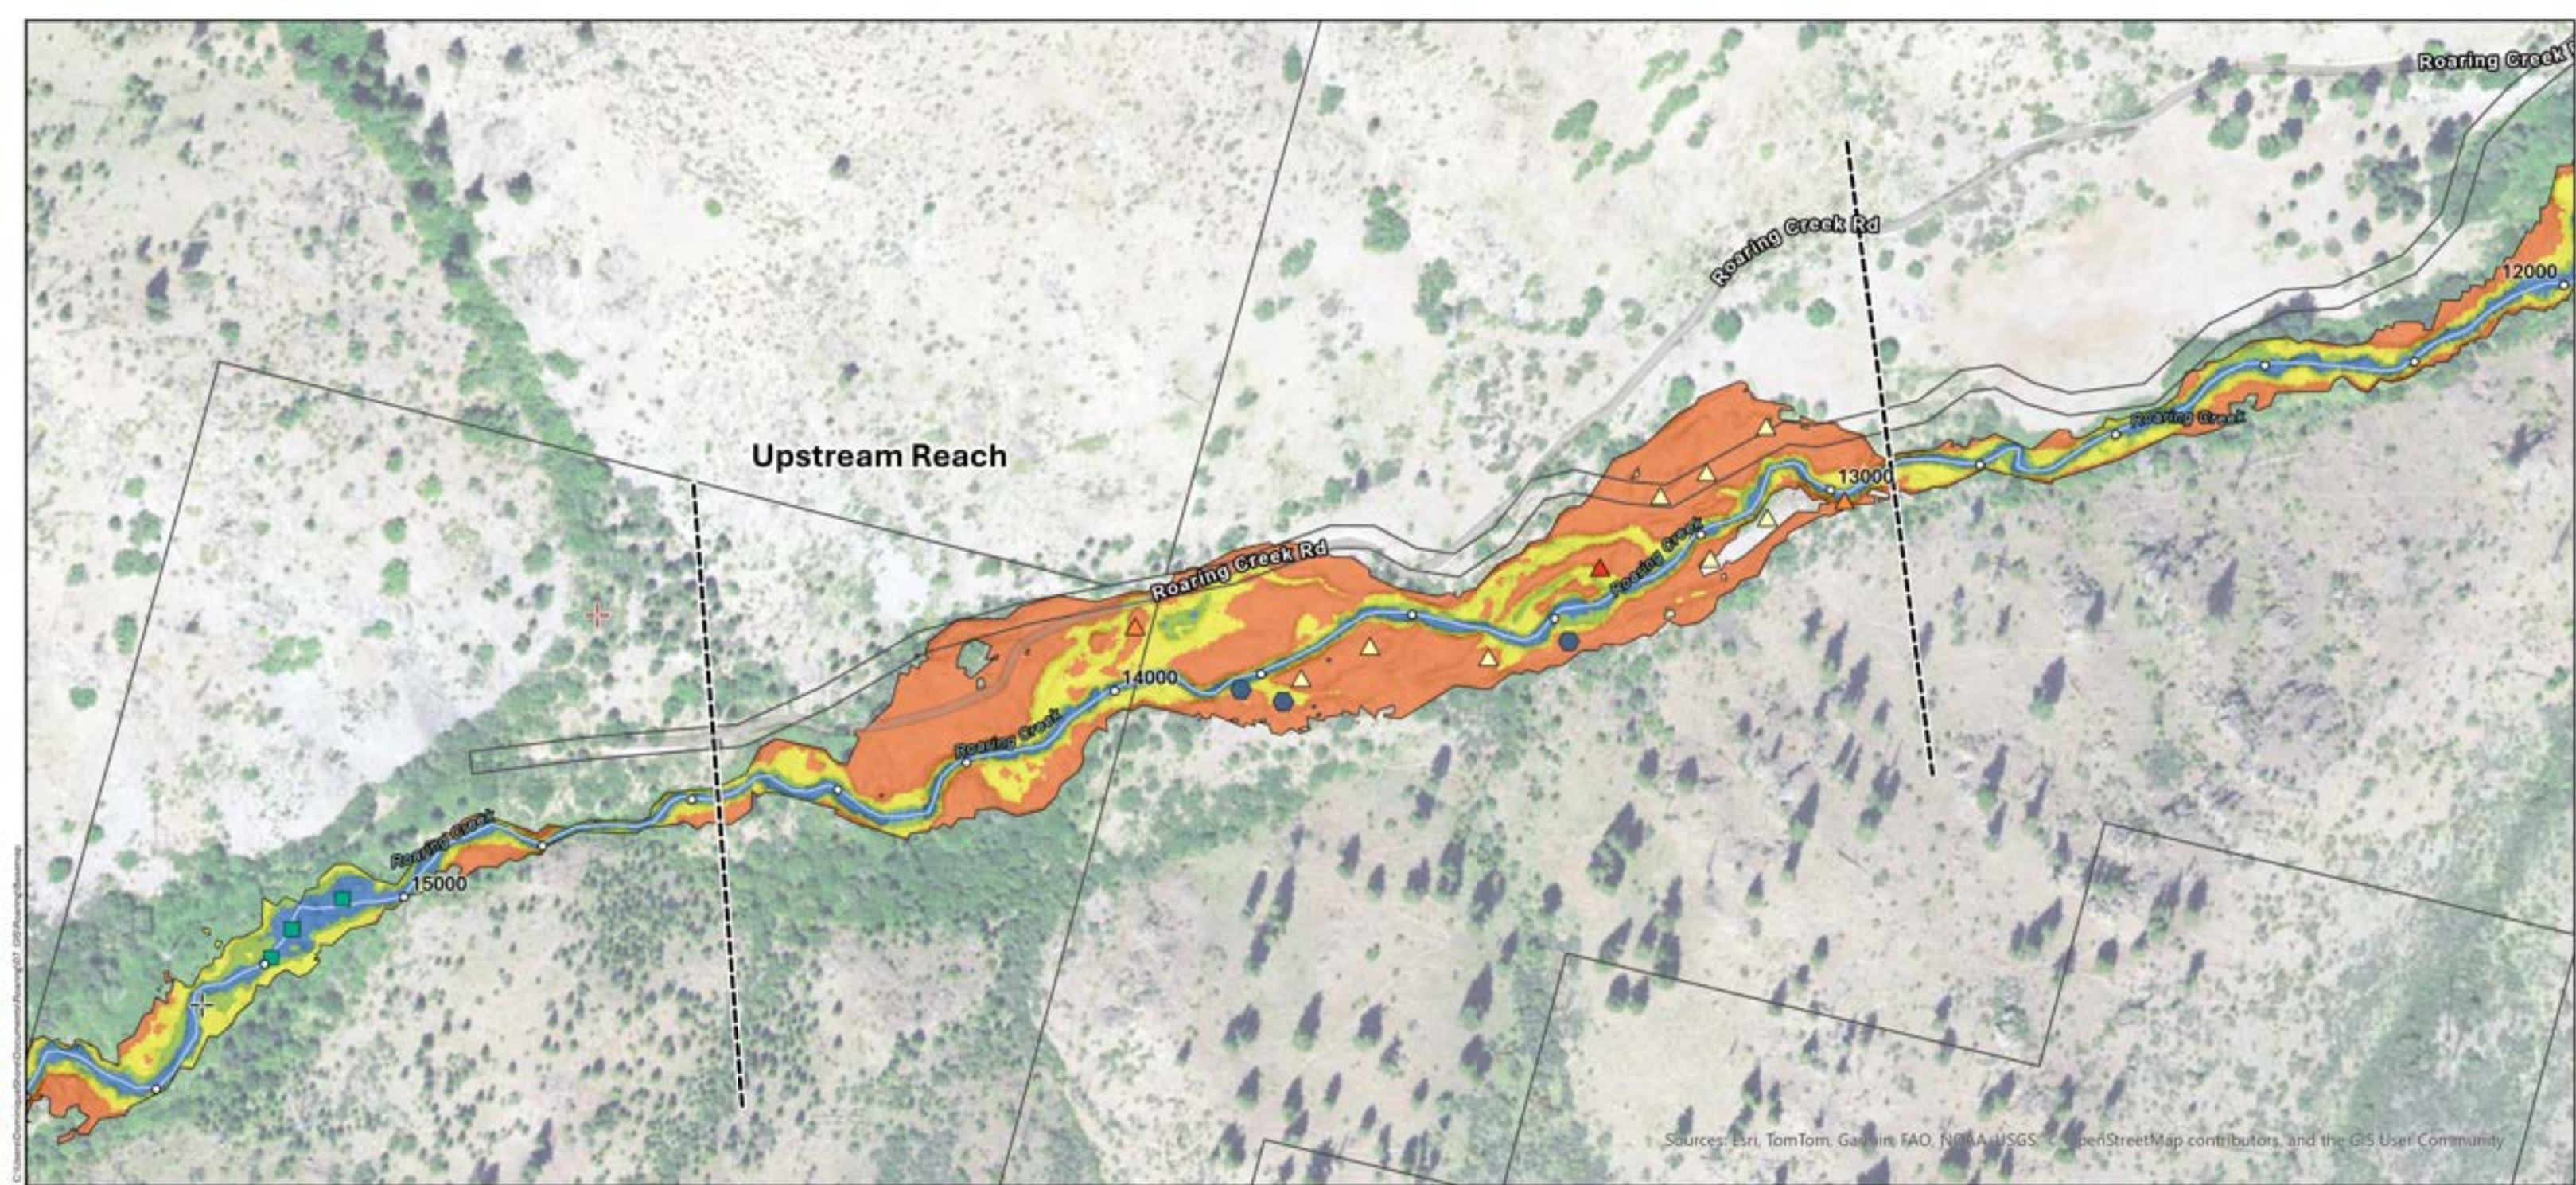
Existing Conditions Map (HAWS)

* Classified landscape zones based on relative elevation model (REM) tied to the streambed centerline elevation. The REM used for landscape classification was developed using topobathymetric LIDAR collected by NV5 Geospatial on behalf of WA Department of Natural Resources (2022).

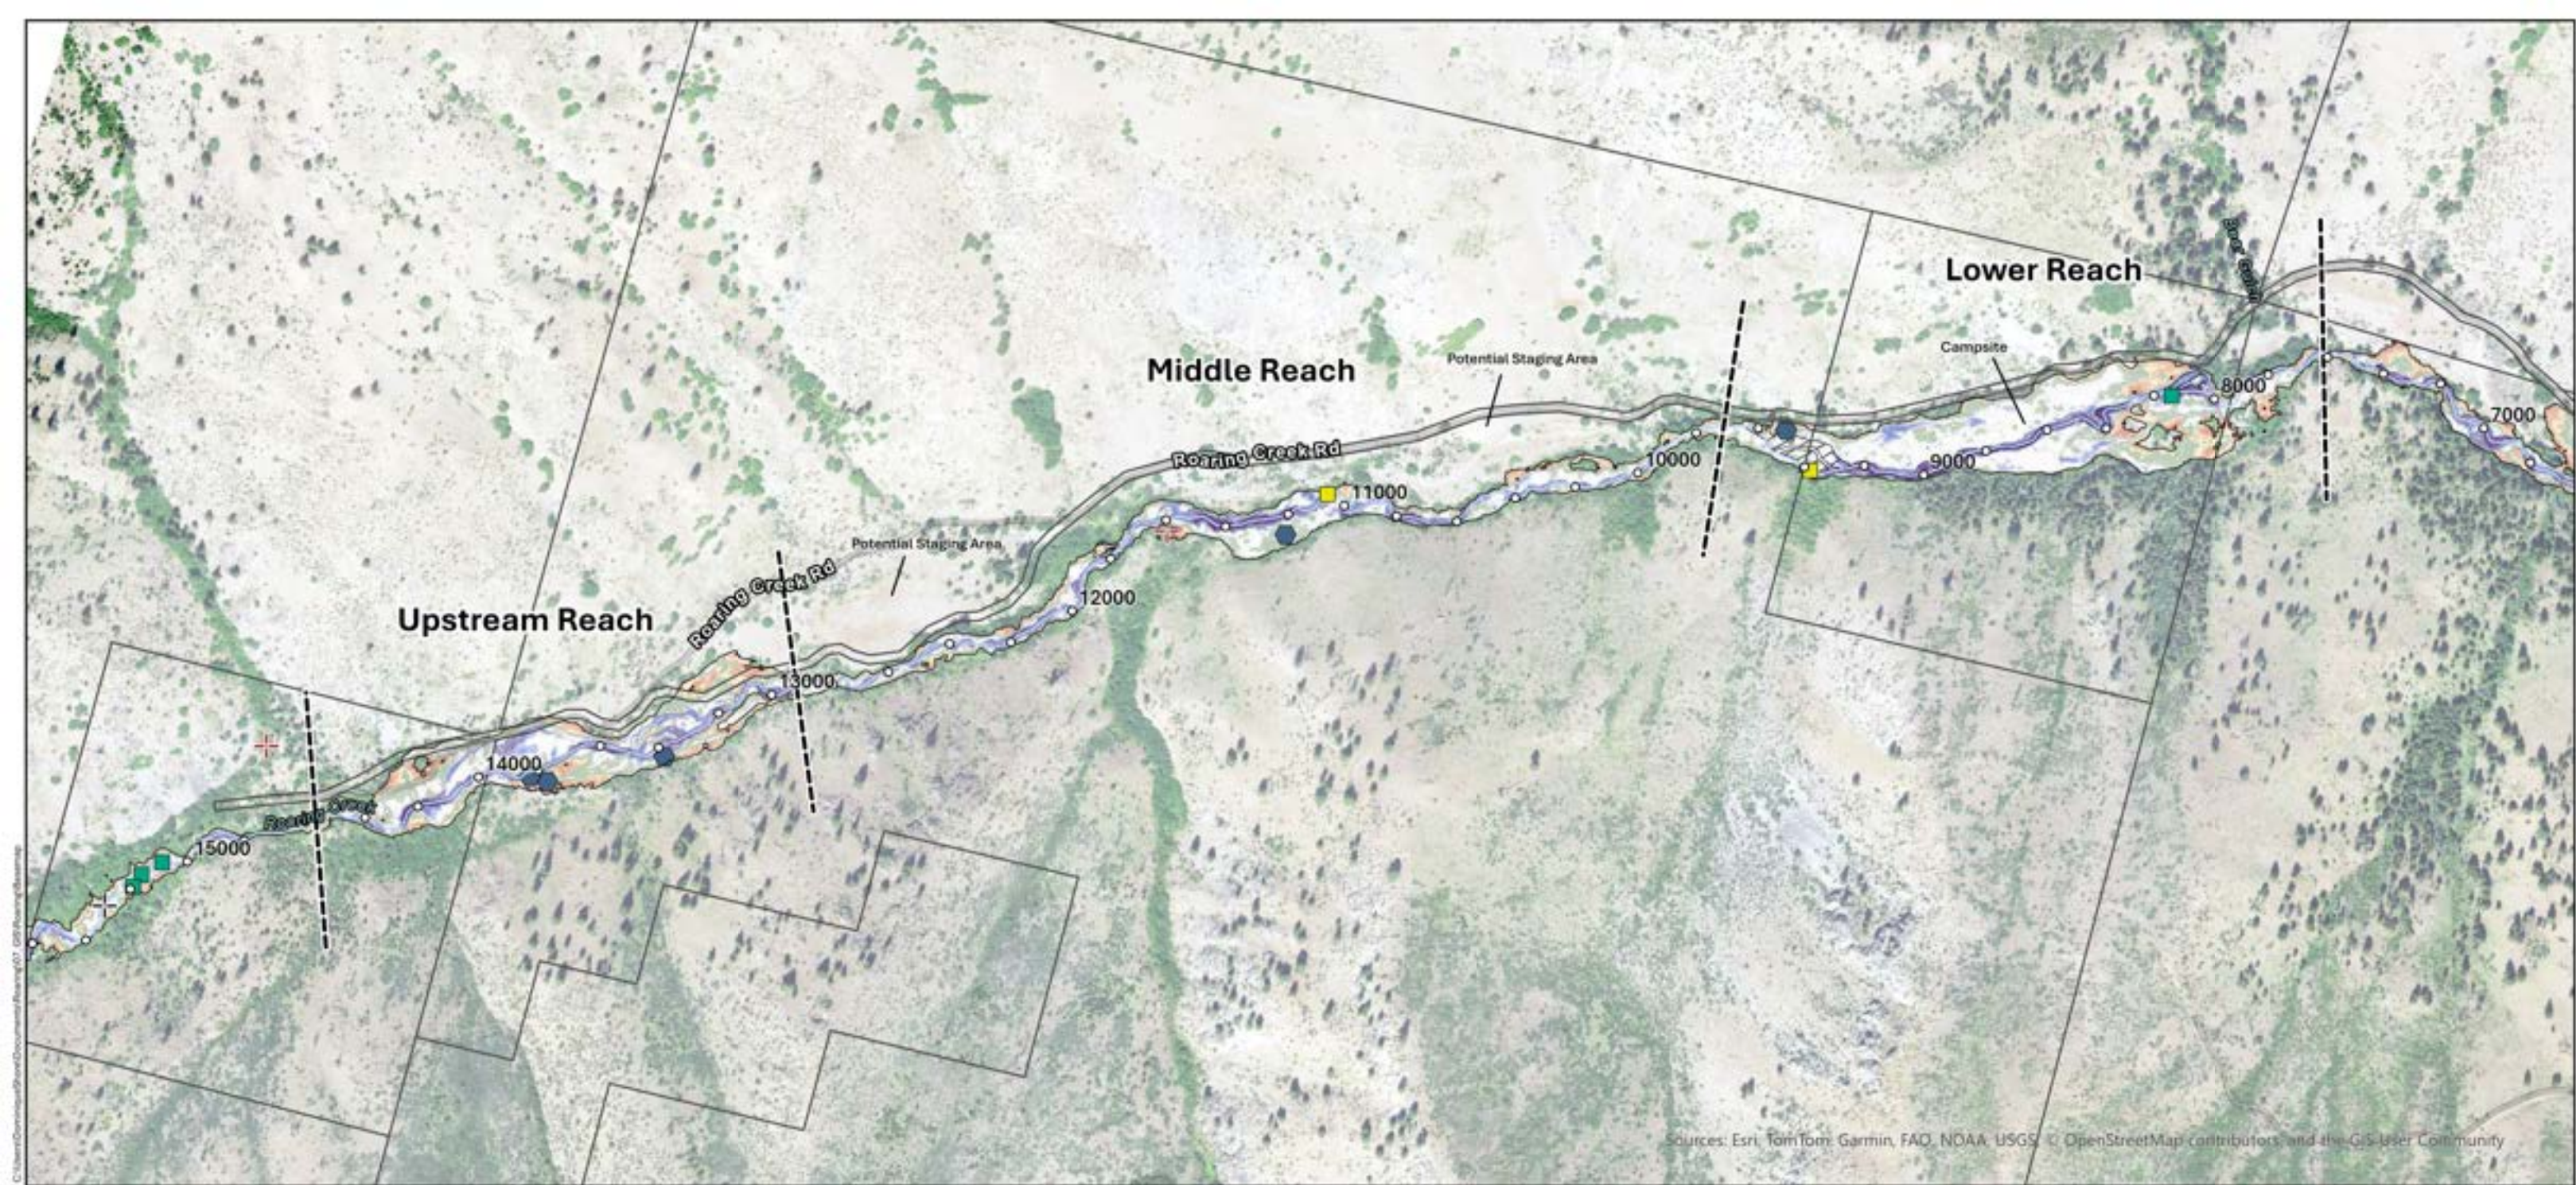
Existing Conditions Map (GGL)

* Geomorphic Grade Line (GGL) Relative Elevation Model (REM) relative to estimated of historic floodplain elevation along baseline shown. GGL REM developed using topobathymetric LiDAR collected by NV5 Geospatial on behalf of WA Department of Natural Resources (2022)

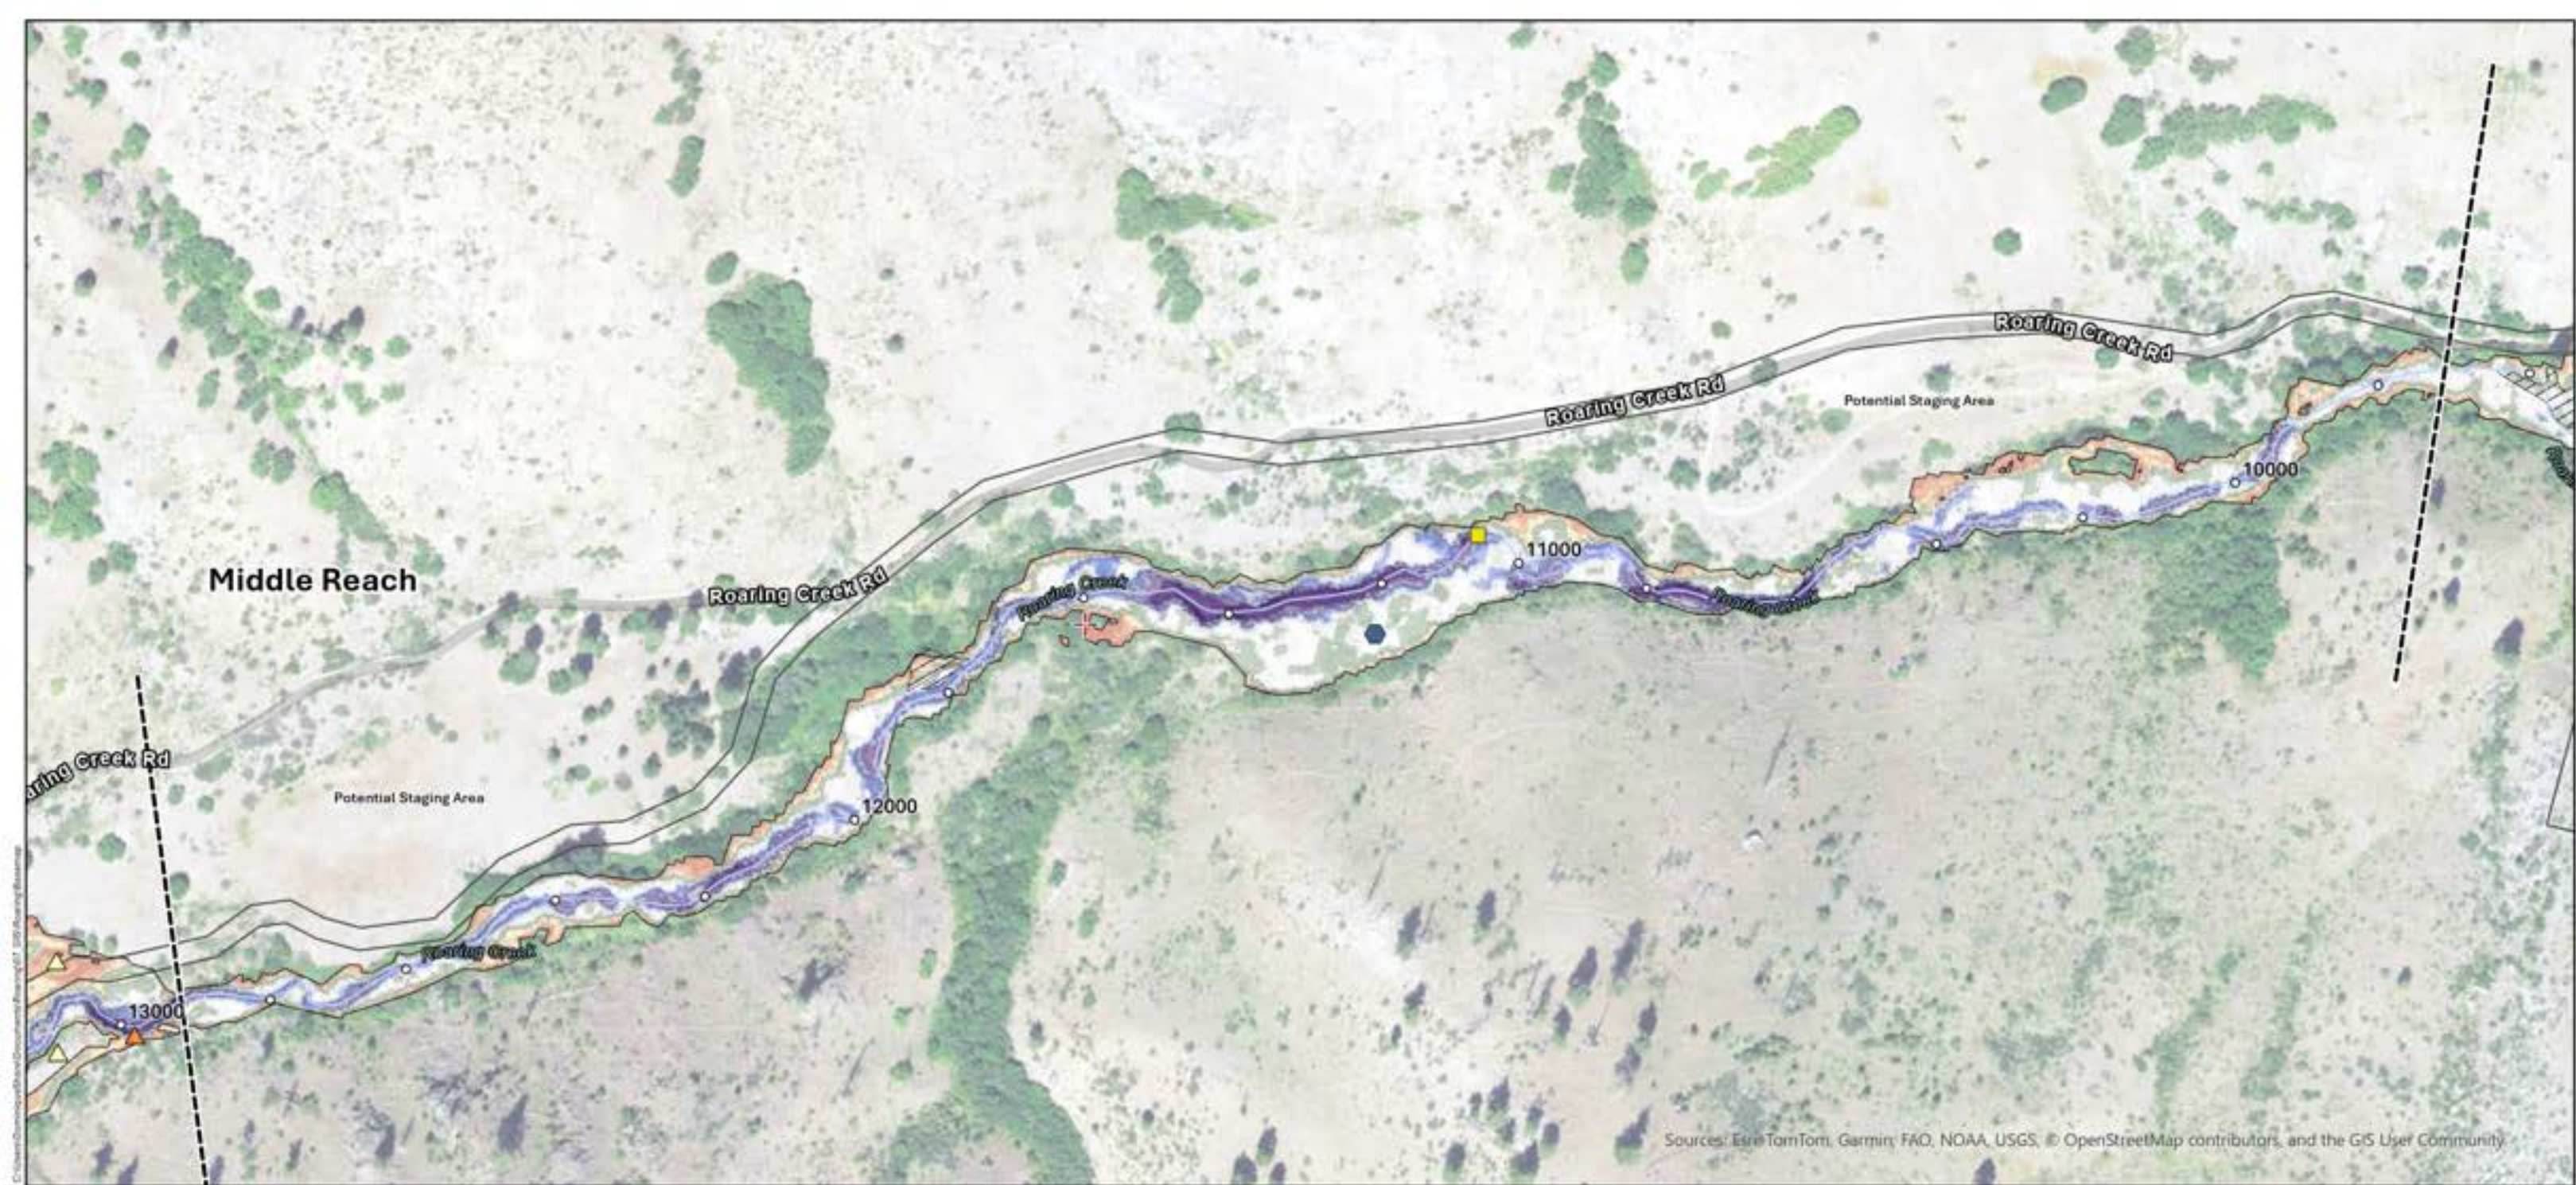
Existing Conditions Map (GGL) Roaring Creek Floodplain Restoration Design

* Geomorphic Grade Line (GGL) Relative Elevation Model (REM) relative to estimated of historic floodplain elevation along baseline shown. GGL REM developed using topobathymetric LIDAR collected by NV5 Geospatial on behalf of WA Department of Natural Resources (2022)

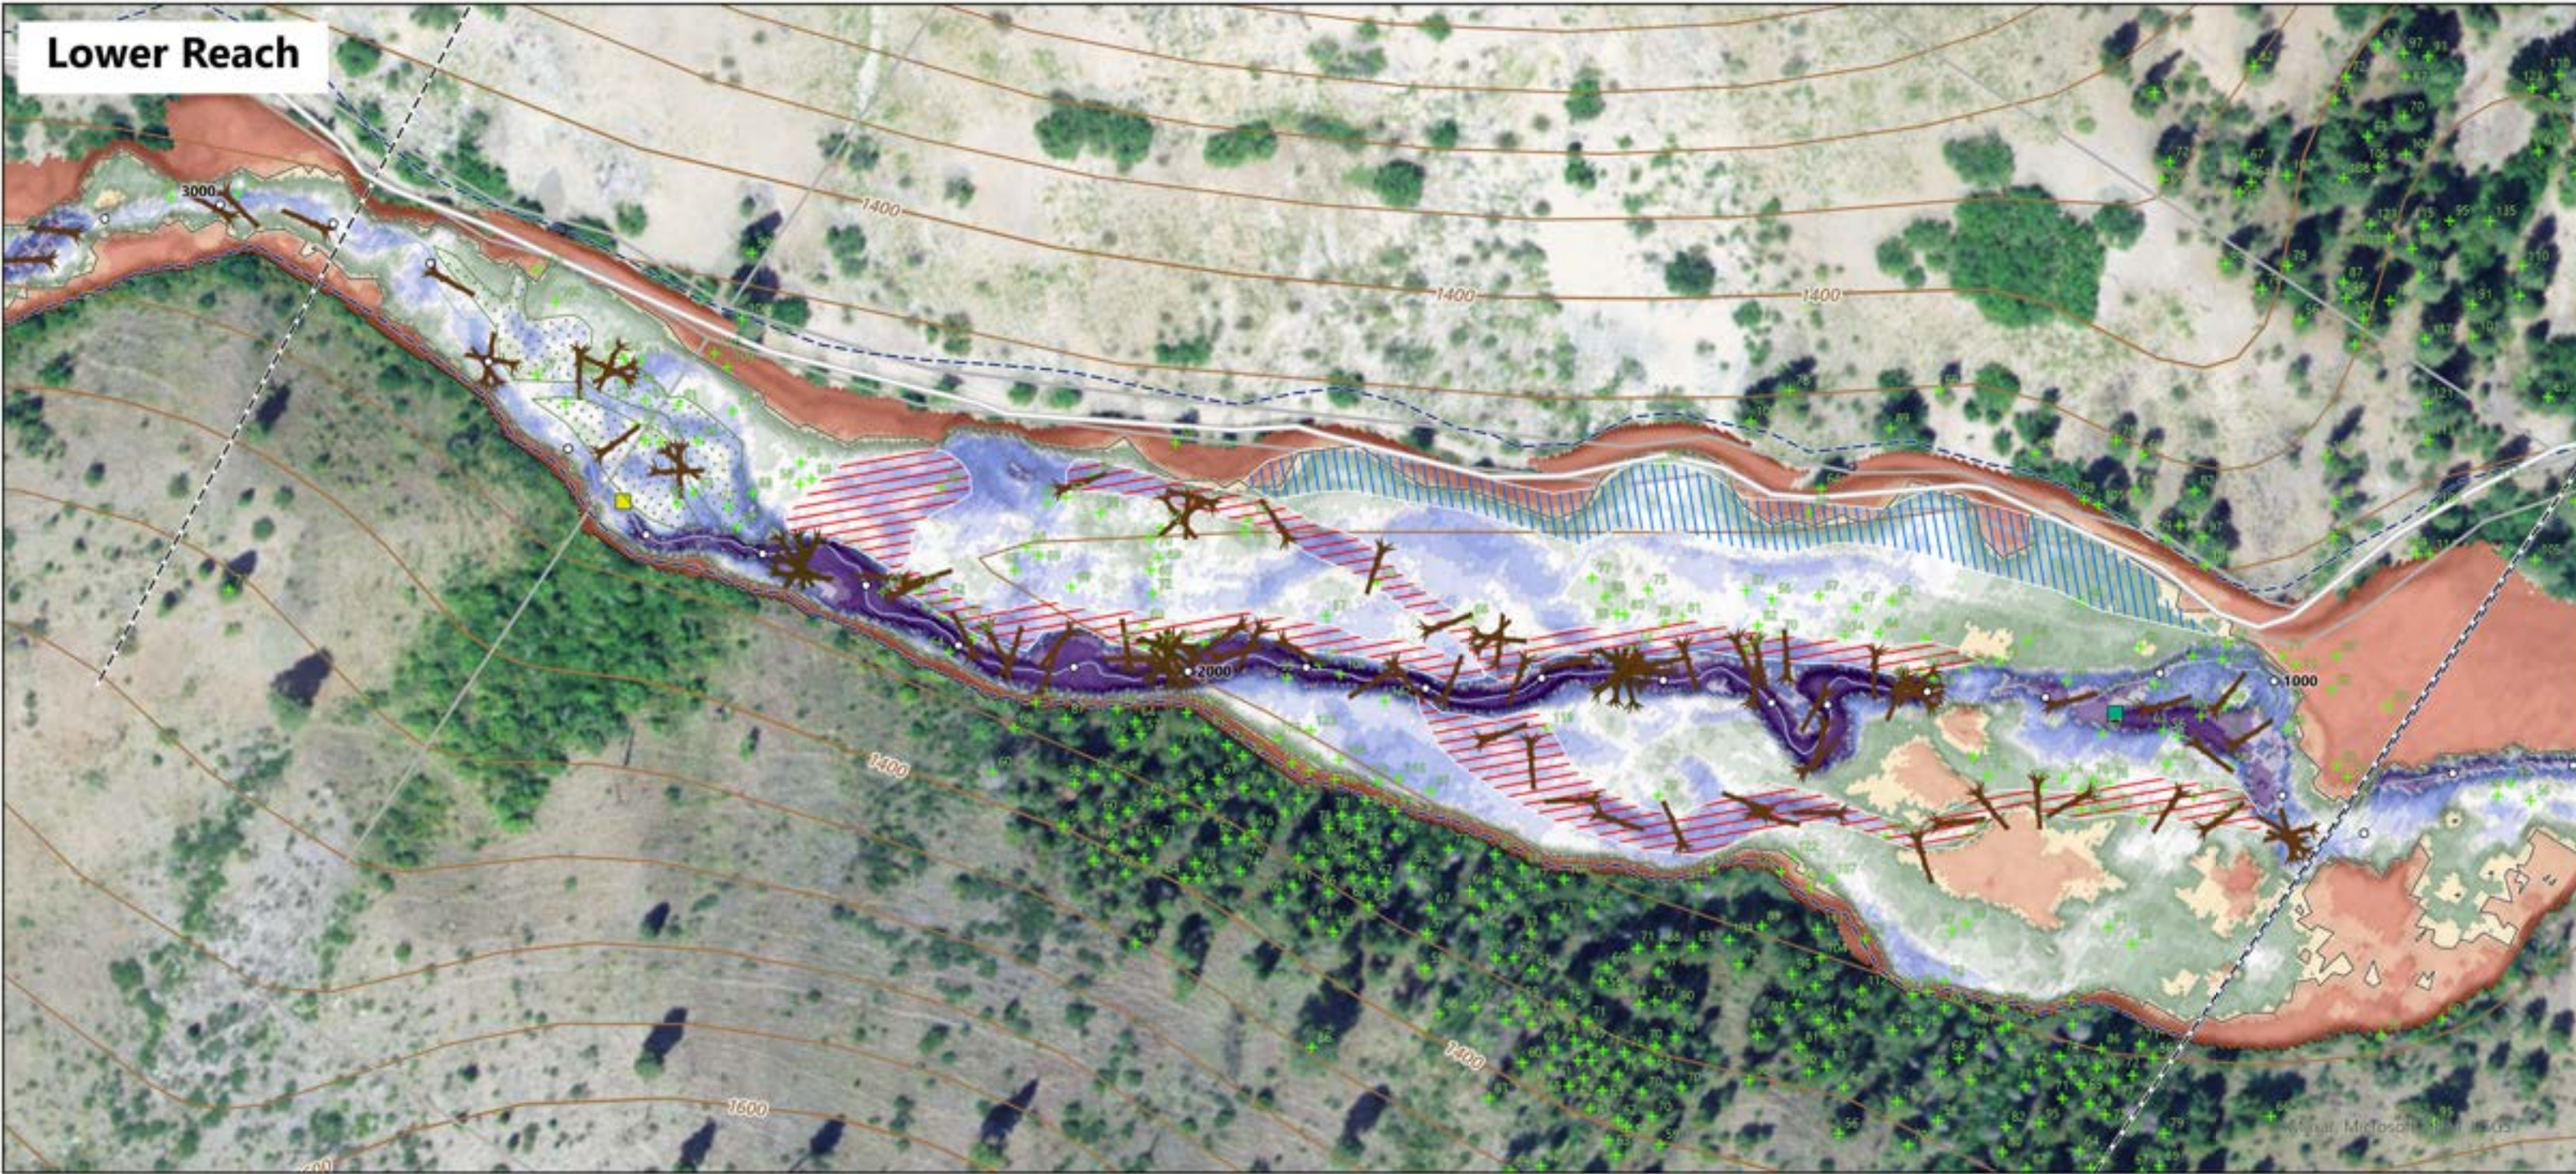
Lower Reach

Geomorphic Grade Line built from topobathymetric LIDAR (2022) collected by NVS on behalf of Washington Department of Natural Resources
