TECHNICAL MEMO (DRAFT)

DATE:	April 17, 2025
TO:	Cascadia Conservation District
FROM:	Lichen: Nick Legg, LG, Dominique Shore RSI: Gabe Williams, PE
PROJECT:	Roaring Creek Restoration Project
SUBJECT:	Conceptual Design - Alternatives Selection

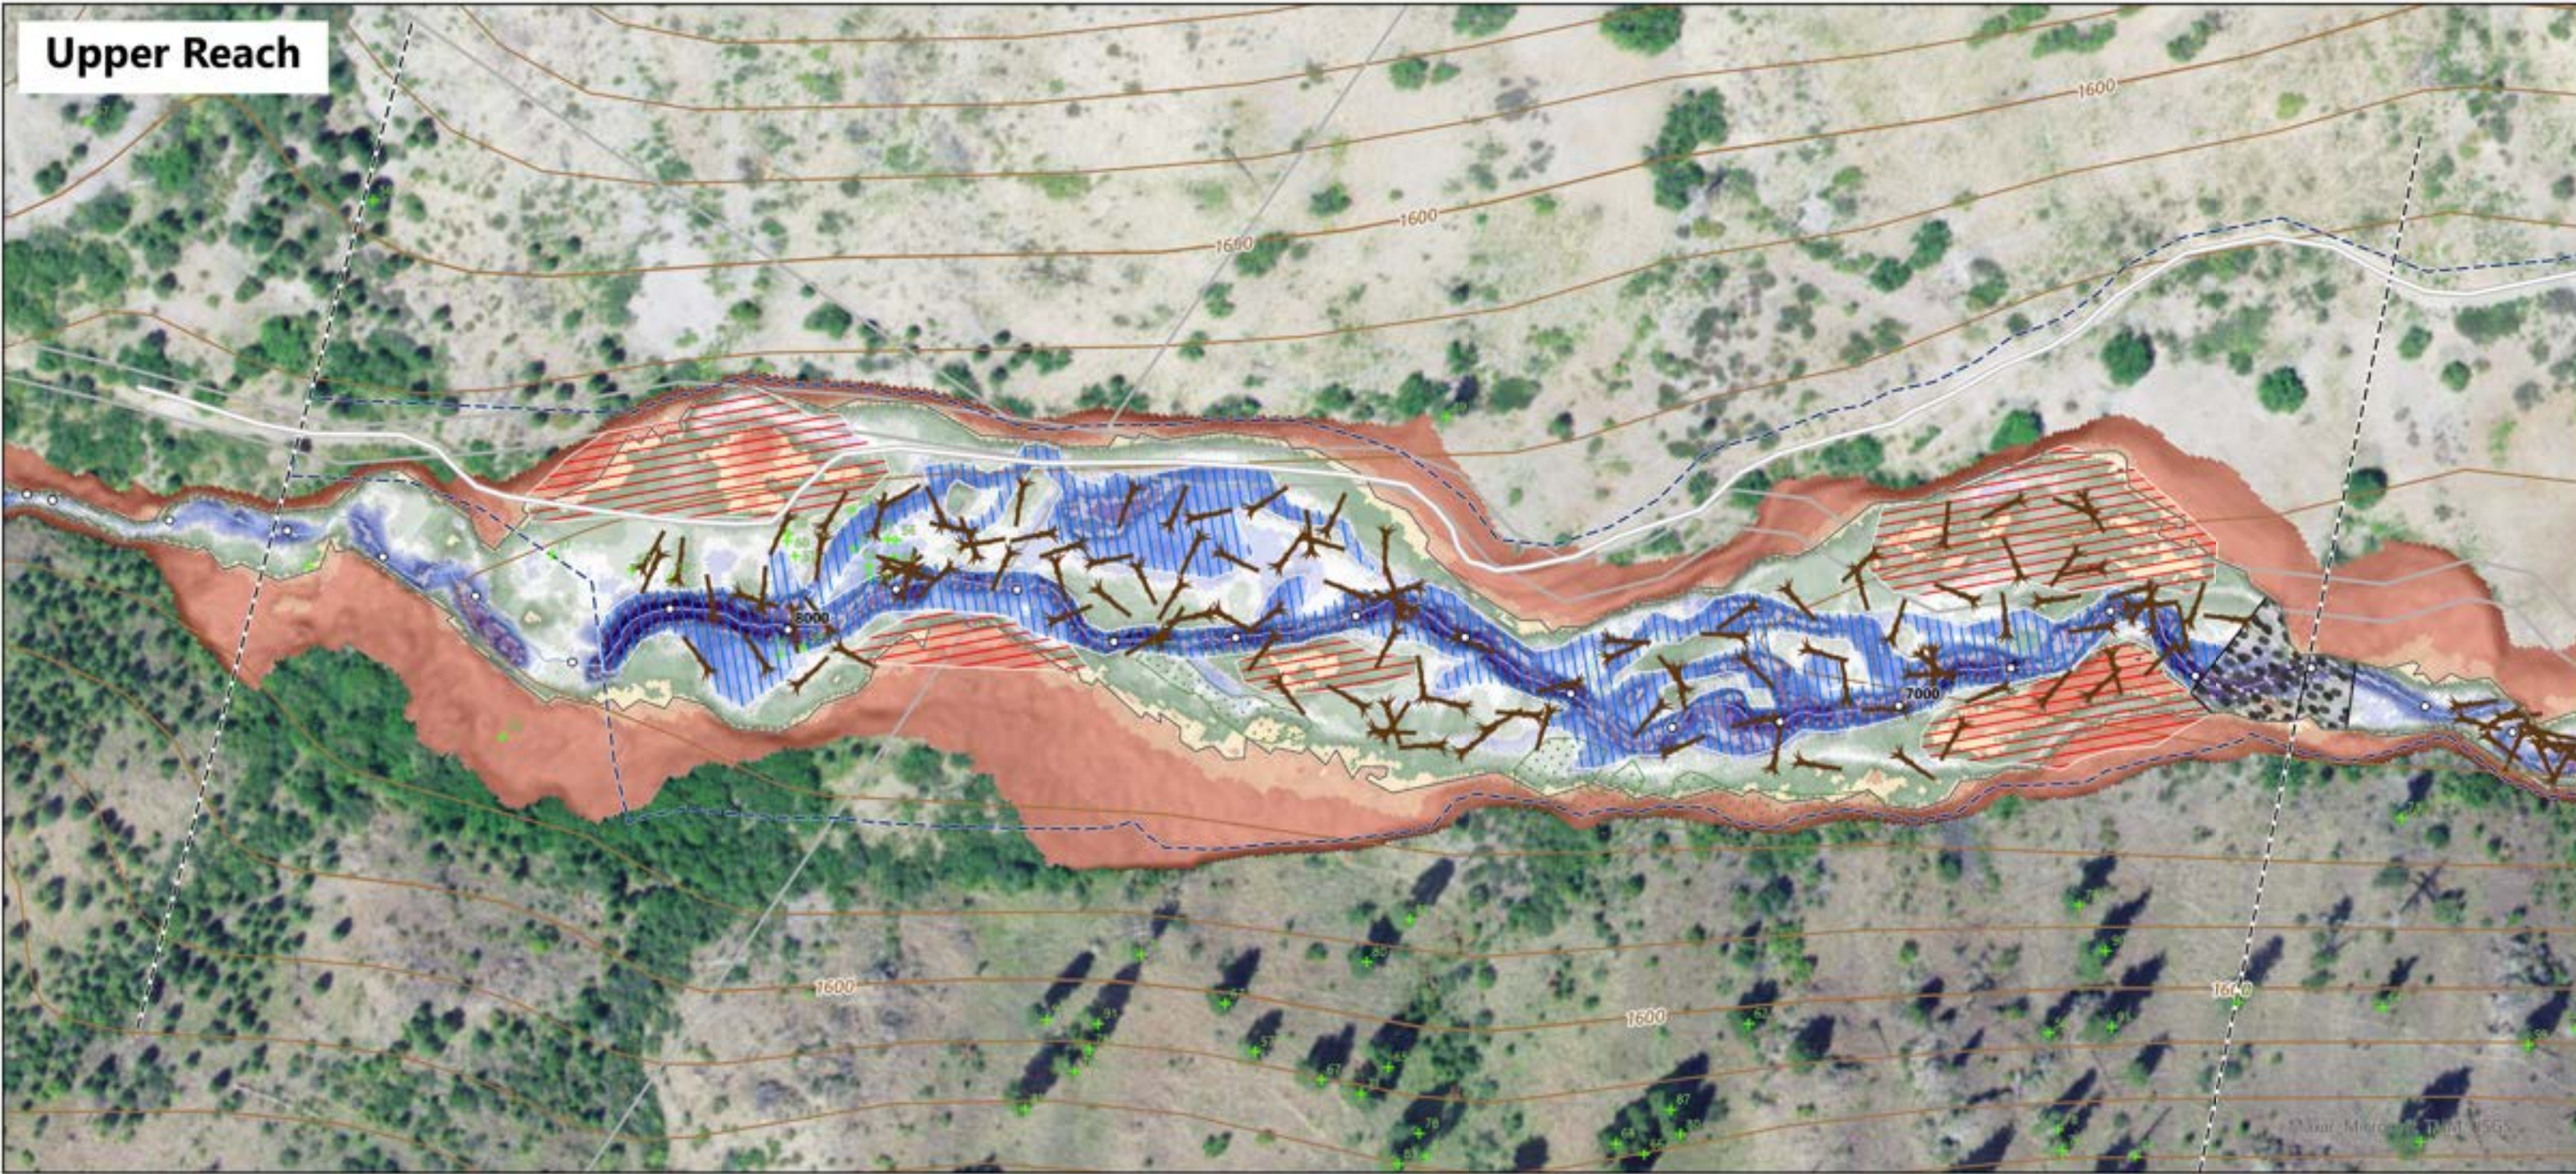
Alternative 3 - Stage 0 and Simulated Landslide Roaring Creek Floodplain Restoration Design 03/18/2025

<ul style="list-style-type: none"> — Roaring Creek Channel ○ Stationing (ft) - - - Reach Boundaries — USFS Road □ Taxlots (approx.) - - - Area of Potential Effects (est.) 	<ul style="list-style-type: none"> □ Estimated Historic Valley Bottom □ Estimated Wetland ■ Beaver Dam Analogs ■ Beaver Dam ★ Trees >55 ft 	<p>Earthwork (Grading)</p> <ul style="list-style-type: none"> /// Floodplain Lowering /// Channel Aggradation ▣ Roughened Channel <p>Wood Structures</p> <ul style="list-style-type: none"> ★ Large Log Jam ★ Log Jam ┆ Single Log 	<p>Elevations relative to the Geomorphic Grade Line (ft)</p> <ul style="list-style-type: none"> 7 - 10 6 - 7 5 - 6 4 - 5 3 - 4 2.5 - 3 2 - 2.5 1.5 - 2 	<ul style="list-style-type: none"> 1 - 1.5 0.5 - 1 0 - 0.5 -0.5 - 0 -1 - -0.5 -1.5 - -1 -2 - -1.5 -2.5 - -2 -3 - -2.5 -4 - -3 < -4
--	--	--	---	--

Alternative 3 | Stage 0 & Targeted Landslide Simulation – This alternative involves full floodplain reconnection in the floodplain reaches through channel fill and distributed wood loading. Alluvial fill placed in the existing (incised) channel would be sourced from high areas and margins of the historical floodplain. This alternative promotes recovery towards a “Stage 0” condition according to the Stream Evolution Model (SEM, Cluer and Thorne, 2014), which means that restoration actions seek to reconnect the historical valley bottom.

The exception to the Stage 0 approach is within the middle reach, where the floodplain is narrower, and the riparian zone is more intact. Here, the proposed strategy is to install natural accumulations of large wood that simulate landslides. This approach aligns with the geomorphic setting, promotes sediment retention, and minimizes disturbance of the riparian zone.
