LOWER CHEWUCH RIVER REACH ASSESSMENT

Methow Salmon Recovery Foundation

December 2025

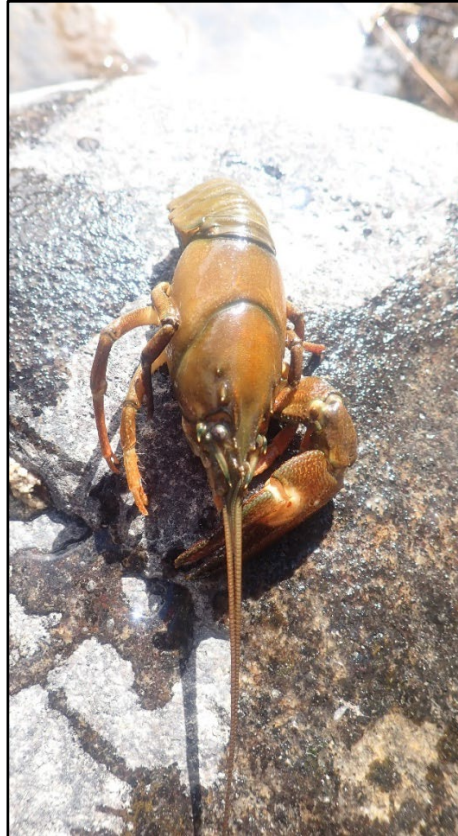
Figure 2.3.1. Signal crayfish were observed in the LCRA area during the 2023 habitat survey.

Freshwater mussels (and other mollusks of conservation concern) are present in the LCRA and shell fragments, but no live specimens, were observed in several locations during the 2023 habitat surveys. Signal Crayfish (*Pacifasticus leniusculus*, Figure 2.3.1), one of several native crayfish in Washington State, was observed during the 2023 habitat survey and in prior years of monitoring (J. Crandall, personal observation). Observations of this crustacean during the habitat survey were most abundant in the Chewuch-Doe AU. The recently classified Okanogan Crayfish, (*Pacifastacus okanaganensis*) is likely also present in the Chewuch River, but was not observed during field surveys.

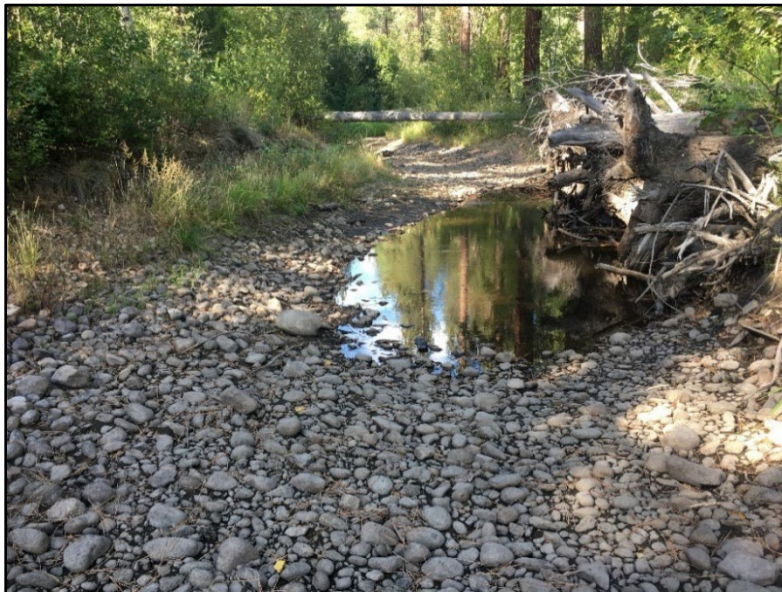
Figure 2.4.1. Isolated pool in the Chewuch River Right Project side channel, Doe 1 reach, 7 Sep 2023.

At least four isolated pools were observed in the restored channel and contained only a few stranded target species fish (Figure 2.4.1). Adaptive management of the site in 2025 sought to establish perennial flow through the side channel which would eliminate the isolated areas observed during the LCRA field surveys.

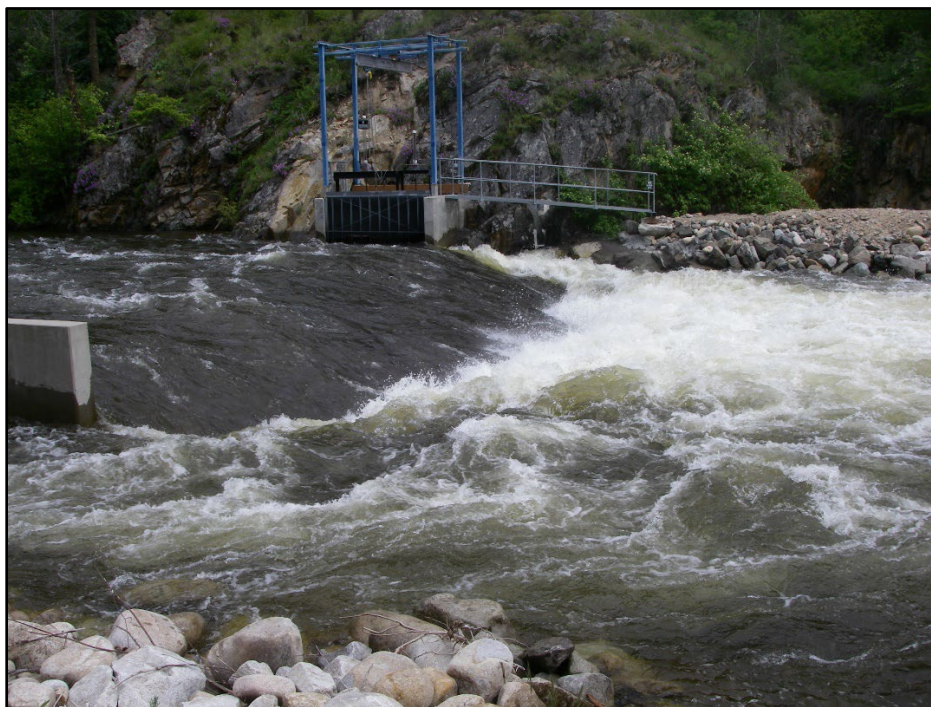
Figure 3.2.3. Chewuch Dam at high flow, June 2010. The fish passage channel can be seen to left of concrete wall at left side of image.

Both dams, to varying degrees, create artificial hydraulics (at all flows) and impede fish passage to some degree. Chewuch Dam has been identified as only 67% fish passable, while Fulton Dam has not been extensively examined for passage (WDFW 2018, J. Novak, WDFW, personal communication).

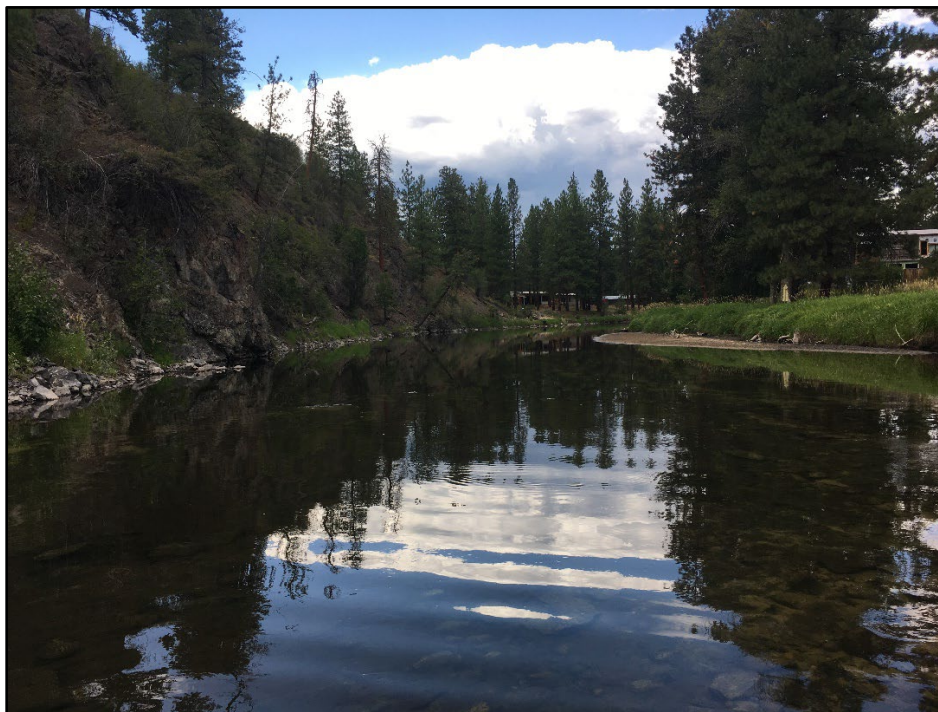
Figure 3.2.4. The Fulton Dam impoundment zone extends upstream for approximately one-quarter mile, July 2023 photo.

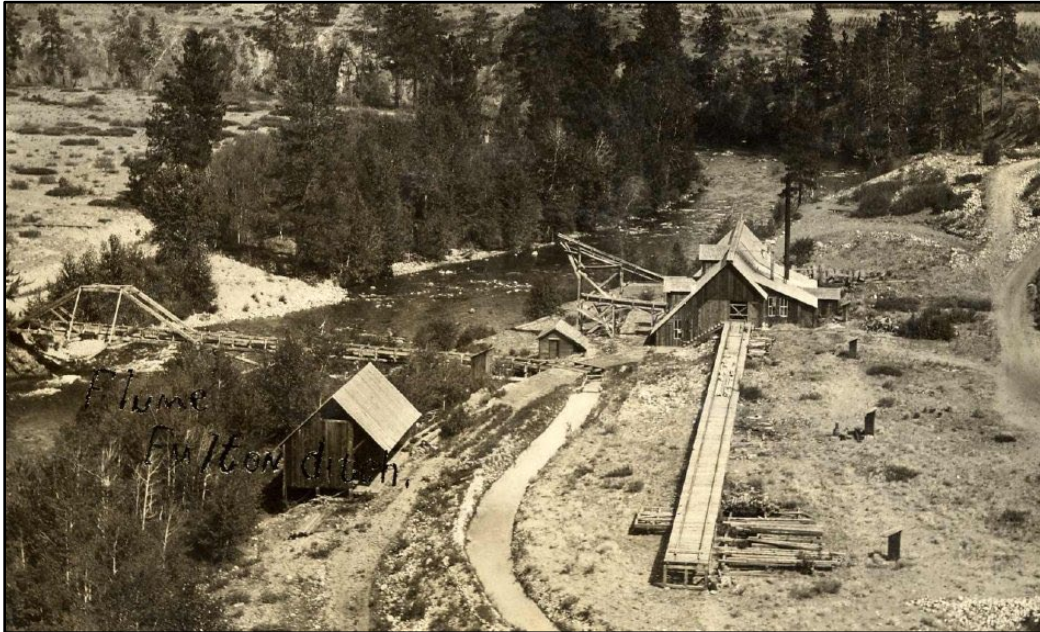
Figure 3.2.5. Early timber harvest in the Chewuch River watershed supplied the sawmill in Winthrop. The Fulton Ditch conveyance pipe can be seen crossing the river to the left of the mill. Photo credit: Okanogan Historical Society.

Prior to the 1930's, logging in the lower Chewuch watershed was relatively light, done mainly by local residents for building materials and firewood. During the 1920s-1930s, annual timber harvest was approximately one million board feet; some of this wood supplied a small sawmill along the banks of the Chewuch River in Winthrop (USFS 1994, USFS 2015, Figure 3.2.5).

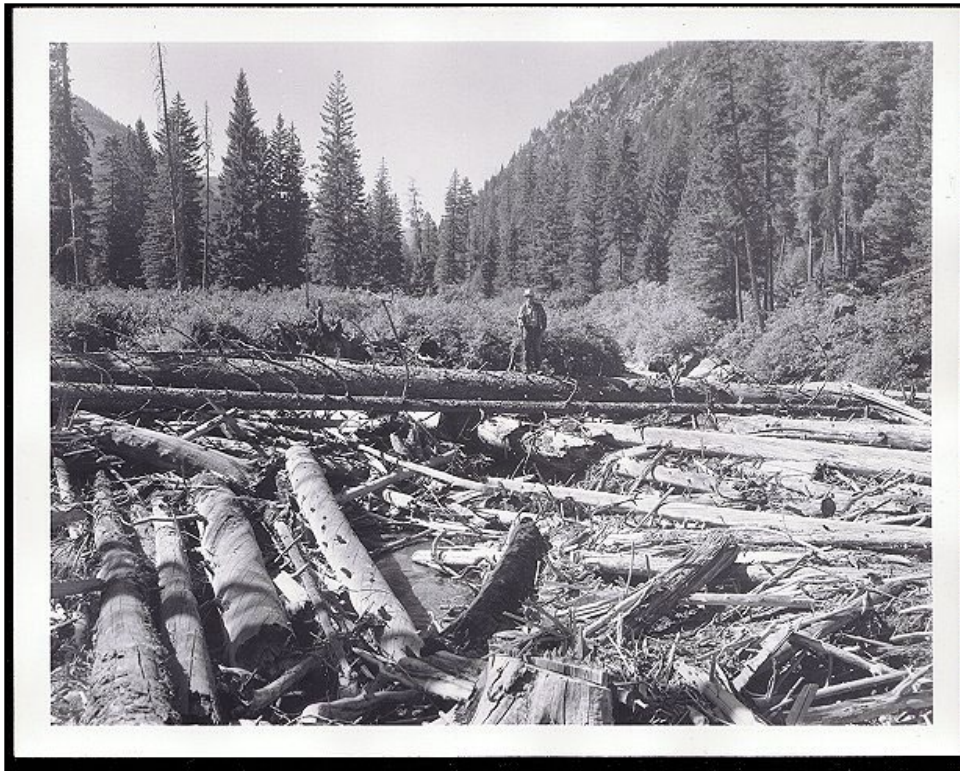
Figure 3.2.6. Chewuch River mainstem wood accumulation, pre-wood clearing event, 1963.

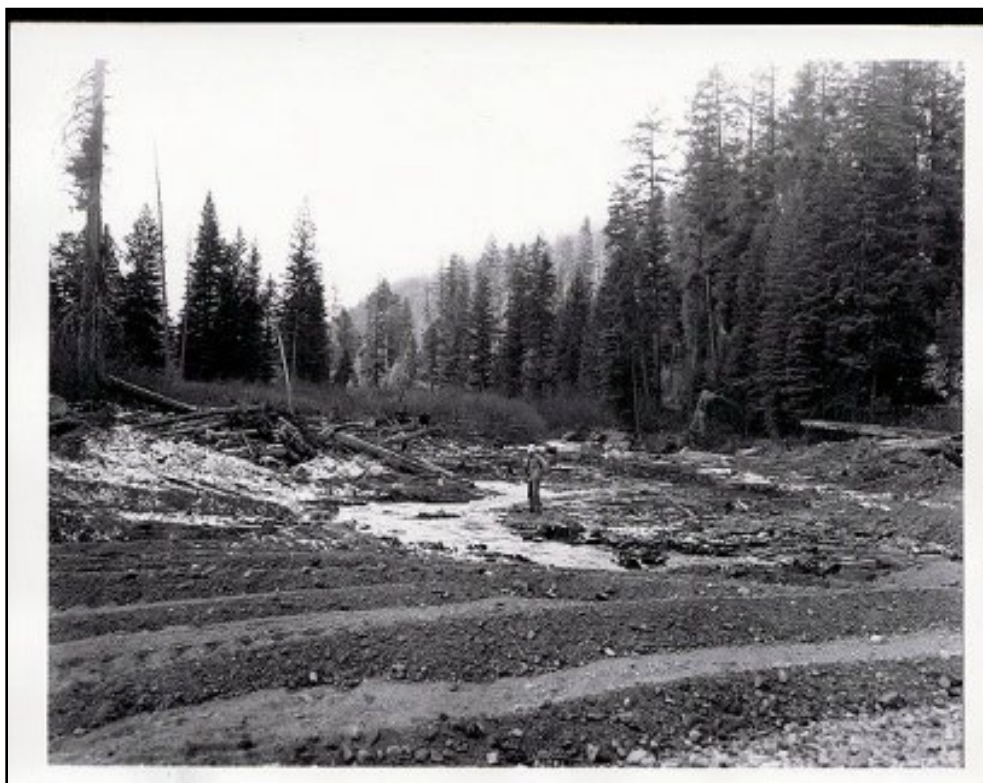
Figure 3.2.7. Chewuch River mainstem channel, post-wood clearing event, 1963.

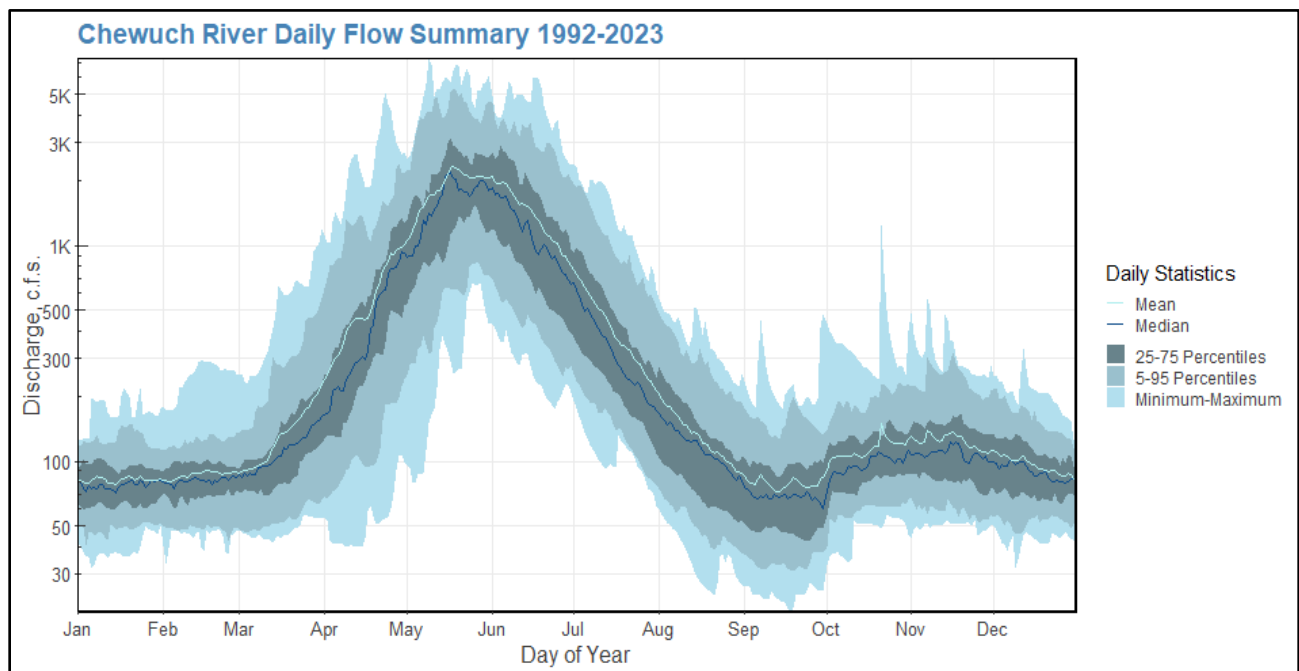
Figure 3.3.1 Annual hydrograph of the Chewuch River at Winthrop, WA. Daily statistics include the minimum, maximum, and the 25/75th, and 5/95th percentiles of the mean daily discharge measured at USGS gage #12448000 (Chewuch River at Winthrop, WA) between 1992-2023.

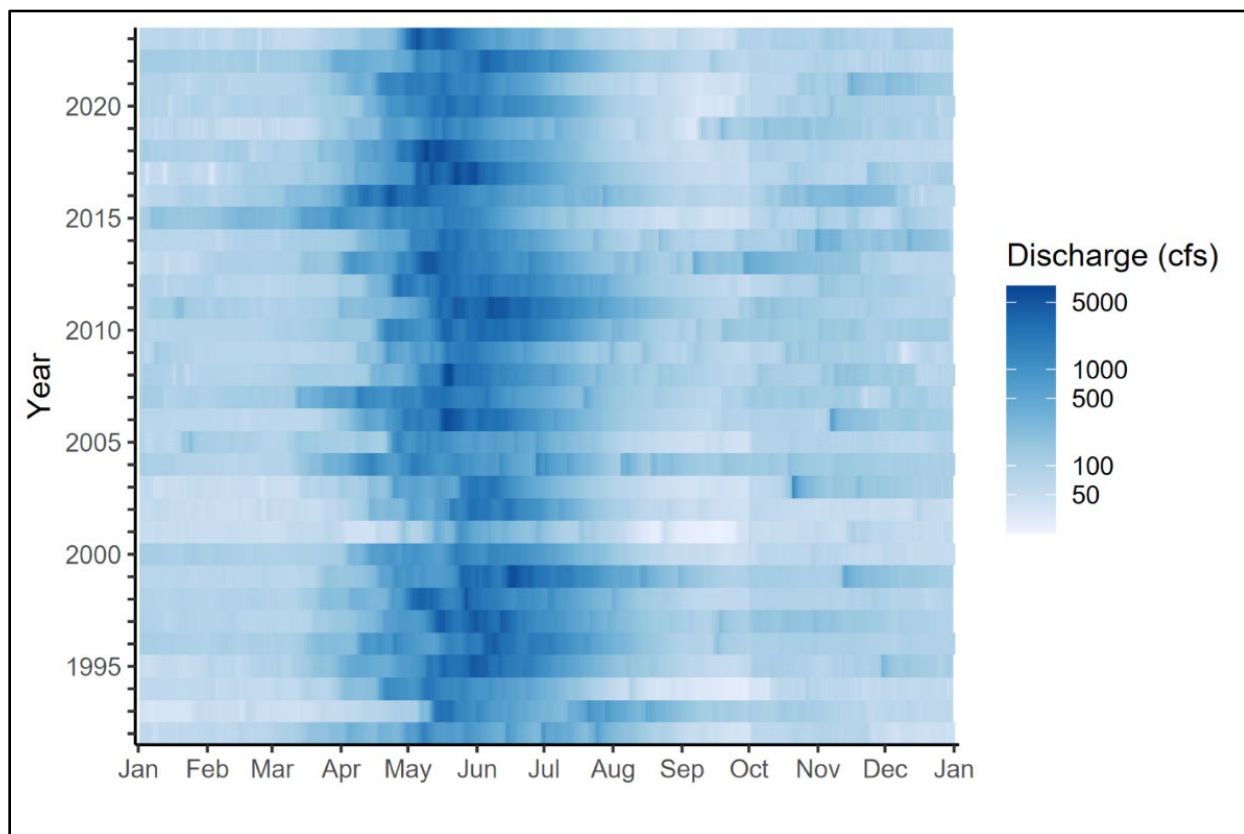
Figure 3.3.2. Annual discharge timing and rate of the Chewuch River at Winthrop, WA (USGS Gauge #12448000) from 1992-2023. Figure from Reclamation Technical Services Center.

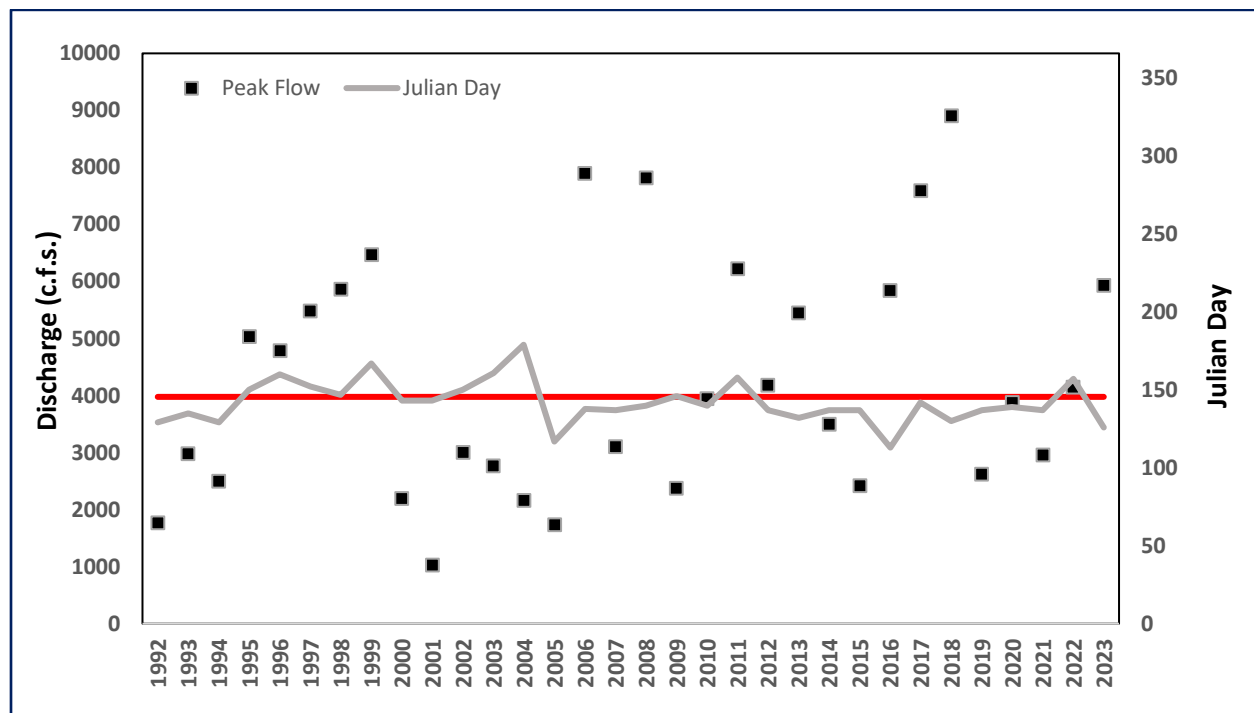
Figure 3.3.5. Annual peak discharge and Julian Day timing of peak flow, Chewuch River at Winthrop, WA (USGS Gauge #12448000) from 1992-2023. Red line denotes estimated Q2 discharge.

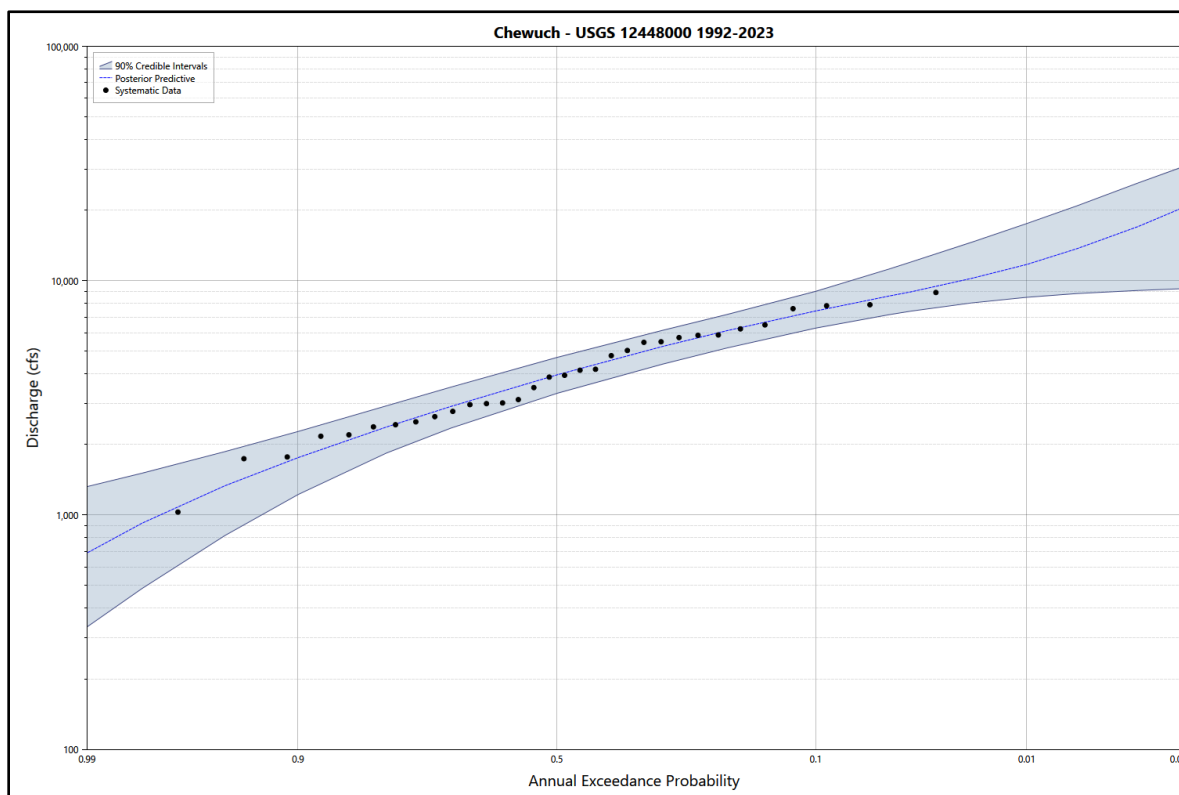
Figure 3.3.6. Flood frequency in the Chewuch River for the period 1992-2023 constructed from discharge measured USGS gauge #12448000 at Winthrop, WA. The curve was developed using the Log-Pearson Type III probability distribution method. Figure courtesy of USBR Technical Services Center.

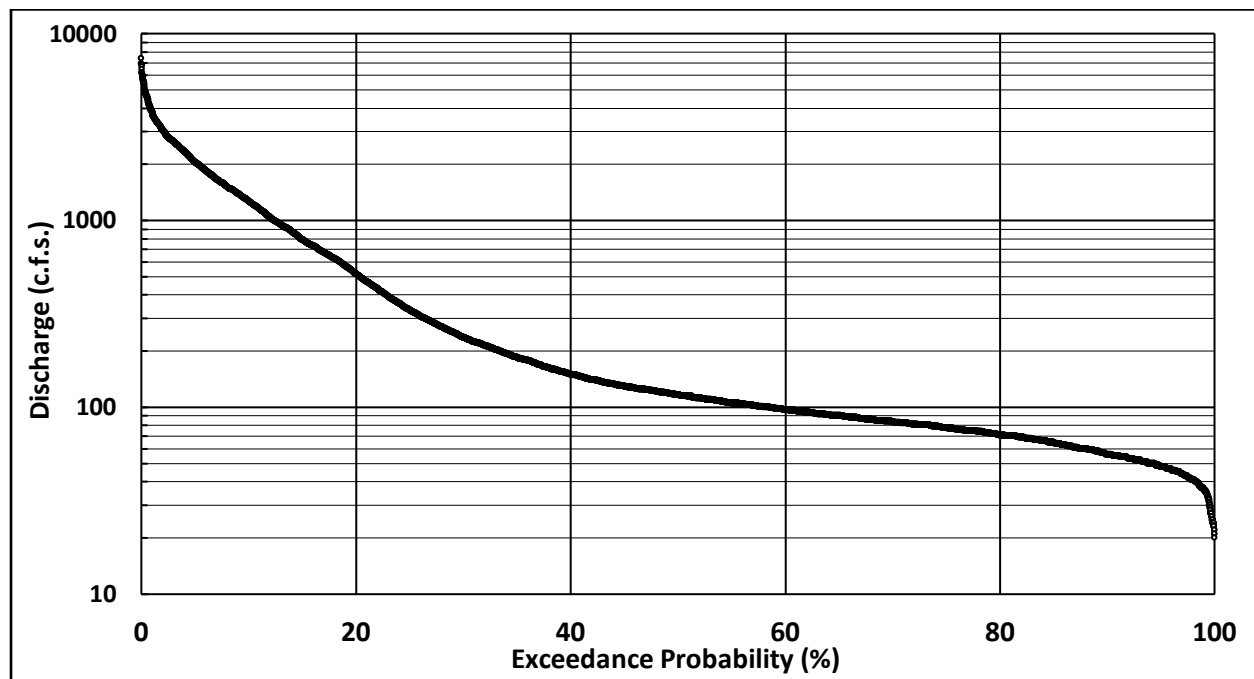
Figure 3.3.7. Flow duration curve for mean daily flow at USGS gauge 12448000 (Chewuch River at Winthrop, WA), 1992-2023.

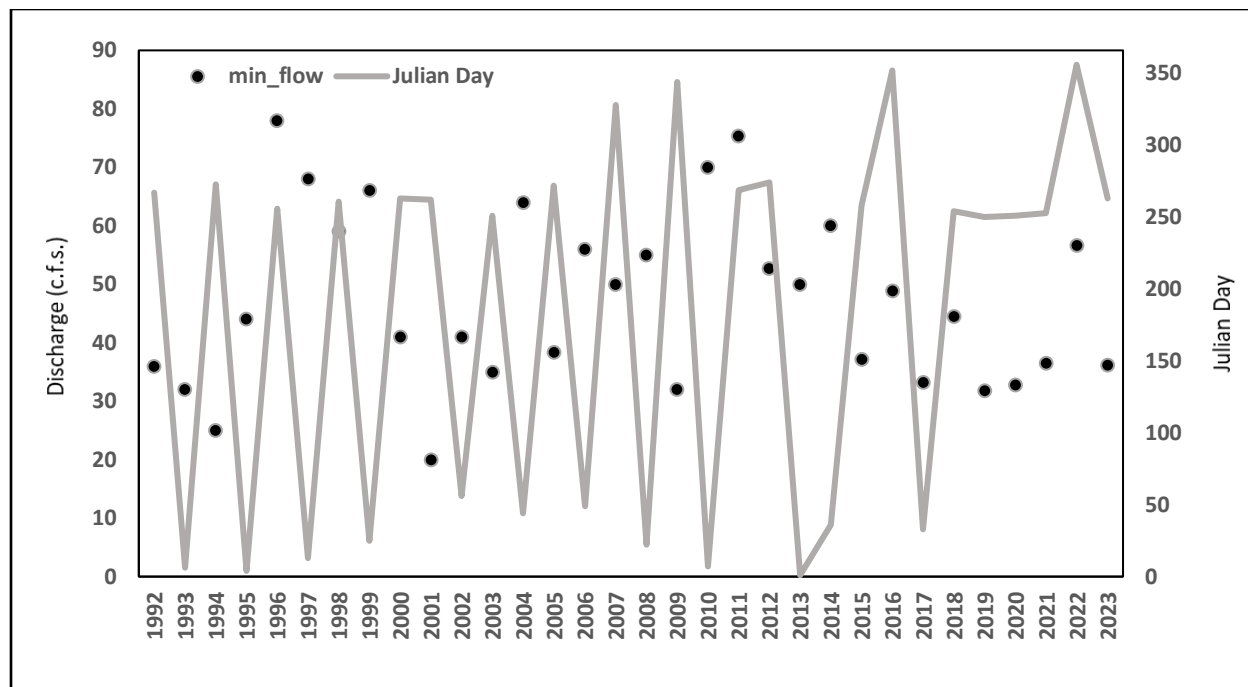
Figure 3.3.8. Annual minimum discharge and Julian Day timing of minimum flow, Chewuch River at Winthrop, WA (USGS Gauge #12448000) from 1992-2023.

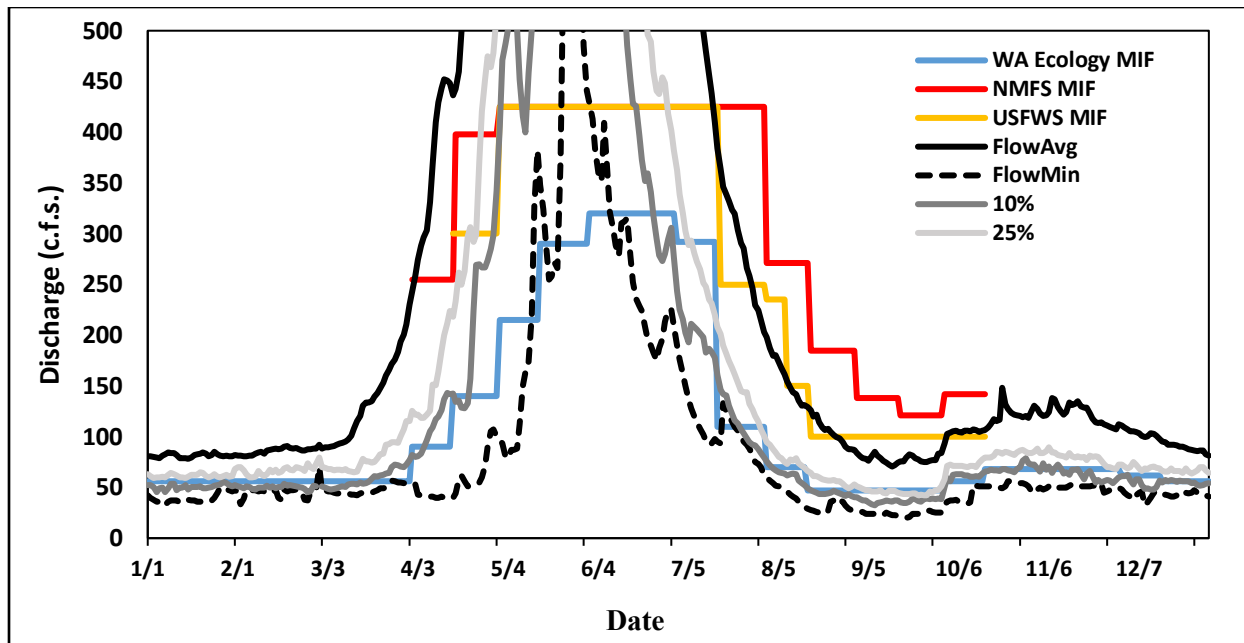
Figure 3.3.9. Minimum instream flow for the Chewuch River from WA Ecology, NOAA Fisheries, and USFWS plotted with mean, minimum, 10%/25% exceedance discharges for the Chewuch River at Winthrop, WA (USGS Gauge #12448000) from 1992-2023.

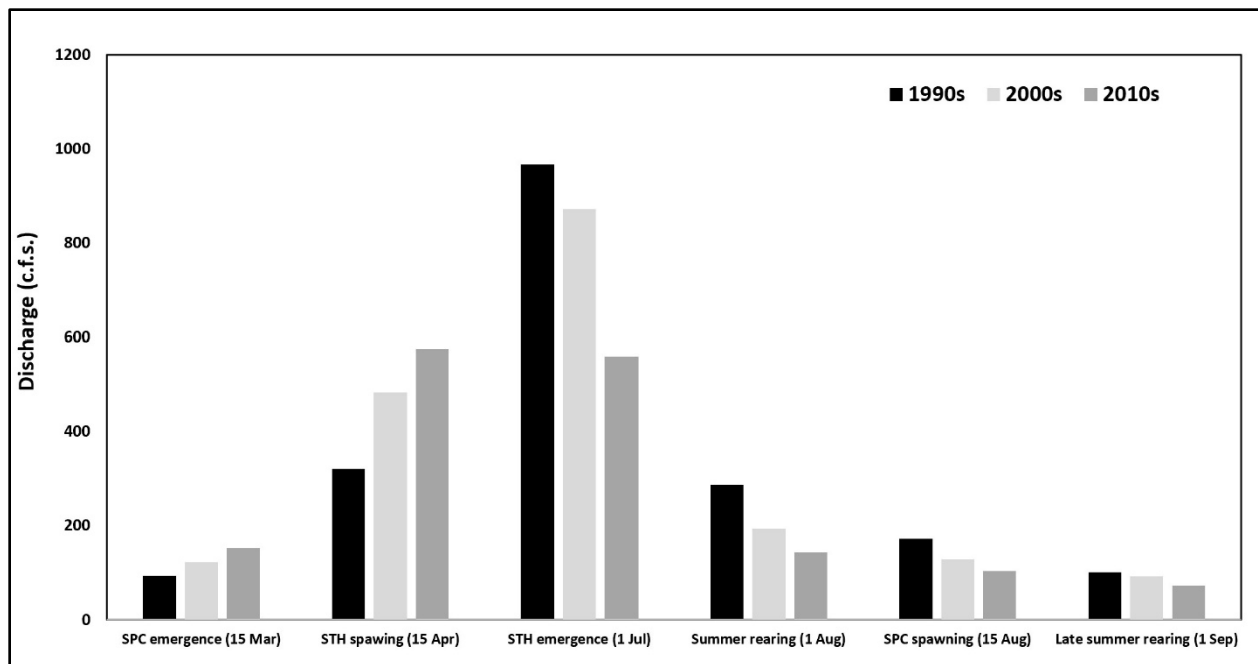
Figure 3.3.12. Chewuch River daily average flow on select dates coincident with fish life stages by decade, 1992-2021, Chewuch River at Winthrop, USGS Gauge #12448000.

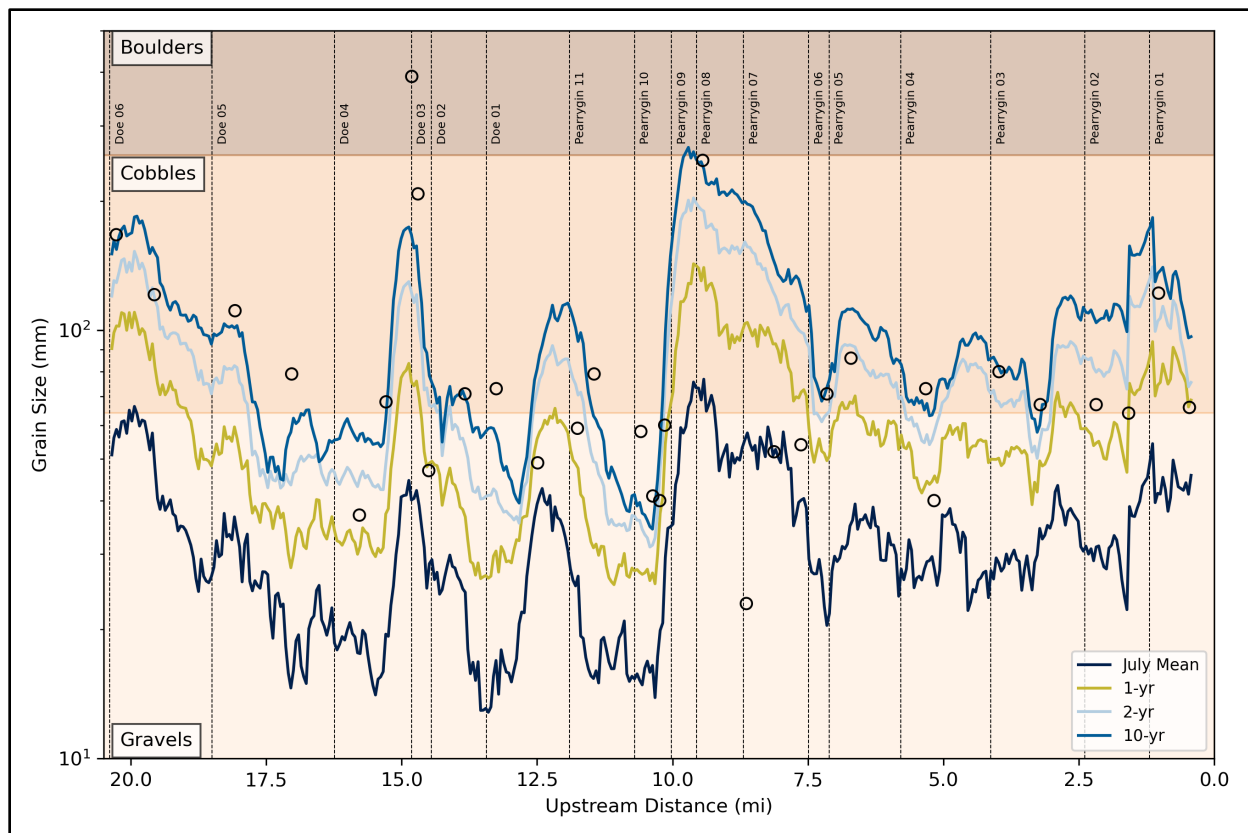
Figure 3.4.4. Predicted grain sizes transported at four flows compared with field measured 50th-percentile grain size (black circles). Shading indicates gravel, cobble, and boulder size classes.

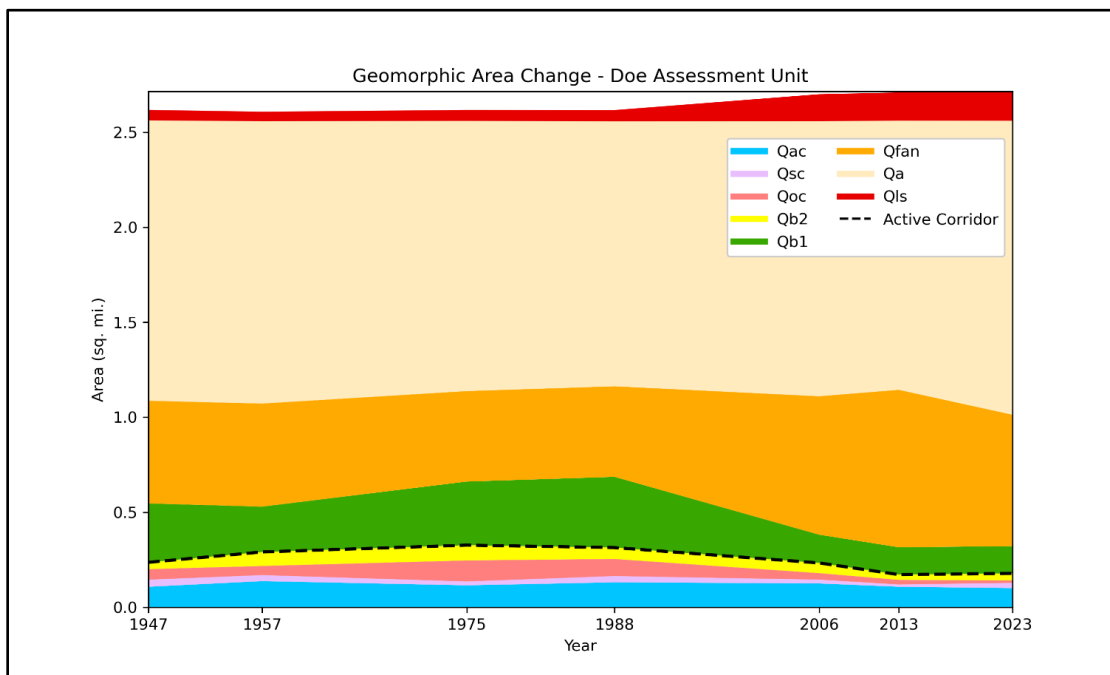
Figure 3.4.6. Chewuch-Doe AU geomorphic unit area change over time, 1947 – 2023.

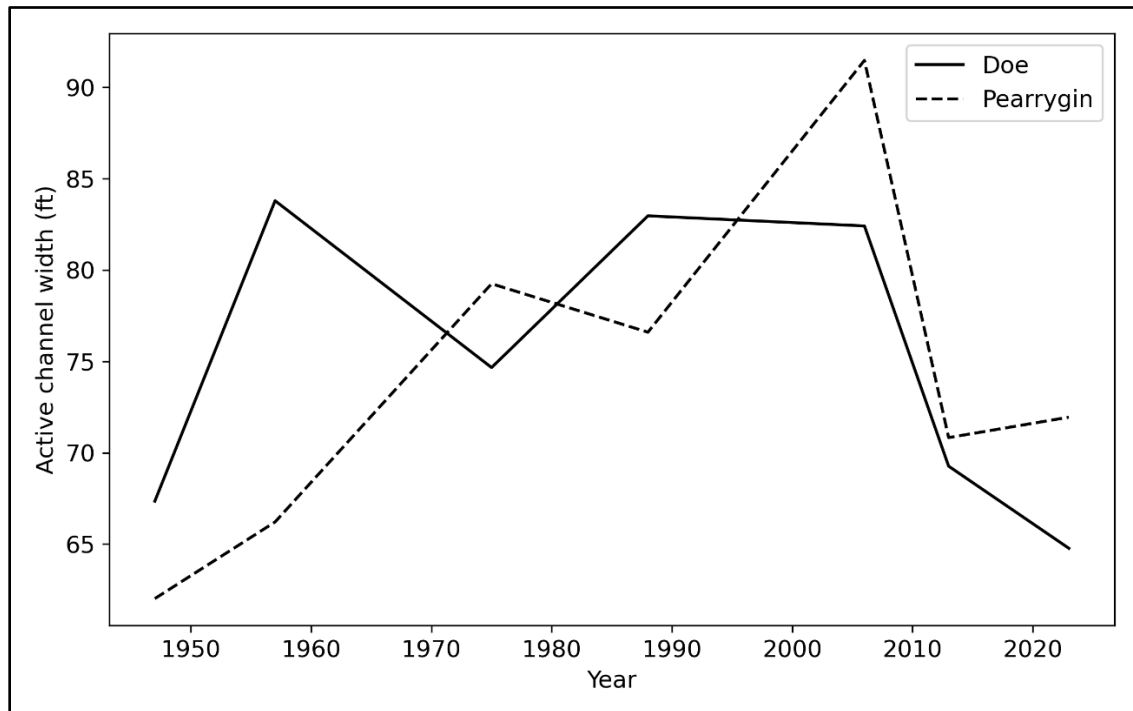
Figure 3.4.7. LCRA AU active channel width change over time, 1947 – 2023.

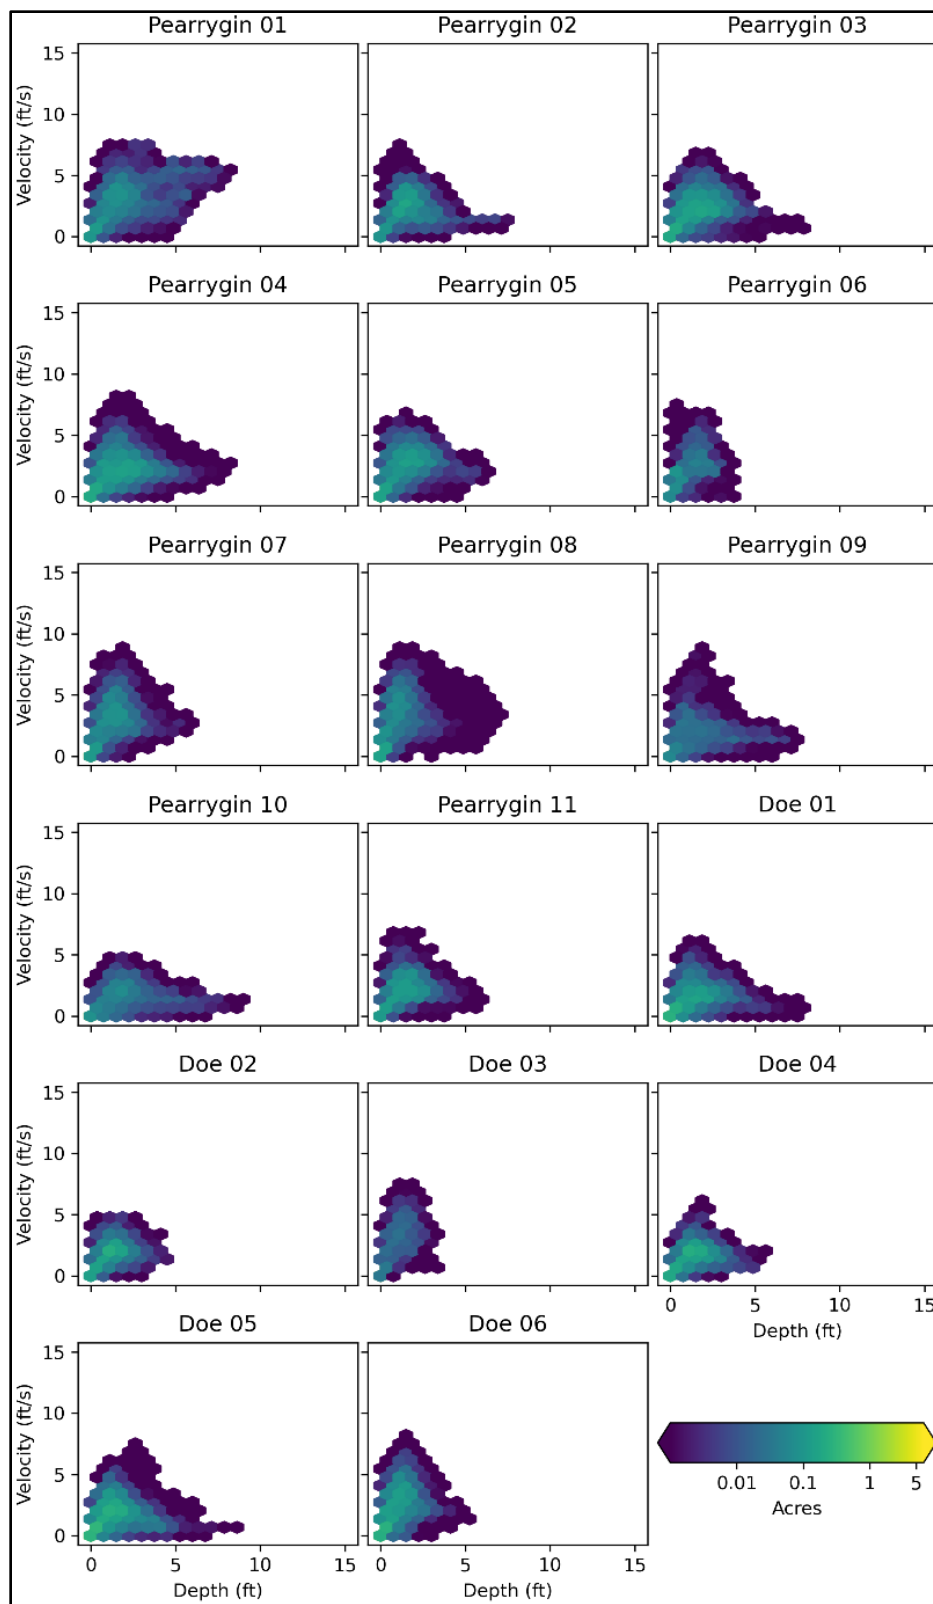
Figure 3.4.11. Total area within reach with given depth and velocity combinations under the July mean flow conditions.

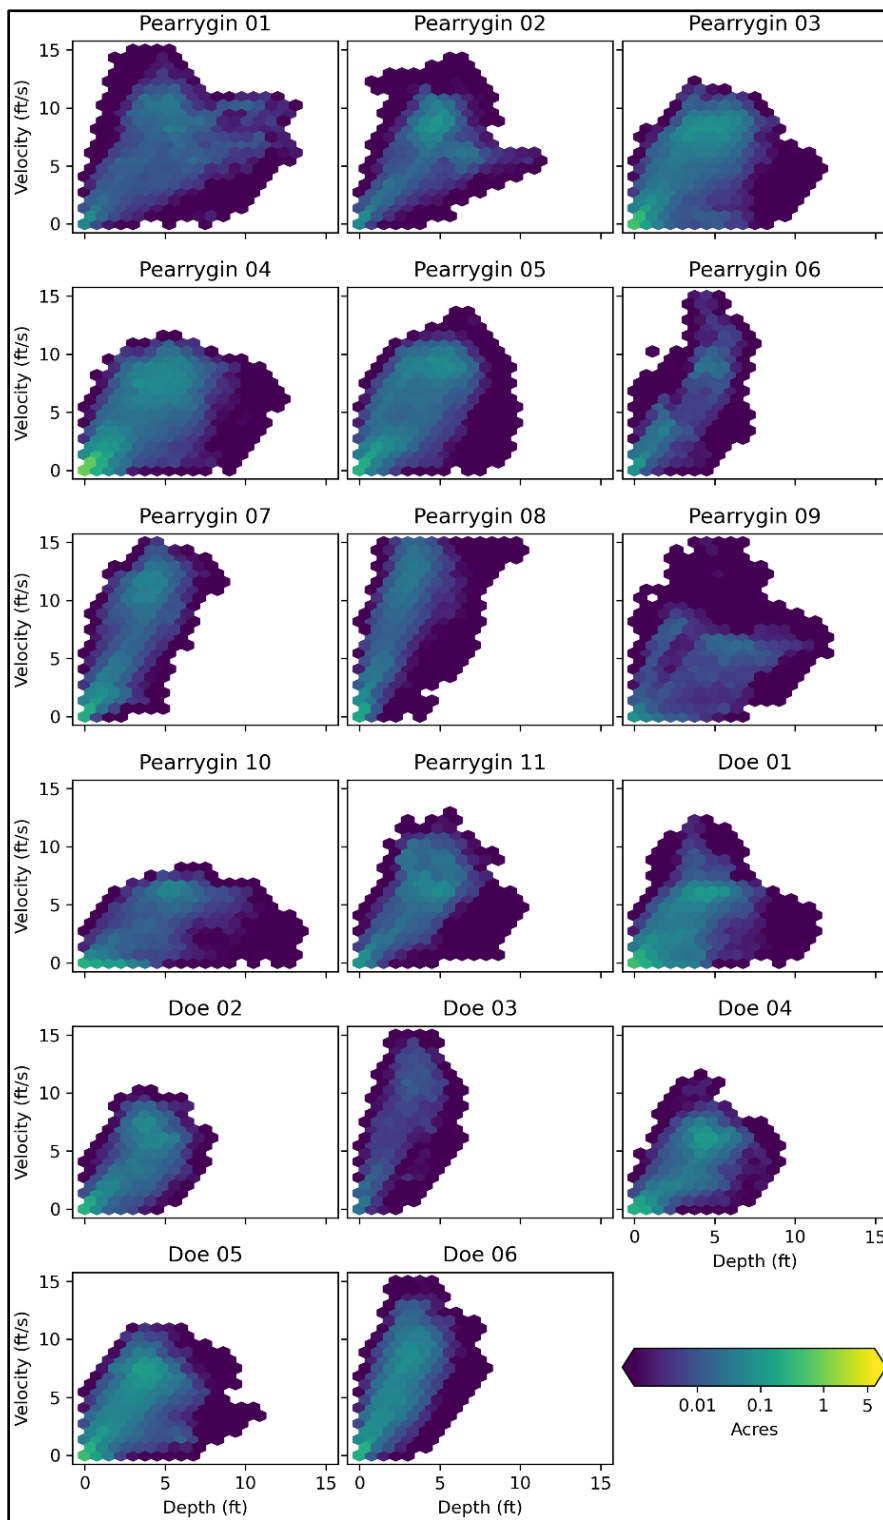
Figure 3.4.12. Total area within reach with given depth and velocity combinations under the 2-year recurrence flow conditions.

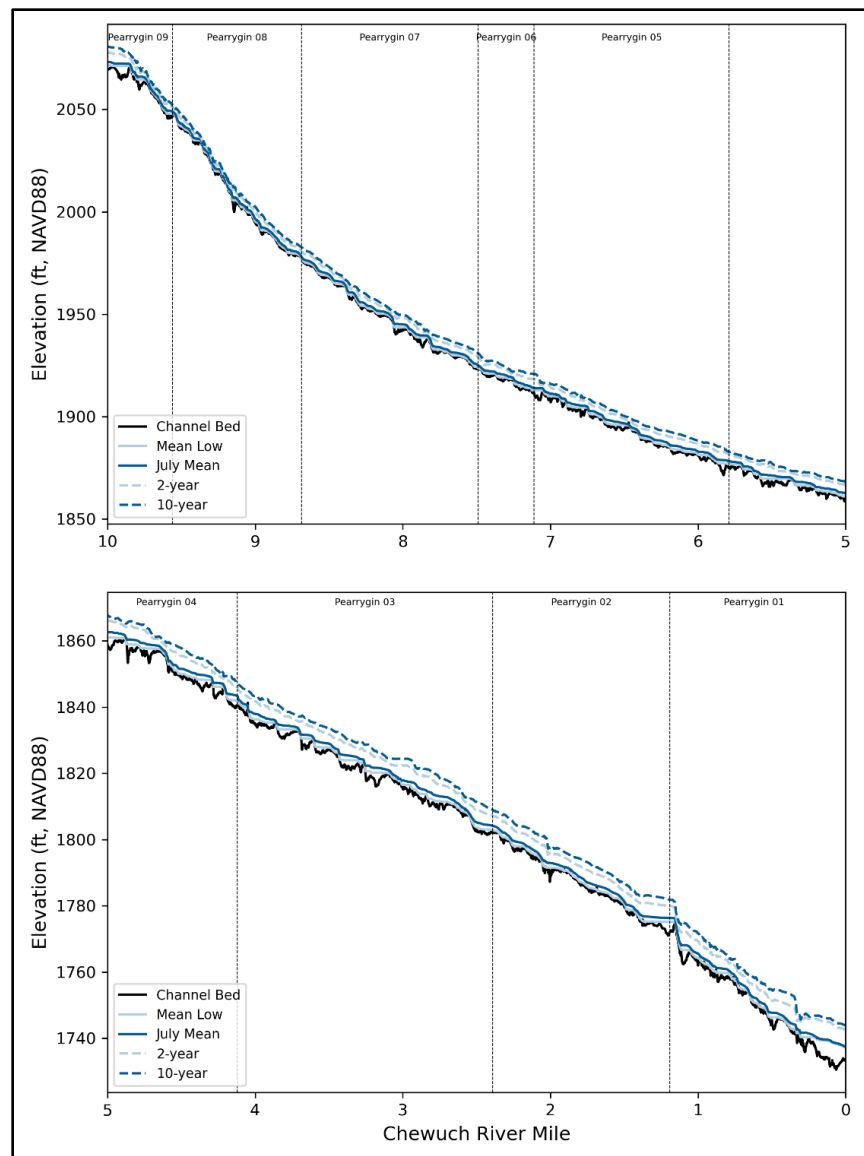
Figure 3.4.14. Longitudinal profile of river bed and water surface elevations for select flows between river miles 0 and 10 along the Chewuch River.

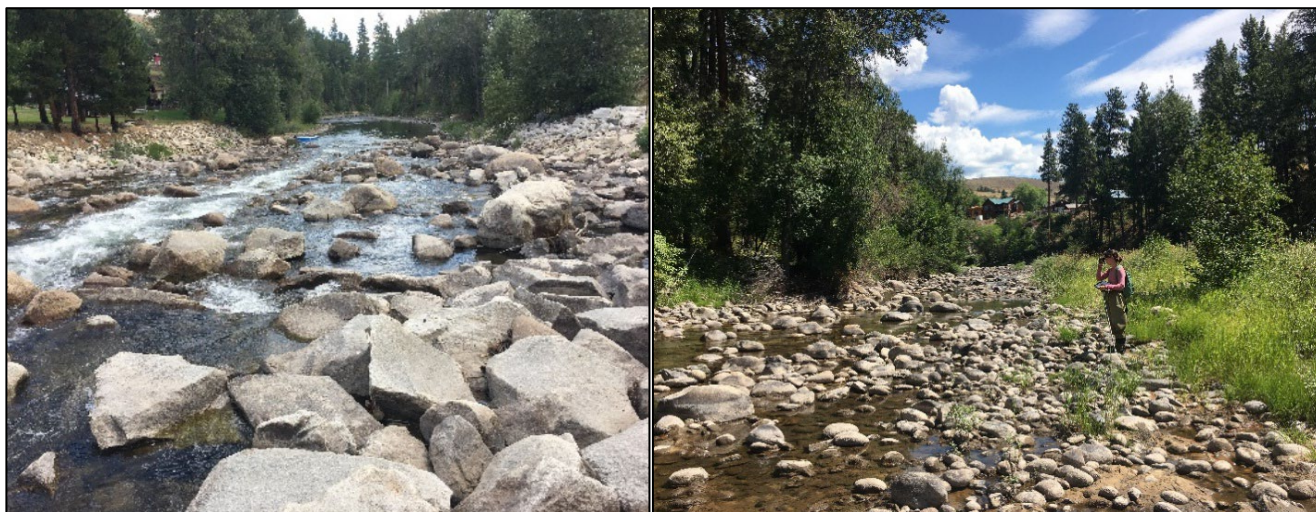
Downstream view of Pearrygin 1 reach from top of Fulton Dam (right). Boulder substrate was placed during dam renovation in 2009. Side channel habitat in Pearrygin 1 reach (left).

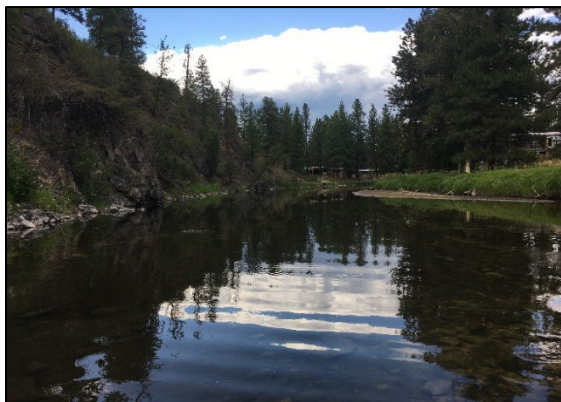
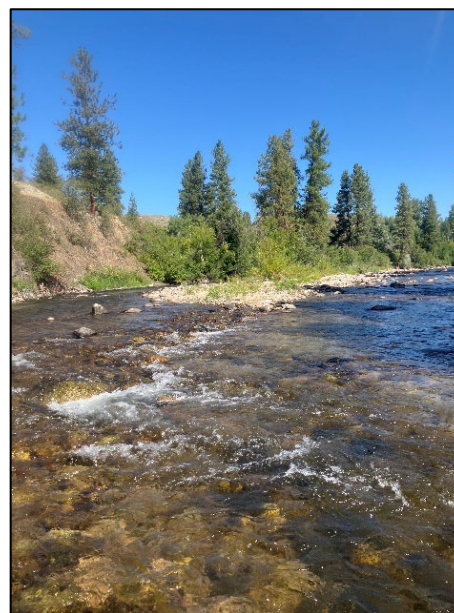
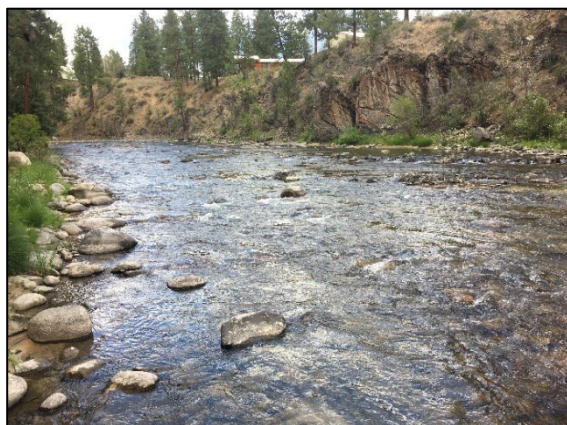
Upstream view from Fulton Dam showing pool inundation and residential development along banks (above left). Typical bedrock outcrop and riffle-cobble habitat in Pearrygin 2 reach (left). Upstream view of low flow side channel habitat and glacial terraces (above).

#Pools: 3		Channel Widths/Pool: 17.1		Pools/mile: 2.4
Wood Count (Nat/ELJ): 14/0		Natural LW Pieces/mile: 11.7		LW Jams (Nat/ELJ): 0/0
Reach Description				
<p>Pearrygin 2 reach is located from Fulton Dam upstream to the confluence with Lake Creek, which enters on river left (east). The reach is confined by glacial terraces and scattered bedrock outcrops. Similar to Pearrygin 1, there is little available floodplain, the 2-year and 10-year inundation areas are similar, and it is primarily a transport reach with little off-channel habitat potential. The reach is riffle-pool-glide habitat dominated by cobble substrate with some gravel patches. Spawning potential is very limited. Pools are not numerous, but are relatively deep and mostly formed by bedrock. Riparian habitat is limited to narrow bands along the bankfull channel with ponderosa pines on the terraces providing overstory shade. There is one short side channel active at low flows that is separated from the mainstem by a sparsely vegetated cobble bar.</p> <p>The reach is affected by the Fulton Dam backwater for approximately 1,300 feet upstream of the dam. Stream power in this inundated area is relatively low, and the substrate is dominated by fines and sand. There is significant residential development along both banks in the inundated reach and upon the terraces further upstream.</p>

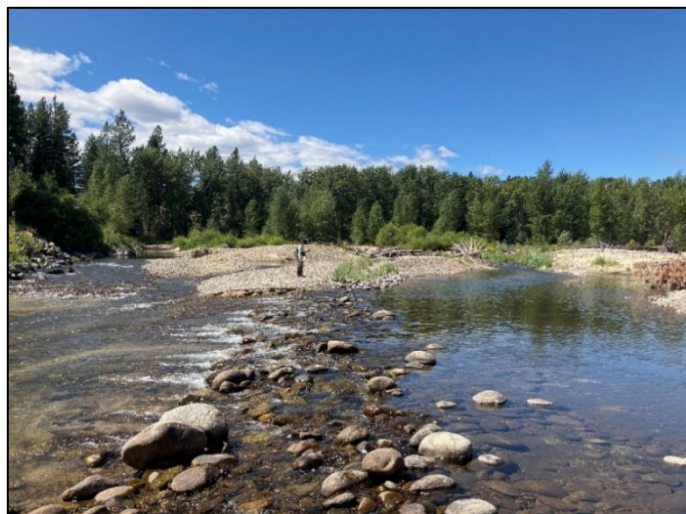
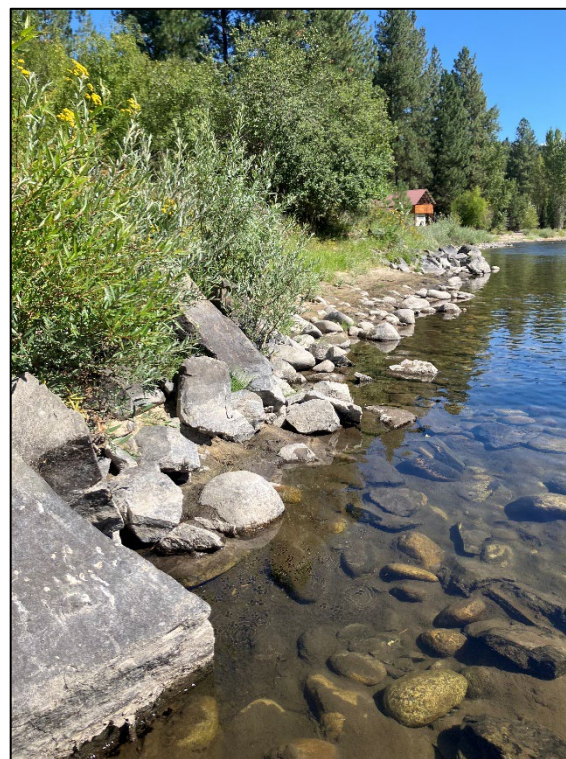
Braid habitat, large wood deposition, and right bank riprap at downstream end of Pearygin 3 reach (above). Typical cobble bank and willow vegetation in Pearygin 3 reach (right).

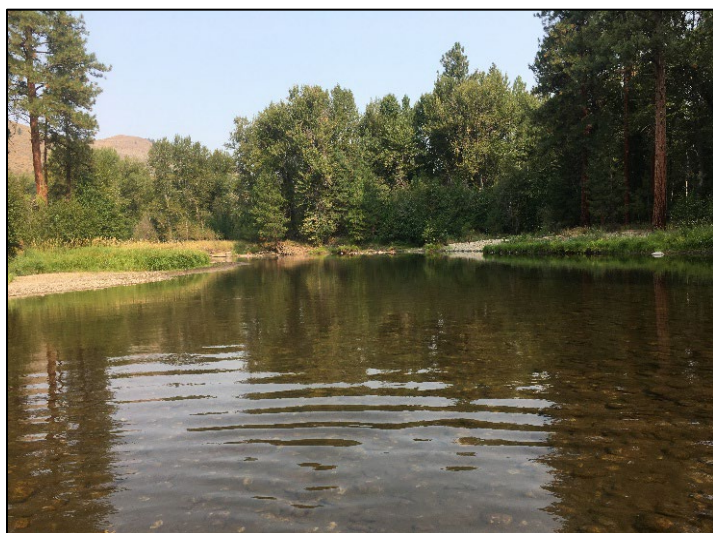
Typical pooltail gravel/cobble habitat and cottonwood/pine riparian overstory in Pearrygin 4 reach (above left). Bank erosion, riparian vegetation, and cobble bank (above right). Residential development with riparian clearing and bank protection in braided section of Pearrygin 4 reach (right).

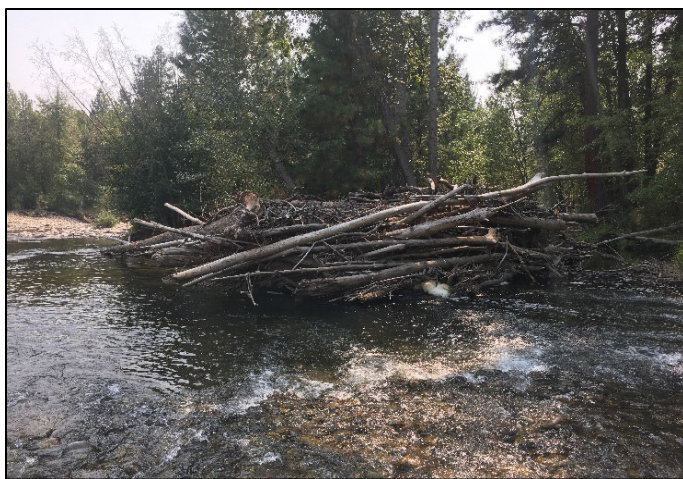
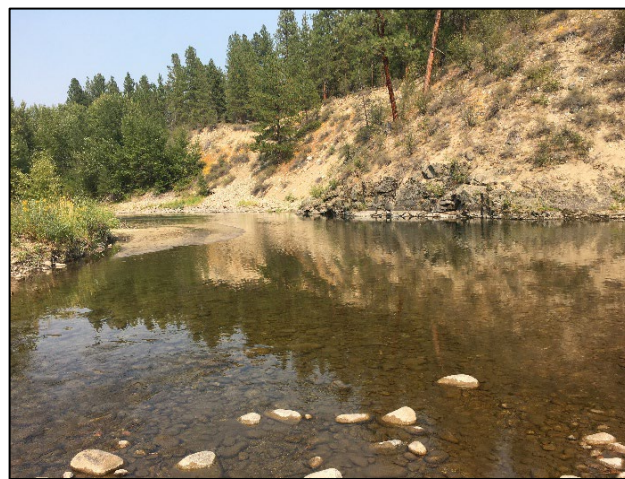
Natural wood jam at island apex in Pearygin 5 reach (above left). Upstream view of lateral scour pool (bedrock formed) and pooltail habitat with adjacent high glacial terrace (above right). Upstream view of typical riffle and pooltail habitat sequence with cobble point bar and eroding outside bank in Pearygin 5 reach (right).
