LOWER CHEWUCH RIVER REACH ASSESSMENT

Methow Salmon Recovery Foundation

December 2025

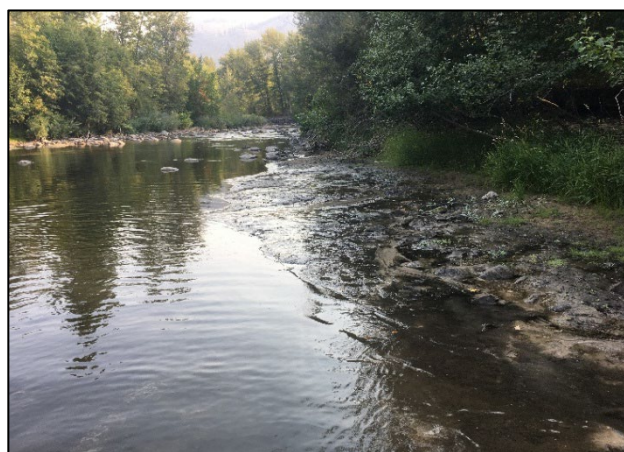
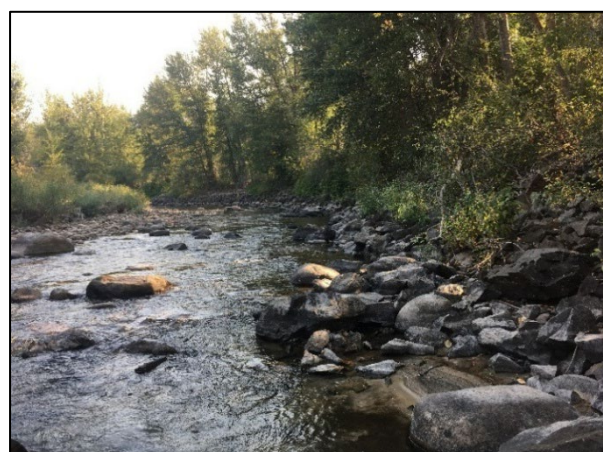
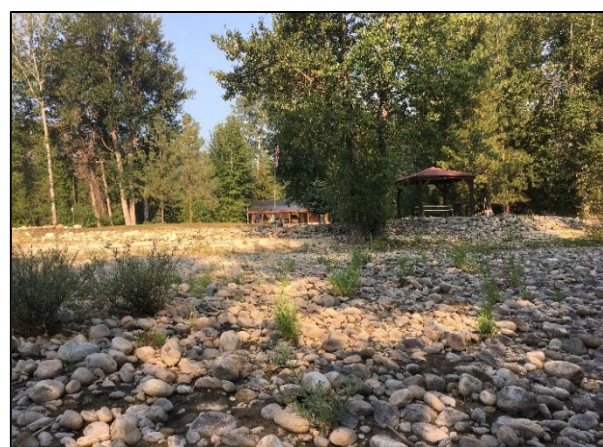
Cold water seepage from the right bank at the downstream end of Pearrygin 6 reach (above left). Upstream view of river left riprapp bank and cobble-boulder riffle habitat with cottonwood riparian overstory (above right). Residential development, riparian clearing, and bank protection in floodplain habitat in Pearrygin 6 reach (right).

#Pools: 0		Channel Widths/Pool: 0		Pools/mile: 0
Wood Count (Nat/ELJ): 3/0		Natural LW Pieces/mile: 10.0		LW Jams (Nat/ELJ): 0/0
Reach Description				
<p>Pearrygin 6 is a relatively short and steep reach extending less than one-half mile upstream from the Cub Creek confluence. Reach 6 has been significantly altered from its historical configuration. Floodplain surfaces are present, but the areas to both the west and east of the current mainstem are relatively disconnected, and nearly the entire east bank (river left) of the reach is riprapped. Residential development on the western (river right) floodplain is protected by some riprap, but most of this area is inundated at the 100-year flood. There is one side channel in the reach that is active at the 2-year flow, but none present at low flows. The reach is dominated by riffle-glide habitat units. Pool habitat is lacking, and the substate is mostly cobble-boulder. Sand deposition, stemming from the 2021 Cub Creek 2 fire, has likely filled in some pool habitat so that they currently function as glides. Riparian vegetation has been significantly impacted over time due to land clearing and development. There are several cold-water patches within the reach, including the Cub Creek confluence and seepage from the left bank across from Cub Creek.</p>

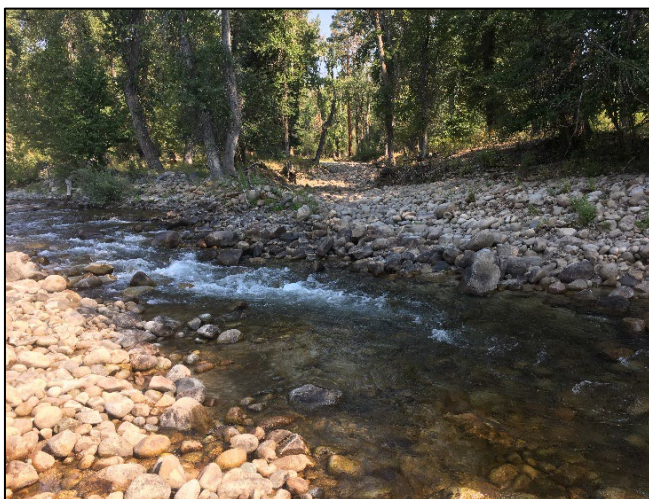
Upstream view of rapid channel unit with right bank high flow side channel flow path and cottonwood riparian overstory in Pearrygin 7 reach (above left). Downstream view of boulder-cobble riffle habitat upstream of MacPherson Bridge (above right). Upstream view of Chewuch Dam and diversion headgate at low water with fish passage channel along river right bank (right).

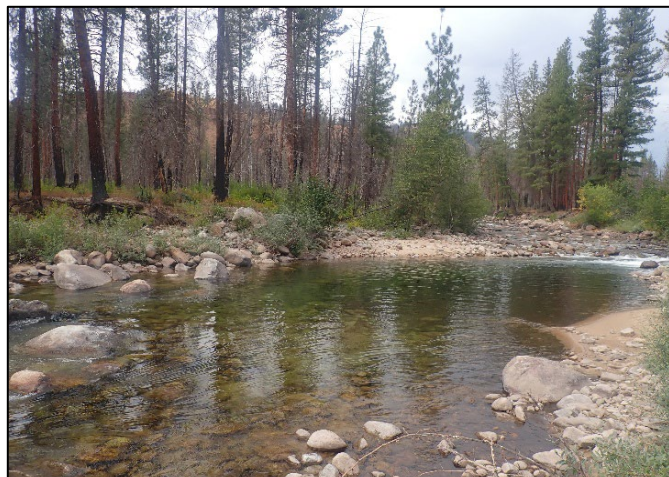
Upstream view of pool habitat in Pearrygin 8 reach within burn scar of 2021 Cub Creek 2 fire (above). Upstream view of high energy riffle boulder-cobble habitat in Pearrygin 8 reach (above right). Upstream view of bedrock formed lateral scour pool just downstream of Boulder Creek confluence in Pearrygin 8 reach (right).

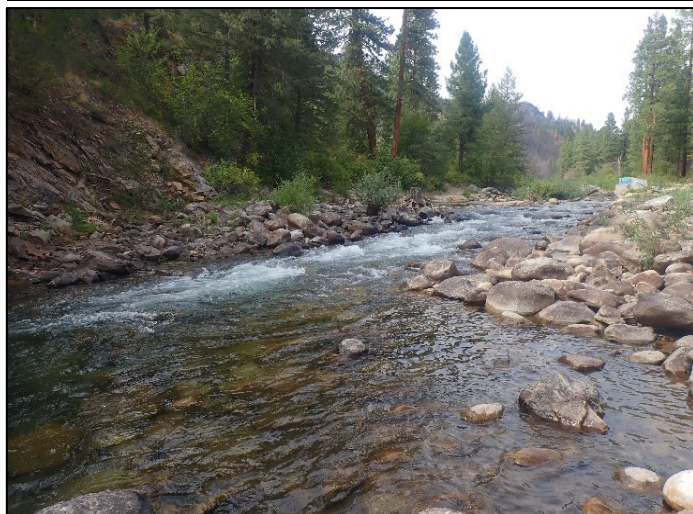
Upstream view of rapid boulder habitat downstream of Memorial Pool in Pearrygin 9 reach (above left). Downstream view of glide habitat with spawning gravel, floodplain surface, and cobble bar on river left, and vegetated riprapp bank adjacent to road, Pearrygin 9 reach (above right). Upstream view of pooltail spawning habitat and cobble bar with emergent willow riparian habitat (right).

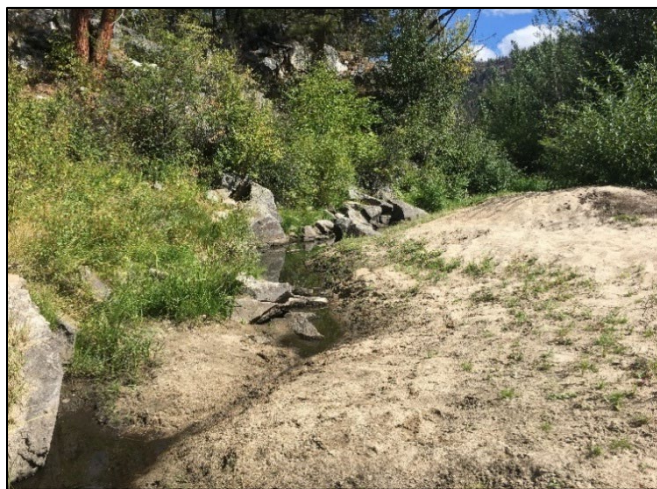
Downstream outlet of restored alcove channel in Pearrygin 10 reach (above). Downstream view of backwater habitat, sand deposition, and residential development and riparian clearing on high glacial terrace in Pearrygin 10 reach (above right). Upstream view of residential development and riparian clearing in river right floodplain habitat in Pearrygin 10 reach

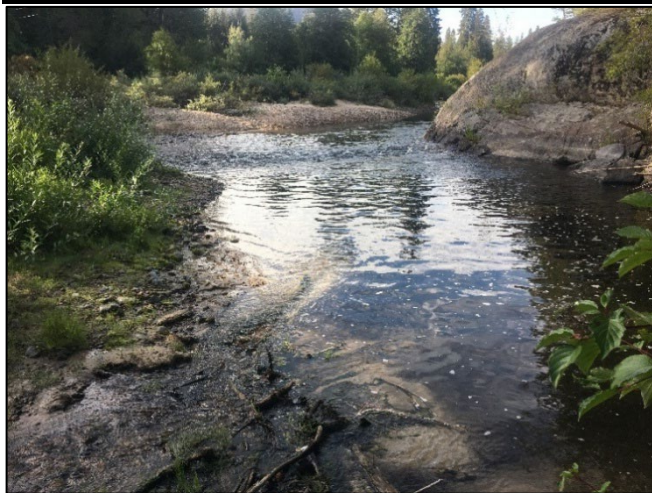
Backwater habitat adjacent to lateral scour pool habitat in Pearrygin 11 reach (above). Upstream view of typical cobble riffle habitat with riprap bank along USFS road (above right). Upstream view of typical riffle habitat, agricultural development, and clearing on high glacial terrace, and limited riparian cover in Pearrygin 11 reach (right).

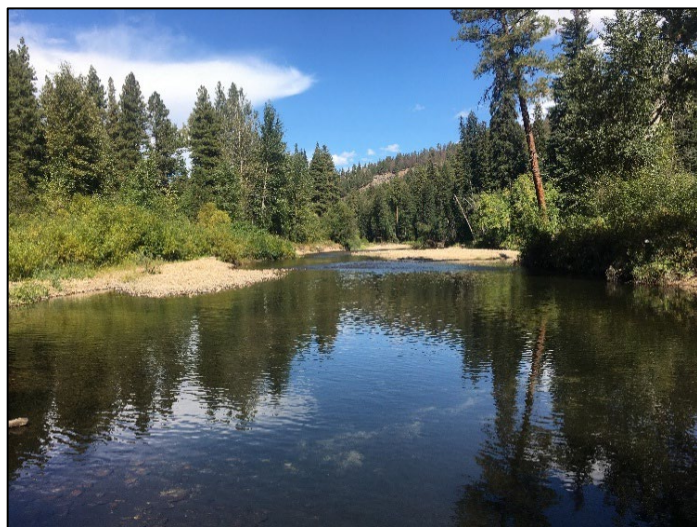
Upstream view of typical pooltail habitat, cobble/gravel bars, and floodplain riparian vegetation in Doe 1 reach (above). Spawning habitat (and redd) in pooltail habitat in mainstem braid in Doe 1 reach (above right). Upstream view of isolated (during low water) pool habitat in restored river right side channel in Doe 1 reach (right).

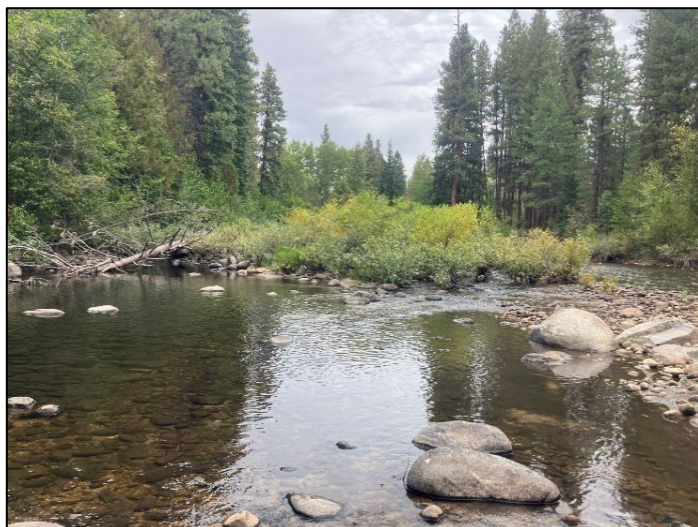
Upstream view of backwater habitat and vegetated cobble bar in Doe 2 reach (above left). Upstream view of lateral scour pool with engineered log structure and riparian vegetation with cottonwood and pine overstory (above right). Natural wood apex jam at upstream end of vegetated island in Doe 2 reach (right).

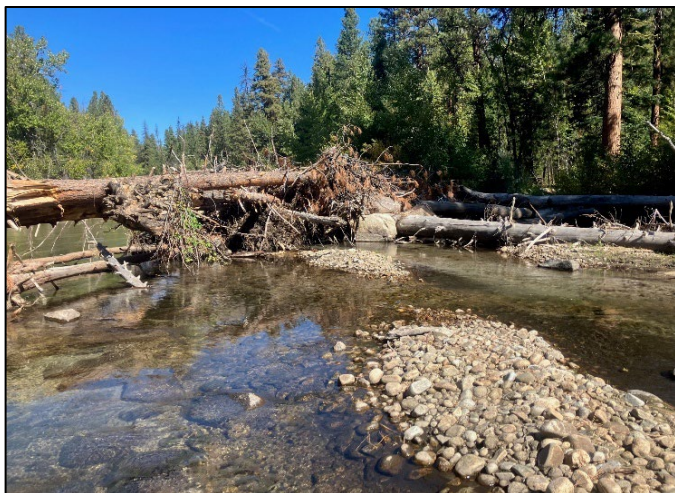
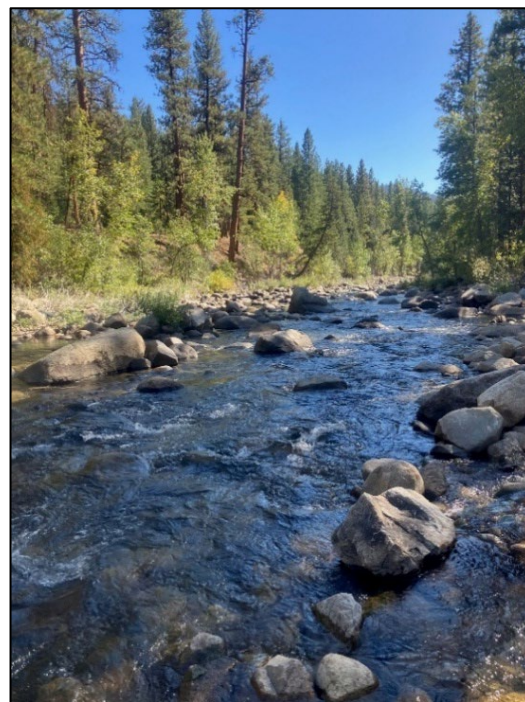
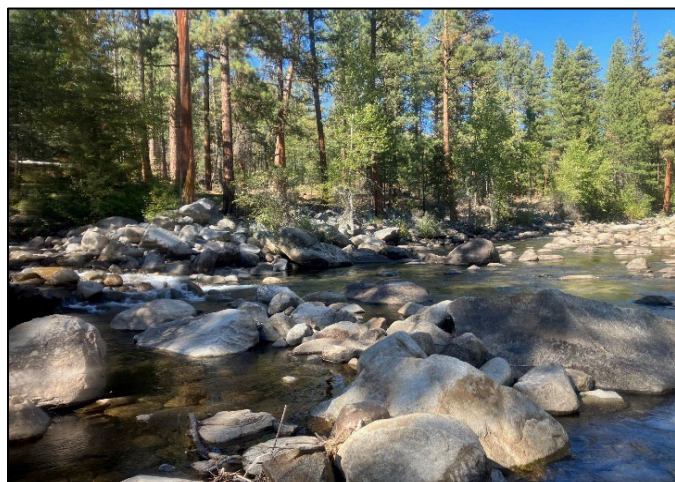
Upstream view of engineered log structure and boulder ballast, river left, Doe 3 reach (above left). Upstream view of mainstem channel at Falls Creek confluence with bolder substrate and campground associated clearing on river right bank (left). Downstream view of rapid-boulder/cobble habitat and riparian vegetation with pine overstory (above).

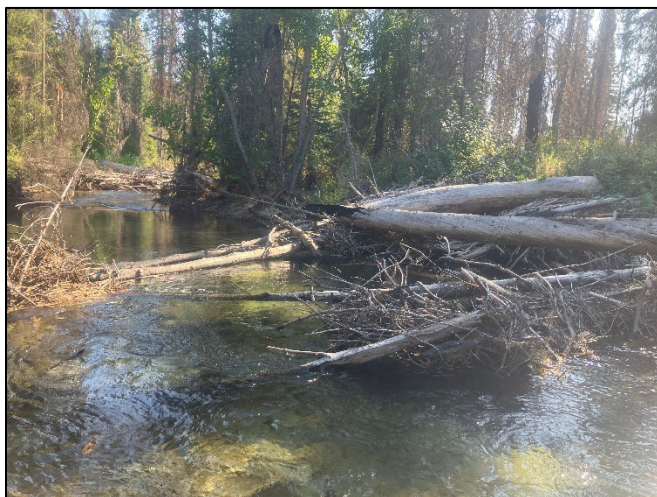
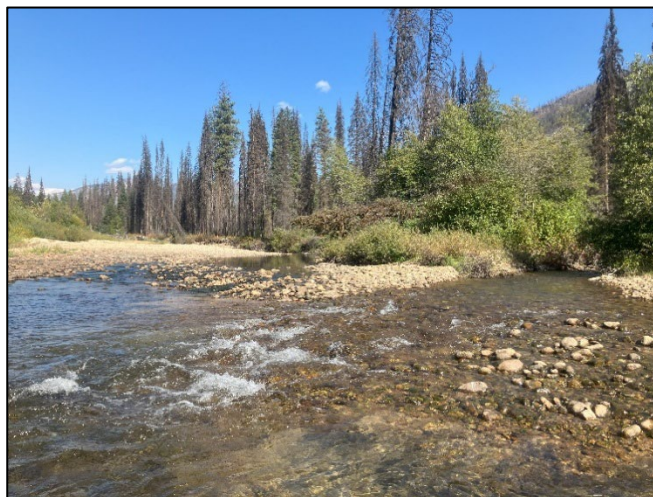
Downstream view of complex pool habitat in newly established mainstem channel in Doe 4 reach (above left). Upstream view of confluence of mainstem (former side channel) and former western mainstem (dry) channel with vegetated island separating the two channels at upstream end of Doe 4 reach (above right).

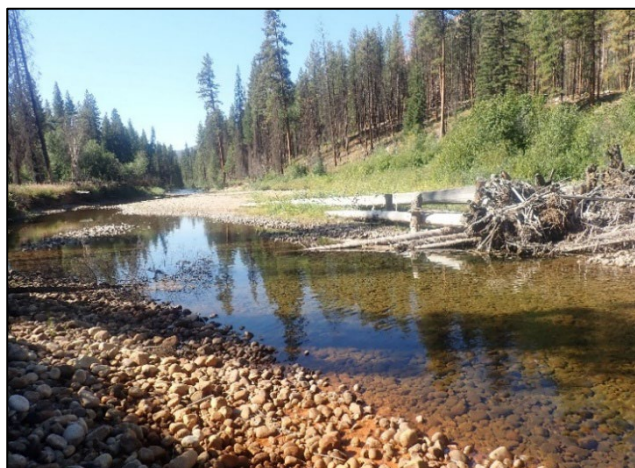
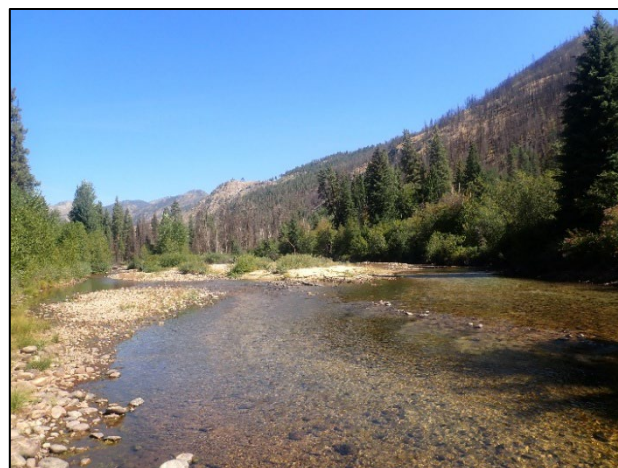
Downstream view in former mainstem channel (now a seasonally disconnected side channel, including engineered log structure (above)). Upstream view of braid habitat with glide cobble-gravel habitat (above left). Downstream view into newly established mainstem channel from apex of island currently separating the two channels (right).

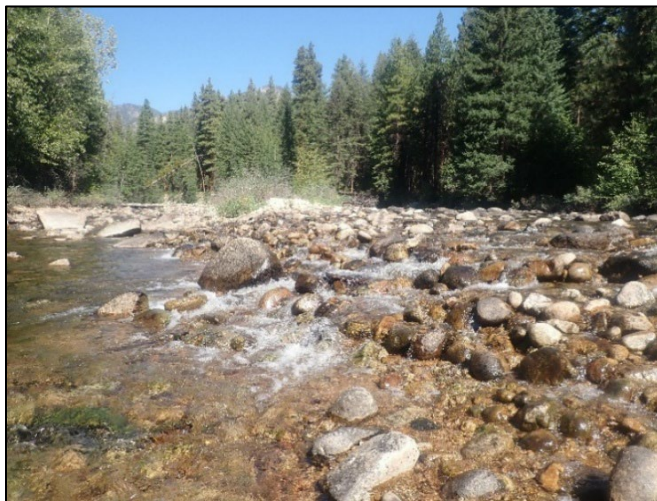
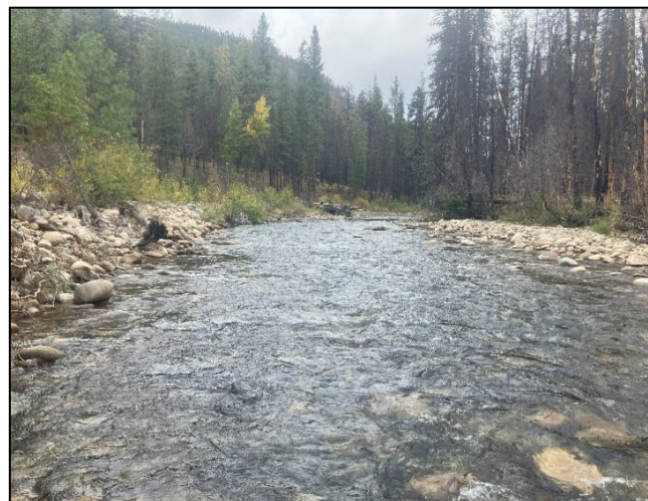
Upstream view of channel split around vegetated cobble bar in Doe 6 reach (above). Upstream view of riffle habitat within burn scar of the 2021 Cub Creek 2 fire, with road visible above river right (above right). Upstream view of typical cobble riffle habitat in Doe 6 reach with riparian vegetation and pine and cottonwood overstory (right).

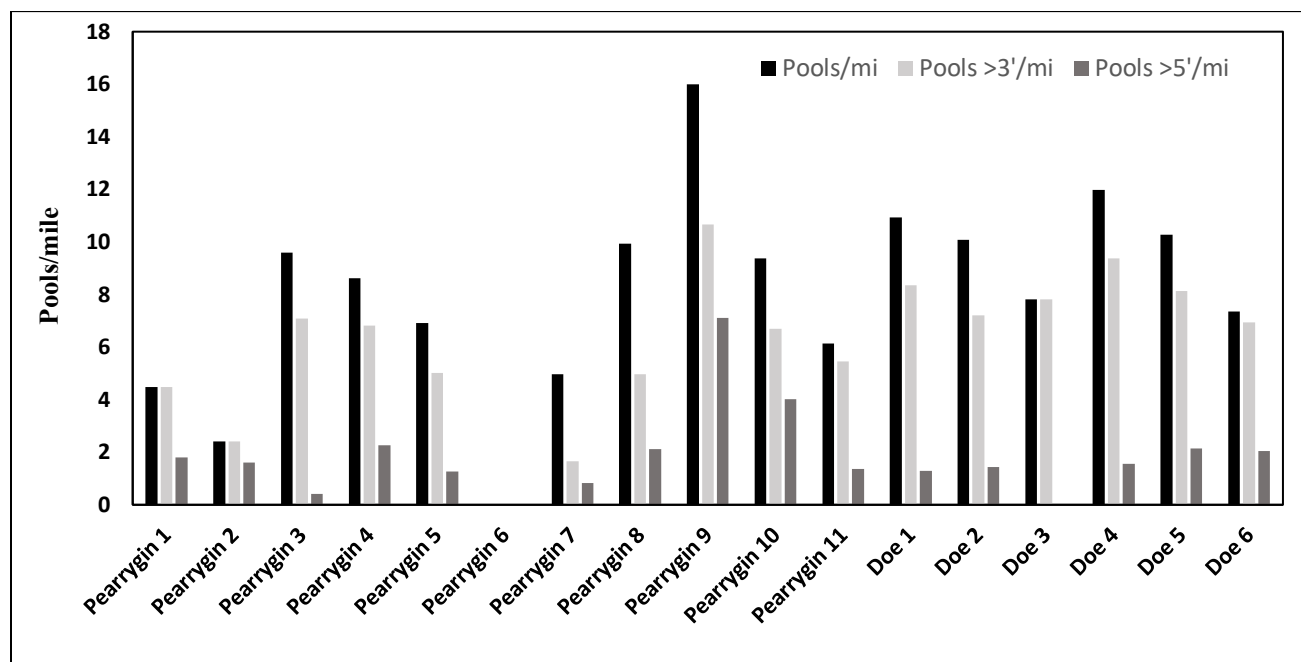
Figure 3.6.2. Pool frequency (pools/mile), within LCRA reaches, 2023.

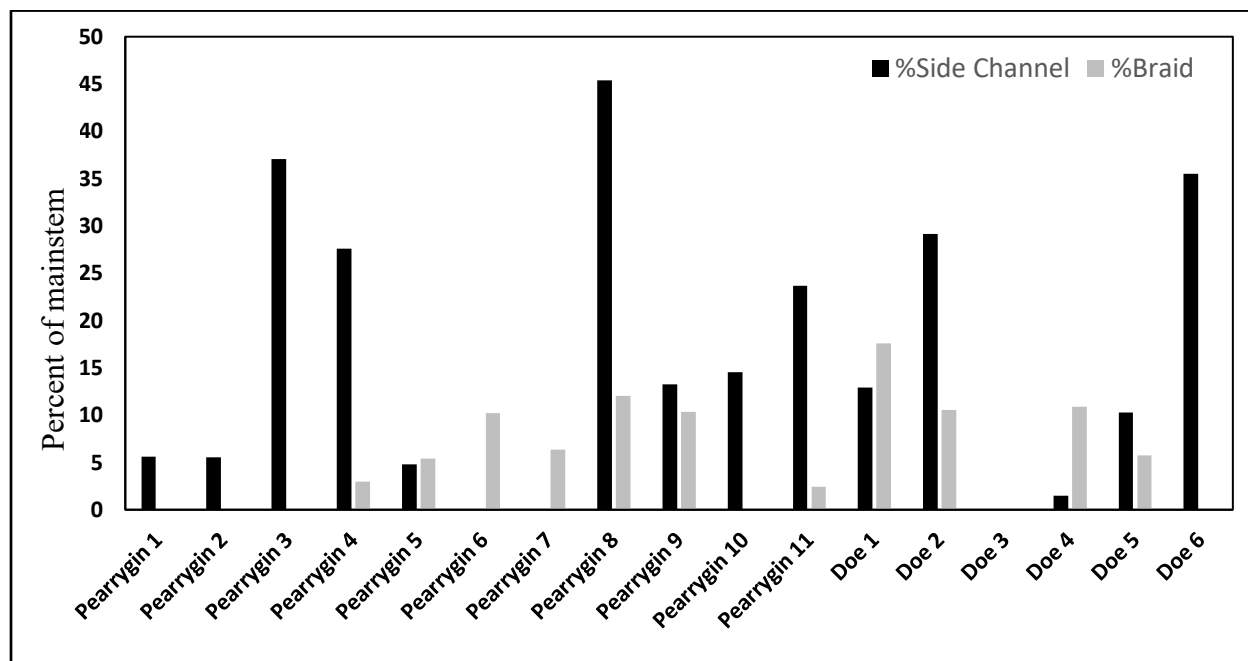
Figure 3.6.3. Side channel and braid length as percent of mainstem channel length, LCRA area, 2023.

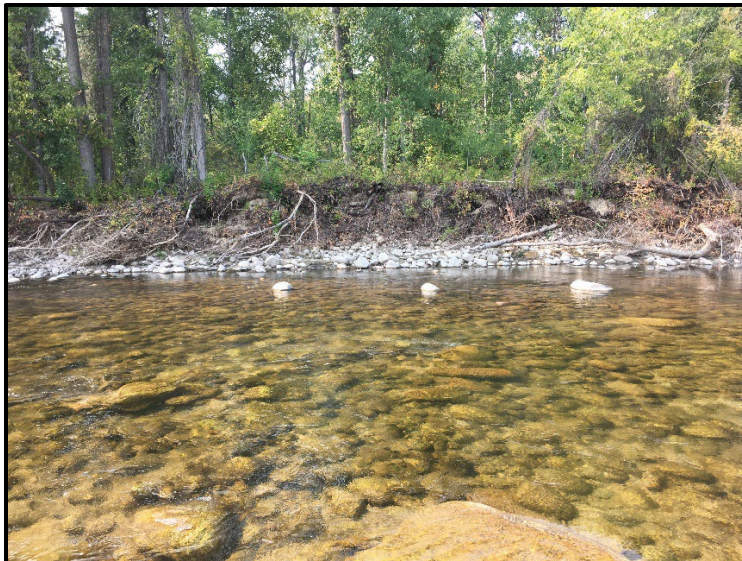
Figure 3.6.4. Typical cobble and gravel substrate within the LCRA area, Pearrygin 5 reach, 2023.

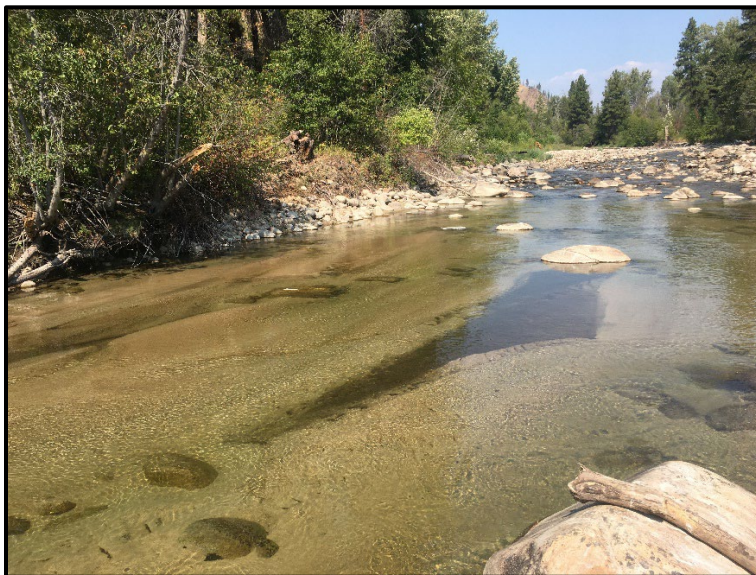
Figure 3.6.5. Sand substrate within pool habitat, Pearrygin 7 reach, 2023.

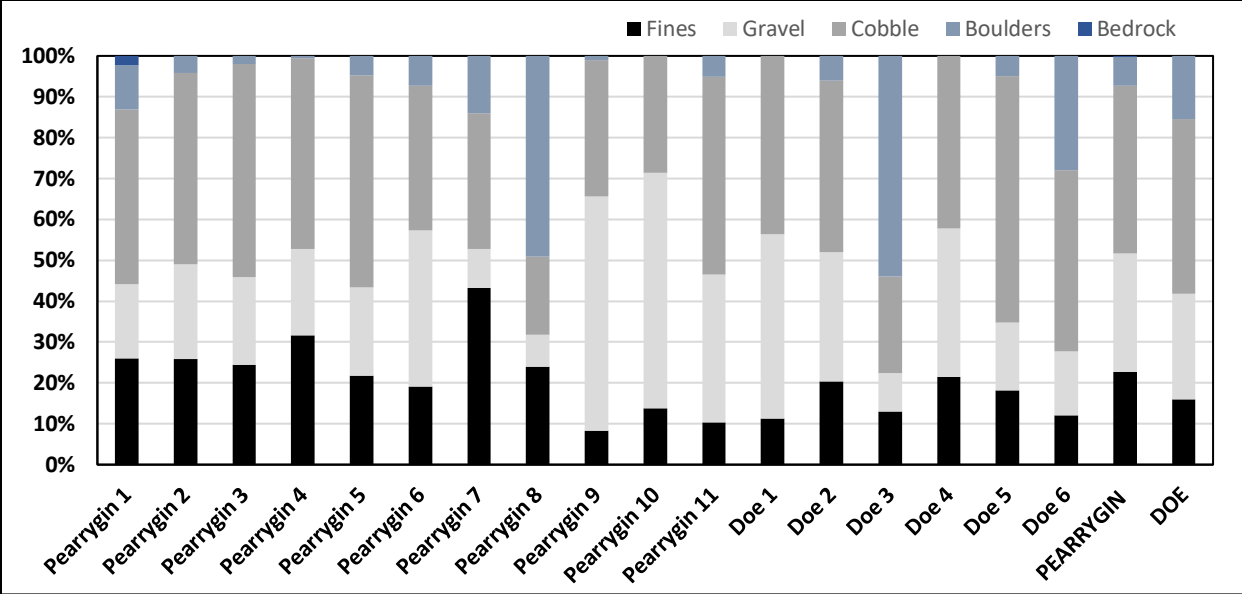
Figure 3.6.6. Average substrate composition from pebble counts, LCRA area, 2023.

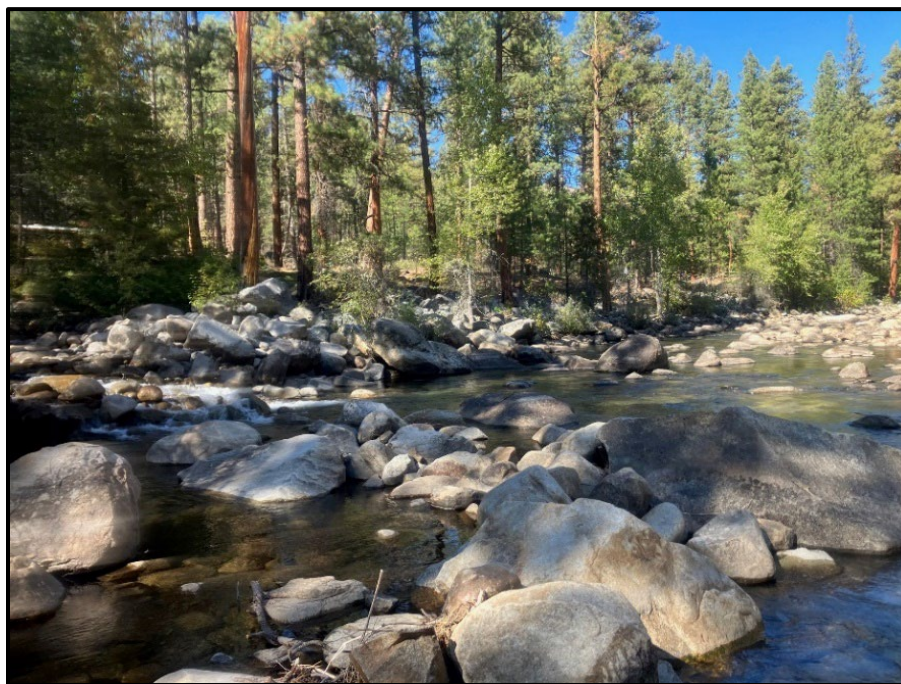
**Figure 3.6.7.** Boulder substrate, Doe 3 reach, 2023.

Reach	D50	D84
Pearrygin 1	94	216
Pearrygin 2	66	147
Pearrygin 3	74	149
Pearrygin 4	57	111
Pearrygin 5	79	161
Pearrygin 6	54	176
Pearrygin 7	38	243
Pearrygin 8	249	703
Pearrygin 9	50	88
Pearrygin 10	50	88
Pearrygin 11	69	149
PEARRYGIN AU	73	179
Doe 1	61	110
Doe 2	59	155
Doe 3	300	827
Doe 4	53	104
Doe 5	95	185
Doe 6	144	348
Doe AU	119	288

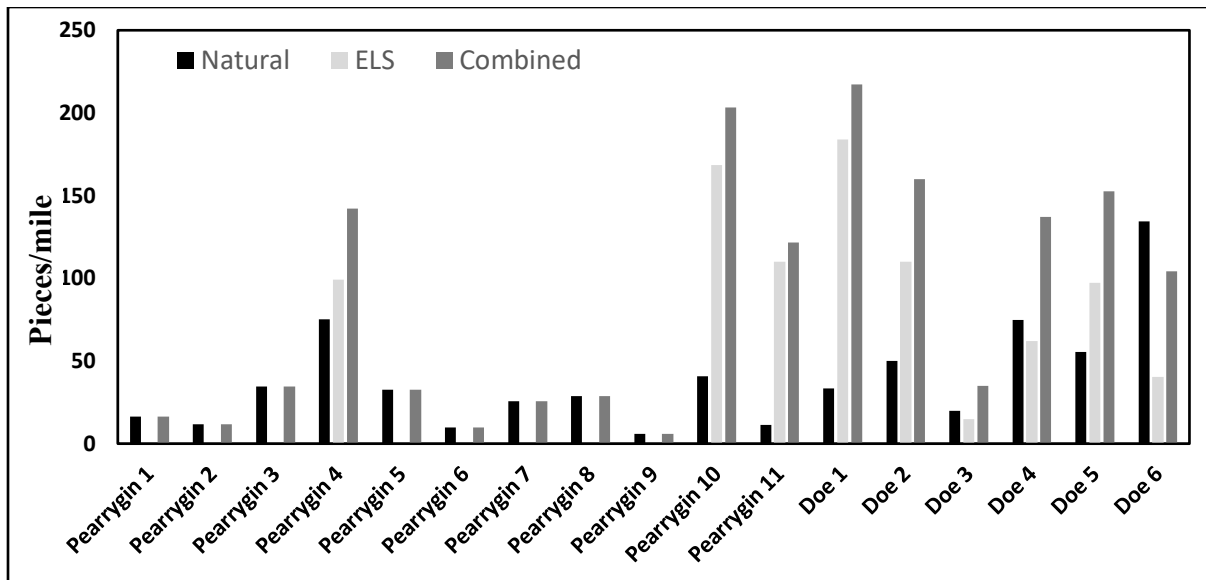
Figure 3.6.8. Natural and ELS wood per mile, LCRA reaches, 2023.

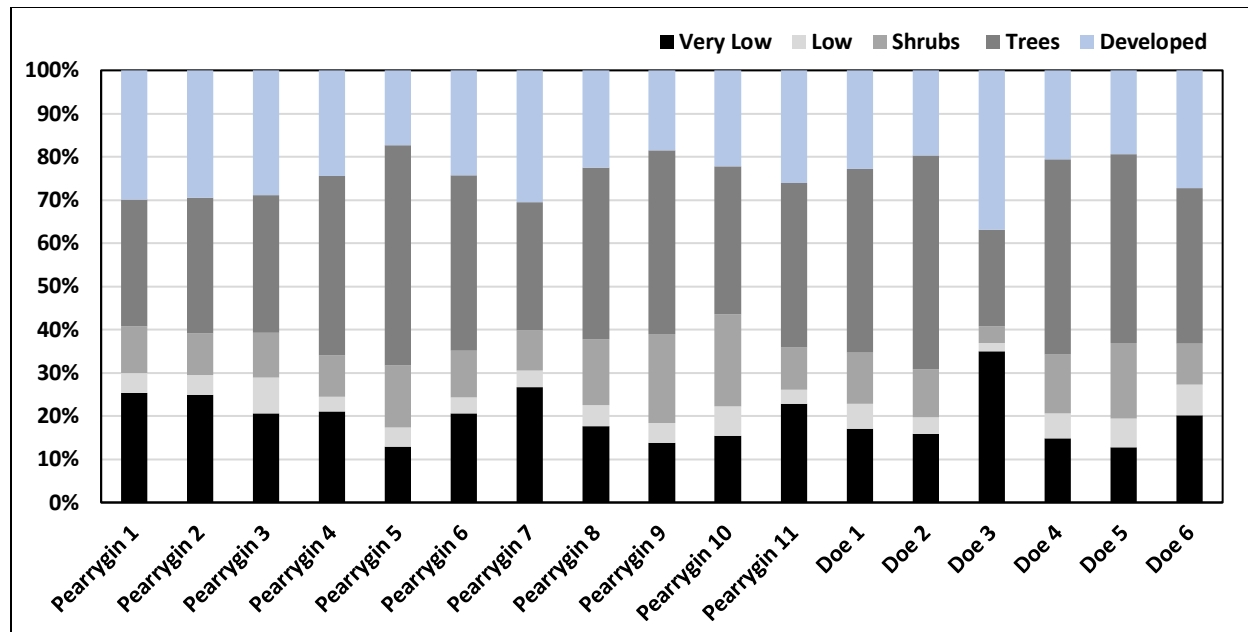
Figure 3.6.9. Reach-scale floodplain cover classification, LCRA area.

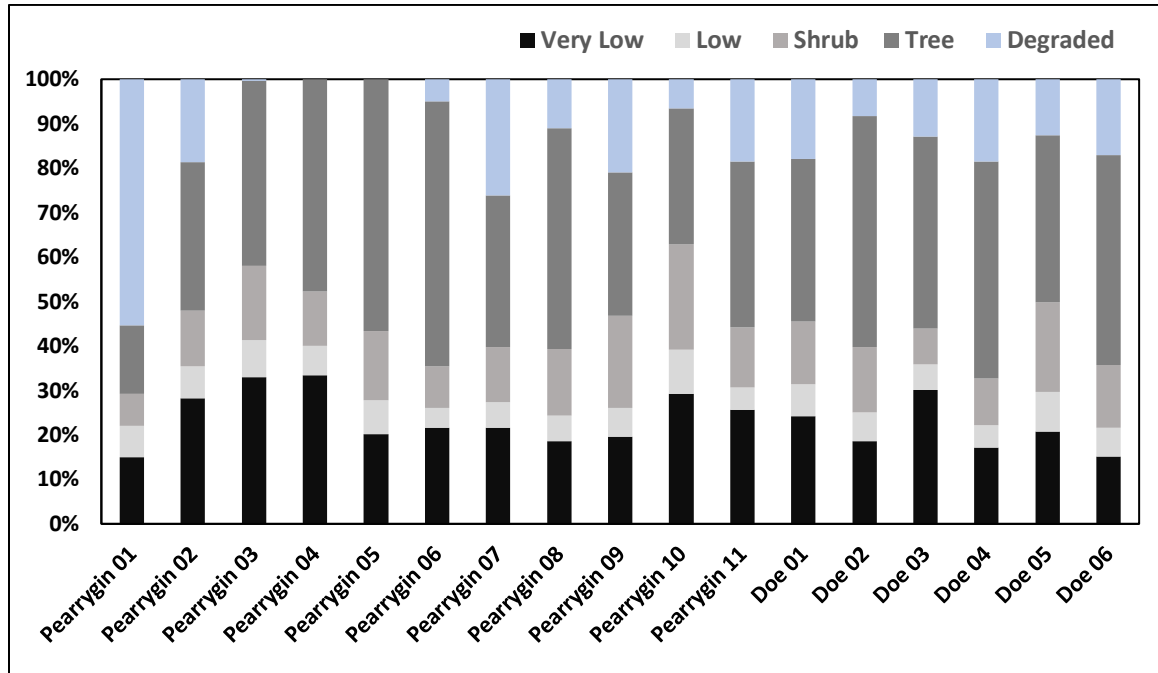
Figure 3.6.10. Streambank cover by reach, LCRA area.

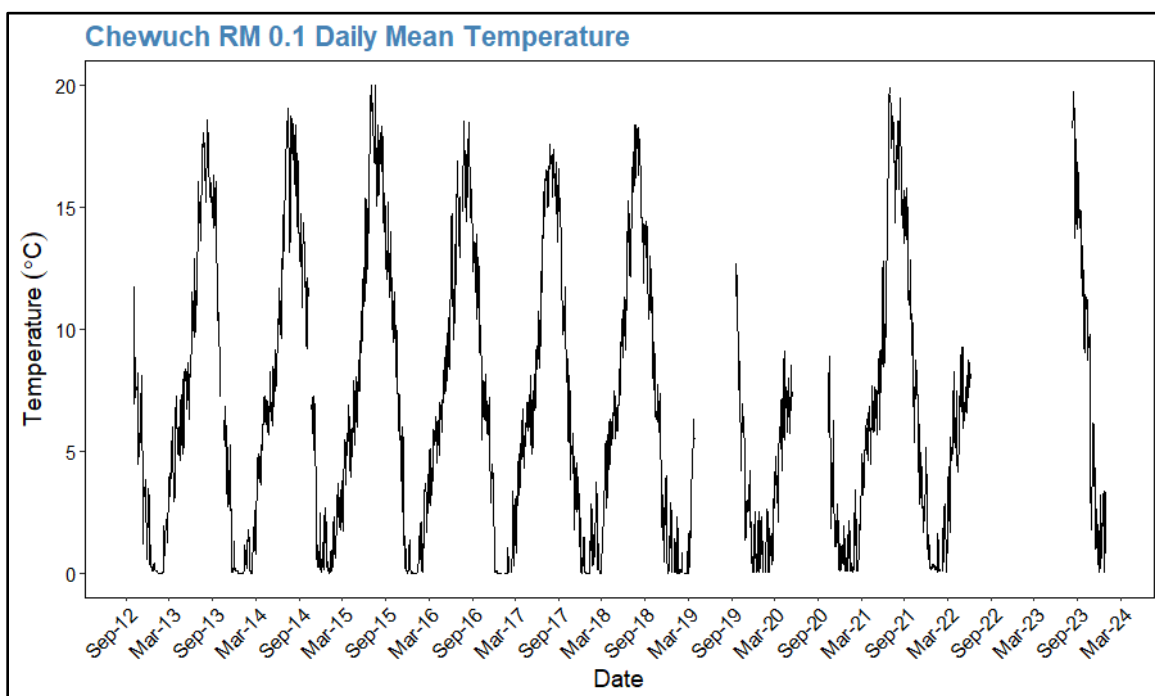
Figure 3.7.1. Mean daily water temperature, Chewuch River at RM 0.1, 2012-2023.

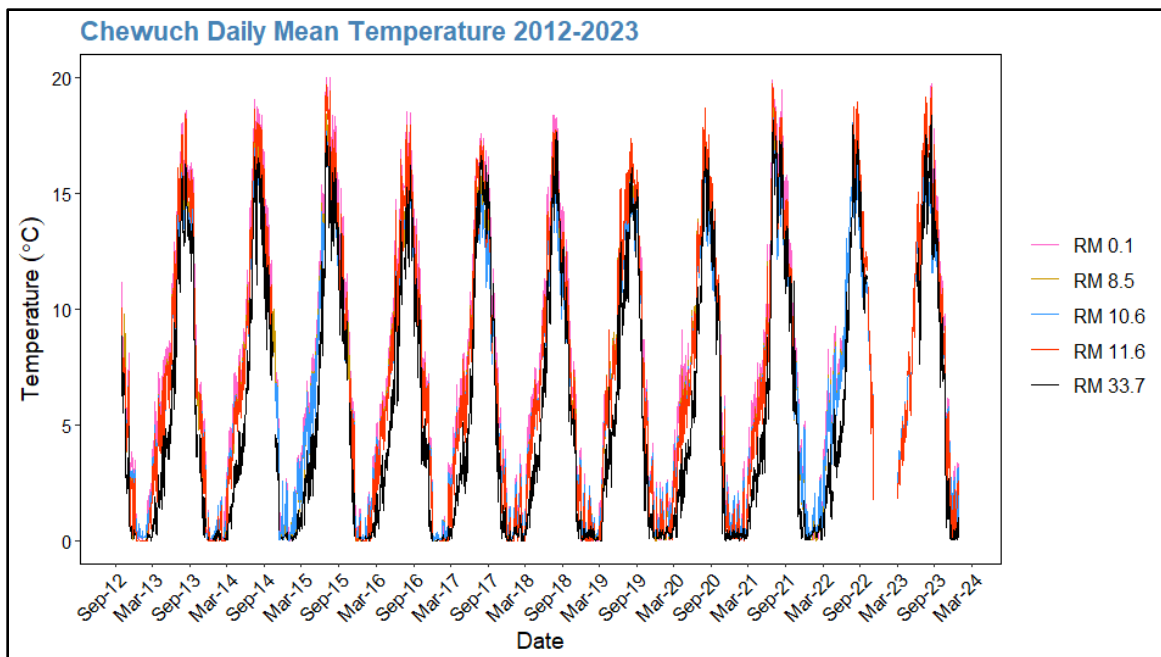
Figure 3.7.2. Mean daily water temperature, Chewuch River at several locations, 2012-2023.

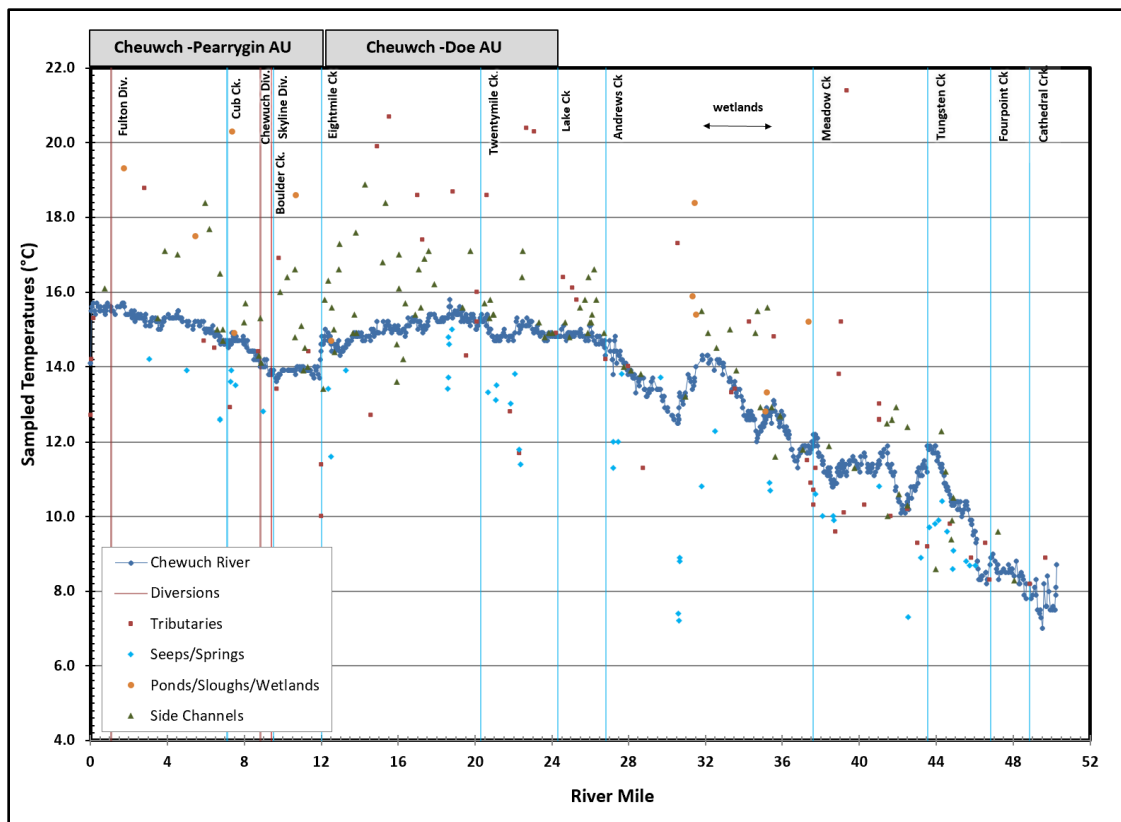
Figure 3.7.3. Surface water temperature longitudinal profile, Chewuch River, August 26, 2009. Data collected through aerial thermal infrared survey. Figure modified from Watershed Sciences, 2009.

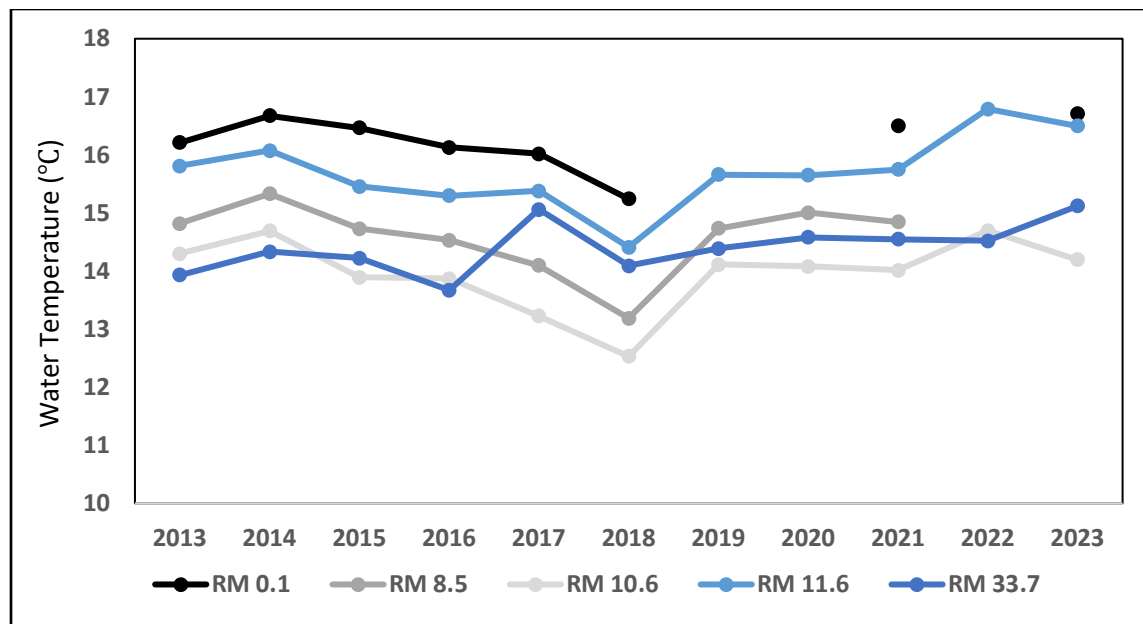
Figure 3.7.4. Mean August water temperature at five locations, Chewuch River, 2013-2023.

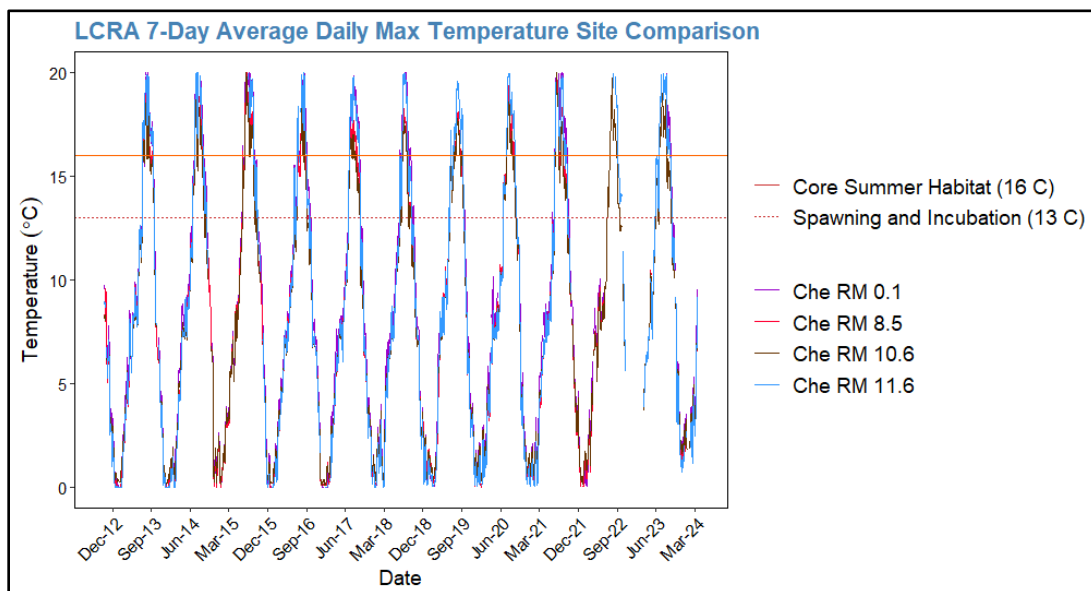
Figure 3.7.6. 7-day average daily maximum stream temperatures, LCRA area, 2012-2023.

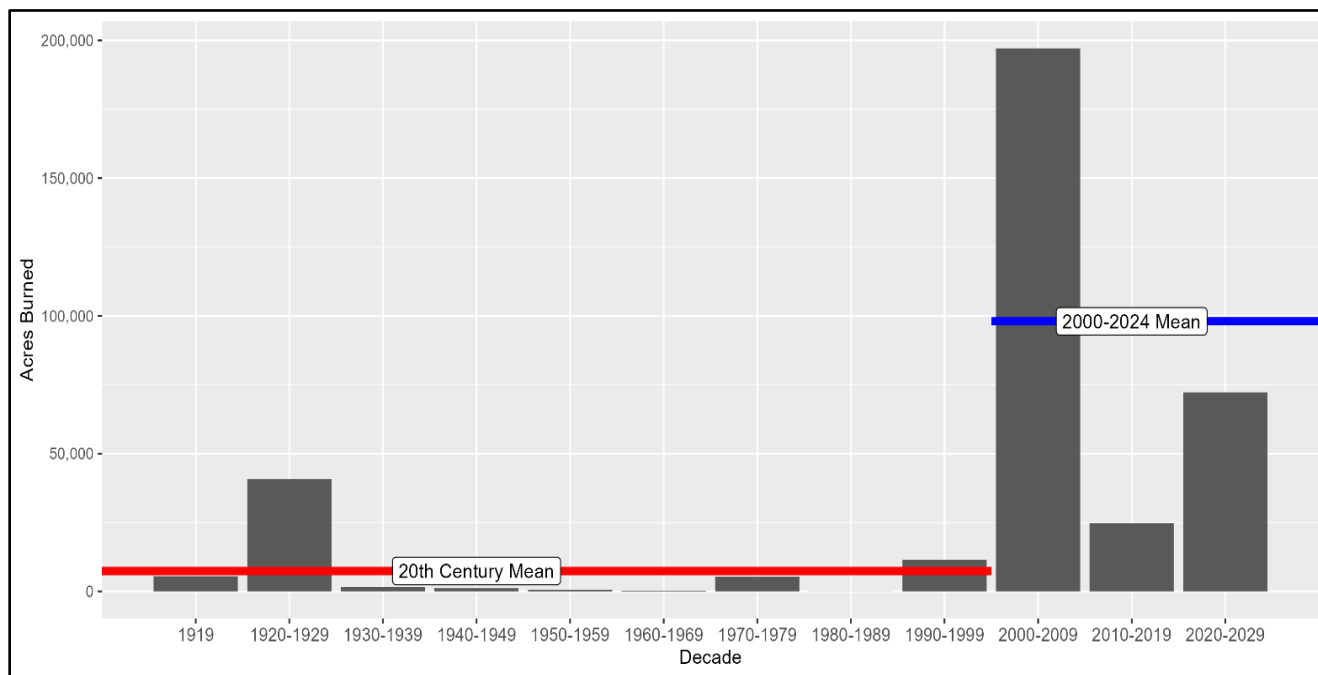
Figure 3.8.2. Total number of acres burned in the Chewuch Watershed by decade 1919-2024. Data from Chewuch Watershed Analysis (USFS 1994).

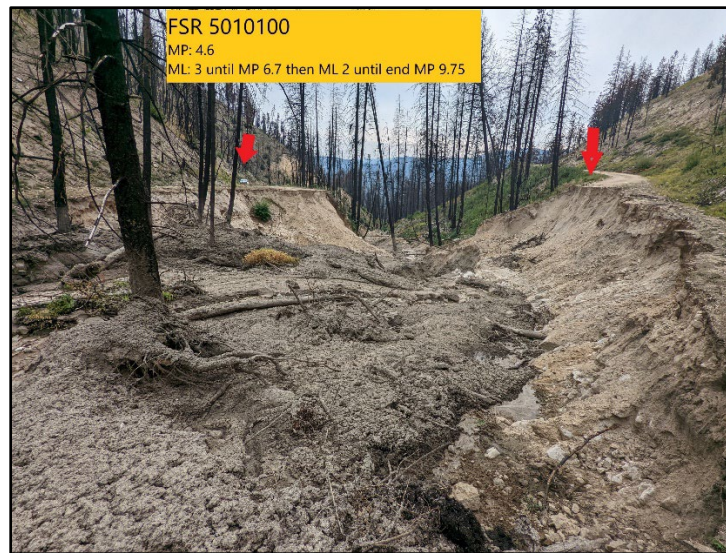
Figure 3.8.4. Post-Cub Creek 2 Fire debris flow and road washout, Butte Creek. Photo credit: Methow Ranger District.

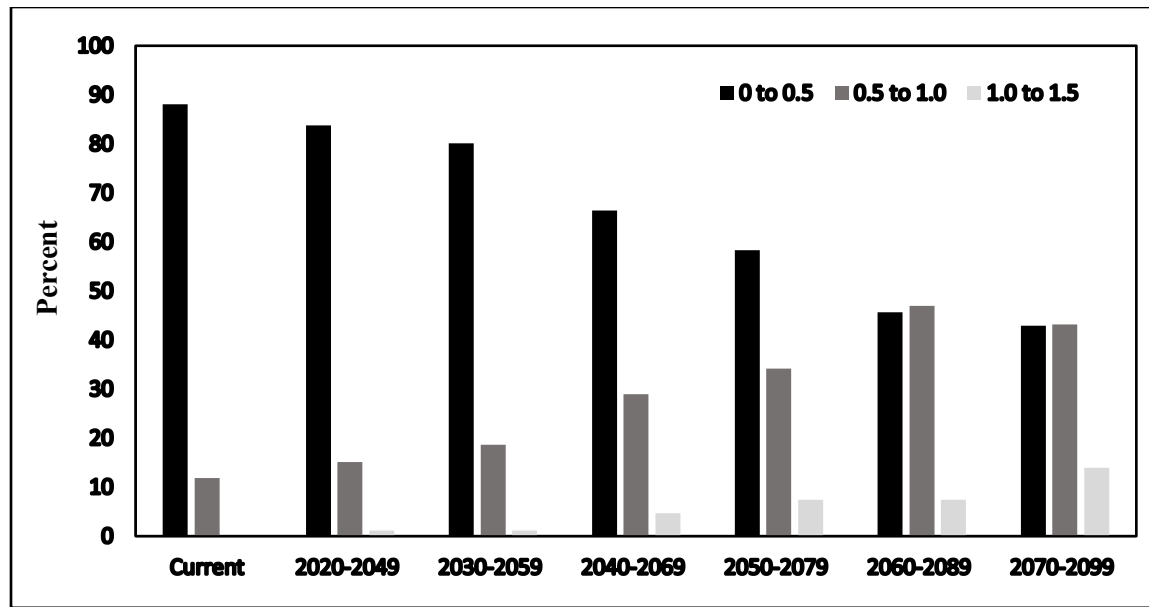
Figure 3.9.1. Percent of stream length in Okanogan County within three winter to spring runoff ratio classes. Data represent baseline high emissions scenario conditions. Data source: Climate Impacts Group, <https://cig.uw.edu/resources/analysis-tools/climate-mapping-for-a-resilient-washington/>.

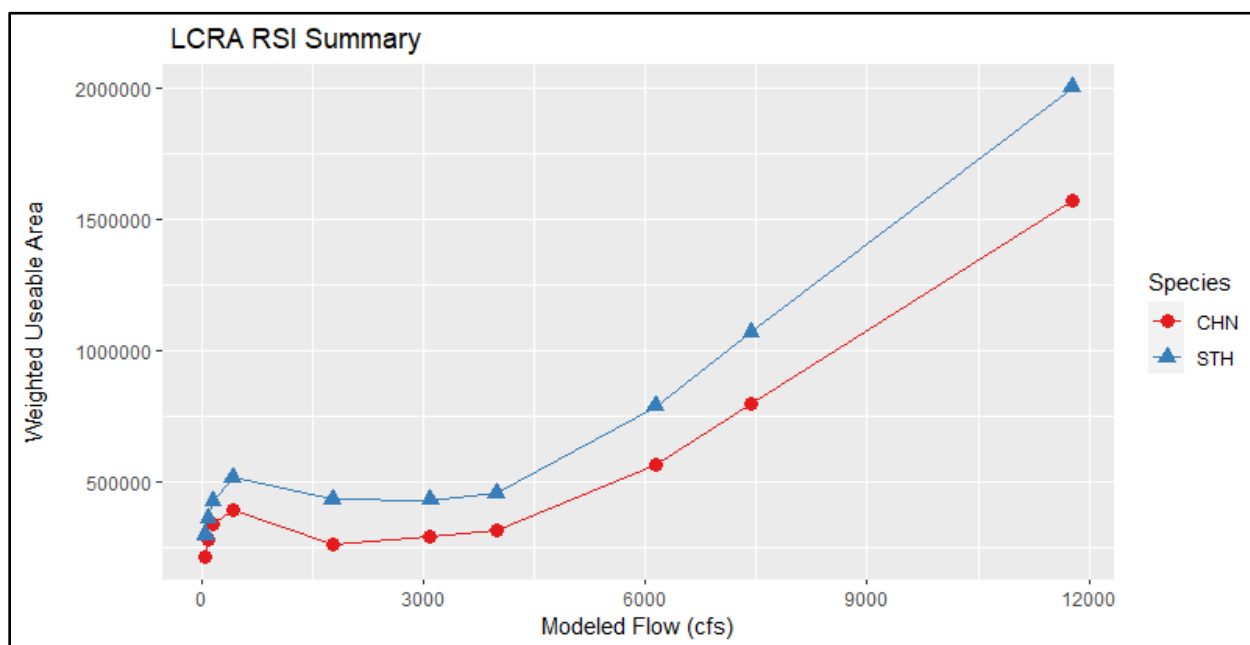
Figure 3.10.1. Relative habitat suitability for spring Chinook and steelhead rearing across the range of hydraulically modeled flows for the LCRA area.

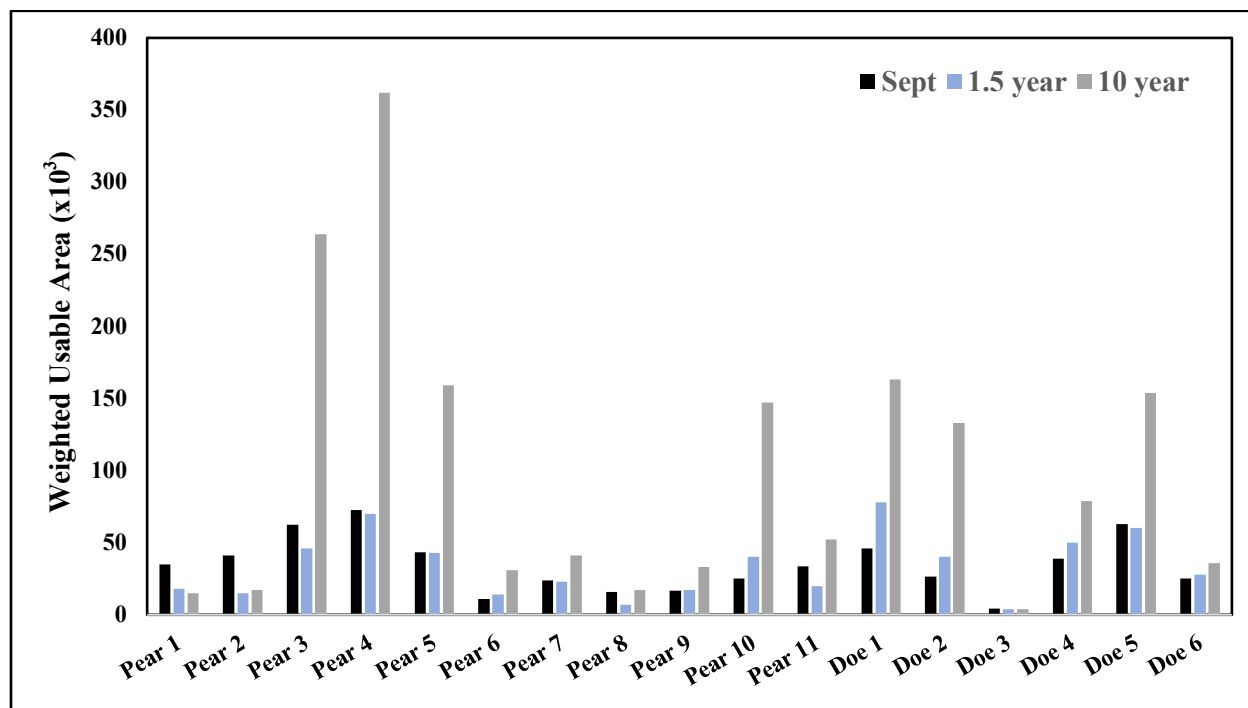
Figure 3.10.3. Relative habitat suitability for spring Chinook and steelhead rearing for LCRA reaches at September (79 ft³/s), 1.5-year (3,087 ft³/s), and 10-year (7,427 ft³/s) flows.
