White River Reach Assessment & Restoration Strategy

Final Report

PREPARED FOR
Yakama Nation Fisheries

PREPARED BY
Inter-Fluve

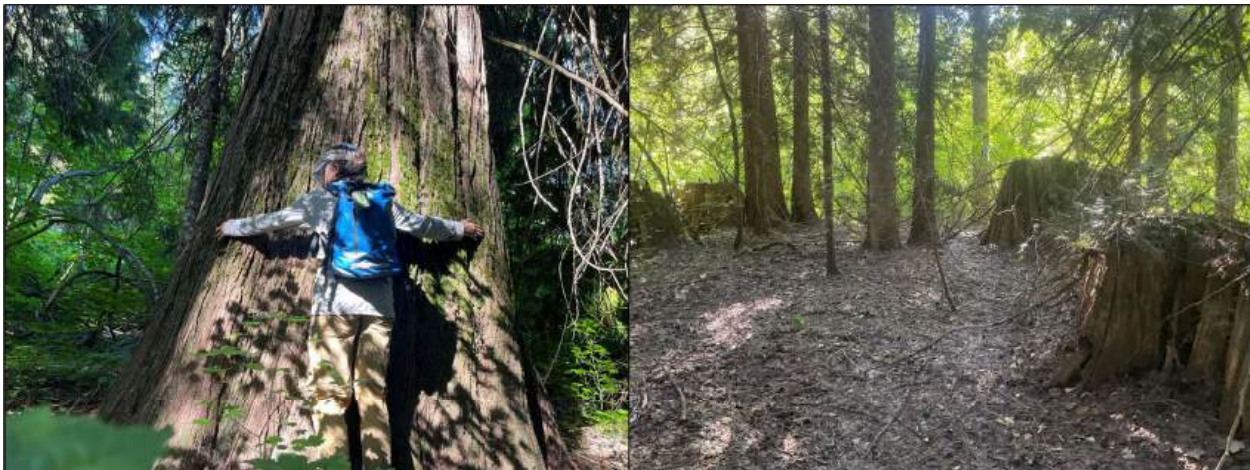
Figure 10. Left: Remnant old-growth western redcedar on White River floodplain (August 2024). Right: Western redcedar stumps on the White River floodplain near RM 6.92 (August 2024).

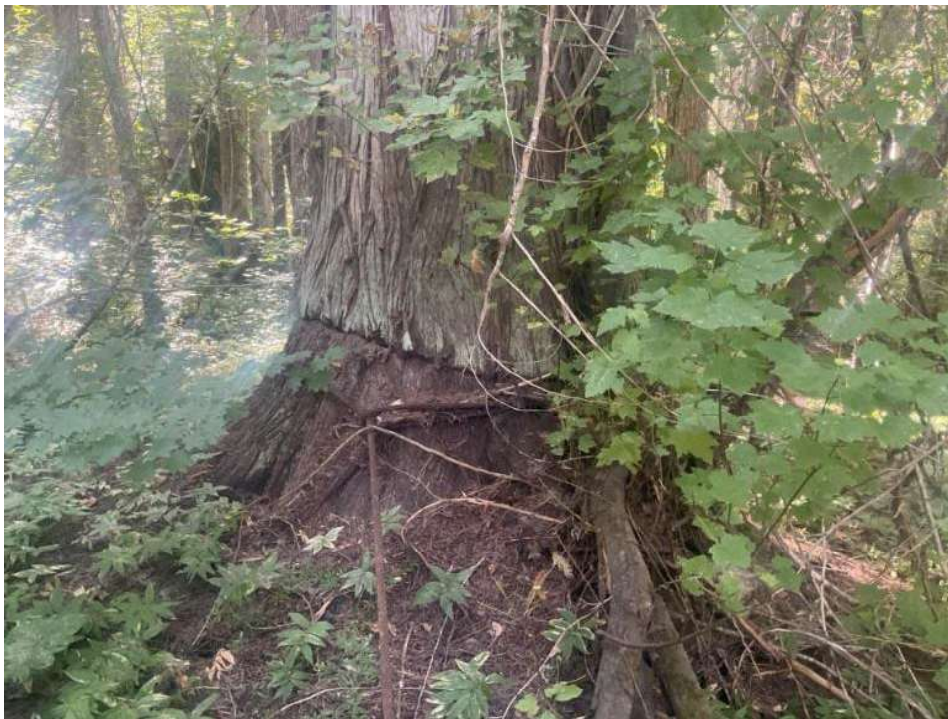
Figure 15. Scar from cable logging of western redcedar in White River floodplain near RM 12.73 (August 4, 2024).

By the early 1900s, the lumber industry began to expand in the Wenatchee basin. In 1926, sawmills in Chelan County processed an estimated 80,000,000 board feet of lumber. Across Washington, trees over 100 years old remained the dominant age class until 1980 (Wadsworth et al., 1994). Timber harvests in the Wenatchee basin grew significantly by the 1950s and reached peak levels in the 1980s. Per reports from the USFS, extensive logging occurring on private land has significantly impacted the Upper Wenatchee River drainage. Although the White River basin had comparably "...little timber harvest overall" compared to elsewhere in the Wenatchee basin (USFS, 2003), approximately 63% of the riparian area in the lower White River watershed and 23% of the riparian area in the upper White River watershed was converted from old growth cedar forests to second growth forests consisting of densely-spaced even-aged trees and pastures (Mariah Mayfield et al., 2022), and disturbance from timber harvest in the White River assessment areas remains on the landscape. This was observed during the assessment in the form of logged stumps of old-growth conifers (Figure 15), abandoned logging roads through the western (river right) floodplain and still functioning roads on the east (river left) side of the valley, including bridges and valley-crossing roads, and through assessments of historical aerial imagery dating back to 1957. Recently logged surfaces on hillslopes within the assessment area are visible in historical aerial imagery from 1985, suggesting that widespread logging within the basin continued into the 1980s. Forest clearing on the valley floor concluded prior to 1957 with the exception of a portion of the river left floodplain from RM 4.2 – 5.2. The White River has been straightened against White River Road on river left throughout much of Reaches 4 and 5. The Sears Creek Road crossing at RM 7 laterally confines the White River and creates entrenchment of the channel in its current location. The channel was likely re-aligned and shifted toward river-left to accommodate Sears Creek Road and logging activities in reaches 8-9 (USFS, 1999, 2003).

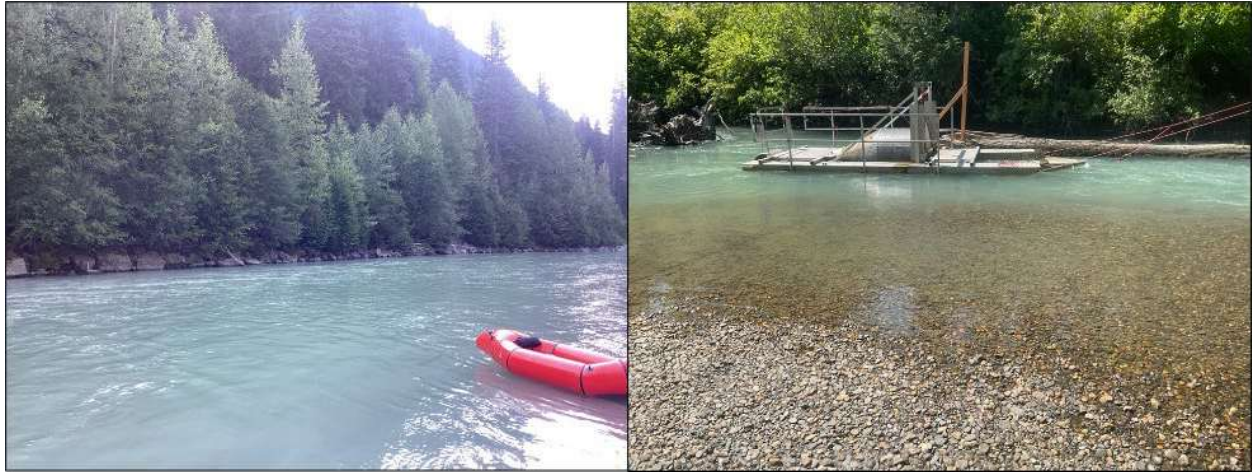
Figure 16. Left: Riprap protecting White River Road downstream of the Napeequa River confluence at RM 12.43 (August 3, 2024). Right: Screw trap located at approximately RM 5.8, viewed from mid-channel bar, looking toward river right bank (August 13, 2024).

A screw trap located at approximately RM 5.8 is used seasonally to monitor fish populations (Figure 16). Sheetpile installed on the river left bank just downstream of the RM 2 bridge protects an access road used to monitor a PIT tag station installed near RM 1.8 (Figure 19). A weir used for fish monitoring at approximately RM 1.65 acts as a grade control for the channel bed. Homes are located on floodplains sporadically from approximately RM 1 to RM 11, and ditches constructed to drain the floodplain in several locations downstream of RM 9 form a web that inhibits normal floodplain hydrology and likely influences seasonal recharge (Figure 18).

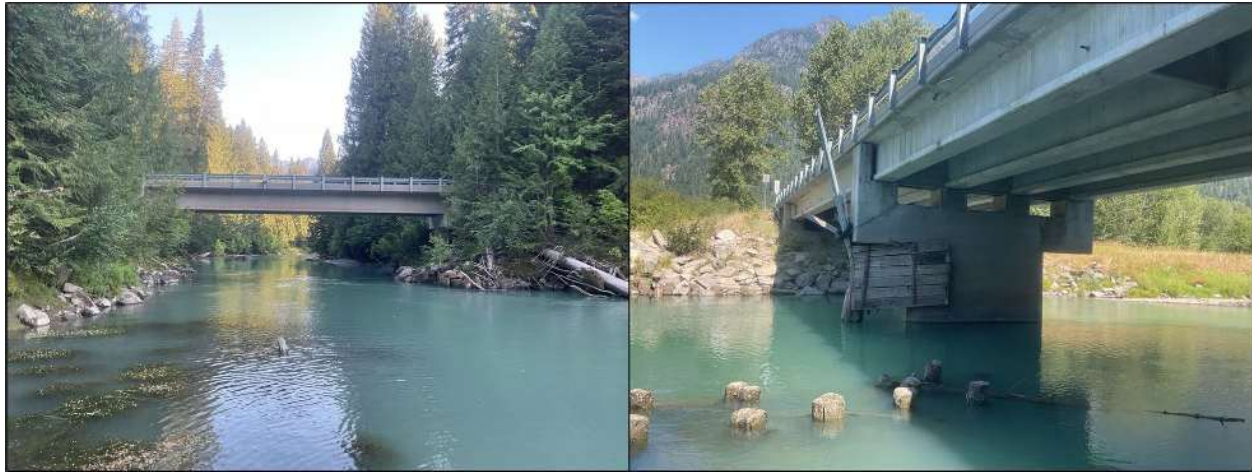
Figure 19. Left: Bridge and riprap over the White River at RM 7 (August 6, 2024). Right: Bridge and riprap crossing White River at RM 2 (August 15, 2024).

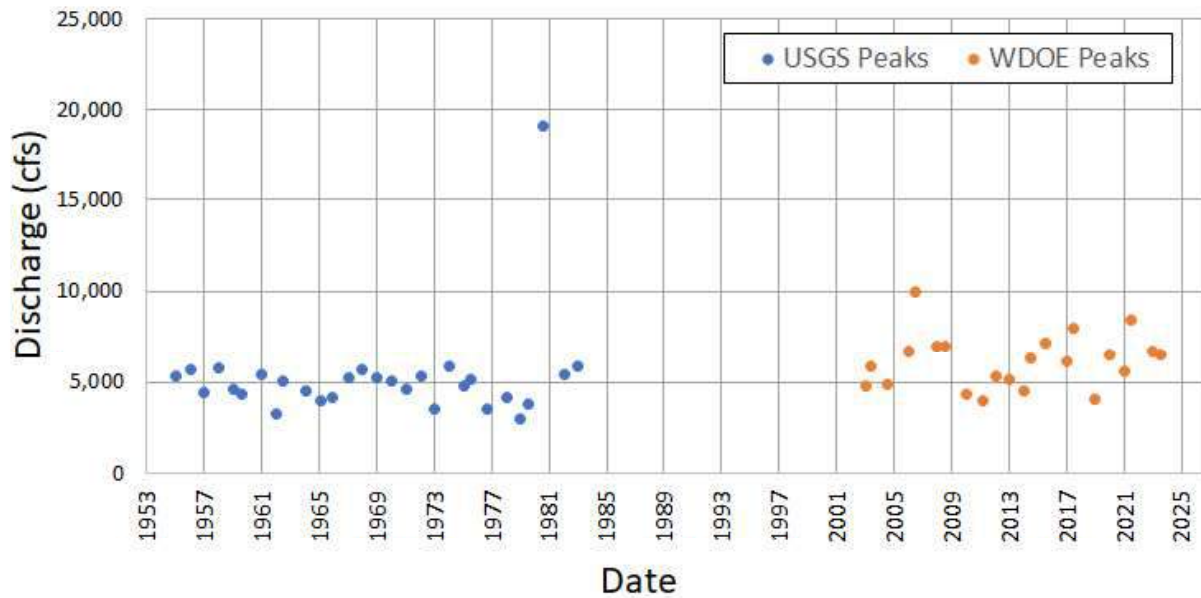
Figure 24. Annual peak flows (instantaneous data) from the USGS and WDOE gages.

There is relatively little available information on flood history for the White River. Annual peak flows from the available gage data are shown in Figure 24. The highest recorded peak flow on the White was on December 26, 1980. However, the available gage data is missing many years of record when there were high flows in the Wenatchee Basin. Based on the Wenatchee River USGS gage at Plain (#12457000), since 1911, two of the largest peaks in the basin occurred in November 1990 and November 1995.

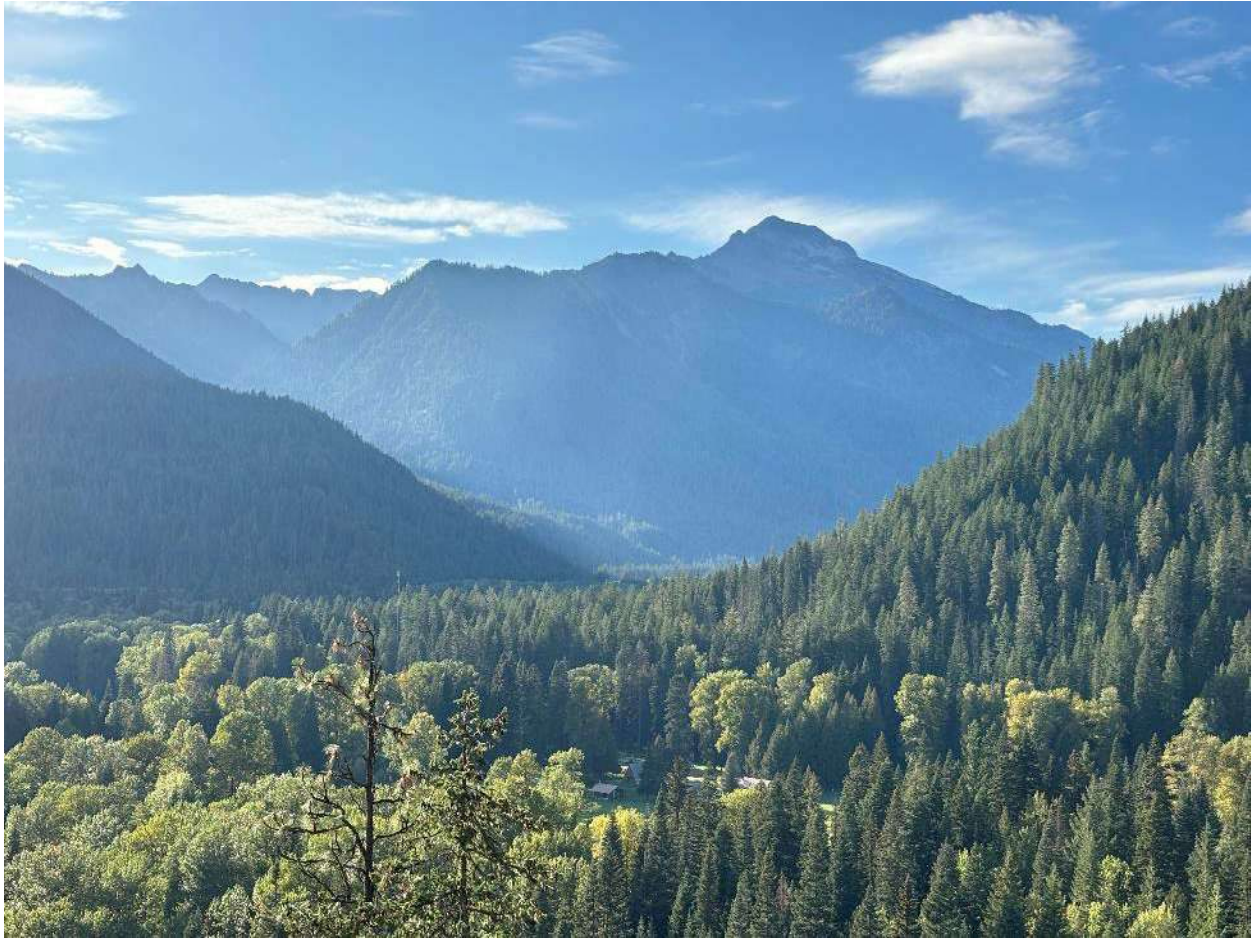
Figure 33. White River U-shaped valley looking up-valley from the Twin Lakes Trail near Reach 7. Foreground: Napeequa River alluvial fan with structures. Mid-photo background: Panther Creek entering the White River Valley on river right (September 11, 2024).

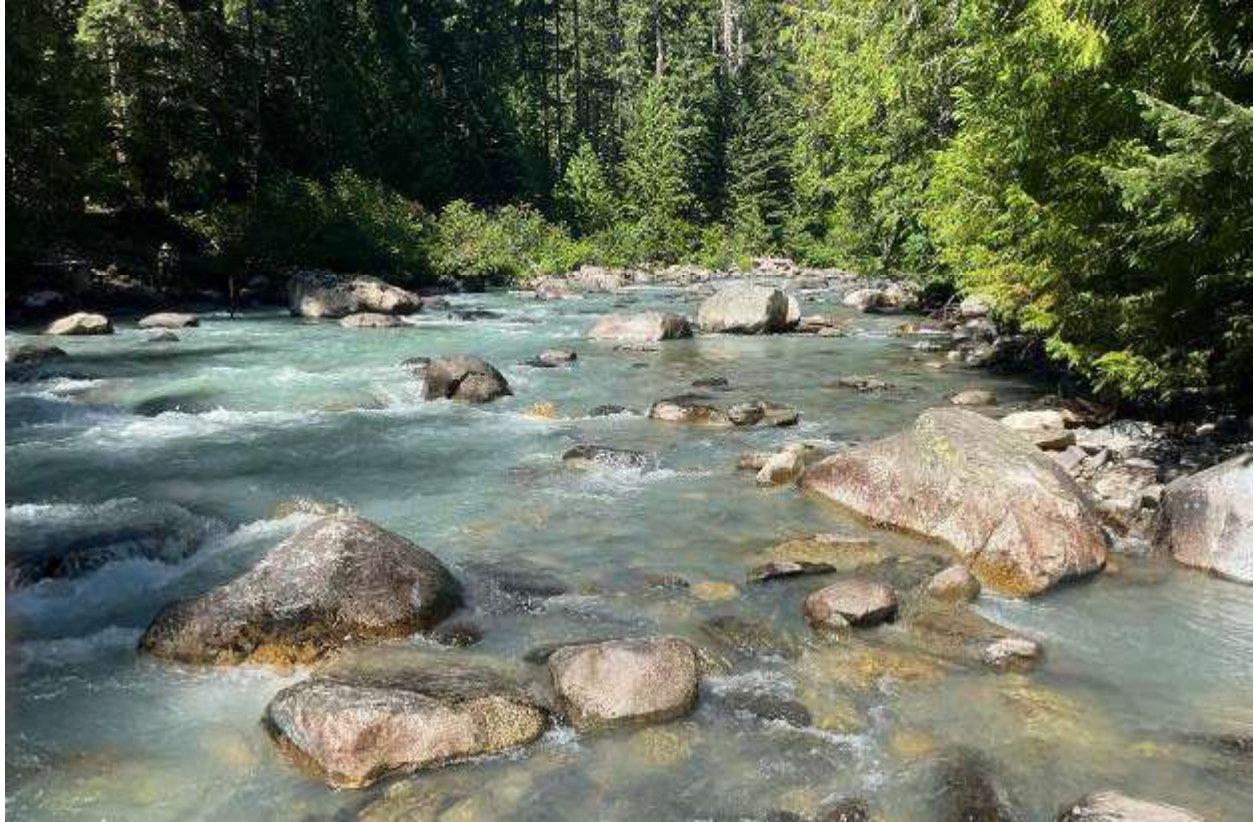
Figure 36. Photograph of characteristic steep, confined, high gradient, and relatively straight channel conditions with primarily boulder substrate, common in the upper portion of the assessment area, looking upstream from RM 15.56 (August 1, 2024).

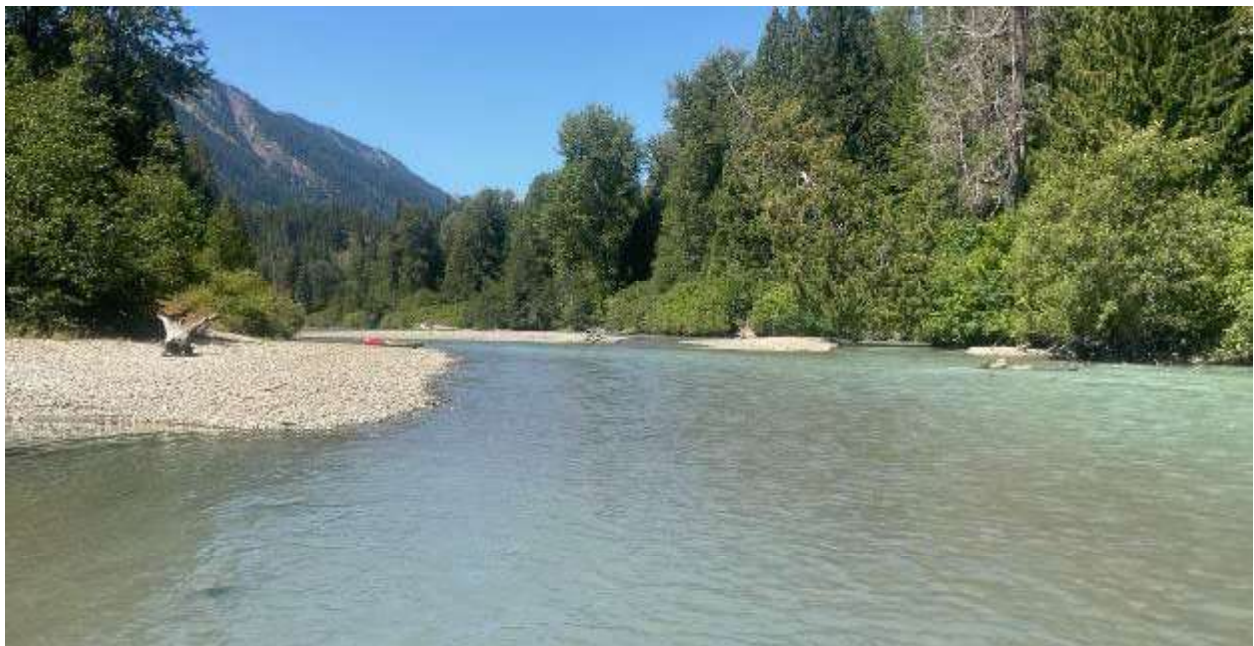
Figure 37. Photograph of characteristic channel conditions within the middle portion of the assessment area: point bars, unconfined valley bottom, and split-flow around mid-channel bars, looking upstream from RM 9.86 (August 5, 2024).

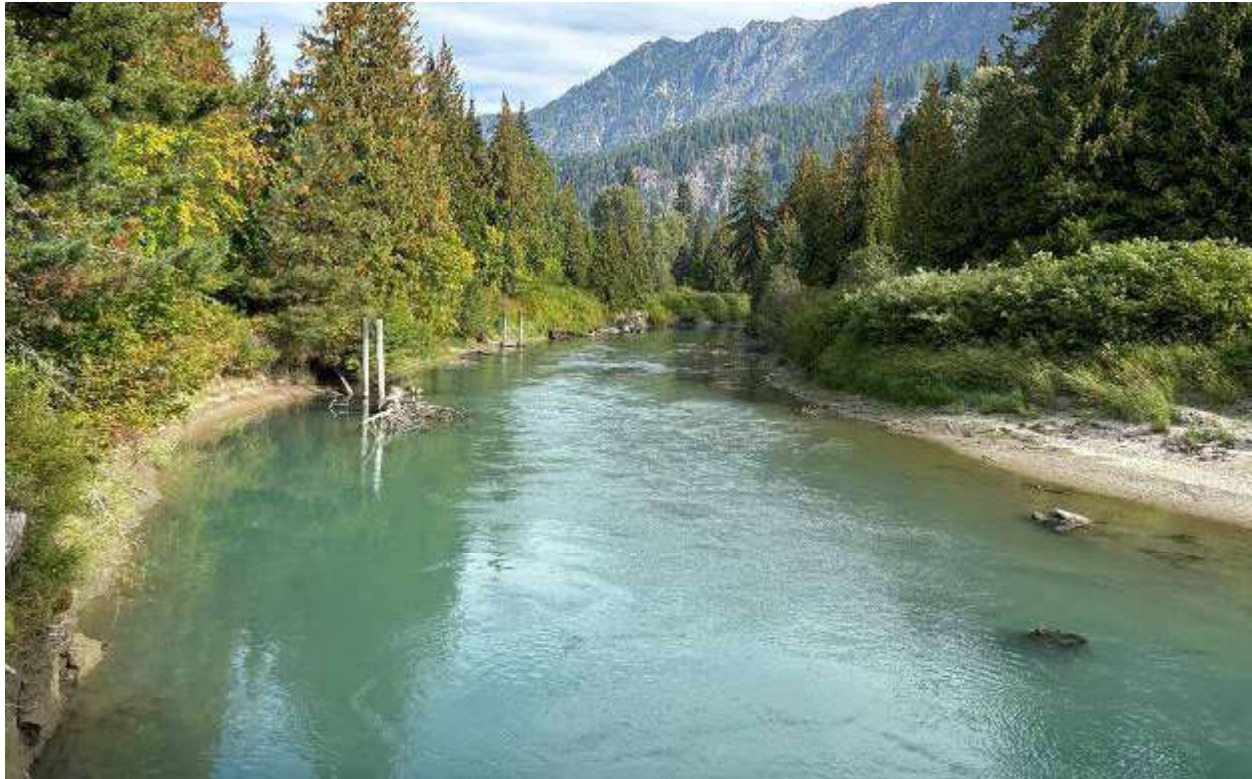
Figure 38. Photograph of characteristic channel conditions within the lower portion of the assessment area: low gradient, wide valley bottom, and increased presence of sand within bars, looking upstream from RM 3.4 (September 9, 2024).

Downstream of the bedrock falls at the upper end of the assessment area, the single-thread channel is straight to slightly meandering, and alternates between a confined and partially confined condition, with bedrock and terraces restricting lateral channel movement and overbank flow (Figure 36). High channel slope and confinement create a high energy environment in which large wood and sediment inputs are frequently mobilized and transported downstream, rather than retained locally. Substrate is primarily cobble-boulder alluvium, with cobbles and occasional large gravels only present in areas where low velocities have induced sediment deposition, such as channel margins and behind very large boulders. Below the Panther Creek confluence, the White River valley widens and the channel becomes unconfined (Figure 37). Channel scars visible in the topography of the valley floodplains suggest a history of active lateral migration. Channel slope decreases considerably between the Panther Creek and Napeequa River confluences, and again below the Sears Creek Road bridge crossing at RM 7, reducing the transport capacity of the river. Substrate transitions to primarily gravel-cobble alluvium through the middle portion of the assessment area, and to primarily sand-gravel alluvium in the lower portion downstream of RM 7. Boulders are generally absent from the channel downstream of Panther Creek aside from areas impacted by hillslope contacts, mass wasting deposits, and tributary alluvial fan inputs. Although the planform remains primarily single-threaded, large wood and local flow dynamics create low-flow splits at mid-channel bars with large wood jams. Split-flow is most common downstream of the Napeequa Confluence. The channel remains straight to slightly meandering through the Napeequa confluence, and transitions to meandering as sinuosity increases considerably near and downstream of the Sears Creek confluence area (Figure 38).

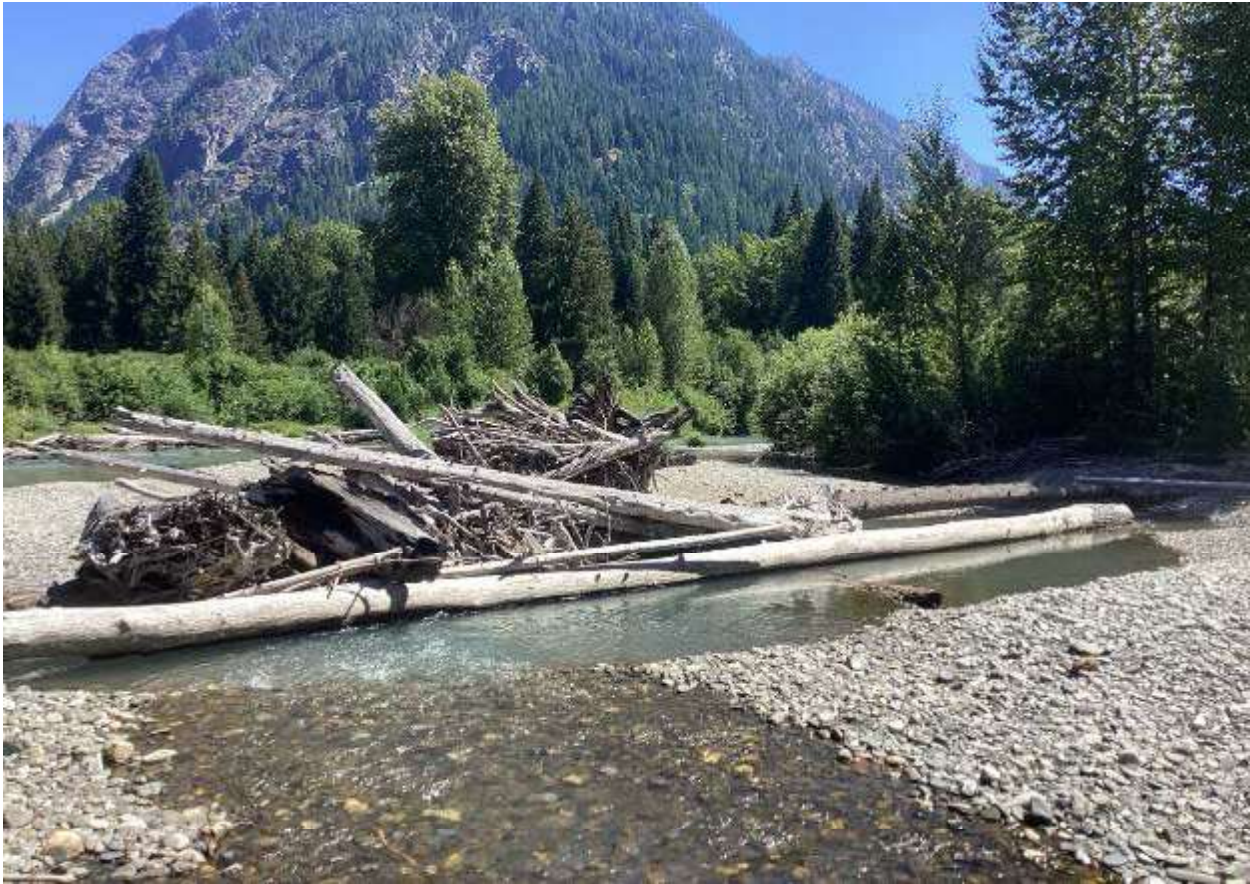
Figure 40. Large wood jam in Reach 8 increasing channel complexity by promoting scour, sorting sediment, and promoting split-flow conditions, looking downstream from RM 12.95. The main channel is to the left of the photograph (August 4, 2024).

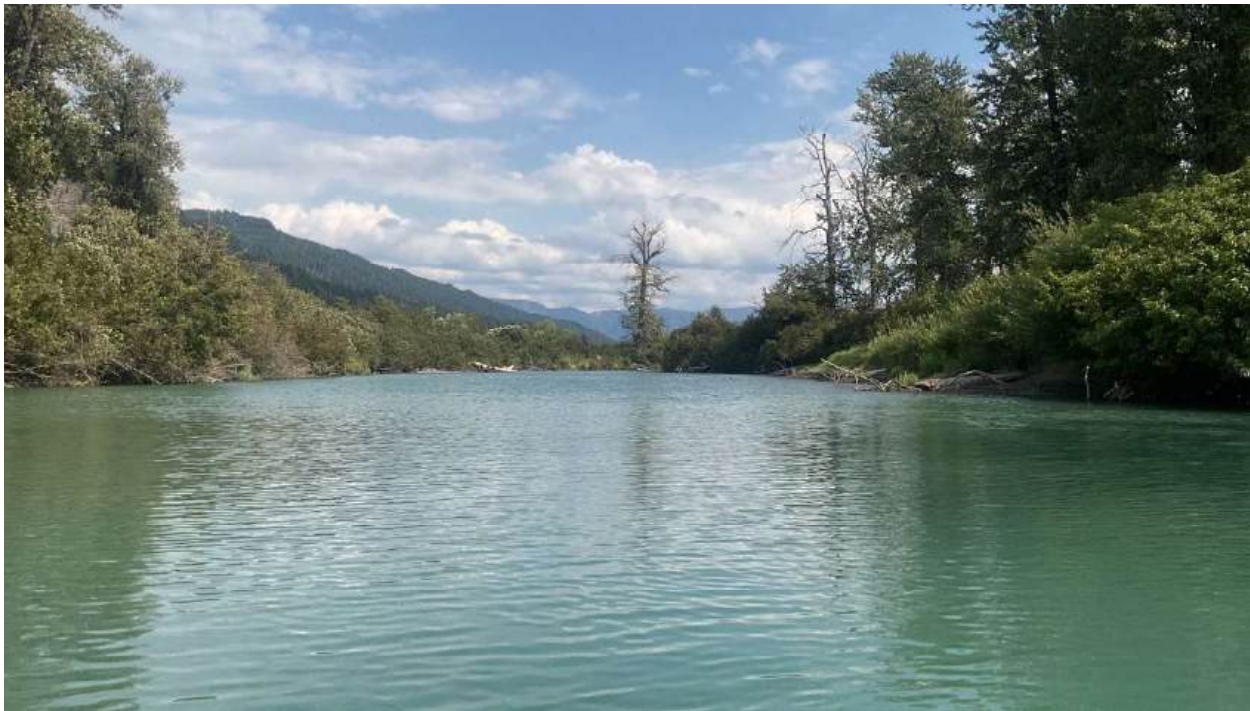
Figure 45. Representative photo of the White River in Reach 1 at RM 0.33, looking downstream (August 16, 2024).

Reach 1 is two miles long and extends from the mouth of the White River at Lake Wenatchee to the Little Wenatchee Road bridge crossing at RM 2. The channel in Reach 1 is sinuous ($S = 1.47$), single thread in planform, and unconfined (Figure 45, Table 9). The reach experiences backwatering from Lake Wenatchee, especially in the downstream portion. The average gradient of Reach 1 (0.02%) is lower than that of any other reach within the assessment area. The average bankfull width for Reach 1 is estimated to be approximately 130 feet using NAIP aerial imagery from 2023 following the Habitat Assessment. The majority of the geomorphic surfaces in the valley are mapped as low floodplain (inundated ~ 1-5 years). The remainder is mapped as medium floodplain (inundated ~ 5-10 years), although a section of the river-right floodplain adjacent to the Little Wenatchee Road bridge at RM 2, was identified as anthropogenically disconnected. Vegetation on the low floodplain surfaces typically consists of dogwood, willow, and reed canary grass, with dogwood being the most prevalent species. The higher floodplain surfaces are vegetated with dogwood, reed canary grass, cottonwood, and western redcedar. Human alterations to the channel and floodplain in Reach 1 include Little Wenatchee Road which perpendicularly dissects the entire floodplain at the upstream end and confines the channel in a locked location. The road disrupts channel migration and floodplain flow paths. Ditching and draining, as well as several homes and other structures, and an abandoned road also impact flow routing and inundation patterns on the river-left floodplain.

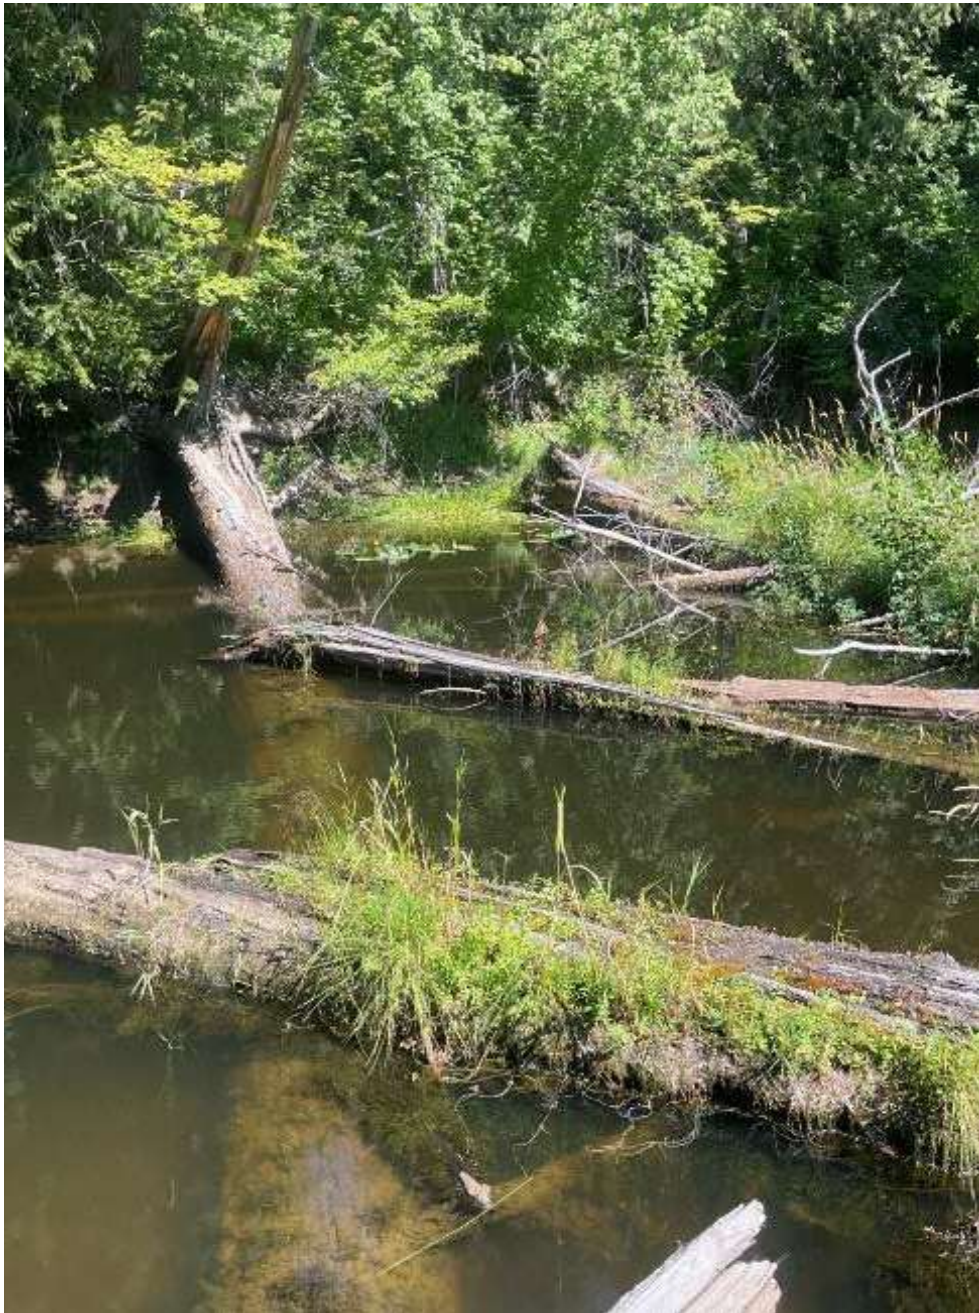
Figure 46. Wetted oxbow containing large wood on river right floodplain at RM 1.8 (August 15, 2024).

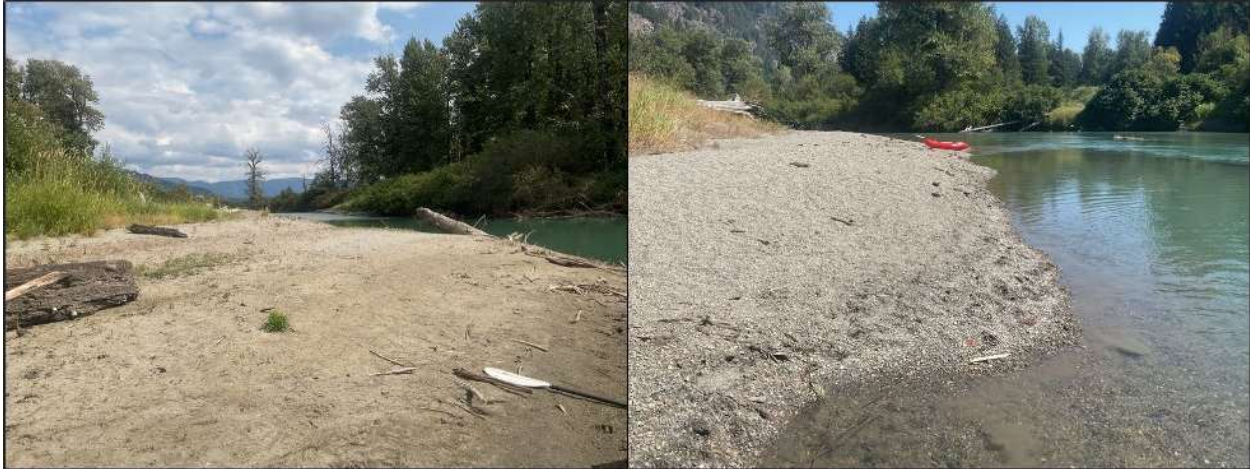
Figure 49. Left: Sand bar on river left at RM 0.37. (August 16, 2024) Right: Gravel-sand bar on river left at RM 1.82 (August 15, 2024).

Channel substrate in Reach 1 is primarily small gravels topped with coarse sand and fines in the upstream half of the reach and in the downstream half substrate is dominated by coarse sands. Point bars are located on the insides of all meander bends. The bars downstream of RM 1 are primarily composed of sand, whereas the bars from RM 1 – 2 are composed of small gravels (Figure 49).

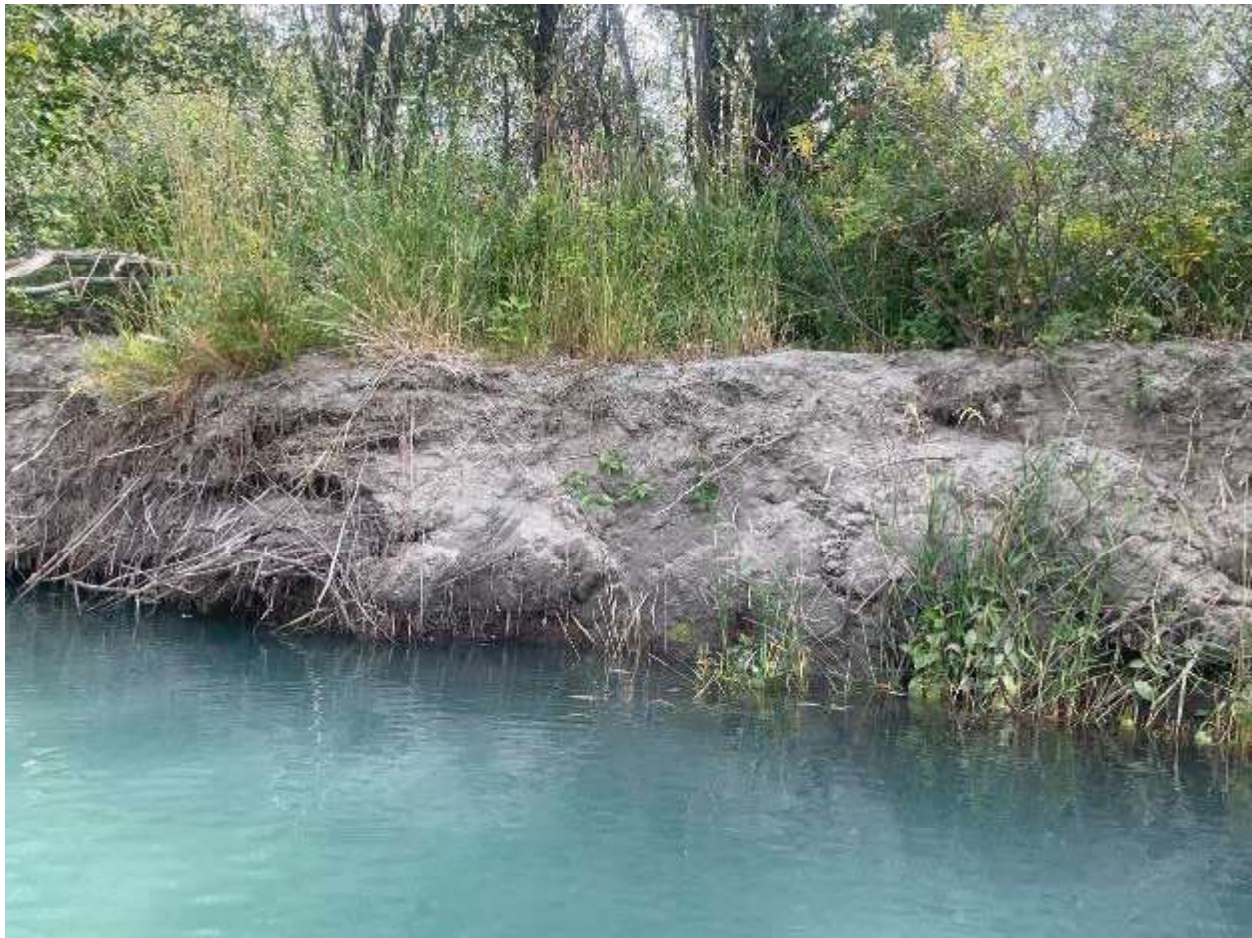
Figure 51. Eroding sandy stream bank on river-right at RM 0.35 (August 16, 2024).

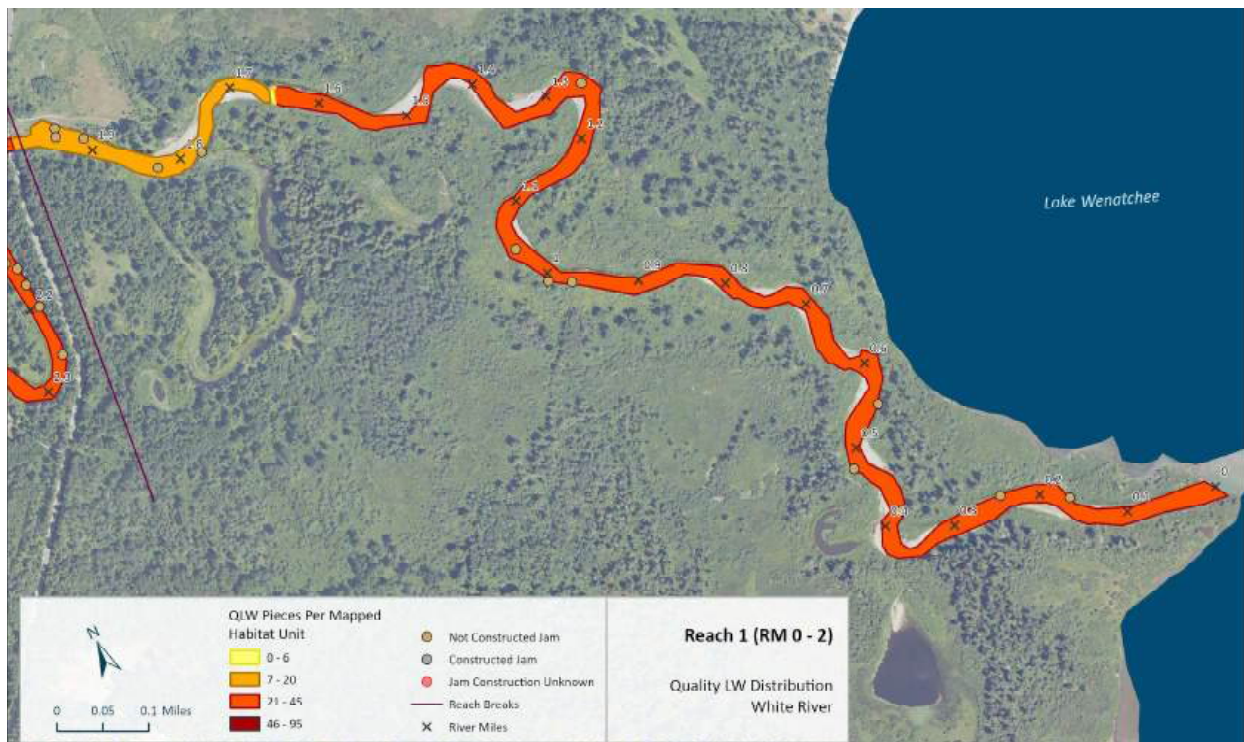
Figure 52. White River, Reach 1: Quality large wood (QLW) distribution maps and surveyed habitat units (2024). QLW count does not include pieces from jams.

A total of 135 pieces of large woody material (LWM) and 14 log jams (accumulation of >3 LWM) were observed in the channel during the habitat survey (Summer of 2024). Figure 52 is a map of the surveyed large wood in Reach 1. Of the 135 pieces, 50 pieces are considered quality large wood (QLW); 20 classified as large size class (>20-inches diameter and >35-feet long); and 30 as medium size class (12 to 20-inch diameter and at least 35-feet long). Of the 14 log jams in Reach 1, eleven have multiple pieces of QLW and thus are effective at influencing the channel complexity and being habitat forming structures. Effective large wood in Reach 1 is responsible for influencing sediment deposition and sorting and providing cover. Although large wood is present, many of the large wood accumulations are not anchored by key logs or attached to the stream bed or banks and thus are considered temporary as they are expected to be mobile at higher flows (Figure 53). Key piece size of a log containing a rootwad was estimated to be 2+ feet in diameter and 50 ft long for Reach 1, during the Geomorphic Assessment.

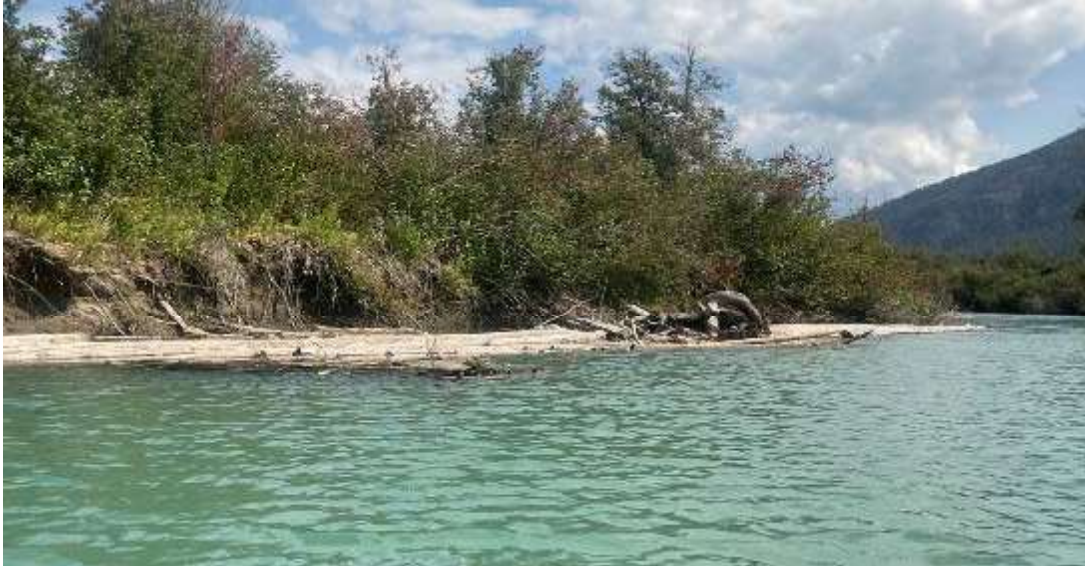
Figure 53. Mobile accumulation of large wood, on river left at RM 0.16 (August 16, 2024).

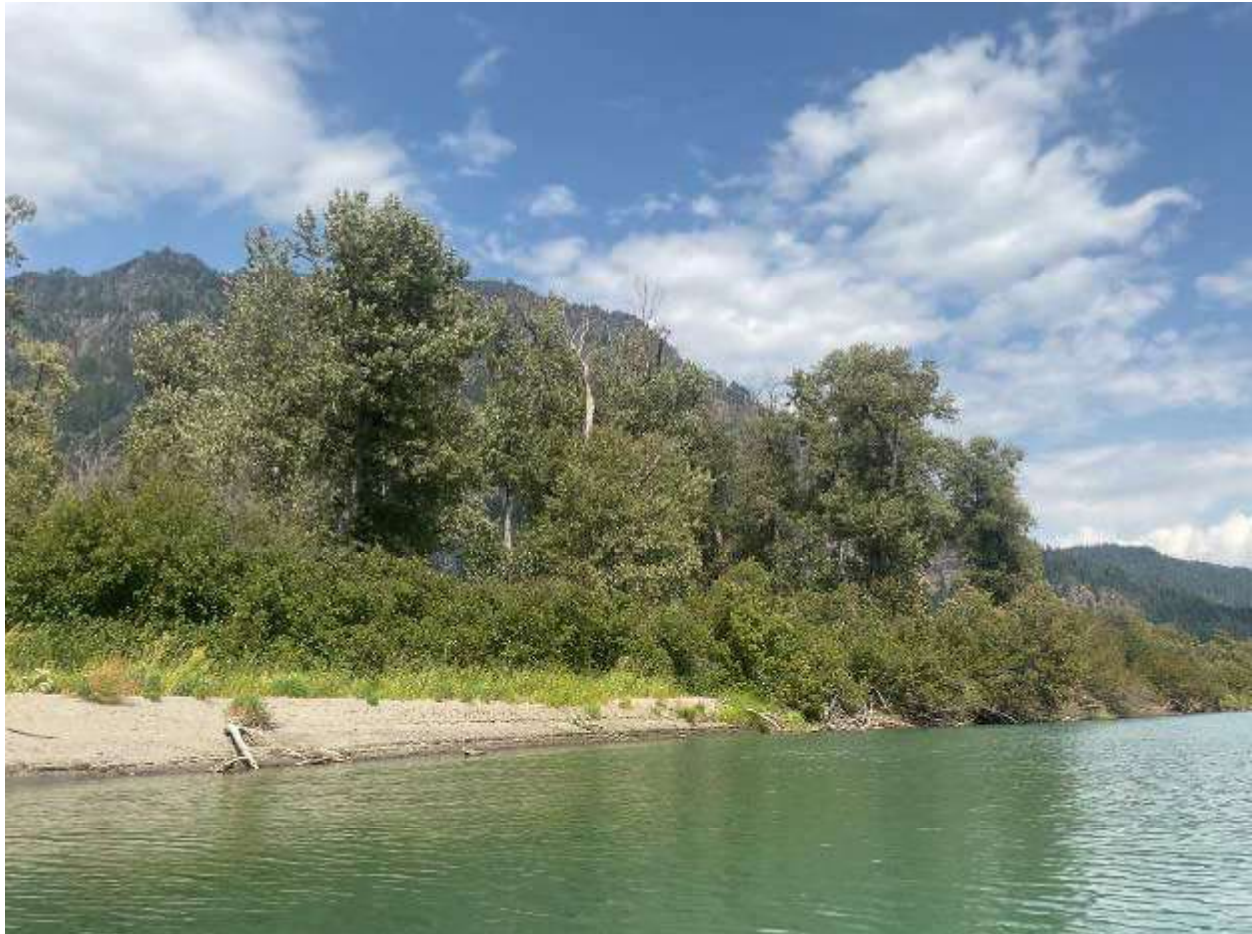
Figure 55. Floodplain vegetation with small cluster of large cottonwood trees at RM 0.31, looking downstream (August 16, 2024).

Vegetation established on the adjacent floodplain surfaces in Reach 1 is primarily riparian shrubs and small trees. Dense dogwood thickets are common along the floodplains and back side of point bars or along wetted oxbows along with reed canary grass and, to a lesser extent, willow. Where large trees do exist, cottonwood and western redcedar are the dominant overstory species. The floodplain understory is composed primarily of dogwood, vine/Douglas maple, and other shrubs (Figure 55).

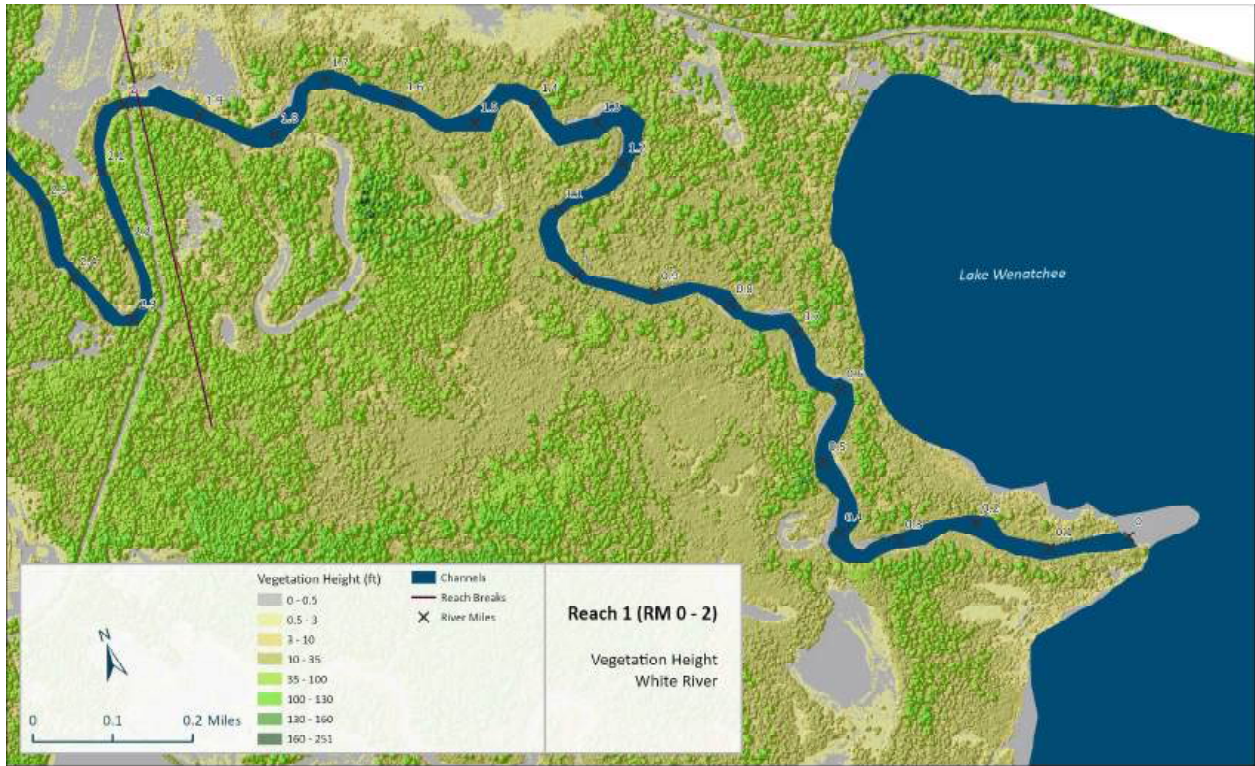
Figure 56. White River, Reach 1: Map of vegetation height classification analysis (LiDAR – based analysis).

Although large wood recruitment in Reach 1 is limited by a lack of large trees adjacent to the channel, clusters of large overstory trees at RM 0.31 and 0.5 do provide localized sources of large wood to the channel. A map showing the vegetation height size class distribution in Reach 1 is provided as Figure 56. The map reveals the lack of large and very large trees along the banks and across the floodplain. The existing riparian vegetation likely provides limited stream shading because channel width is so much greater than vegetation height.

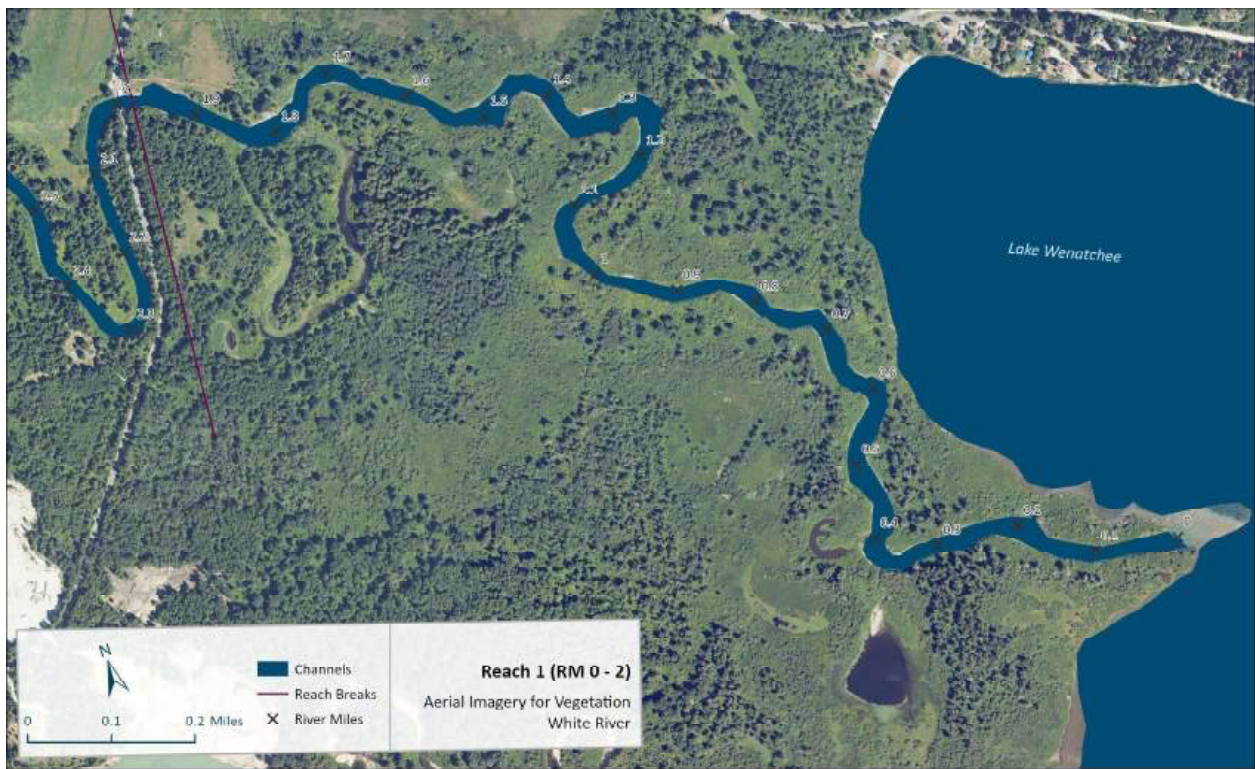
Figure 57. White River, Reach 1: Map with aerial imagery for vegetation identification.

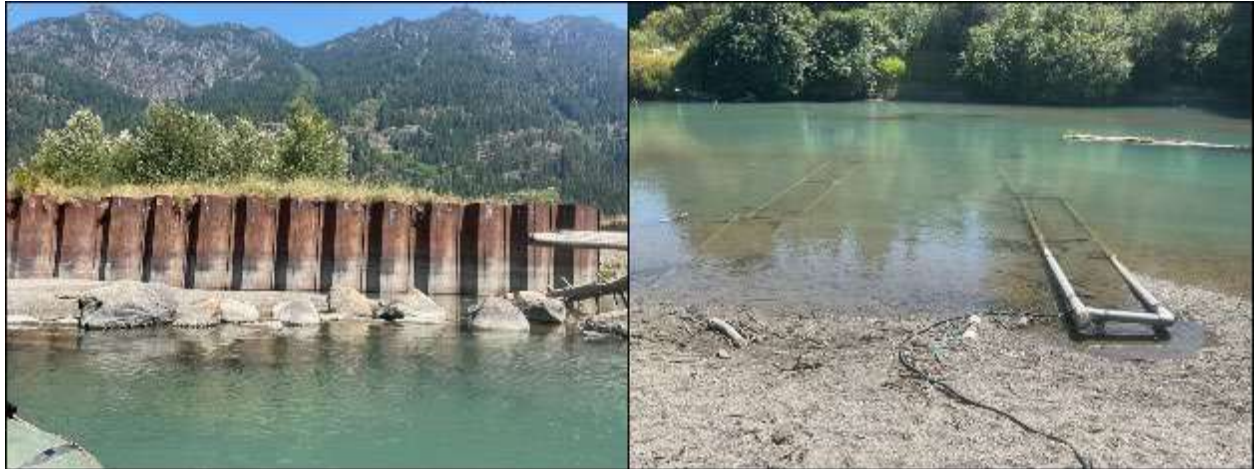
Figure 59. Left: Sheet piles and riprap protect the river left bank from ~RM 1.94-2. (August 15, 2024). Right: PIT tag readers installed on river left at RM 1.8 (August 15, 2024).

Downstream of the bridge, riprap and sheet piles protect the river-left bank and further limit lateral migration and floodplain connection between ~RM 1.94 – 2 (Figure 59). At RM 1.8, a PIT tag reader extends into the White River channel (Figure 59). The constructed rock and wood weir that spans the White River at ~RM 1.65 currently provides grade control for the channel in an area where meander neck cut-offs reduced channel length and likely instigated incision (Figure 60). The weir spans the channel but is low profile and has a defined chute and does not appear to block fish migration. A cluster of large wood pilings installed on the river-right edge of the channel at ~RM 0.06 appears to have minimal impact on channel processes and does not appear to be effective at trapping large wood or sorting sediments (Figure 60).

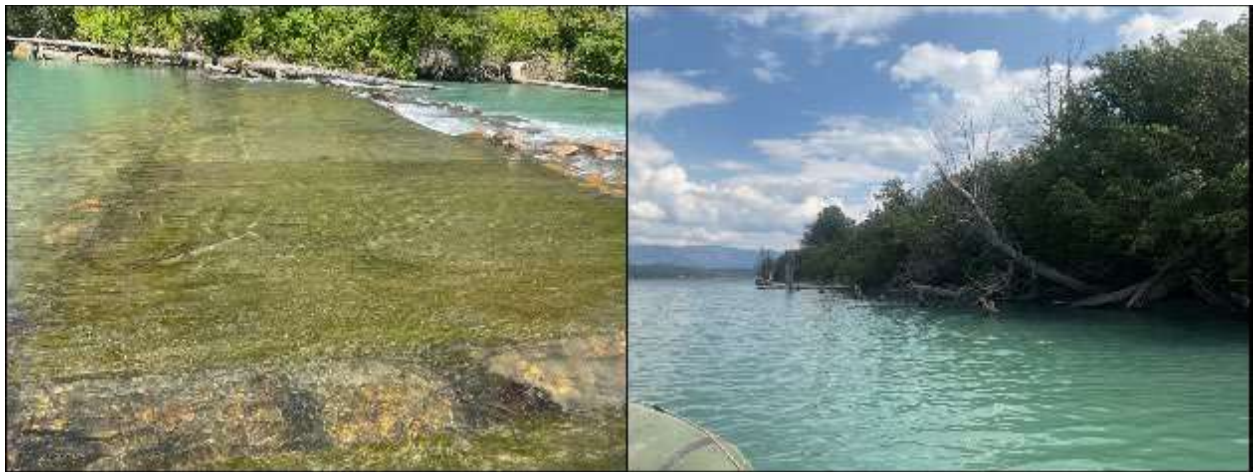
Figure 60. Left: Channel-spanning weir of rock and wood at RM 1.65, viewed from river right. (August 15, 2024) Right: Constructed large wood pilings at RM 0.06, looking downstream (August 16, 2024).

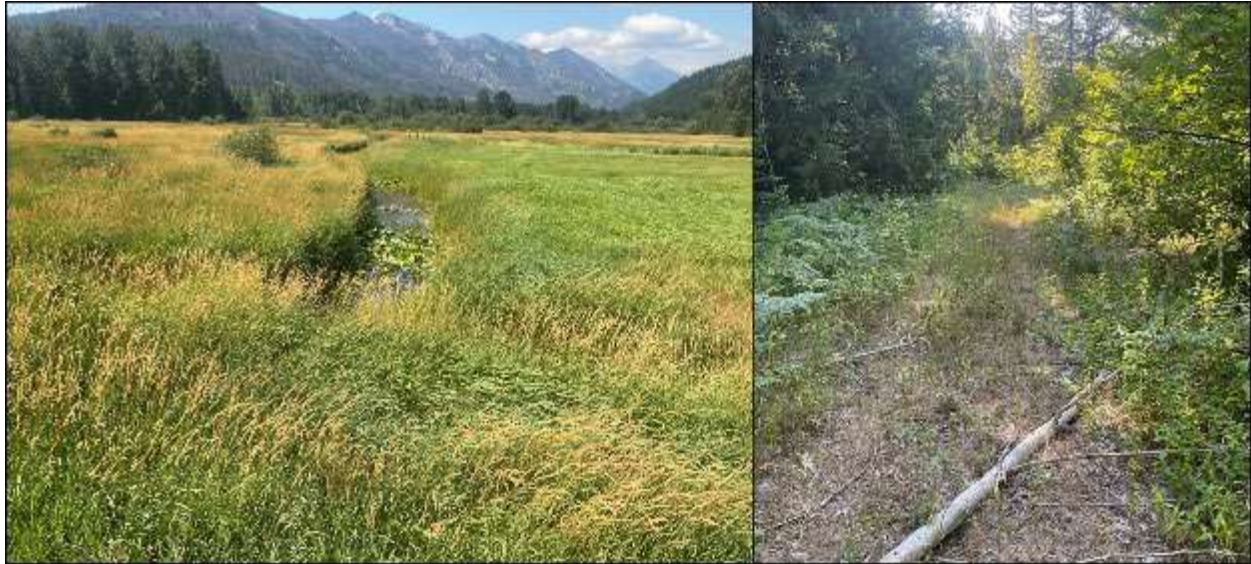
Figure 61. Left: Drainage ditch floodplain, looking up-valley from Little Wenatchee Road (August 15, 2024). Right: Abandoned access road on river-right floodplain in Reach 1 (August 15, 2024).
