White River Reach Assessment & Restoration Strategy

Final Report

PREPARED FOR
Yakama Nation Fisheries

PREPARED BY
Inter-Fluve

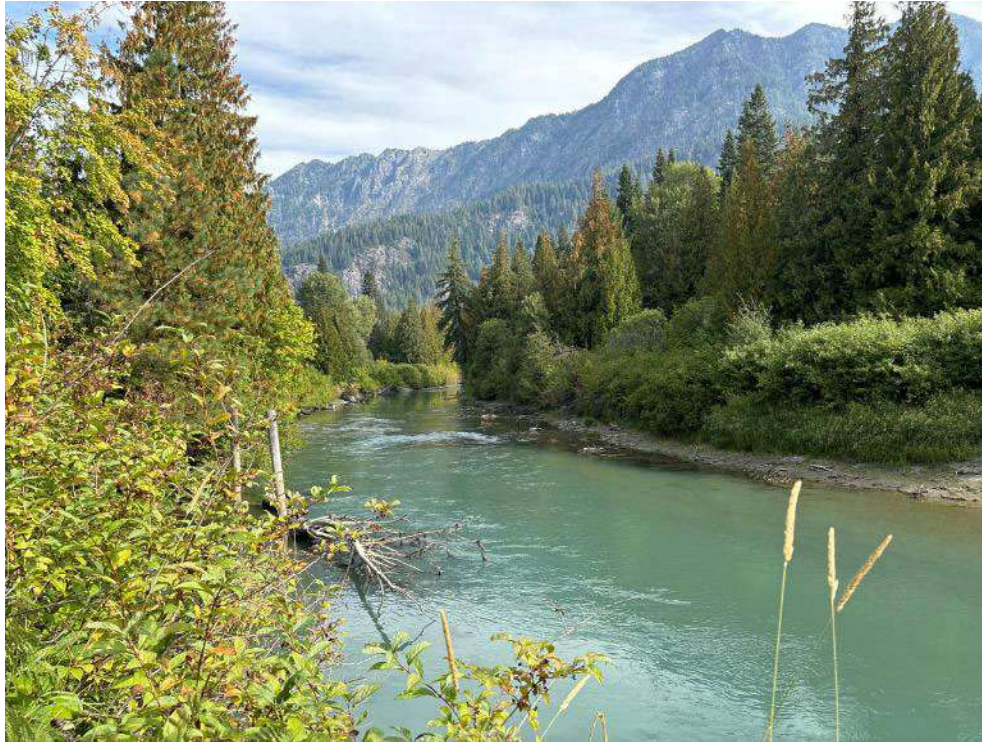
Figure 62. Representative photo of the White River in Reach 2 at ~RM 3.4, looking upstream (September 9, 2024).

Reach 2 is 2.13 river miles long and extends from the Little Wenatchee Road bridge over the White River at RM 2 upstream to RM 4.13, above which the White River channel is briefly in contact with the river-right hillslope. Reach 2 has the highest sinuosity ($S = 2.42$) of any reach within the assessment area (Table 10). Sinuosity is expressed as a series of seven unconfined meanders that curve through the center portion of the valley. The channel contacts the river-right valley wall from RM 3.95 – 4.18, near the upstream reach boundary. From ~RM 2 – 2.3 the channel is artificially held in place along the bank armoring that protects Little Wenatchee Road, which dissects the river-right floodplain after crossing the White River at RM 2. The road's bank protection maintains the downstream half of a large meander bend, but it has also led to local incision and floodplain disconnection, limiting the amount of floodplain available to the White River downstream of RM 2. The reach gradient in Reach 2 (0.05%) is slightly higher than in Reach 1 (0.02%), and only slightly lower than that of Reach 3 (0.07%). The average bankfull width of the channel, measured during the Habitat Assessment (See Appendix A) is 120 feet. Low floodplain surfaces (inundated ~ 1-5 years) are common in the upstream portion of the reach; however, low floodplain surfaces are rare in the downstream portion of the reach where natural levees and incision related to the bridge at RM 2 have reduced floodplain connectivity. The majority of the remaining valley bottom is medium floodplain surfaces (inundated ~ 5-10 years). The exception is a section of meander bends at ~RM 2 and ~RM 2.3 where forced incision instigated by the downstream road bridge crossing and upstream bank-armoring has resulted in abandonment of the floodplain such that it now functions similar to a terrace. Vegetation on low floodplain surfaces in Reach 2 consists primarily of reed canary grass, willow, and dogwood. Vegetation on medium and high floodplain surfaces consists of reed canary grass, dogwood, cottonwood, and cedar. Human alterations in Reach 2 include a series of large wood structures from a prior river restoration effort, evidence of logging on the river right floodplain, several homes along the valley margins, the Little Wenatchee Road bridge at RM 2, and associated upstream bank protection.

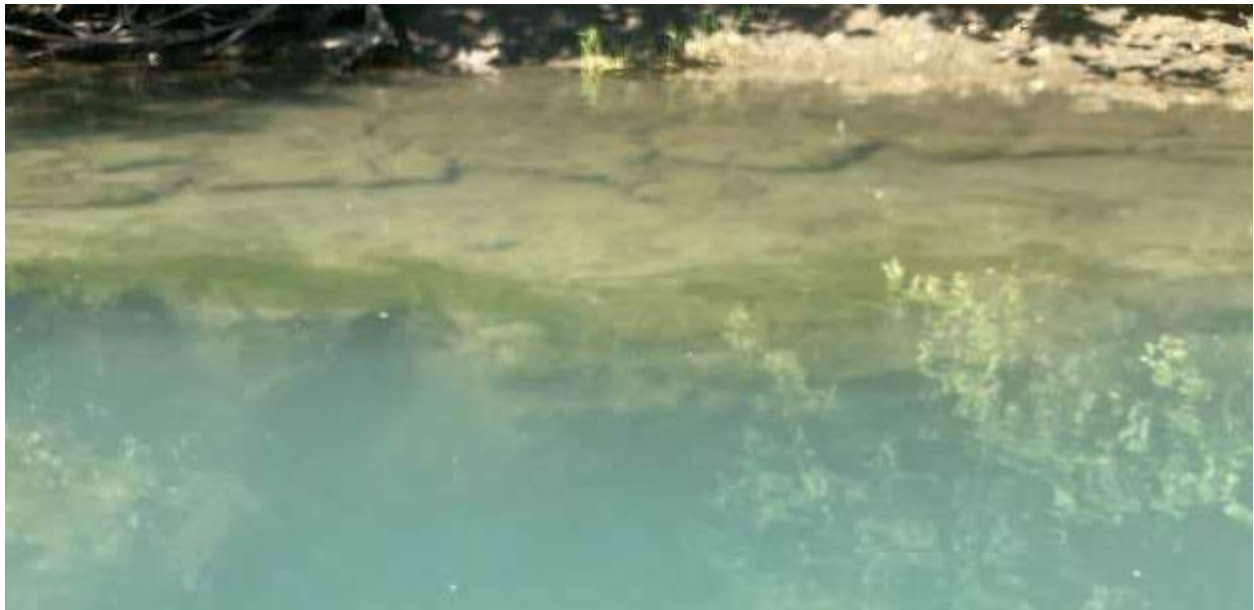
Figure 65. Mudstone shelf in the bed of the White River along river-right near RM 2.77 (August 15, 2024).

Channel substrate in Reach 2 is dominated by small-fraction gravel and coarse sand. Intermittent mudstone outcrops were observed in the stream bed between ~ RM 2.3 – 2.8 (Figure 65). Large sand and gravel point bars are present upstream of ~RM 3 but are absent in approximately the lower mile of the reach (Figure 66). The point bars occur on the inside of meander bends and the short channel-spanning gravel riffles are commonly located at the upstream end of the point bars.

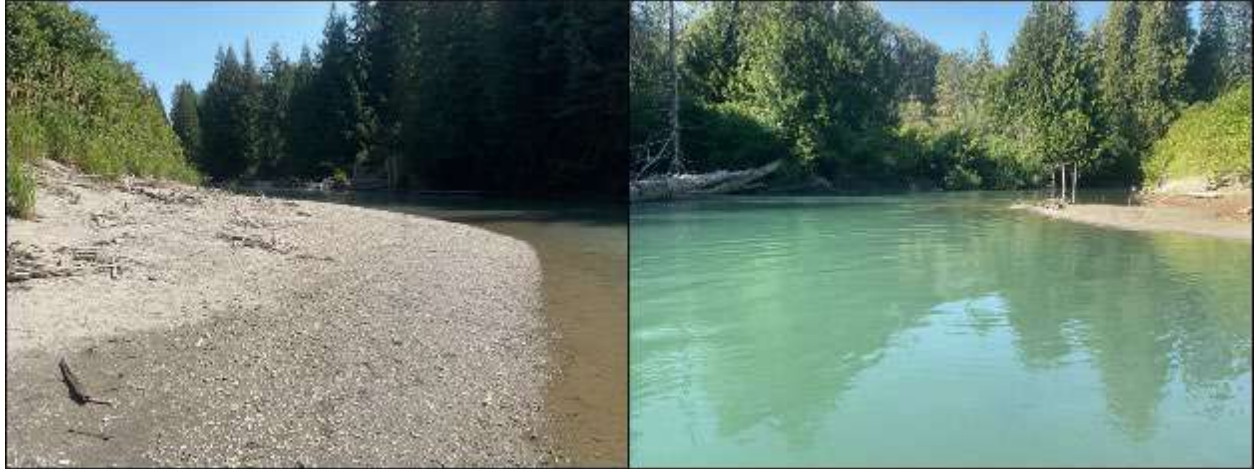
Figure 66. Left: Large point bar composed of gravel and topped with sand at RM 3.4, looking downstream. (August 14, 2024) Right: minor point bars composed of sand at RM 2.68, looking upstream (August 15, 2024).

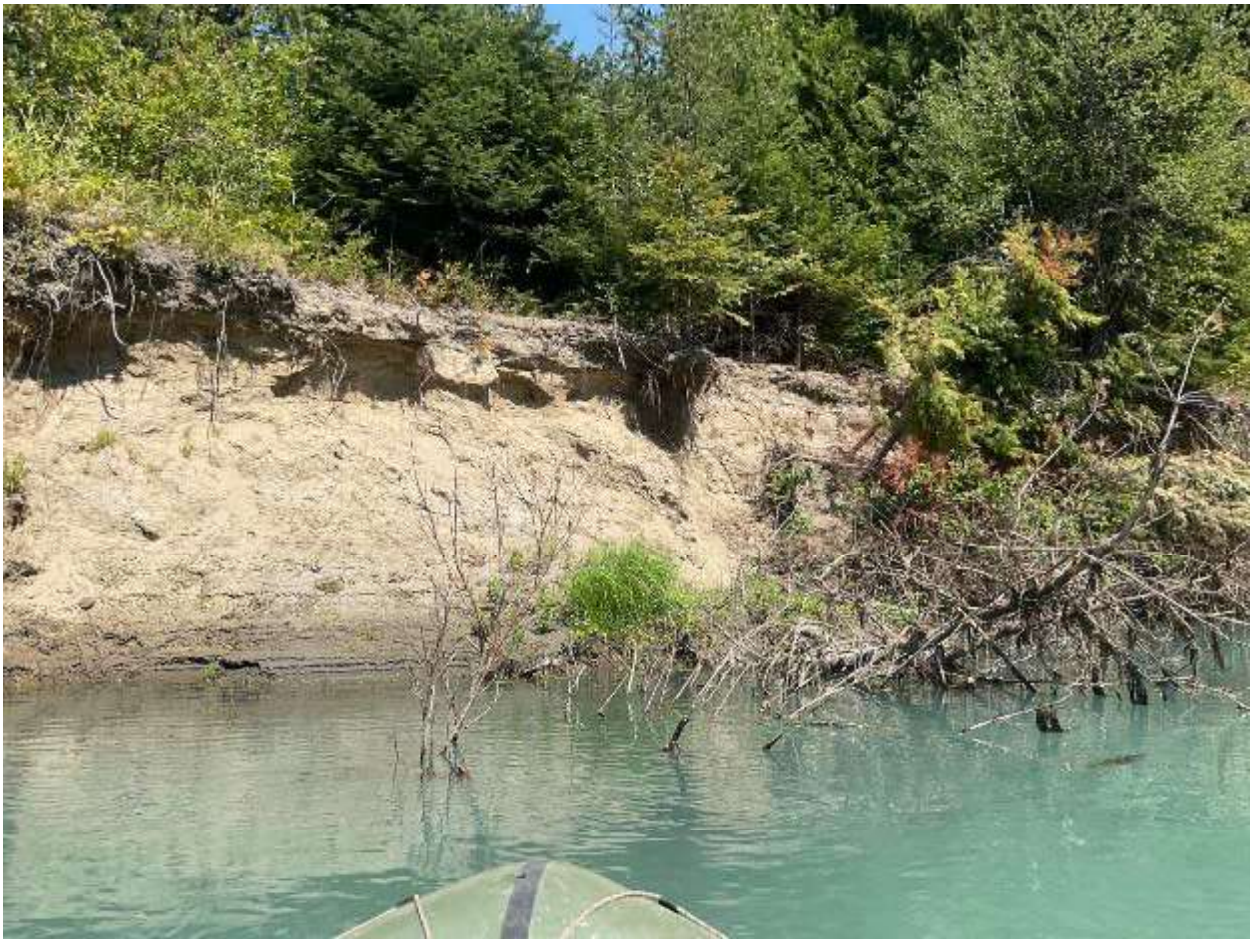
Figure 68. Exposed cut bank at RM 3.82, on river right. (August 14, 2024)

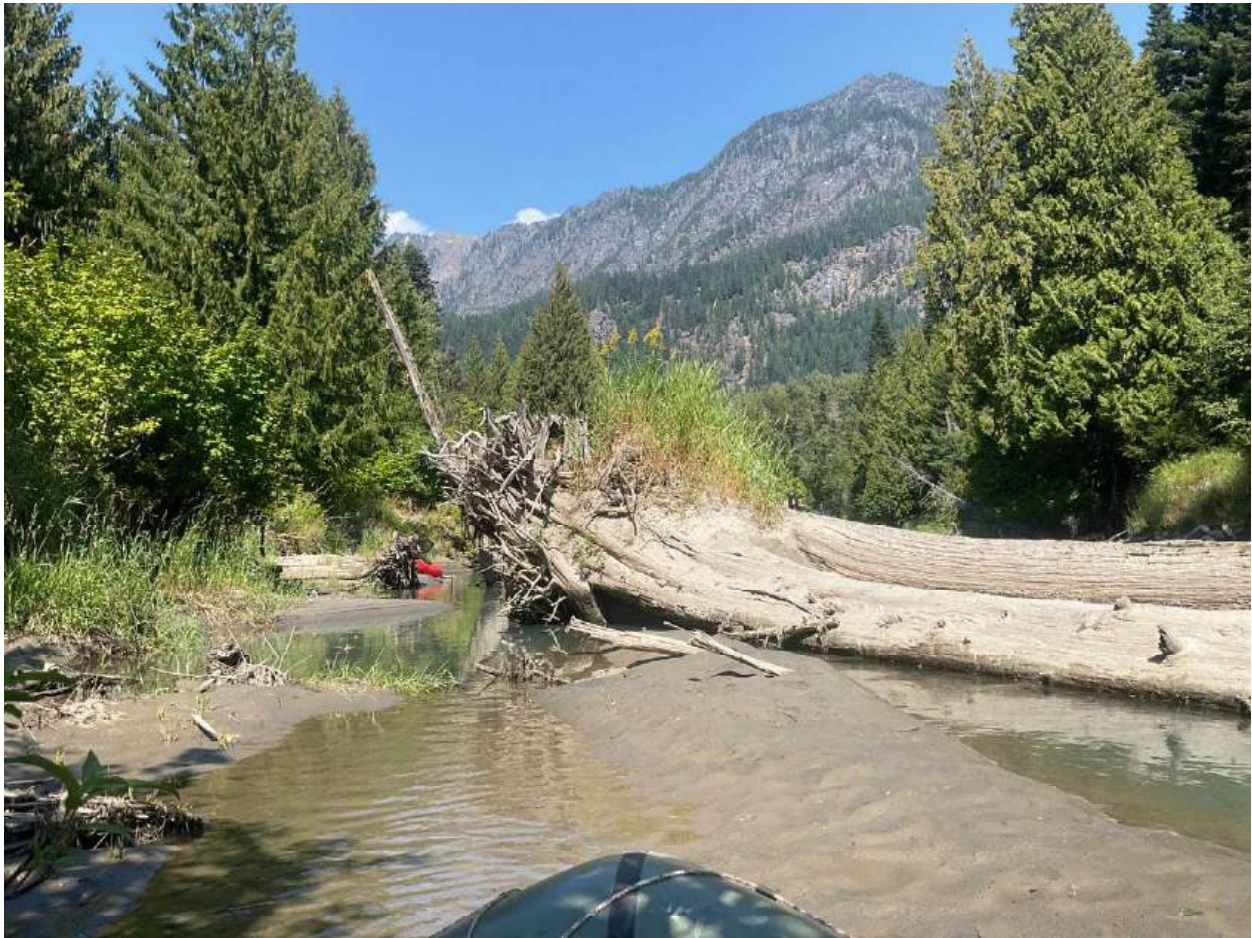
Figure 70. Effective large trees with rootwads influencing sediment sorting and local scour near RM 3.48 (August 14, 2024).

Large wood accumulations in Reach 2 are responsible for creating alcove habitat, driving deposition of sand and fine sediments, and causing small amounts of pool scour (Figure 70). Large wood is not responsible for creating split flow or multithreaded flow paths in Reach 2. Large wood is responsible for instigating lateral migration that generates additional wood recruitment and sediment sourcing. Large wood recruitment in Reach 2 is most successful when lateral erosion occurs where large cottonwood and cedar are located adjacent to the channel. Key pieces (effective at maintaining geomorphic influences and sustaining jams) were observed as being 2+ feet in diameter and at least

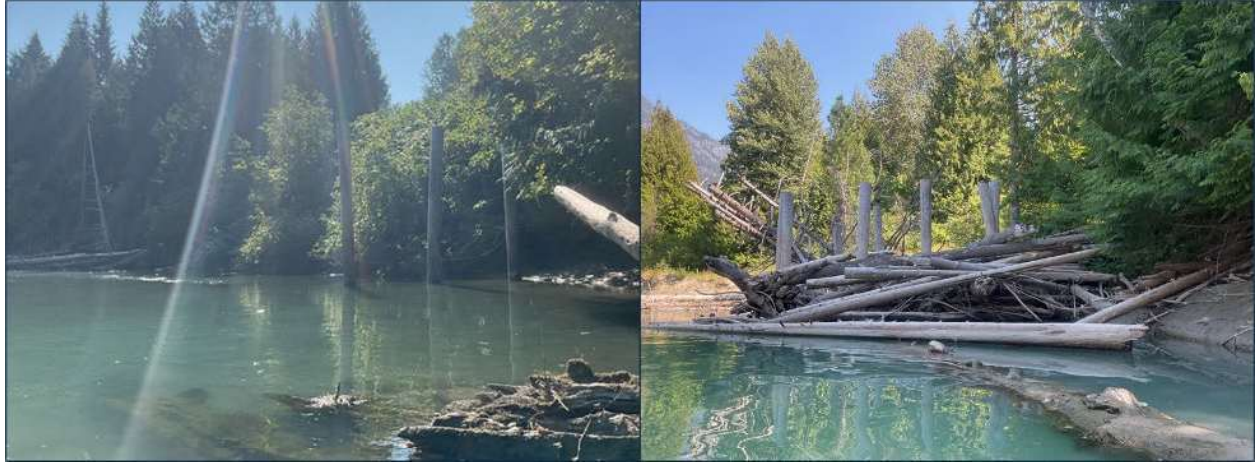
Figure 71. Left: Example of constructed wood piling structure with no effective function at RM 2.73 (August 15, 2024). Right: constructed wood piling structure effectively accumulating and retaining large wood at RM 3.32 (August 14, 2024).

40 ft long in Reach 2. In several locations, the ends of large wood pieces have been sawed off, likely by boaters to improve navigability of the lower White River. Although large wood is present in locations throughout Reach 2, many of the large wood accumulations are not anchored by key logs or attached to the stream bed or banks and thus considered temporary influences as they are expected to be mobile at higher flows. A series of engineered large wood structures consisting of clusters of large wood pilings were installed in Reach 2 as part of prior restoration efforts. The locations of the constructed jams are depicted as a grey dot in Figure 69. The effectiveness of the constructed jams is mixed as several of the structures are currently retaining little to no large wood (Figure 71).

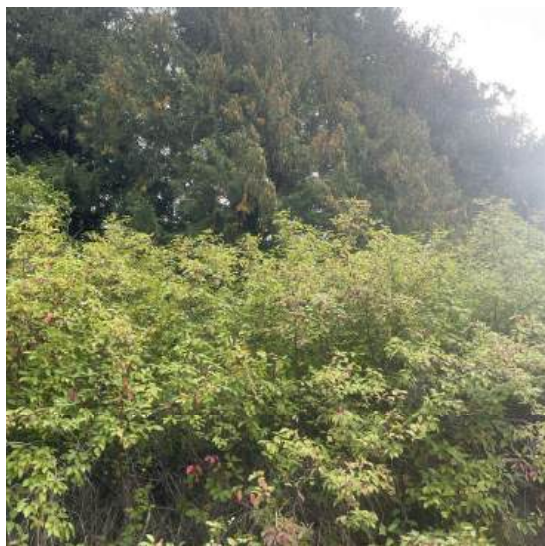
Figure 72. Representative riparian vegetation of dense dogwood backed by western redcedar overstory, at RM 2.56 (September 12, 2024).

Vegetation in Reach 2 consists of an overstory primarily composed of western redcedar and cottonwood, and an understory consisting primarily of dense dogwood thickets, and sparse pockets of vine/Douglas maple (Figure 72). Although a narrow riparian buffer is generally present throughout the reach there has been substantial forest clearing on the river left floodplain from downstream of the Reach 2 boundary at RM 2, to approximately RM 3.1, and on the river right floodplain from approximately RM 2.7 – 2.9. Forest clearing and relative distribution of forest maturity is provided in the Vegetation Height Analysis map provided as Figure 73. The cleared surfaces now contain abundant reed canary grass, with little to no natural recruitment of native woody species (Figure 75). Almost no large trees of sufficient size to be effective key logs (2+ ft dbh) are available along the banks of the channel in Reach 2.

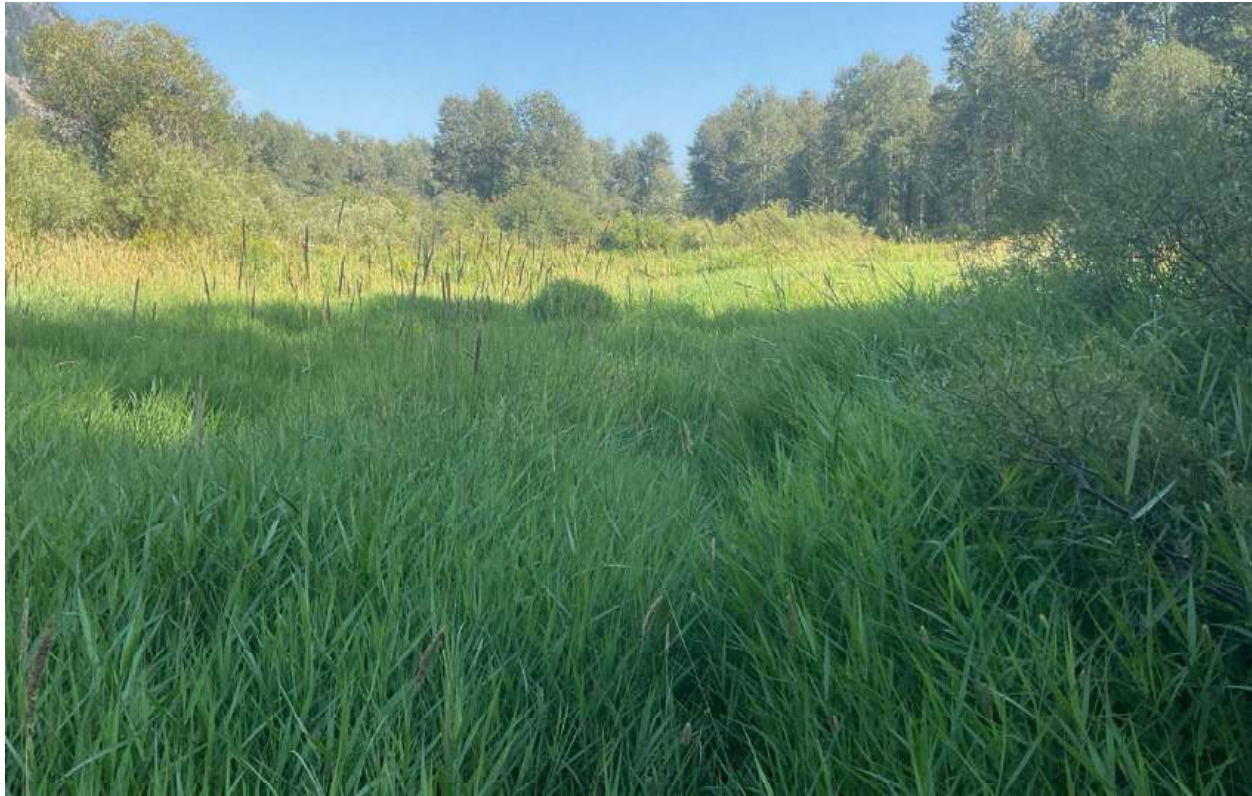
Figure 75. Medium height floodplain surface at RM 3 on river left. Forests on the river left floodplain have been cleared and surfaces have been colonized by reed canary grass (August 14, 2024).

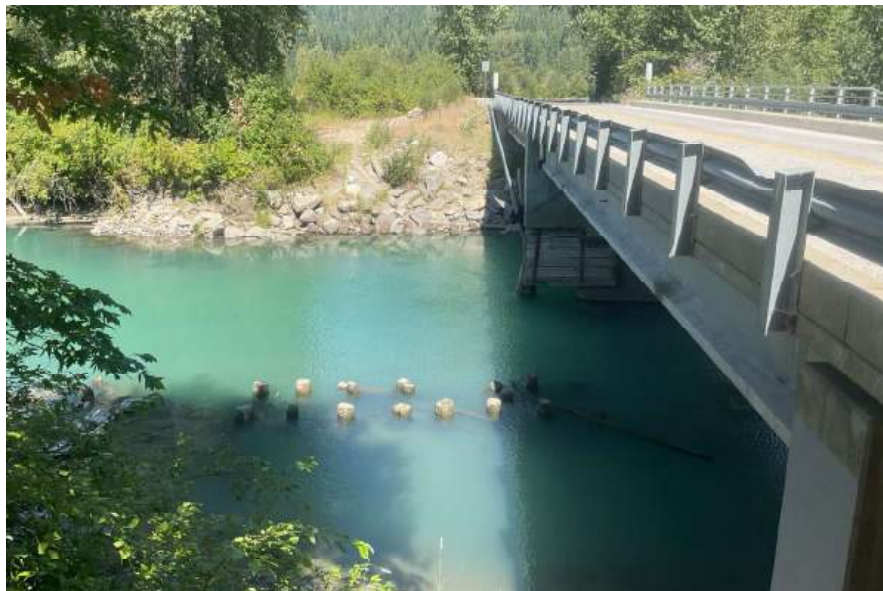
Figure 77. Bridge over White River channel at RM 2, viewed from river right (August 15, 2024).

Human alterations in Reach 2 include impacts to channel and floodplain processes, and past restoration efforts to improve wood retention and function (Figure 76). Little Wenatchee Road perpendicularly dissects the floodplain at the downstream boundary of Reach 2, including a confining bridge crossing and road-protecting riprap (Figure 77). Bank protection related to Little Wenatchee Road and the bridge lock the White River into place in this section, preventing channel migration, limiting surface flow connection across the floodplain between Reach 1 and 2, and exacerbating local incision and floodplain disconnection. Riprap is placed at the base of the bridge at RM 2 as well as on the outside of the meander bend upstream of the bridge at ~RM 2.28 where Little Wenatchee Road passes within 75 feet of the White River channel.

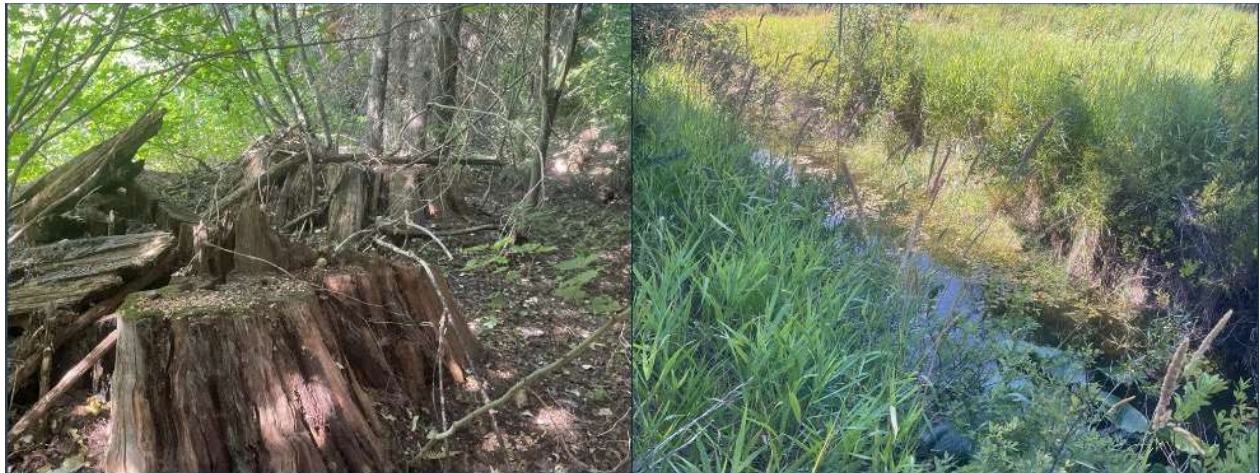
Figure 78. Left: Old-growth western redcedar stumps on the river-right floodplain near RM 3.47. (August 14, 2024) Right: Drainage ditch on river-left floodplain parallel to Little Wenatchee Road at RM 2. (August 15, 2024)

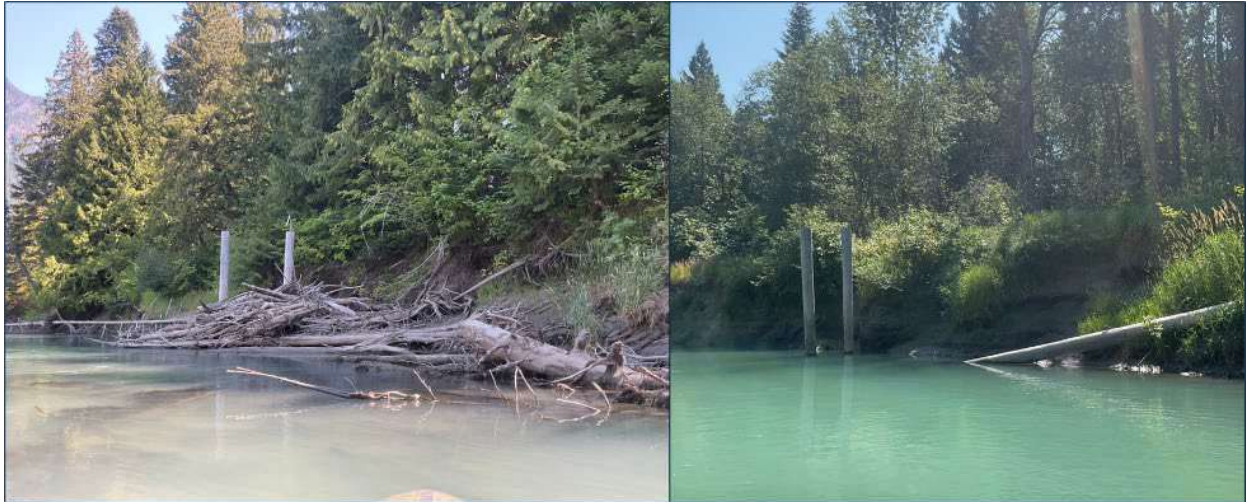
Figure 79. Left: Installed vertical wood pilings with wood accumulation, at RM 3.71 (August 14, 2024). Right: Installed pilings lacking large wood accumulation and retention, at RM 3.92 (August 14, 2024).

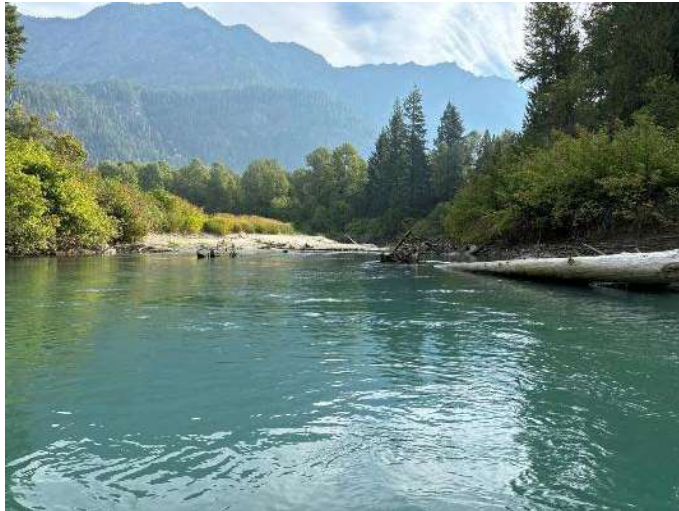
Figure 80. Representative photo of the White River in Reach 3 at RM 4.64, looking upstream (August 9, 2024).

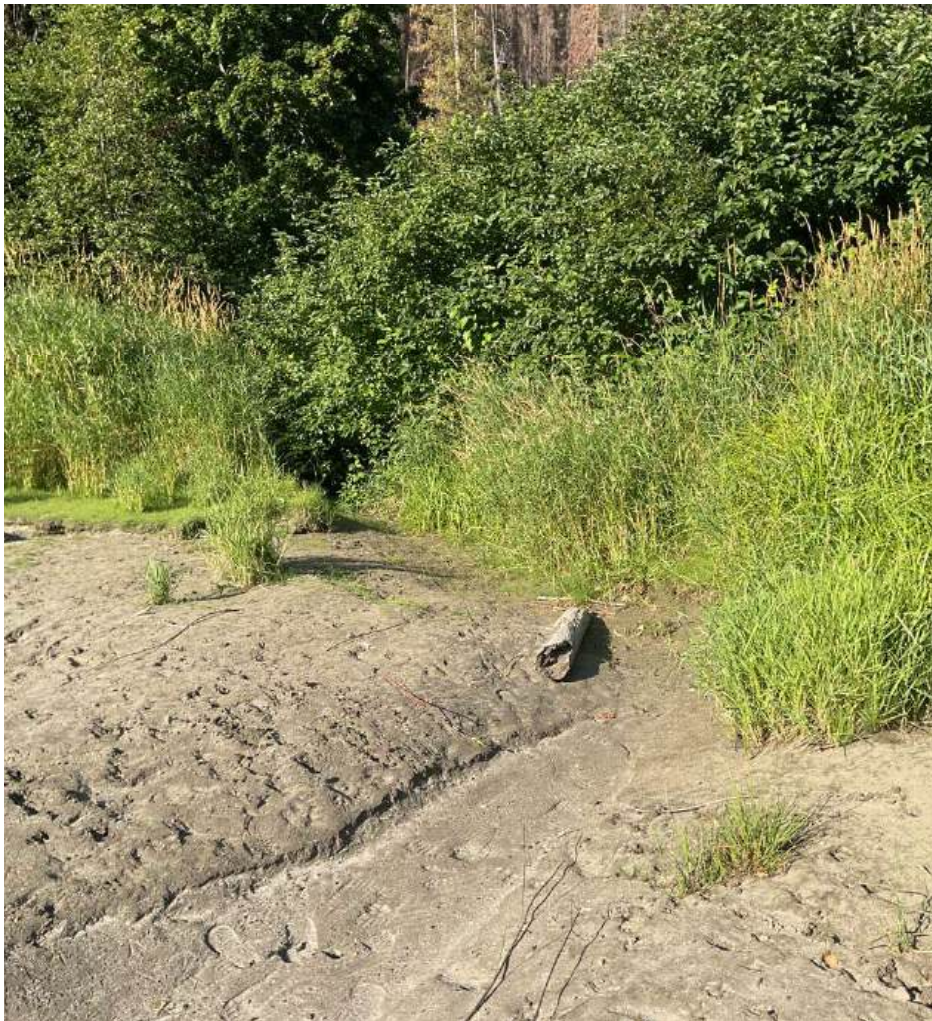
Figure 81. Outlet of dry tributary entering from river right just downstream of RM 4.7 (August 14, 2024).

The White River in Reach 3 is a low gradient meandering channel with relatively high sinuosity. Channel units are mapped as two extended pools with one notable glide and several short riffles (Figure 82). The Habitat Assessment (See Appendix A) recorded 97% of the habitat as pool, and 3% of the habitat as glide. Riffles in Reach 3 are rare, and are shorter than channel width, therefore they were not included in the Habitat Assessment. The White River is unconfined in Reach 3 and meanders diagonally across the valley. However, it contacts the river-right valley wall from ~RM 4.3 – 4.37, and the river-left valley wall from ~RM 5.44 – 5.48 at the upstream boundary. There are no perennial tributaries to the White River in Reach 3, although two ephemeral floodplain tributaries that likely convey wet-season runoff meet the White River on river left at ~RM 4.52 and on river-right at ~RM 4.7 (Figure 80). Neither channel appears to contribute significant flow, coarse sediments, or other materials to the White River on an annual basis.

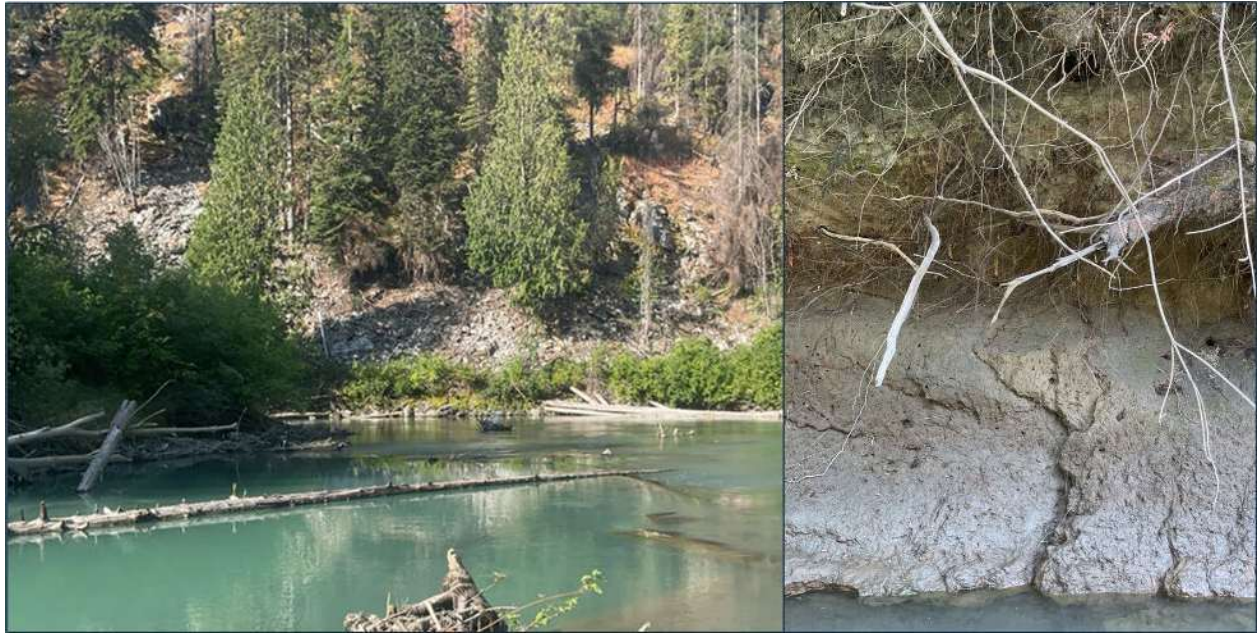
Figure 85. Left: Cobble to boulder sized sediment hillslope source at RM 4.3 (August 14, 2024). Right: Floodplain cut bank at RM 5.25, river left (August 13, 2024).

Local sediment sources to the White River channel in Reach 3 include a hillslope contact from RM 4.3 – 4.37 which contributes angular cobble-to-boulder sized coarse sediments, upstream in-channel contributions, and eroding stream banks throughout the reach (Figure 85). Cobbles and boulders are only locally present in close proximity to the hillslope contact because typical flows in Reach 3 are likely not capable of transporting sediments of this size further downstream. Stream banks in Reach 3 are composed of a clay-dominant layer at the base overlain by coarser silts and sandy-loam, topped with organic soil (Figure 85).

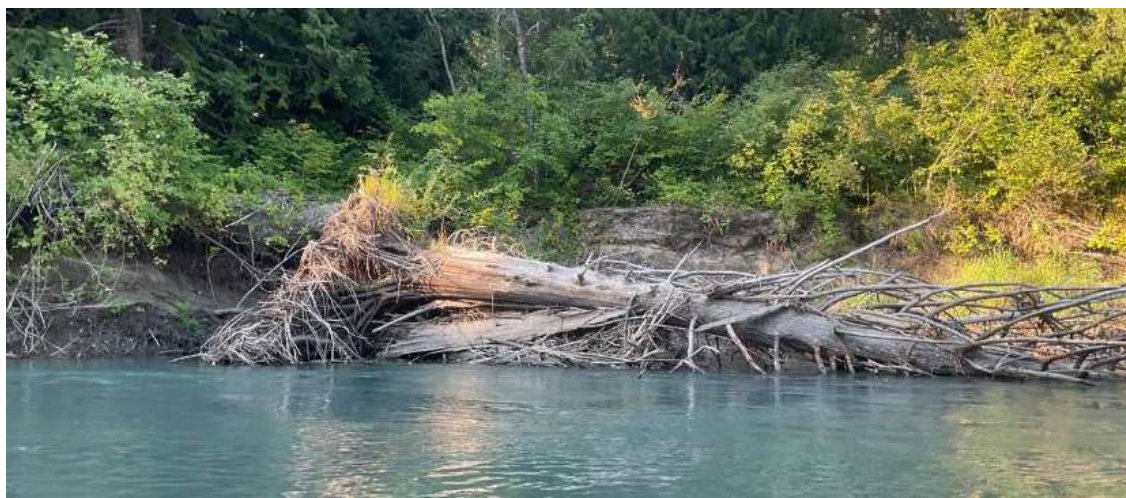
Figure 87. Large wood recently recruited from the adjacent floodplain surface through lateral bank erosion at RM 4.88, river left (August 14, 2024).

pieces and jams in Reach 3 were associated with local bed scour, backwater alcove formation, and deflection of streamflow into eroding banks. Large wood was not observed to be responsible for driving split flow conditions or sorting sediment and several large wood pieces appeared to have been sawed off, likely by boaters to improve navigability of the White River. Key pieces observed during the geomorphic assessment were typically 1.5 - 3 ft in diameter and at least 40 ft long. Large wood in Reach 3 is generally recruited to the channel by bank erosion (Figure 87).

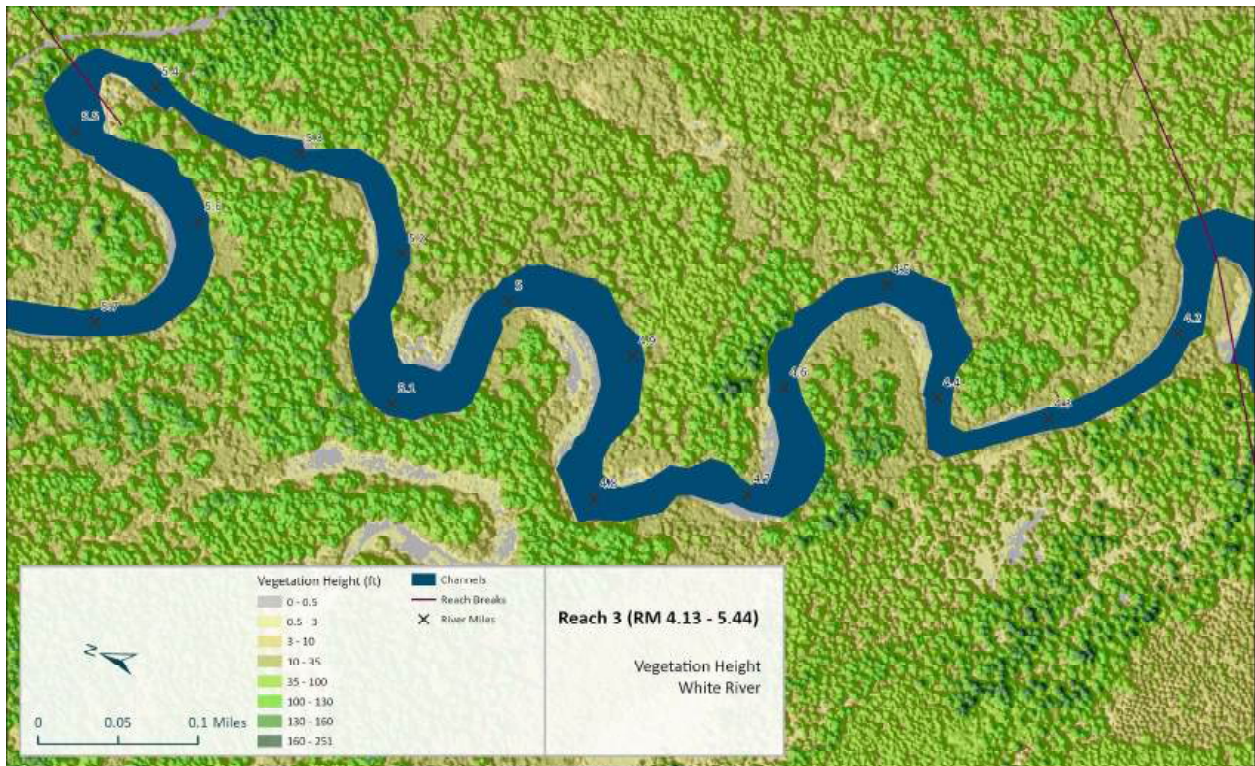
Figure 88. White River, Reach 3: Map of vegetation height classification analysis (LiDAR—based analysis).

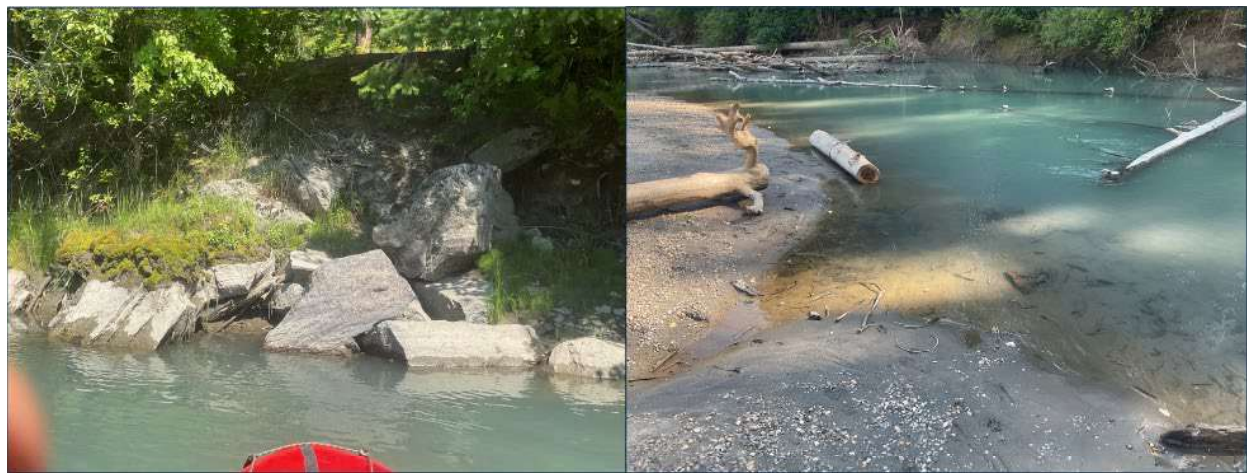
Figure 91. Left: Riprap protecting White River Road on river left at RM 5.43 (August 13, 2024). Right: Sawed off portion of in-stream large wood at RM 5.1 (August 13, 2024).

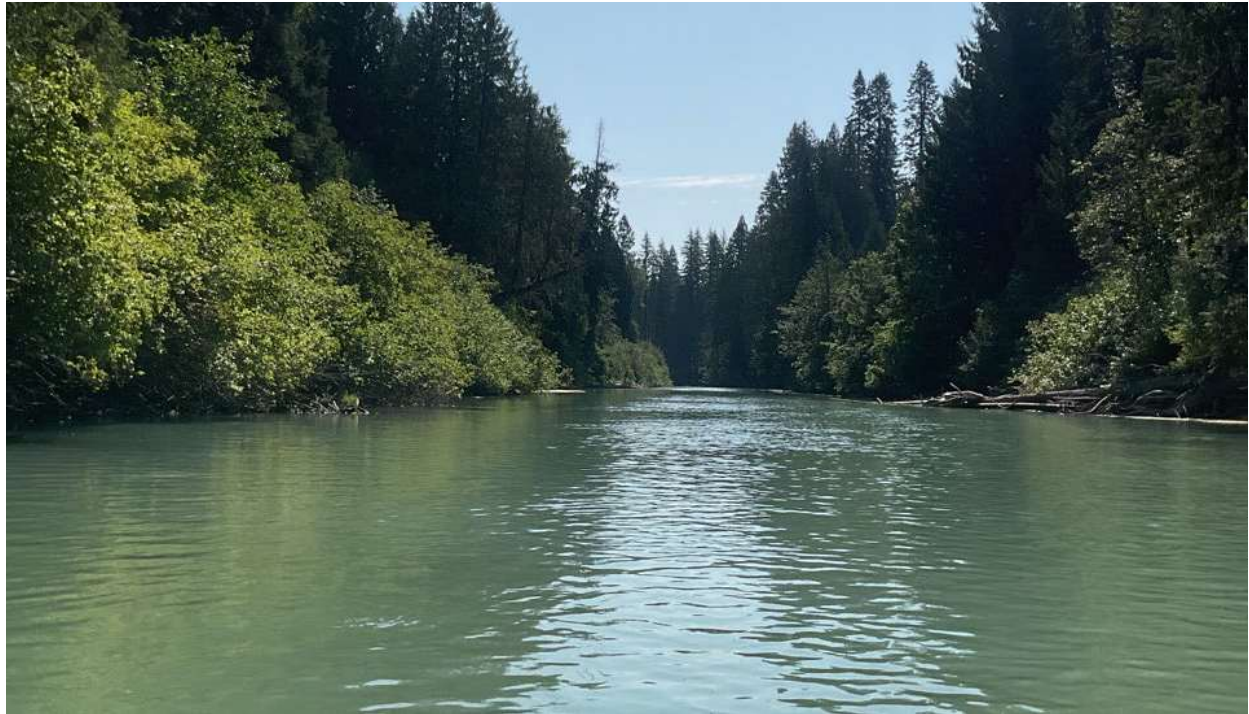
Figure 92. Representative photo of the White River in Reach 4 at RM 6.2, looking downstream (August 13, 2024).

Reach 4 is 1.56 river miles long and extends from RM 5.44 to the Sears Creek Road bridge at RM 7 (Table 12). Although the valley is wide and unconfining, for most of the reach the White River is simplified and straightened along the east side hillslope and White River Road. Despite significant straightening of the channel, Reach 4 is classified as sinuous ($S = 1.55$) due to the meandering section at the downstream end RM 5.44 – 5.9 and another at the upstream end RM 6.45-6.9. The average reach gradient of Reach 4 is 0.09%, which is slightly larger than Reach 3 (0.07%) and slightly smaller than Reach 5 (0.18%). Average bankfull width measured during the Habitat Assessment (Appendix A) is 140 ft, identical to that of Reach 3. Low floodplain surfaces (inundated ~ 1-5 years) are located behind point bars, although these features are limited in Reach 4 due to channel straightening. Medium floodplain surfaces (inundated ~ 5-10 years) comprise the majority of the river right valley bottom, and high floodplain surfaces (inundated ~ 10-100 years) comprise the majority of the river left valley bottom as well as a portion of the river right valley bottom that is influenced by channel incision related to the bridge at RM 7. Vegetation on low floodplain surfaces consists of reed canary grass, willow, and dogwood, whereas vegetation on higher floodplain surfaces consists primarily of dogwood, cottonwood, and cedar. A series of wetland features with standing water exist within historical channel scars (oxbows) on the river-right floodplain. The oxbow wetlands are wetted via groundwater, seasonal hillslope runoff, and high flow surface inundation from the White River. Human impacts in Reach 4 include forced straightening and channel simplification, logging, riprap, and upstream bridge confinement. A representative photo of Reach 4 is provided in Figure 92.

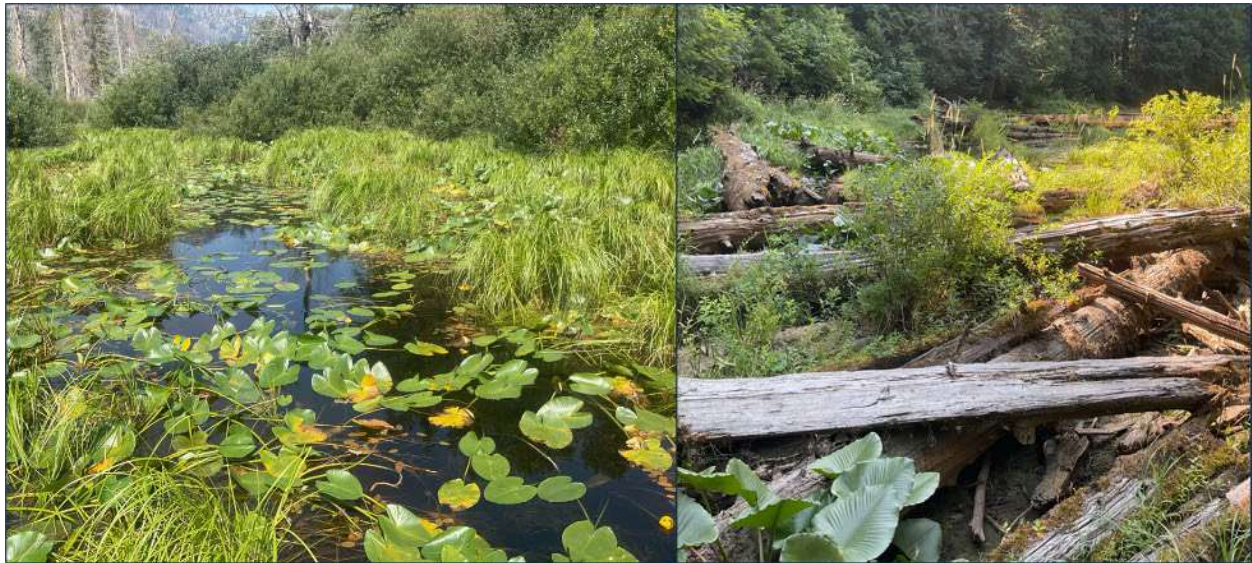
Figure 93. Left: Wetted oxbow in abandoned channel scar, river right at ~ RM 6.3. Right: Large wood accumulations in a seasonally dry oxbow at RM 6.1, river right (August 13, 2024).

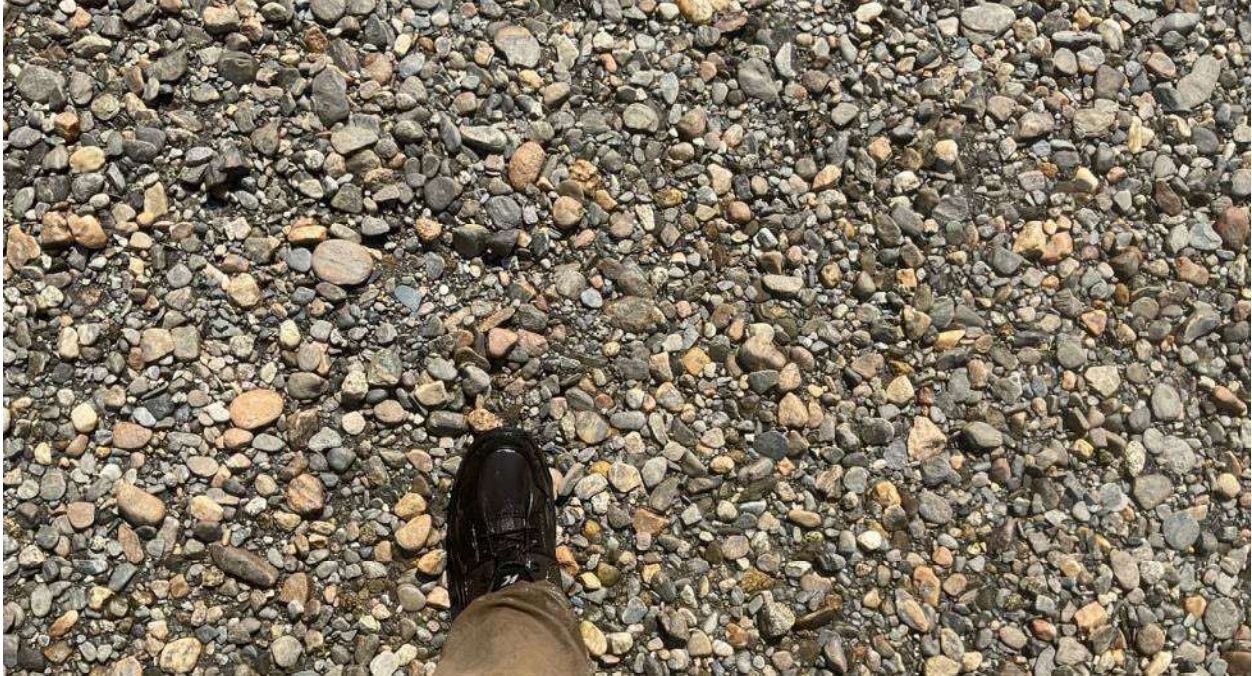
Figure 96. Representative photograph of Reach 4 gravel-sized bar sediments at RM 5.81 (August 13, 2024).

Channel substrate in Reach 4 is primarily gravel alluvium (Figure 96). Cobbles are infrequent, and boulders are absent, except where they have been placed for bank protection. A Wolman Pebble Count (1954) was conducted on riffle crests at RM 5.81 (GC 07) and RM 6.75 (GC 08). The median grain size at GC 07 of $D_{50} = 17.59\text{mm}$ is slightly larger than at the upstream GC 08 median grain size of $D_{50} = 15.52\text{mm}$. Additional ocular observations recorded throughout the reach confirm that bedload and bar sediment composition is relatively the same (gravel) through Reach 4. The data from the two pebble counts are plotted on a map (Figure 97) of the Reach 4 incipient motion analysis results (see Sediment Mobility – Incipient Motion Hydraulic Analysis: Section 2.9.4). The analysis indicates that at the 2-yr modeled discharge, the channel’s shear stress is capable of mobilizing

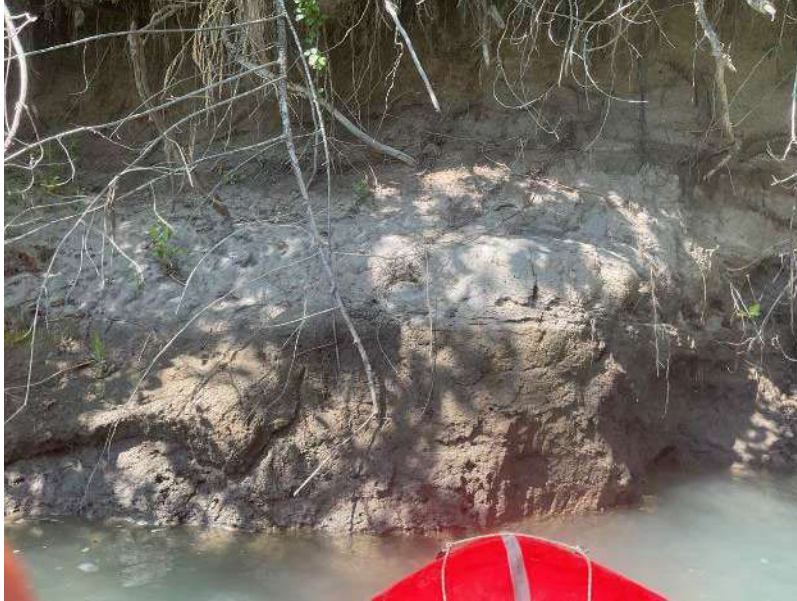
Figure 98. Fine material in exposed stream bank sediments, river left at RM 5.47 (August 13, 2024).

The primary source of bedload material sediment to Reach 4 is delivery from upstream. The observed channel banks are composed of a silty-clay base overlain by sand (Figure 98). Gravels may be present beneath the silty-clay layer in Reach 5 but were either absent in the banks observed during the survey or below the surface of the water in Reach 4.

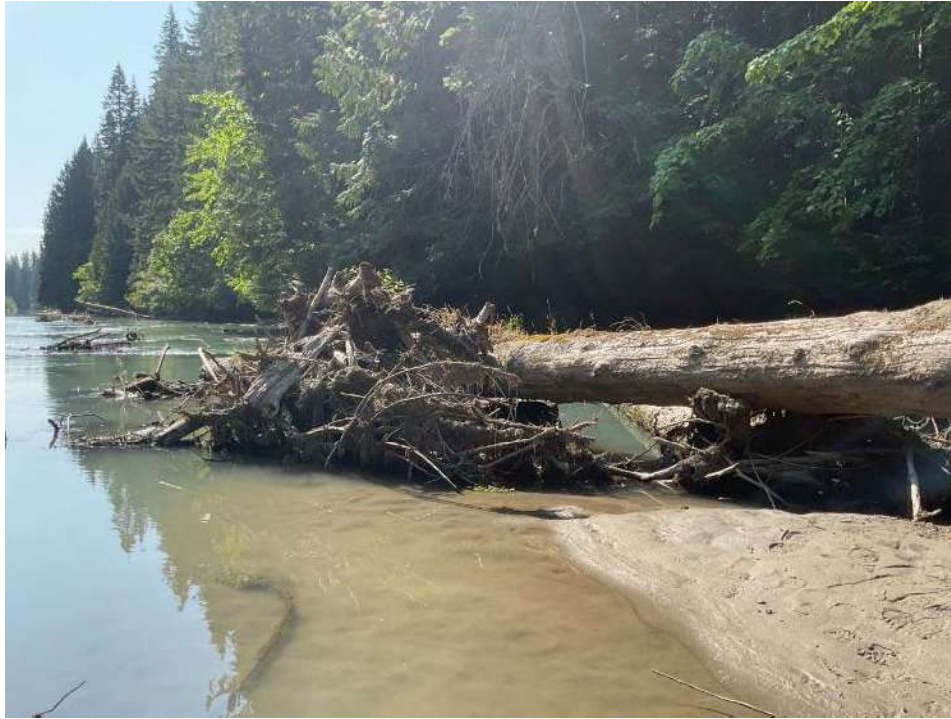
Figure 100. Large wood accumulation with alcove and localized scour at RM 6.35, looking downstream (August 13, 2024).

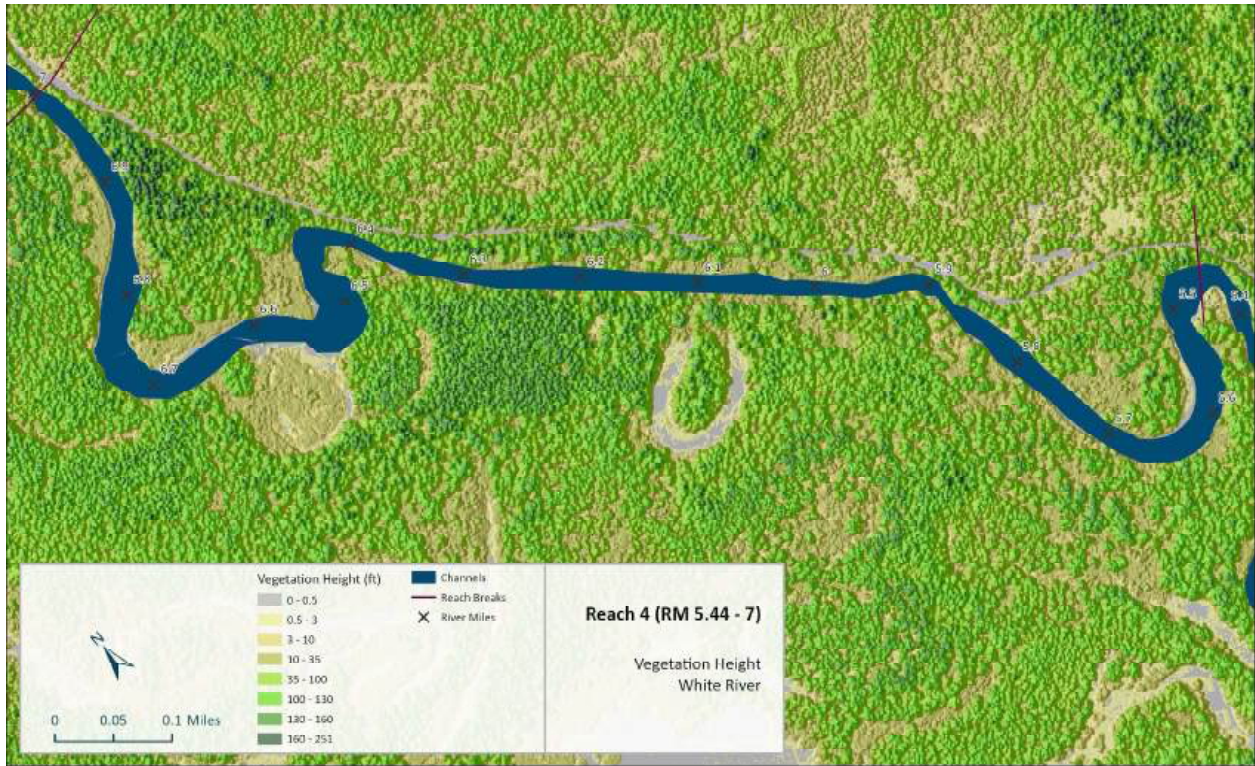
Figure 101. White River, Reach 4: Map of vegetation height classification analysis (LiDAR – based analysis).

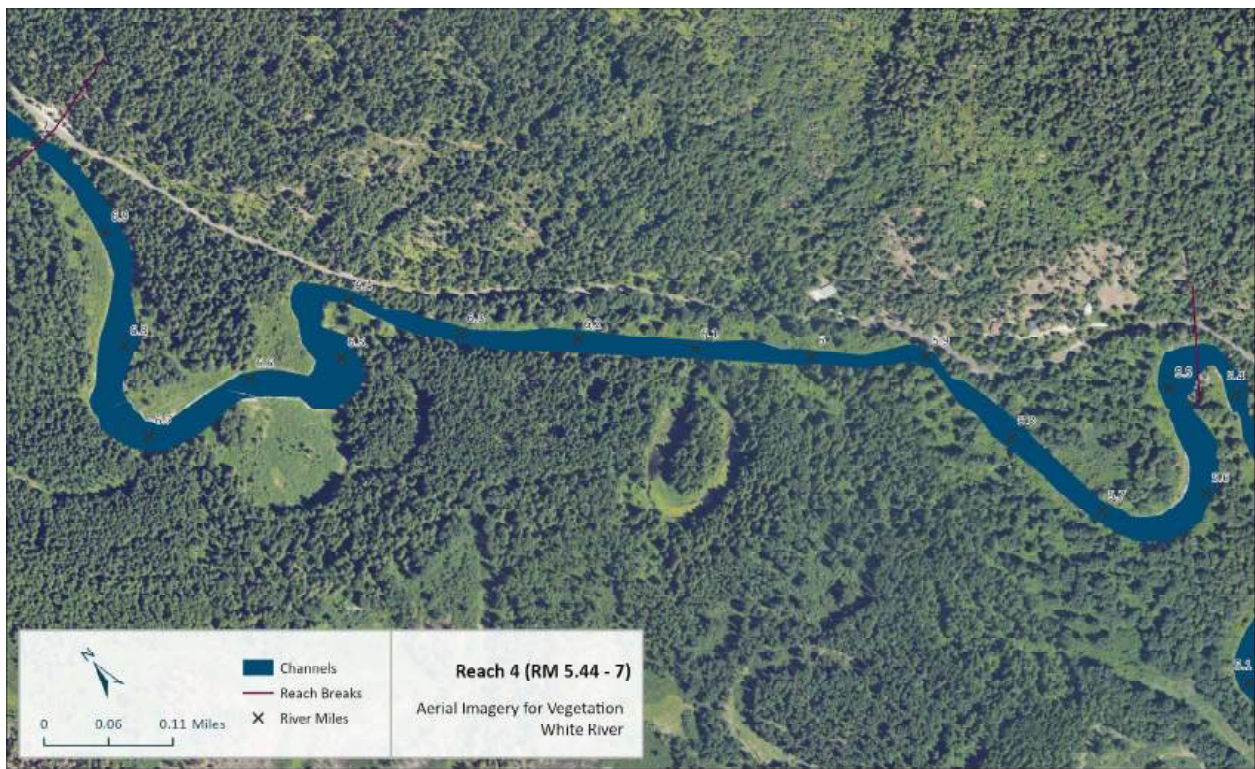
Figure 102. White River, Reach 4: Map of aerial imagery for vegetation identification.
