White River Reach Assessment & Restoration Strategy

Final Report

PREPARED FOR
Yakama Nation Fisheries

PREPARED BY
Inter-Fluve

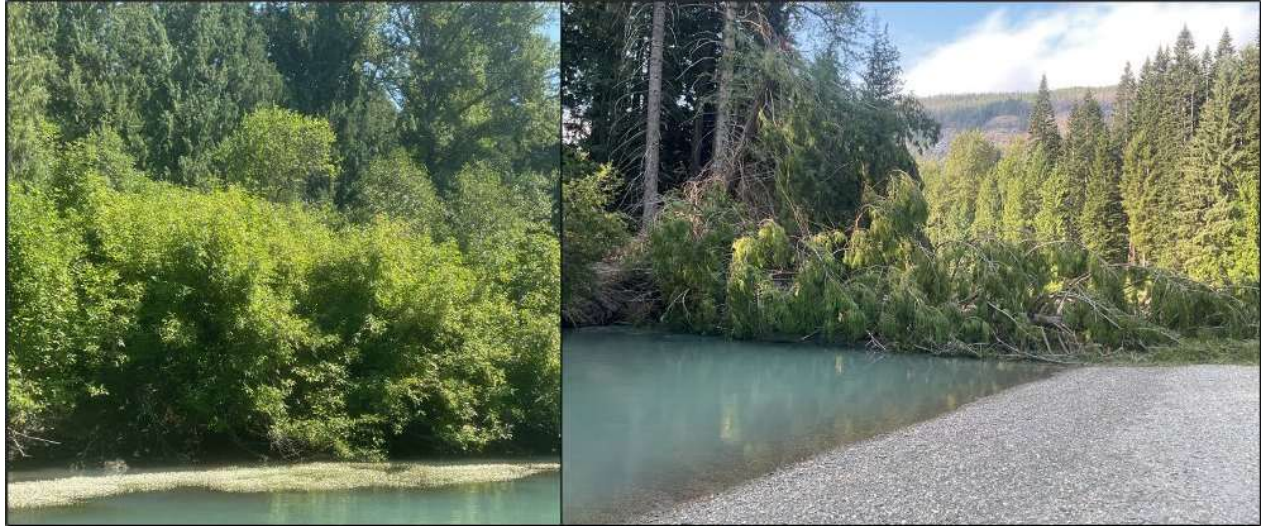
Figure 103. *Left: Riparian vegetation – dense dogwood thicket on low floodplain surface at ~ RM 6.1. Right: recruited western redcedar large wood inputs to the channel near RM 6.78 (August 13, 2024).*

The floodplains in Reach 4 are vegetated primarily with an overstory of western redcedar, fir, and cottonwood and an understory dominated by vine/Douglas maple and dense dogwood thickets (Figure 103). Mature old growth conifers were not observed in Reach 4 during the assessment. Western redcedar stumps were observed at various locations on the river-right floodplain including ~RM 6.31 and RM 6.92, confirming that very large trees were more common across the floodplain and likely contributed to the complexity of the channel historically. Reed canary grass, willow, and dogwood are the dominant species on the low floodplain surfaces. The vegetation height analysis map shows smaller height class vegetation bordering much of the channel and a second-growth forest maturing on much of the valley floor that could be a source of large wood to the channel (Figure 101). However, active lateral migration is not occurring in the straightened section from RM 5.9-6.4, reducing potential recruitment of large wood, which in turn, limits channel complexity. Elsewhere, large wood is recruited where lateral migration is active on the outside of meander bends (Figure 103). Where reed canary grass has colonized riparian areas, other species are generally absent, reducing riparian and forest establishment potential, and limiting sources of food for beaver. The adjacent hillslope vegetation is dominated by conifers. Evidence of a recent wildfire is present on the river right floodplain near RM 6.3, and on river right hillslopes in Reaches 2-5.

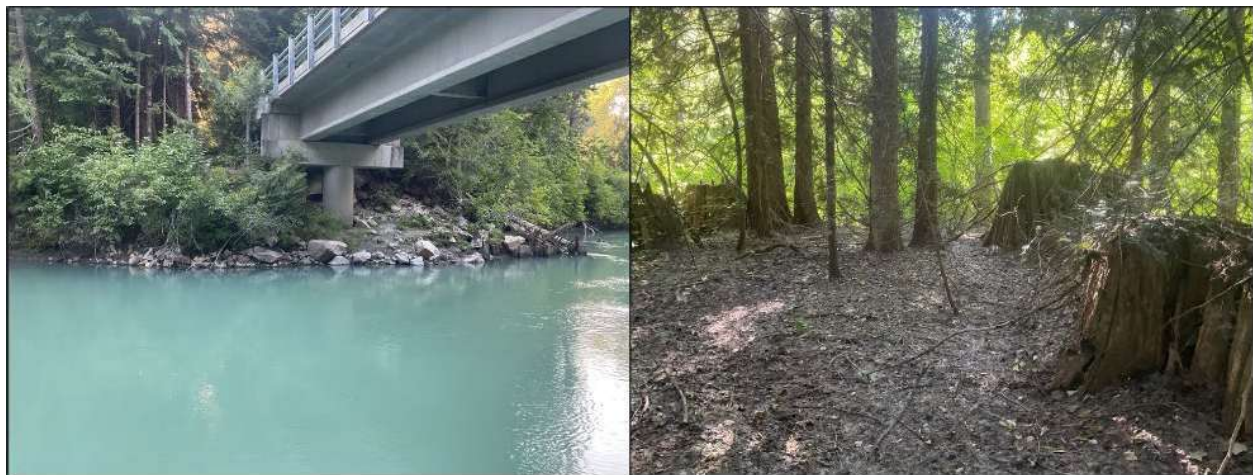
Figure 105. Left: Sears Creek Bridge and associated bank protection at RM 7, upstream Reach 4 boundary (August 6, 2024). Right: Stumps on old growth western redcedar on river-right floodplain at RM 6.92 (August 12, 2024).

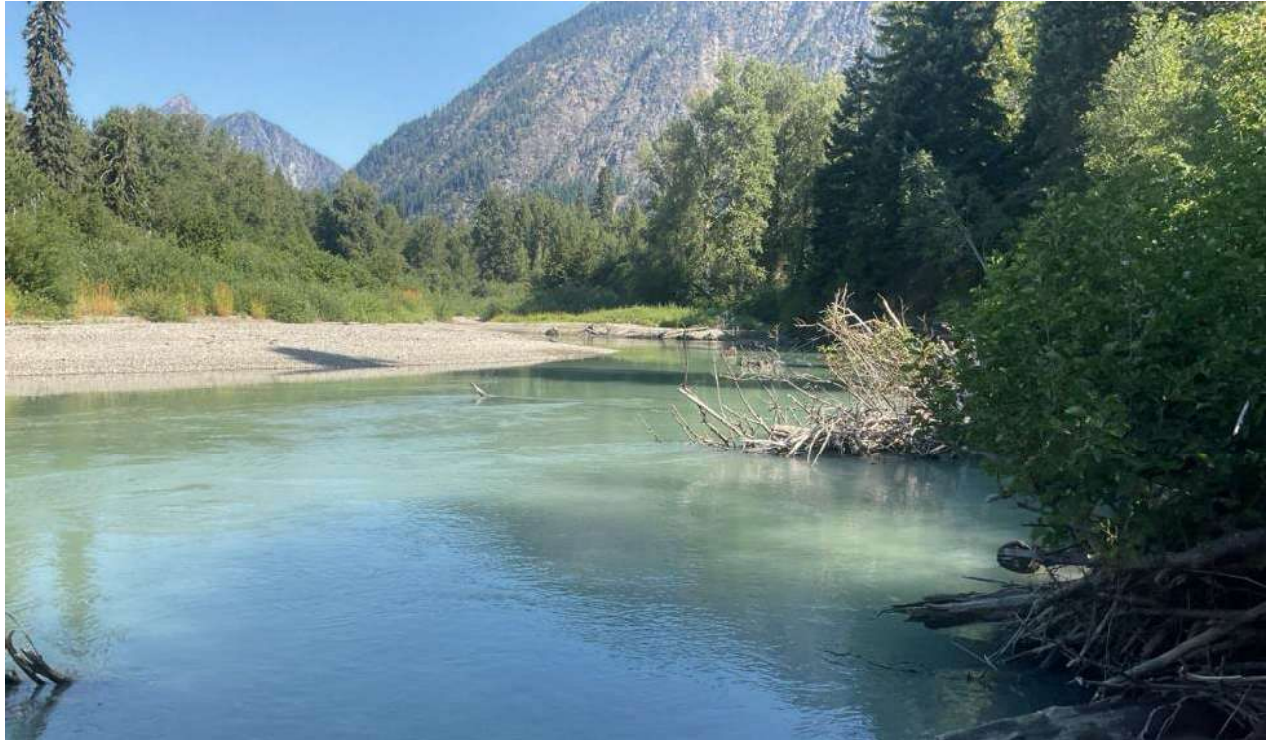
Figure 106. Representative photo of White River channel in Reach 5 at RM 8.76, looking upstream (August 6, 2024).

Anthropogenic straightening of the channel to accommodate the bridge at RM 7 has instigated channel incision and floodplain disconnection. Reach 5 is single thread in planform and the second most sinuous reach ($S = 1.93$) in the assessment area (Figure 106). The forced channel straightening at the downstream end of the reach from RM 6.9 – 7.33 has slightly reduced the natural sinuosity. The reach average gradient (0.18%) is double that of Reach 4 and is similar in gradient to Reach 6. The average bankfull width, recorded during the Habitat Assessment (Appendix A) is approximately 145 feet. Low floodplain surfaces (inundated ~ 1-5 years) generally occur behind point bars on the inside of meander bends. The low floodplain surfaces transition to medium floodplain surfaces (inundated ~ 5-10 years), which are the main geomorphic surface on in the valley through Reach 5. High floodplain surfaces (inundated ~ 10-100 years) exist along RM 6.6 – 7.46 where incision associated with confinement at the bridge crossing is reducing floodplain connectivity. Low floodplain surfaces are vegetated with willow and reed canary grass. Vegetation communities on medium and high floodplain surfaces are mostly reed canary grass, dogwood, cottonwood, and mixed conifers. In addition to the Sears Creek bridge crossing and related riprap, anthropogenic features in Reach 5 also include boulder riprap, unmaintained access roads on both sides of the channel, built structures such as homes, historical logging impacts, ditching and draining of floodplain surfaces, loss of riparian buffer and floodplain vegetation, and culverts that route flow under both White River Road and Sears Creek Road.

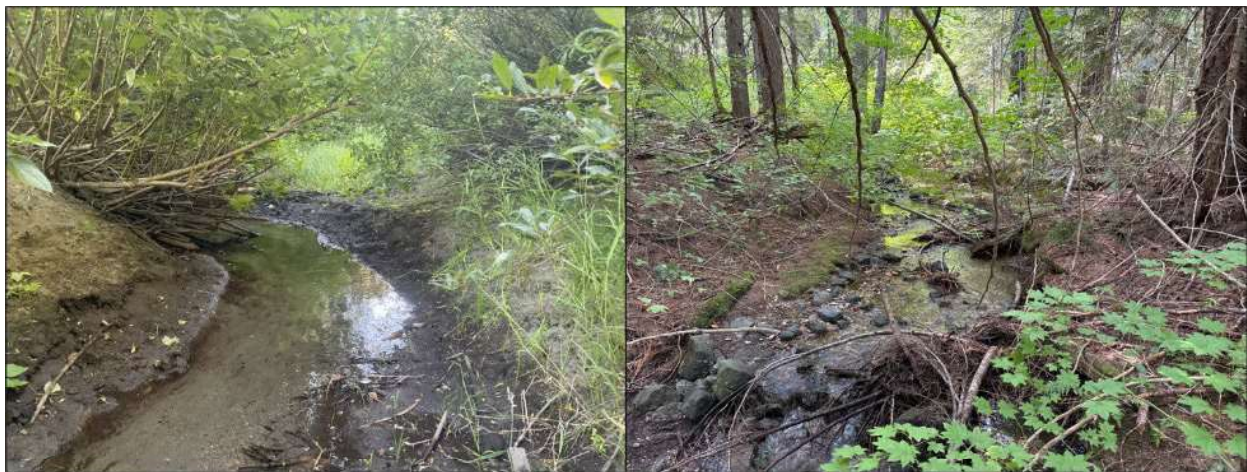
Figure 107. Left: Small floodplain tributary that meets White River on river-left at RM 7.26 (August 6, 2024). Right: Sears Creek flowing across its alluvial fan prior to reaching the valley floor (September 9, 2024).

Tributaries to the White River in Reach 5 include Sears Creek and a minor ditched perennial creek sourced from the river-left floodplain that meets the channel at RM 7.26 (Figure 107). The hydraulic analysis (See Section 2.8) estimates that Sears Creek conveys approximately 6% of the total flow of the White River measured at the outlet into Lake Wenatchee. Sears Creek is perennial where it crossed through a culvert under Sears Creek Road and flows across its historical alluvial fan (Figure 107) into the White River valley. However once on the valley floor, Sears Creek currently occupies a network of ponds maintained by active beaver dams which disperse the Sears Creek flow across the floodplain, resulting in no clearly defined confluence point with the White River. Therefore, in its modern configuration, Sears Creek contributes flow to the White River but it does not regularly contribute bedload sediment or wood. The general source of flow from Sears Creek to the White River is somewhere between RM 8.55 – 8.9 along river-right.

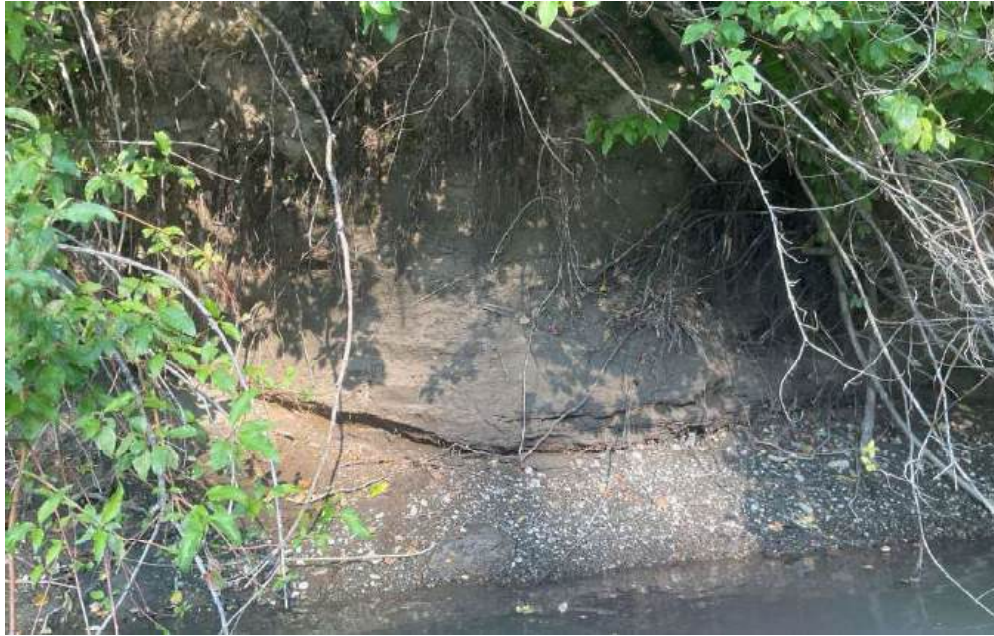
Figure 111. Cut bank exhibiting typical floodplain composition - at RM 7.23, river left (August 6, 2024).

The primary source of gravel bedload material to Reach 5 is a combination of upstream inputs as well as local bank erosion, reactivation of temporarily stored bar material, and hillslope contacts. The hillslope contacts at the upstream and downstream bounds of the reach also provide angular cobble-to-boulder sized material that is likely mobilized very infrequently. Stream banks in Reach 5 are typically composed of gravel mixed with sand or silt at the base (< 2ft), which is often overlain with silty loam or sandy loam. (Figure 111).

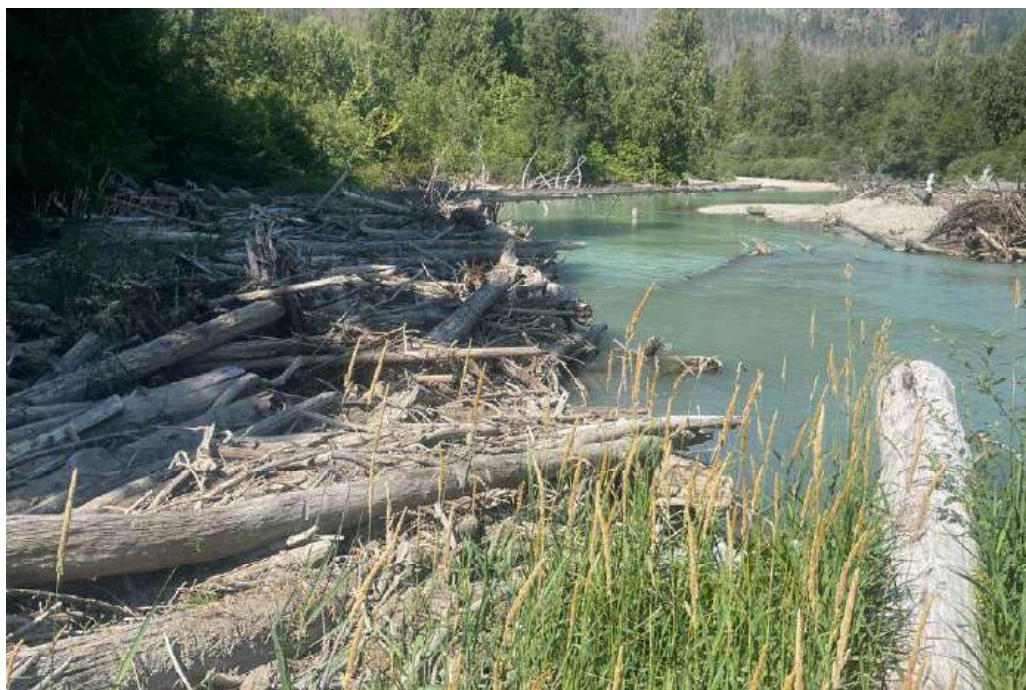
Figure 113. Large wood jam at RM 8.67 with some cut pieces for navigation (August 6, 2024).

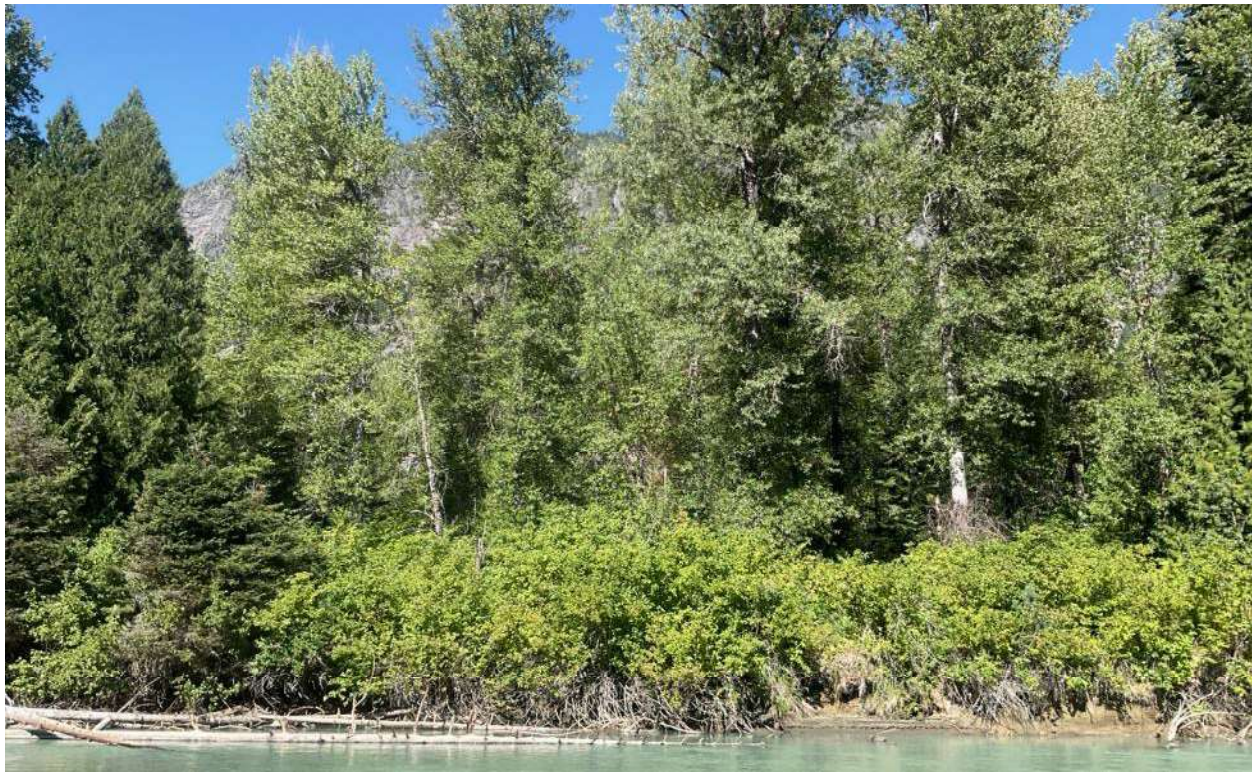
Figure 114. Representative photo of riparian vegetation, including dogwood, cottonwood, and cedar (at RM 9.27) (August 5, 2024).

Floodplain vegetation in Reach 5 has an overstory of mixed-conifer (cedar, Douglas-fir) and cottonwood, and an understory of conifers, dogwood, aspen, vine/Douglas maple, and reed canary grass (Figure 114). Mature old growth conifers are rare in Reach 5, although small pockets of old growth western redcedar exist on river-right medium floodplain surfaces at approximately RM 9, and RM 8.7. These mature trees are located far from the river channel and are unlikely to be recruited to the channel in the absence of significant westward lateral migration. Willow and reed canary grass are the dominant species on low floodplain surfaces. The vegetation height analysis map shows that larger overstory trees grow in small clusters, although there has been significant forest clearing and vegetation removal on the river-left floodplain throughout the reach and adjacent to the channel from RM 7.65 - 8.3 (Figure 115), and shorter trees dominate most of the Reach 5 floodplain. Therefore, large wood recruitment potential is generally limited throughout the reach, which reduces the ability for large wood to drive channel complexity. The adjacent hillslope vegetation is dominated by conifers. Evidence of a recent wildfire is present on river right hillslopes in Reaches 2-5.

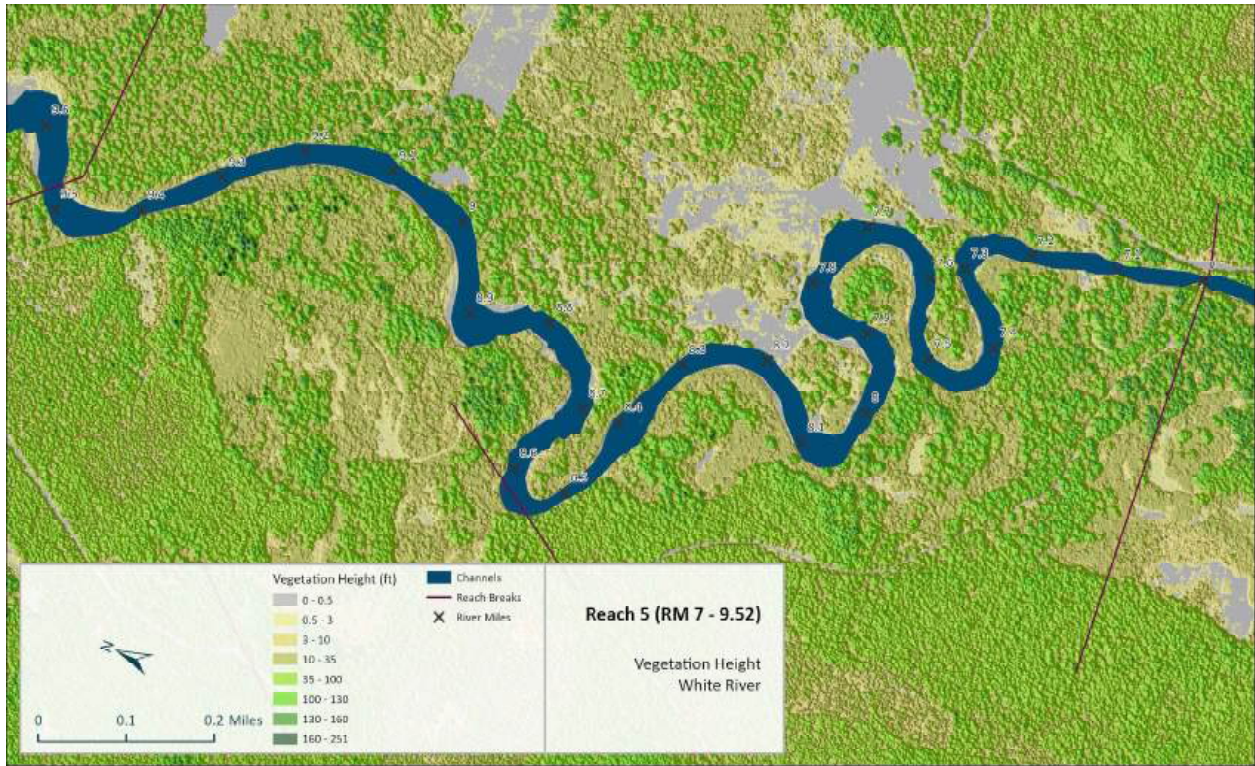
Figure 115. White River, Reach 5: Map of vegetation height classification analysis (LiDAR – based analysis).

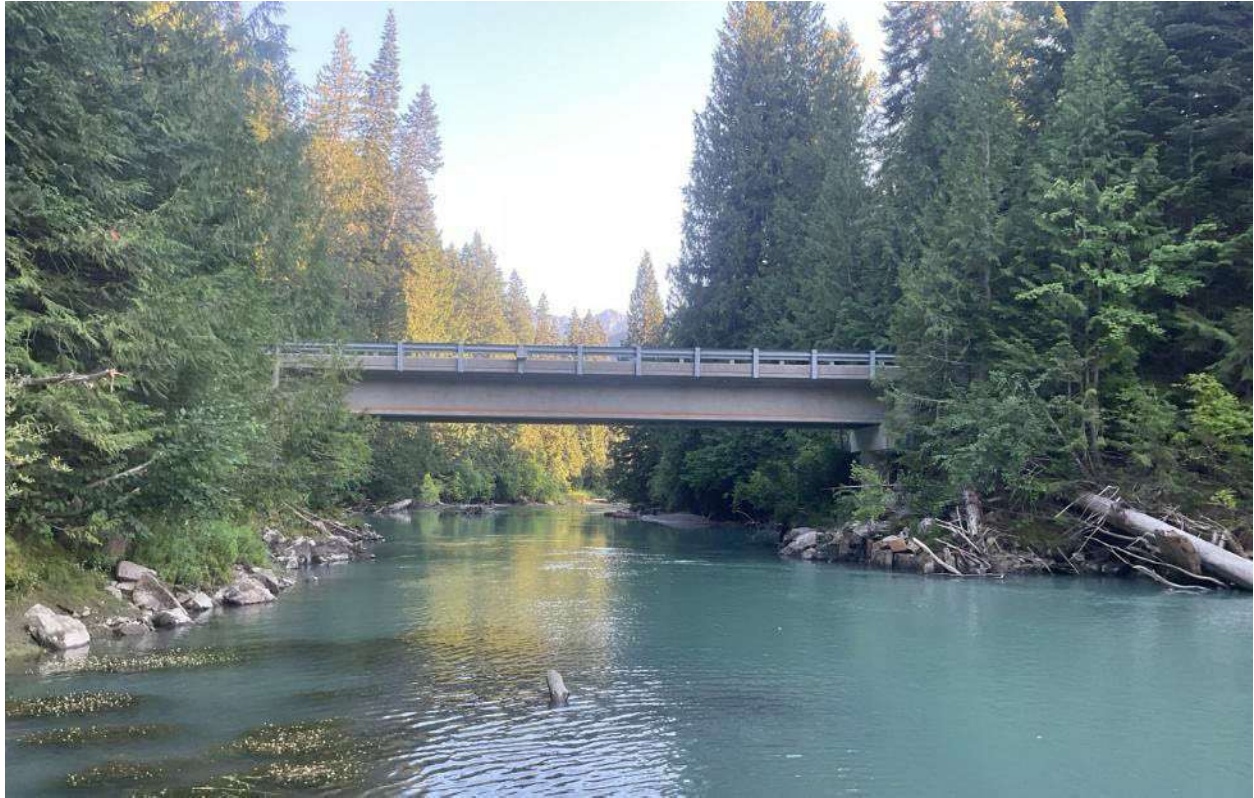
Figure 118. Sears Road bridge and associated bank riprap at RM 7, looking downstream (August 6, 2024).

Anthropogenic features impact channel function and trends in Reach 5. The downstream portion of the reach (RM 6.9 – 7.3) has straightened to accommodate the Sears Creek Road bridge at RM 7 (Figure 117). The bridge confinement has instigated additional local incision that has decreased local floodplain connectivity and is at risk of extending incision and channel simplification upstream. Forests adjacent to the White River channel have been clear from RM 7.74 – 7.95 and RM 8.14 – 8.24, reducing potential large wood recruitment opportunities as well as resulting in reduced shading and nutrient benefits that riparian forests provide. The cleared floodplain surfaces have been ditched and drained. The White River channel is not near the White River Road in Reach 5 except for at the RM 7 bridge, therefore there is minimal riprap associated with road protection. However, there is riprap along the river-right bank from RM 9.41 – 9.44 to limit hillslope erosion near a home and at the bridge crossing at RM 7 (Figure 118). Stumps of old growth western redcedar on the river-right floodplain at RM 7.1, RM 7.6 and 8.74, and abandoned logging access roads on river right at RM 8.9 and river left at RM 9.05 provide evidence of historical timber removal and confirm that historical forest conditions in Reach 5 and the greater White River watershed area have been significantly altered by the logging history of the region (Figure 119).

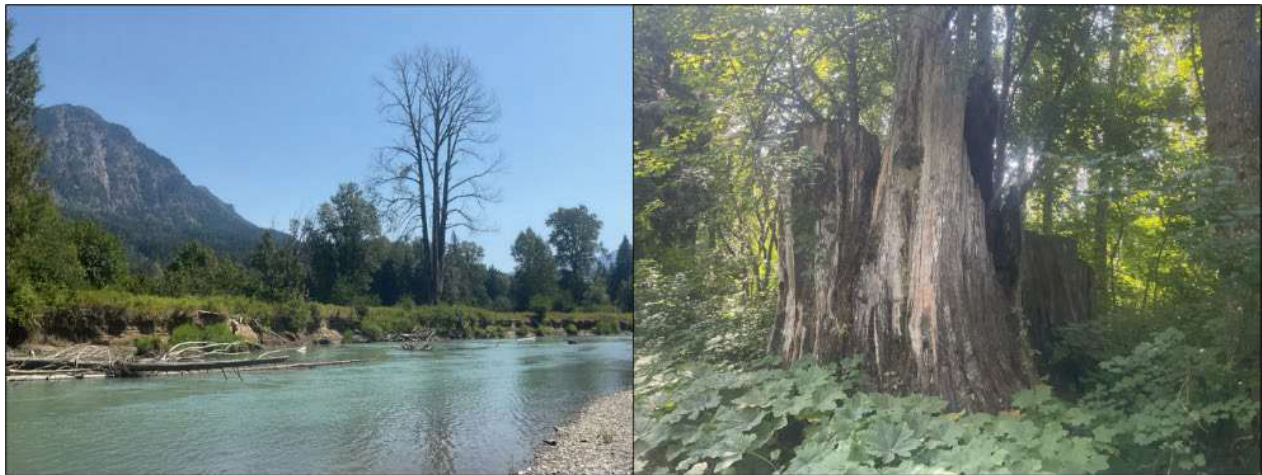
Figure 119. Left: Representation of cleared riparian and floodplain forest, at RM 8.24 (August 6, 2024). Right: Stump of old growth western redcedar on floodplain at RM 7.1 (August 17, 2024).

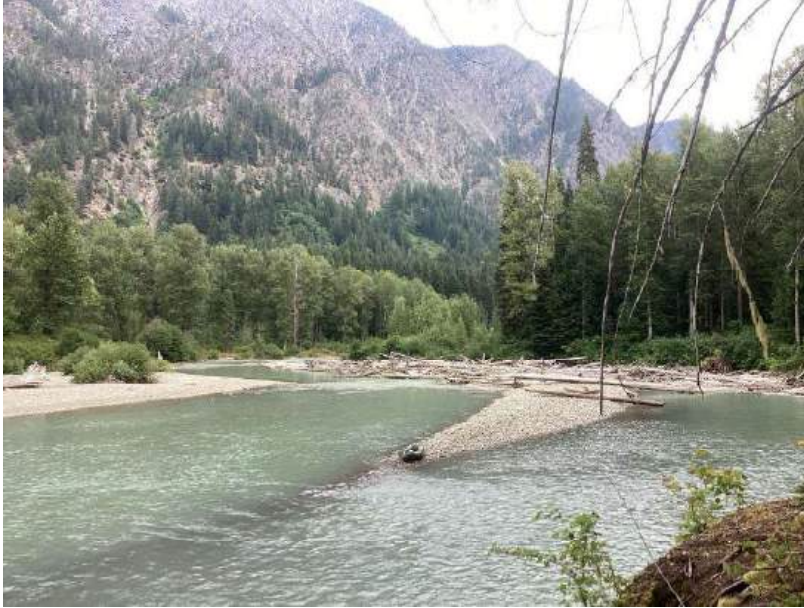
Figure 120. Representative photo of White River in Reach 6, looking downstream from RM 11.24 (August 3, 2024).

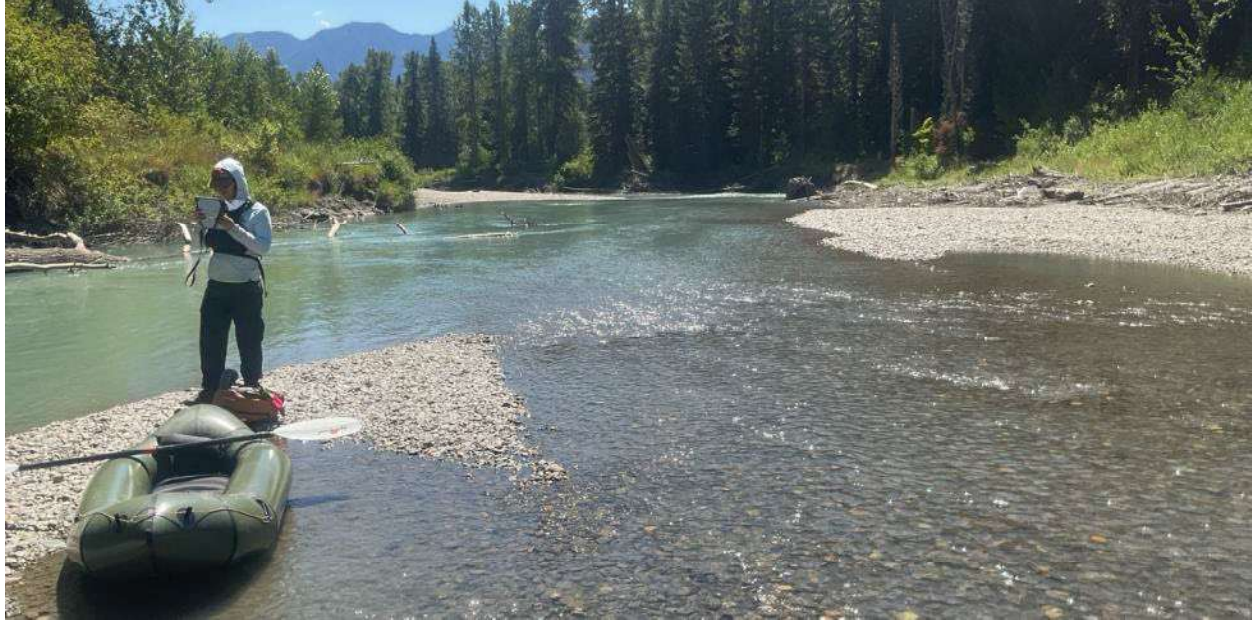
Figure 122. Representative photo of split flow braiding with extended pools, glides, and short riffles – at RM 9.77 (August 5, 2024).

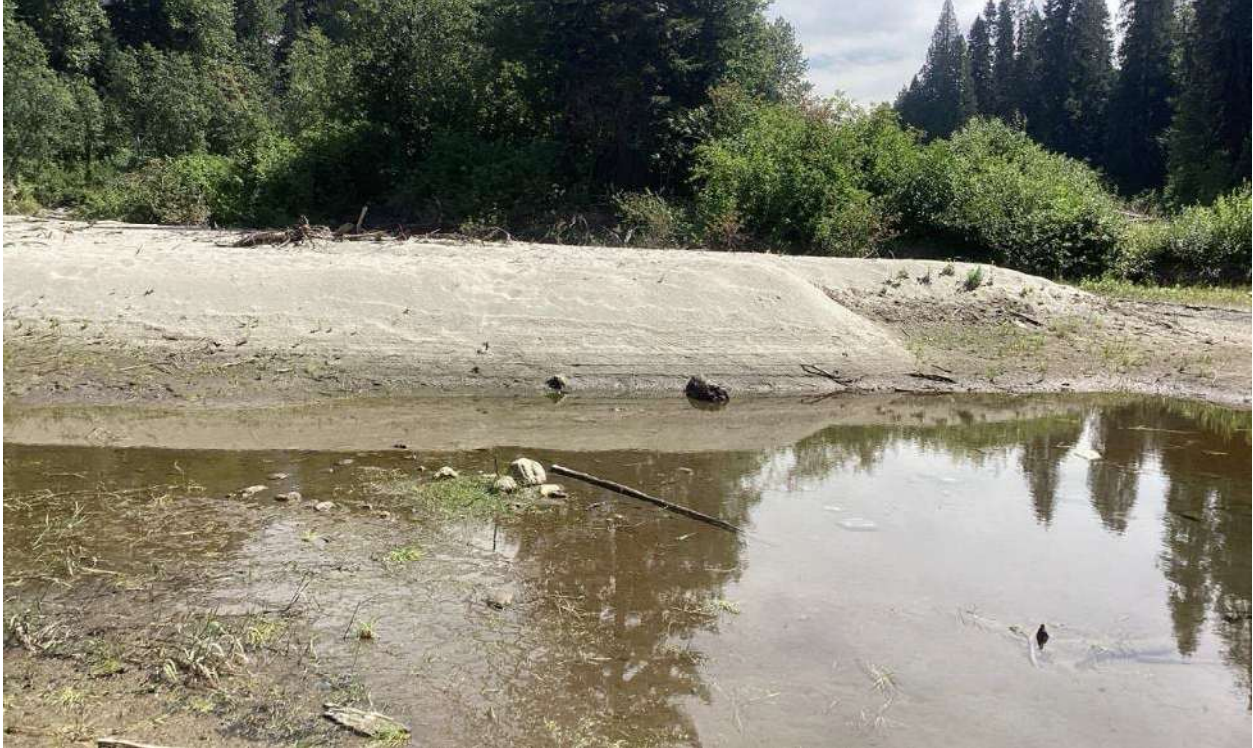
Figure 124. Wetted oxbow at RM 11.6 – formed at meander neck cutoff between 1985 and 2023 (August 3, 2024).

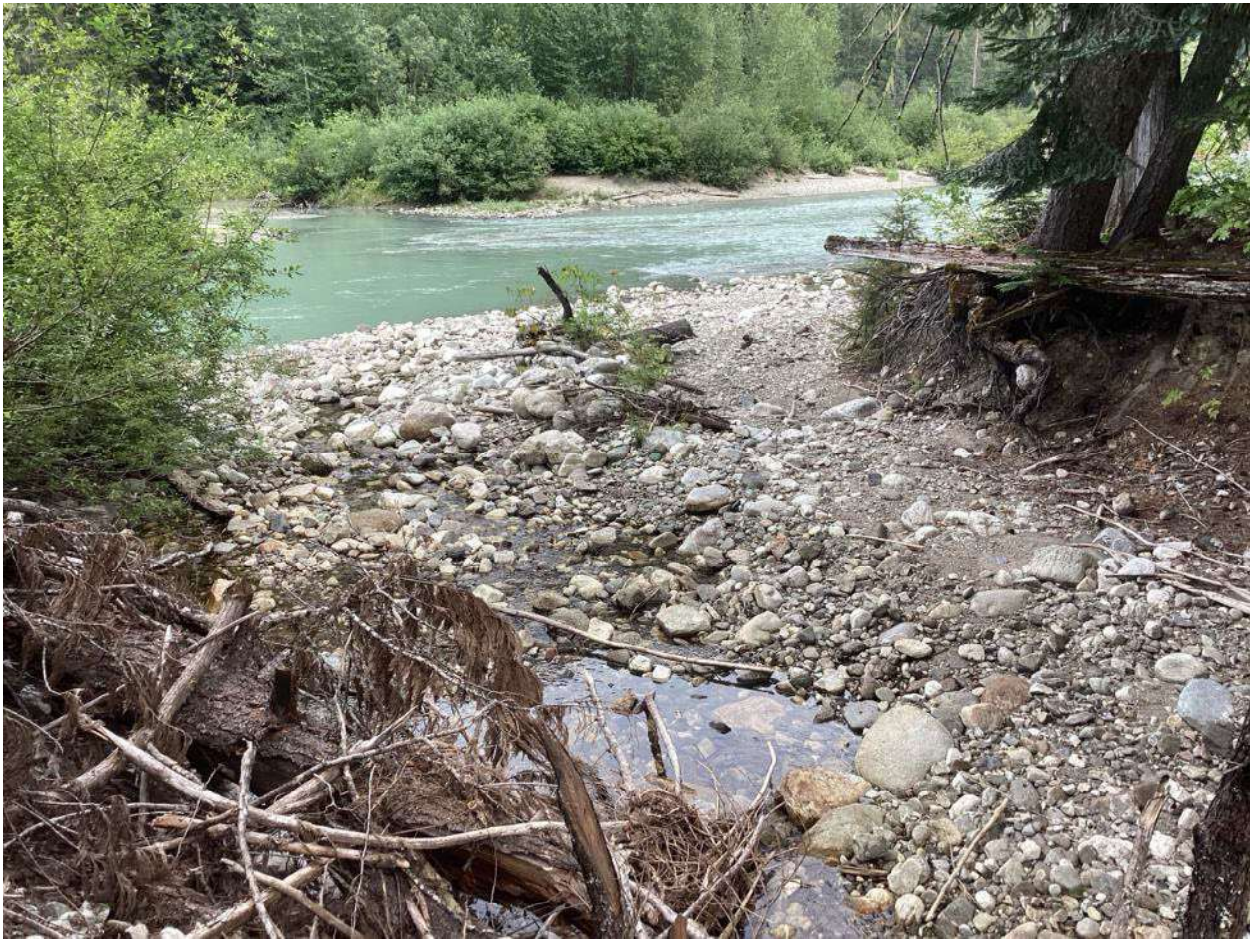
Figure 126. Confluence of Canyon Creek with the White River at RM 11.26 (August 3, 2024).

Tributaries to the White River in Reach 6 include perennial Canyon Creek (RM 11.26 on river right), and a minor ephemeral tributary entering the channel from the river-left hillslopes at RM 11.03. Canyon Creek contributes approximately 6% of the White River's 2-year discharge according to hydraulic models developed for this assessment (See Section 2.8) and is a source of gravel-cobble alluvium to the White River channel.

Sediment is primarily sourced from active bank erosion, stored bedload in bars, and inputs transported into the reach from upstream and Canyon Creek. Exposed floodplain banks reveal a general floodplain composition characterized by a fining upward sequence of cobbles and gravels at the base overlain by sand and loam topped with a developing organic soil horizon. Canyon Creek and its alluvial fan at the downstream portion of the reach provide a source of large cobbles that are generally coarser than other sediments contributed to the White River in Reach 6 (Figure 126).

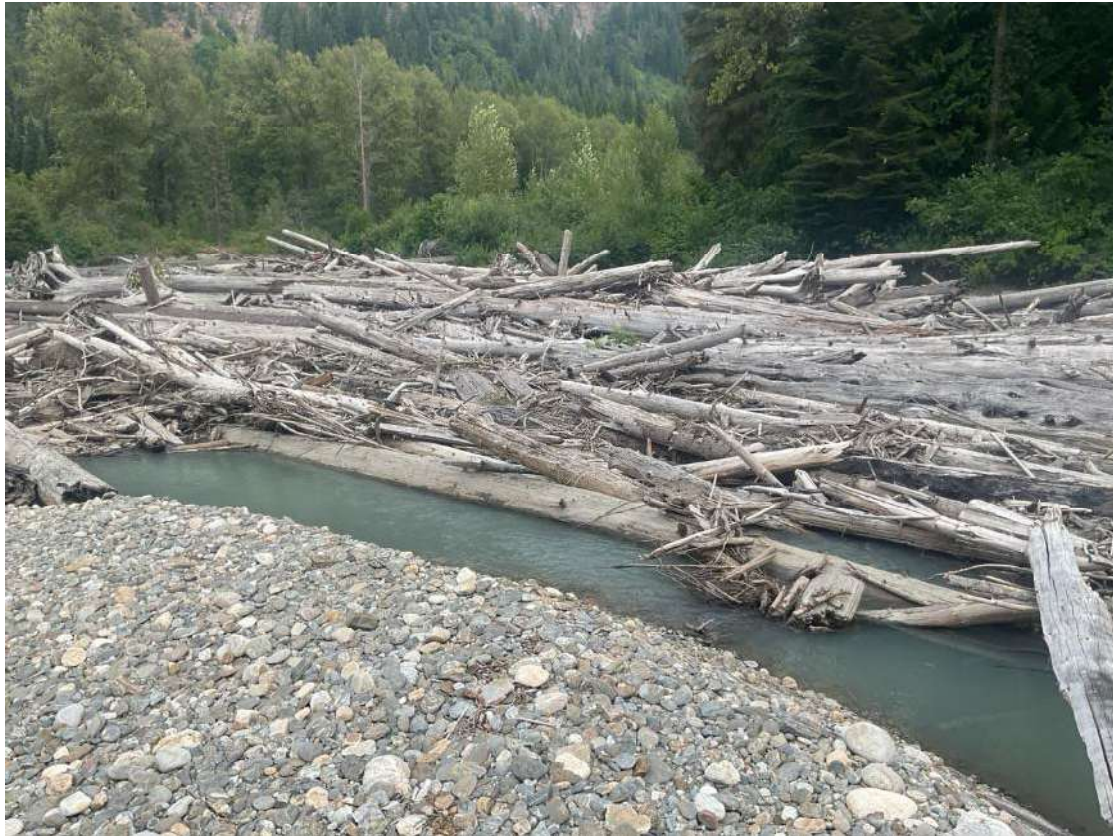
Figure 128. Large wood jam at RM 11.16 (August 3, 2024).

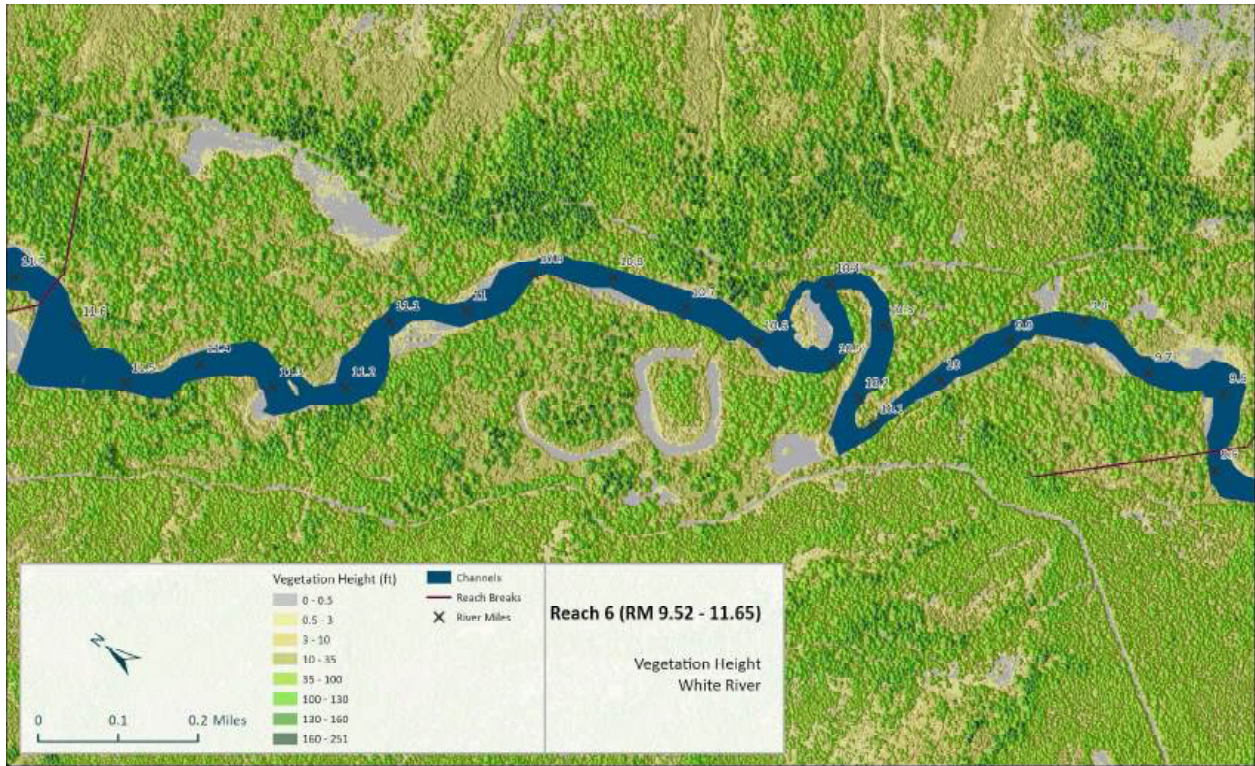
Figure 129. White River, Reach 6: Map of vegetation height classification analysis (LiDAR – based analysis).

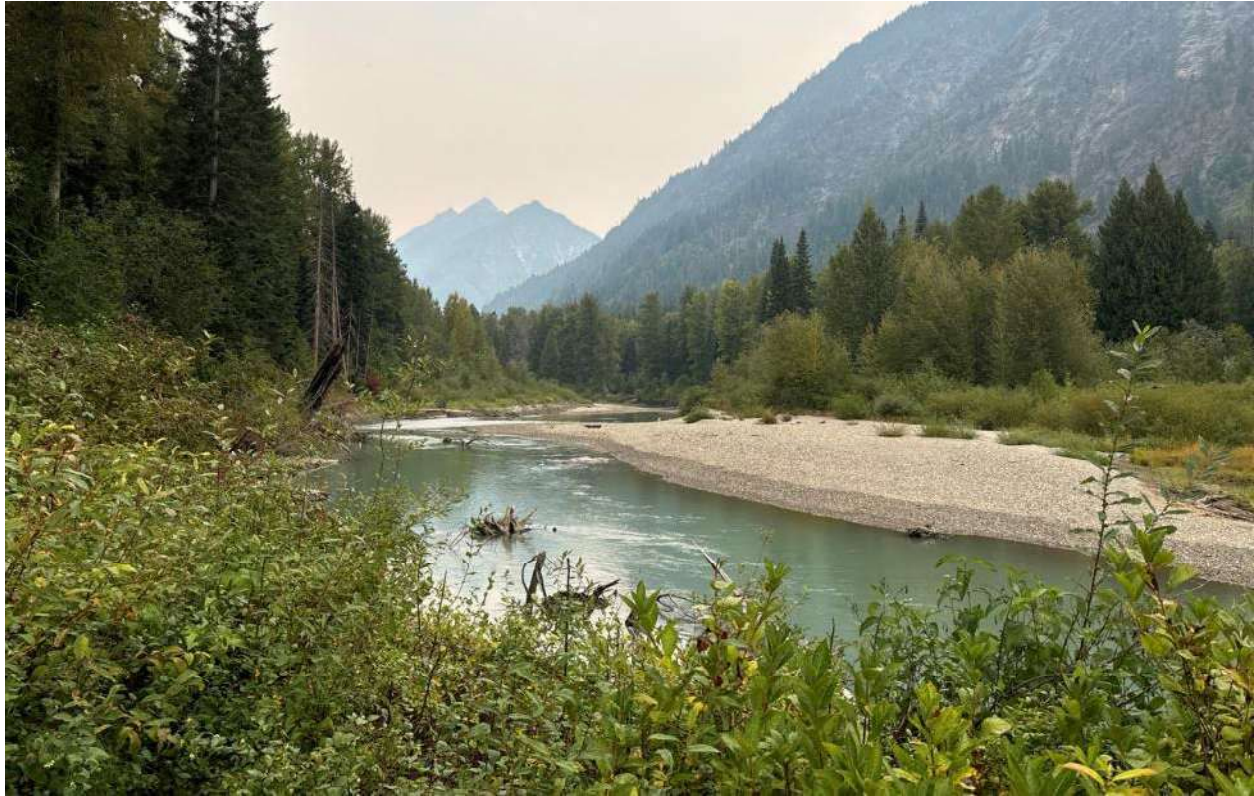
Figure 131. Representative photograph of Reach 6 riparian and forest vegetation distribution (RM 9.63 looking upstream) (September 8, 2024).

Floodplain vegetation in Reach 6 is a mix of conifer and/or cottonwood overstory with a relatively sparse understory of dense dogwood thickets and willow. Conifer species present along the channel are dominated by cedar, Douglas-fir, grand fir, and ponderosa pine. At present, overstory trees are generally second growth forests. The vegetation height analysis map shows that mature or old-growth trees are currently uncommon (Figure 129), although historically, they would likely have been widespread across the valley floor. The large second-growth overstory trees adjacent to the river in areas of active lateral migration provide a source for large wood recruitment into the channel. Large overstory trees are generally lacking from floodplain surfaces adjacent to the channel where recent neck cutoffs created new floodplain surfaces at RM 10.66, 11.3, and 11.65, but are well distributed elsewhere in Reach 6. Willow is the dominant species on low floodplain surfaces. Willow was observed to be a source of food and habitat-building material for beaver in the reach, evidenced by abundant beaver chew. Dense dogwood thickets are present on medium floodplain surfaces that had been previously cleared of larger vegetation. The adjoining hillslope vegetation is dominated by sparse small to large conifers (Figure 131).

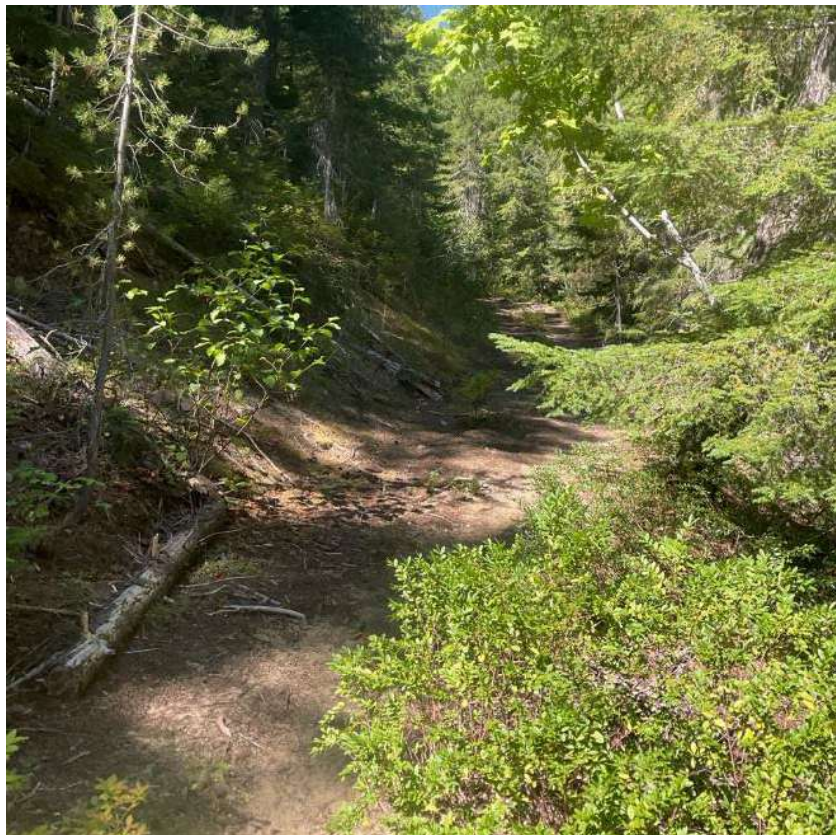
Figure 133. Unmaintained road extending from Sears Creek Road on river right, near RM 10.05 (August 5, 2024).

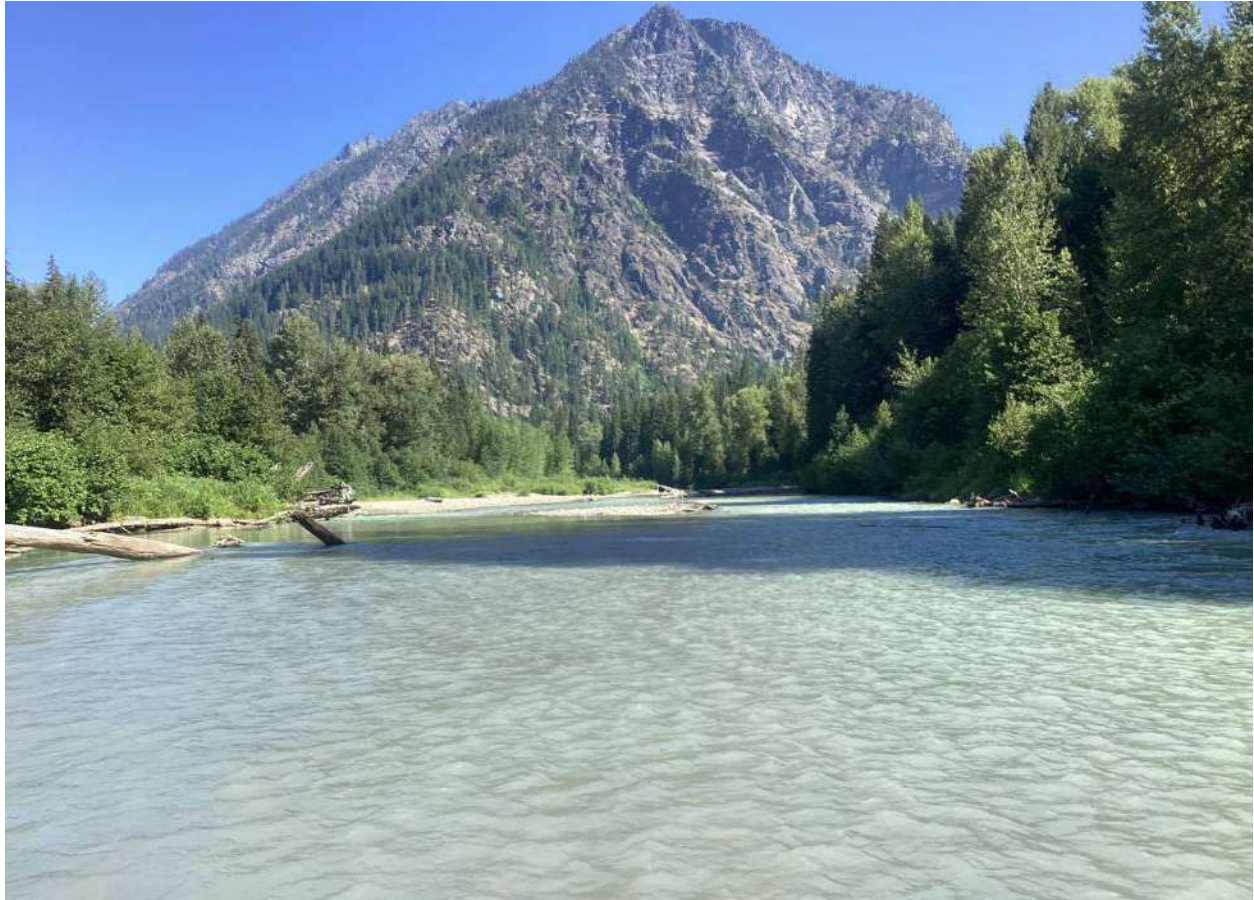
Figure 134. Representative photo of White River channel in Reach 7 - at RM 12.06, looking upstream (August 3, 2024).

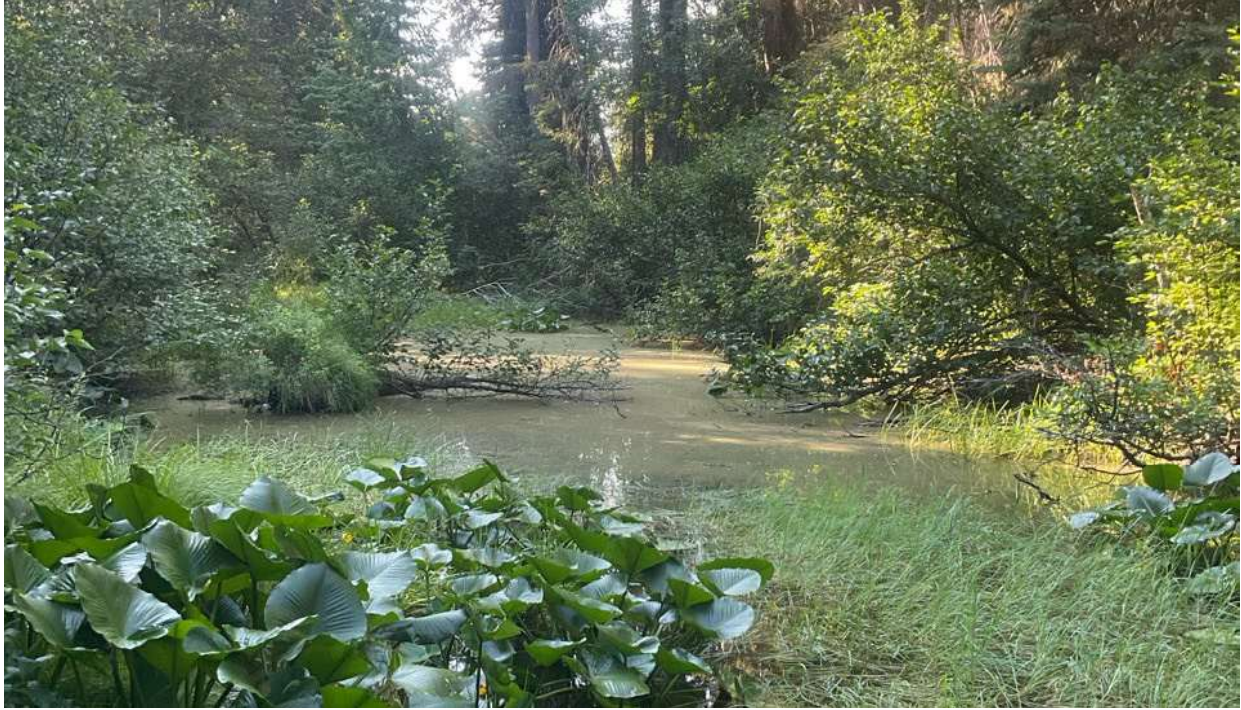
Figure 137. Disconnected but groundwater wetted oxbow on river-right floodplain near RM 12.2-12.3 (August 3, 2024).

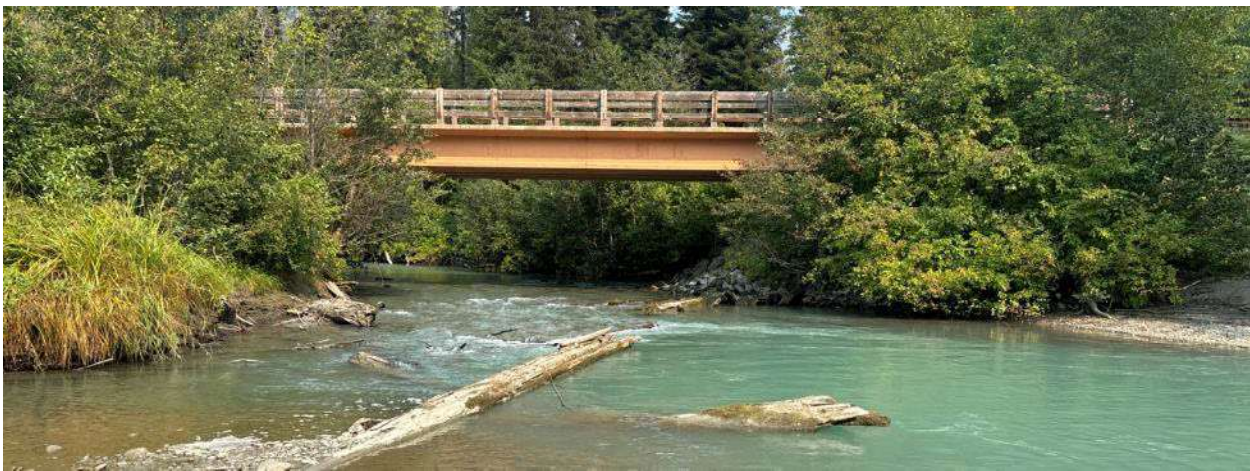
Figure 138. Bridge over the mouth of the Napeequa River at its confluence with the White River at RM 12.43, at upstream boundary of Reach 7 (September 7, 2024).

The Napeequa River (Figure 138) is a major tributary to the White River and its confluence is located at the upstream boundary of Reach 7 (See Section 2.8) In addition to contributing 23% of the White River’s discharge into Wenatchee Lake, the Napeequa River also contributes fine-to-cobble sized sediment and woody material. A minor unnamed tributary enters the White River from the river-left floodplain at RM 11.88. This small tributary is likely fed seasonally by hillslope runoff and subsurface groundwater inputs. The unnamed tributary does not currently contribute significant flow, sediment, or other material.

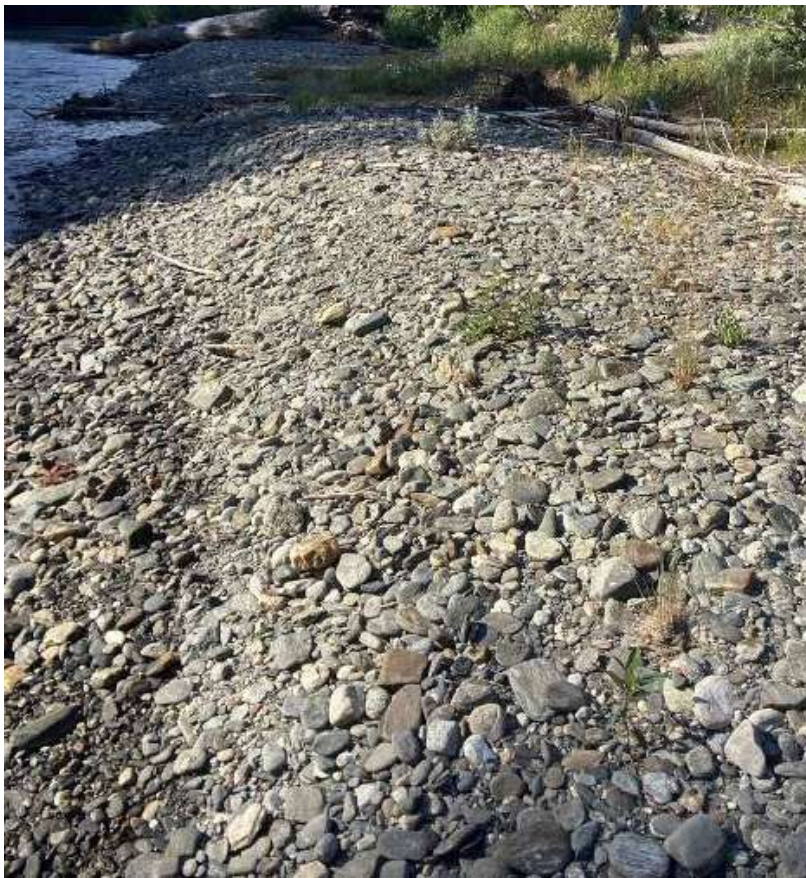
Figure 139. Gravel-cobble lateral bar at RM 12.26, looking downstream (August 3, 2024).

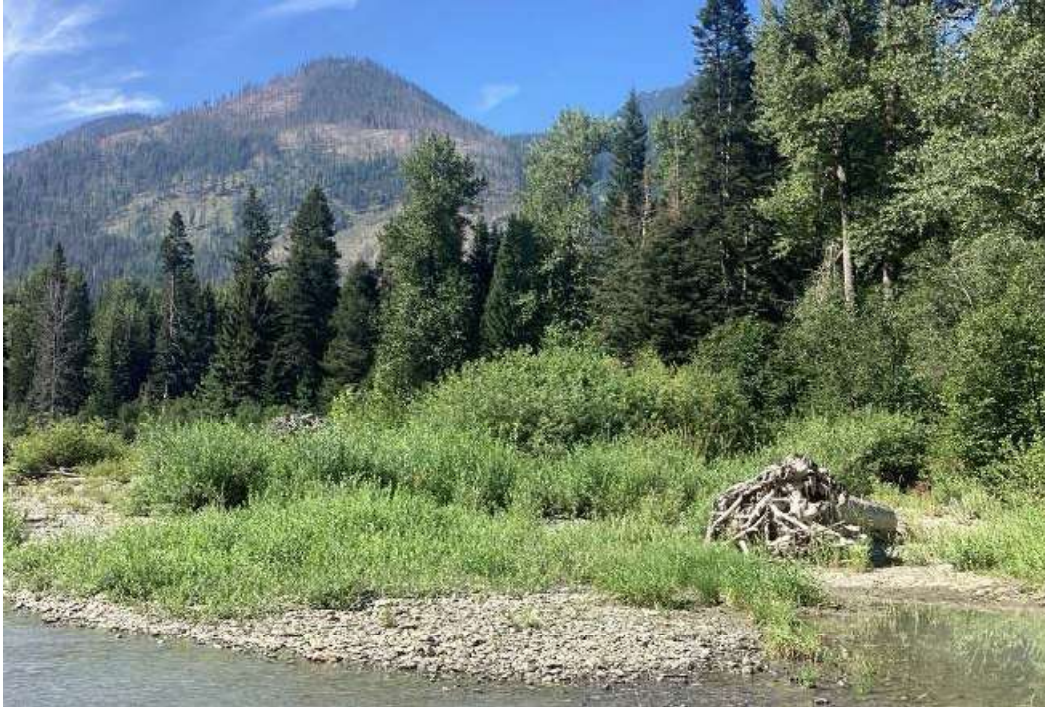
Figure 141. Low and medium river right floodplain surfaces at RM 11.98 (August 3, 2024).
