White River Reach Assessment & Restoration Strategy

Final Report

PREPARED FOR
Yakama Nation Fisheries

PREPARED BY
Inter-Fluve

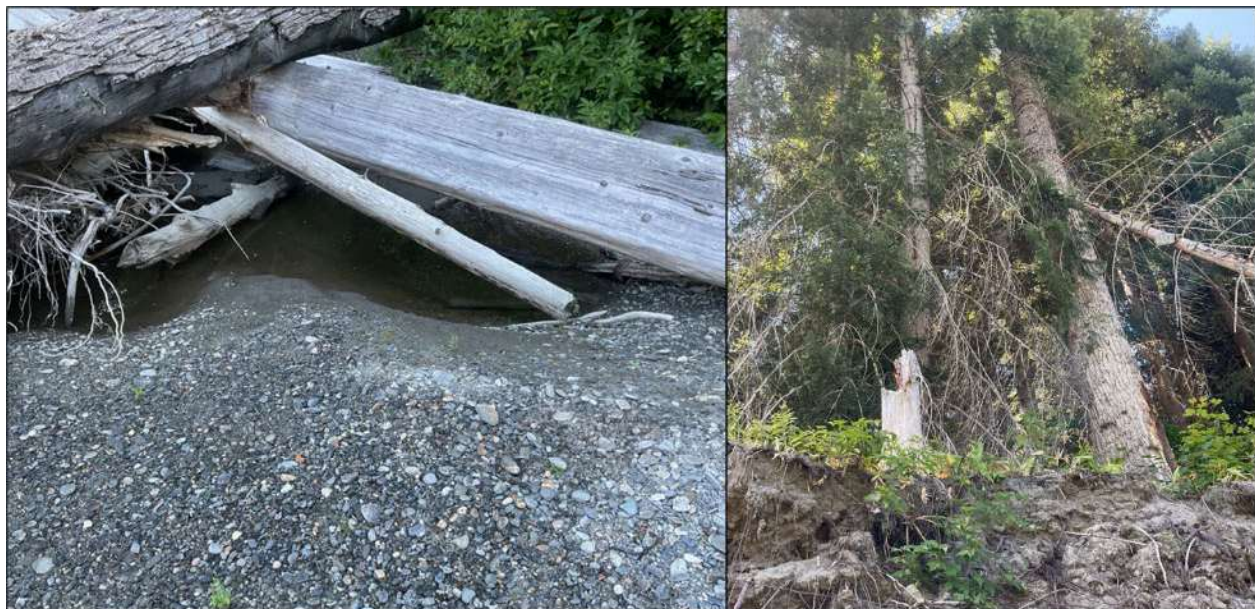
Figure 143. Left: Large wood induced scour and sediment sorting at log jam on bar at RM 12.28 (August 3, 2024). Right: Large wood recruitment potential (Cottonwood) atop river-right bank at RM 11.75 (August 3, 2024).

A total of 127 pieces of large woody material (LWM) and 11 log jams (accumulation of >3 LWM) were observed in the channel during the survey (August 2024) (See Figure 142). Of the 127 pieces, 61 are considered Quality Large Wood (QLW); 29 classified as large size class (>20-inches diameter and >35-feet long); and 32 as medium size class (12 to 20-inch diameter and at least 35-feet long). Of the 11 wood jams, 10 contained multiple pieces of QLW. During the assessment, logs greater than 24 inches diameter were noted as sufficient size to be effective. Where wood exists in the channel it is responsible for creating pockets of habitat complexity by promoting pool scour (Figure 143), influencing sediment deposition, and providing cover. Large wood in Reach 7 was not observed forcing split-flow conditions. Given the straightness of the channel through Reach 7, wood input through lateral erosion of stream banks was less common than in other more sinuous reaches. However, the banks are vegetated with conifer forests that offer potential large wood recruitment if bank erosion occurs (Figure 143). Large wood recruitment is currently occurring at RM 11.75 and 11.84.

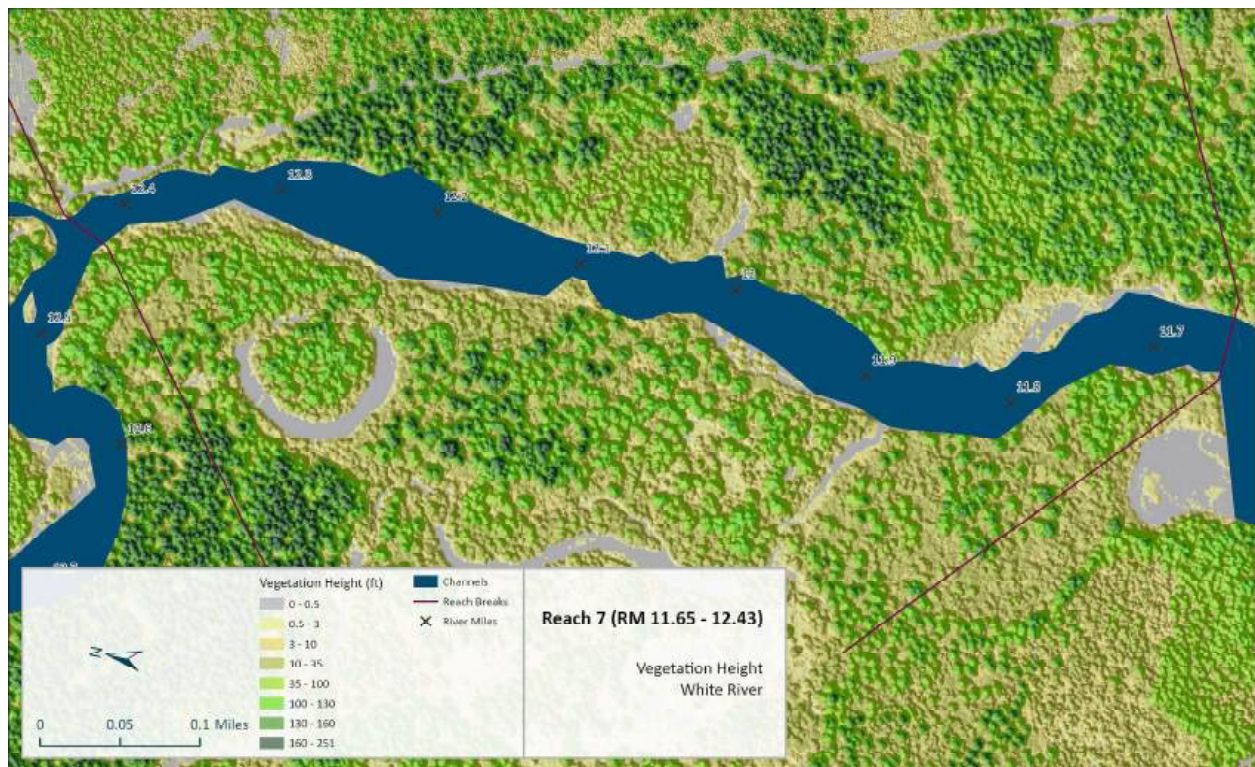
Figure 144. White River, Reach 7: Map of vegetation height classification analysis (LiDAR – based analysis).

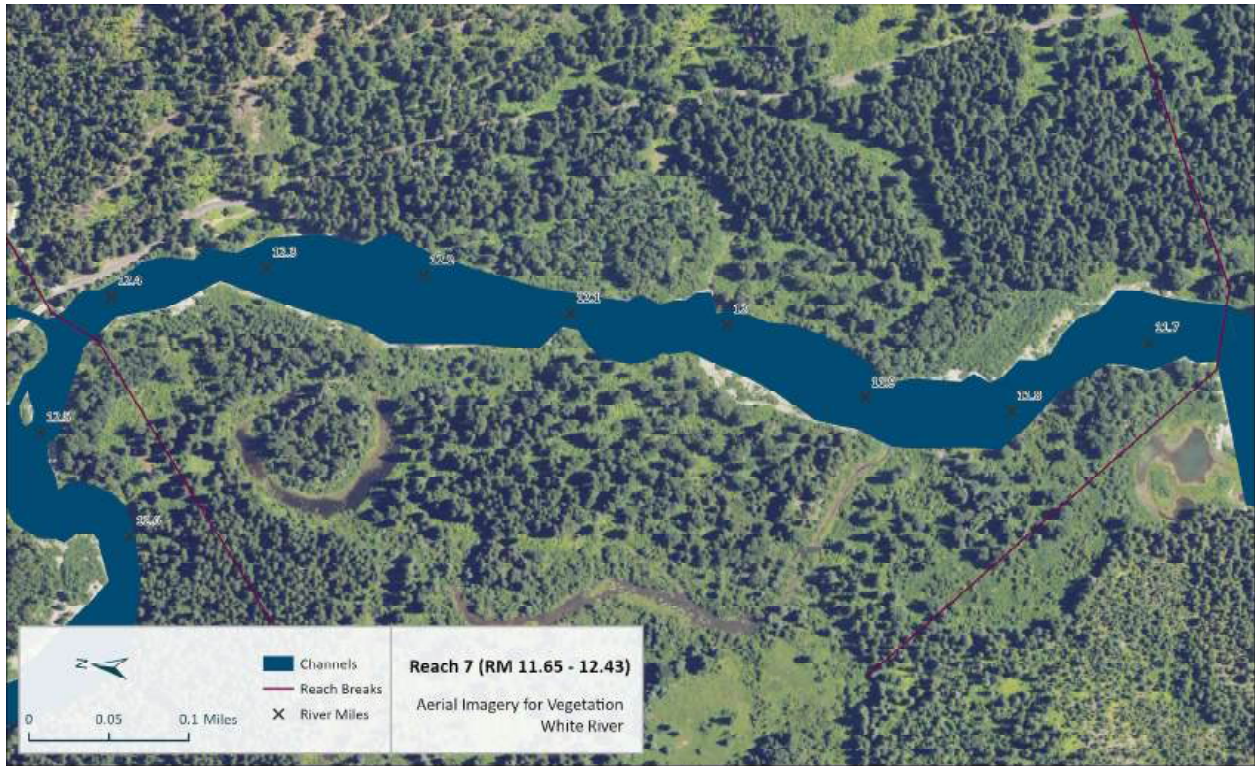
Figure 145. White River, Reach 7: Map of aerial imagery for vegetation identification.

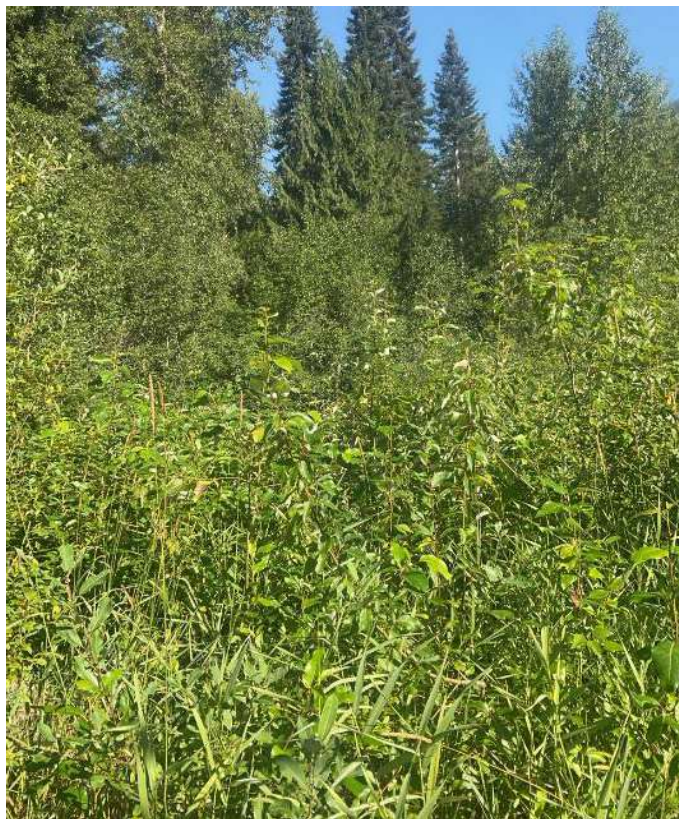
Figure 146. Representative riparian and floodplain vegetation at RM 12.25 on river-right (August 3, 2024).

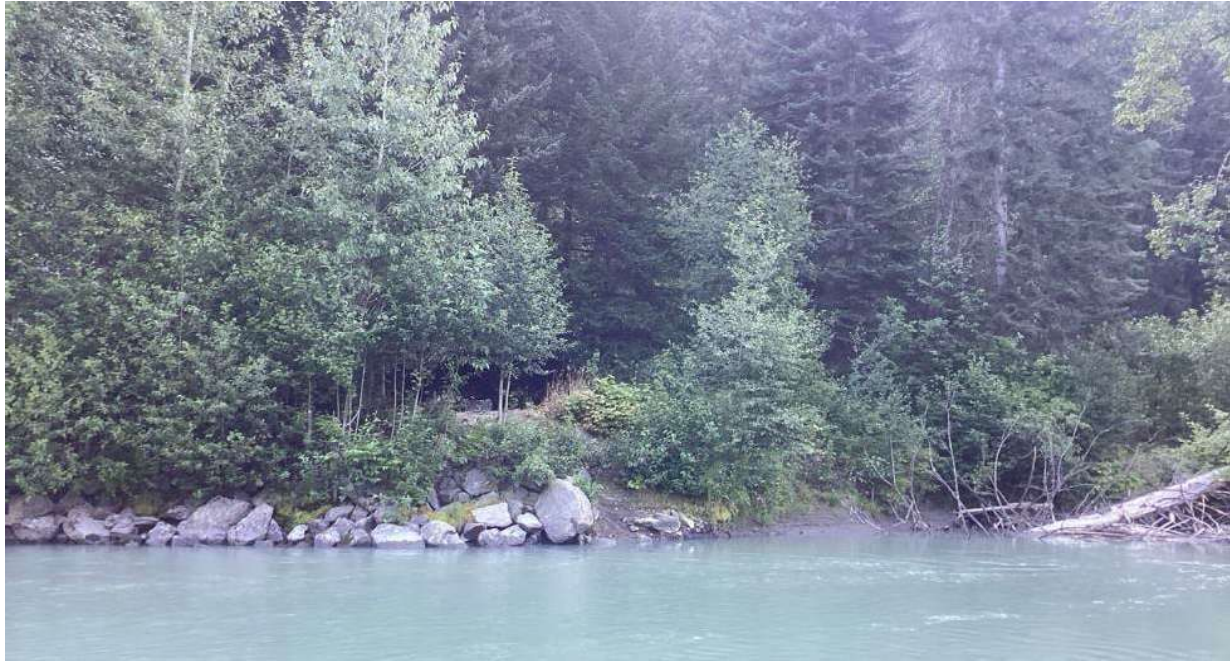
Figure 148. Riprap and parking area downstream of Napeequa River confluence, at RM 12.35 (August 3, 2024).

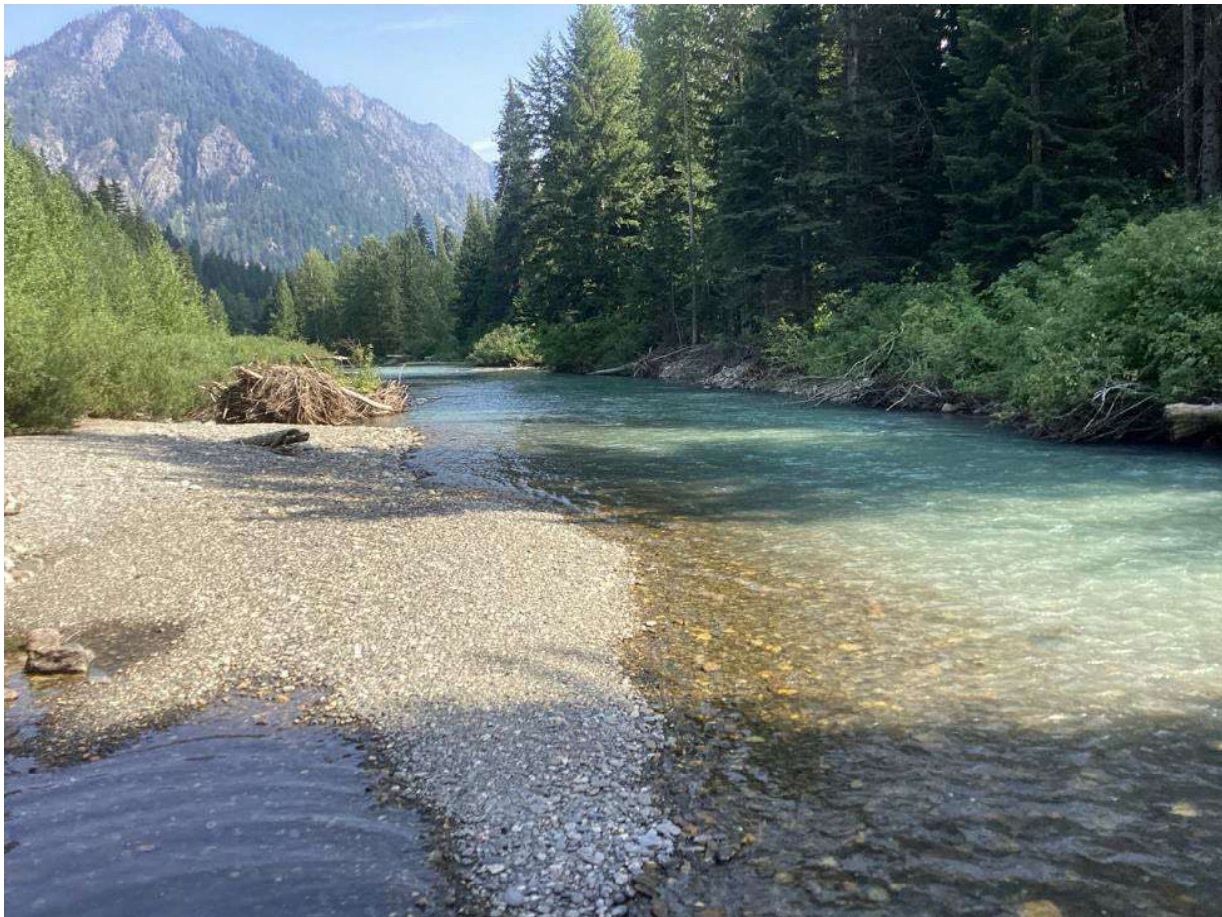
Figure 149. Representative photo of White River at RM 13.95 looking downstream (August 2, 2024).

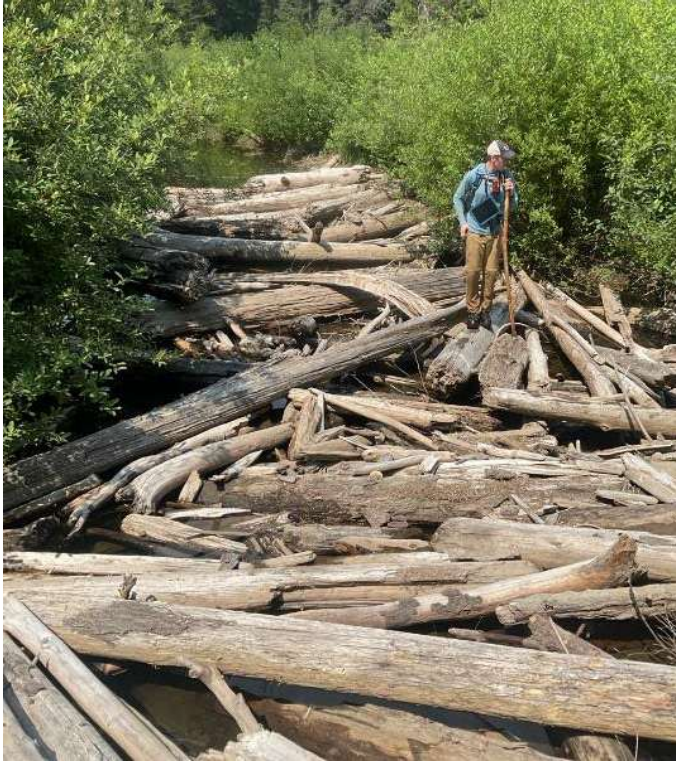
Figure 152. Large wood jam occupying approximately 100 ft of oxbow meander between RM 14.16 and RM 14.27 on river-right floodplain (August 2, 2024).

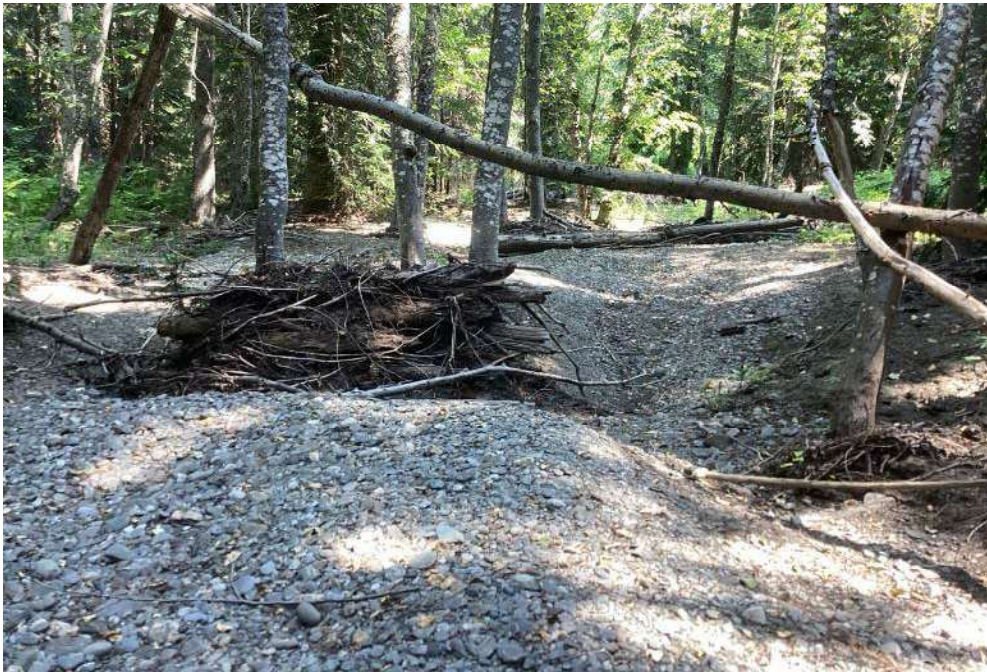
Figure 153. High-Flow or flood-activated side channel on river right at RM 14.23 with gravel-cobble bedforms and raked wood, indicating frequent high-energy flows (August 2, 2024).

A series of floodplain tributaries convey water across the river-right floodplain, from the wetted oxbow (RM 14.16-14.27) to approximately RM 13.54, as well as across the inside of the meander from RM 14.1-14.2. The floodplain tributaries are sourced from emergent groundwater during low-flow conditions such that they are perennial contributor to the White River at RM 13.52. During seasonal snow melt or high-flow events, they also receive and convey surface water. Given that these floodplain tributaries maintain connectivity with the White River during low flow, they likely provide or have the potential to provide important off-channel refugia and rearing habitat for juvenile salmonids and other species. This type of off-channel habitat is currently limited within the assessment area. The active high-flow channels contain gravel-to-cobble sized substrate and racked large wood (Figure 153) and thus appear to convey significant amounts of flow during flood events.

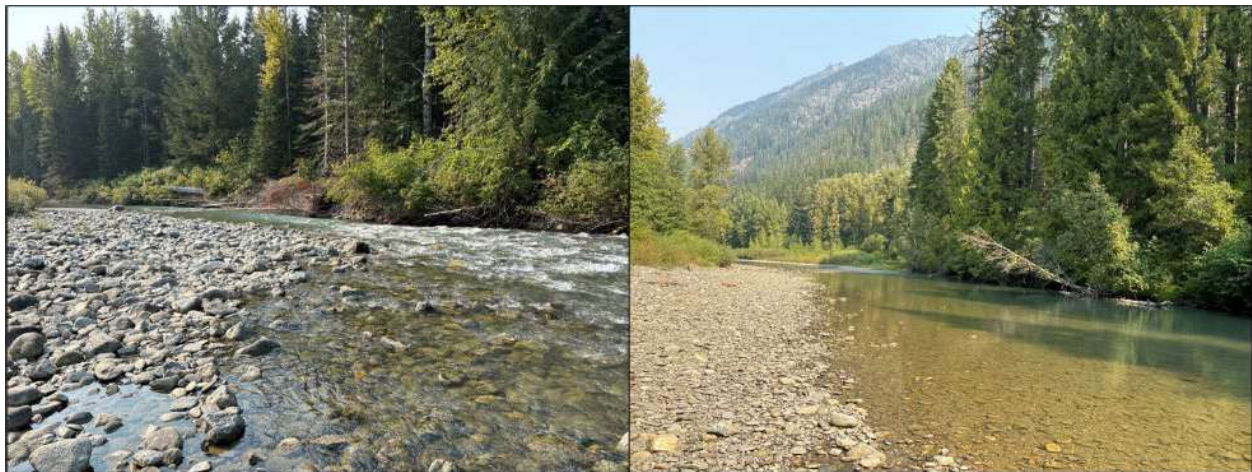
Figure 154. Left: Cobble-boulder substrate at RM 13.99. Right: Gravel-cobble substrate at RM 13.35 (September 7, 2024).

Channel substrate in Reach 8 is cobble-gravel alluvium, with boulders present in the upstream section. The reach hosts large point and lateral bars composed of gravel and cobble in the downstream half of the reach. Channel substrate coarsens significantly with distance upstream, corresponding with an increase in channel slope and a decrease in active bars (Figure 154). Wolman pebble counts were conducted on representative riffle crests at RM 12.76 (GC 15) and RM 13.7 (GC 16). The median grain size at GC 16 of $D_{50} = 60.50$ mm is significantly larger than that of the downstream pebble count GC 15 of $D_{50} = 31.41$ mm. The data from the two pebble counts are plotted on a map (Figure 155) of the Reach 8 incipient motion analysis results (see Sediment Mobility – Incipient Motion Hydraulic Analysis: Section 2.9.4). The analysis indicates that at the 2-yr modeled discharge, the channel's shear stress is capable of mobilizing coarse gravels downstream of RM 13.1 with patches of higher shear capable of mobilizing cobble. Upstream of RM 13.1, modeled shear indicates a capacity through the channel to mobilize cobbles. The ocular grain size notes recorded during the survey concur, indicating a decrease in stream energy downstream of RM 13.1, where slope decreases, sinuosity increases, and channel complexity and habitat function also increase.

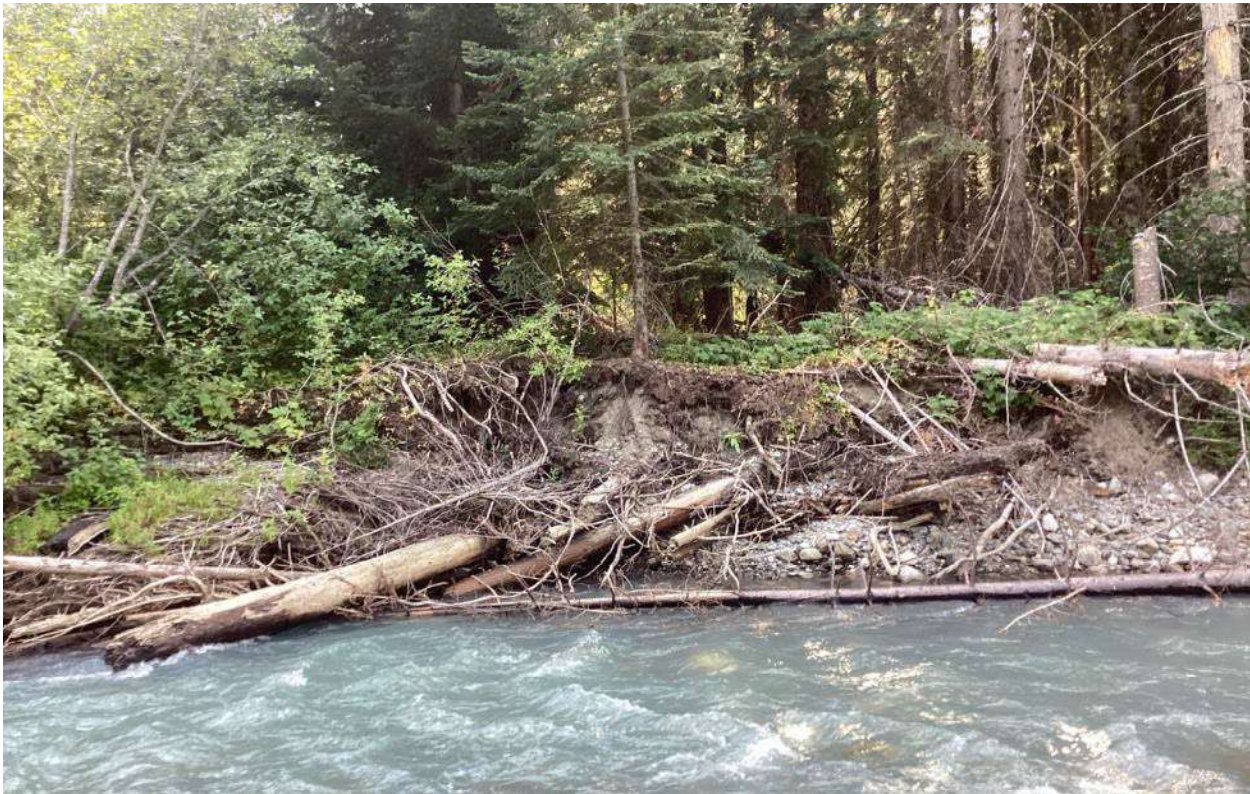
Figure 156. Cut bank at RM 13.95 (river right) revealing floodplain composition of alluvial cobbles overlain by gravels and fine sediments (August 2, 2024).

Floodplains in Reach 8 are vegetated, and consist of low (inundation ~1-5 yrs), medium (inundation ~ 5-10 yrs), and high (inundation ~ 10-100 yrs) floodplain surfaces (see Figure 150). Evidence of inundation such as overbank deposits and flotsam indicate that the channel is moderately well-connected to its floodplain in Reach 8. Low floodplain surfaces in Reach 8 are typically extend from point bars on the inside of meander bends. An additional large swath of low floodplain is located on river right between RM 13.6 and RM 14.25. Moving away from the channel, low floodplains at point bars generally transition to medium and then to high floodplain surfaces. Terrace surfaces are located along the valley wall on river right, and adjacent to the channel on river left from RM 12.84 – 12.96. Low floodplains surfaces are typically populated with willow, whereas medium floodplains are populated with dogwood, alder, cottonwood, and mixed-conifers. Vegetation on high floodplains and terraces is generally mixed-conifer. Meander bends typically exhibit a sequence of floodplain development that extends from the channel as relatively active point bars that step up to low floodplain surfaces, which then transition to medium and/or high floodplain surfaces. Based on exposed banks, floodplains are composed of a cobble-gravel base overlain by gravels and sometimes sand topped with developing organic soil (Figure 156).

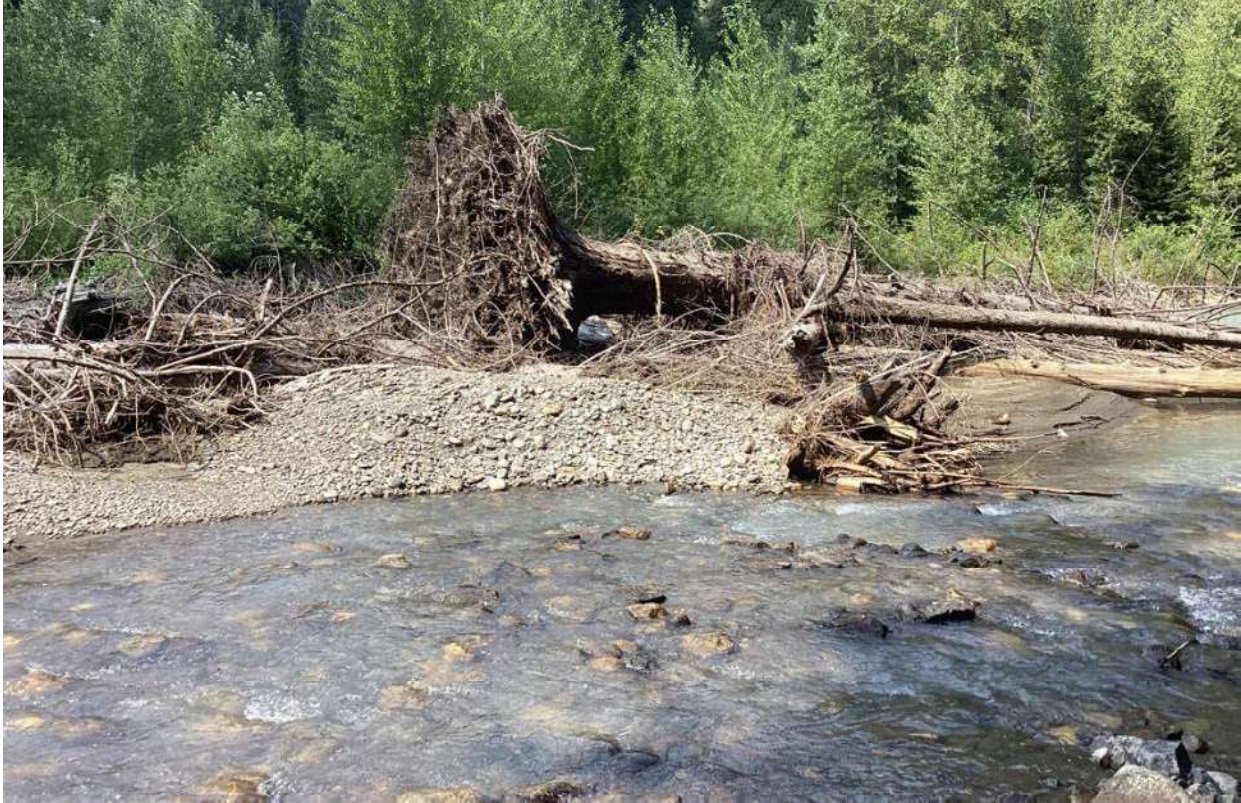
Figure 158. Log jam deflecting flow, splitting flow, and collecting gravels in Reach 8. Located at RM 14.2 on mid-channel bar, looking downstream from river-right (August 2, 2024).

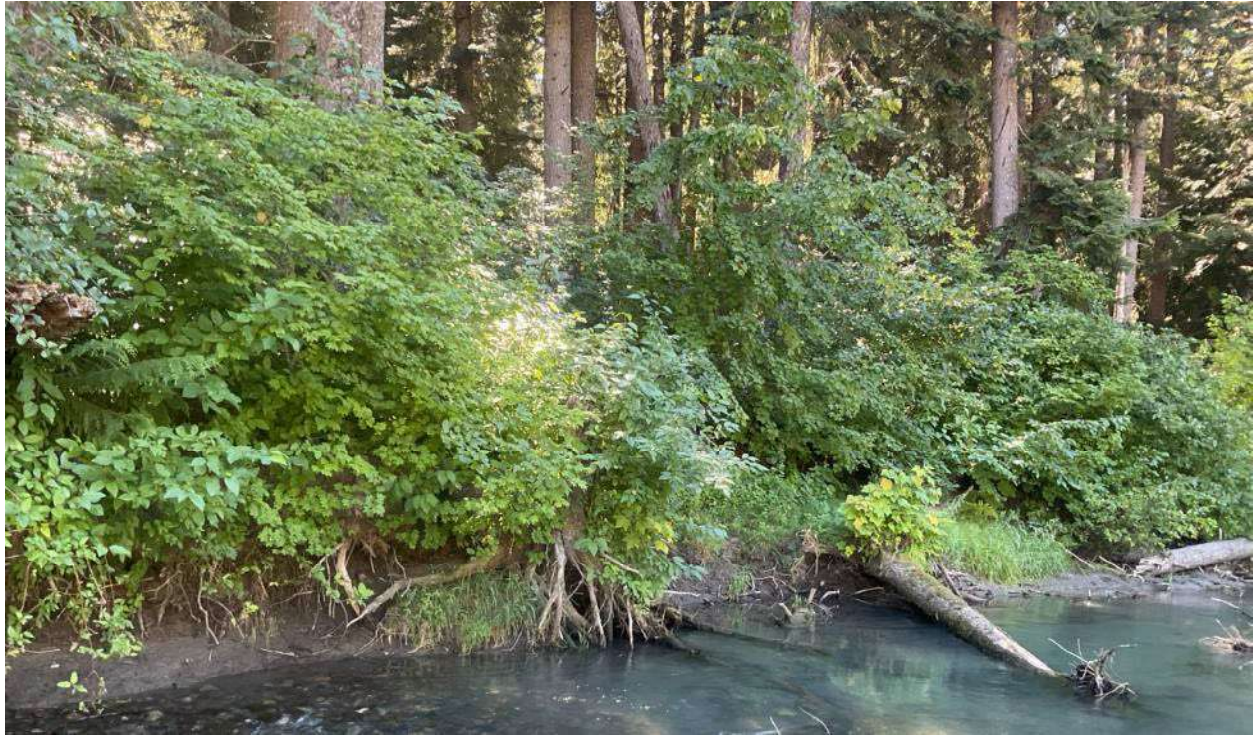
Figure 159. Representative photograph of Reach 8 vegetation (RM 12.65, looking upstream) (August 4, 2024).

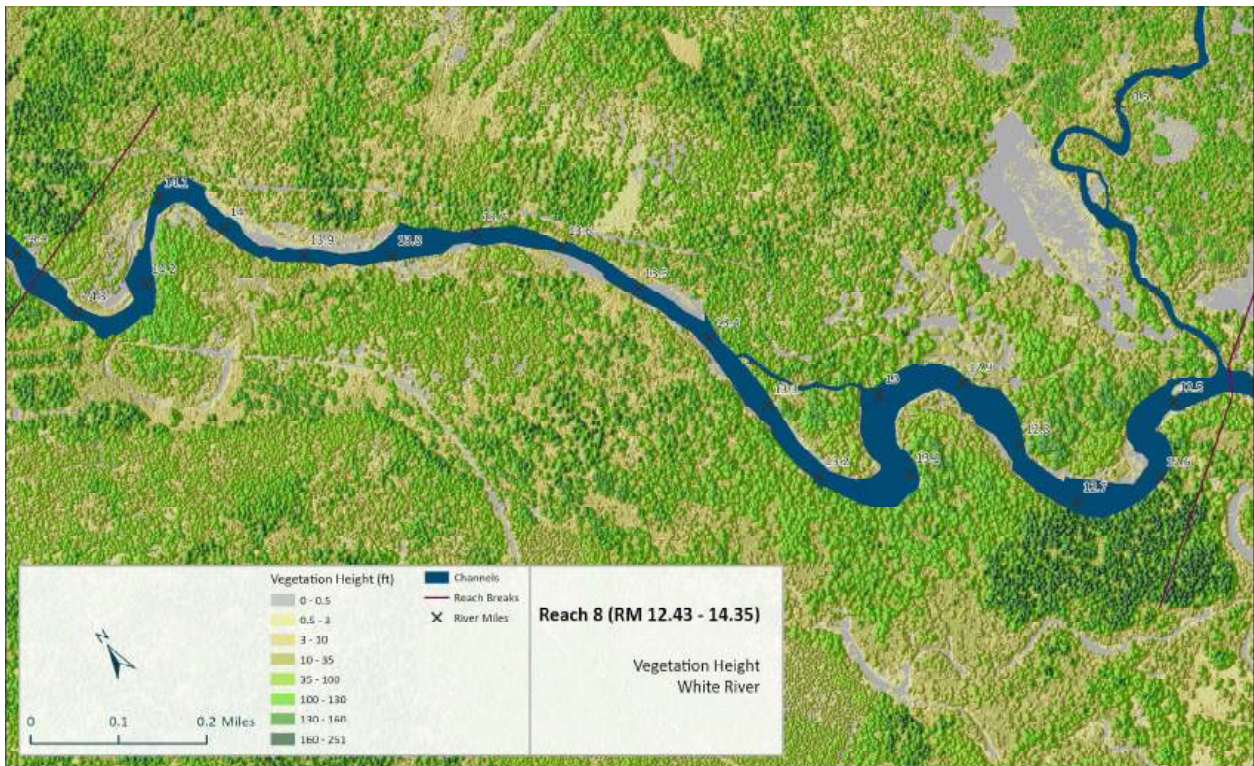
Figure 160. White River, Reach 8: Map of vegetation height classification analysis (LiDAR – based analysis).

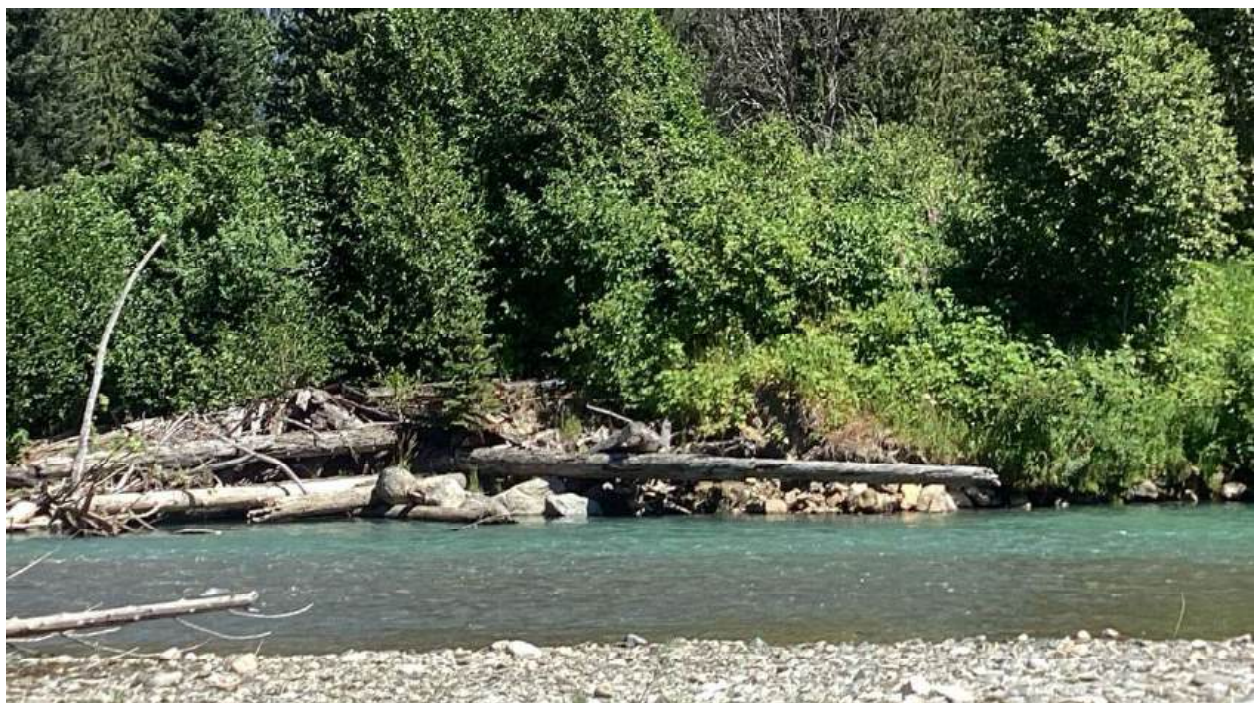
Figure 163. Riprap and large wood constructed bank protection along White River Road at RM 12.92 (August 4, 2024).

Human alterations in Reach 8 are associated with roads, trails, and historical logging (See Figure 162). Riprap boulders placed along the river's bank to protect White River Road are located on river left at the base of the bridge of the mouth of the Napeequa River, from RM 12.9 – 12.94, and from RM 13.54 – 13.6. Bank protection constructed of riprap and bank-attached large wood is also meant to protect White River Road from RM 12.9 – 12.94 (Figure 163). Trails extending from the Tall Timber Ranch property to the White River channel at RM 12.77 and RM 13.15 have minimal impact on channel and floodplain processes. Evidence of past logging was observed in several locations on the river-right floodplain including stumps and cable scars (Figure 164). Sears Creek Road enters the valley bottom at ~RM 13.8 on the river-right floodplain. The road is currently unmaintained beyond ~RM 12.7, although it appears to have been active to ~RM 14.6 as recently as 1985 according to historical imagery. The unmaintained portion of the road bisects a large oxbow in the upstream portion of Reach 8. It is also presumed that road construction and historical logging are associated with channel straightening from RM 13.3 to 14.75

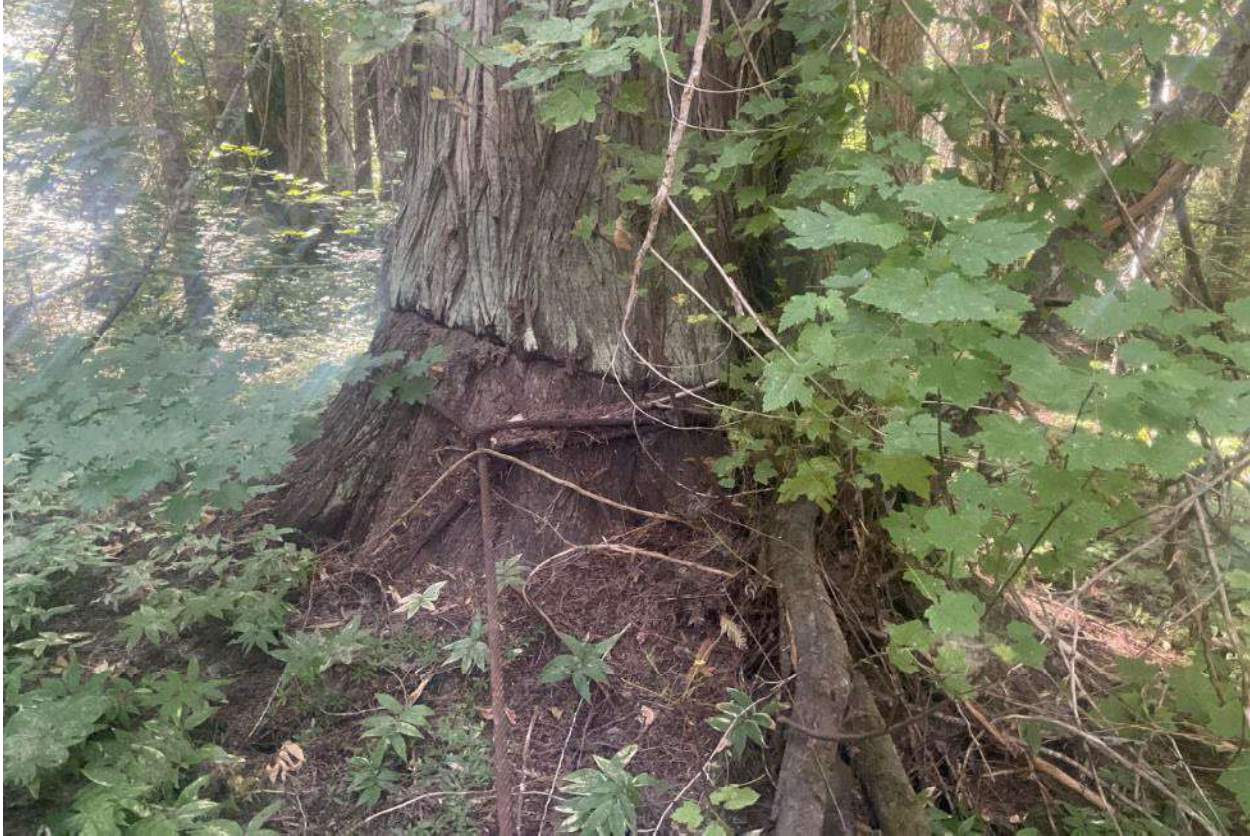
Figure 164. Example of historical logging cable scar on remnant old-growth western redcedar on river-right floodplain at RM 12.75 (August 4, 2024).

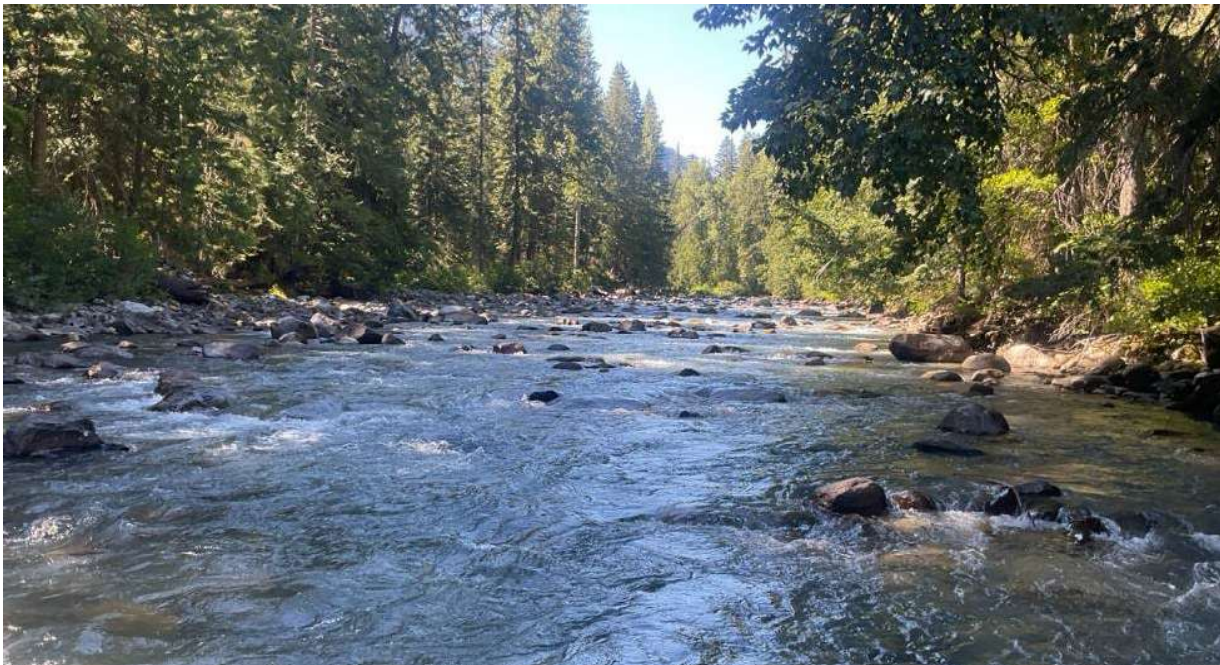
Figure 165. Representative photo of White River at RM 14.7, looking upstream (August 1, 2024).

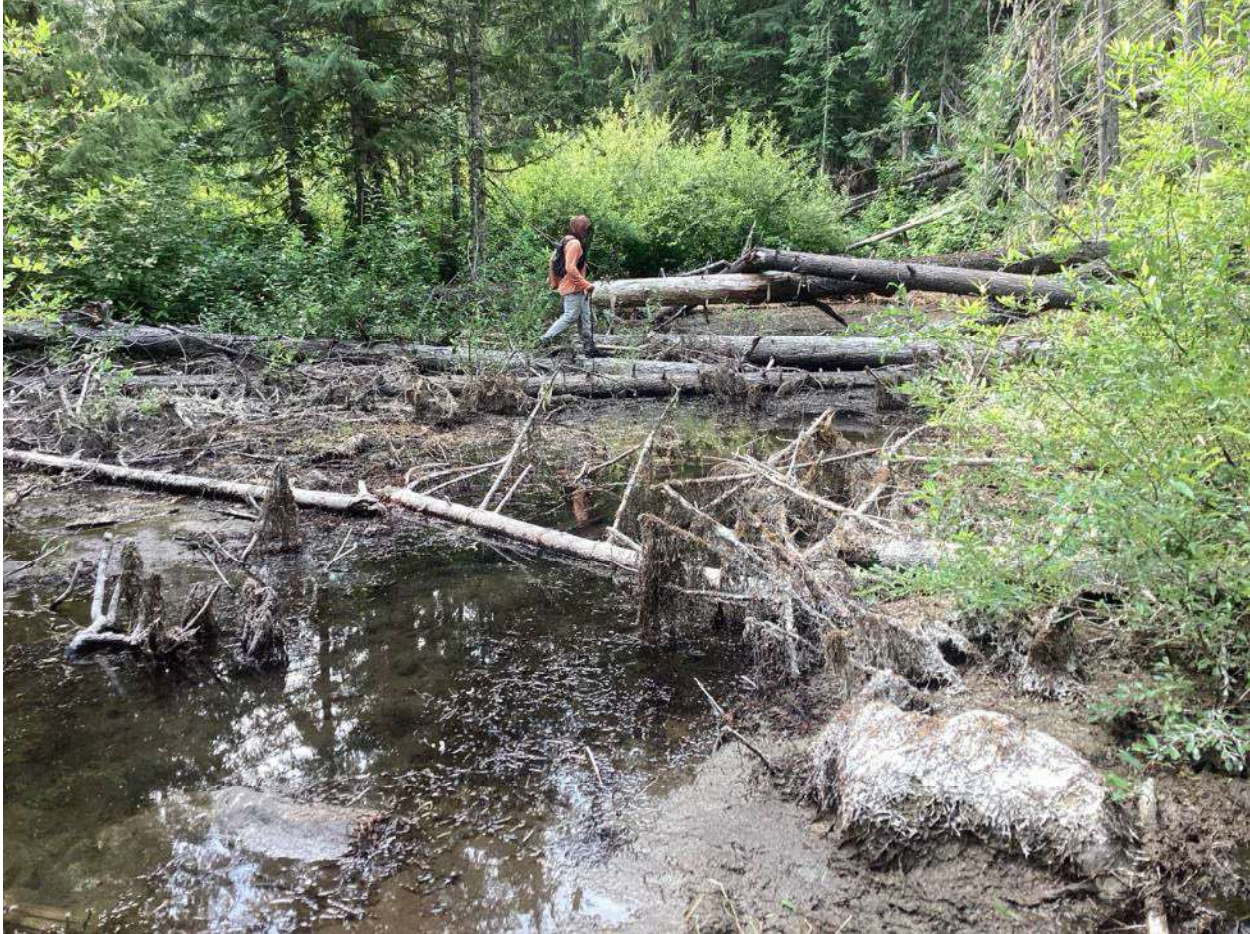
Figure 167. Groundwater wetted abandoned historical channel scar with intermittent surface water connectivity on the river-right floodplain near RM 14.7 (August 2, 2024).

The extended channel scar or sequence of modern oxbows is currently disconnected from the White River but sections of it remain wetted perennially via groundwater inputs likely sourced from both the toe of the Panther Creek alluvial fan and through the substrate of the White River valley. Additional surface water inputs to the historical channel scar appear to be sourced from a hillslope tributary that enters the valley at RM 14.66. Active beaver dams increase surface water retention in the oxbow along the river right hillslopes between RM 14.6 and RM 14.7. Coarse gravel to cobble alluvium on the bed of the historical channel scar was noted qualitatively as finer than that of the modern mainstem White River. Boulders are generally absent from the historical channel scar, where the bed is visible. This indicates that stream energy and transport capacity of the current main channel is likely higher than that of the historic channel. This is likely due to simplification of the channel in the last 100 years (channel straightening and removal of large wood from the channel and the adjacent floodplain). Large wood is present along the historic channel scar and is found as large jam features.

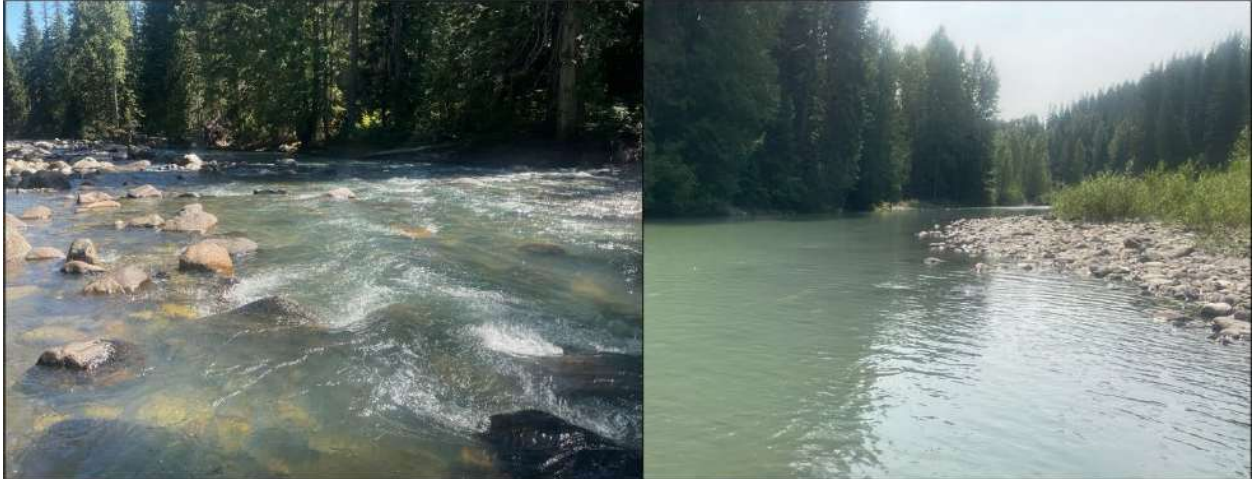
Figure 169. Left: White River at RM 14.86, dominant boulder-cobble substrate (August 1, 2024). Right: White River channel at RM 14.46, dominant cobble substrate (August 2, 2024).

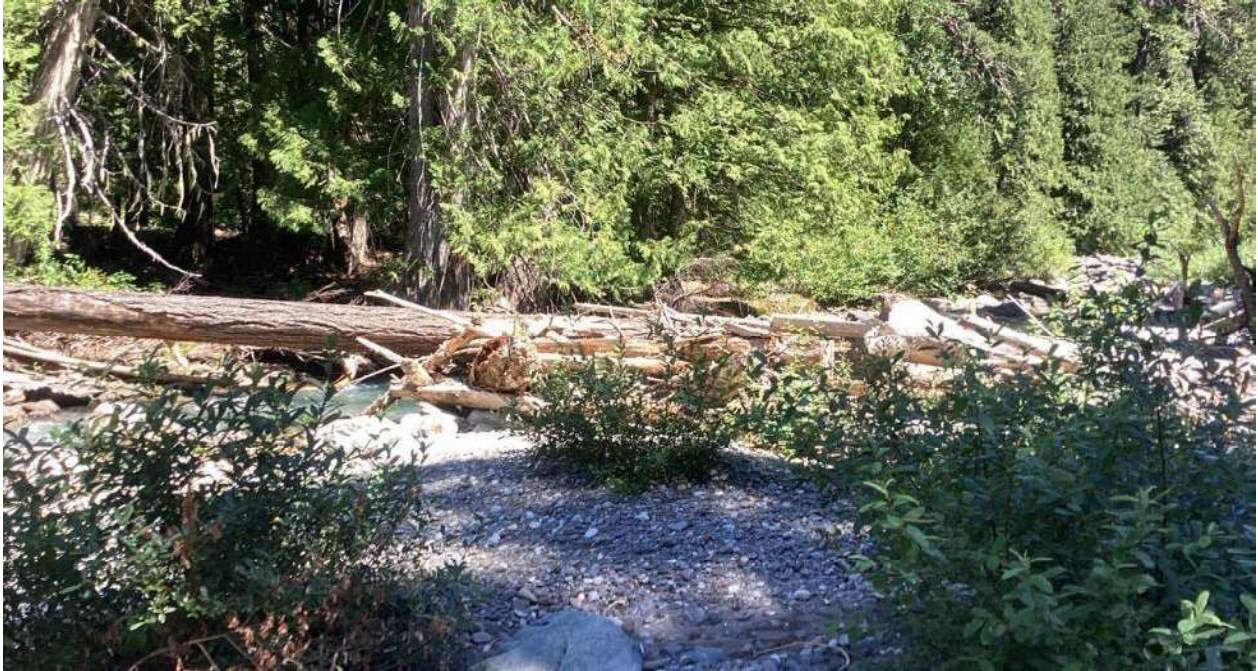
Figure 172. Large wood accumulation located on the river left bar within the river right flow split at RM 14.91, looking upstream (August 1, 2024).

A total of 63 pieces of large woody material (LWM) and 3 log jams (accumulation of >3 LWM) (Figure 172) were observed in the channel during the Habitat Assessment (Appendix A) (August, 2024) (See Figure 171). Of the 63 pieces, 35 pieces are considered Quality Large Wood (QLW); 12 classified as large size class (>20-inches diameter and >35-feet long); and 23 as medium size class (12 to 20-inch diameter and at least 35-feet long). All three jams have multiple pieces of QLW and thus are considered to be effective channel influencing and habitat forming structures. All three log jams were associated with pool scour and sediment sorting (Figure 172). The abundance of large wood in Reach 9 is likely diminished compared to historical conditions due to past logging activities on the floodplain. The forced straightening of the river channel between RM 14.3 and RM 14.75 has likely created high energy conditions that are less favorable to large wood retention. At present, large key pieces with at least 3 feet in diameter are likely necessary to create effective and persistent log jams. Trees adjacent to the White River channel in Reach 9 are generally smaller than 3-ft dbh, although some sufficiently large trees do exist sporadically and could be recruited into the channel by encouraging bank erosion, or through intentional felling.

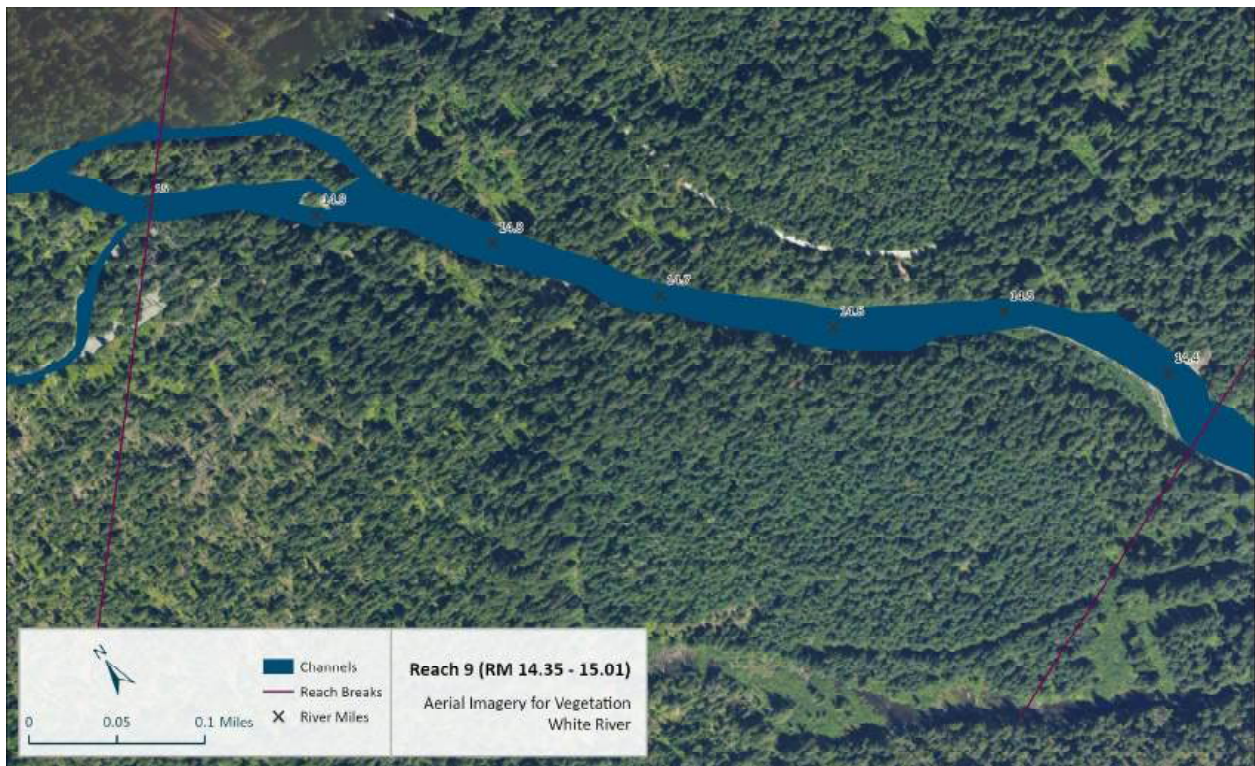
Figure 174. White River, Reach 9: Map of aerial imagery for vegetation identification.

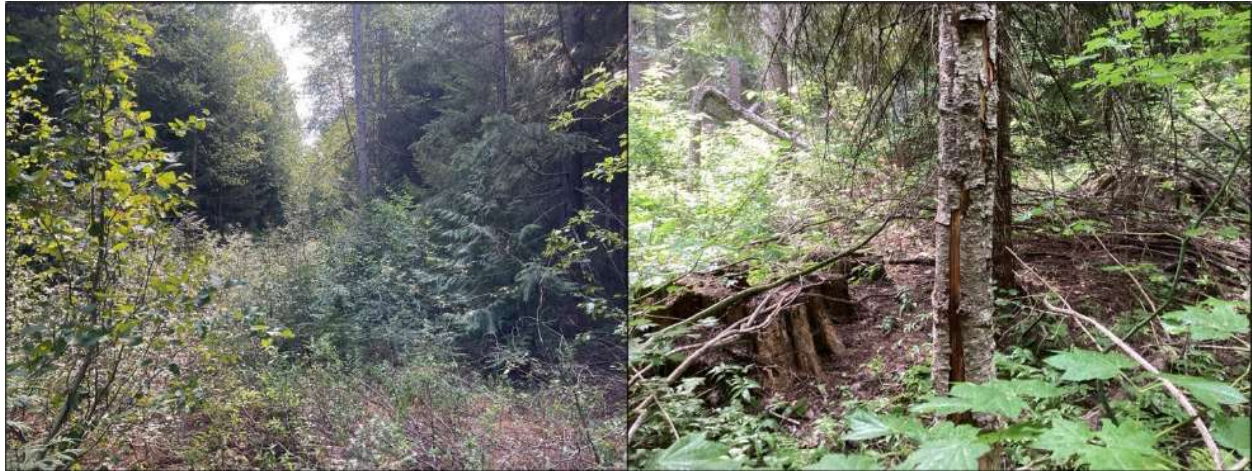
Figure 176. *Left: Abandoned logging road on river-right floodplain, extending from Sears Creek Road to RM 14.7. Right: Western redcedar stumps on river-right floodplain near RM 14.7 (August 2, 2024).*

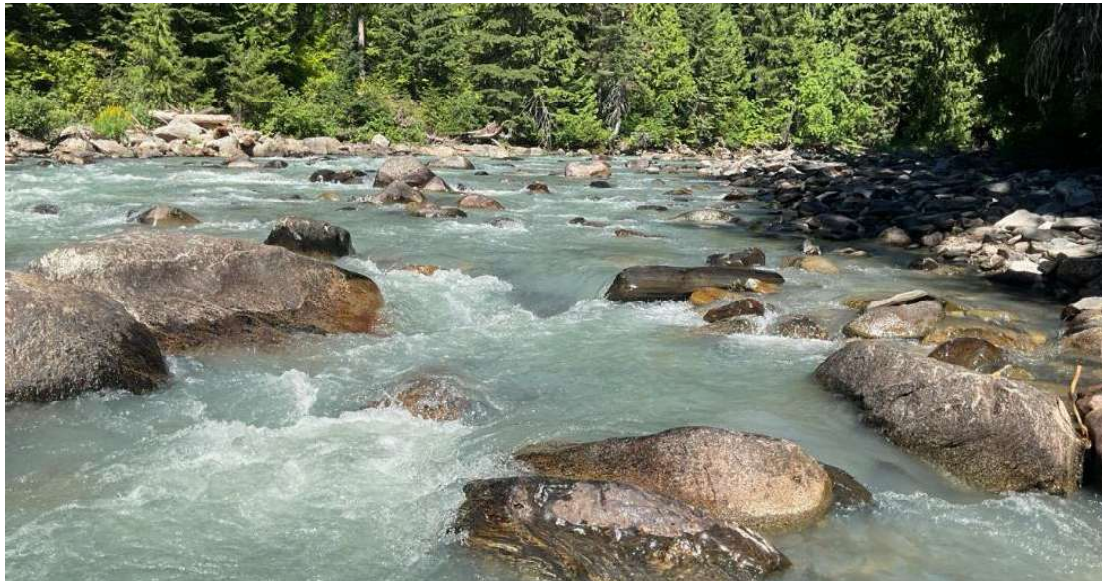
Figure 177. Representative photo of White River at RM 15.6, looking upstream (August 1, 2024).

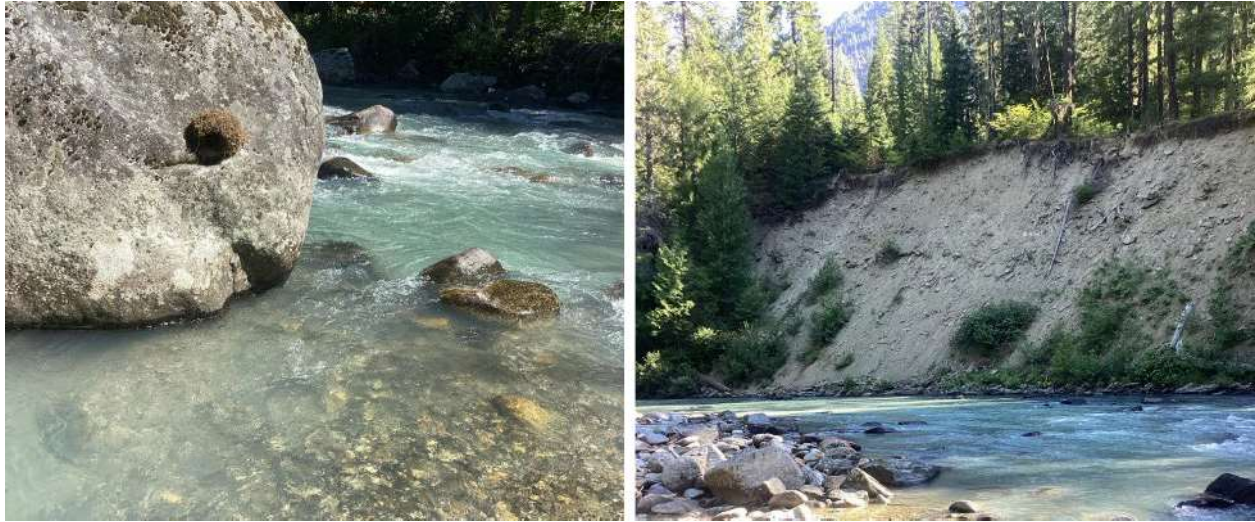
Figure 181. *Left: Gravel-cobble accumulation in hydraulic refuge downstream of large boulder, at RM 15.33 (August 1, 2024). Right: Exposed terrace bank at RM 15.77 with direct contributions to the channel (August 1, 2024).*

Channel substrate in Reach 10 is composed of boulders with sparse gravels and cobbles. The large boulders sourced from hillslope contributions and lag material from glacial outwash are the primary drivers of aquatic habitat complexity in the channel. Wolman Pebble Counts were conducted on riffle crests and associated bars at ~RM 15.26 (GC 19) and ~RM 15.93 (GC 20). The median grain size at GC 20 is $D_{50} = 77.00\text{mm}$ and at GC 19 is $D_{50} = 83.50\text{mm}$. The data from the two pebble counts are plotted on a map (Figure 180) of the Reach 10 incipient motion analysis results (see Sediment Mobility – Incipient Motion Hydraulic Analysis: Section 2.9.4). The analysis indicates that at the 2-yr modeled discharge, the channel's shear stress is capable of mobilizing cobbles. Patches of higher shear capable of mobilizing boulder-sized substrate also occur throughout Reach 10 and become the dominate size class of potential mobilization upstream of RM 15.85. Reach 10 is a transport reach, where sediment inputs are regularly mobilized. Gravel-sized sediments are stored temporarily in small pockets where low velocity hydraulic refuge conditions occur behind large boulders or as a thin band along channel margins (Figure 181).

Sediment sources to the channel in Reach 10 include inputs transported from upstream reaches, tributaries, and adjacent hillslopes and terraces. The adjacent hillslopes and terraces contribute alluvium and colluvium ranging in size from sand to large boulders (Figure 181). Lateral processes, including channel widening as high energy systems contact boulder lag, also generate material from floodplains. Based on exposed banks, floodplains are composed of a boulder-cobble base overlain by gravels and sand that is topped with developing soils. Floodplain and terrace soils upstream of RM 15.4, and terrace soils downstream of RM 15.4 are described as gravelly fine sandy loam, whereas floodplain soils downstream of RM 15.4 are described as stony fine sandy loam (Natural Resources Conservation Service, 2007).
