White River Reach Assessment & Restoration Strategy

Final Report

PREPARED FOR
Yakama Nation Fisheries

PREPARED BY
Inter-Fluve

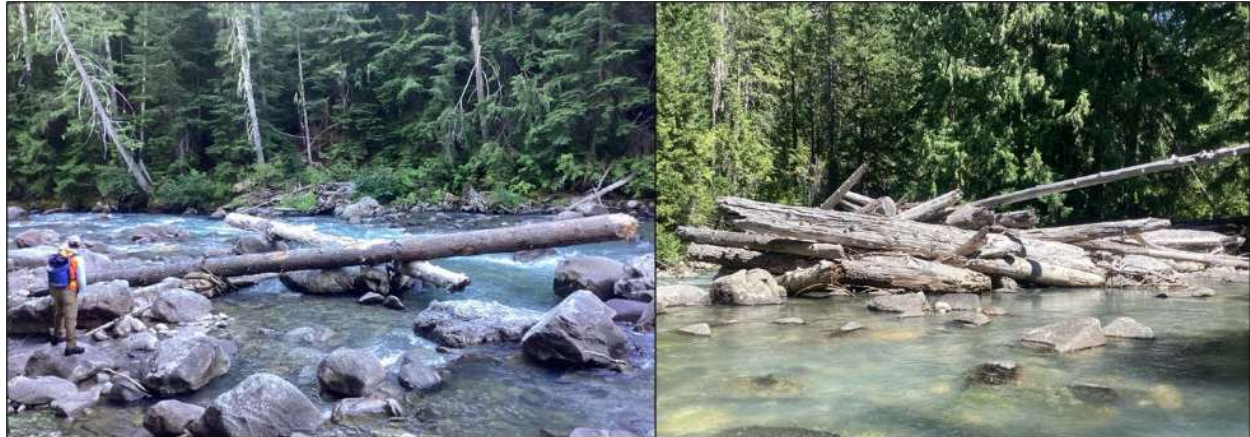
Figure 183. Left: Large wood atop boulders providing minimal geomorphic influence at low flows, at RM 15.99 (July 01, 2024). Right: Apex jam upstream of mid-channel island, at RM 15.05 (August 1, 2024).

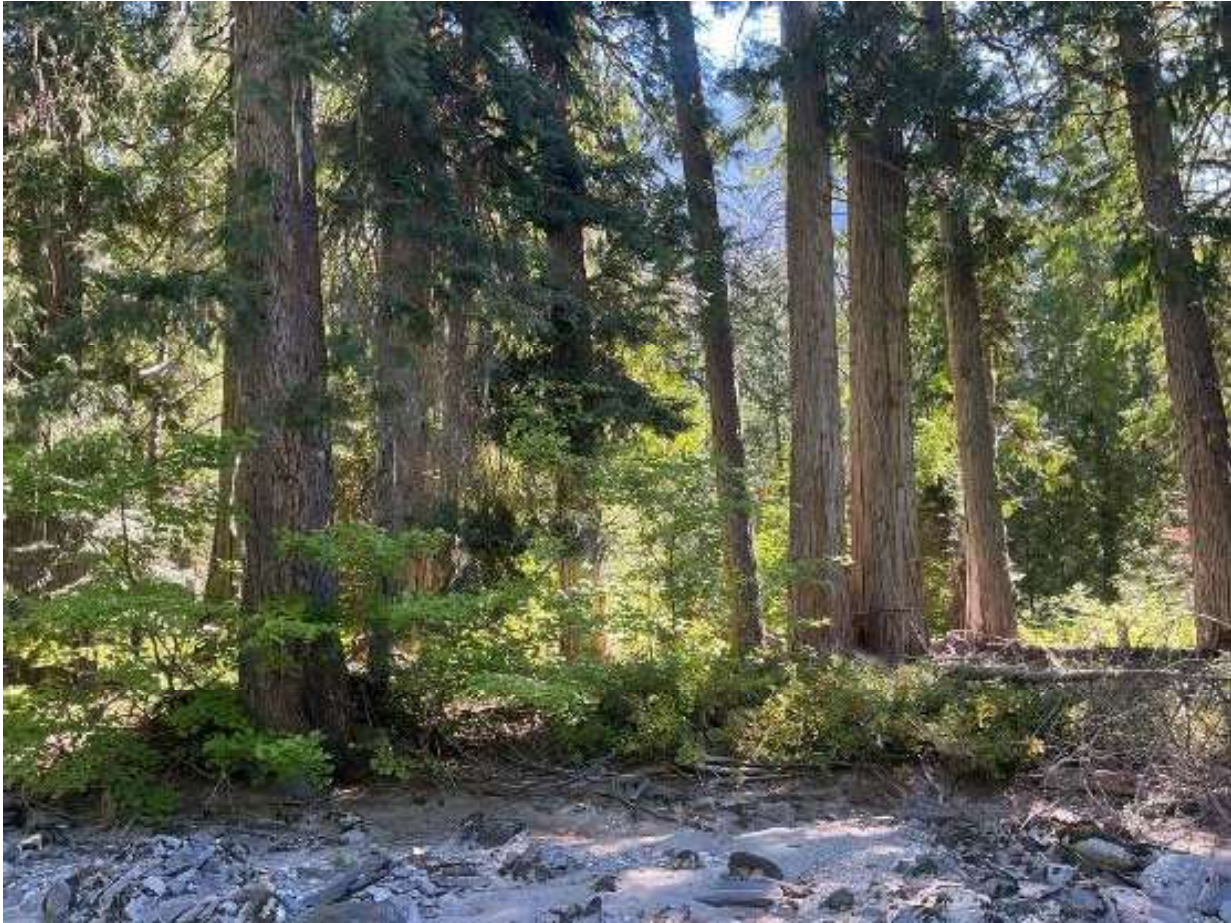
Figure 184. Example of Reach 10 riparian and floodplain vegetation (15.67) (August 1, 2024).

Riparian and floodplain vegetation in Reach 10 is dominated by well-established conifer forest (Figure 184). The overstory consists of western redcedar, grand fir, and Douglas-fir. Historical logging reduced the size of trees on floodplain and terrace surfaces. The vegetation height analysis map shows pockets of large trees along the banks of the channel located on river-right from ~RM 15.65 – 15.9, and river-left from RM 15.8 – 15.9 (Figure 185). Mature old-growth trees are rare in Reach 10 today. The presence of old-growth stumps confirms pre-logging conditions likely consisted

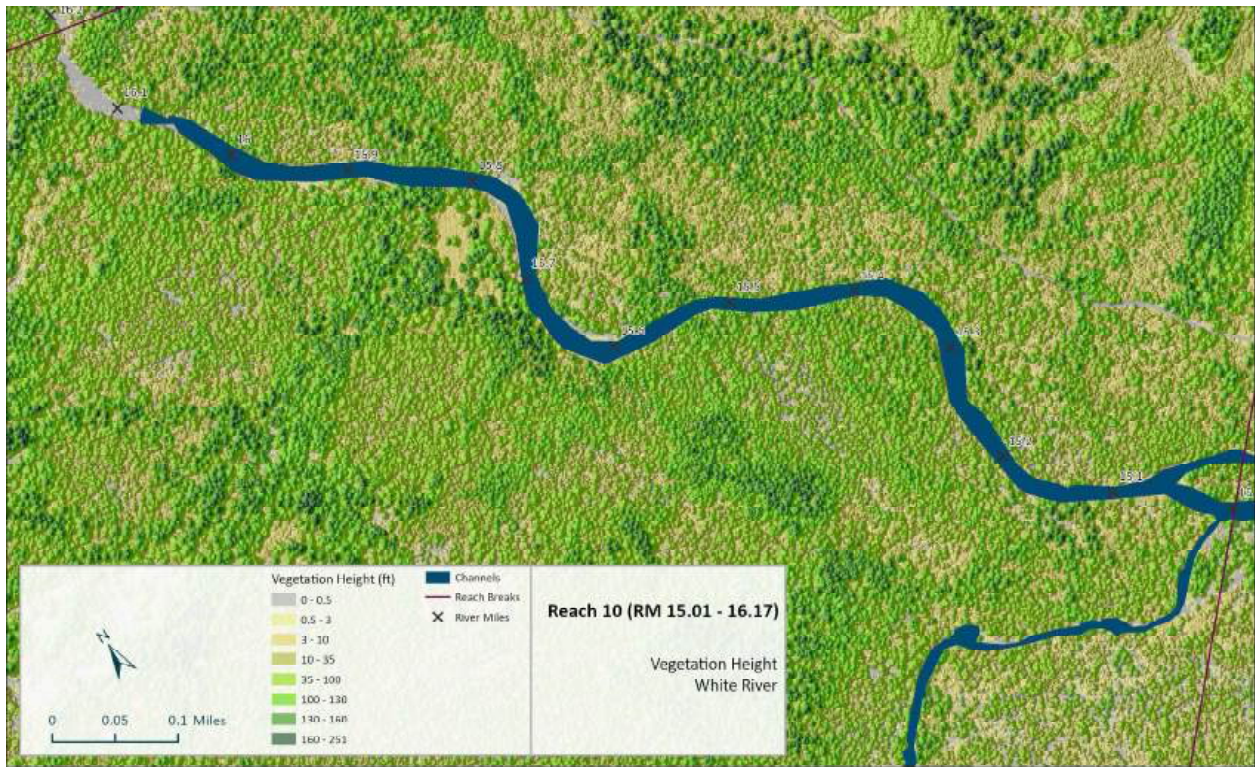
Figure 185. White River, Reach 10: Map of vegetation height classification analysis (LiDAR – based analysis).

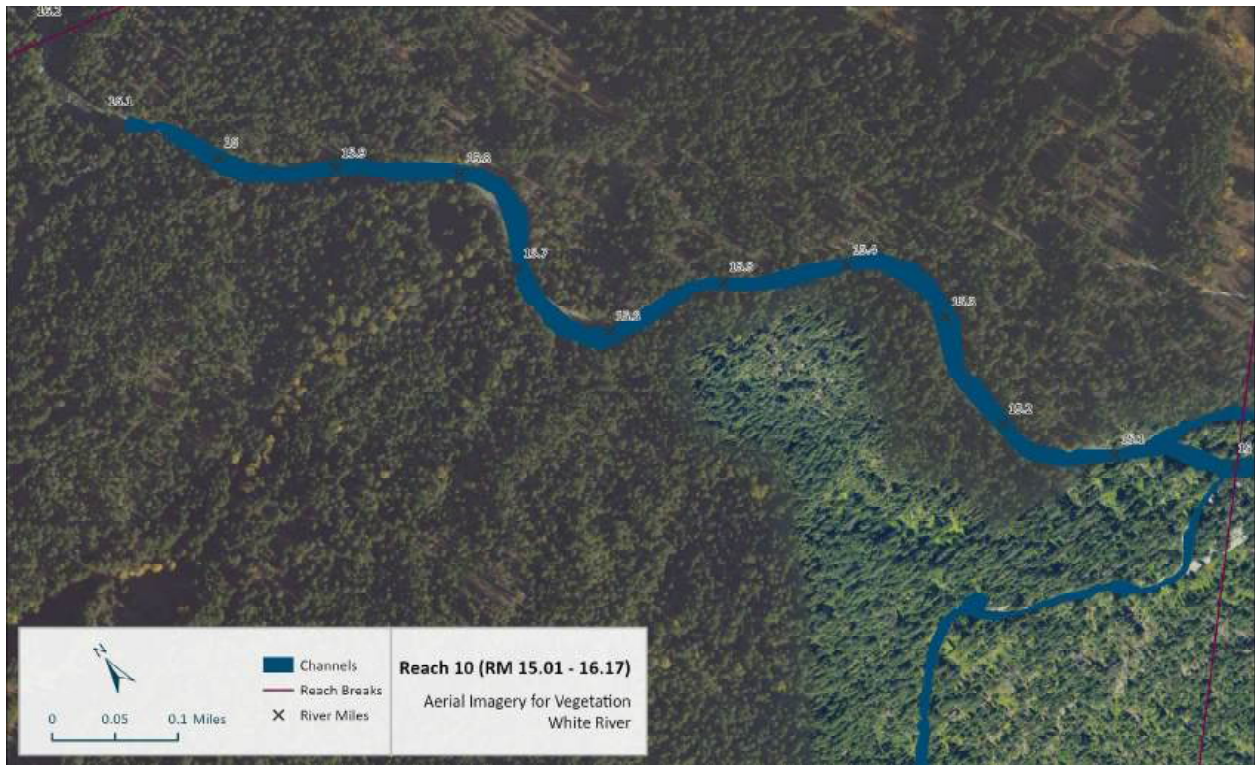
Figure 186. White River, Reach 10: Map of aerial imagery for vegetation identification.

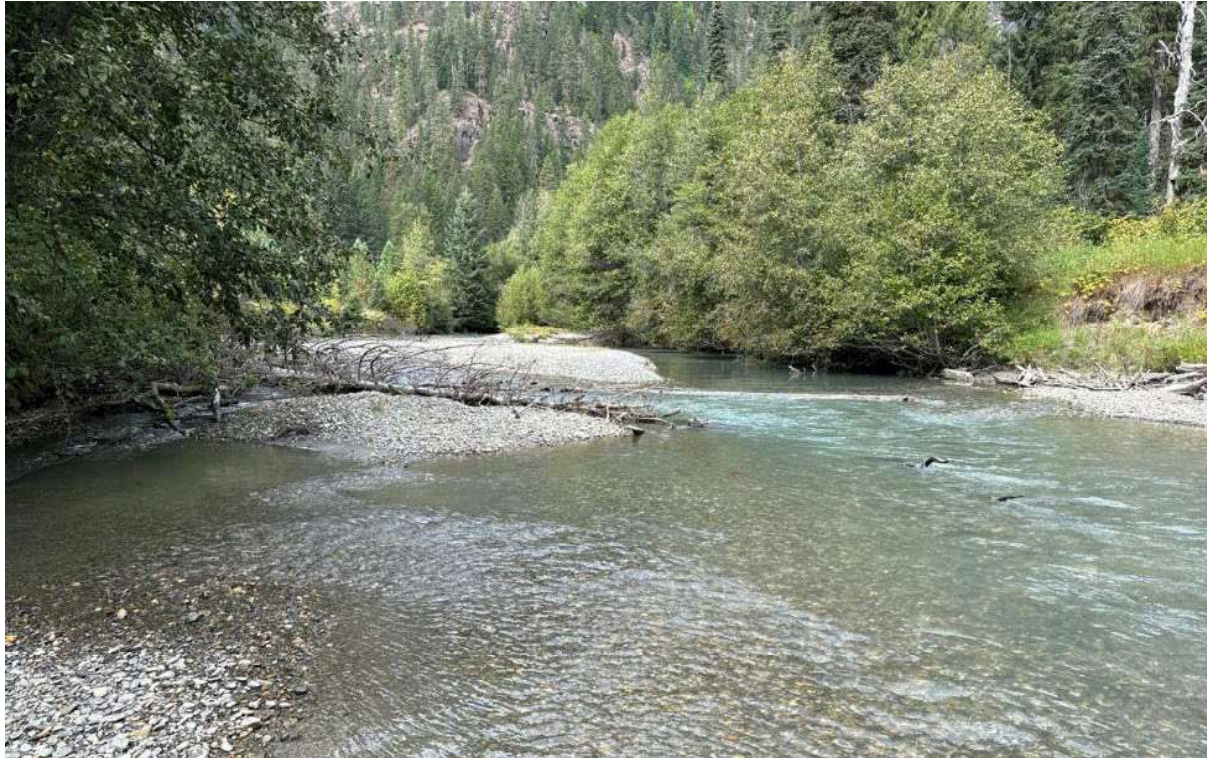
Figure 189. Representative photo of Napeequa River in Reach 1, looking upstream from RM 0.2. Large wood and plentiful sediment supply support channel complexity (September 11, 2024).

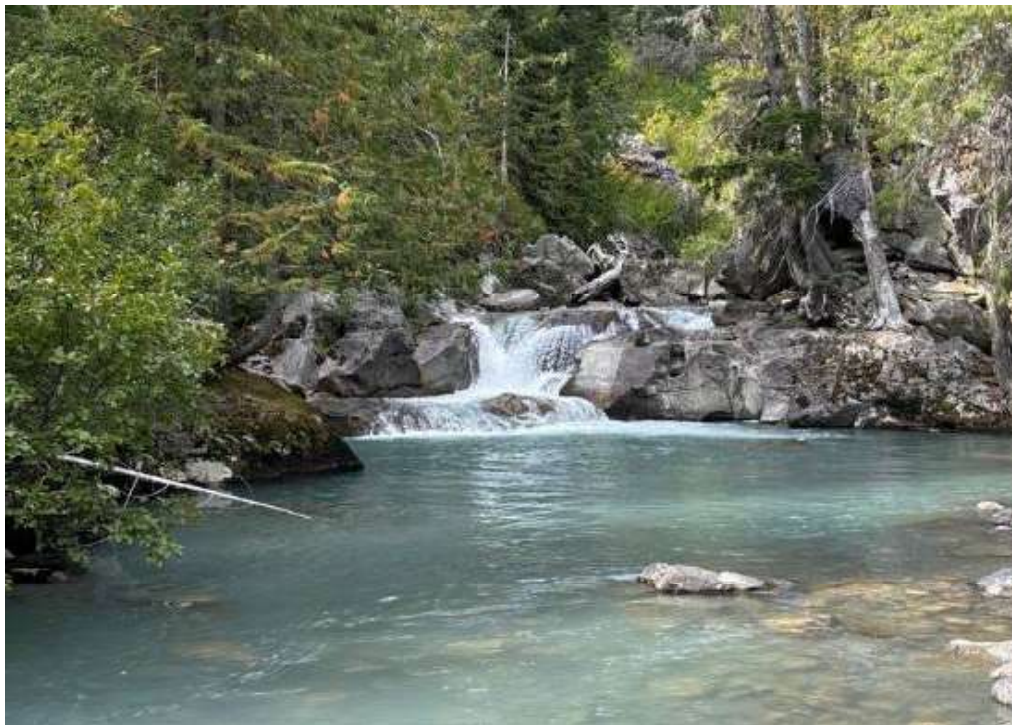
Figure 190. Falls on the Napeequa River at RM 1.7. Downstream of the falls, the channel transitions from a confined canyon to a wide valley (September 10, 2024).

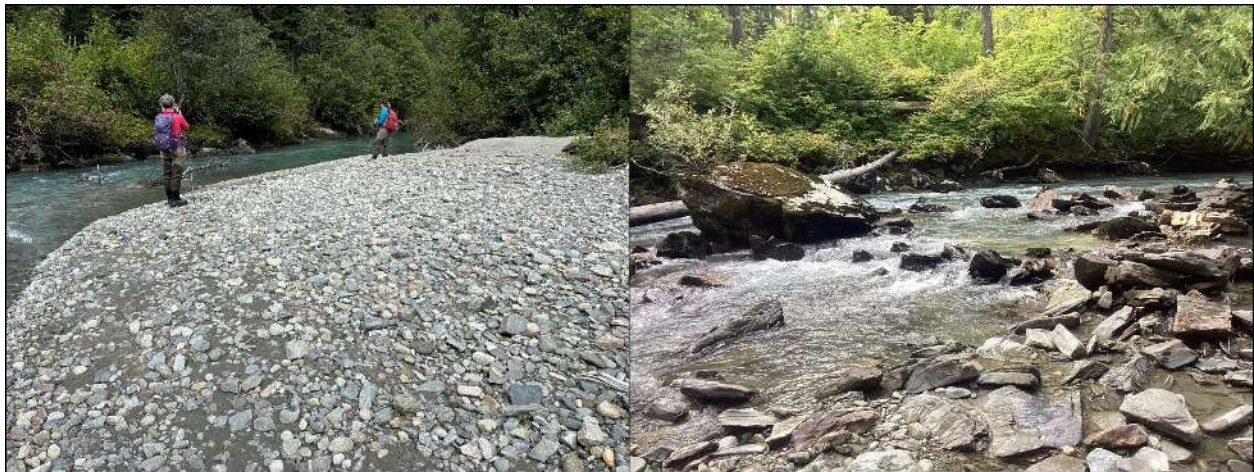
Figure 192. Left: Representative photograph of Napeequa River gravel-cobble bar substrate, RM 0.95 looking downstream (September 11, 2024). Right: Angular cobble-boulder colluvium substrate at RM 1.38 (September 10, 2024).

Channel substrate in Reach 1 is primarily gravel-cobble alluvium (Figure 192) except for a section from RM 1.29-1.48, where angular cobble-to-boulder sized colluvially-sourced sediments line the channel (Figure 192). Wolman Pebble Counts (Wolman, 1954) were conducted on representative riffle crests in Reach 1 at RM 0.57 and RM 1.11. Gravels 45-64 mm in diameter were the dominant size class at both pebble counts. Gravels (2-64 mm diameter) accounted for >50% of sediments. Boulders were absent from the downstream pebble count but present at the upstream pebble count. Fine sediments (< 2mm) were present at the upstream pebble count location only. Grain size of sediments typically decrease from upstream to downstream in Reach 1. The data from the two pebble counts are plotted on a map (Figure 193) of the Reach 1 incipient motion analysis results (see Sediment Mobility – Incipient Motion Hydraulic Analysis: Section 2.9.4). The analysis indicates that at the 2-yr modeled discharge, the channel’s shear stress is capable of mobilizing cobbles and even boulders in some zones in the upper portion of the reach and gravels throughout the lower portion of the reach.

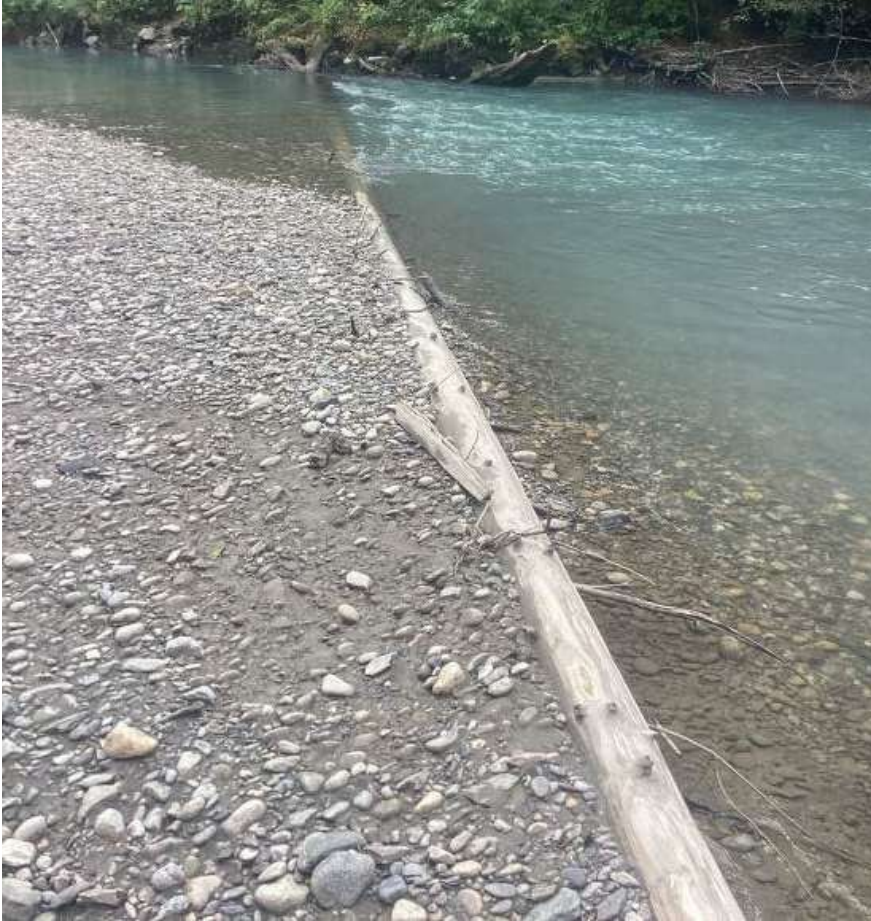
Figure 195. Sediment sorting associated with large wood in Napeequa channel, RM 0.58 (September 11, 2024).

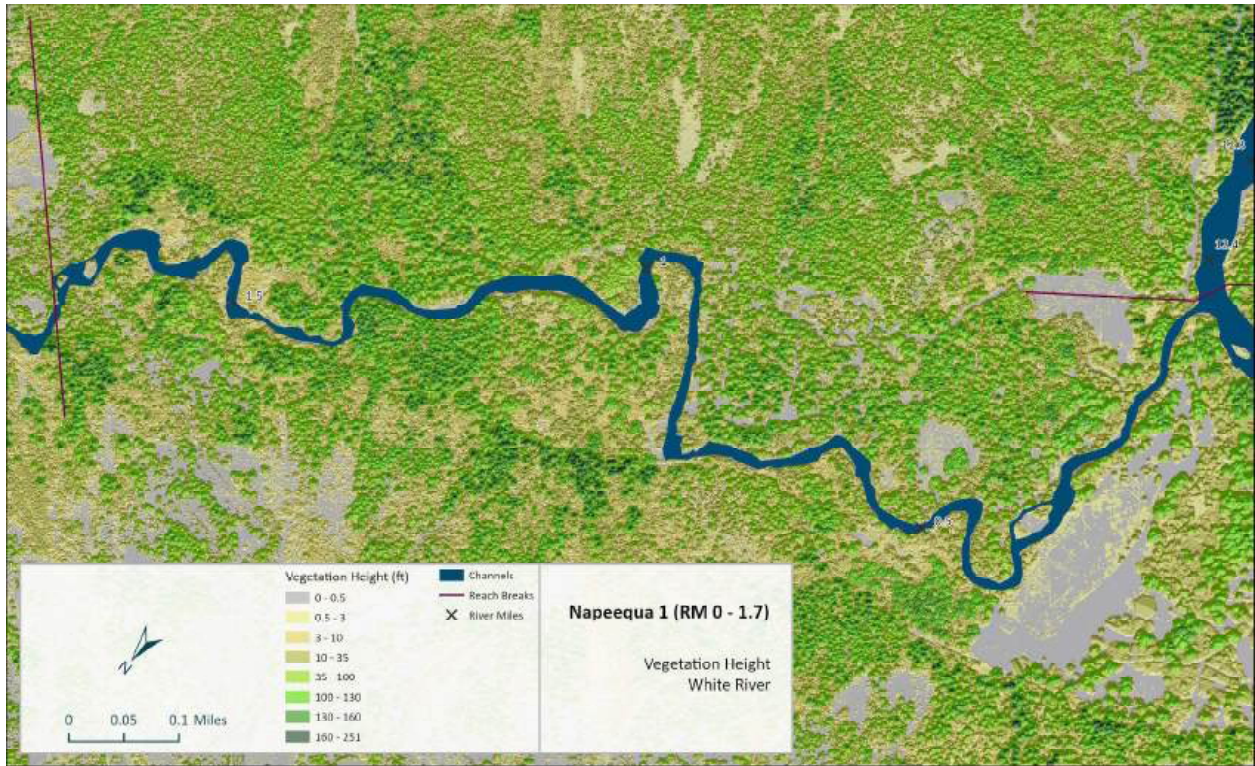
Figure 196. Map of Napeequa Reach 1 vegetation height.

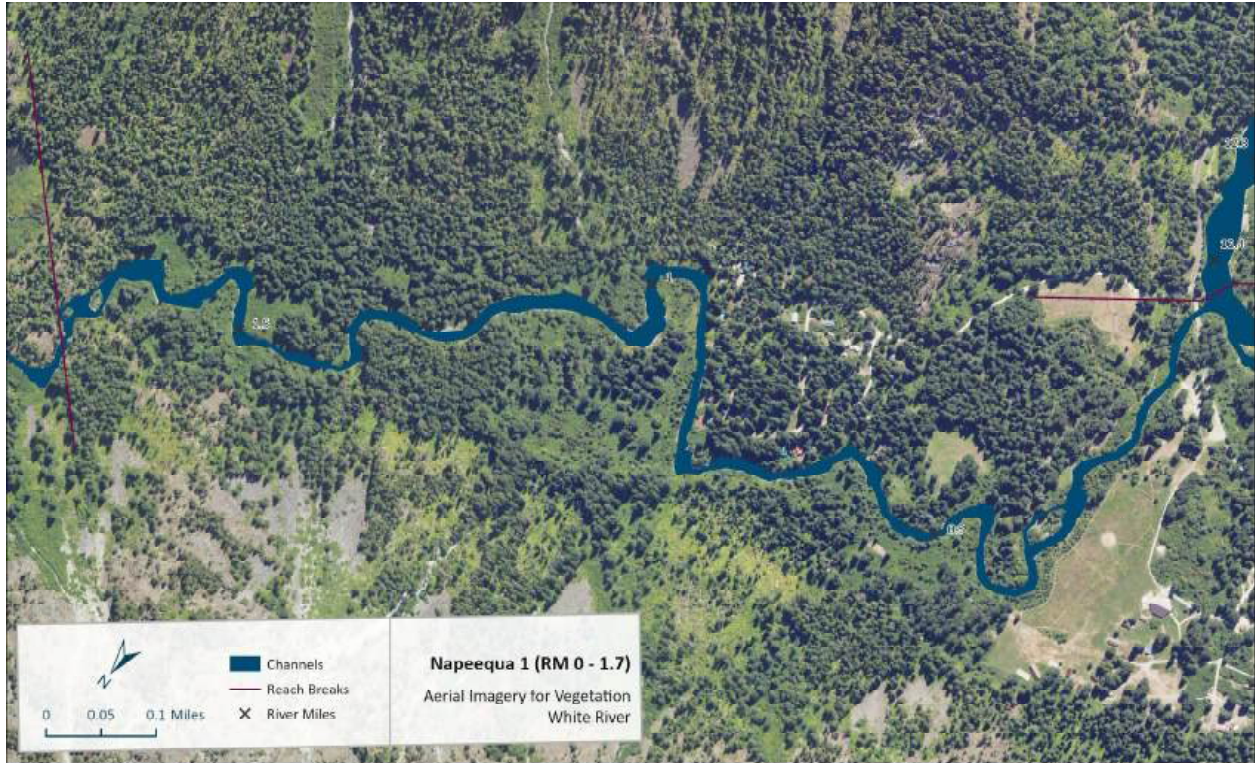
Figure 197. Napeequa River, Reach 1: Map of aerial imagery for vegetation identification.

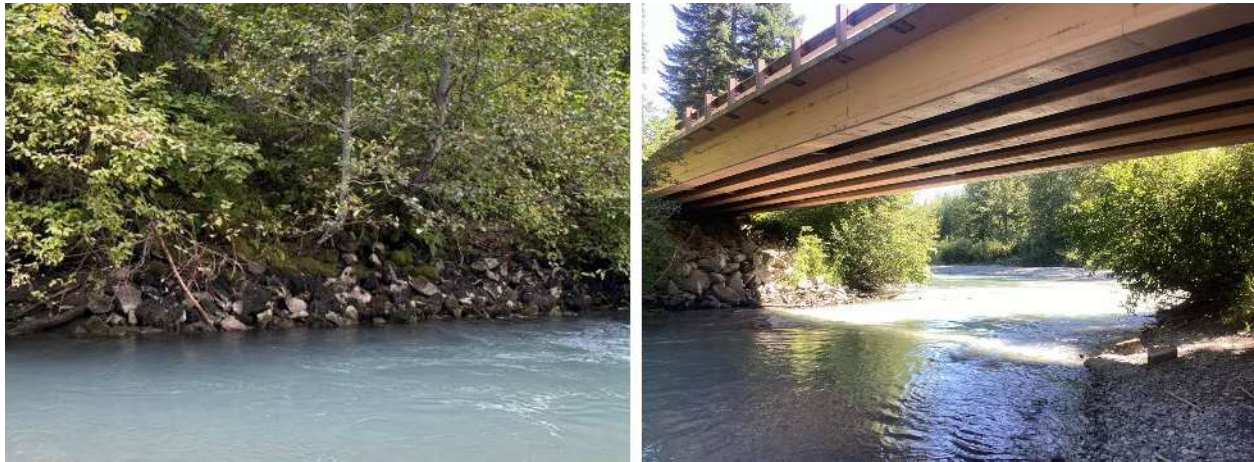
Figure 199. Left: Bank protection (riprap) at RM 0.05 on river-right (September 11, 2024). Right: White River Road bridge over mouth of Napeequa River and associated bank protection (September 3, 2024).

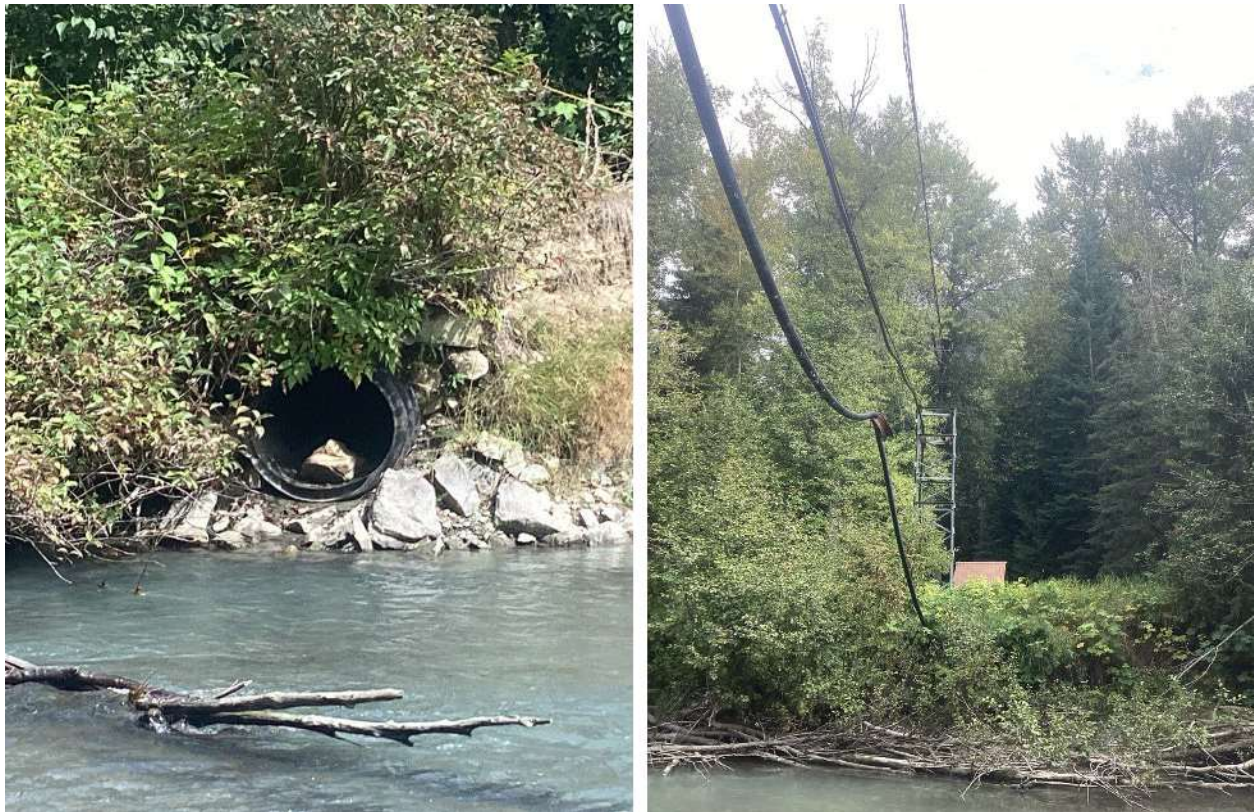
Figure 200. Left: Culvert draining historic channel on river left, entering the Napeequa River at RM 0.1 (September 11, 2024). Right: Cables over Napeequa River at RM 0.17 (September 11, 2024).

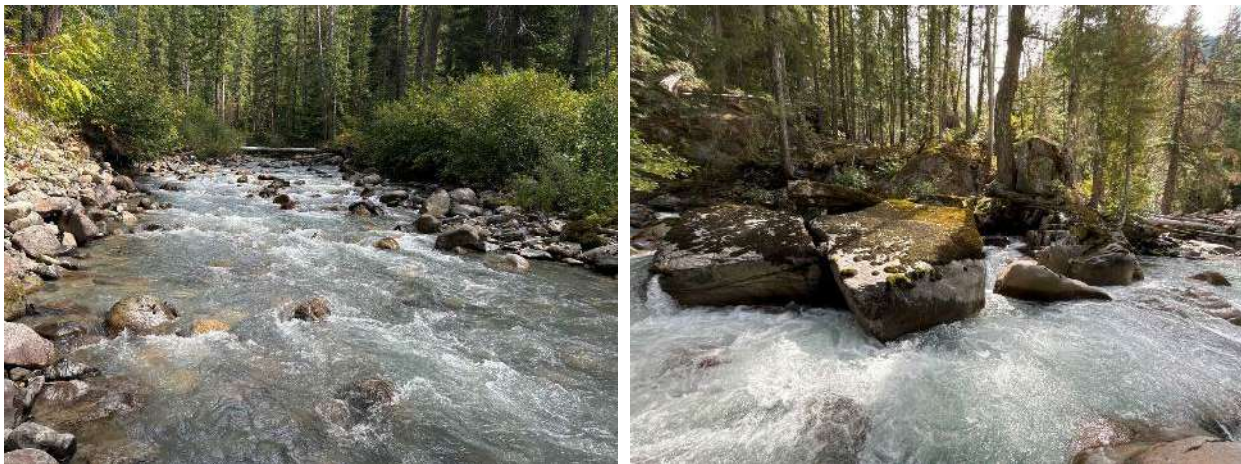
Figure 201. Representative photographs of Napeequa River in Reach 2. Left: long boulder riffle RM 1.9, looking upstream (September 10, 2024). Right: bedrock cascade at RM 2.1, viewed from river right (September 10, 2024).

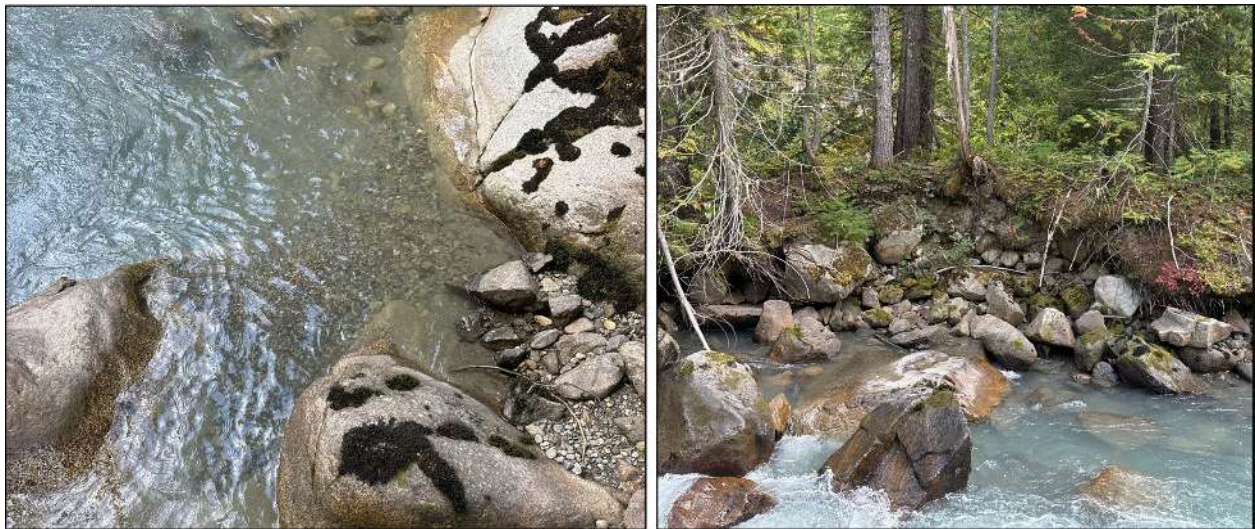
Figure 203. Left: Gravel deposition in backwater eddy, RM 2.1 (September 10, 2024). Right: Cobble-boulder sediment eroding from stream banks on river-right side of vegetated island at RM 2.17 (September 10, 2024).

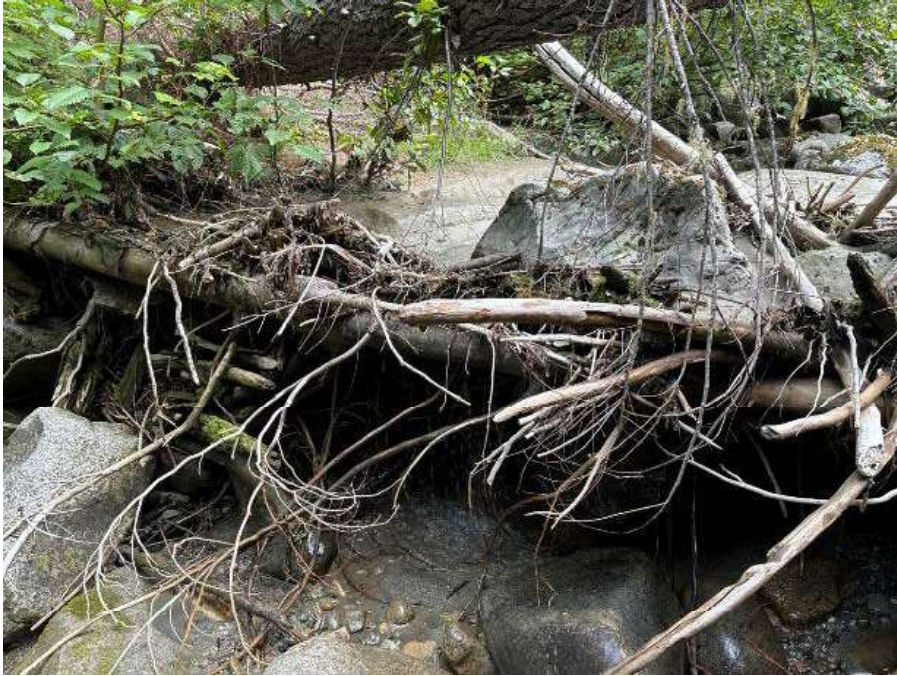
Figure 206. Large wood maintaining pool and 3-foot grade break at RM 2.02.

A total of 128 pieces of large woody material (LWM) and 14 log jams (accumulation of >3 LWM) were observed in the channel during the survey (August 2024) (Figure 205). Of the 128 pieces, 65 are considered Quality Large Wood (QLW); 17 classified as large size class (>20-inches diameter and >35-feet long); and 48 as medium size class (12 to 20-inch diameter and at least 35-feet long). Of the 14 wood jams, 13 contained multiple pieces of QLW. Large wood pieces greater than 12-18 inches, wedged between boulders, are effective in influencing geomorphic processes. Large wood pieces wedged between boulders maintain a wood-forced step-pool sequence on the river left channel just upstream of RM 2 (Figure 206) and create split-flow conditions near RM 1.74.

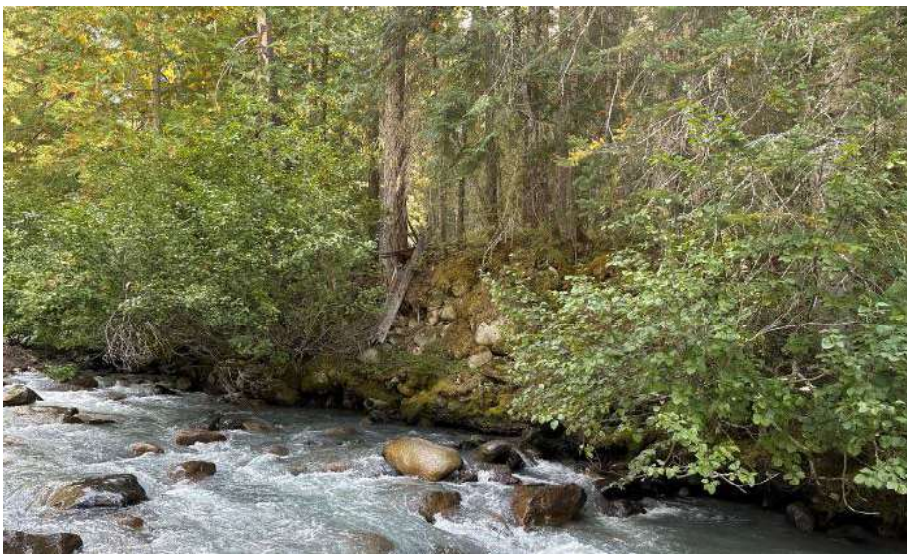
Figure 207. Representative photograph of vegetation in Reach 2 (September 10, 2024).

Vegetation adjacent to the Napeequa River channel in Reach 2 consists of western redcedar, Douglas-fir, and vine/Douglas maple on medium and high floodplain surfaces, terraces, and hillslopes, and alder in riparian areas (Figure 207). Taller trees provide shade to the channel and a local source of large wood recruitment. Sparse old-growth western redcedar and Douglas-fir were observed on terraces and the high floodplain surface that comprises the majority of the vegetated island that spans nearly half of the reach. Overstory and understory vegetation occupy the banks along the channel throughout the majority of the reach (Figure 208).

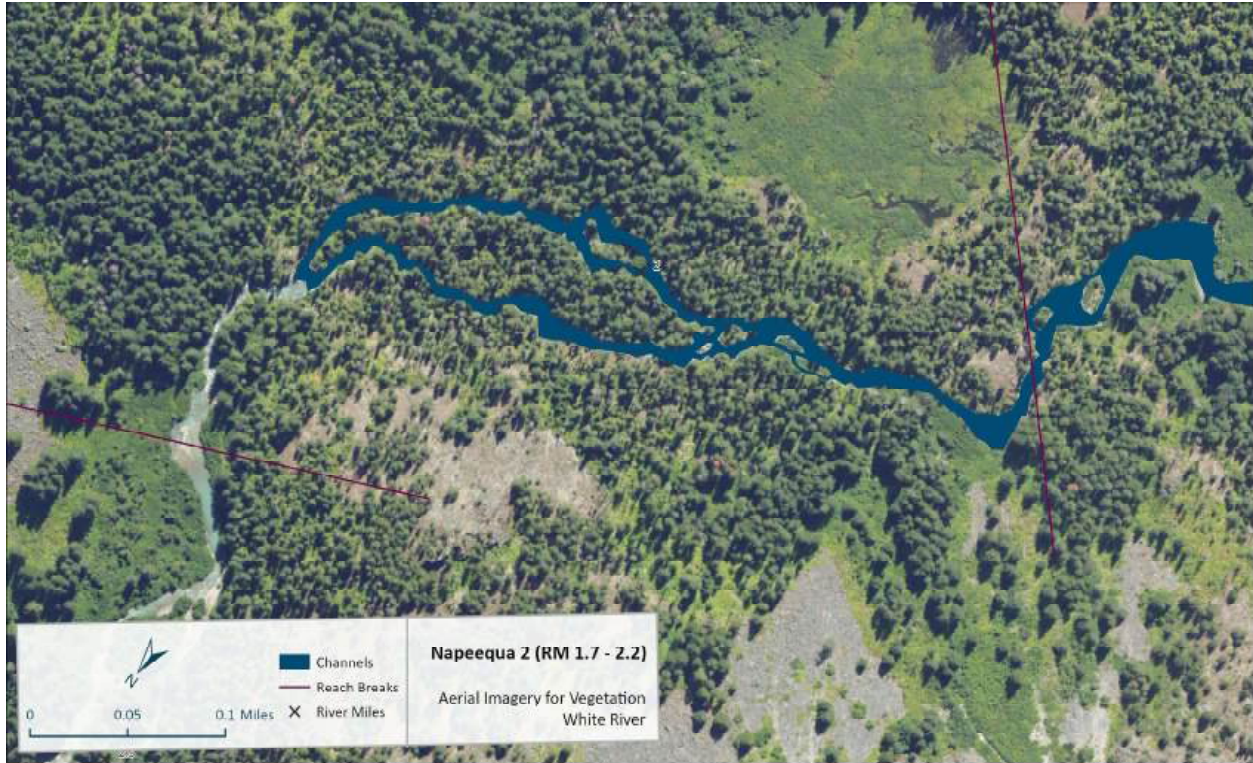
Figure 209. Napeequa River, Reach 2: Map of aerial imagery for vegetation identification.

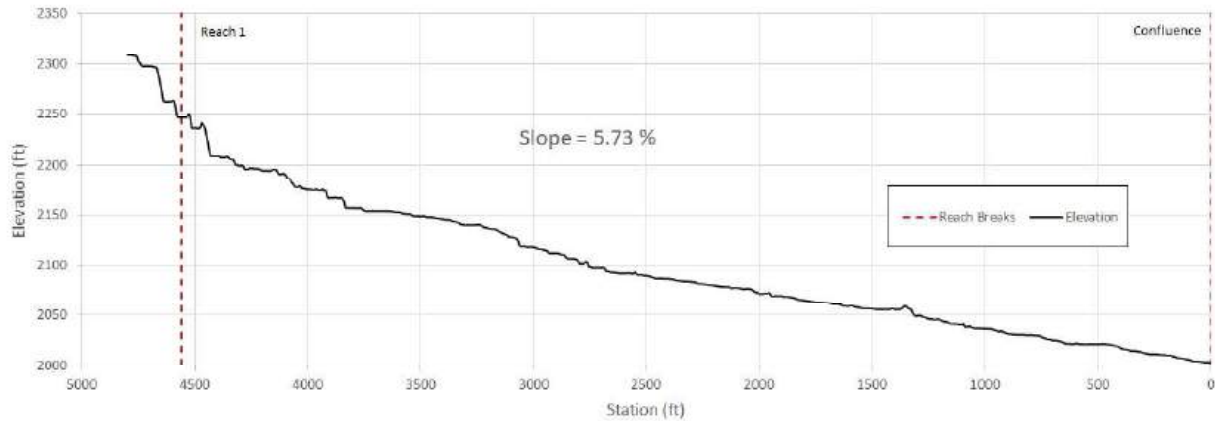
Figure 211. Longitudinal profile for Panther Creek.

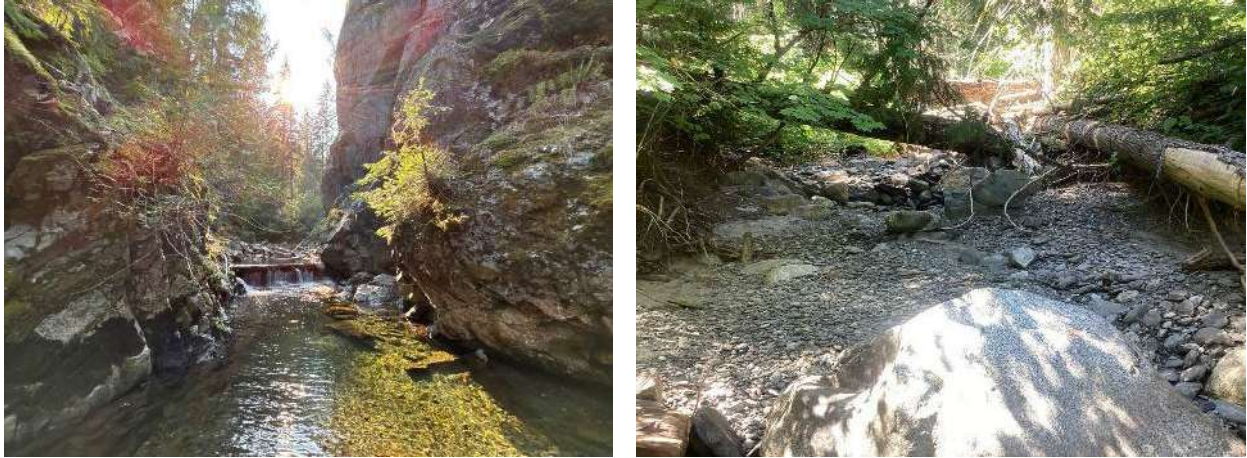
Figure 214. Left: Bedrock canyon near RM 0.4, looking upstream (September 6, 2024). Right: Panther Creek ephemeral distributary channel outlet (dry) near White River RM 14.86 (August 1, 2024).

Reach 1 is a high gradient, partially confined channel with low sinuosity. The Habitat Assessment (See Appendix A) recorded 69% of the habitat as riffle, 30% as pool, and 1% as cascade (Figure 213). The channel is confined on both sides by a bedrock canyon upstream of ~RM 0.4 (Figure 214). Downstream of ~RM 0.4 the channel cuts through the coarse sediments of the Panther Creek alluvial fan which limits potential surfaces on which floodplains can be established. Sparse pockets of low floodplain were observed between RM 0.1 and the bedrock canyon at RM 0.4. Narrow low floodplain surfaces line both sides of the channel for the last few hundred feet before the White River confluence, and medium height floodplain surfaces occupy a portion of the Panther Creek alluvial fan downstream of RM 0.1 (Figure 213). Floodplains are composed of coarse cobble-boulder alluvial fan deposits overlain by a thin layer of fine sediment and soil. High surfaces on the alluvial fan function like terraces. Multiple ephemeral distributary channels branch off of the Panther Creek mainstem channel downstream of the canyon on river-right (Figure 214). These appear to be active only at very high flows. Some of these have headcuts that are approaching the main channel and so may soon become more active. There is a prominent distributary channel on river-right near RM 0.1 that was not active at the time of the survey but would be active during annual high flow periods. This channel contains multiple channel threads, high complexity, abundant gravel, and abundant quantities of LWM in large rafts and jams (Figure 215). This distributary channel connects to the mainstem White River approximately 800 feet downstream of the active Panther Creek channel. There are no tributaries to Panther Creek Reach 1.

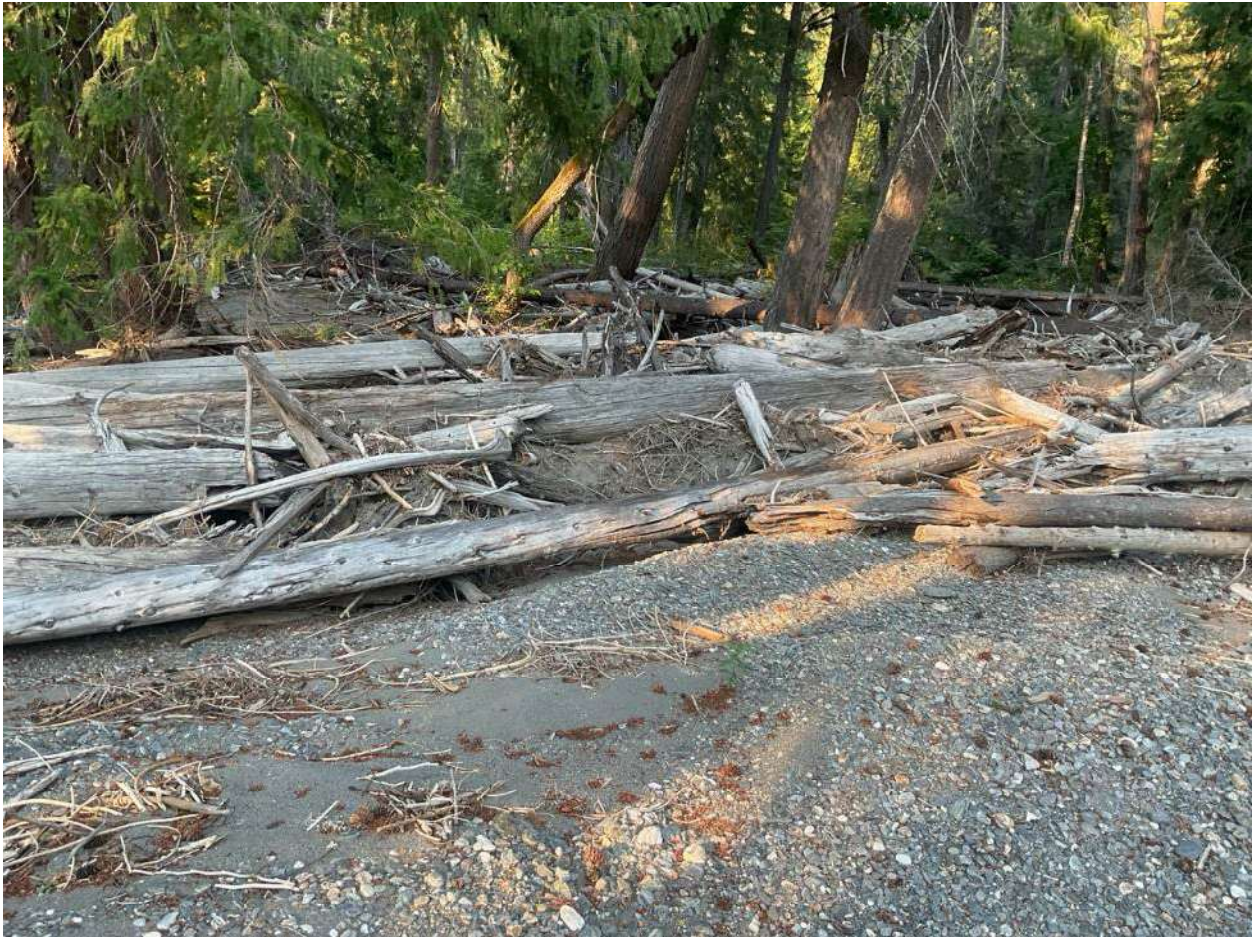
Figure 215. Large jam and gravel deposits in prominent distributary channel at lower end of Panther Creek (not active at time of survey) (September 6, 2024).

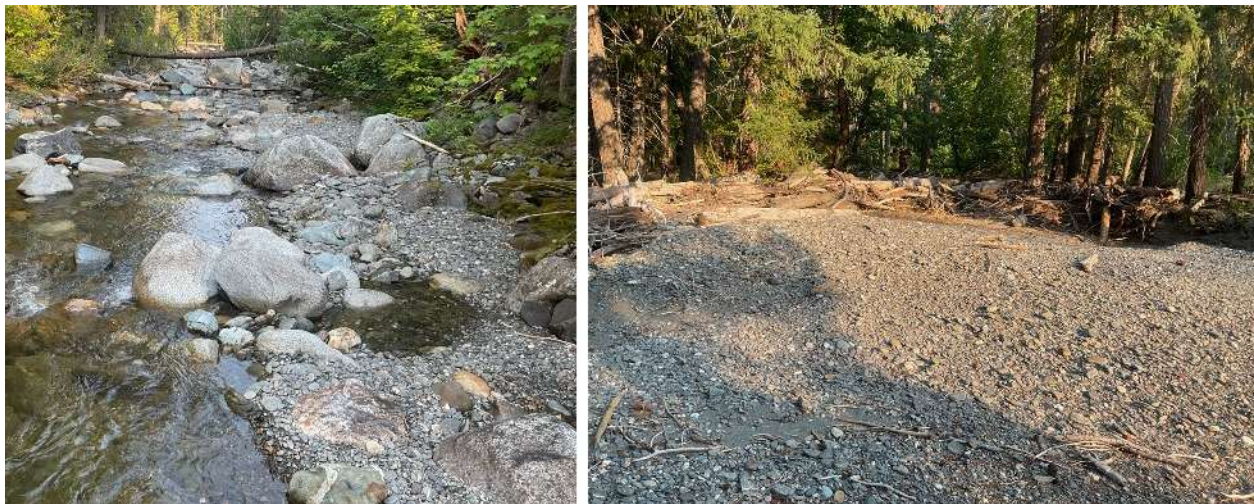
Figure 216. Left: gravel deposition behind boulders along the channel margin of Panther Creek near RM 0.2 (September 6, 2024). Right: large gravel deposit in distributary channel that branches off near RM 0.1 (September 6, 2024).

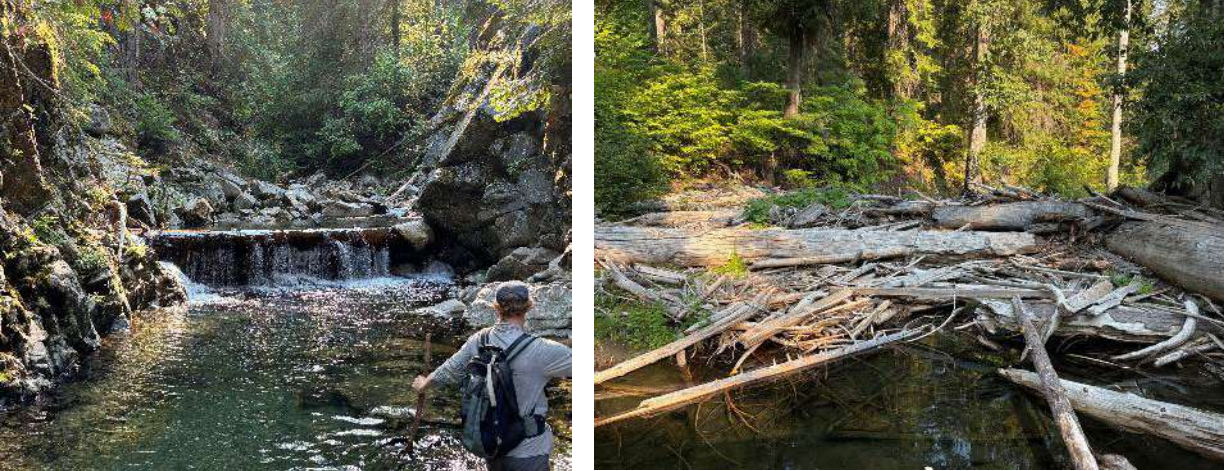
Figure 219. Left: Wood-forced pool and ~3.5-foot-tall step upstream of RM 0.4 on Panther Creek (September 6, 2024). Right: Large wood jam at ~RM 0.26 creating pool and forcing flow to river-right (September 6, 2024).

A channel-spanning log wedged between bedrock outcrops on either side of the channel forces a large pool that flows over a ~3.5-foot vertical step into a scoured bedrock plunge-pool where the channel exits the canyon near RM 0.4 (Figure 219). Downstream near RM 0.26, a large wood jam on river-left creates a large pool and small mid-channel bar upstream, and abruptly forces flow river-right. Elsewhere on Panther Creek large wood jams appear to have been blown out by high flows and exert a limited geomorphic influence. LWM greater than 2 feet diameter and wedged between boulders or bedrock exposures were observed to be effective in maintaining geomorphic influences and sustaining jams, whereas smaller pieces, or those not anchored in some way, appeared mobile at higher flows, and thus ineffective. Several large jams in the ephemeral Panther Creek distributary channels on river right downstream of RM 1 maintain split-flow conditions and promote pool scour and coarse sediment sorting when activated (Figure 220).

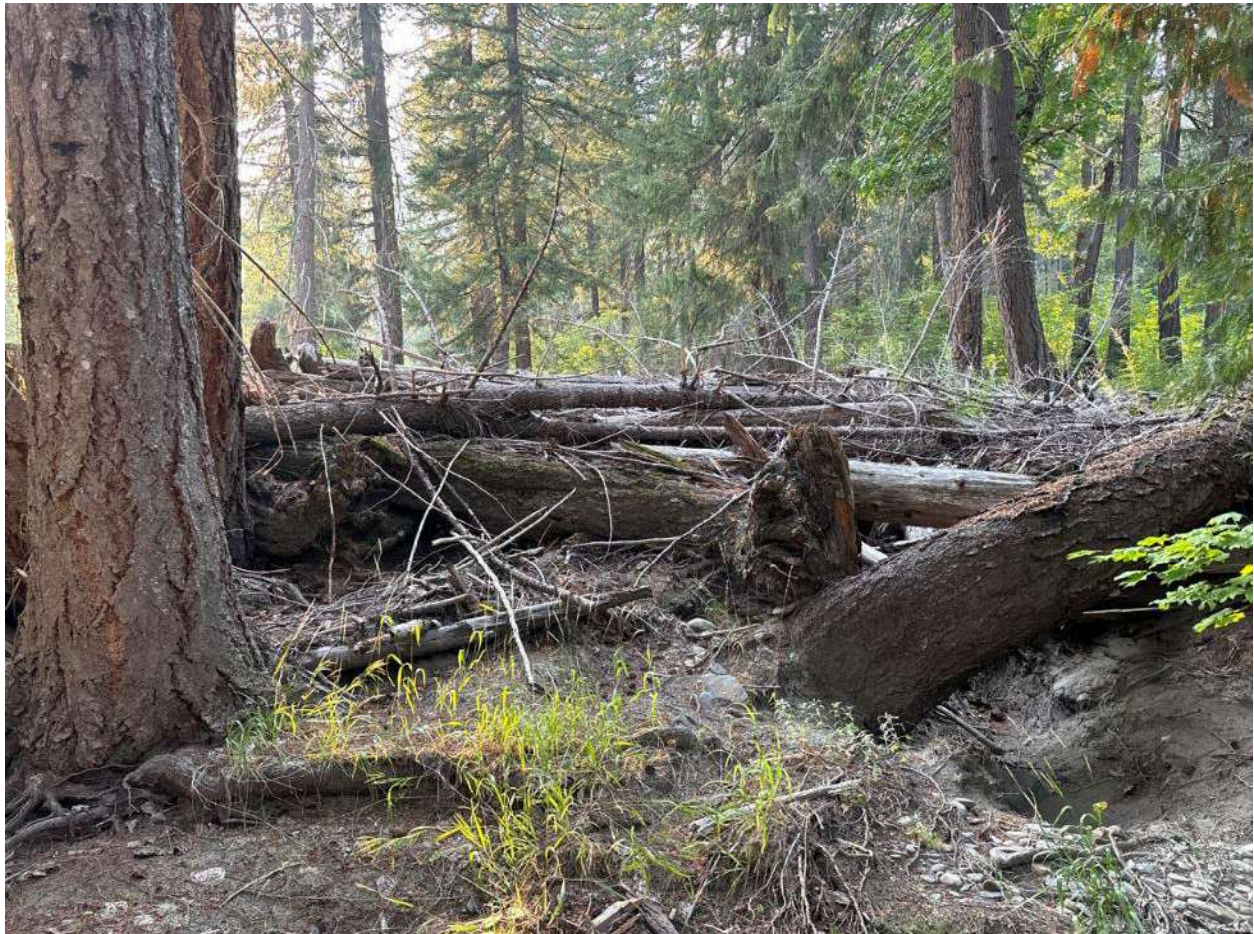
Figure 220. Large wood jam in Panther Creek ephemeral distributary channel (dry) downstream of RM 0.1 (September 6, 2024).

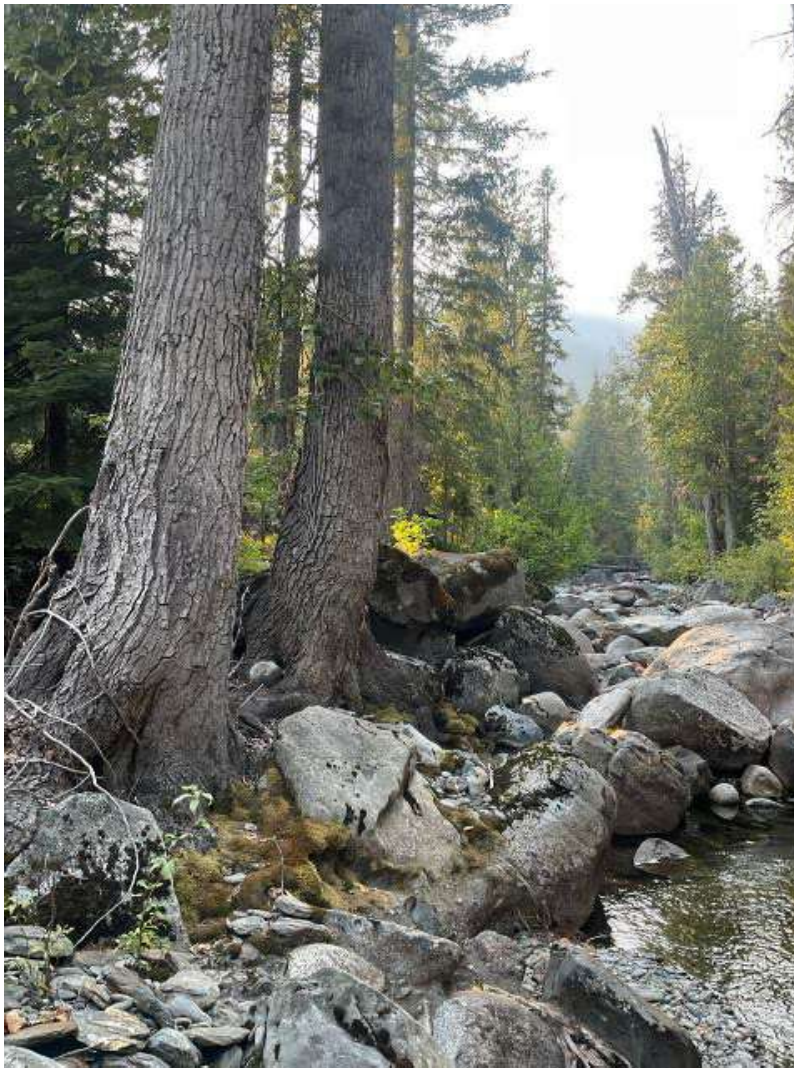
Figure 221. Cottonwood, western redcedar, Douglas-fir, and vine/Douglas maple adjacent to the Panther Creek channel at ~RM 0.17, looking upstream (September 6, 2024).

Vegetation in Panther Creek Reach 1 consists of an overstory composed of second-growth western redcedar, grand fir, Douglas-fir, and cottonwood, and an understory of small conifers, vine/Douglas maple, and huckleberry (Figure 221). Seedling and sapling cottonwood are present on low floodplain surfaces. Old-growth trees were not observed, although the largest trees adjacent to the Panther Creek channel exceeded the estimated 2-foot diameter requirement for effective key LWM pieces. Recruitable streamside trees are present throughout the reach except for portions of the bedrock-confined canyon upstream of RM 0.4 (Figure 222).

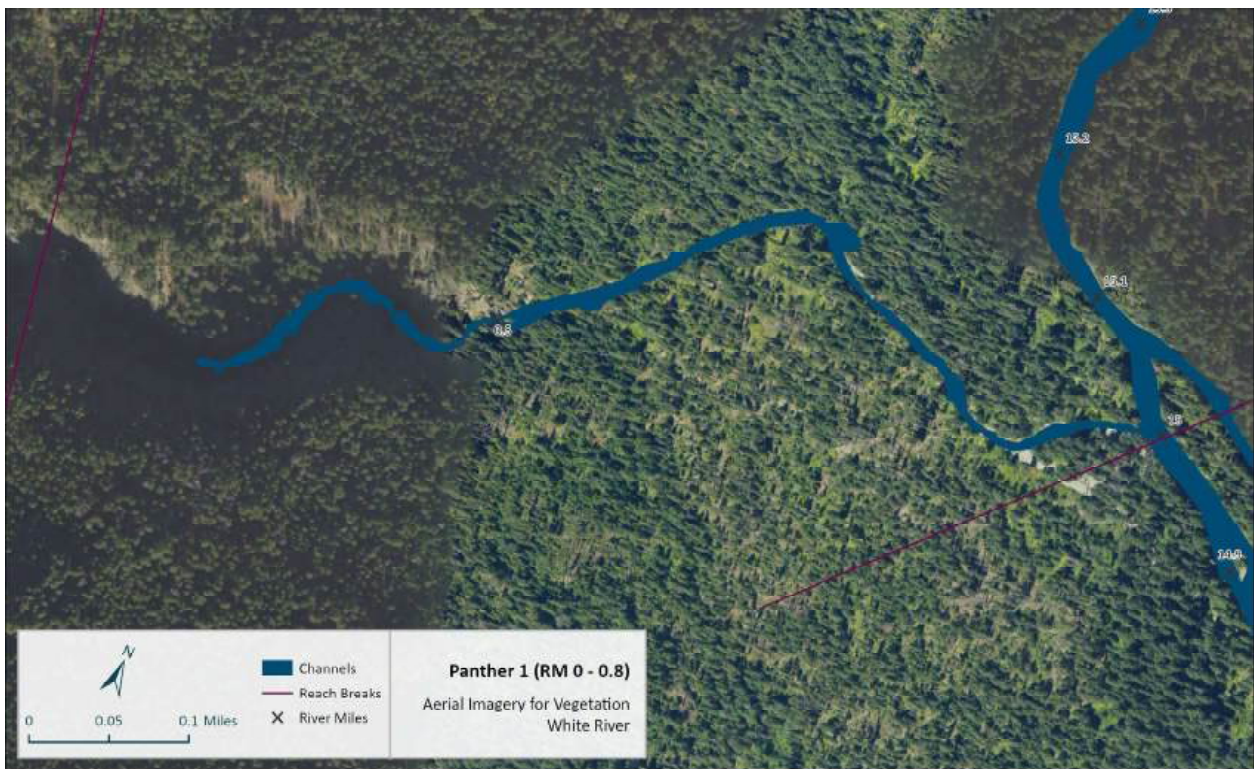
Figure 223. Panther Creek, Reach 1: Map of aerial imagery for vegetation identification.
