White River Reach Assessment & Restoration Strategy

Final Report

PREPARED FOR
Yakama Nation Fisheries

PREPARED BY
Inter-Fluve

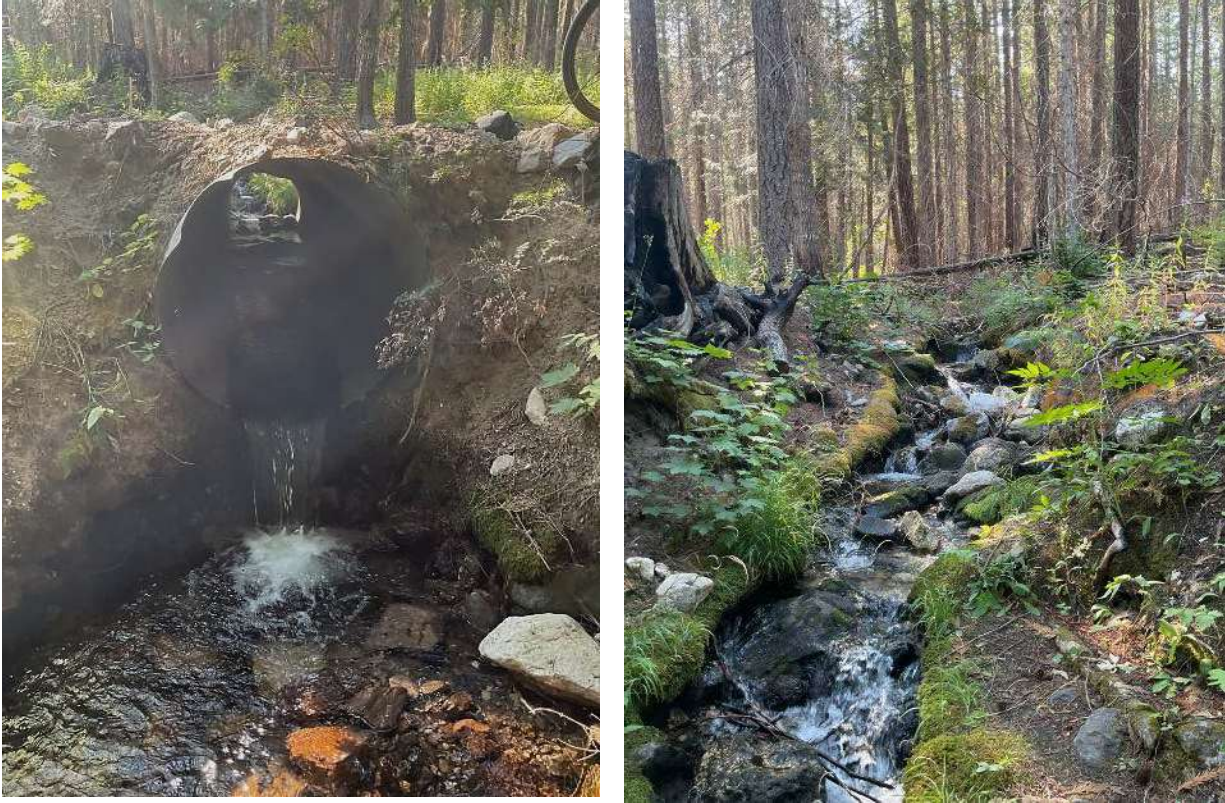
Figure 225. Left: Sears Creek crossing under Sears Creek Road (Forest Road 6404). Right: Sears Creek upstream of the crossing (August 2024).

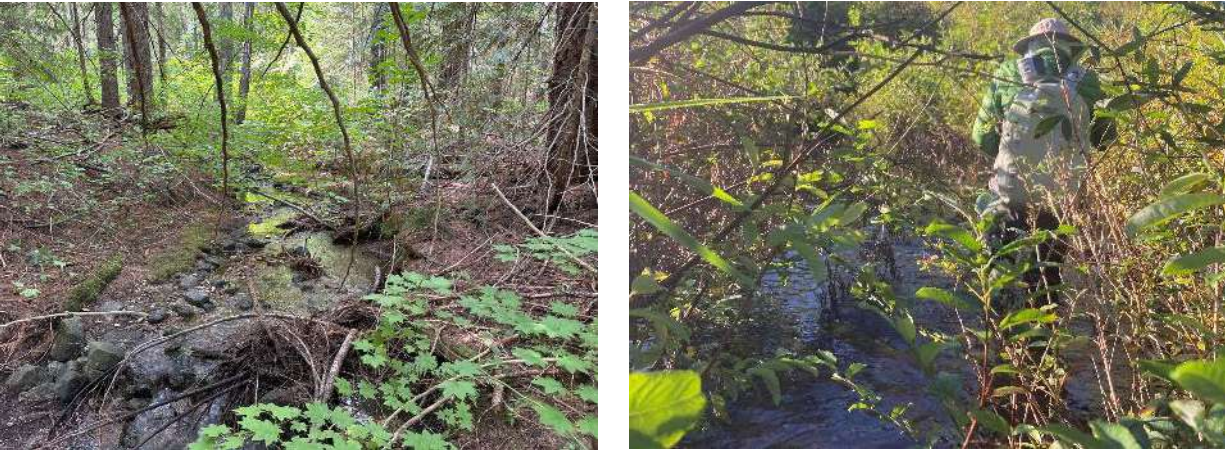
Figure 226. Left: Sears Creek downstream of Sears Creek Road (Forest Road 6404) crossing. Right: Beaver pond wetland complex on Sears Creek.
