Technical Report No. ENV-2025-020

Chewuch River Reach Assessment – Geomorphology and Hydraulics

**Methow River Sub-Basin, Okanogan County, Washington
Columbia-Pacific Northwest Region**

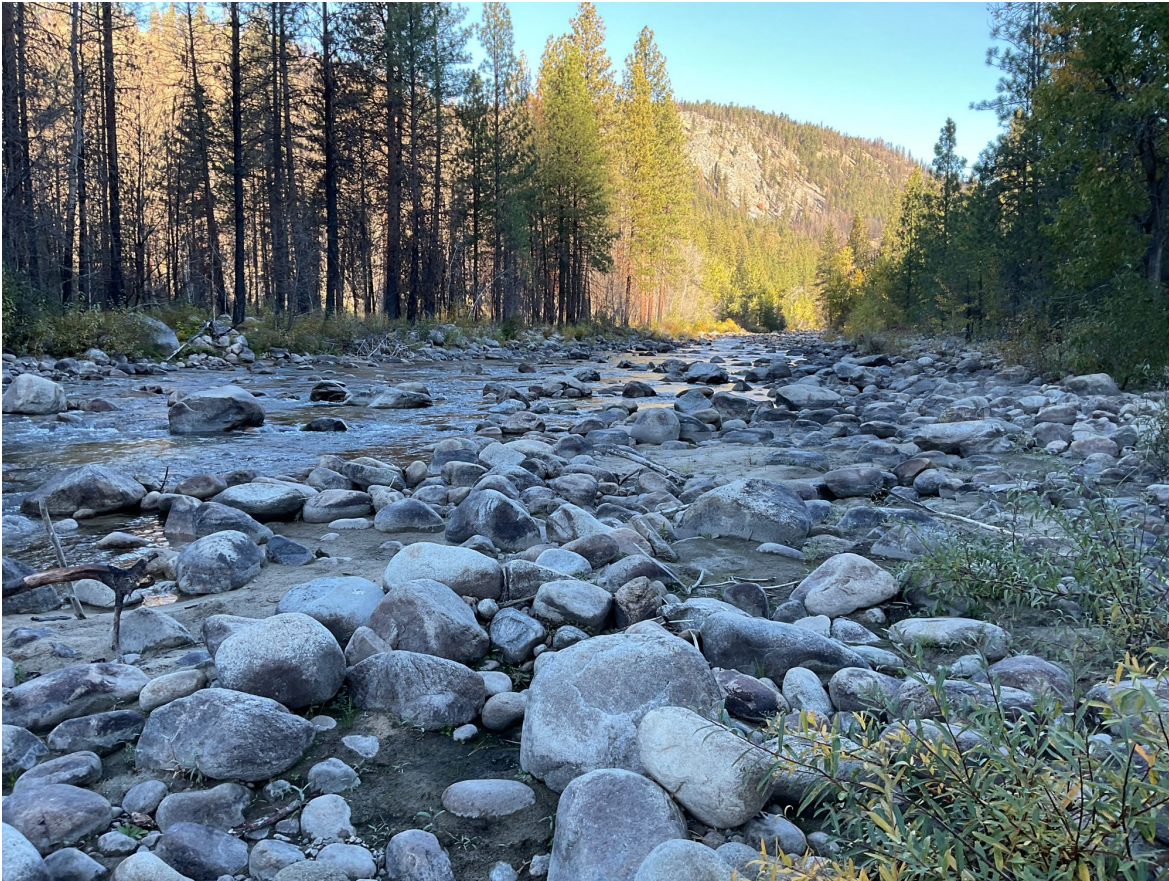
Figure 4.—Boulder-sized bed material in the vicinity of River Mile 9 (Reclamation/Aaron Hurst).

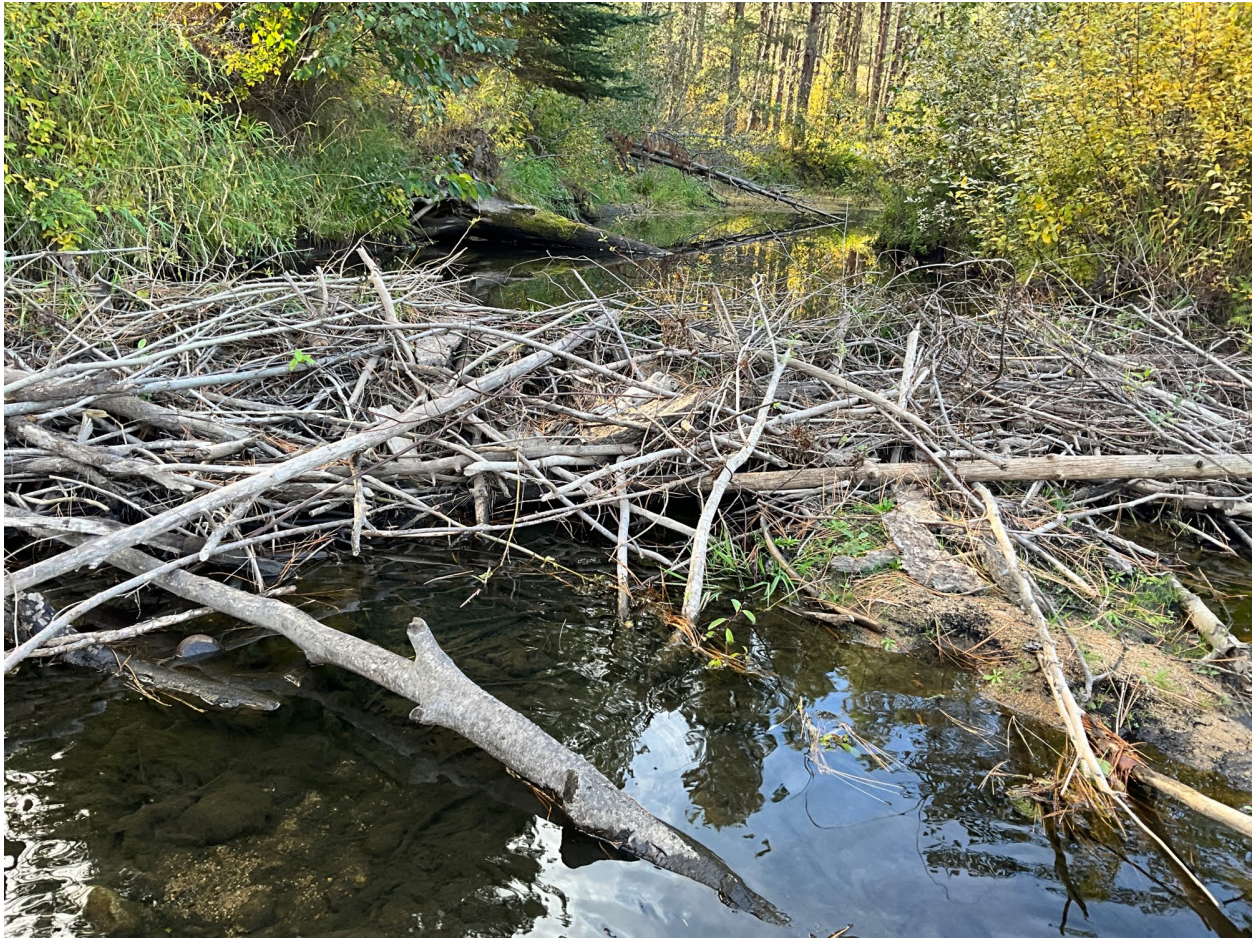
Figure 5.—A small beaver dam at a side channel outlet near River Mile 12.5. Photo taken looking upstream (Reclamation/Aaron Hurst).

We conducted a field mapping effort in October 2023 to validate the aerial and satellite imagery mapping outlined above. In the field, we used the program StraboSpot installed on an iPad to create shapefiles of observed features. We waded the river from upstream to downstream. Areas where we stepped out of the river are noted below. Anywhere there was a flow split, one person traveled down each flow path. We noted anywhere we saw evidence of side channels and overflow channels, including flotsam, which is evidence of recent flow. As we mapped, we used the REM and aerial imagery as a basemap and tried to confirm evidence of low-confidence channels from the REM. We also made observations of bank erosion and channel bed composition (figure 4). We did not map wood in the field but did note locations of observed beaver dams (figure 5).

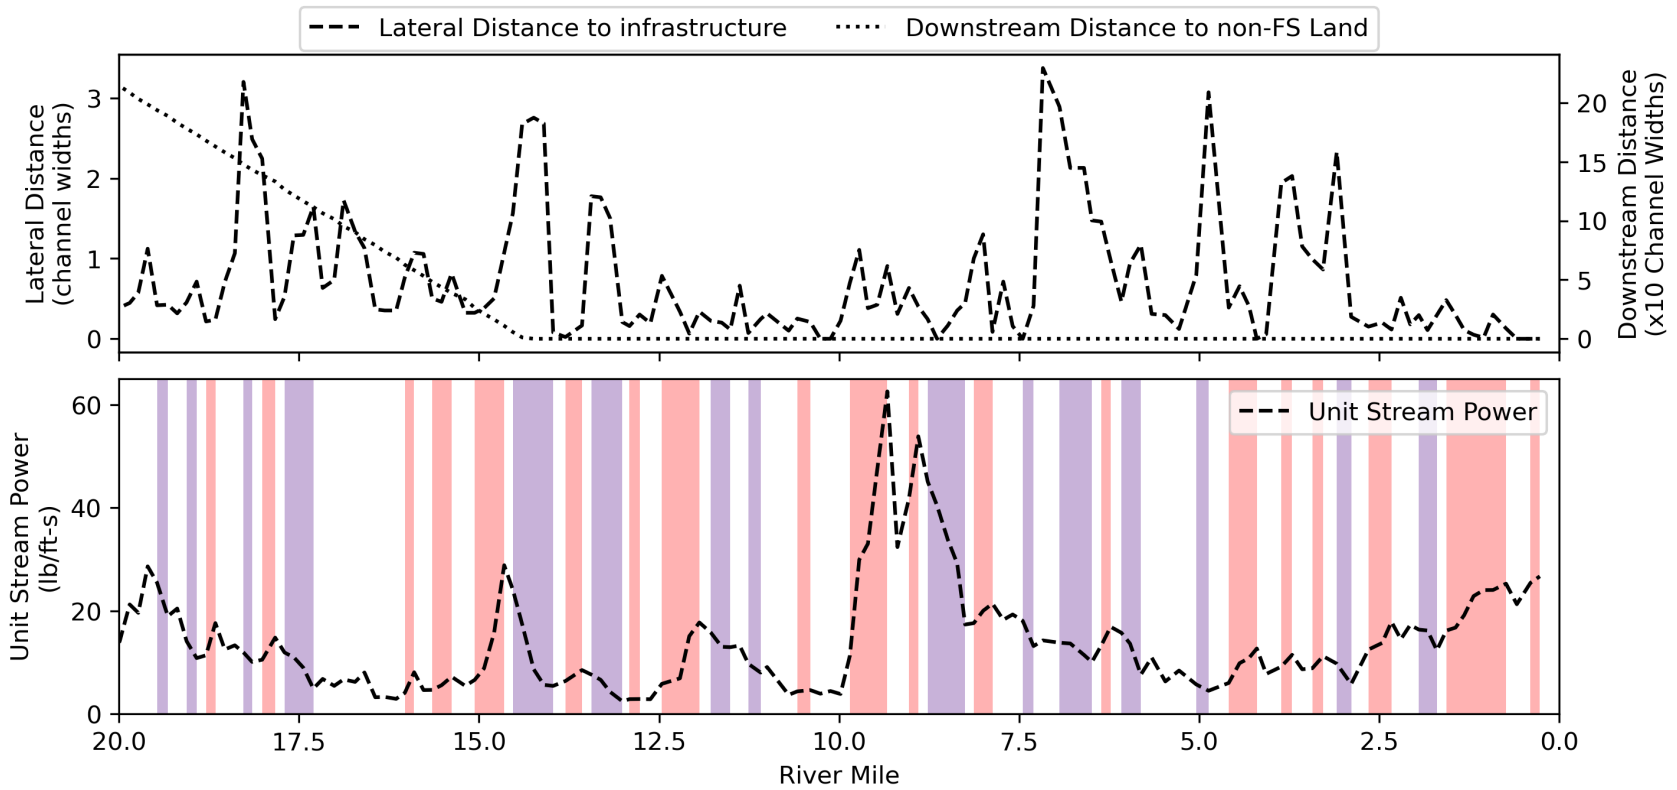
Figure 14.—Upper most plot shows lateral and downstream distances to infrastructure and non-federal property. The lower plot shows unit stream power values and change in unit stream power. Lengths of river where unit stream power is either increasing or decreasing for at least two 1/8th-mile risk segments are represented by red and purple shading, respectively.

are small bars and pockets of floodplain where more lateral space exists, however the inundation width differences between low and high flows is minimal throughout most of the reach (figure 19; figure 73). The increased gradient and confinement from Pearrygin 2 are likely the cause for increased stream power and mobile grain size within the reach (figure 14; figure 20).

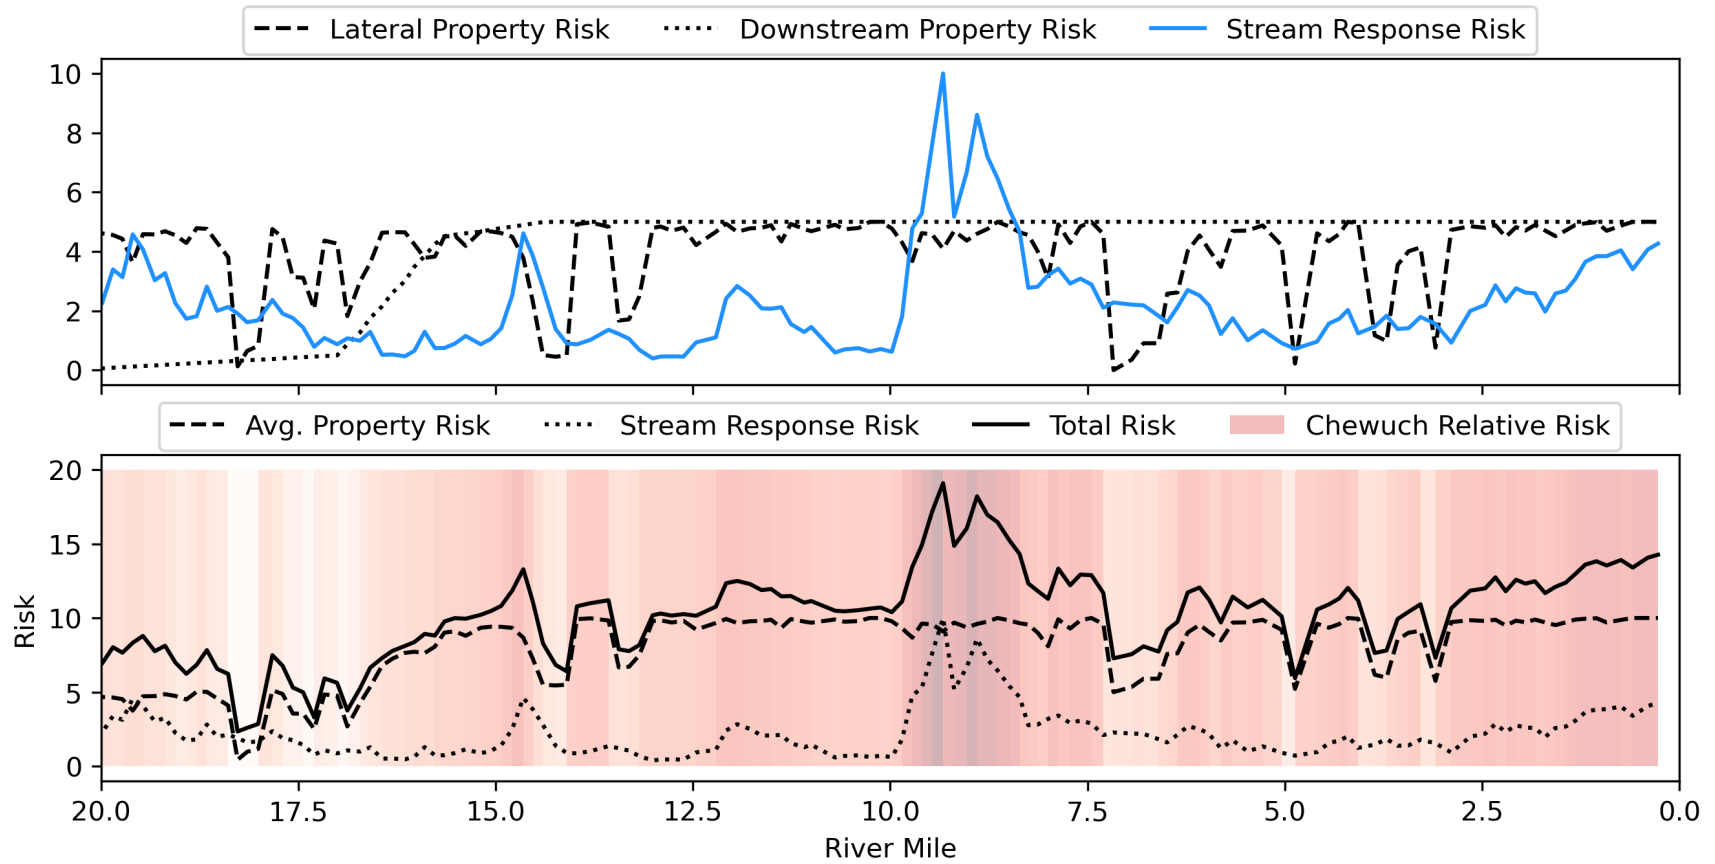
Figure 15.—Components of risk computation and overall risk score calculated at each 1/8-mile segment. The top plot shows the individual risk scores for lateral and downstream property risk as well as stream response risk. The bottom plot shows property risk and stream response risk, which are combined to estimate total risk. Darker shades of red represent more risk.

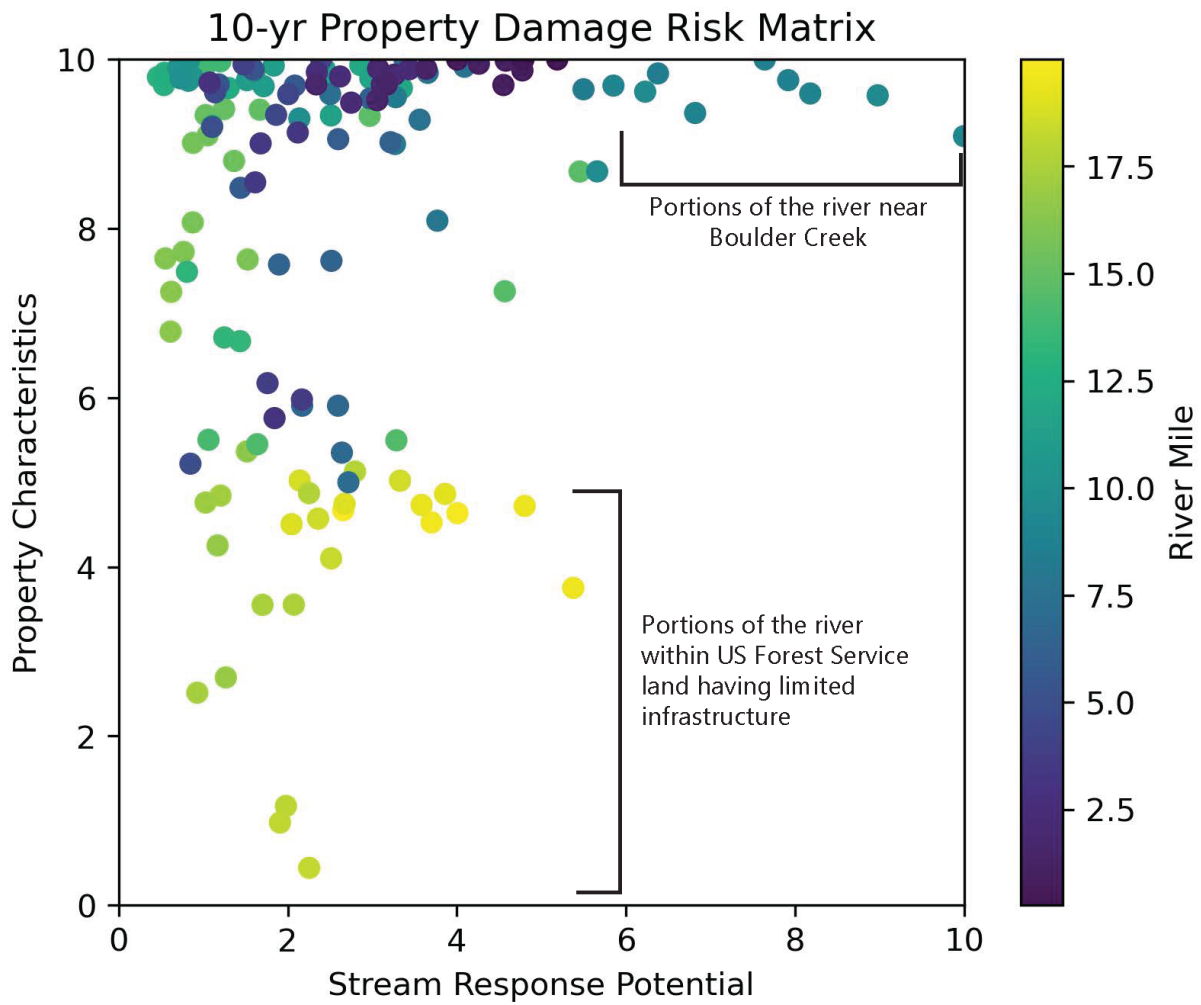
Figure 16.—Quantitative property risk matrix for Chewuch River for RM 20 to 0.

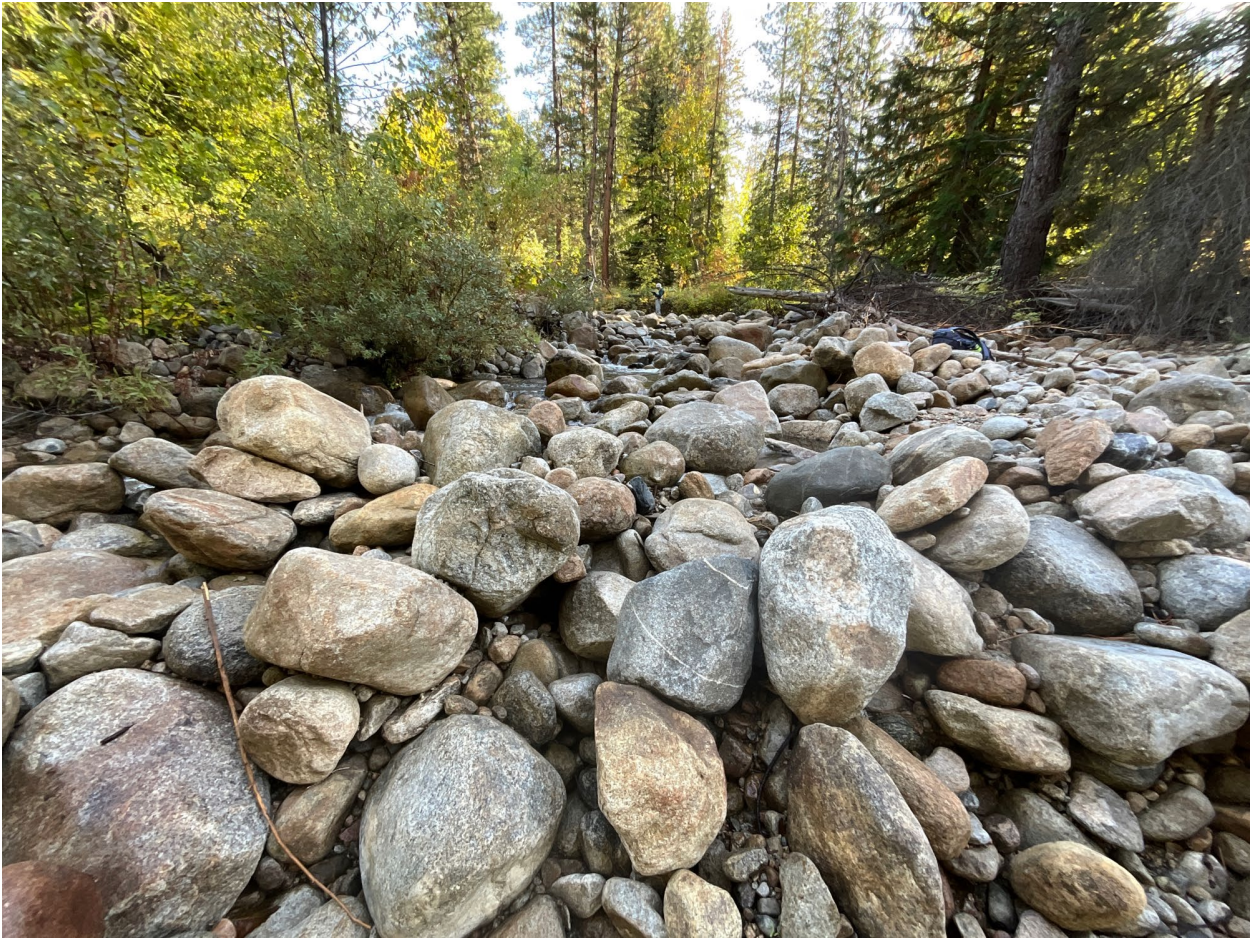
Figure 23.—Looking upstream within Twentymile Creek from the mainstem Chewuch River. Backpack in the background for scale (Reclamation/Aaron Hurst).

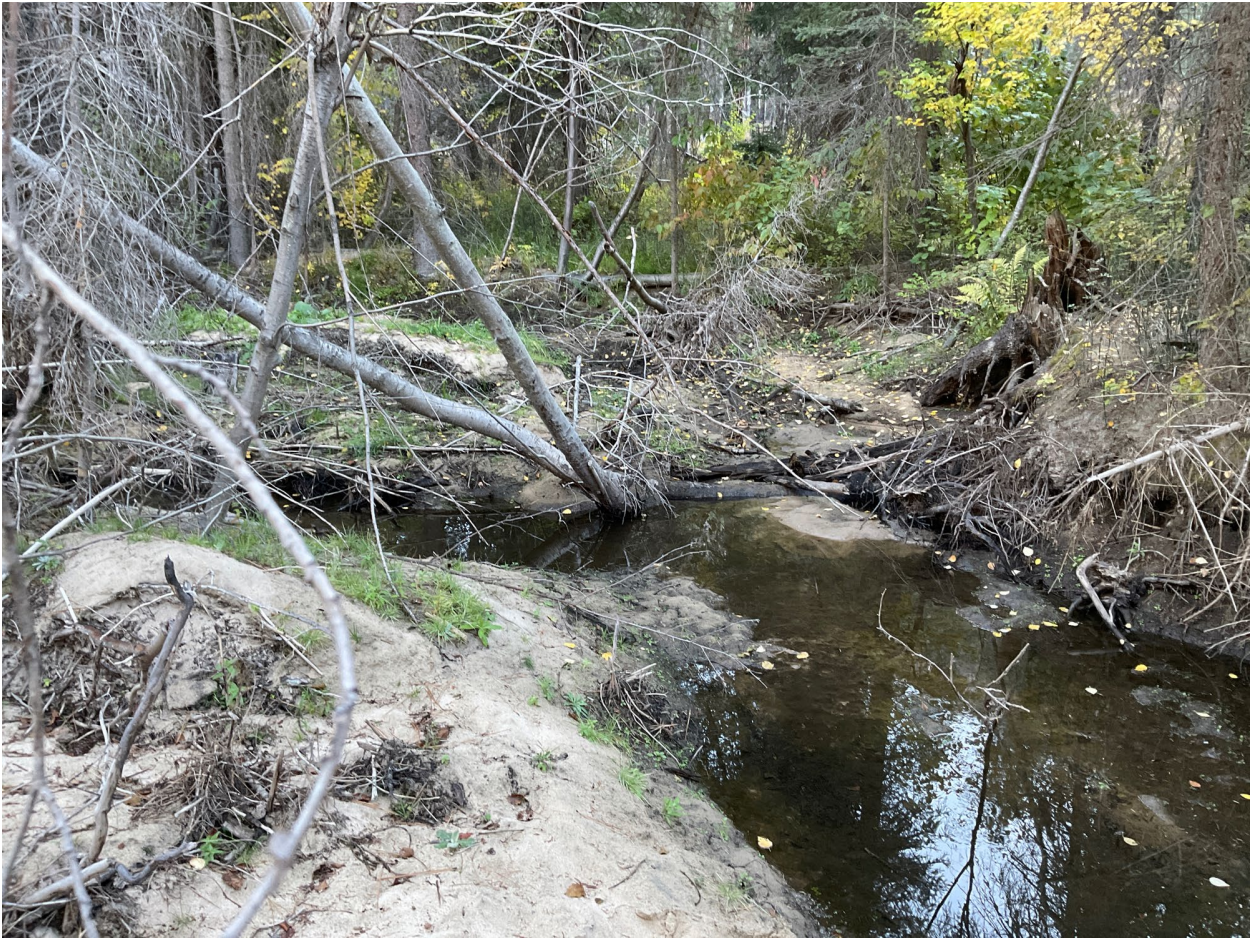
Figure 26.—Image is taken near River Mile 16.3 looking downstream within a side channel that carries low flows, while the mainstem, larger channel (not pictured) connects at most flows as well (Reclamation/Melissa Foster).

At the RM 16.5 channel split, the lowest flows travel through a small side channel, but the larger main channel is also active at most flows. The apex of this split flow is influenced by a river restoration project with large wood structures and additional wood racking (figure 26). Small alluvial fans exist throughout the reach, but the large fan at the upstream boundary and the fan at RM 17 are probably the only ones that impact channel mobility (figure 27). The Doe 5 reach experienced an almost steady narrowing of the active geomorphic corridor from 1975 to 2023 (figure 28). This is largely due to abandonment of overflow channels and an accompanying decrease in the vegetated bar area. This reach is less confined than the upstream reach and historically had an extensive overflow channel network that was likely connected to the main channel at higher flows.

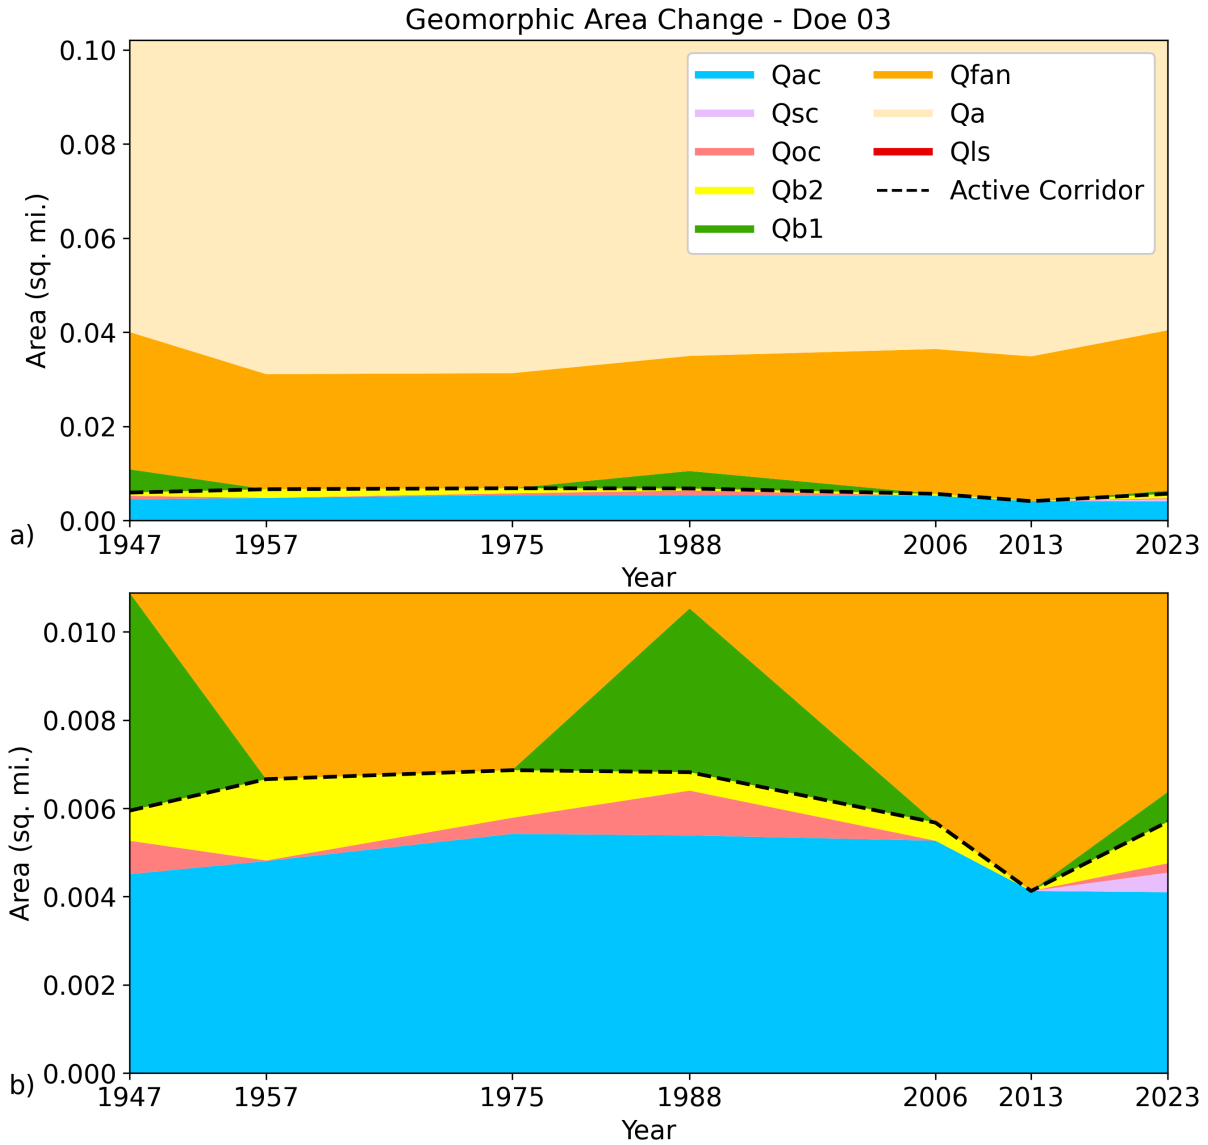
Figure 34.—Geomorphic area change for the Doe 3 reach (RM 14.8 to 14.4) from 1947 to 2023. The bottom figure is zoomed in to look more closely at features with smaller areas. Qac = active channel, Qsc = side channel, Qoc = overflow channel, Qb1 = vegetated bar, Qb2 = unvegetated bar, Qfan = alluvial fan, Qa = Quaternary alluvium, and Qls = landslide.

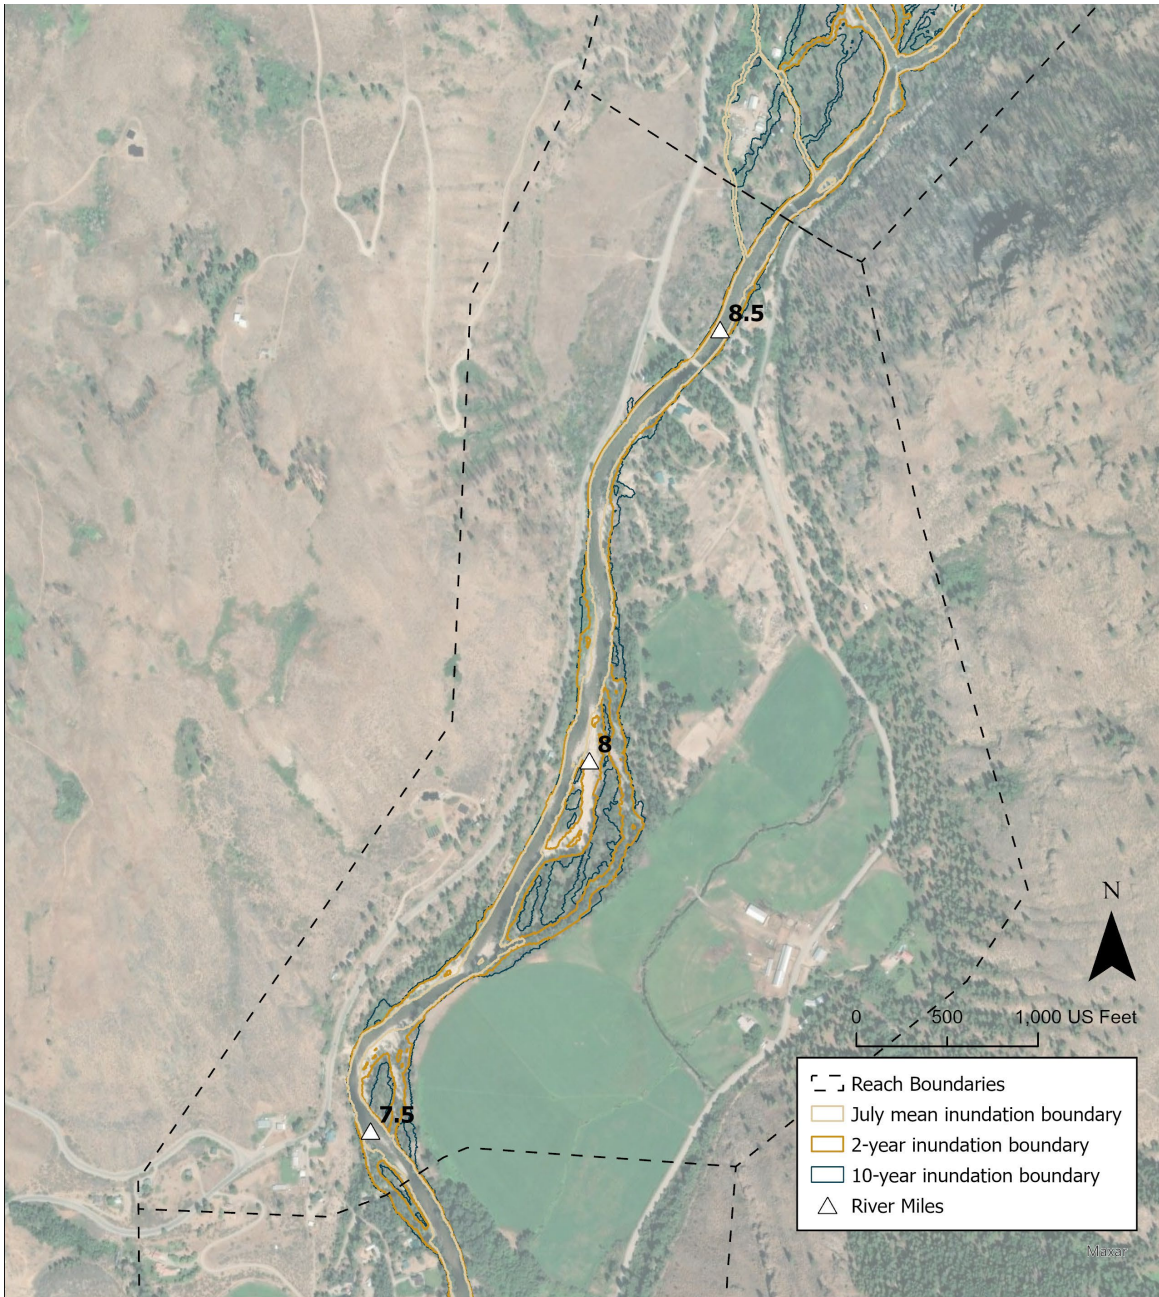
Figure 54.—Inundation boundaries for the July mean, 2-year, and 10-year flows in Perrygin 7.

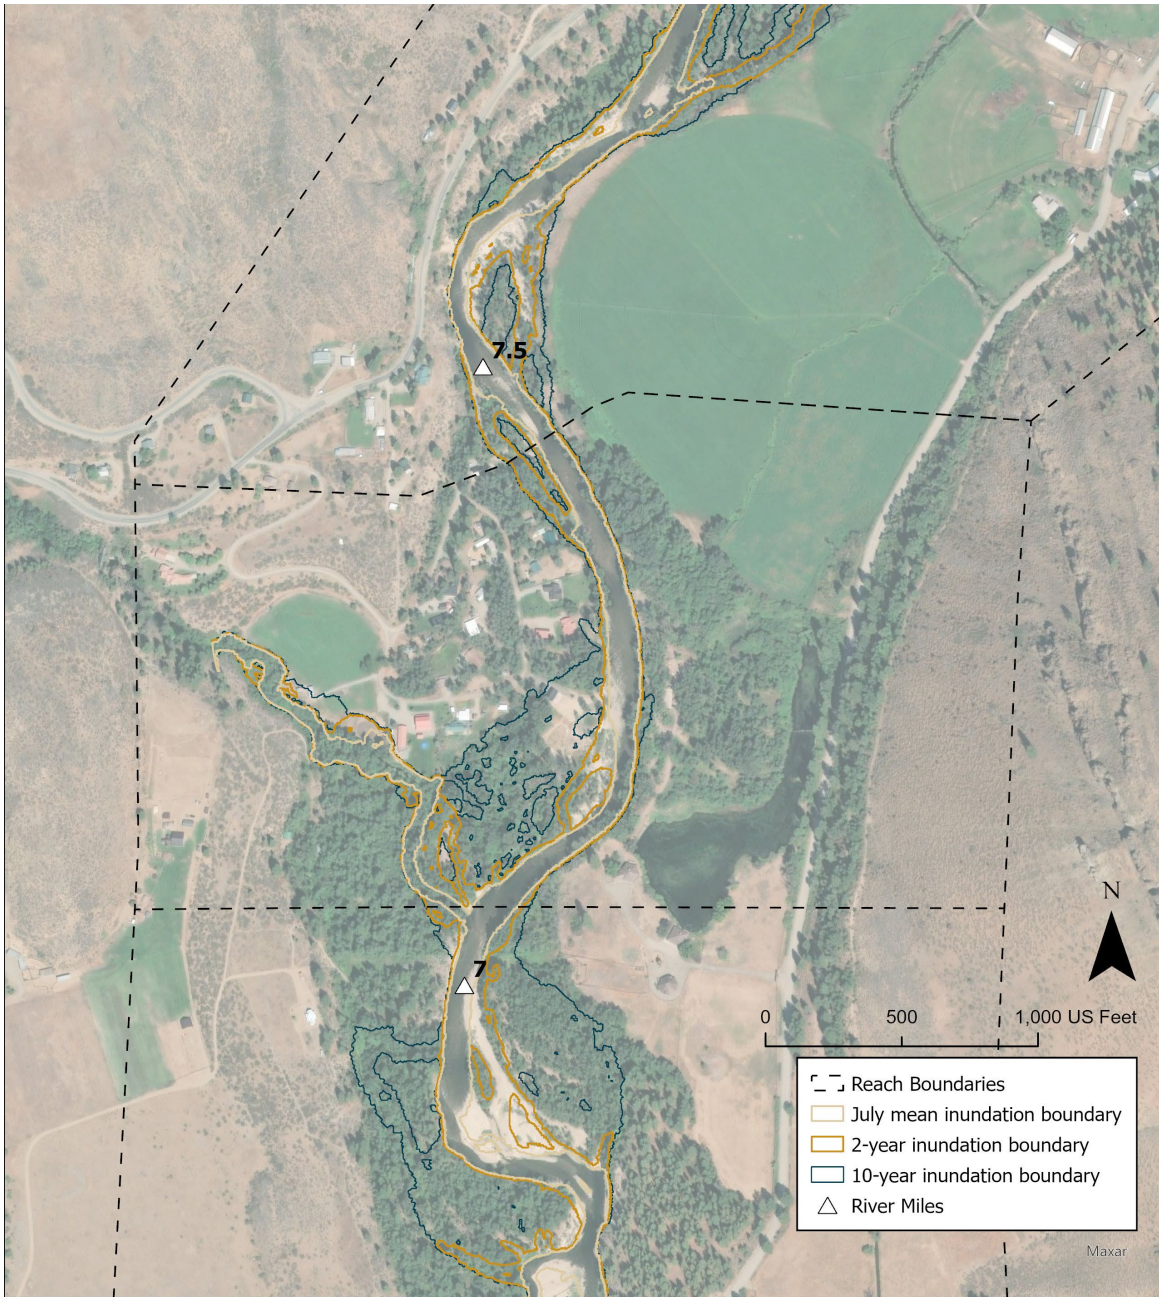
Figure 57.—Inundation boundaries for the July mean, 2-year, and 10-year flows in Perrygin 6.

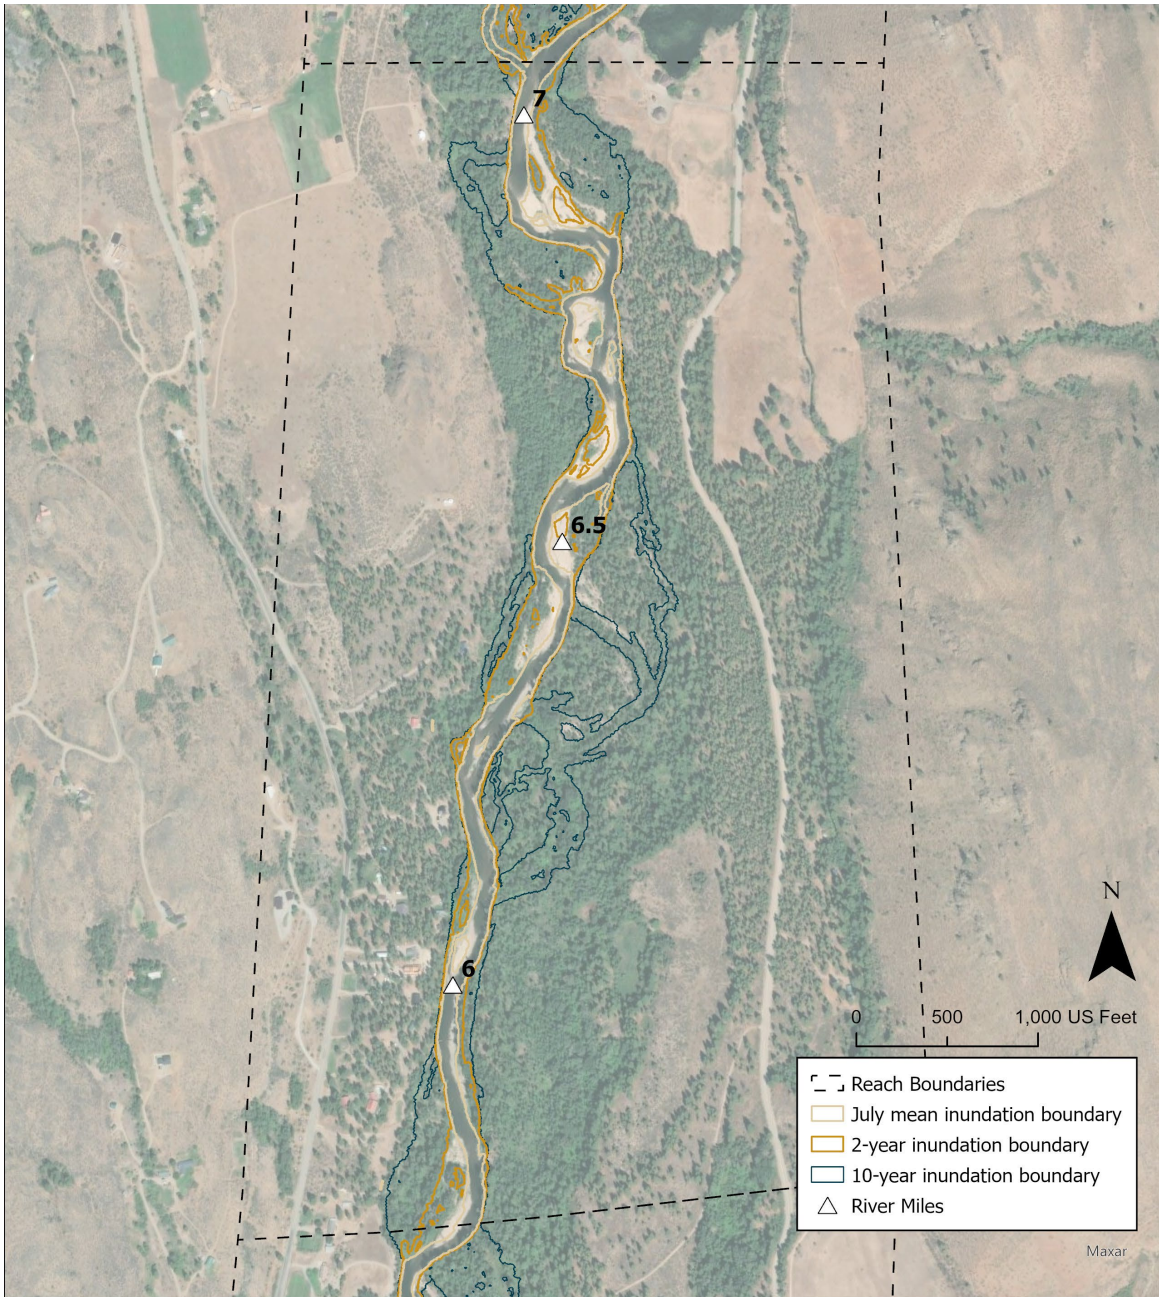
Figure 60.—Inundation boundaries for the July mean, 2-year, and 10-year flows in Pearrygin 5.

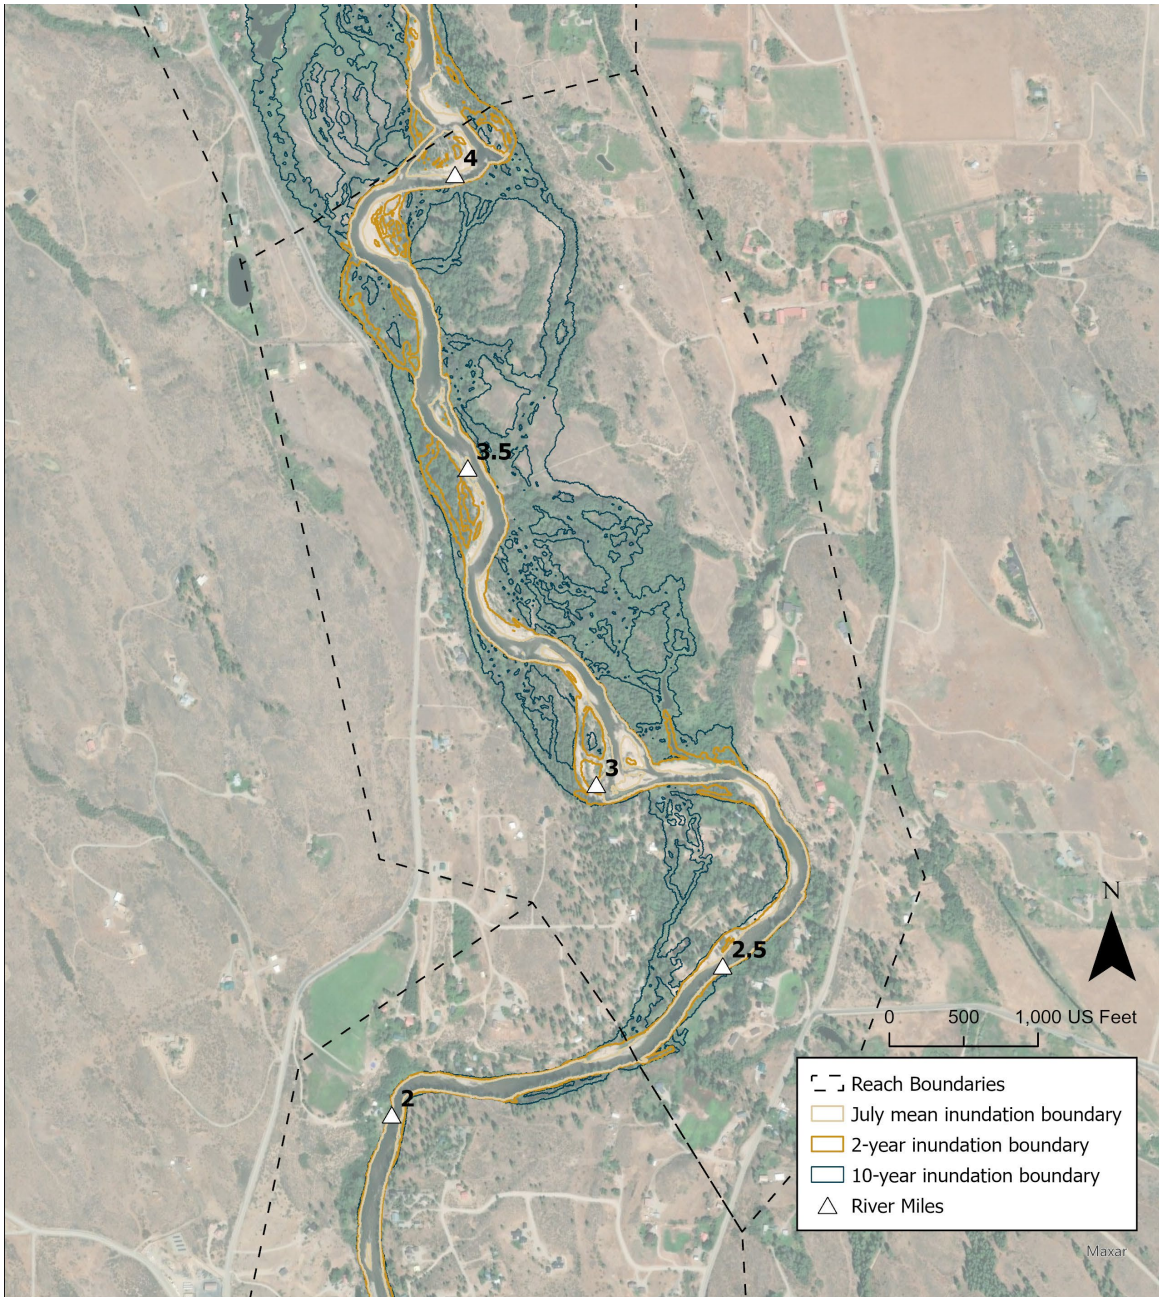
Figure 67.—Inundation boundaries for the July mean, 2-year, and 10-year flows in Perrygin 3.

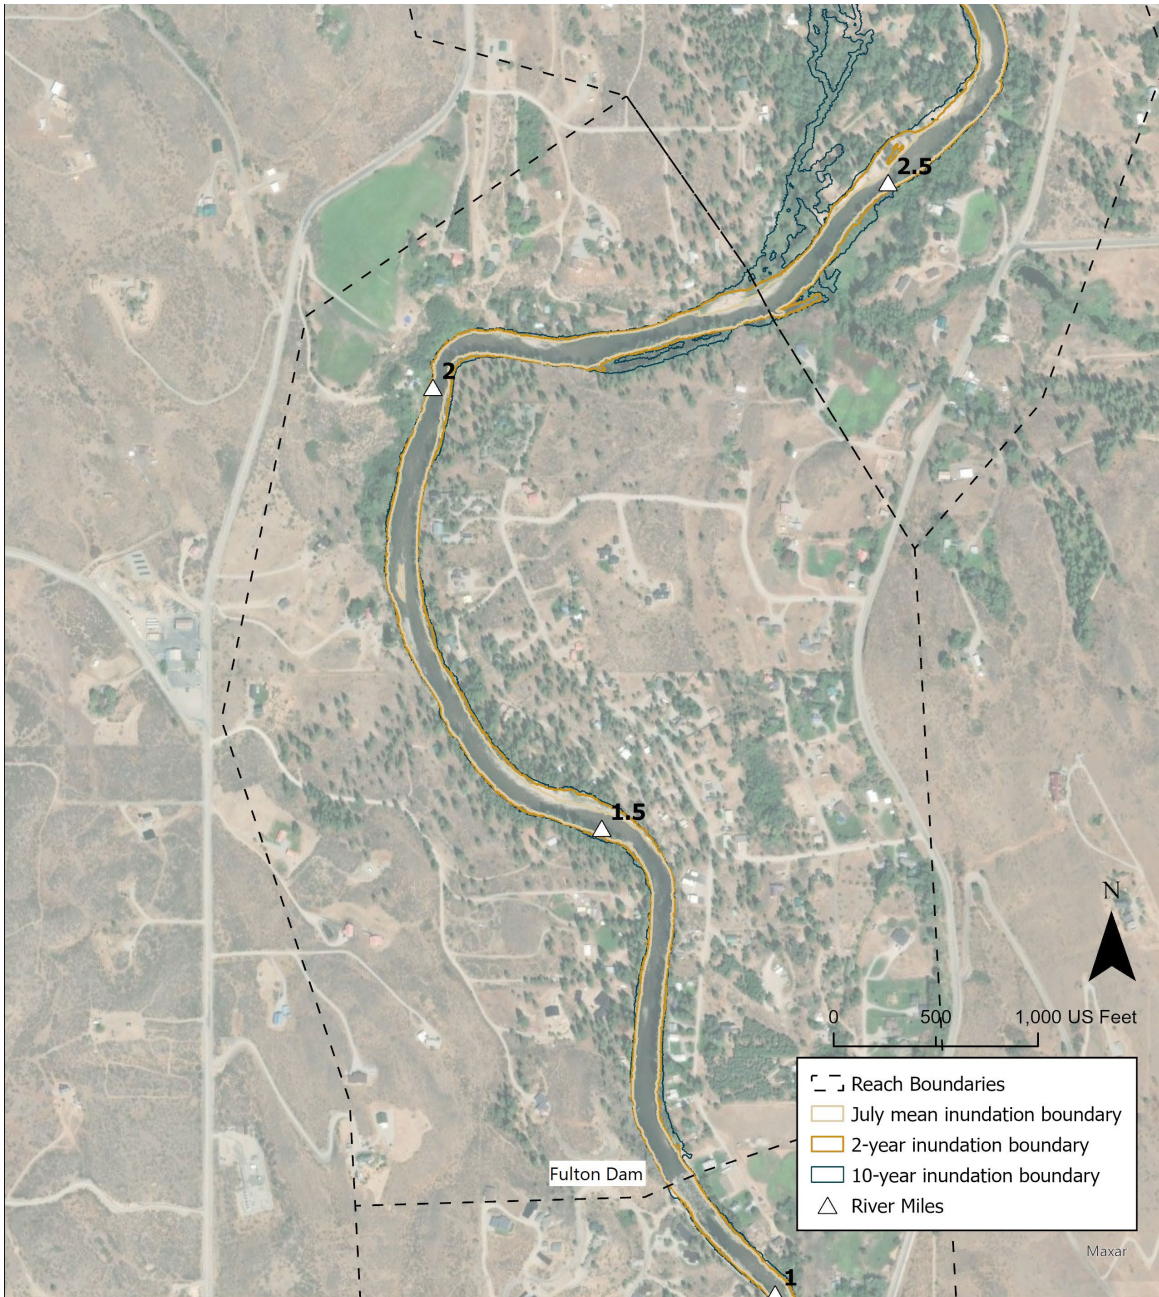
Figure 70.—Inundation boundaries for the July mean, 2-year, and 10-year flows in Pearrygin 2.

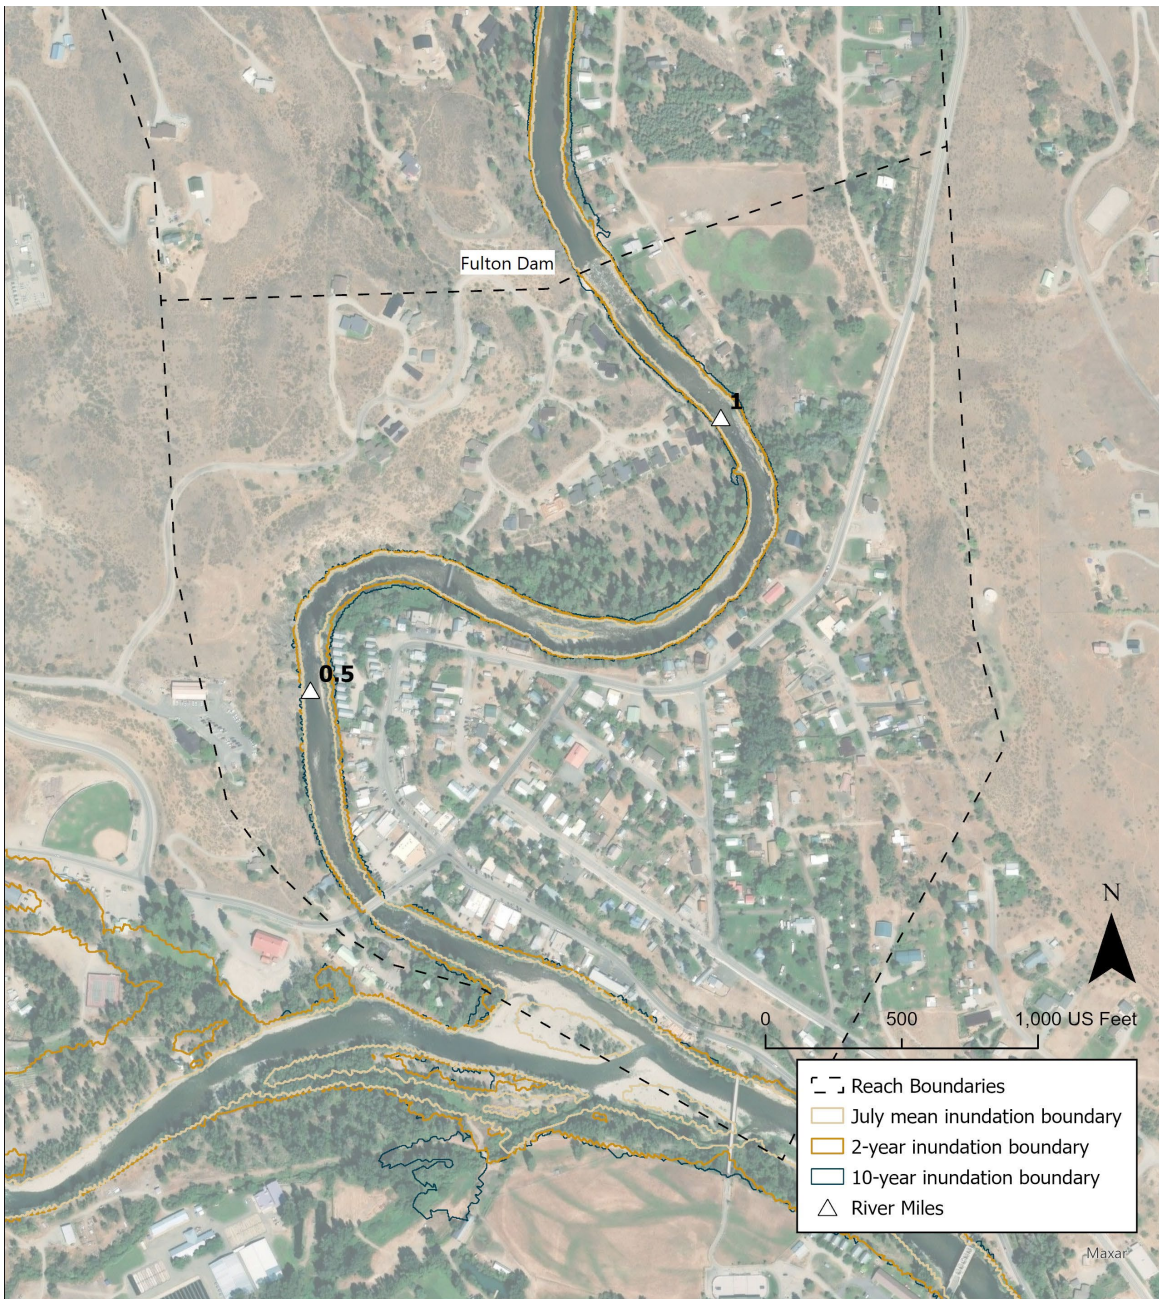
Figure 73.—Inundation boundaries for the July mean, 2-year, and 10-year flows in Perrygin 1.
