**Technical Report No. ENV-2024-077**

# **Chewuch River Risk Assessment and Restoration Design Concepts**

**Methow River Sub-Basin, Okanogan County, Washington  
Columbia-Pacific Northwest Region**

**Bureau of Reclamation  
Technical Service Center  
Denver, Colorado**

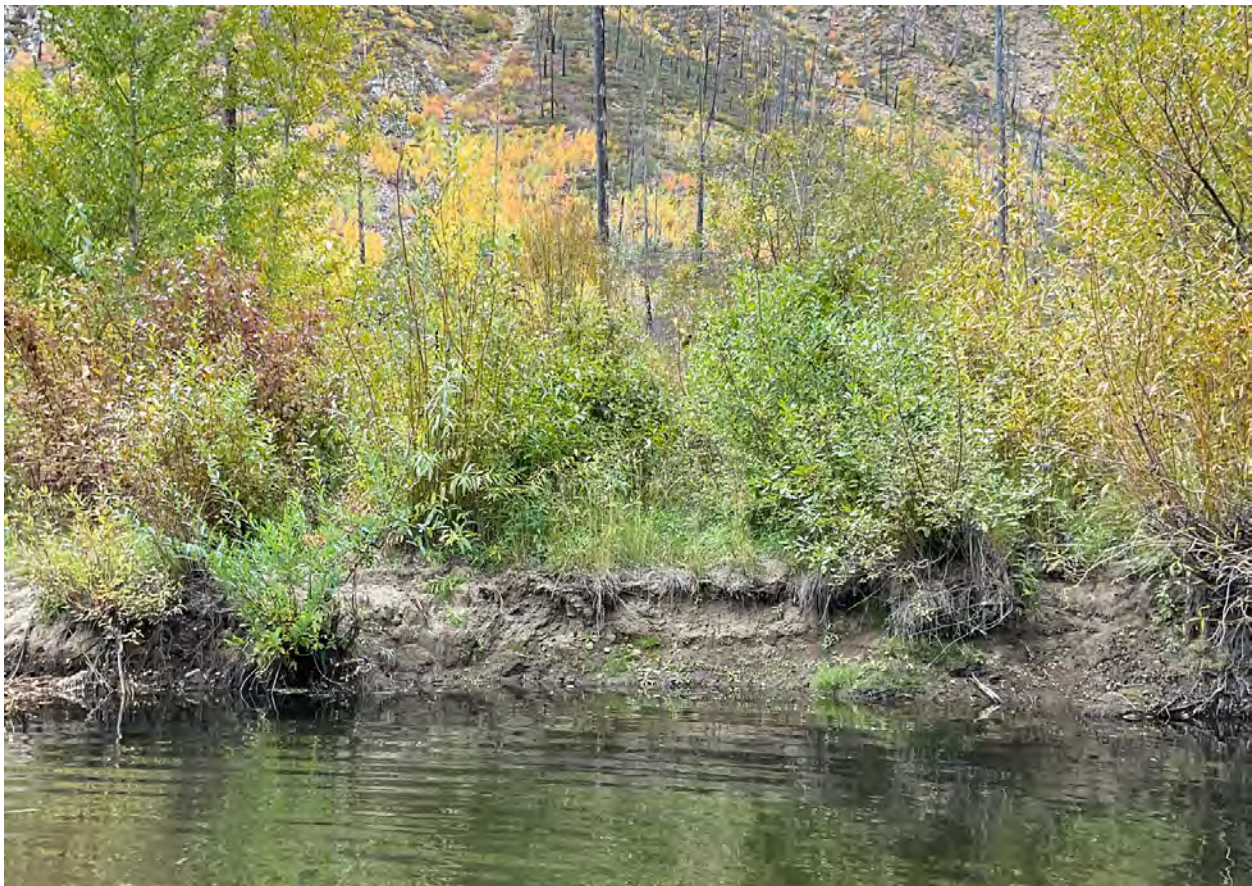
Figure 6.—Bank erosion in the vicinity of River Mile 31.25 is indicative of channel widening or lateral migration (photo by Aaron Hurst/Bureau of Reclamation).

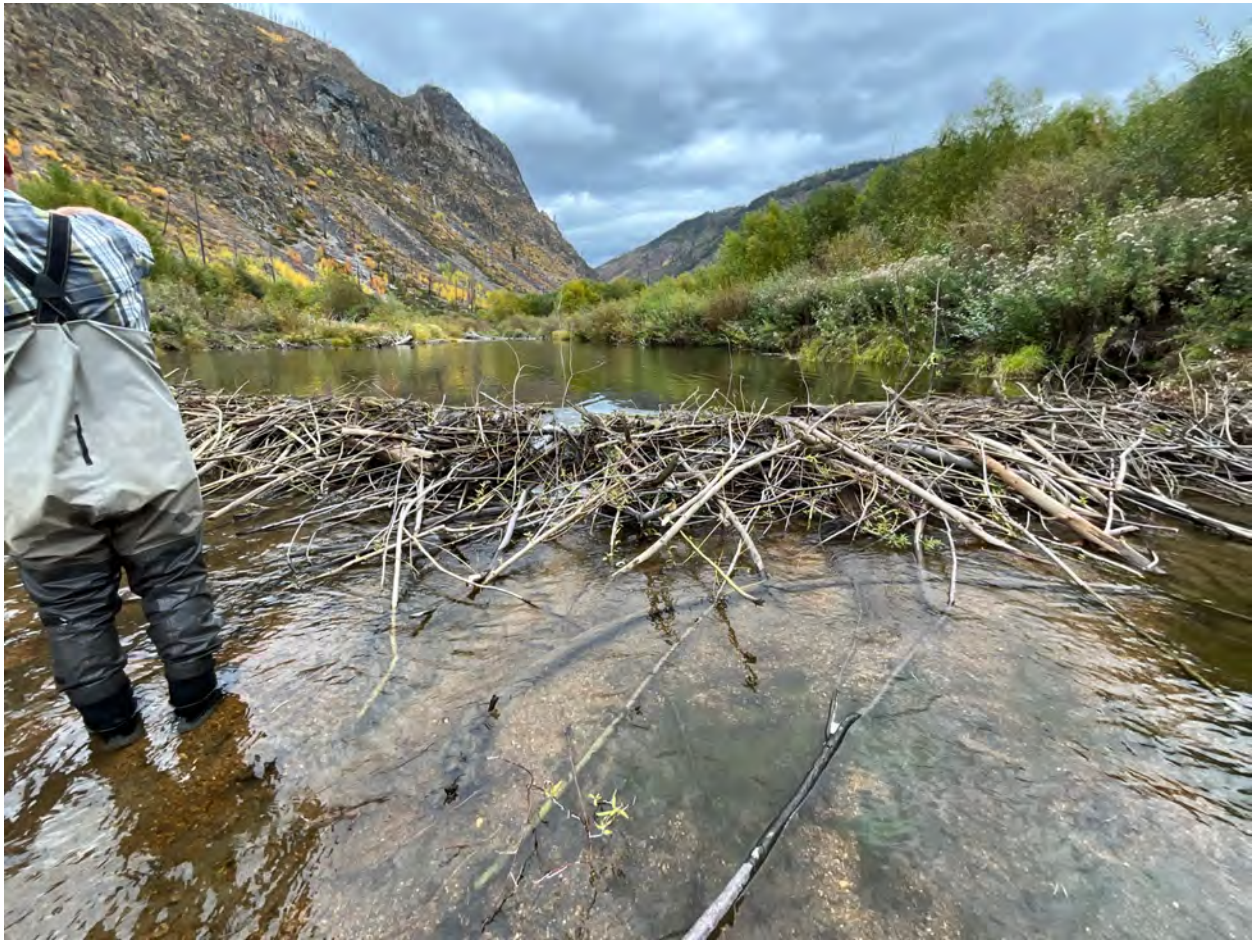
Figure 7.—A large, channel-spanning beaver dam near River Mile 31.5. Photo taken looking upstream (photo by Aaron Hurst/Bureau of Reclamation).

We conducted a field mapping effort in October 2023 to validate the aerial and satellite imagery mapping outlined above. In the field, we used the program StraboSpot installed on an iPad® to create shapefiles of observed features. We waded the river from upstream to downstream. Anywhere there was a flow split, one person traveled down each flow path. We noted anywhere we saw evidence of side channels and overflow channels, including flotsam, which is evidence of recent flow. As we mapped, we used the REM and aerial imagery as a basemap and tried to confirm evidence of low-confidence channels from the REM. We also made observations of bank erosion and channel bed composition (figure 6). We did not map wood in the field but did note locations of observed beaver dams (figure 7).

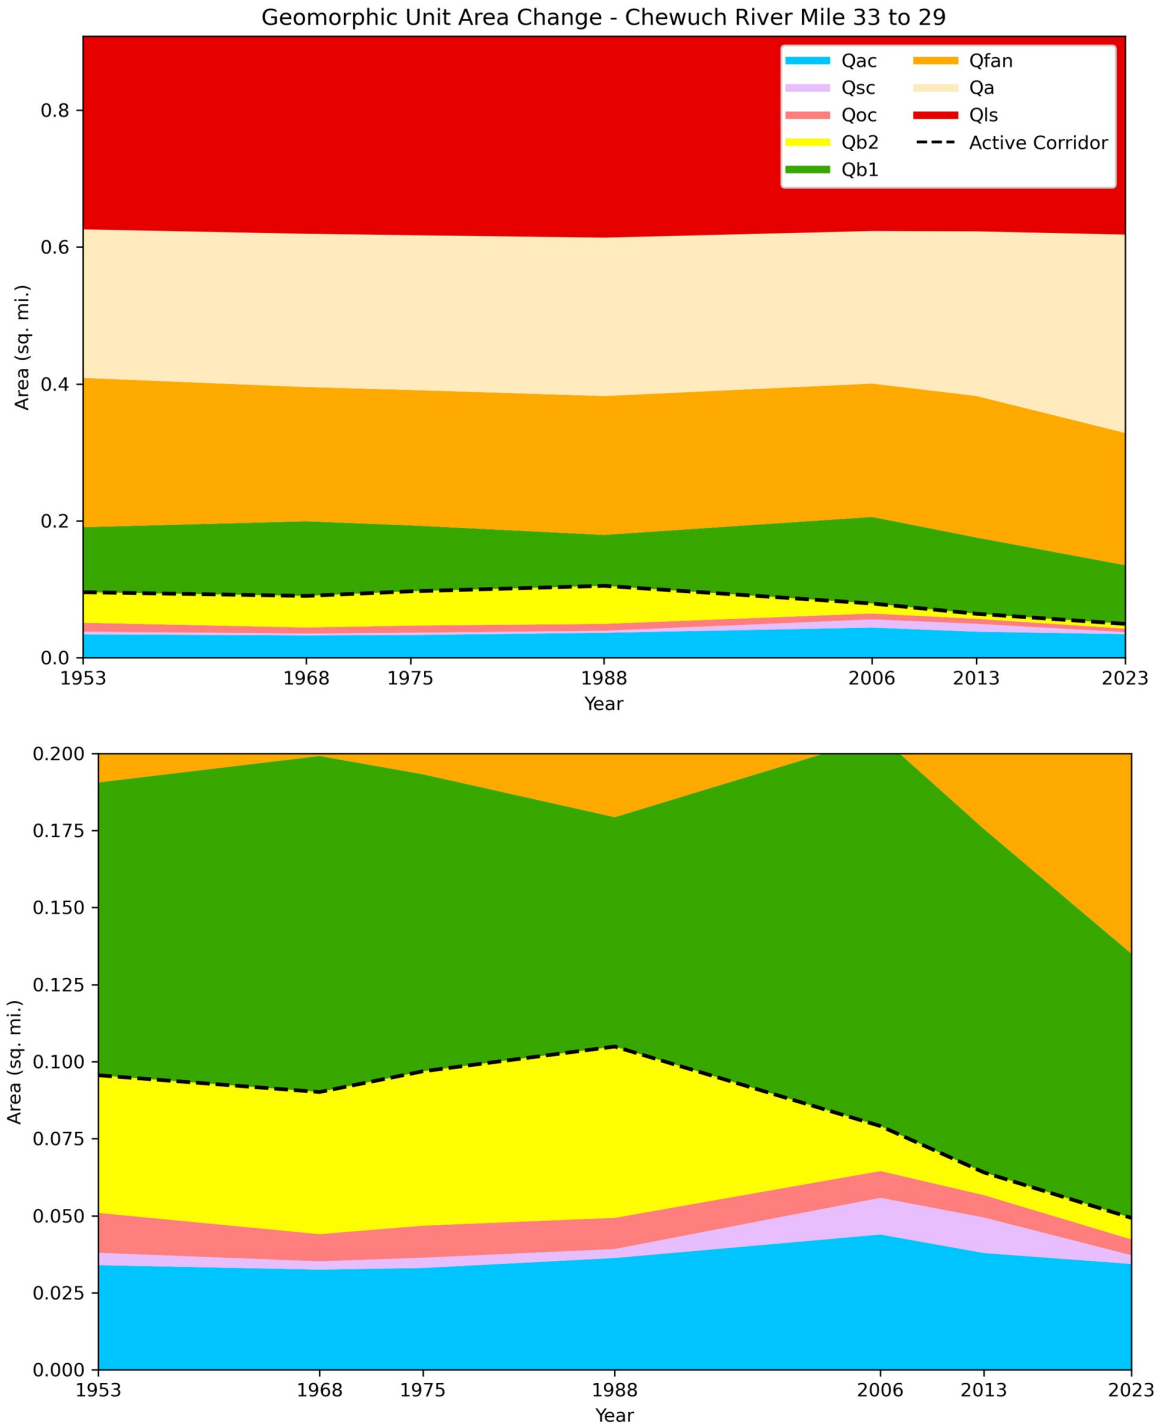
Figure 8.—Geomorphic unit area change from RM 33 to 29. The active channel (Qac), side channels (Qsc), overflow channels (Qoc), and unvegetated bars (Qb2) comprise the active geomorphic corridor. Vegetated bars (Qb1), fans (Qfan), Holocene alluvium (Qa), and landslides (Qls) are outside of the active corridor. The top figure shows the change in all geomorphic units. The zoomed in area in the bottom figure shows a decline in the active corridor area replaced by Holocene alluvium, indicating a decline in geomorphic diversity.

The river channel from RM 33 to 29 has experienced little change in the area of the active corridor between 1953 and 1988 (figure 8). There has been a steady decline in the active corridor area since 1988, decreasing by a total of 47%. Unvegetated bars and wetland complexes upstream of the large landslide at RM 31 have shrunk in size and been replaced by Holocene alluvium (figure 9). However, the area of side channels slightly grew in the mid-2000s before declining back to 1988 levels. This could be a result of post-fire sediment and wood in the channel damming it and creating backwater channels. This reach has exhibited active landslides and steep hillslope transport throughout the entirety of the available imagery. It is likely that the most significant geomorphic changes in this section of river occurred prior to the available aerial imagery during and after logging in the 1800s. The effects of the historical floods cannot be seen in the aerial imagery mapping.

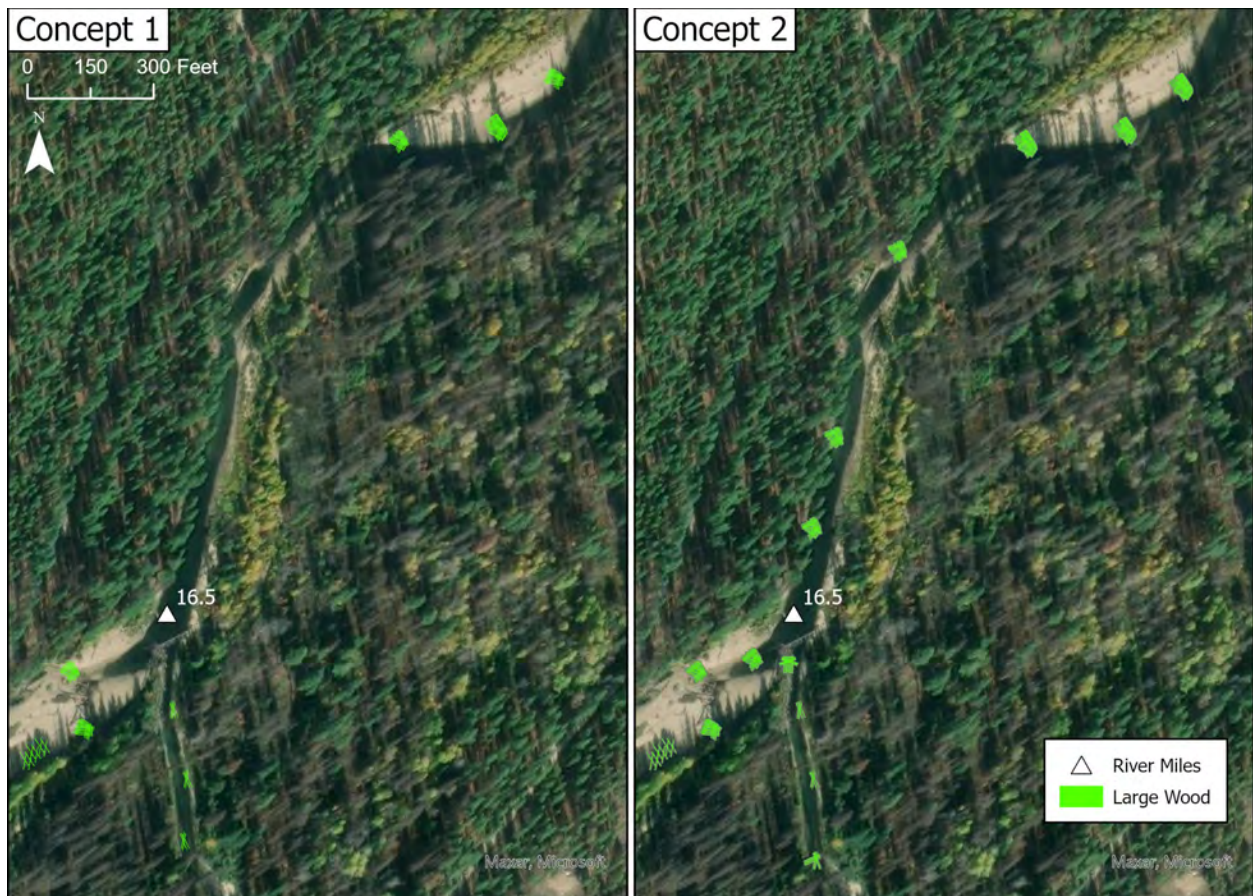
Figure 22.—Example of differences between Concept 1 and Concept 2 designs for RM 17.5 to 16.

After additional field reconnaissance in May 2024 to consider potential design adjustments, the amount of large wood was increased in RM 17.5 to 16 and RM 14.5 to 13.5 (figure 22). Boulders were also added within the RM 14.5 to 13.5 reach (figure 23). A slight change to the RM 10 to 9.5 restoration concept was also made by increasing the size of an apex jam within that reach (figure 24). The Concept 2 design and model results can be found in appendix F.

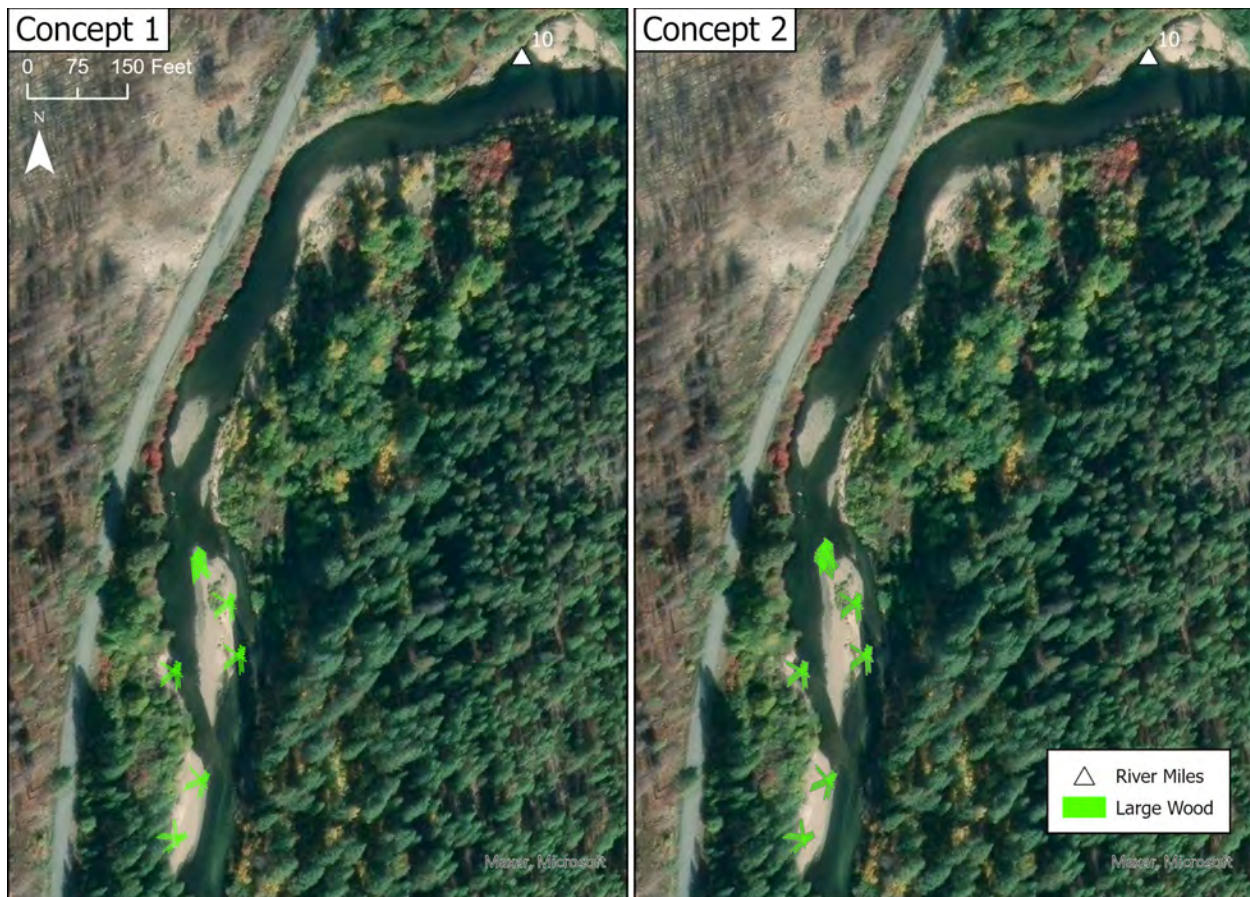
Figure 24.—Example of differences between Concept 1 and Concept 2 designs for RM 10 to 9.5. The only difference between these two concepts is a slightly larger apex structure.

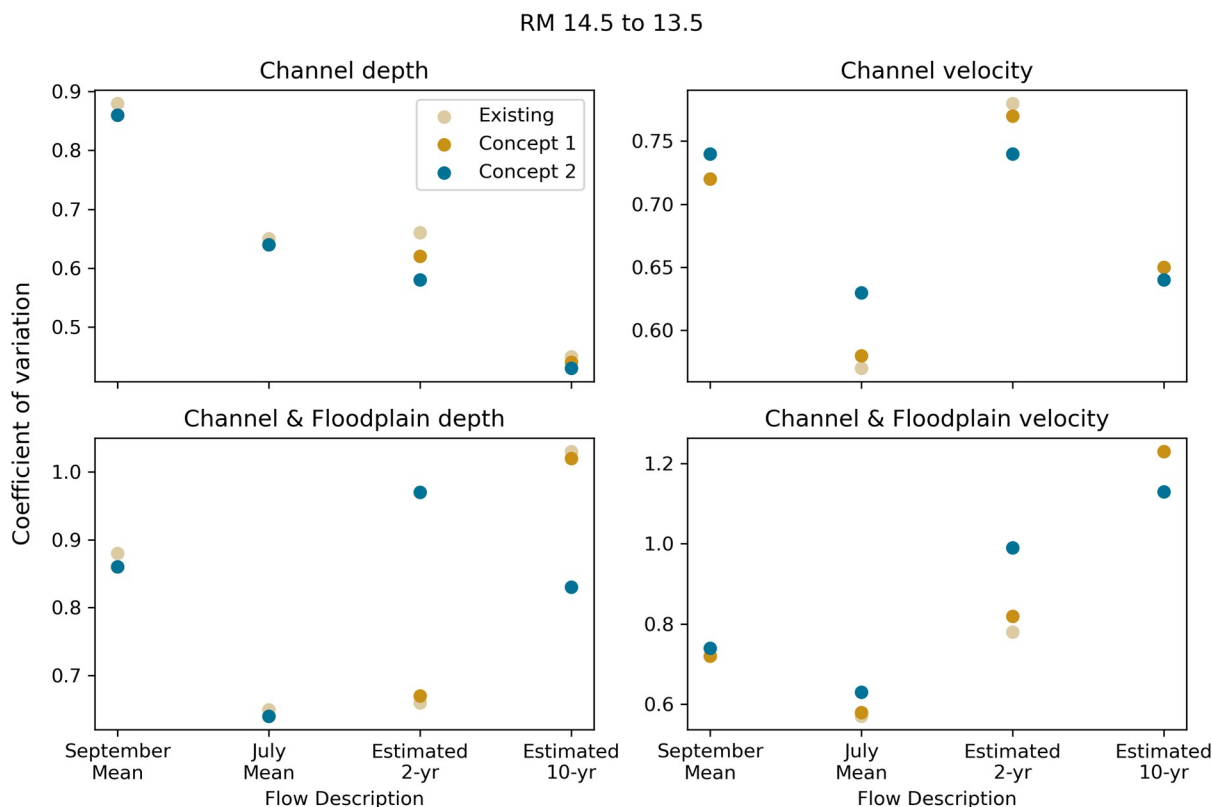
Figure 32.—Coefficient of variation in depth and velocity along the RM 14.5 to 13.5 site.

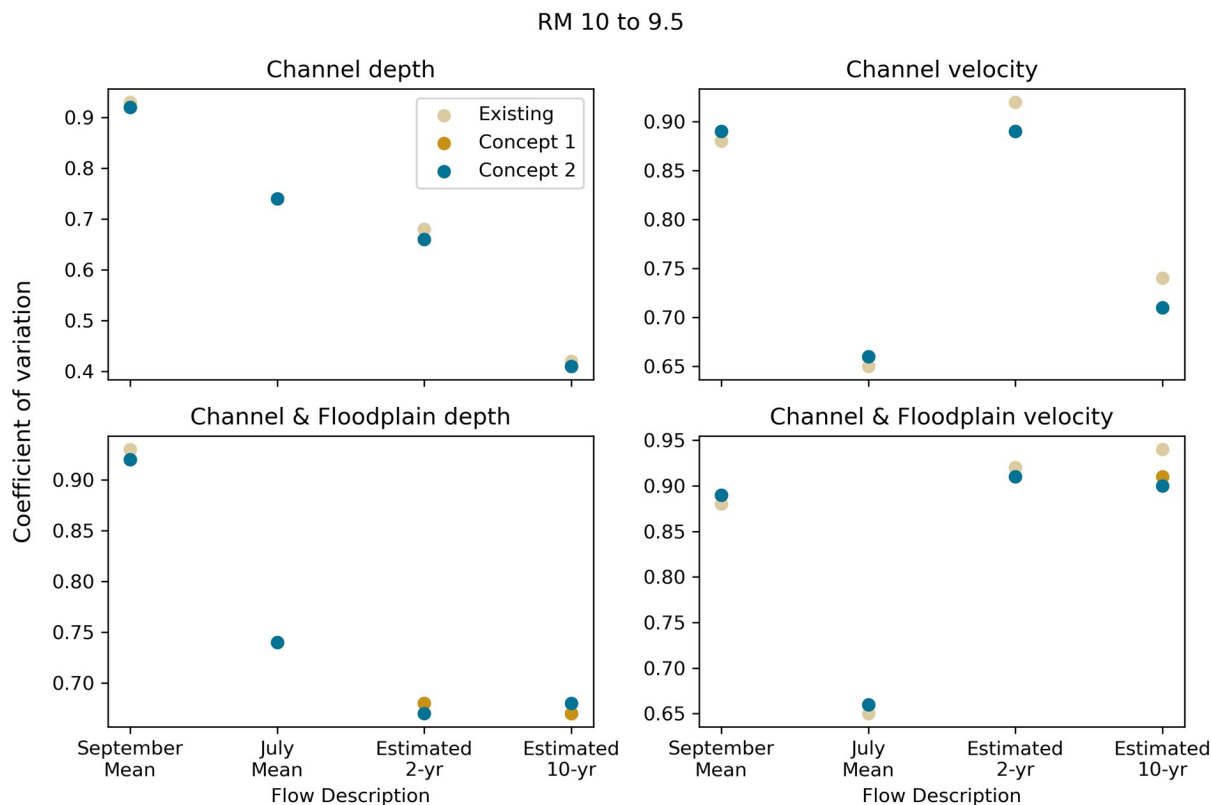
Figure 34.—Coefficient of variation in depth and velocity along the RM 10 to 9.5 site.

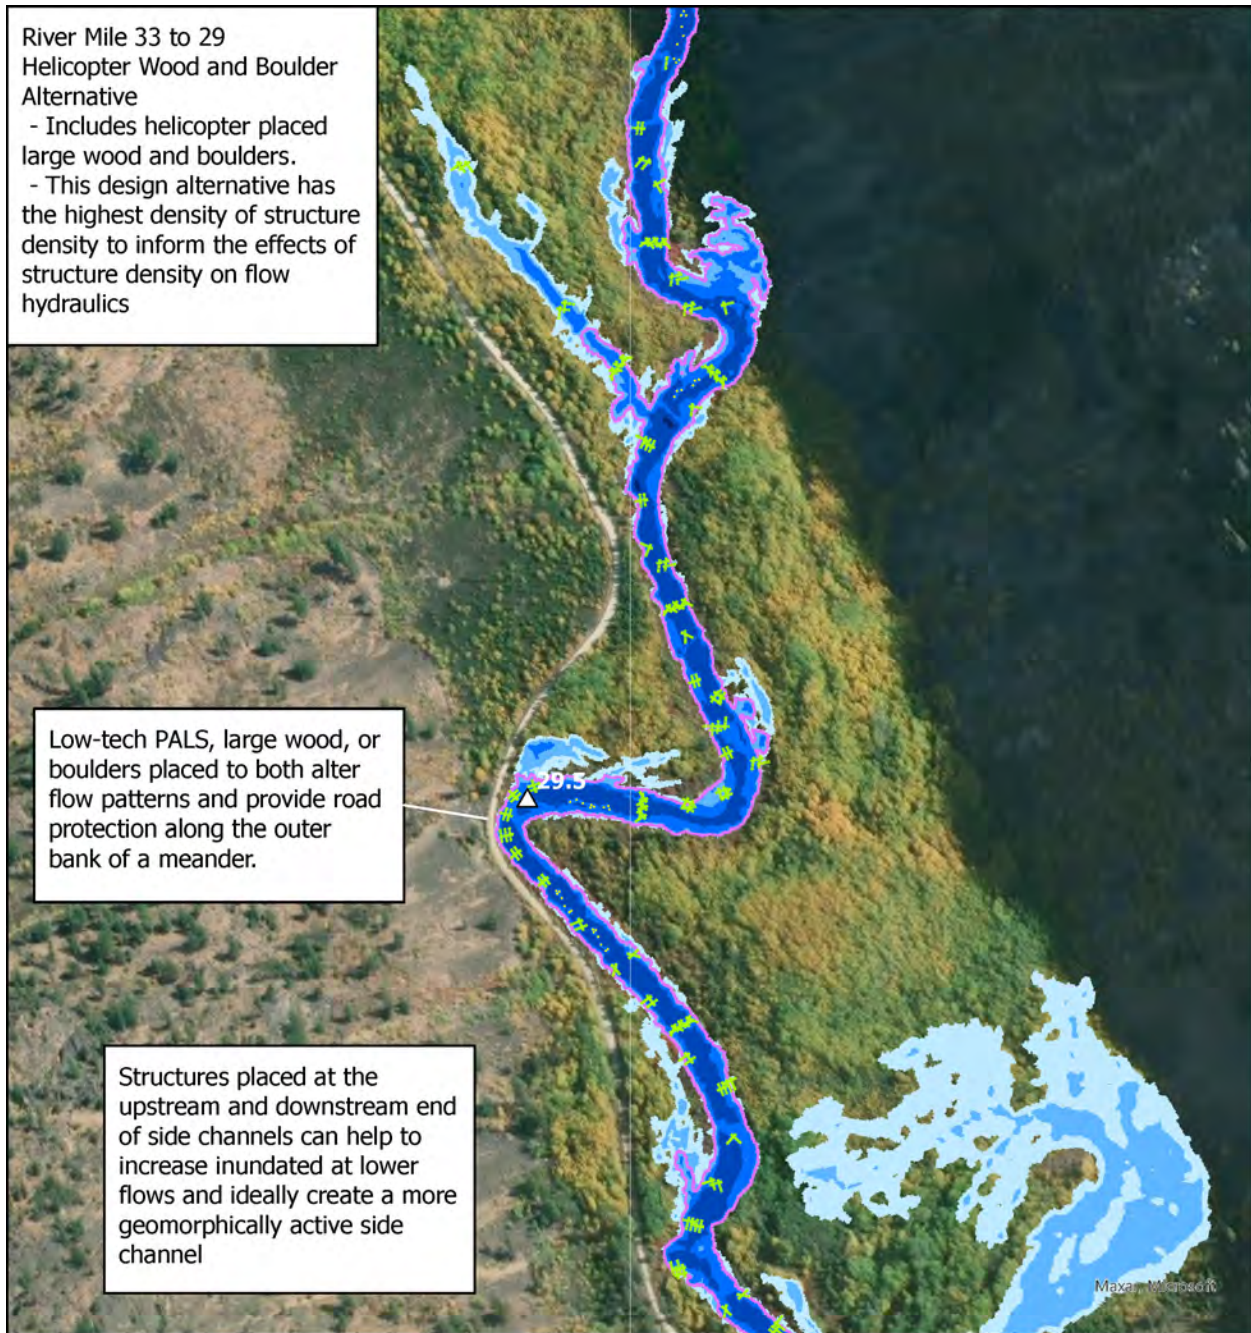
Channel spanning structures  
 primarily slow flow velocities  
 and raise water surface  
 elevations, which can create  
 deposition and channel  
 aggradation. Partially spanning  
 structures will slow velocities  
 upstream of the structure, but  
 increase velocities adjacent to  
 the structure.

River Mile 33 to 29  
 Helicopter Wood and Boulder  
 Alternative  
 - Includes helicopter placed  
 large wood and boulders.  
 - This design alternative has  
 the highest density of structure  
 density to inform the effects of  
 structure density on flow  
 hydraulics

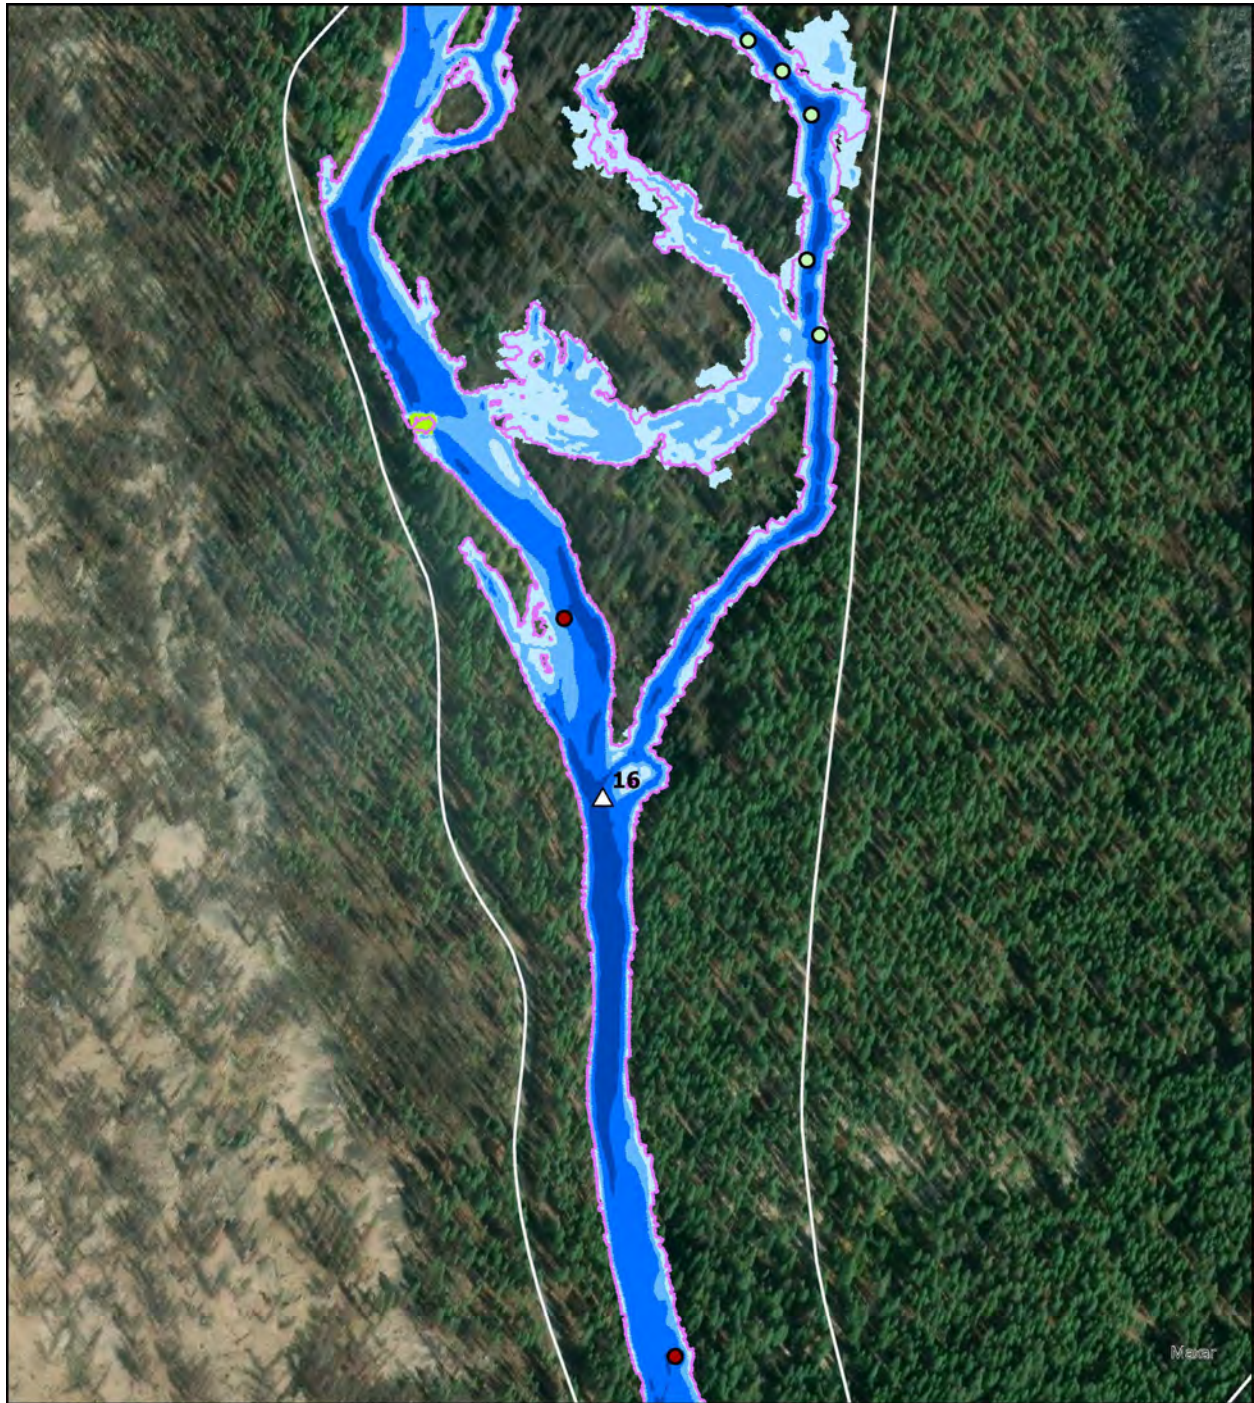
Design 2 inundation depth compared with design 1 inundation extent (purple boundary)

Design 2 included an increased number of large wood structures and boulders based on field reconnaissance

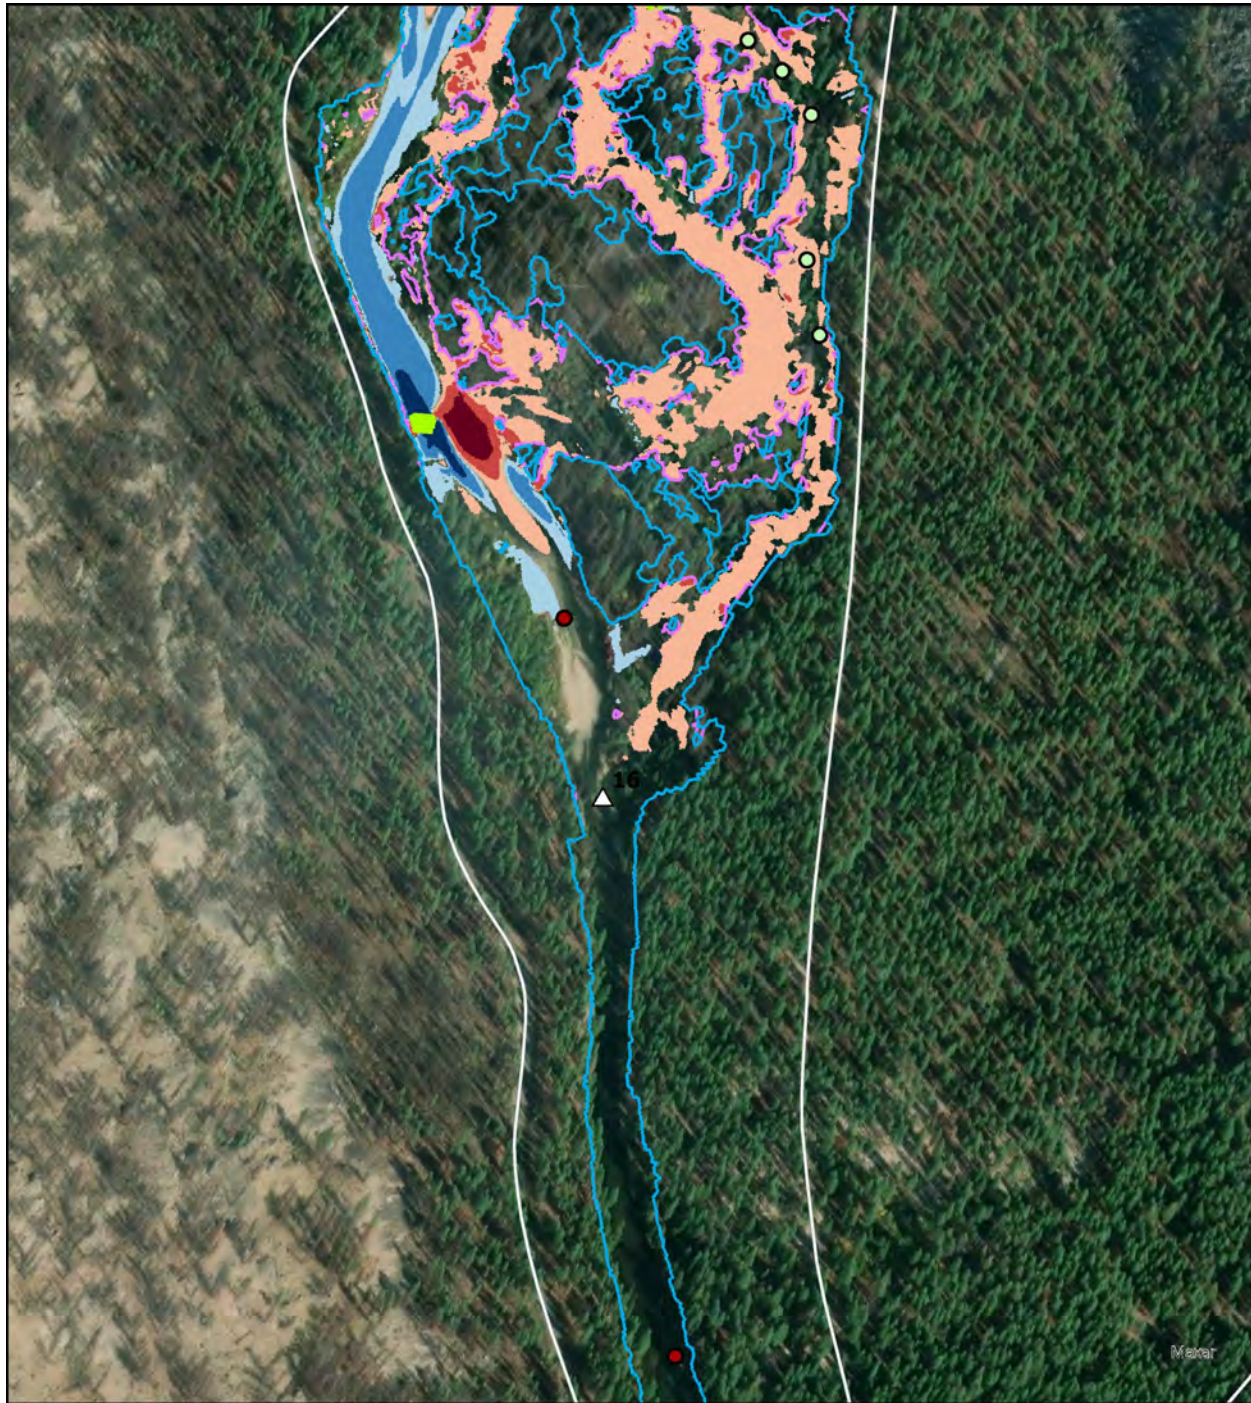
Design 2 vs existing velocity difference with inundation extents (Design 2 minus existing - 10yr flow)

Design 2 included an increased number of large wood structures and boulders based on field reconnaissance

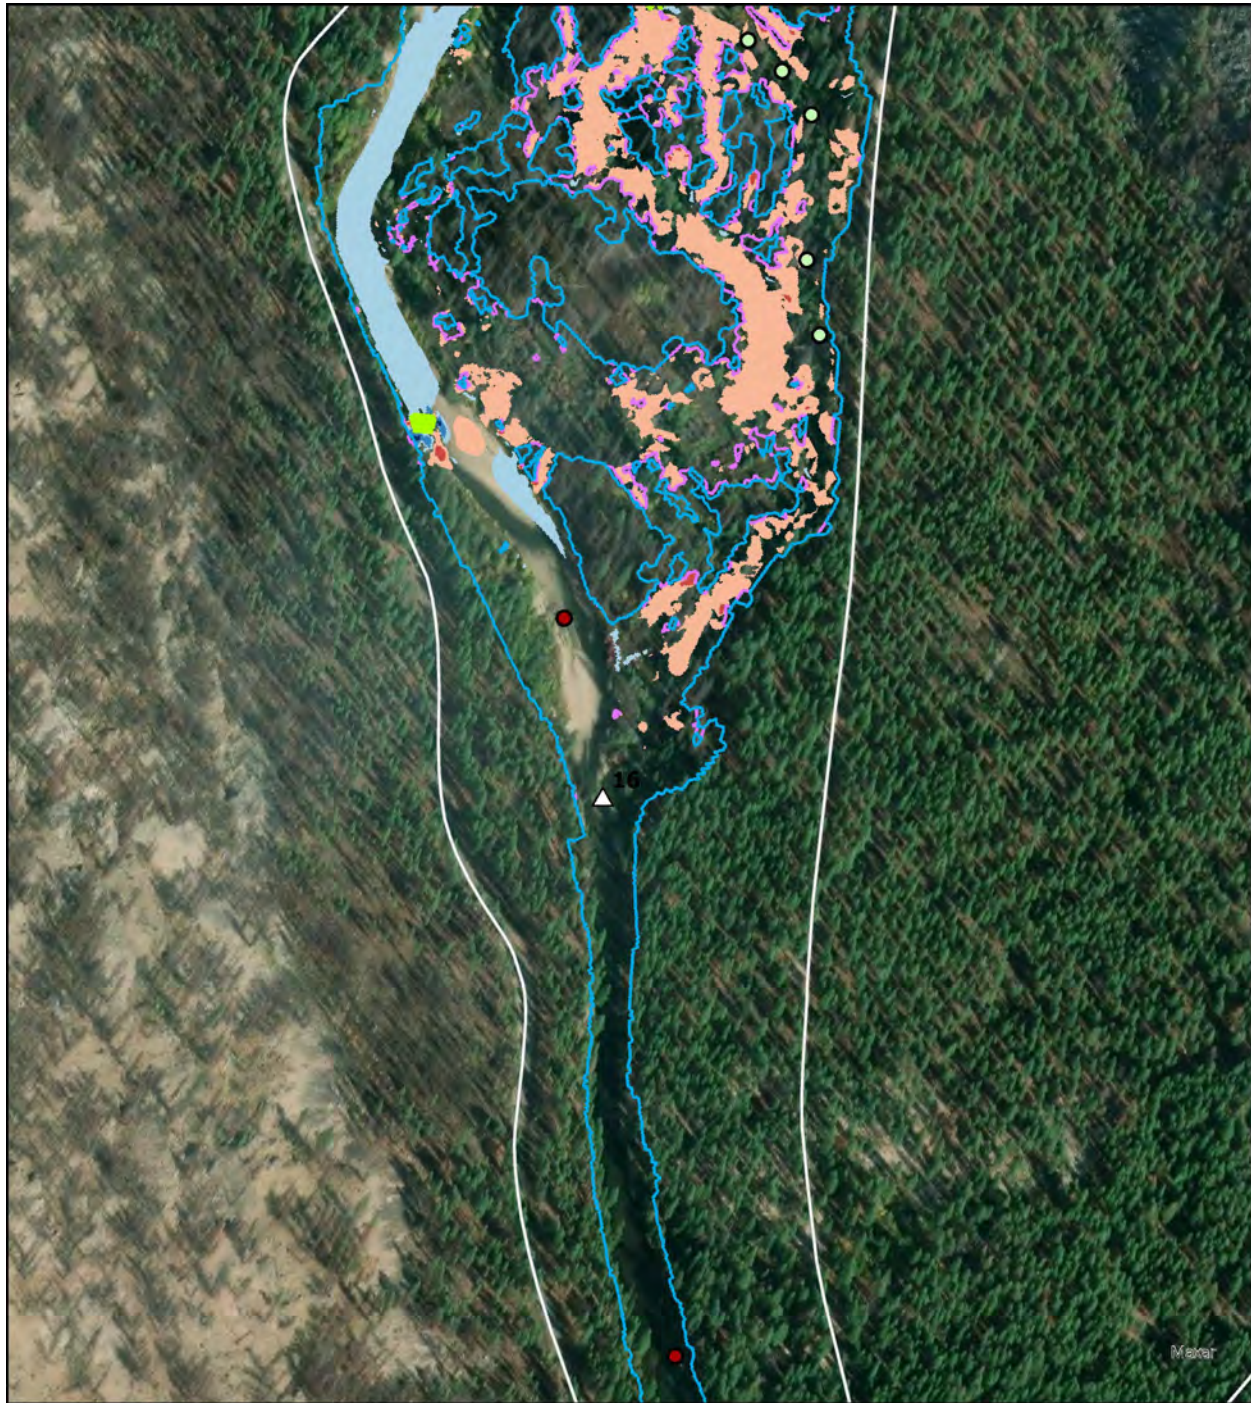
Design 2 vs design 1 velocity difference with inundation extents (Design 2 minus Design 1 - 10yr flow)

Design 2 included an increased number of large wood structures and boulders based on field reconnaissance

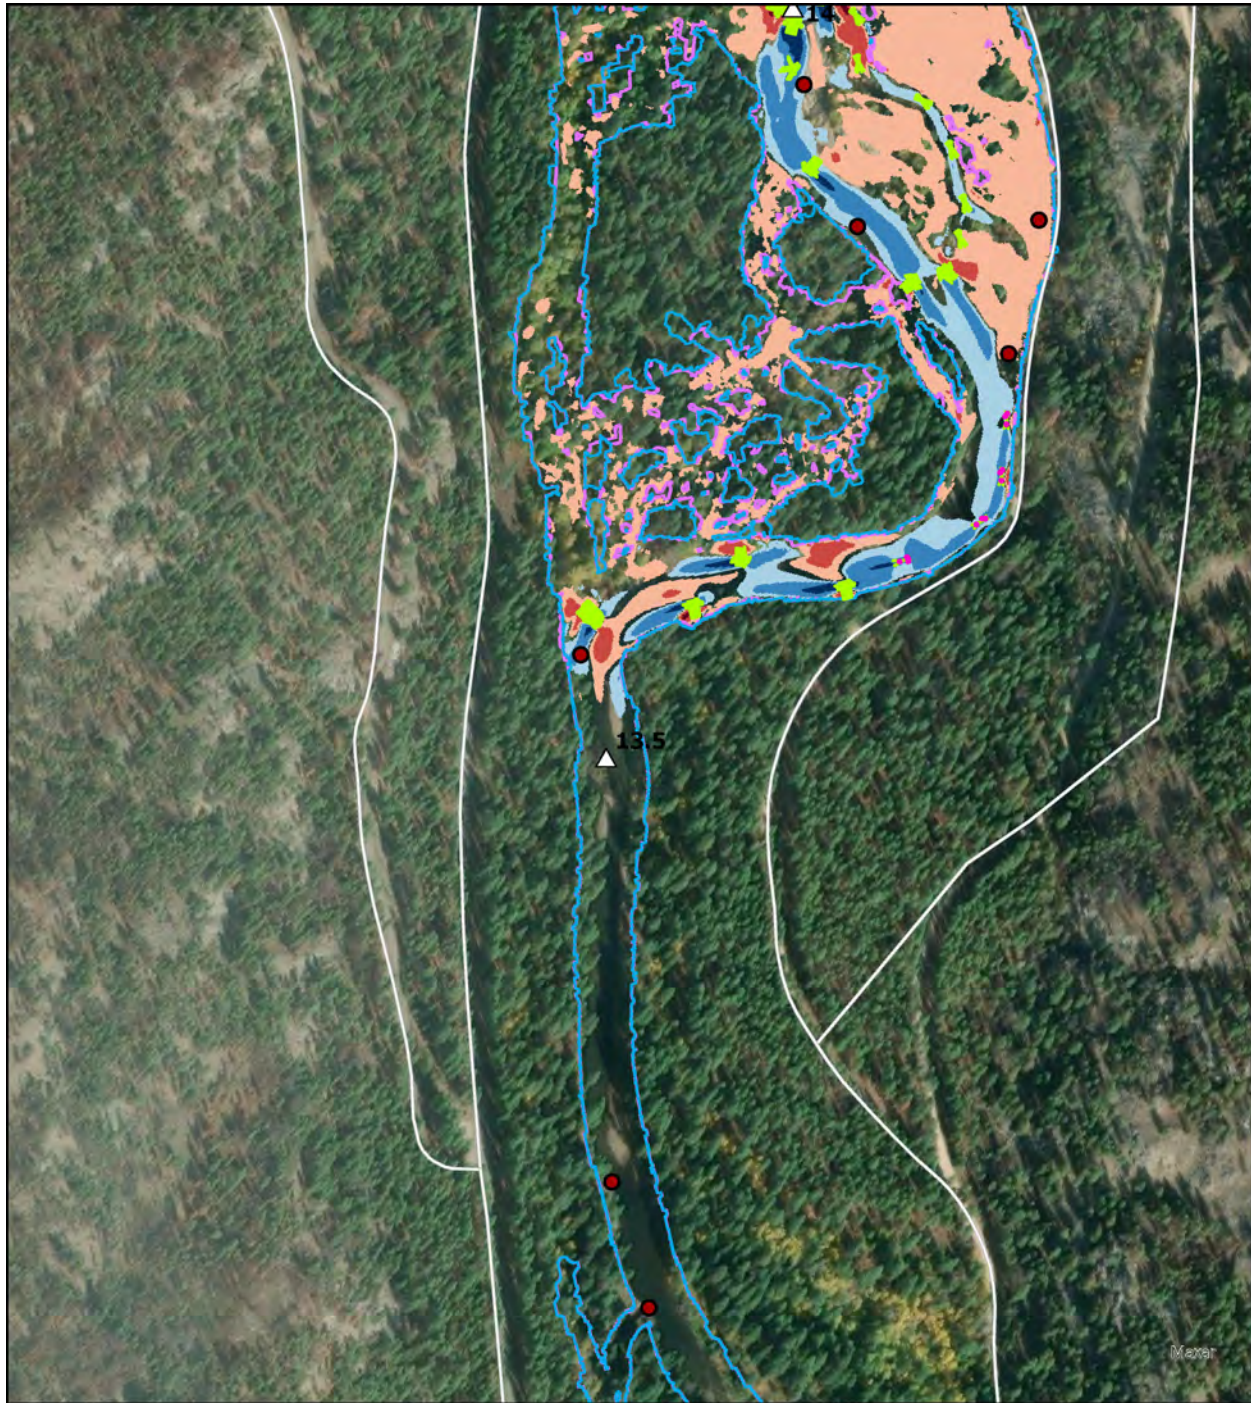
Design 2 vs existing velocity difference with inundation extents (Design 2 minus existing - 10yr flow)

Design 2 included an increased number of large wood structures and boulders based on field reconnaissance

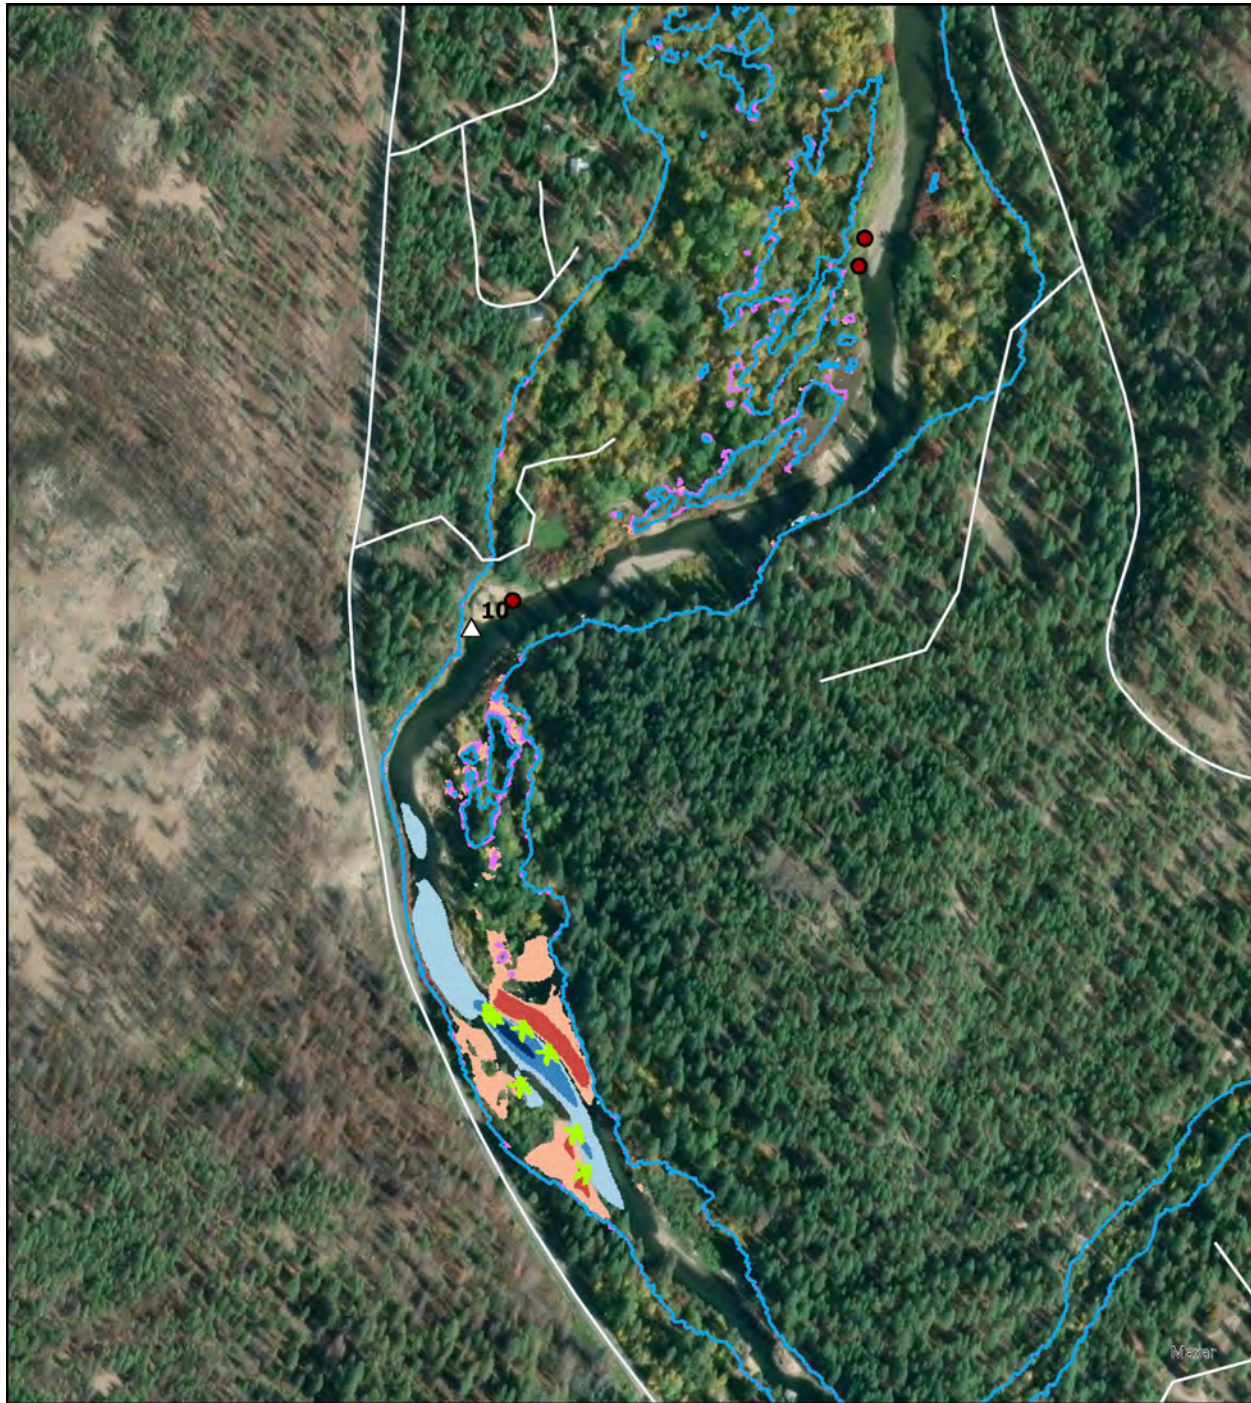
Design 2 vs existing velocity difference with inundation extents (Design 2 minus existing - 10yr flow)

Design 2 included an increased number of large wood structures and boulders based on field reconnaissance
