## Lower Loup Loup Creek REACH ASSESSMENT

Okanogan Conservation District  
July 2024

Confluence Environmental Company  
Eric Doyle  
Jenny Love  
Alexis Huynh

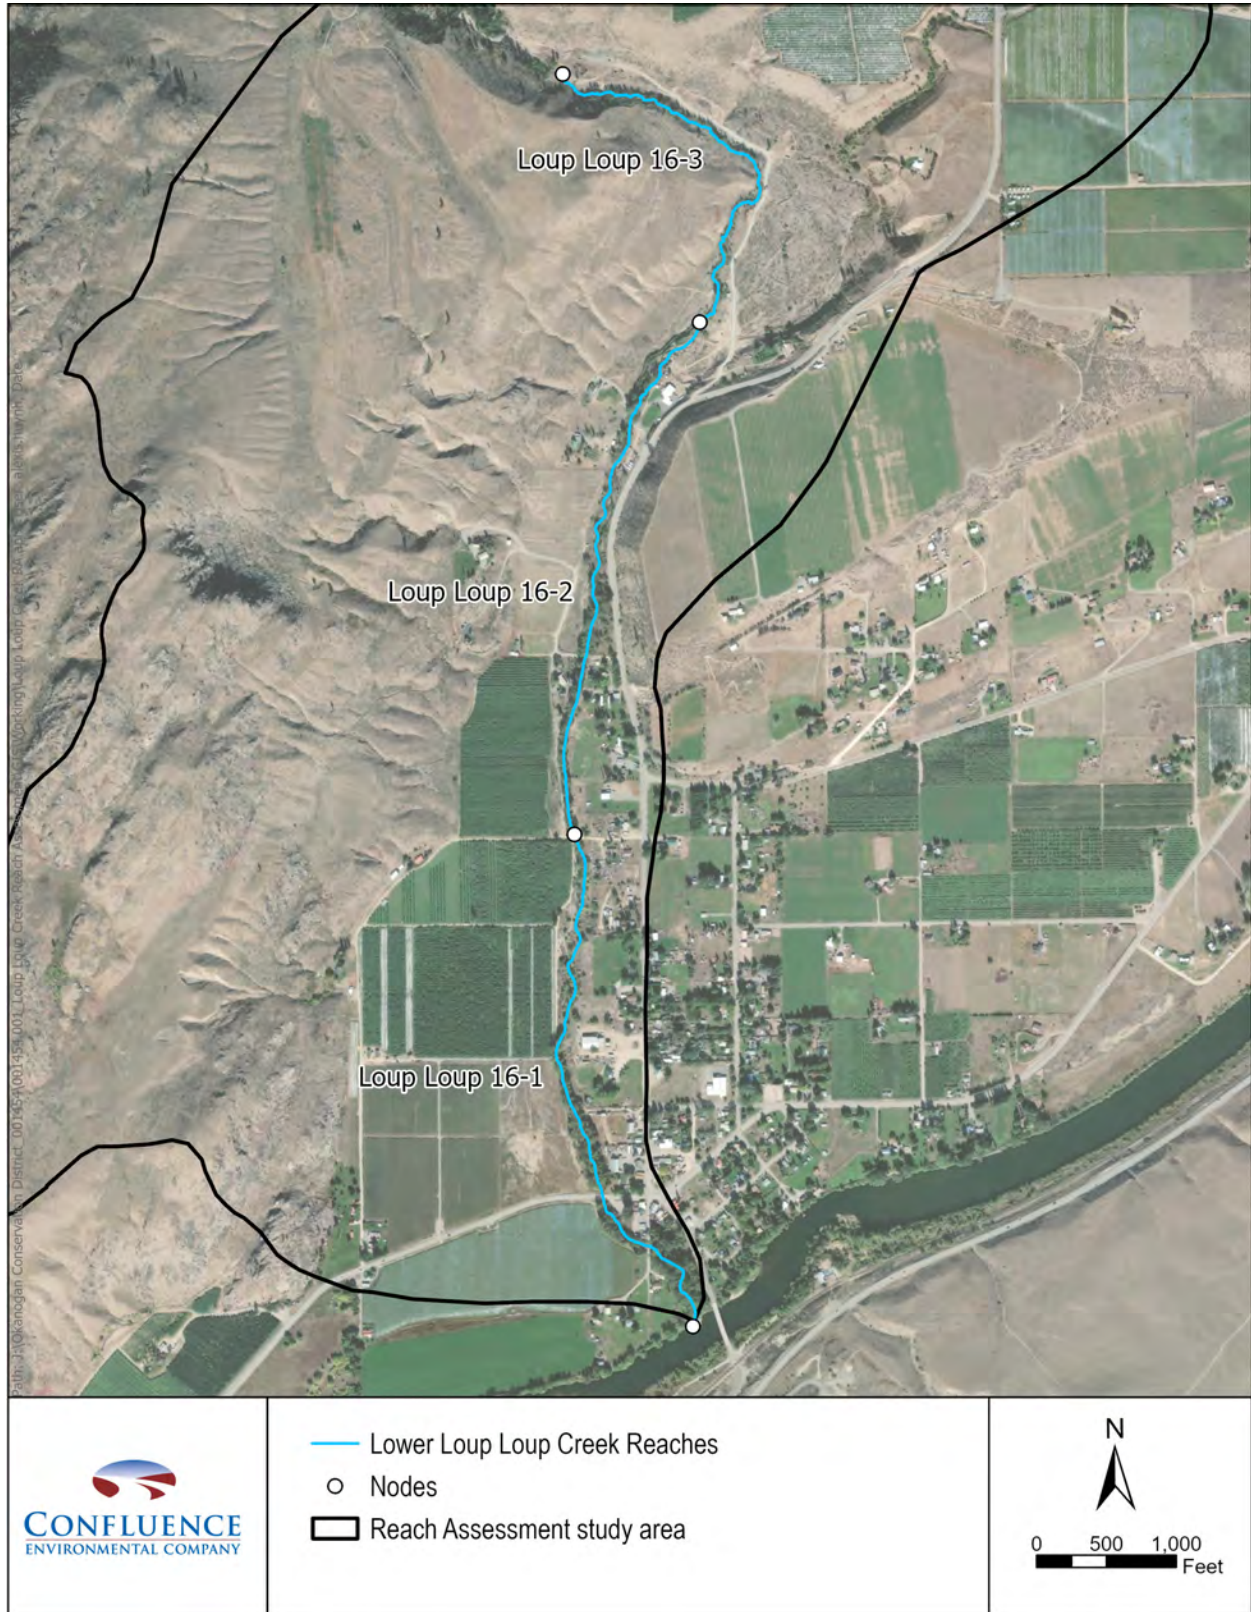
Figure 6. Lower Loup Loup Creek RA reach structure

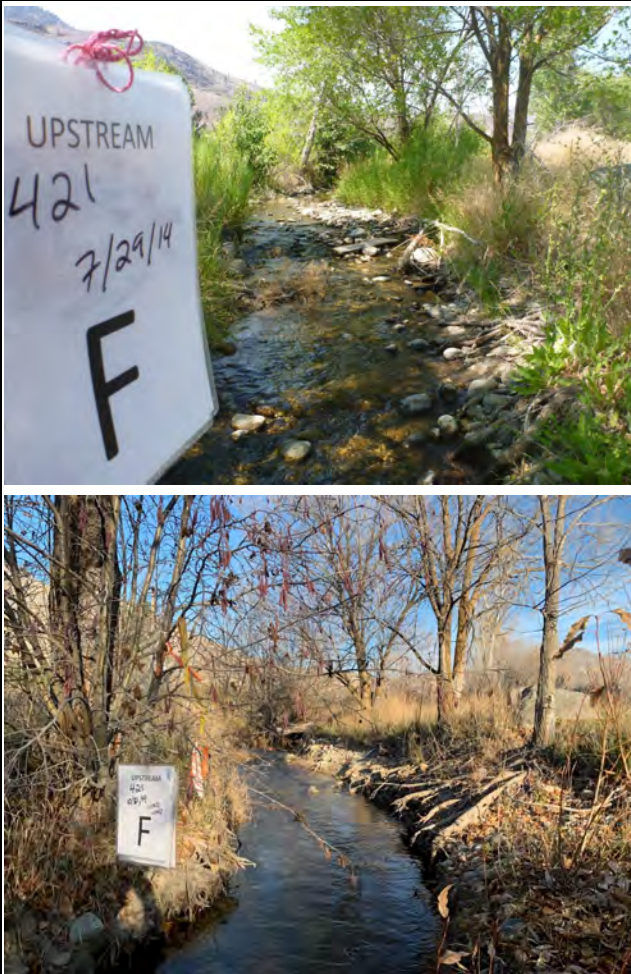
**Table 8. Reach Loup Loup 16-1 physical characteristics and representative photos**

Rosgen type	Type G3	
Gradient (rise/run)	0.015	
Sinuosity (ratio)	1.14	
Bankfull width (m)	4.0	
Width-depth ratio	5.0	
Confinement ratio (valley/bankfull width)	>4 (unconfined)	
Entrenchment ratio	1.4	
Dominant substrate (% of total mass)	Small cobble <128 mm (51-53%)	
Bank armoring (% of length)	50%	
Riparian composition <sup>†</sup>	Established perennial: 62.4%; Unvegetated/seasonal: 37.6%	
Woody debris (pieces/mile)	100.7 (in 2021)	
Woody debris jams (jams/mile)	10.3 (in 2021)	
Habitat composition <sup>Δ</sup>	Backwater pools: 0%; Beaver ponds: 0; Glides: 23%; Large cobble riffles: 36%; Scour pools: 23%; Pool tailouts: 1%; Small cobble riffles: 17%; Side channel: 11%	
Obstructions	Two historical barrier culverts in Malott (removed in 2011).	
Pools frequency (pools/km)	33.7	
Hydraulic radius (m) <sup>†</sup>	0.54	
Basal shear stress (Pa) <sup>†</sup>	6.4

Table 8 provides a summary of reach parameters and representative photographs for Loup Loup 16-1. As shown, this reach is an unconfined Rosgen type G3 channel, with a moderate average gradient of 0.015 (1.5%), a sinuosity index of 1.16, and an average bankfull width of 4.0 m. Bank armoring or other hydromodifications are present over approximately 50% of channel length.

Notable channel incision has occurred in portions of this reach during the last decade. This development is evident in a photographic comparison of channel conditions in 2014 and 2019 at monitoring location OBMEP-421, transect F (Table 8) and changes in channel cross-section and thalweg depth profile observed at this location from 2014 through 2017 (see Section 4.3.3).

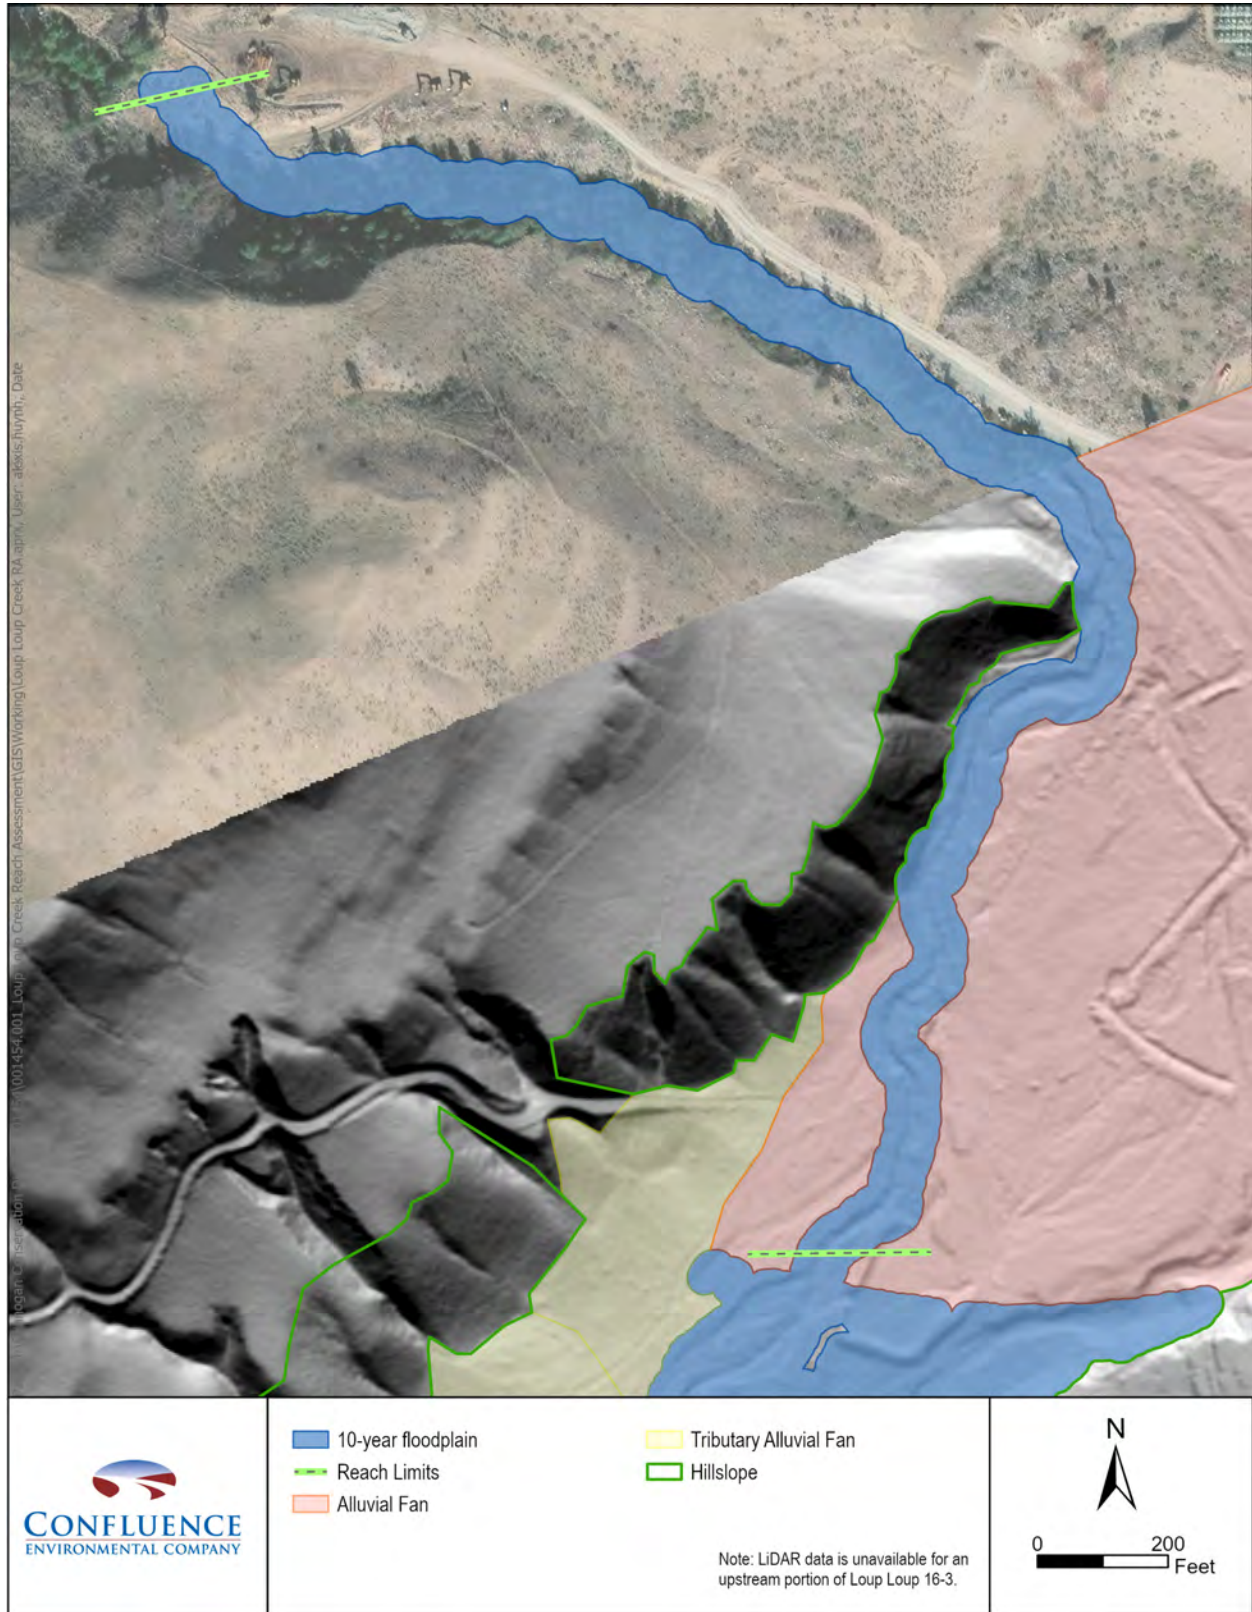
Figure 10. Loup Loup 16-3 reach topography and geomorphic surfaces

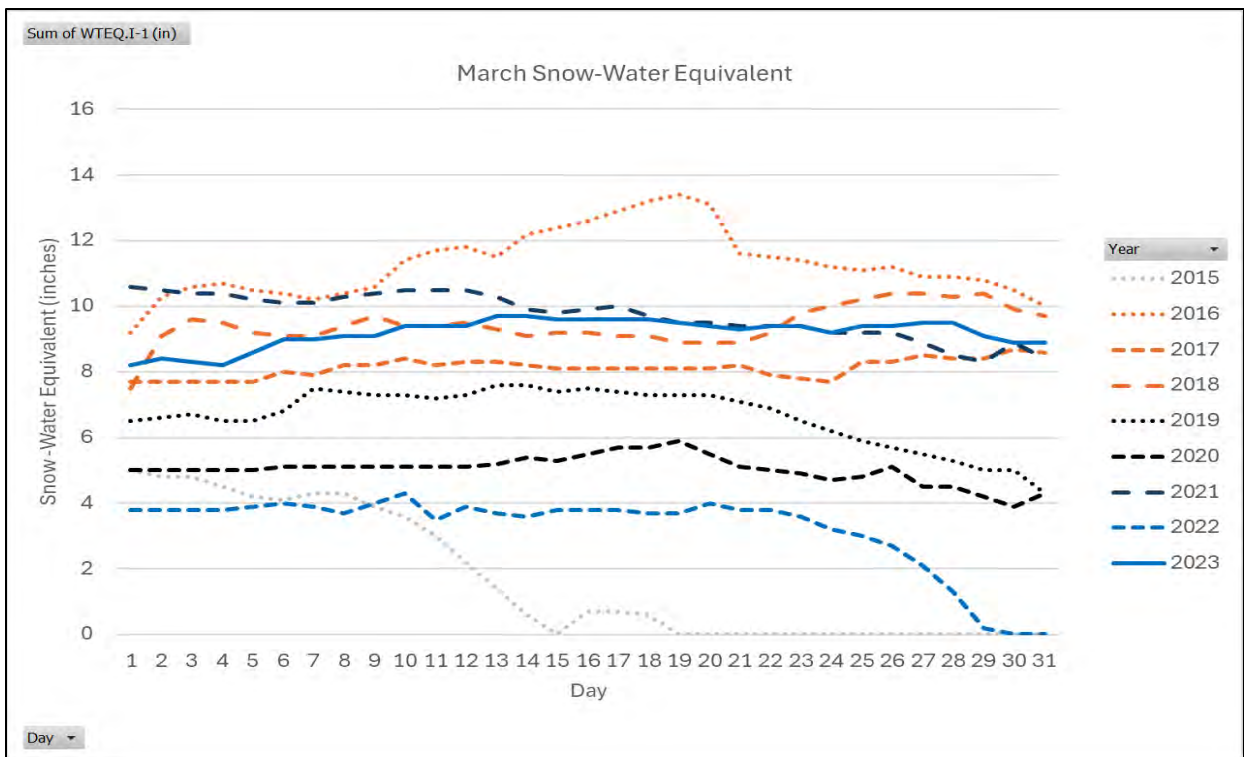
Figure 12. March snow-water equivalent at SNOTEL Site Muckamuck, 2015 to 2023

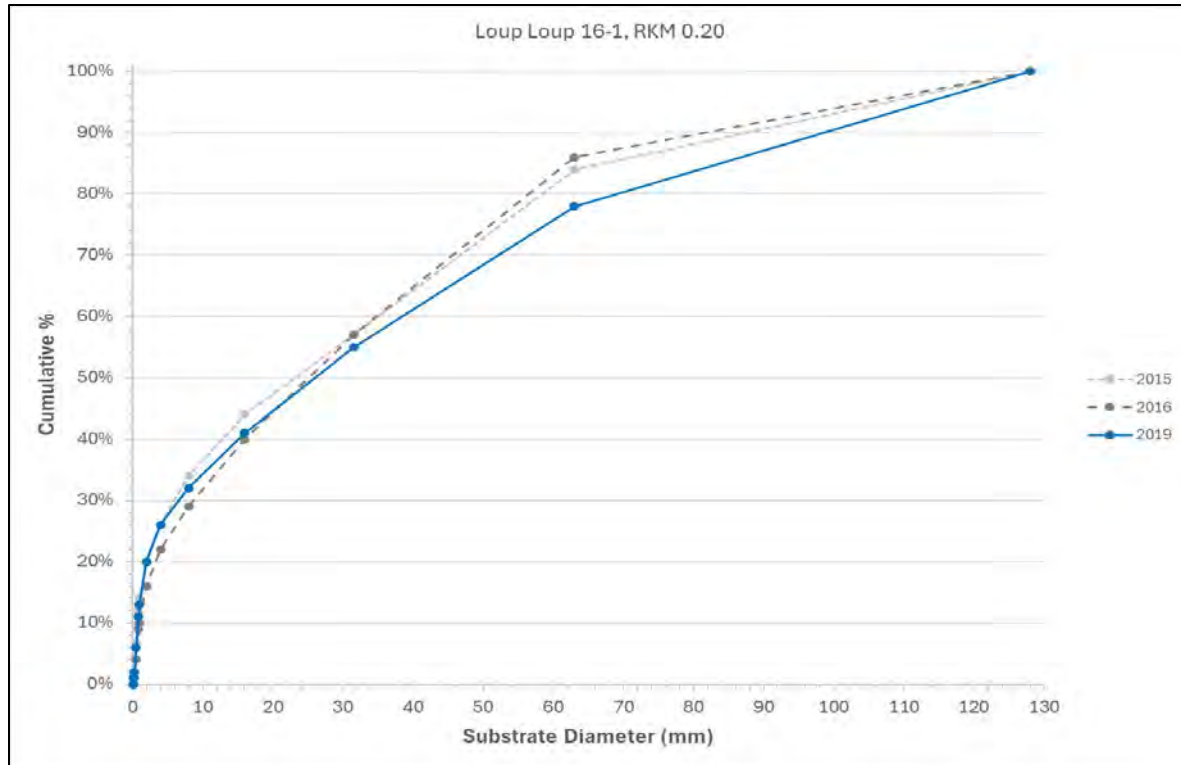
Figure 16. Trend in cumulative substrate composition in Loup Loup 16-1 at RKM 0.20, 2015-2019

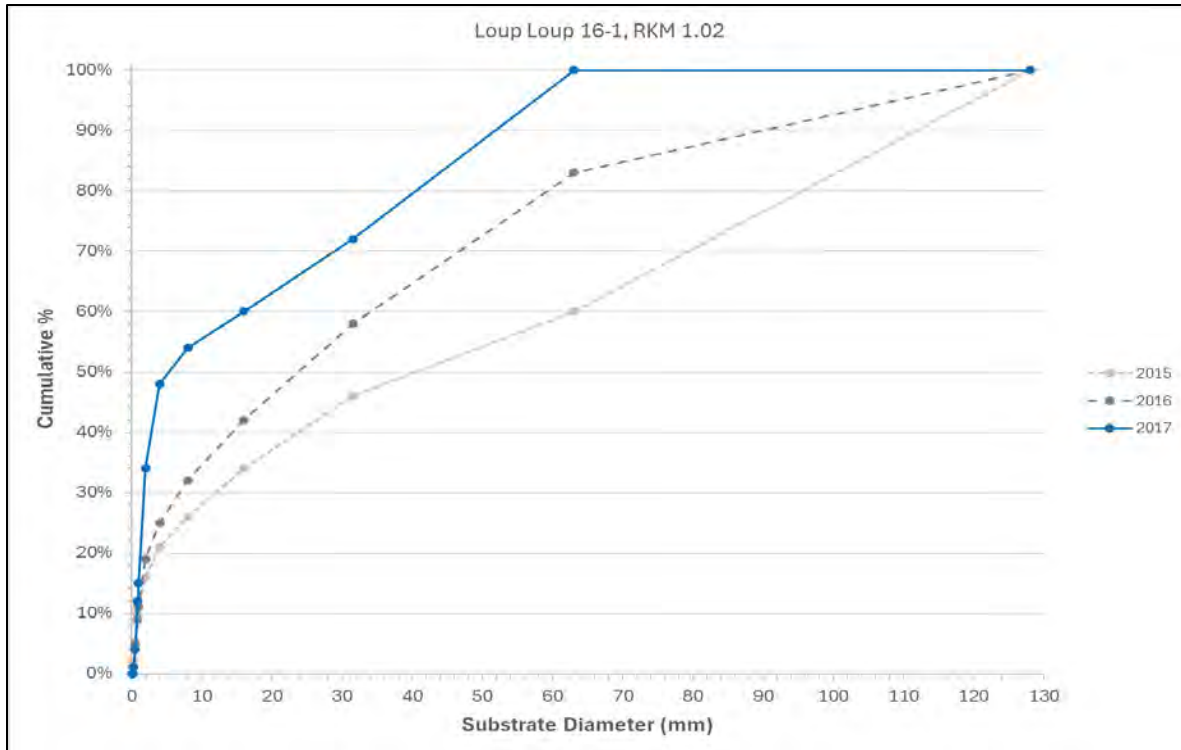
Figure 17. Trend in cumulative substrate composition in Loup Loup 16-1 at RKM 1.02, 2015-2017

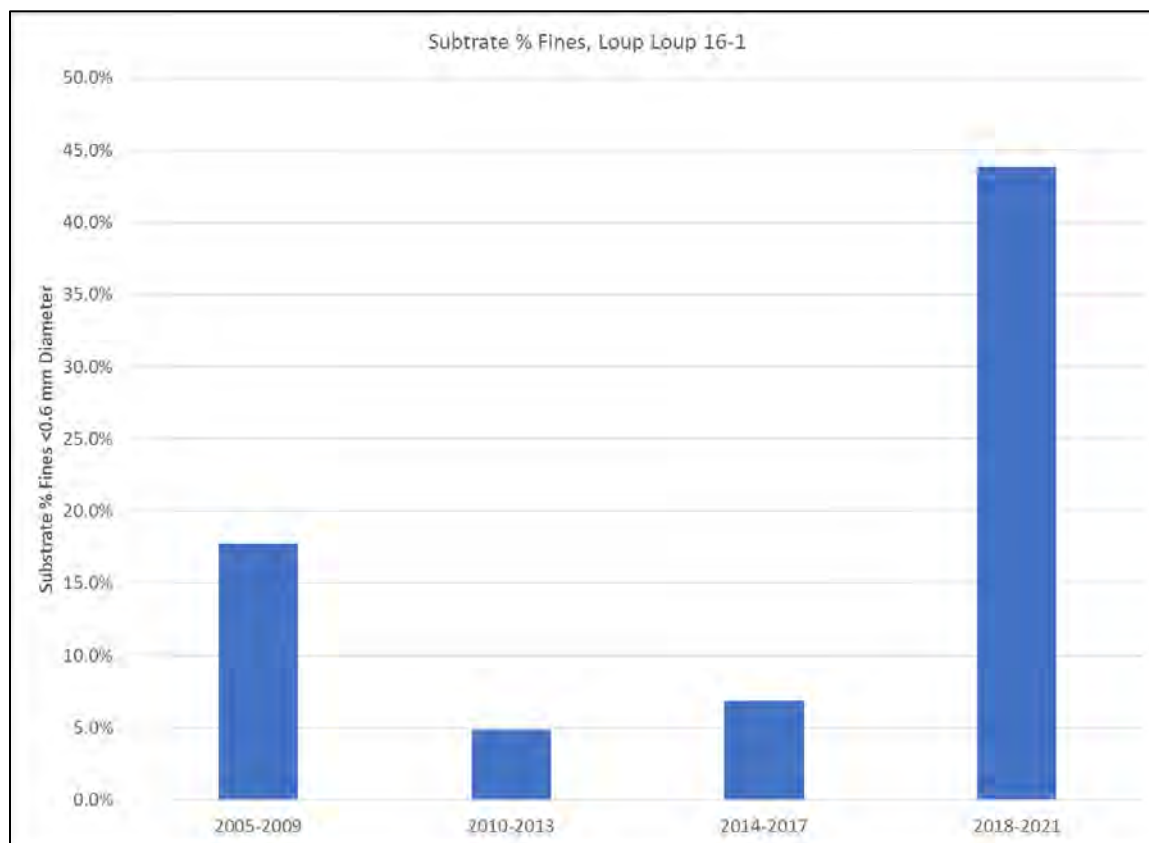
Figure 20. Trend in mean substrate % fines <0.86 mm in steelhead spawning substrates in Loup Loup 16-1 by 4-year OBMEP monitoring cycle

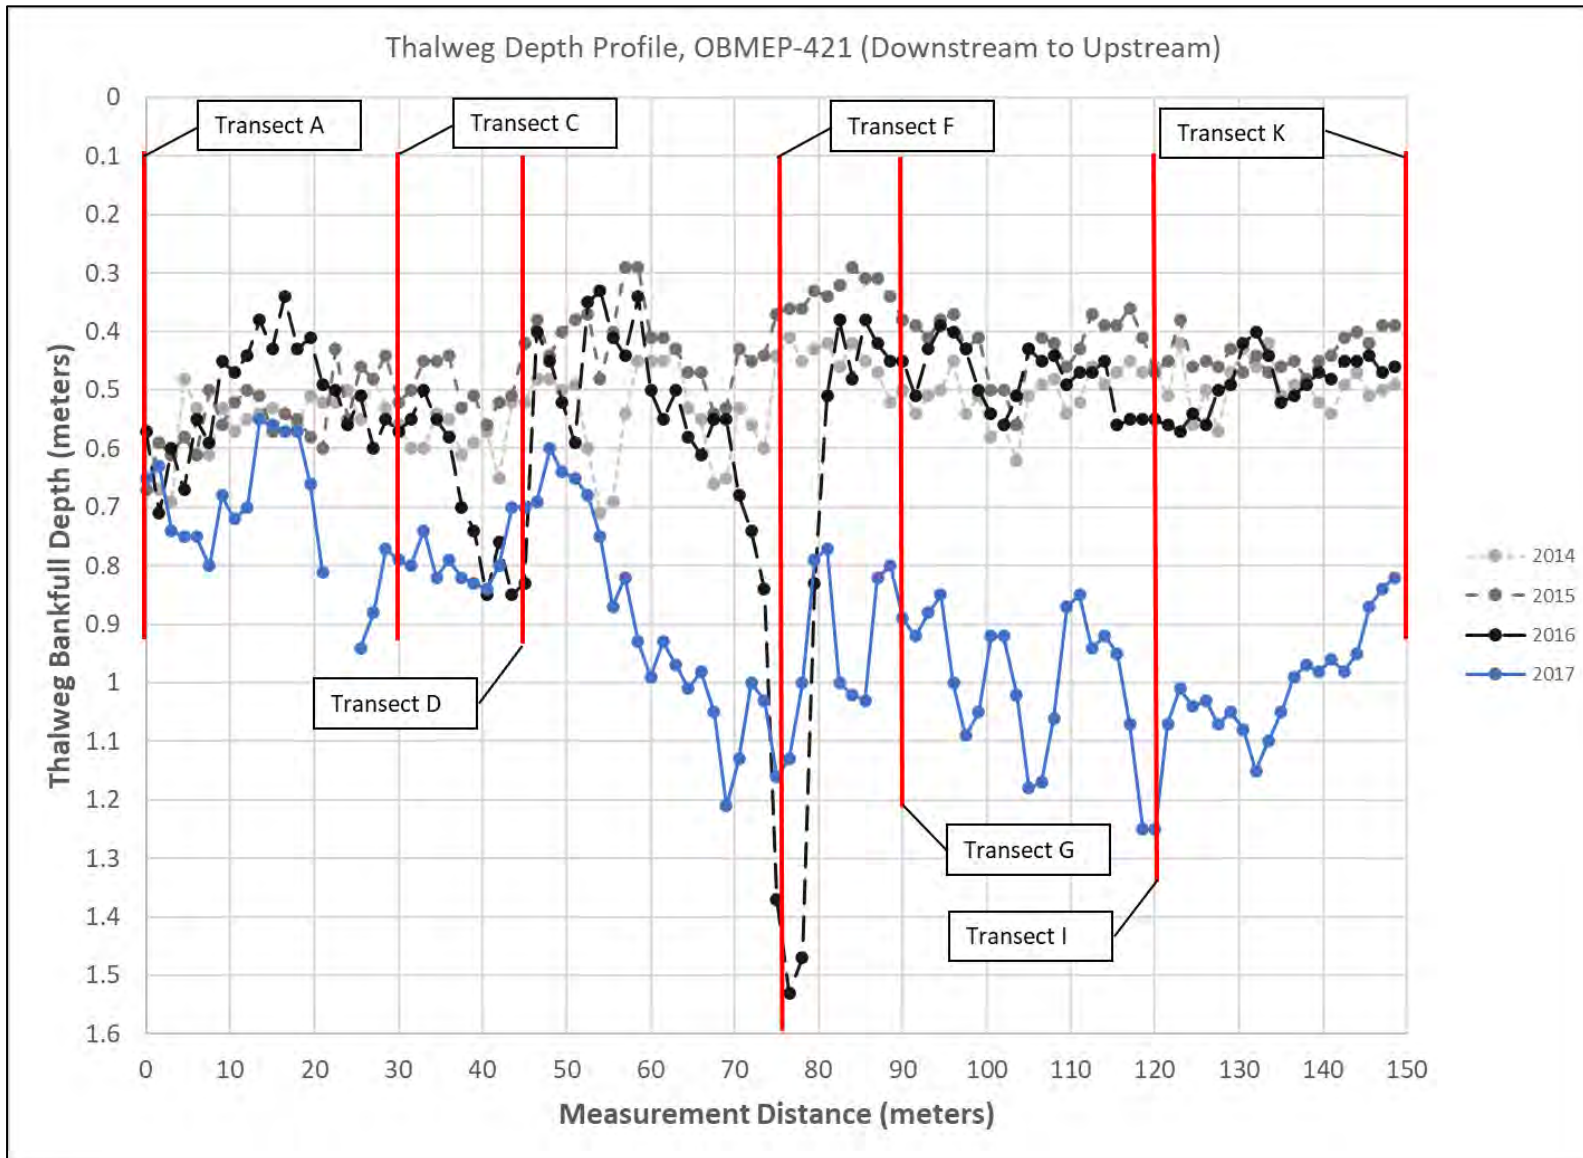
Figure 22. Change in thalweg depth profile in Loup Loup 16-1 at site OBMEP-421, 2014-2017

(Transect positions shown in red.)

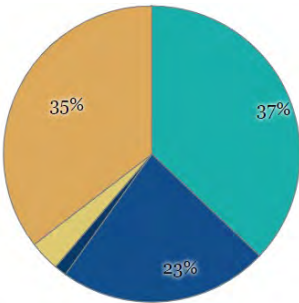
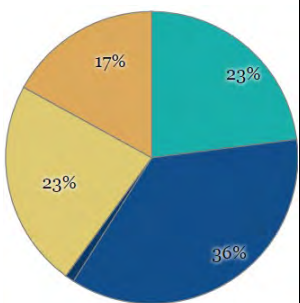
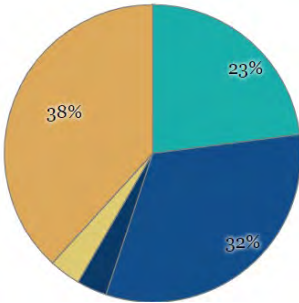
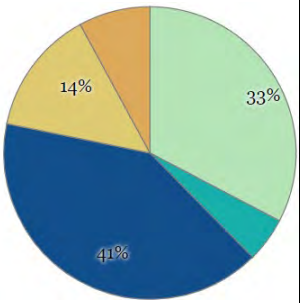
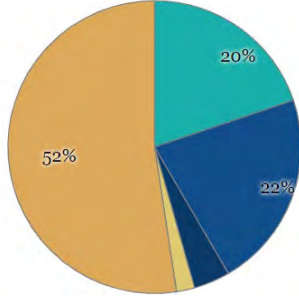
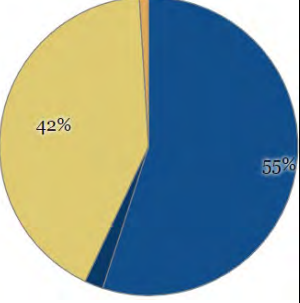
Reach	2013 Habitat Composition	2021 Habitat Composition	Habitat Types
Loup Loup 16-1

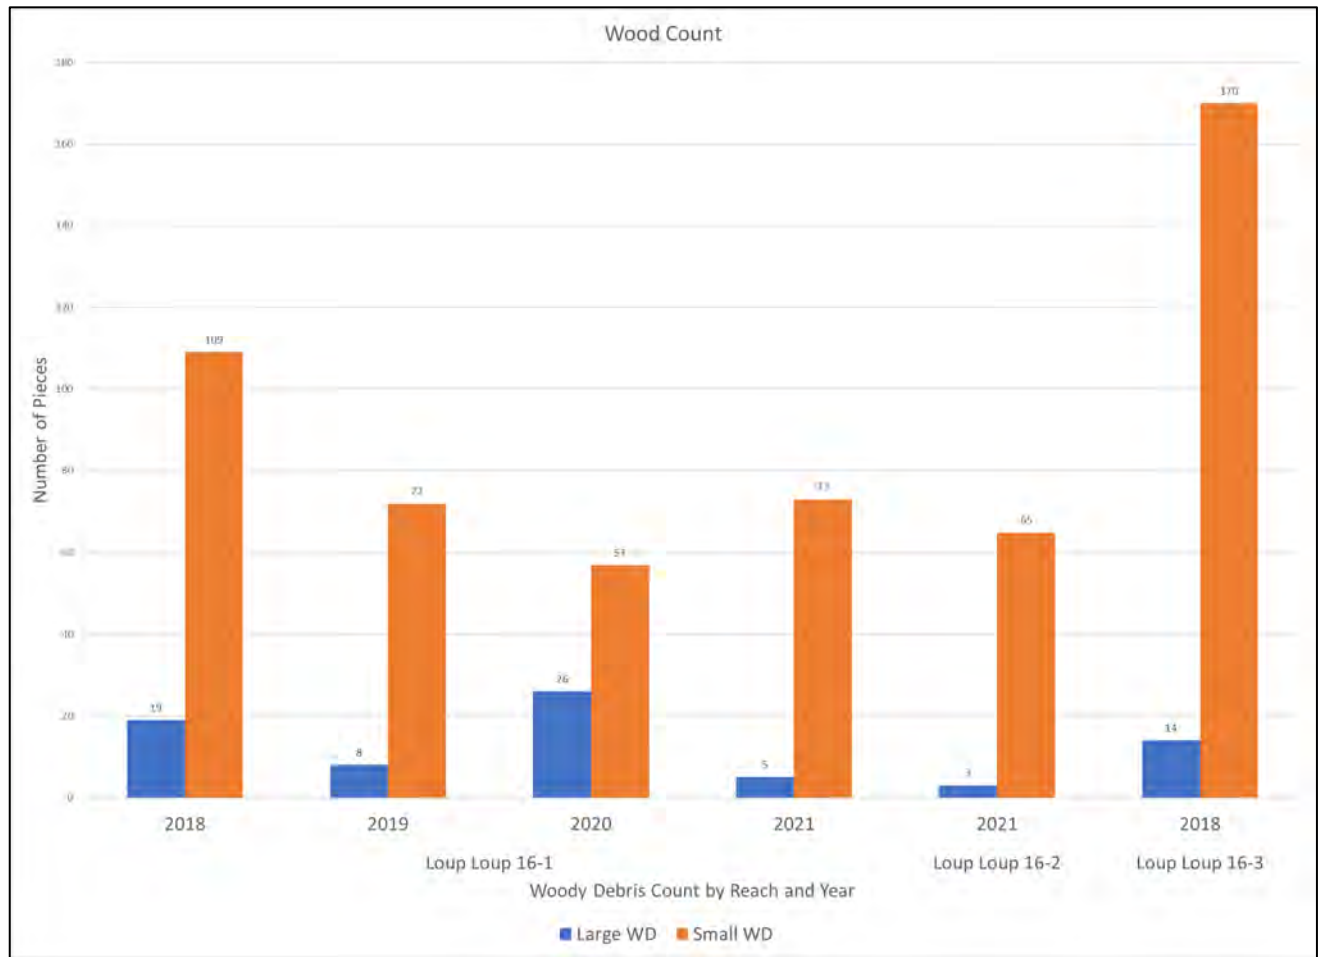
Figure 23. LWD counts in lower Loup Loup Creek

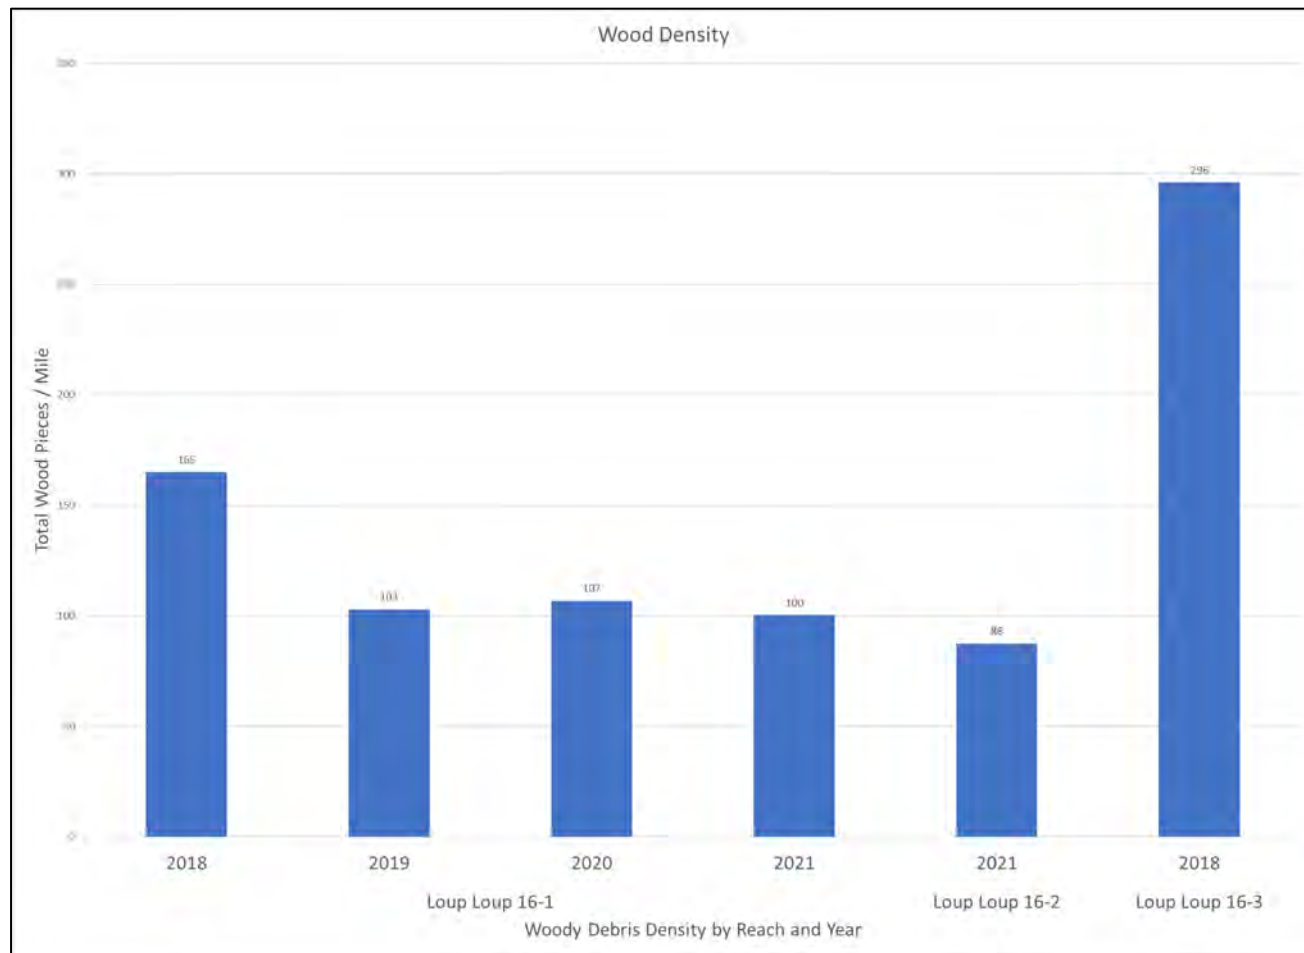
Figure 24. Observed woody debris density in lower Loup Loup Creek, 2018 to 2021

LWD density was highest in Reach 16-3, which had a density of 296 pieces/mile in 2018 (Figure 22). LWD density in Reach 16-1 fell from 165 pieces/mile in 2018 to 101 pieces/mile in 2021. The greatest reduction in LWD density in Reach 16-1 occurred between 2018 and 2019, with density stabilizing between 2019 and 2021. LWD density was 88 pieces/mile in Reach 16-2 in 2021. LWD density was calculated using the quantities of both small and large pieces.

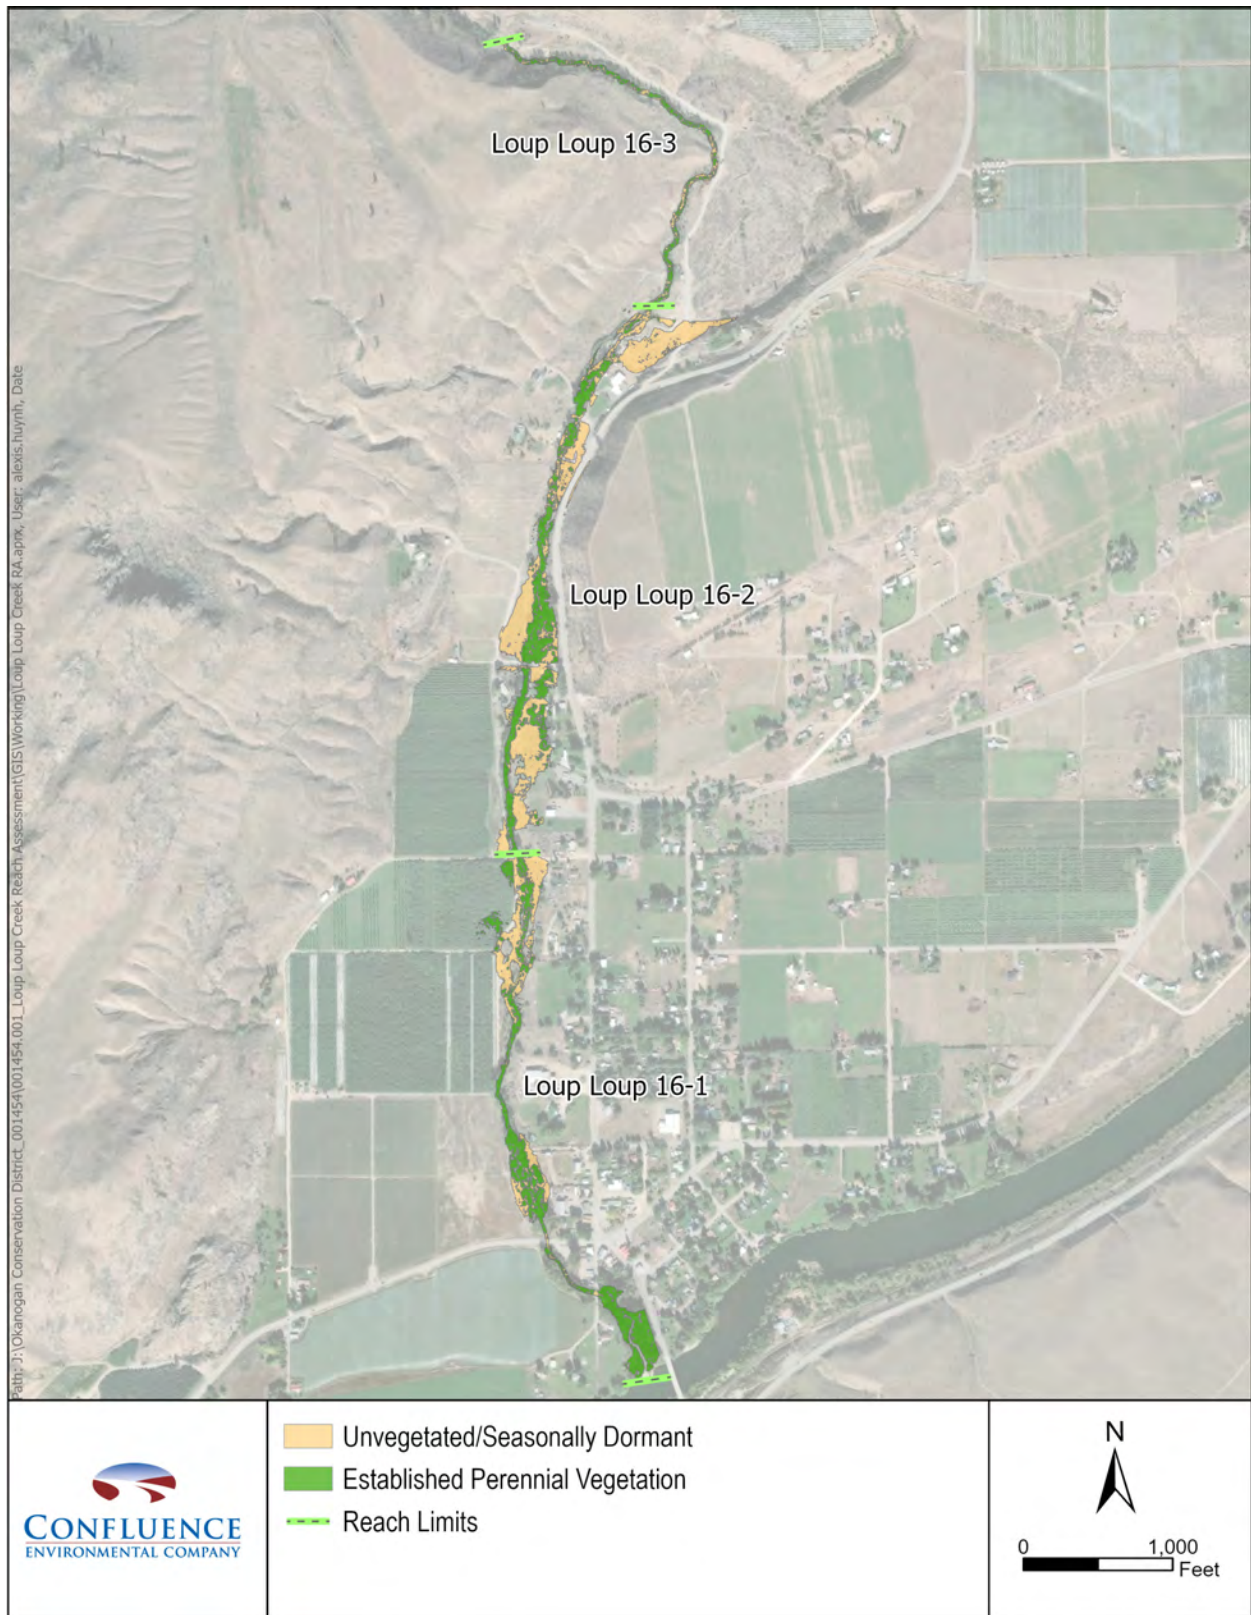
Figure 25. Riparian vegetation composition in the Lower Loup Loup Creek RA study area

Within reach 16-3, approximately 58% of the 10-year floodplain contains established perennial vegetation, while approximately 42% is unvegetated, or contains vegetation that is seasonally dormant. Typical perennial tree and shrub species within the riparian zone of reach 16-3 are listed in Table 14. Seasonal herbaceous species typical to this reach include common and scouringrush horsetail and various native and introduced species of mint (*Mentha* spp.).

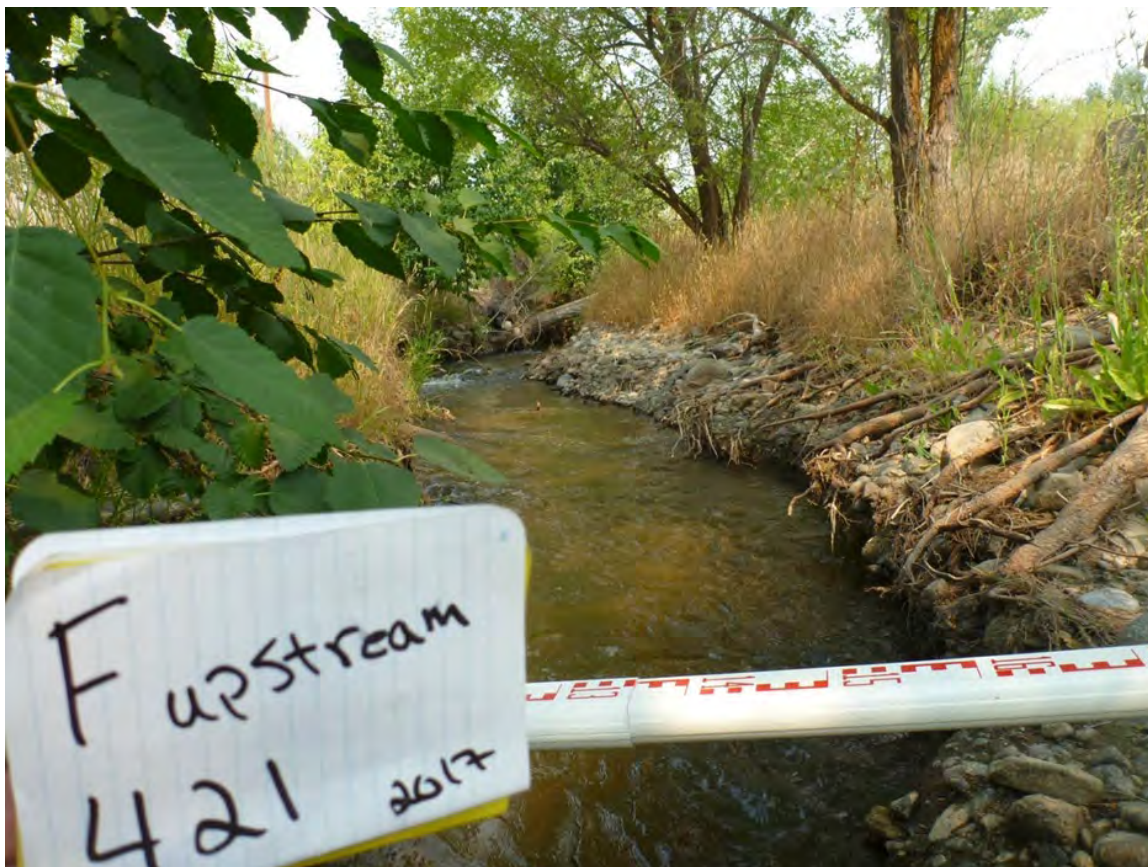
Figure 1. Observed channel incision in reach Loup Loup 16-1, summer 2017 (source: OBMEP).

As stated, channel incision is not considered in EDT and incision conditions cannot be meaningfully derived from model inputs or results. The vertical channel stability indicator rating method could be improved by incorporating REI indicator condition ratings developed by OBMEP staff. These standardized ratings could be incorporated into a hidden HSTR data table supporting the proposed REI report generation function described in Section 4.
