# Middle Entiat River Reach Assessment Update

## Appendix A | Habitat Assessment

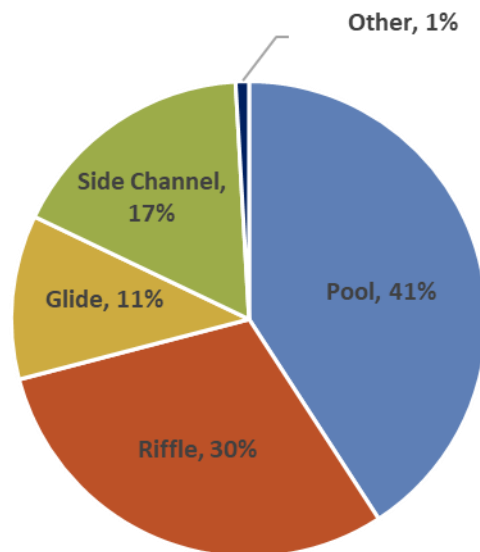
**Figure 1. Habitat unit composition across the entire assessment area.**

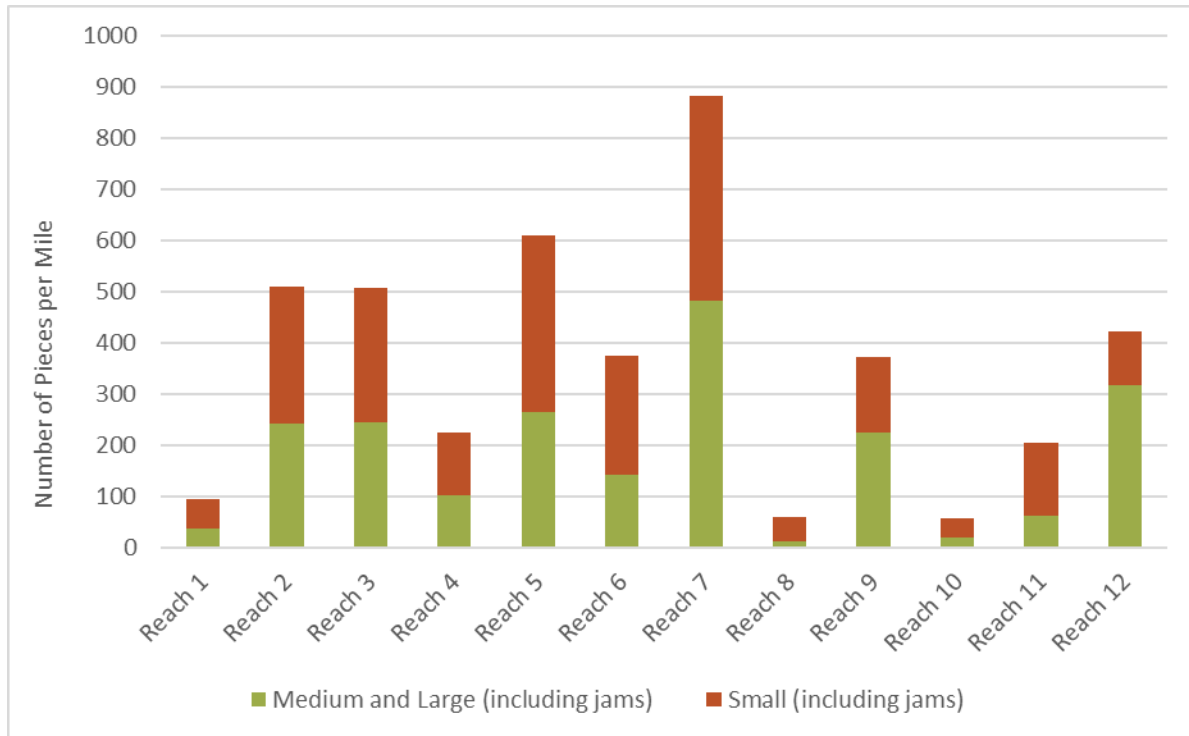
**Figure 4. Number of LWM pieces per mile for each reach, classified by small size class and M+L size class.**

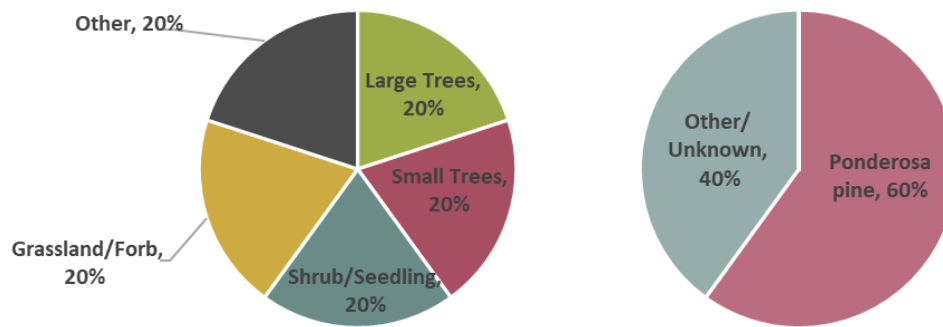
**Figure 14. Dominant overstory riparian vegetation class and species, from five units surveyed, within 100 feet of the Entiat River by ocular estimate.**

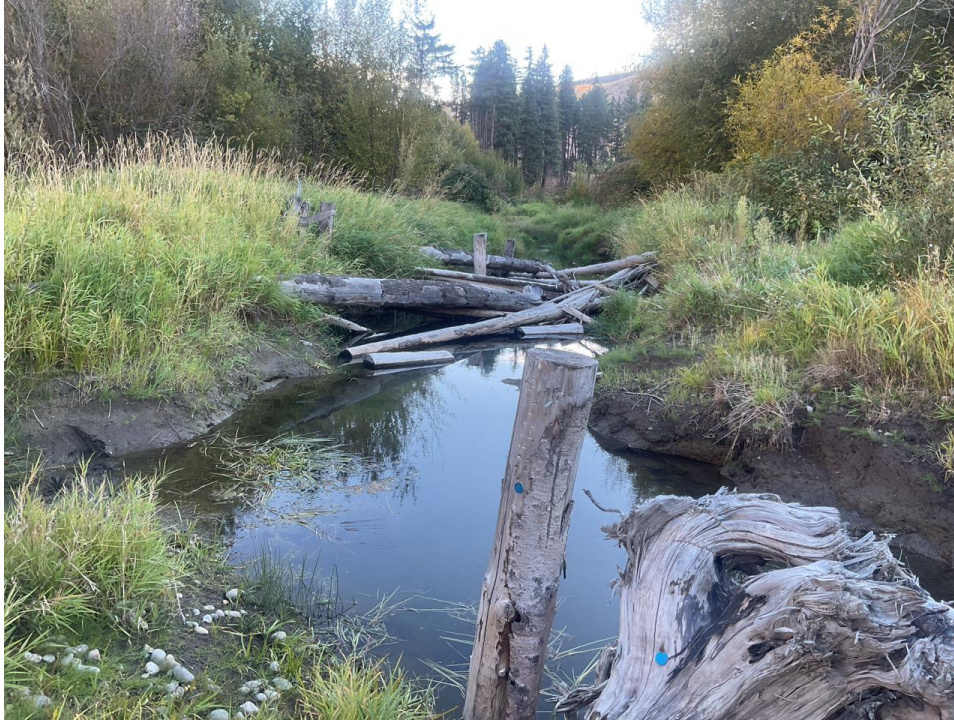
**Figure 19.** *Upstream end of the alcove near RM 16.75.*

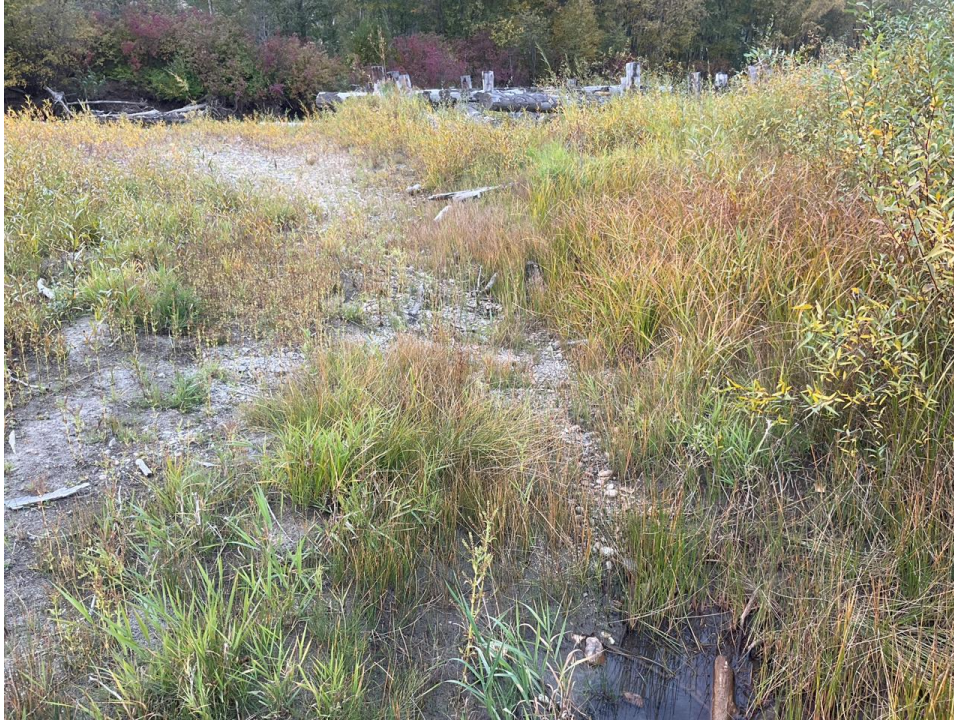
**Figure 26.** Photo shows the dry inlet of the former constructed side channel, filled in with sediment. Surveyors recorded it as an alcove.

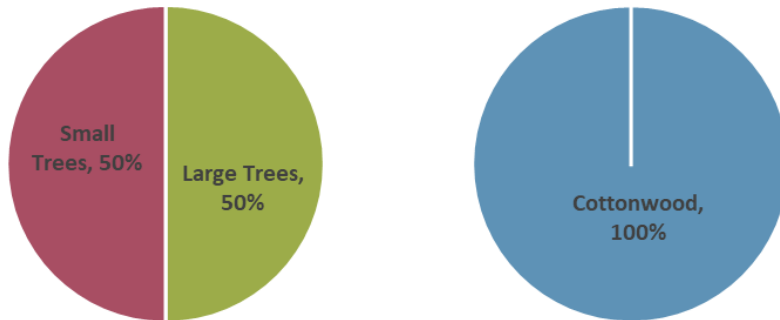
**Figure 27. Dominant overstory riparian vegetation class and species, from two units surveyed, within 100 feet of the Entiat River by ocular estimate.**

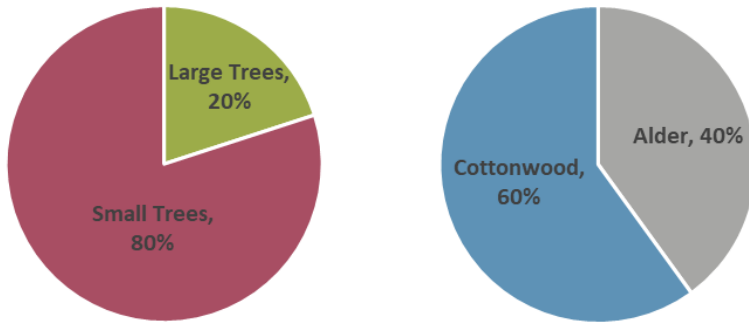
**Figure 43. Dominant overstory riparian vegetation class and species, from five units surveyed, within 100 feet of the Entiat River by ocular estimate.**

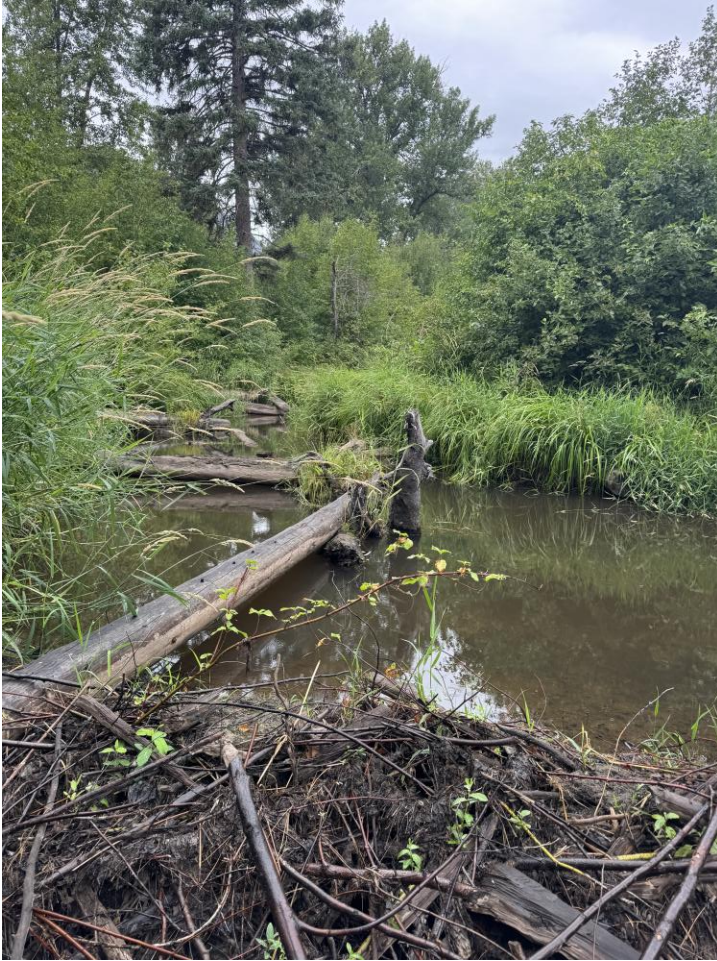
***Figure 73. Photo shows beaver dam in a constructed side channel in Reach 12. Beaver had moved in and created a large marsh in the side channel.***
