Middle Entiat River Reach Assessment & Restoration Strategy Update

Final Report

February 2026

PREPARED BY
Inter-Fluve

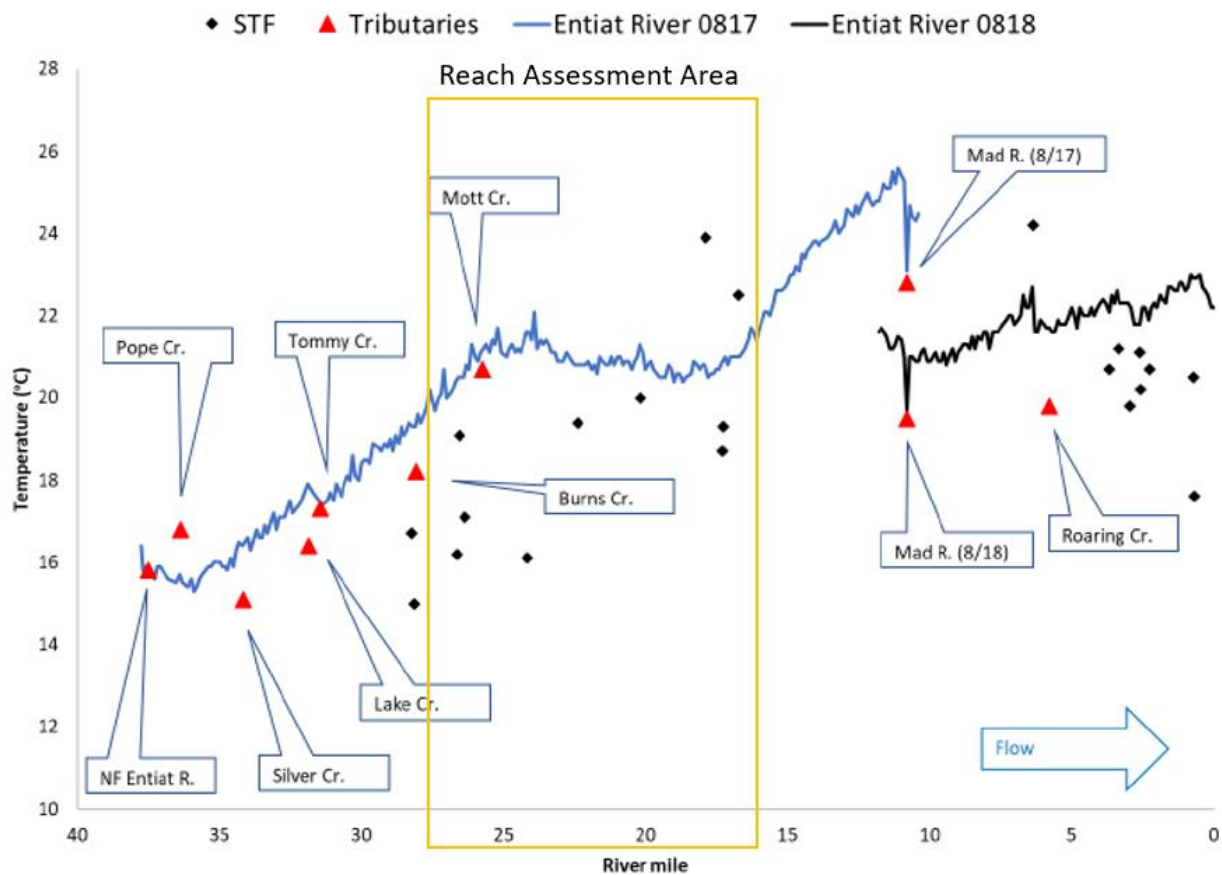
Figure 6. Longitudinal profile of the TIR data, modified from NV5 Geospatial (2023). These data show the warming trend moving downstream from the confluence with the N. Fork Entiat River to the mouth of the Entiat River. The black diamonds are the Significant Thermal Features (STFs). The assessment area for this reach assessment is shown in yellow.

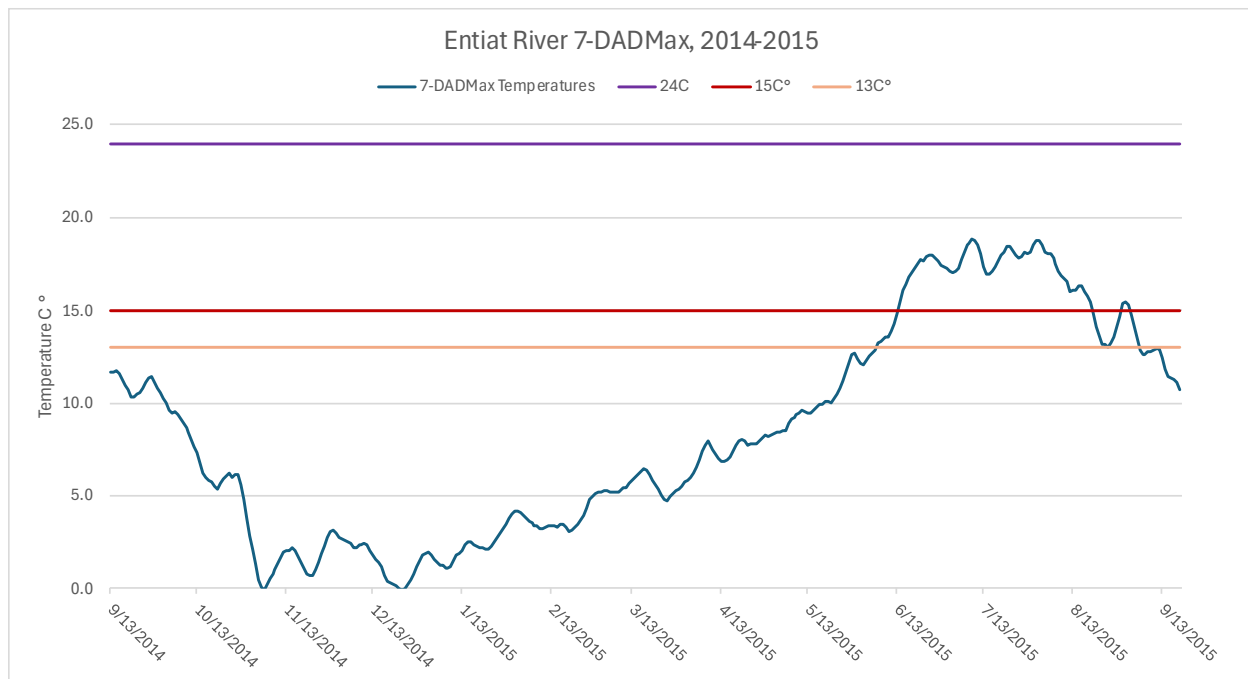
Figure 7. Graph shows 7-DADMax temperatures for the Entiat River for 2014-15. Data is from a data logger installed near RM 25.5 in Reach 11. Temperatures exceeded rearing and spawning temperatures during the summer months.

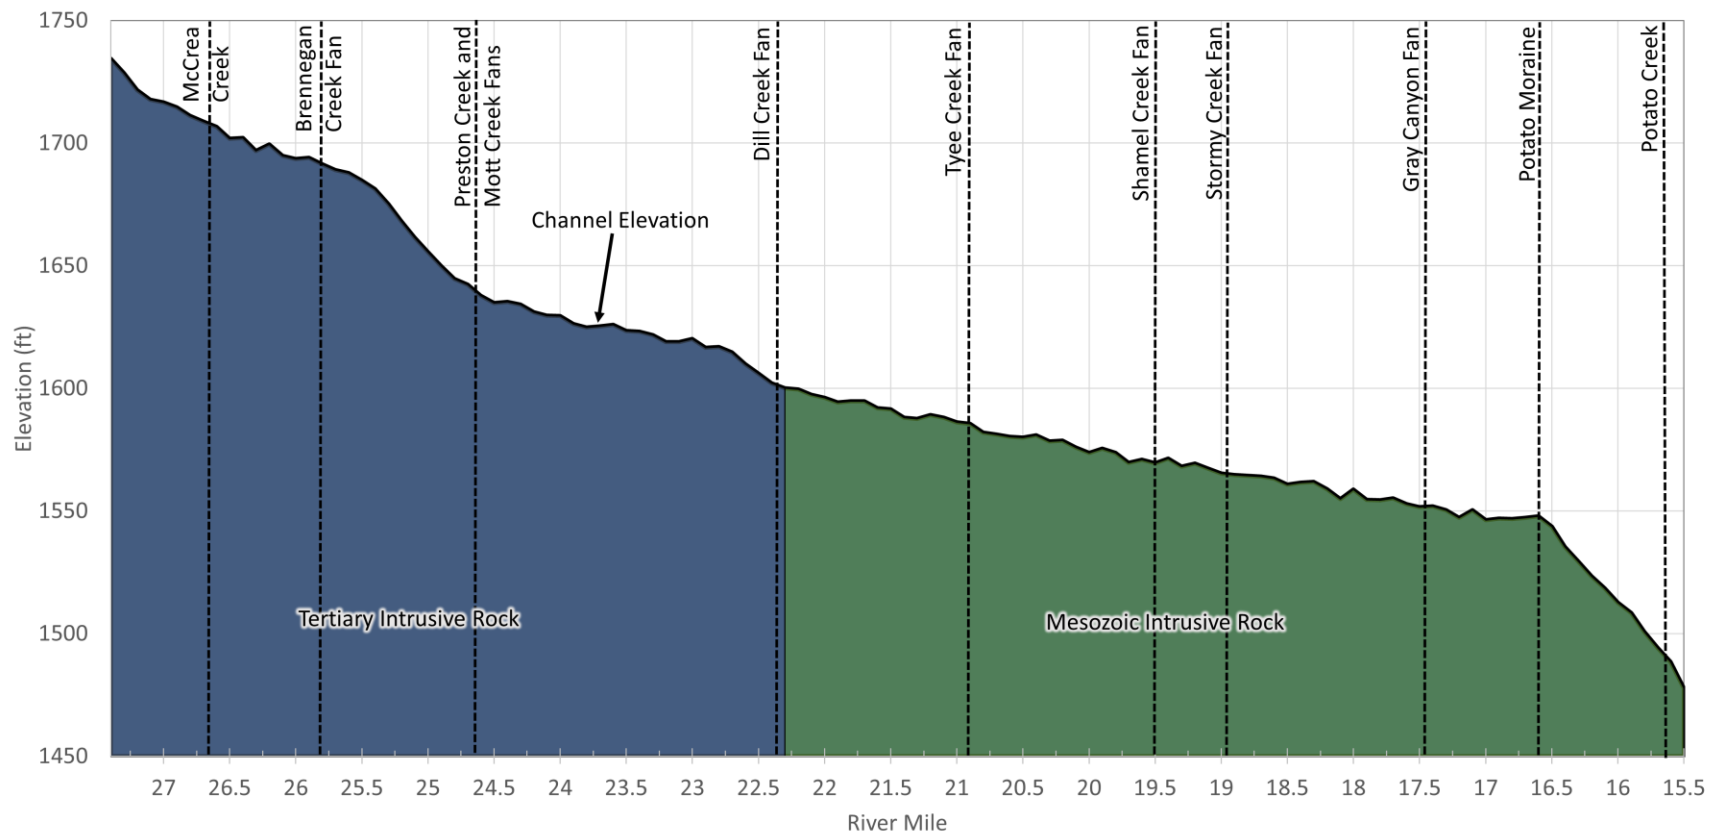
Figure 10. Channel gradient, governing geology, and notable geomorphic features within the Entiat River assessment area. Governing geology derived from Tabor et al., 1987.

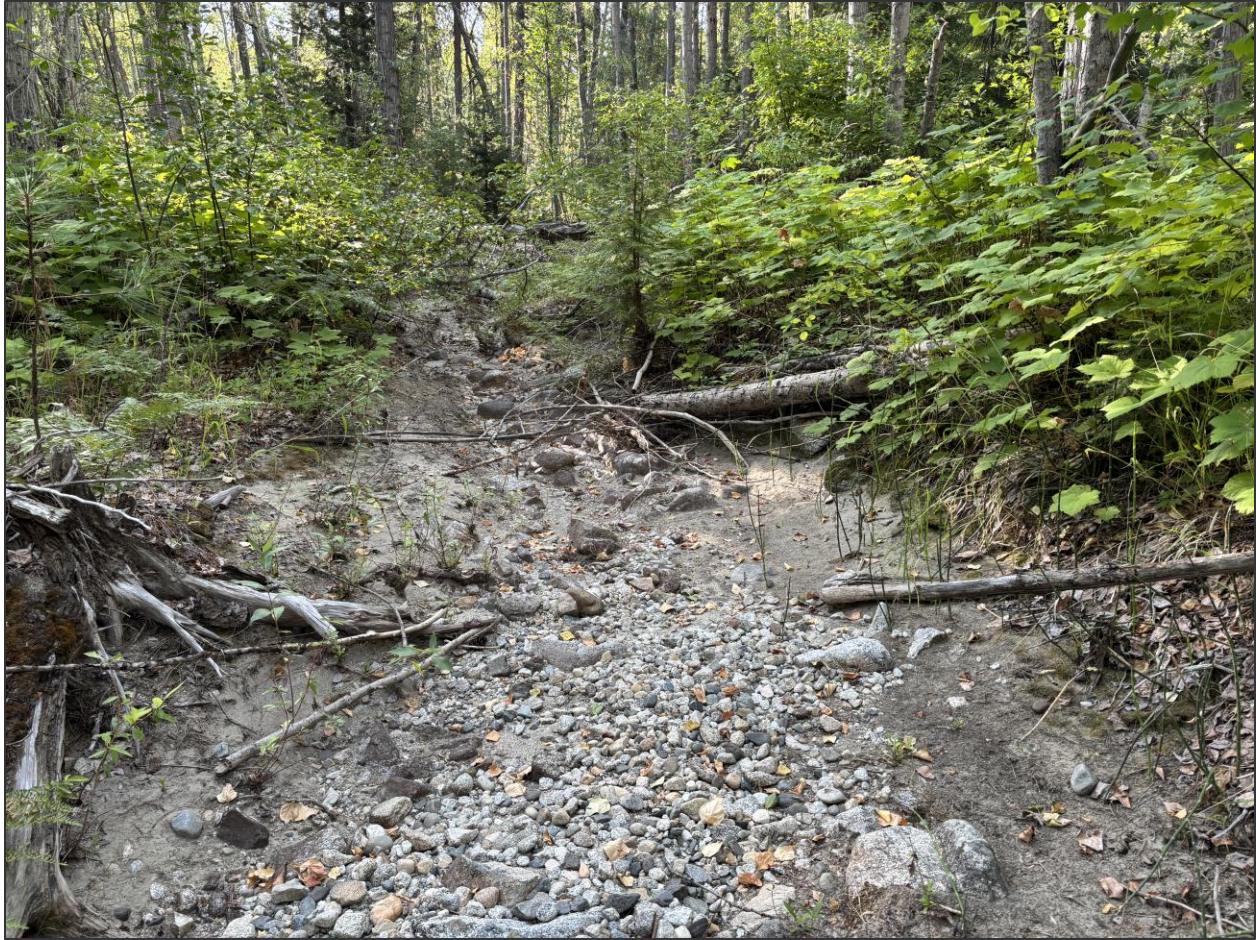
Figure 12. Top: Photograph of side channel extending from RM 26.55 to 26.65, captured during August 2025 Geomorphic Assessment.

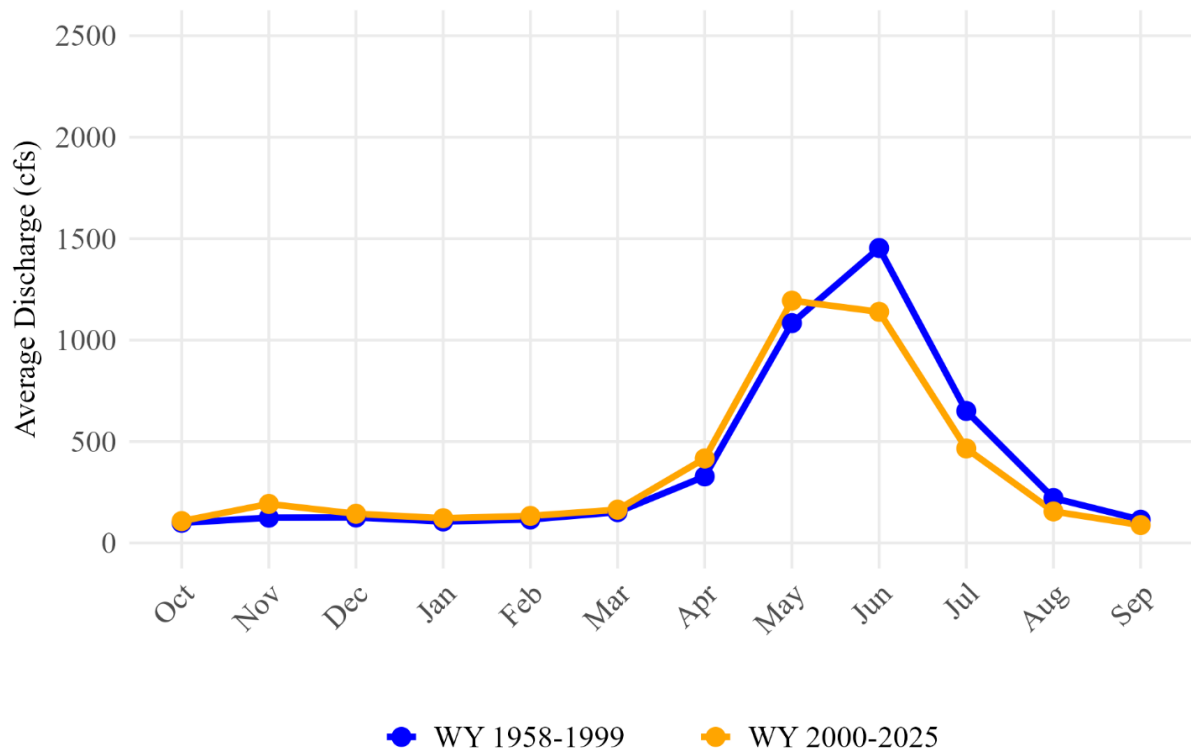
Figure 19. Comparison of mean monthly flows at the USGS gage (Entiat River Near Ardenvoir, WA - 12452800) for two time periods.

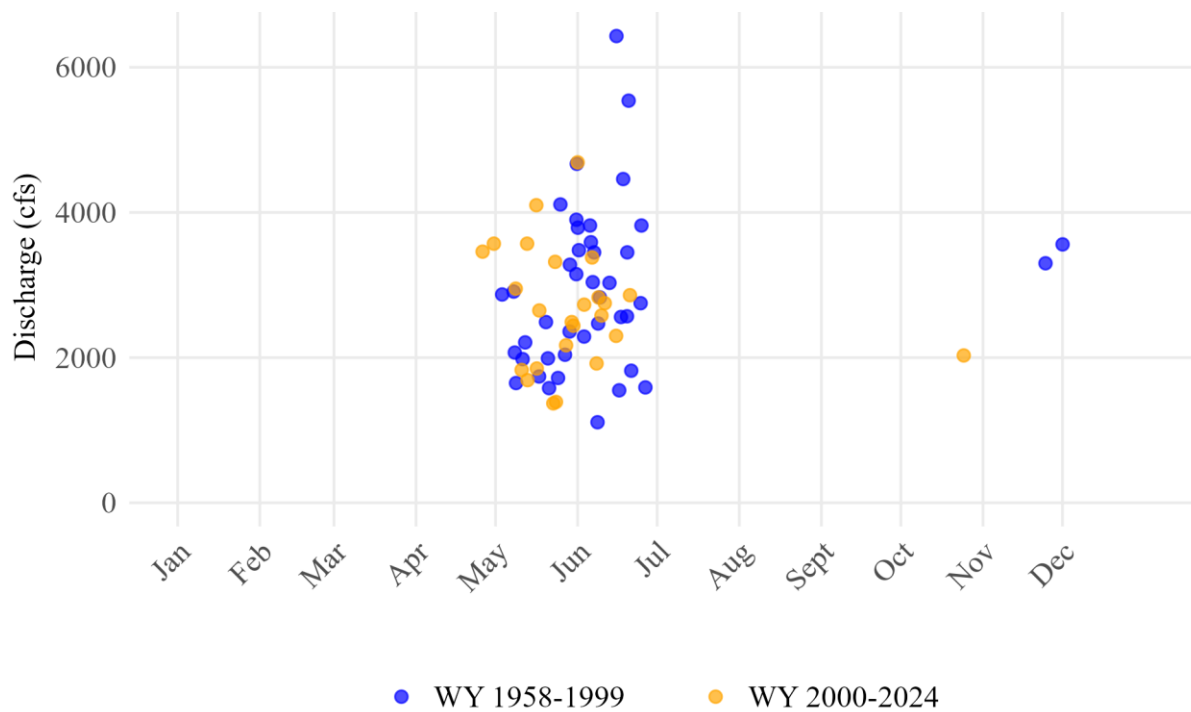
Figure 20. Annual peak flow timing and magnitude at Entiat River Near Ardenvoir, WA stream gage (USGS 12452800).

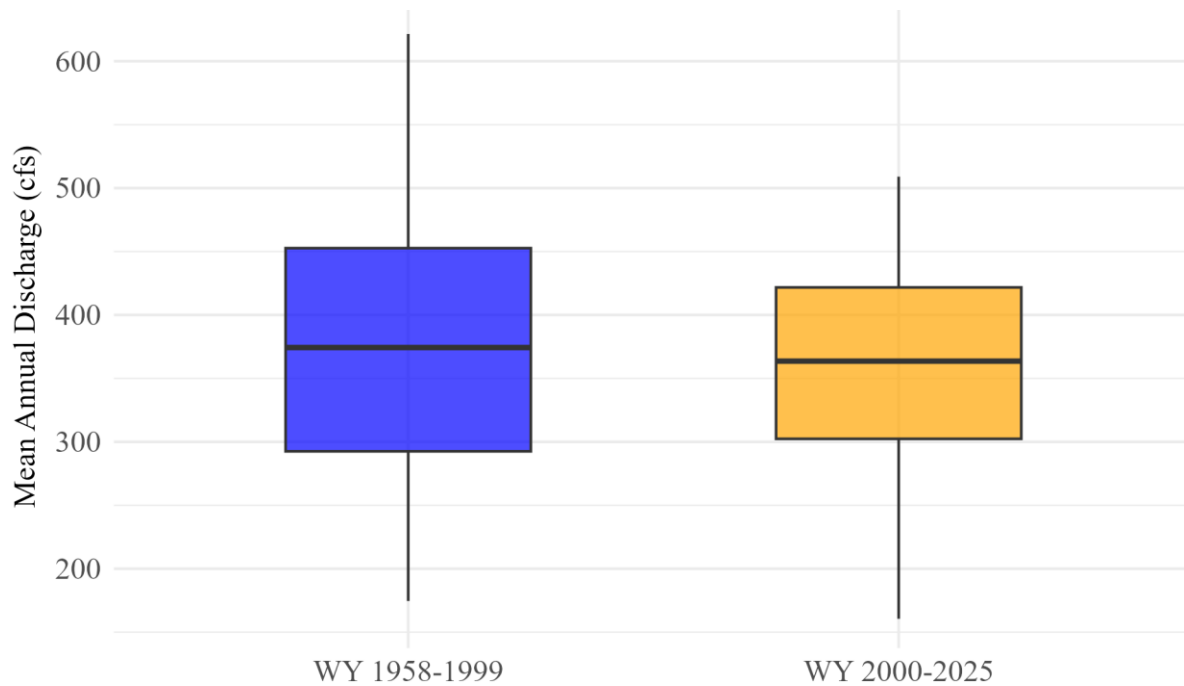
Figure 21. Mean annual discharge at the Entiat River Near Ardenvoir, WA USGS gaging station (12452800). The mean annual discharge for WY 1958 – 1999 was 382 cfs while the mean annual discharge for WY 2000 – 2025 was 361 cfs.

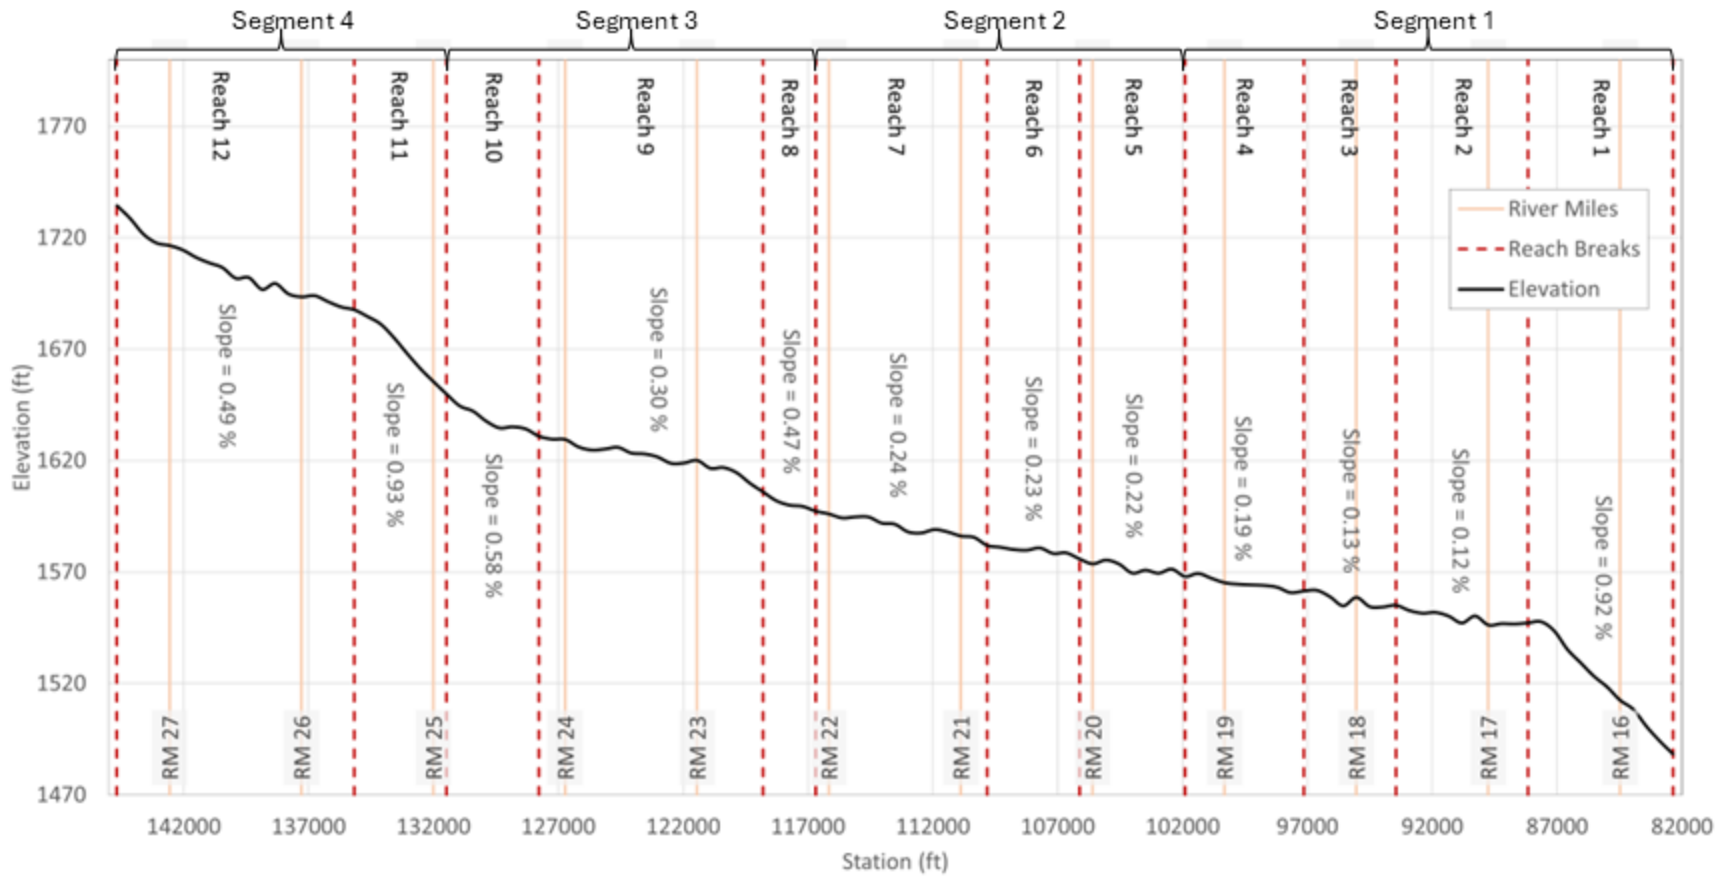
Figure 22. Longitudinal profile for the Entiat River within the assessment area.

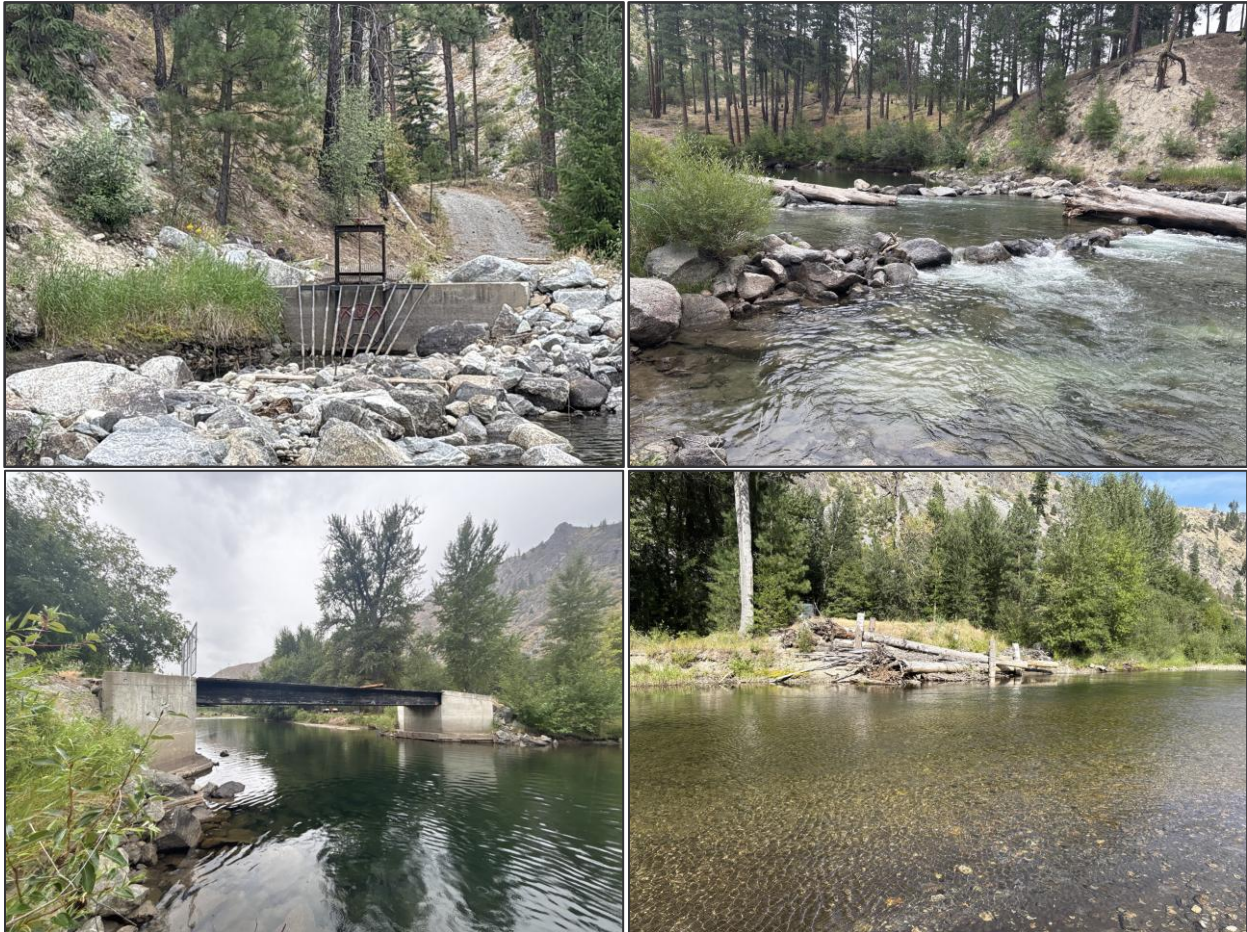
Figure 24. Human alterations in Segment 1. Top left: McKenzie Ditch (RM 16.6); Top right: boulder weirs directing flow into McKenzie Ditch, looking upstream; Bottom left: bridge and associated riprap at RM 18.1, looking downstream; Bottom right: fill associated with former Cottonwood Flats bridge (RM 18.45).

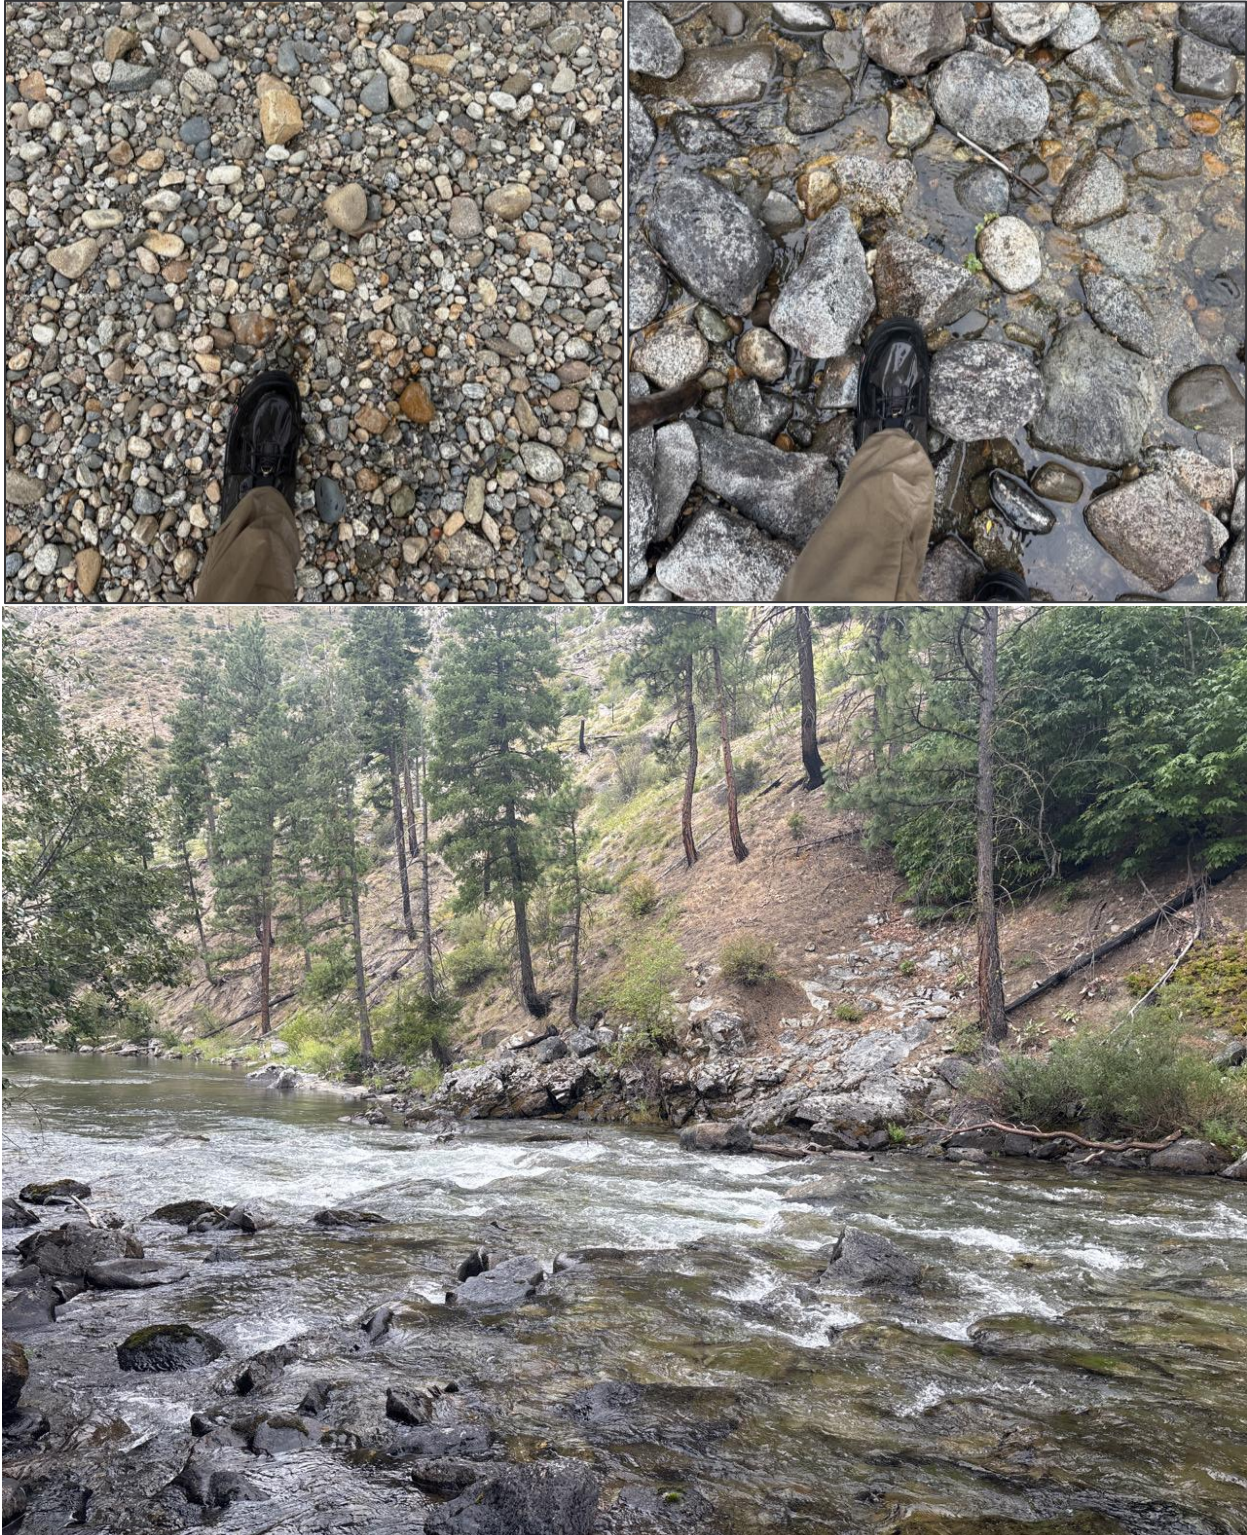
Figure 29. Top: Representative photographs of channel bed substrate in Segment 1. Gravels were the dominant channel substrate in the upstream unconfined portion of Segment 1 (left, RM 16.95), whereas boulders and cobbles were the dominant channel substrate downstream of McKenzie Ditch (right, RM 16.55). Bottom: bedrock exposure creating cascade at RM 16.05, looking downstream.

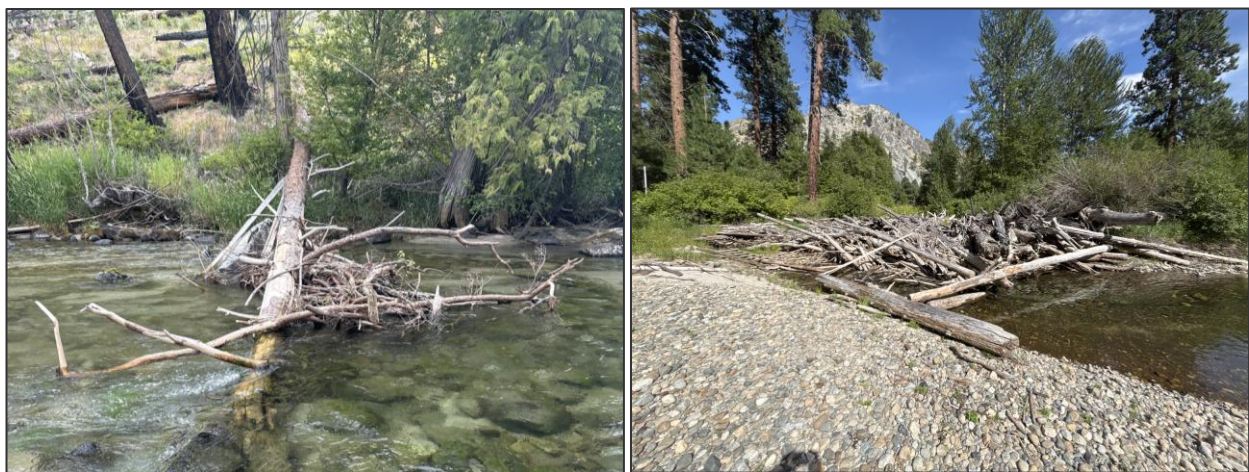
Figure 31. Naturally recruited large wood in Segment 1. Left: large wood wedged against standing tree racks additional transported wood leading to flow deflection and fine sediment deposition (RM 16.15, looking toward river right bank). Right: log jam near RM 18.75 responsible for plugging former side channel through river left floodplain.

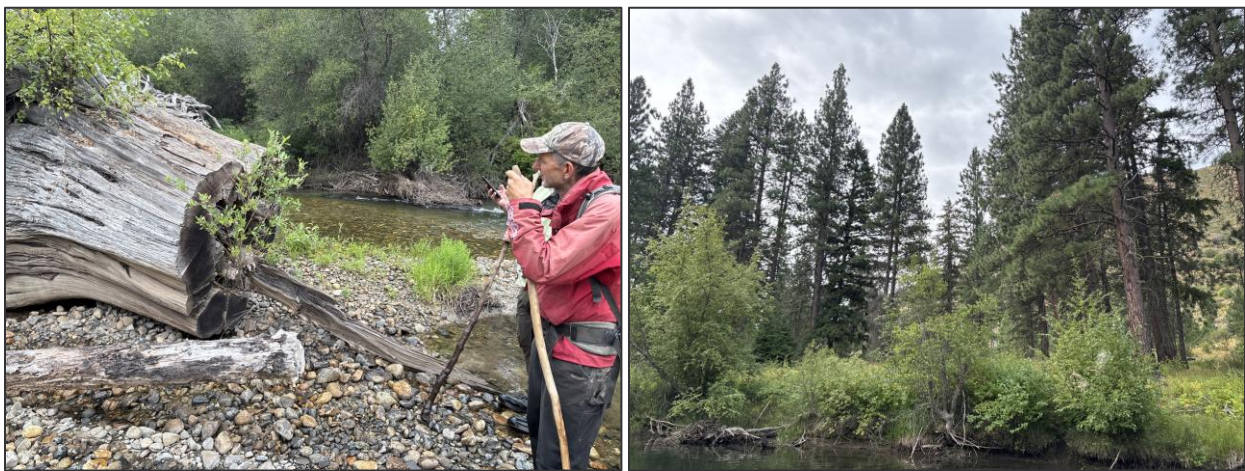
Figure 32. Left: Cut stump of large western redcedar in Entiat River channel near RM 17.5, representative of old growth trees present within the watershed prior to widespread logging beginning in the 19th century. Right: Photograph of larger conifers within Segment 1, which typically do not exceed 2 feet in diameter at present.

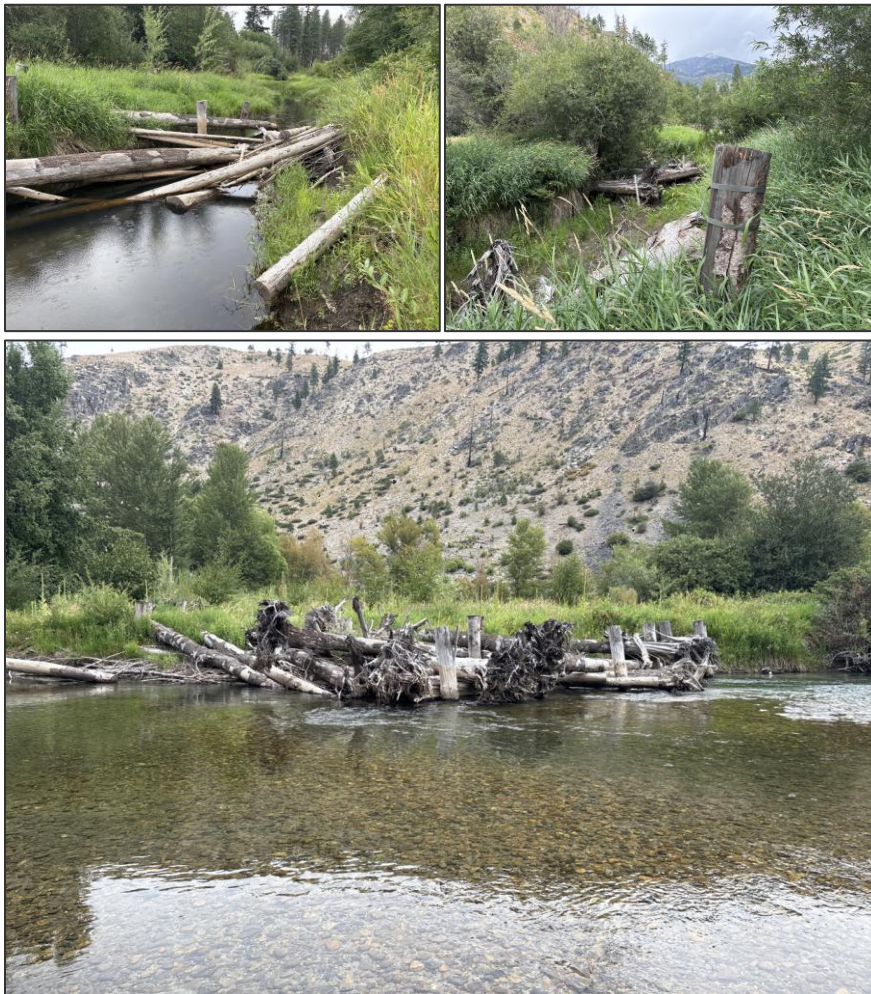
Figure 35. Representative photographs of Gray F restoration project. Top left: wetted side channel through river left side channel downstream of RM 16.8; Top right: dry side channel through river right floodplain near RM 16.85; Bottom: constructed large wood structure on river right near RM 16.8.

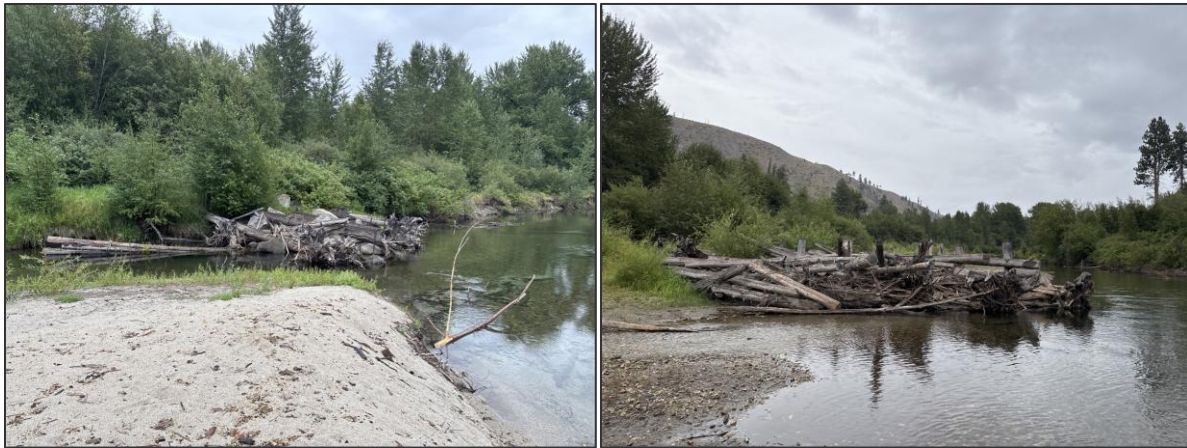
Figure 36. Large wood structures installed during Gray E restoration project near RM 17.8 (left, looking downstream) and RM 17.9 (right, looking downstream).

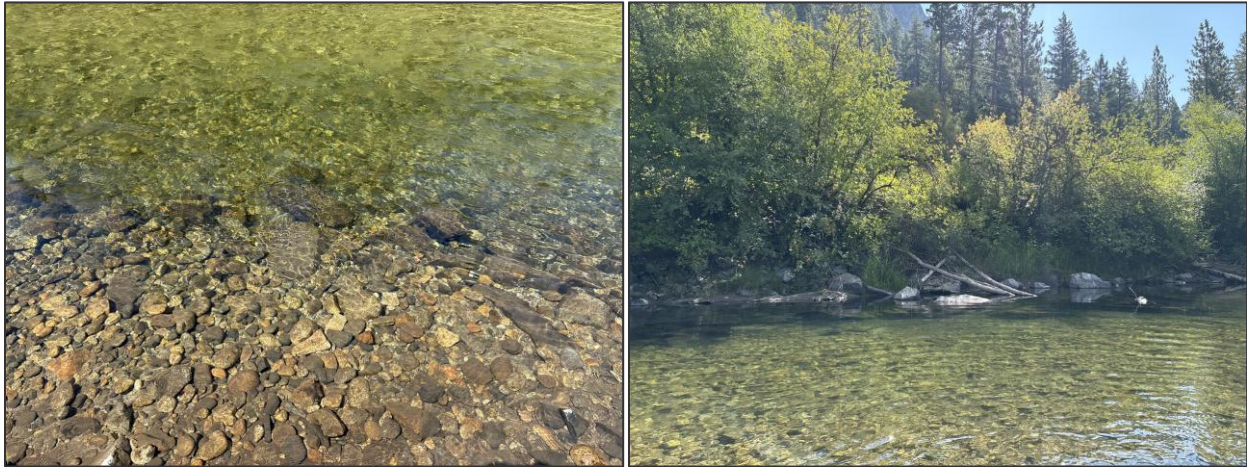
Figure 39. Human alterations in Segment 2. Left: angular small boulders along river left Entiat River channel margin at RM 20.9 are likely remnants of riprap removed as part of Stormy B restoration project. Right: placed boulders along river left channel margin protecting Entiat River road, RM 21.5.

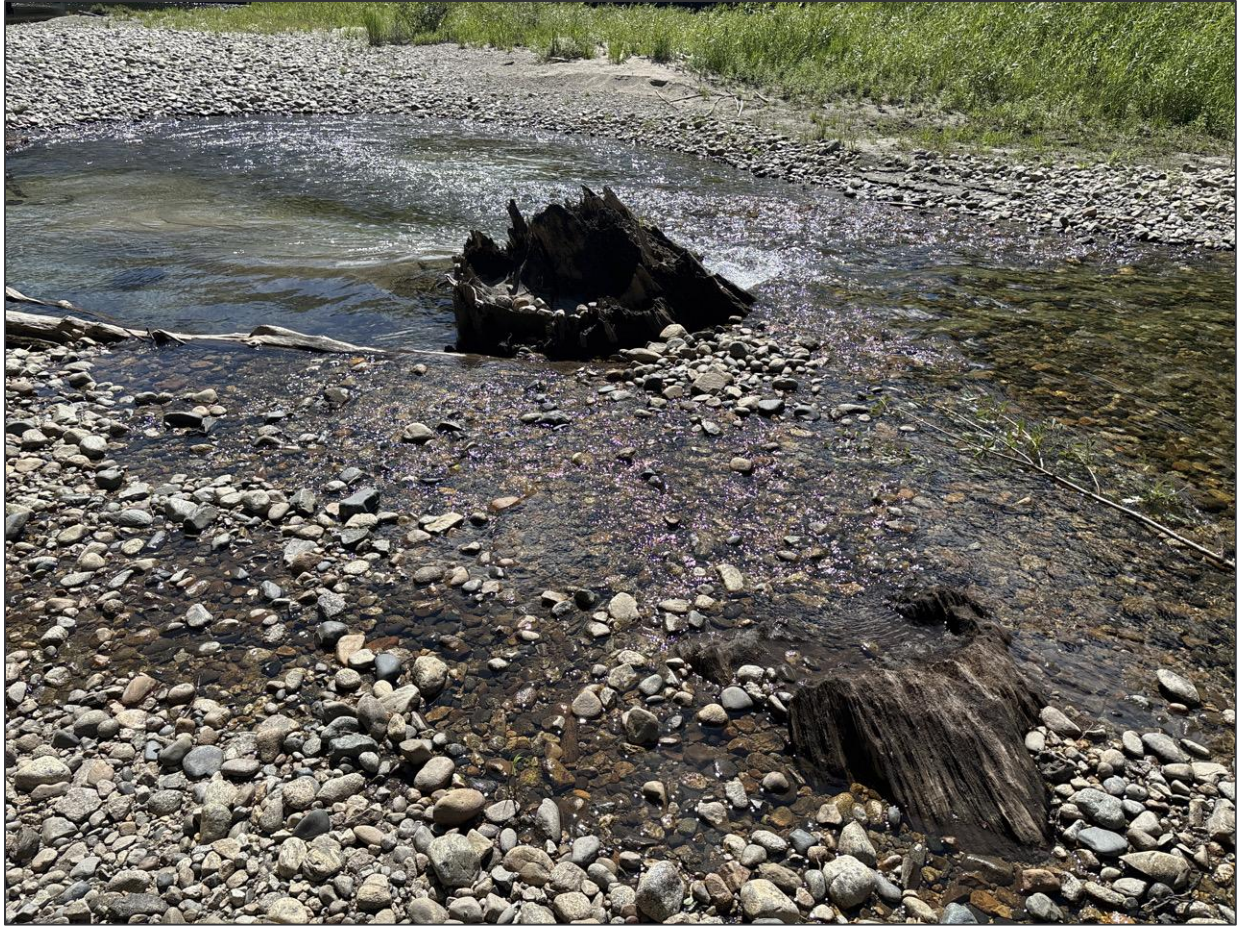
Figure 40. Stumps in river left Entiat River flow split channel, RM 19.7. Stumps are likely a relic of pre-logging era where mature old-growth trees were present within the Entiat River watershed.

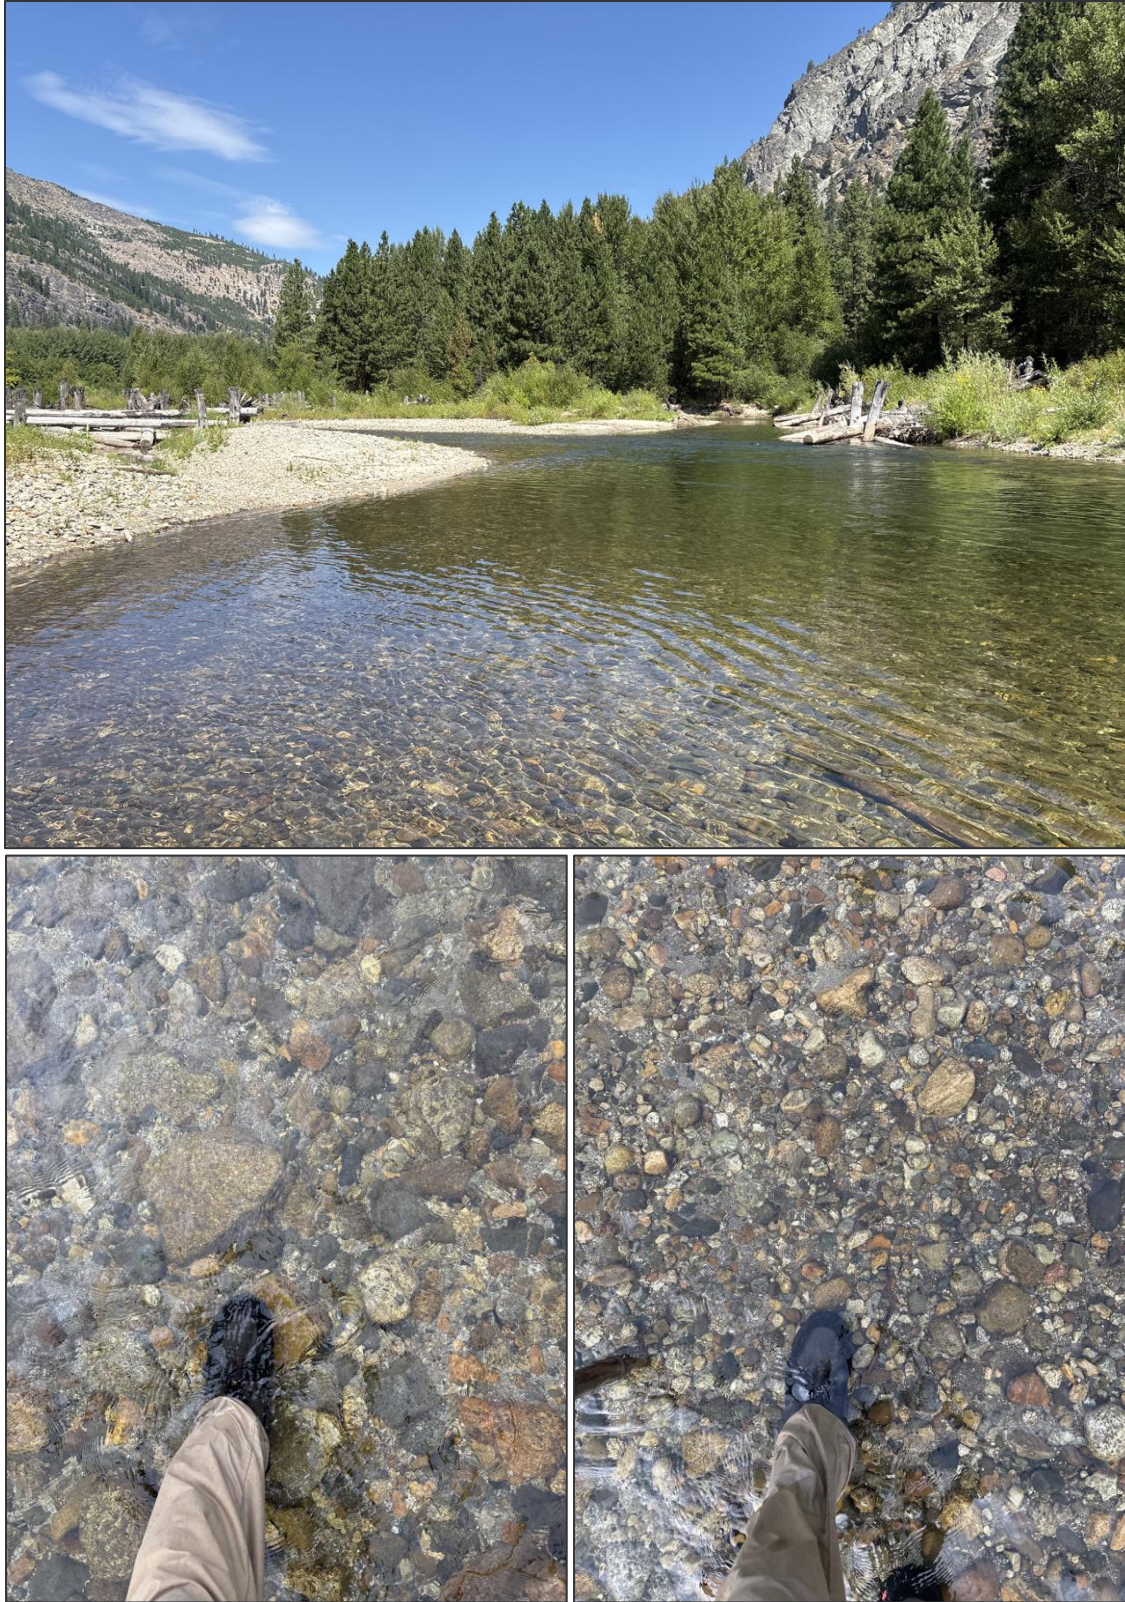
Figure 45. Top: Entiat River mainstem flow split at RM 20.95, looking upstream. Bottom: Representative photographs of Segment 2 channel substrate. Substrate generally consisted of cobbles (left, RM 22) and gravels (right, RM 22.5) in higher energy regions, and sands in deep pools.

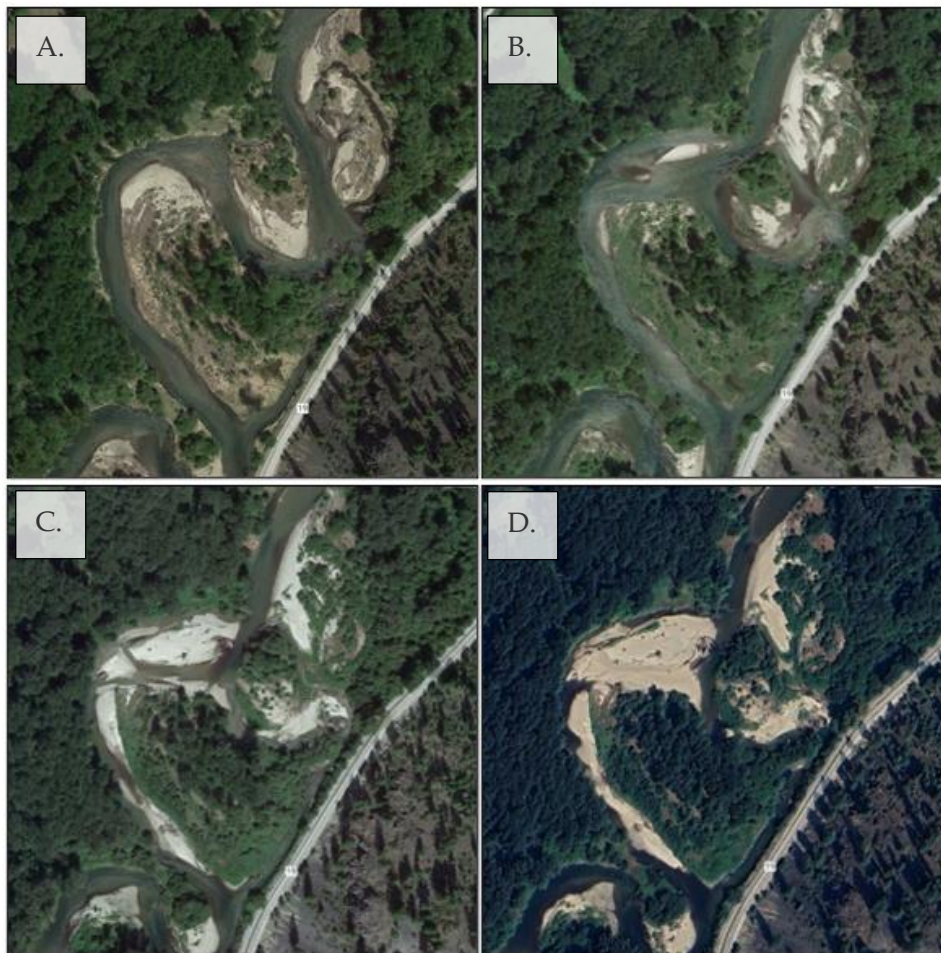
Figure 46. Progression of channel avulsion at RM 20.1 visible in Google Earth aerial imagery: A) pre-avulsion channel alignment with tight meander at RM 20.1 intact, May 2015; B) channel alignment following neck cutoff, July 2017; C) original main channel filling with sediment following neck cutoff, August 2022; D) present-day channel alignment with majority of flow through former side channel on river left, and former main channel mostly plugged with sediment, August 2024.

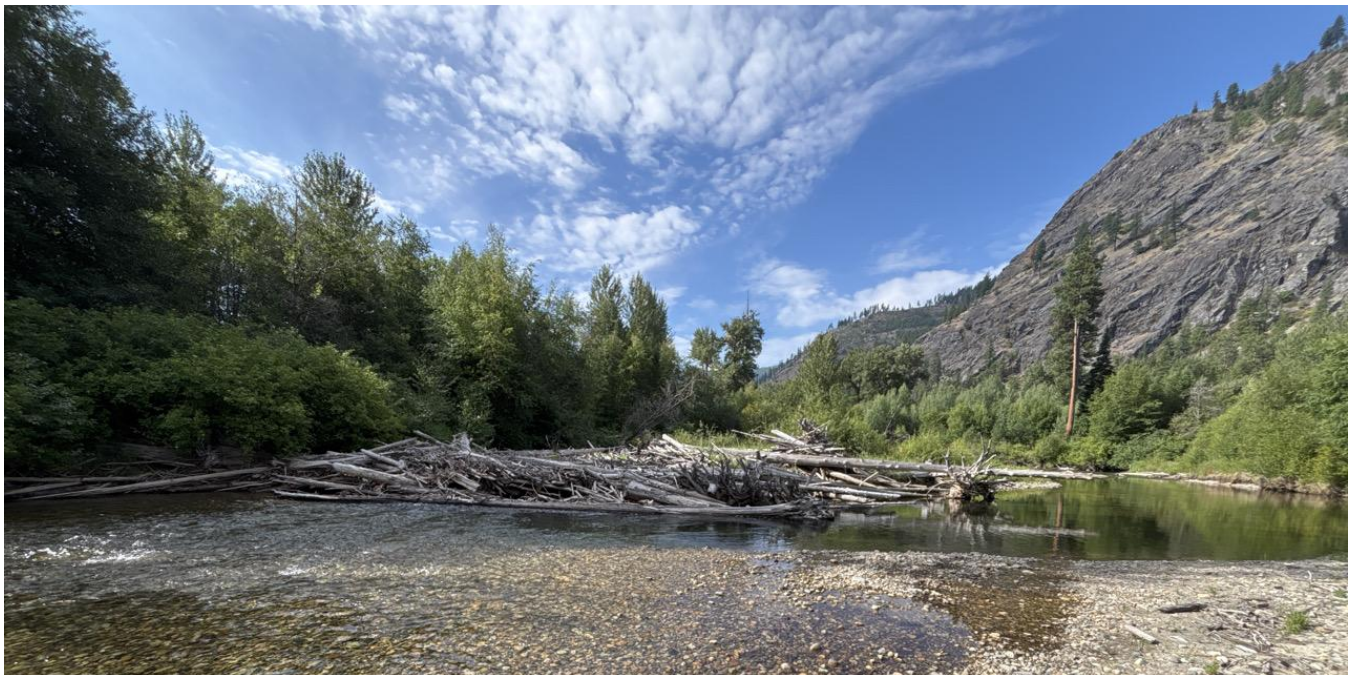
Figure 47. Large wood jam upstream of RM 21.7, looking downstream. Log jam is driving sediment deposition that is plugging a large side channel on river left.

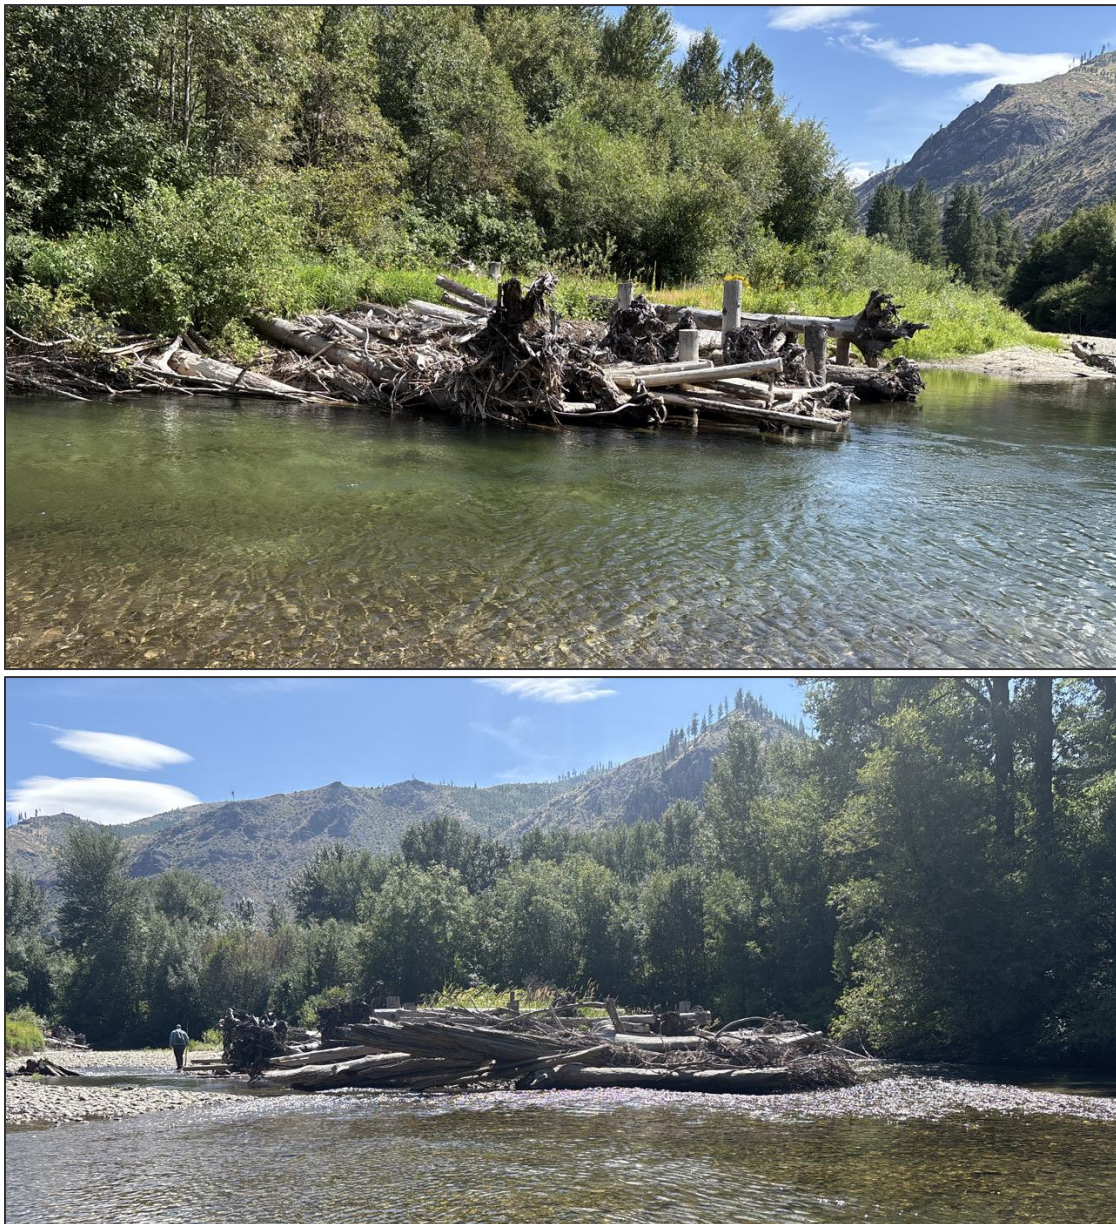
Figure 51. Representative photographs of Stormy C restoration project. Top: Large wood structure on river left at RM 19.5 providing cover to deep pool and deflecting flows into opposite bank. Bottom: constructed apex jam supporting flow split at RM 19.7, looking downstream.
