Middle Entiat River Reach Assessment & Restoration Strategy Update

Final Report

February 2026

PREPARED BY
Inter-Fluve

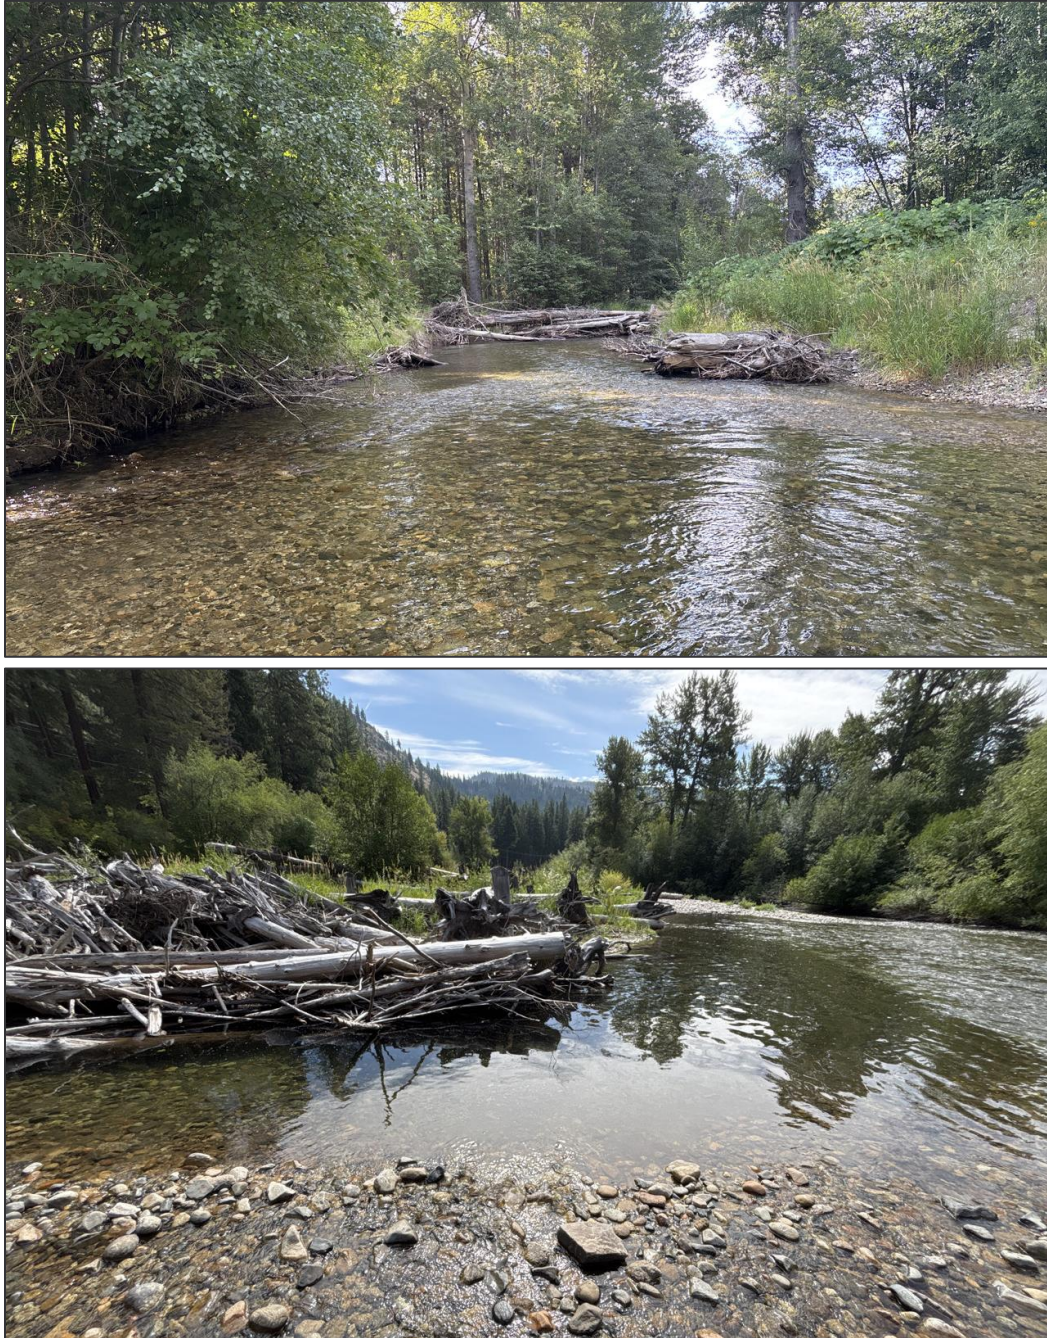
Figure 53. Representative photographs of Stormy A restoration project. Top: constructed side channel looking downstream from the upstream end. Bottom: constructed large wood structure providing cover on river left at RM 21.35.

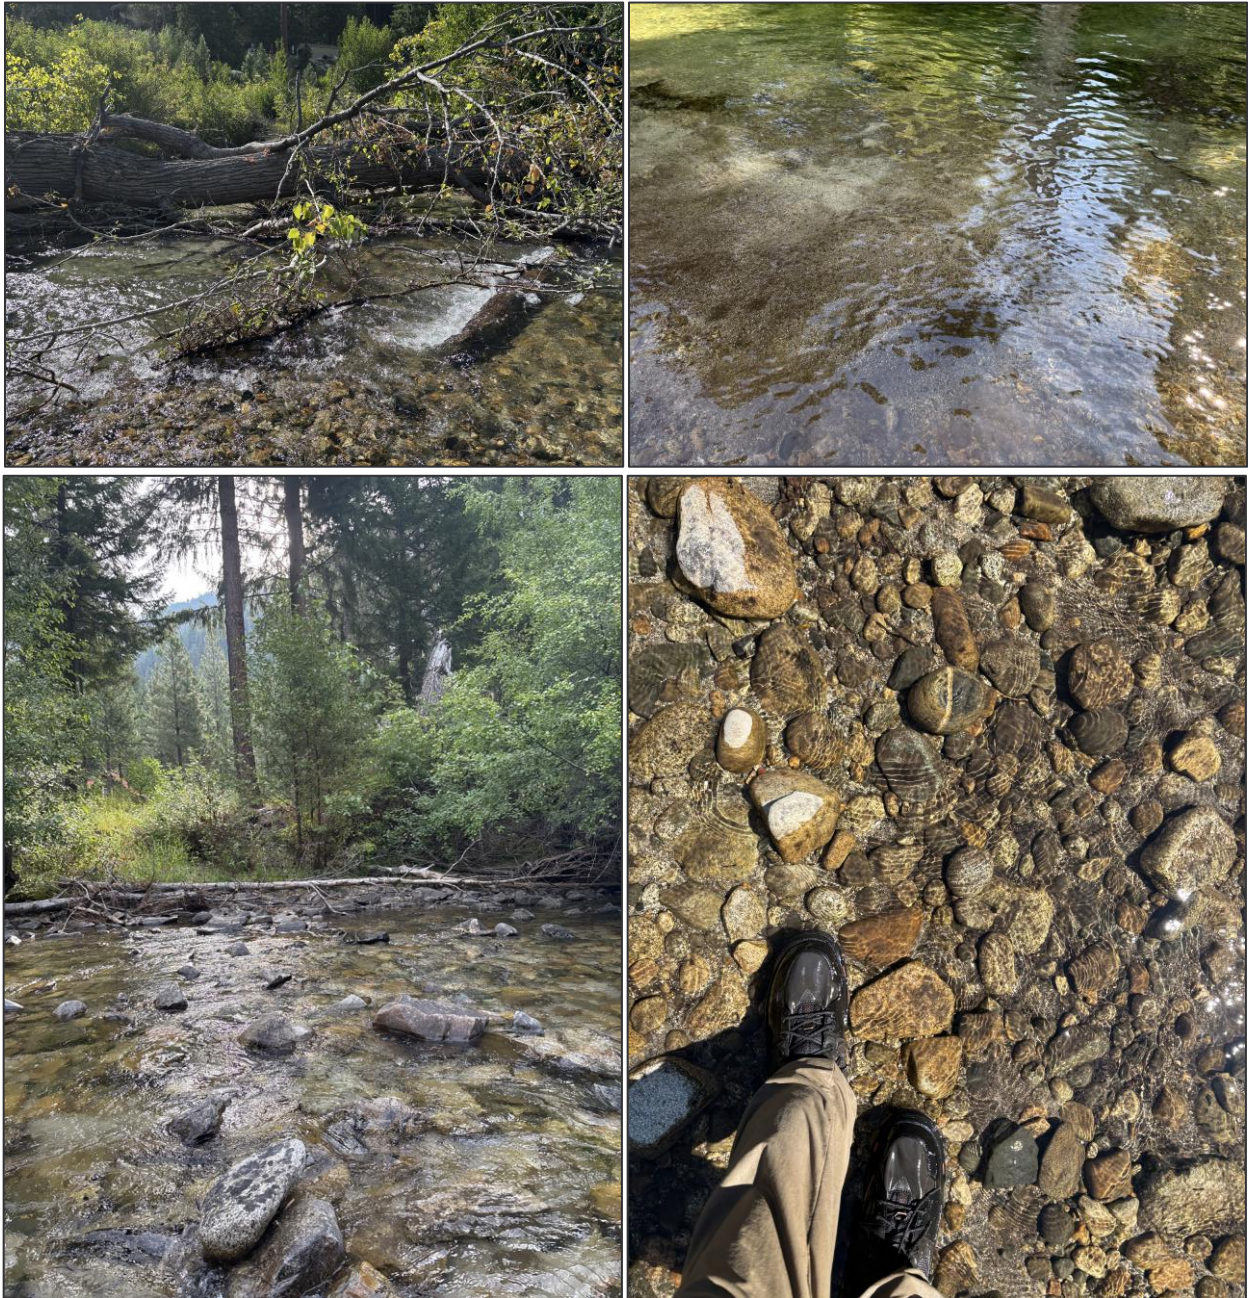
Figure 60. Clockwise from top left: Large, downed cottonwood tree at entrance to avulsion channel near RM 23.05, looking toward river right; Sand depositing in the Entiat main channel just downstream of the avulsion channel inlet; gravel/cobble substrate near RM 24.05; boulder dominated substrate at downstream end of Segment 2 by Dill Creek fan.

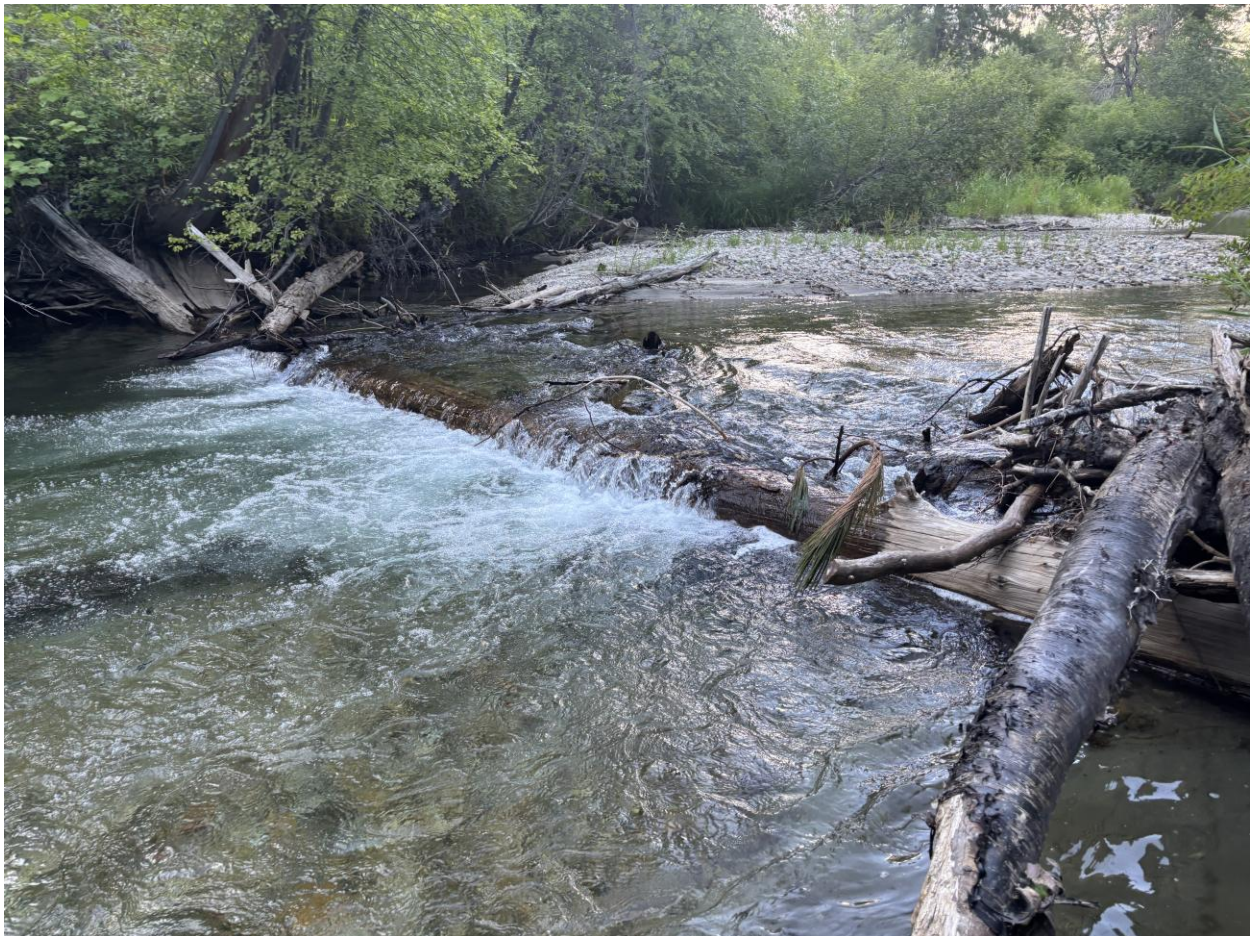
Figure 62. Channel spanning downed tree driving geomorphic processes within the Segment 3 avulsion channel. The downed tree has created a scour pool downstream, and coarse sediment deposition upstream.

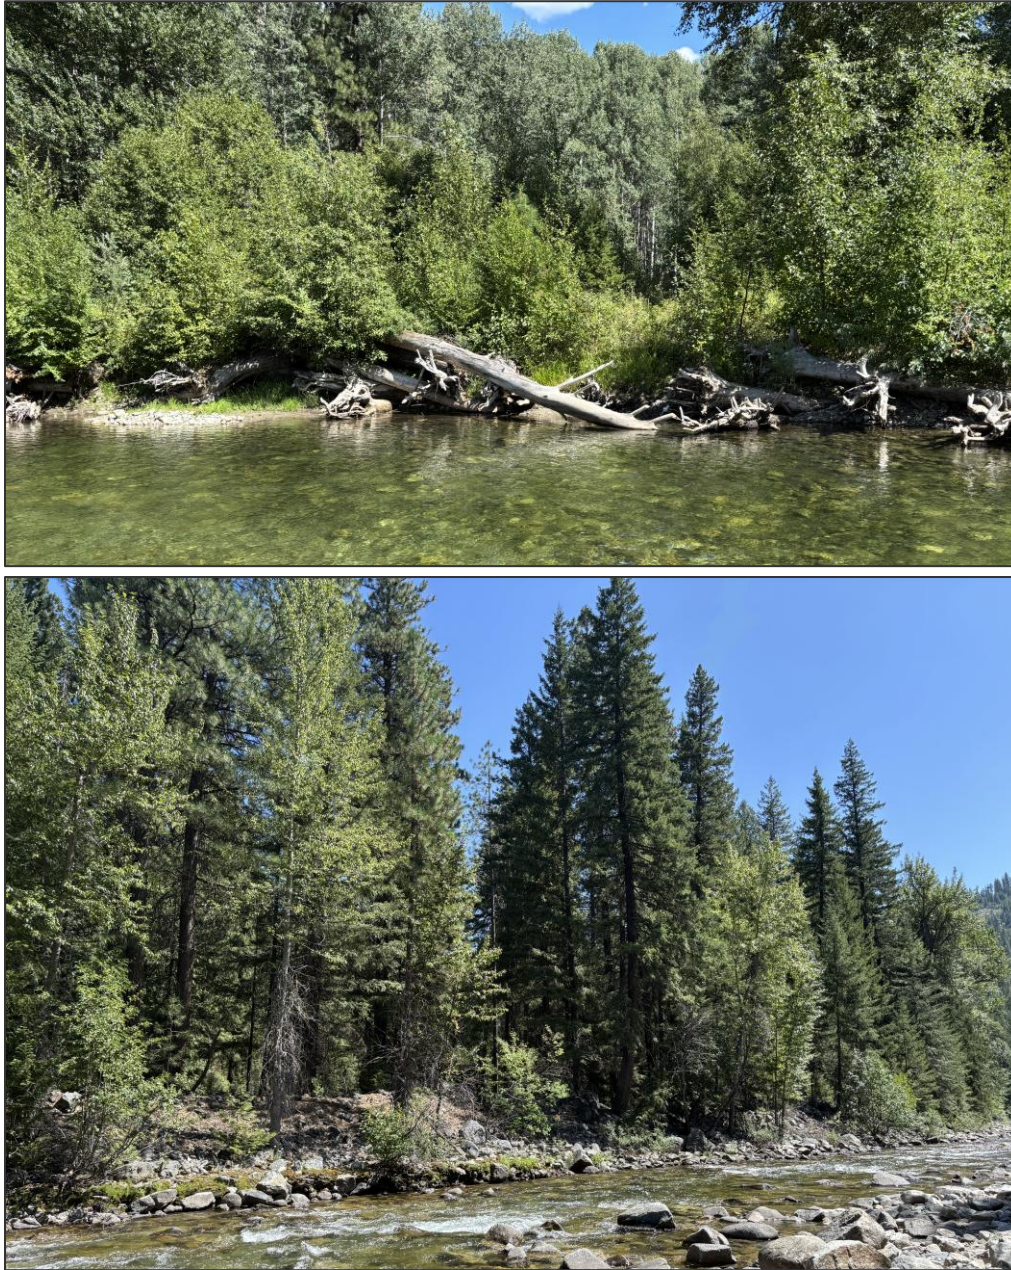
Figure 63. Representative photographs of vegetation in Segment 3 showing differentiation between deciduous trees within riparian areas and pocket floodplain surfaces, and conifers (e.g., ponderosa pine) on higher floodplain surfaces.

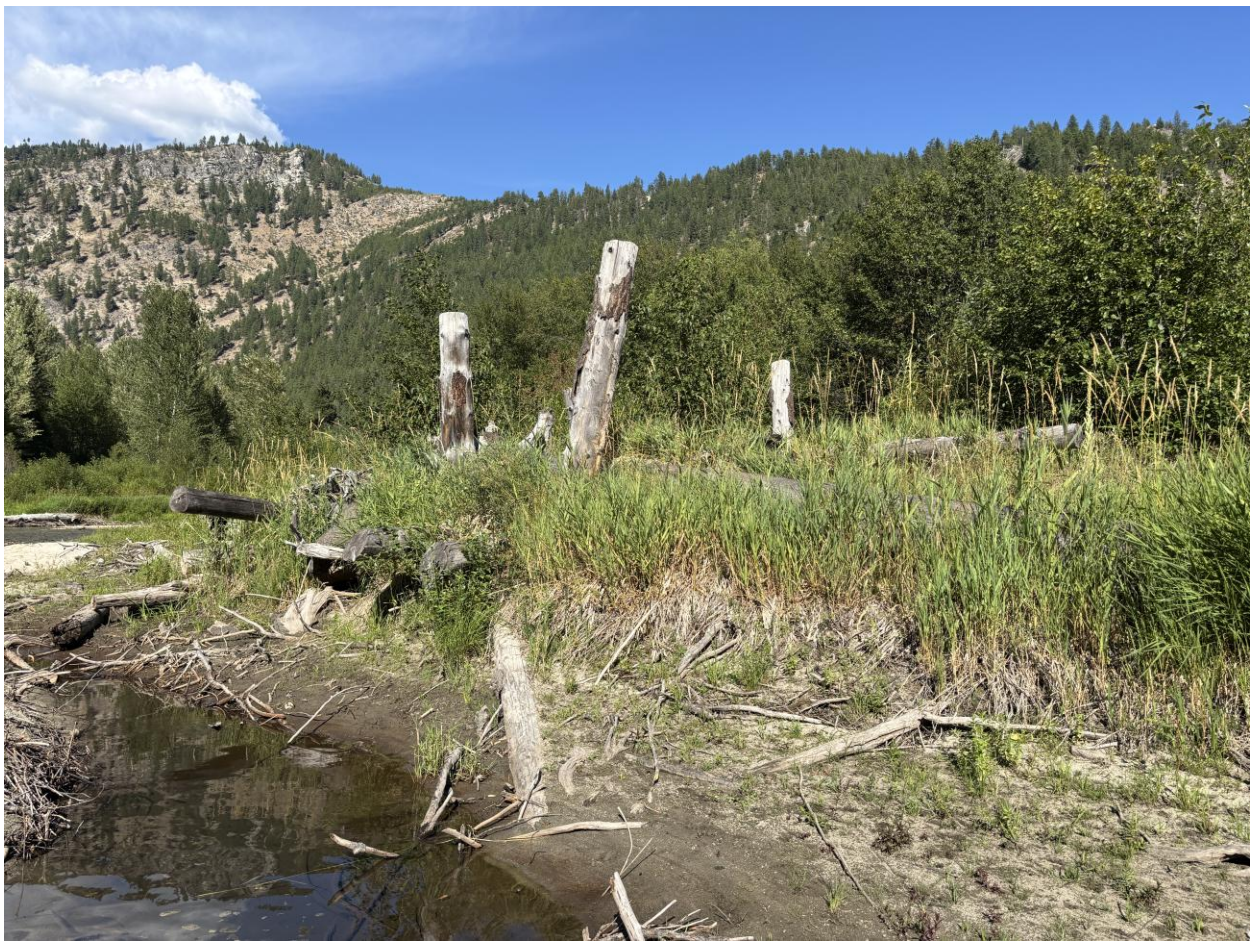
Figure 66. Engineered log structure associated with Dillwater LWD Enhancement project in Segment 3. Structure was originally installed within the Entiat River channel but is now partially buried by sediment on the river left floodplain.

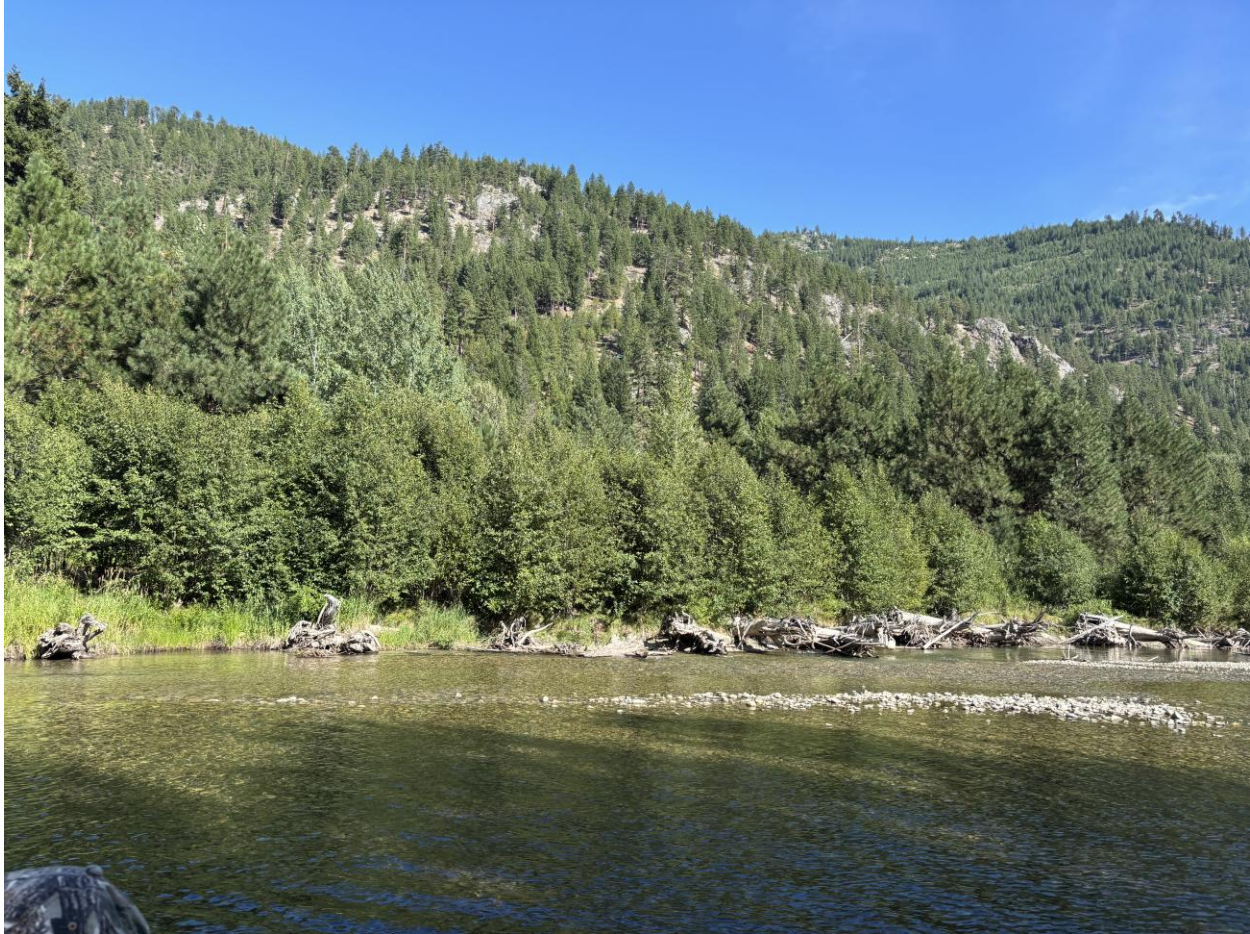
Figure 67. Bank structures on river left associated with the Cascadia Conservation District Entiat RM 21.5 LWD and Riparian Restoration project.

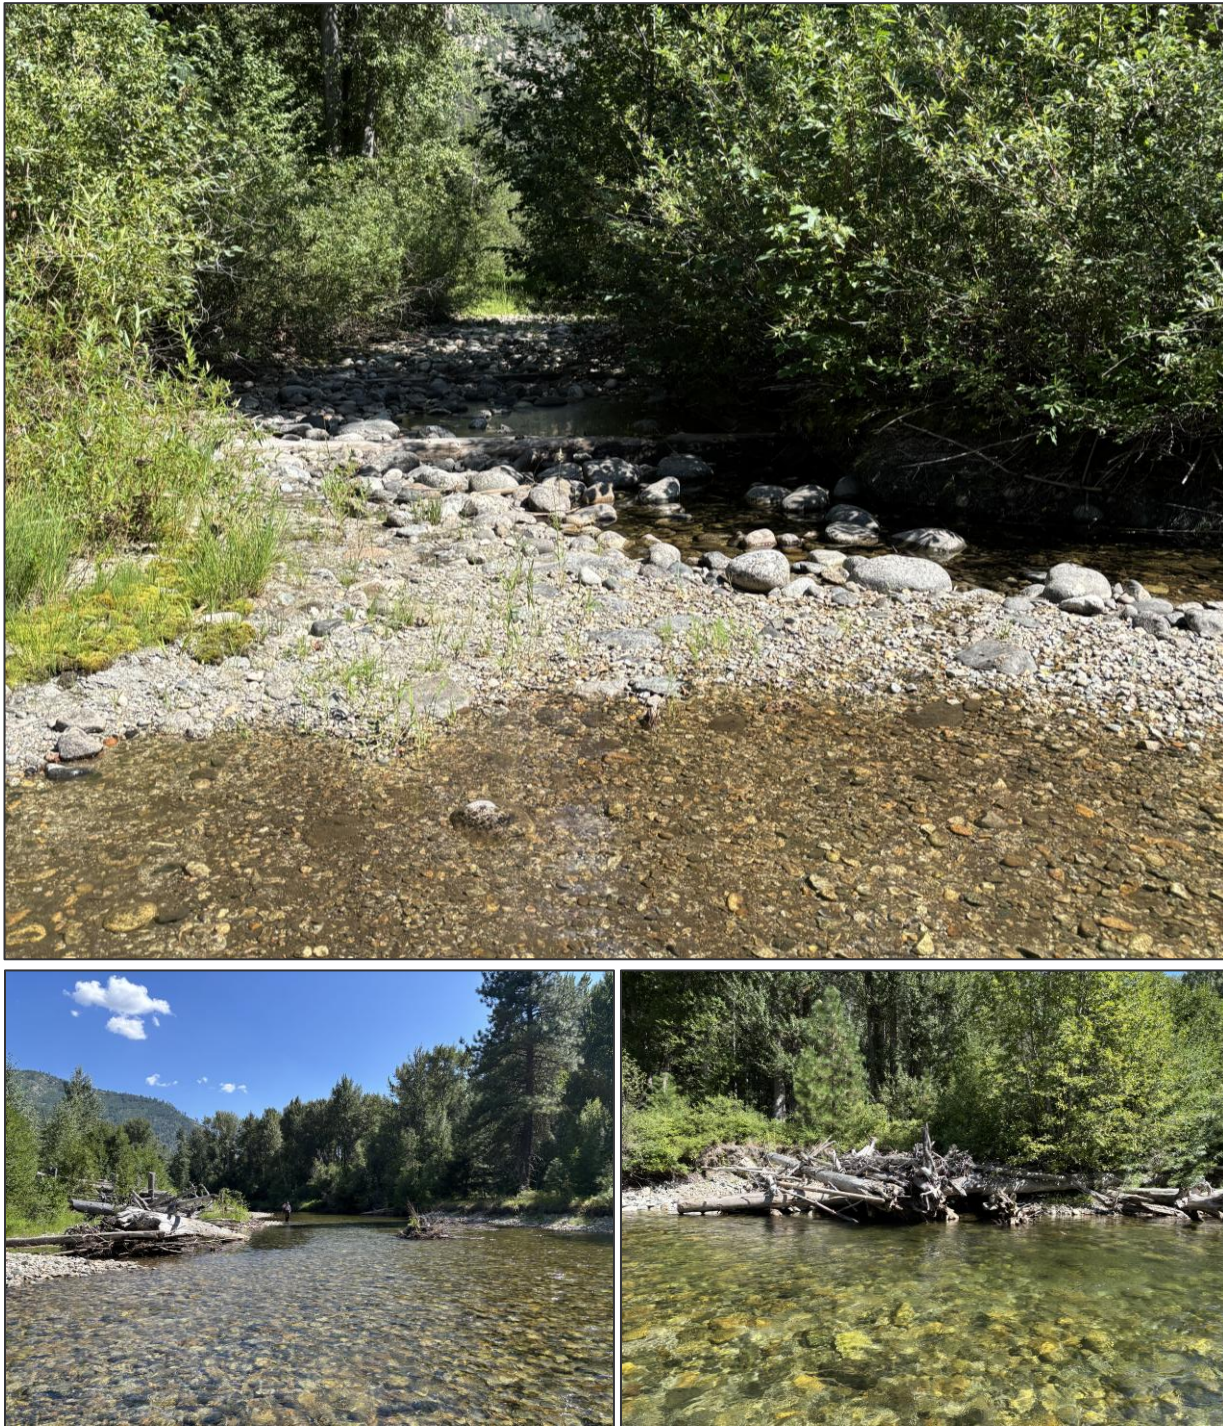
Figure 68. Top: Entrance to side channel reconnected by breaching Upper Tye Levee. Bottom: Constructed large wood structures associated with the Entiat Tye restoration project in Segment 3. Left: looking downstream near RM 23.6. Right: looking toward river left, RM 23.85.

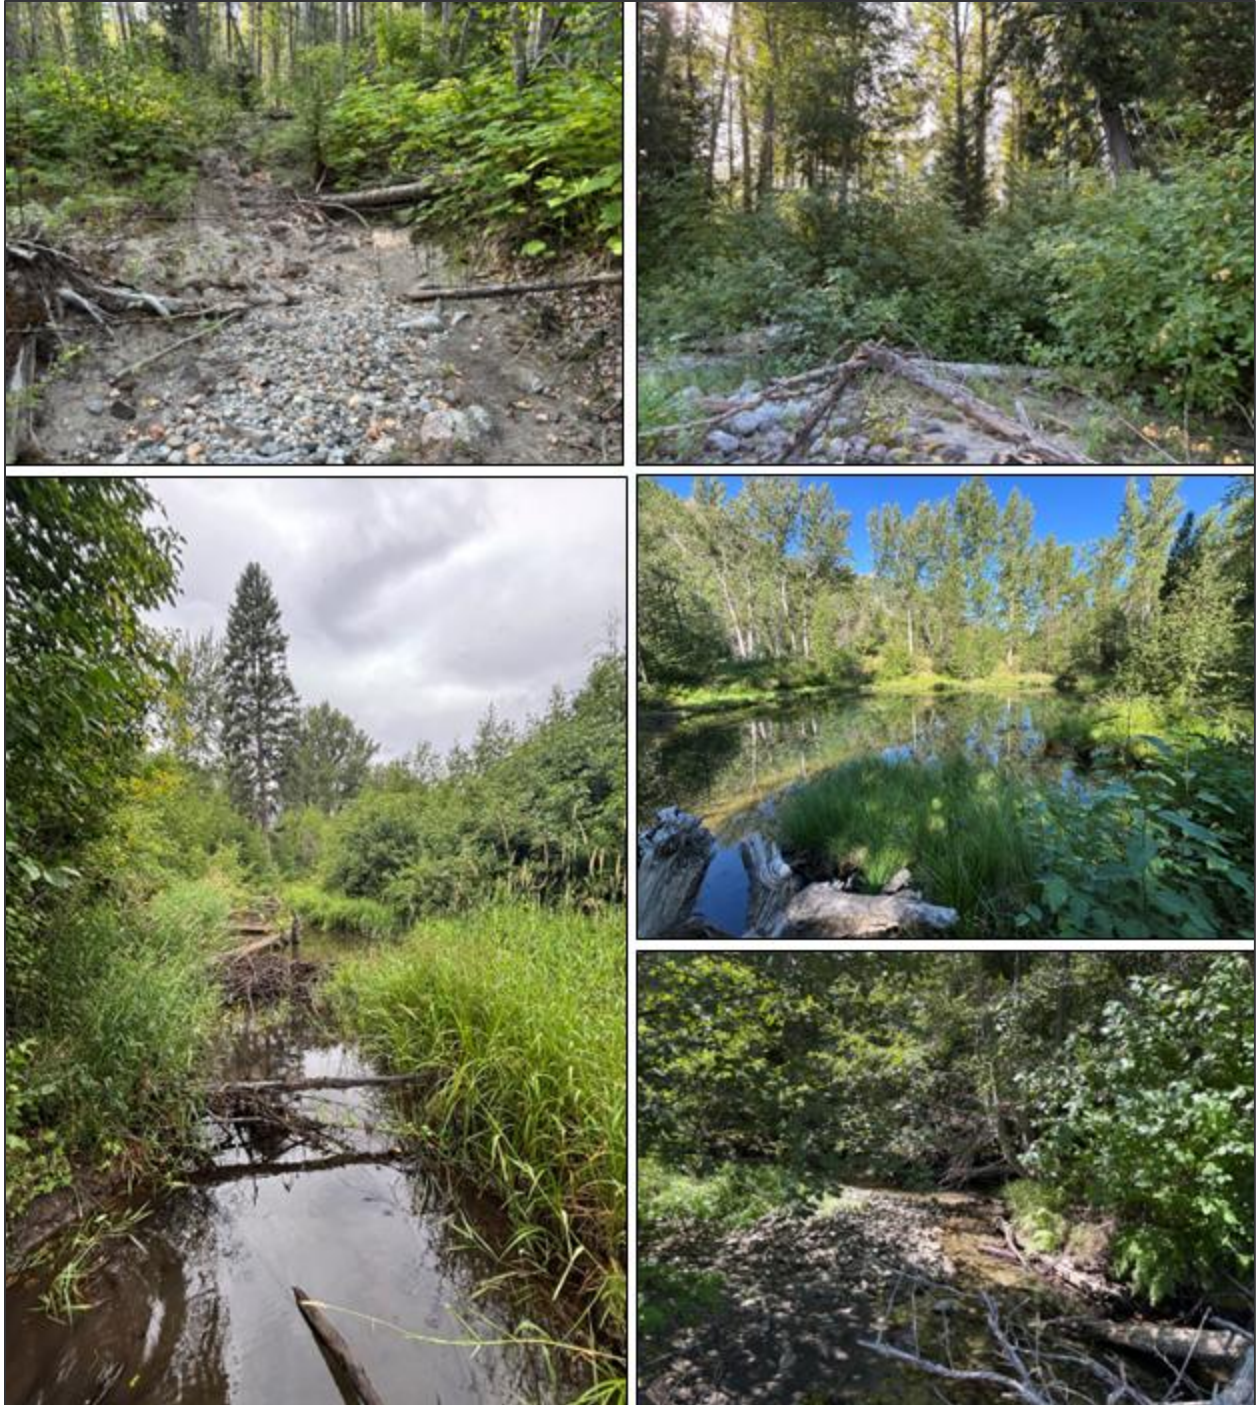
Figure 75. Representative photographs of off channel habitat in Segment 4. Clockwise from top left: Dry high flow side channel on river left near RM 26.6; Entrance to dry high flow side channel on river right near RM 26.5; connected pond on river right floodplain near RM 26.25; Entrance to perennial side channel near the downstream end of Segment 4 (RM 25.15) on river right; Side channel flowing through river left floodplain in Segment 4 near RM 25.75.

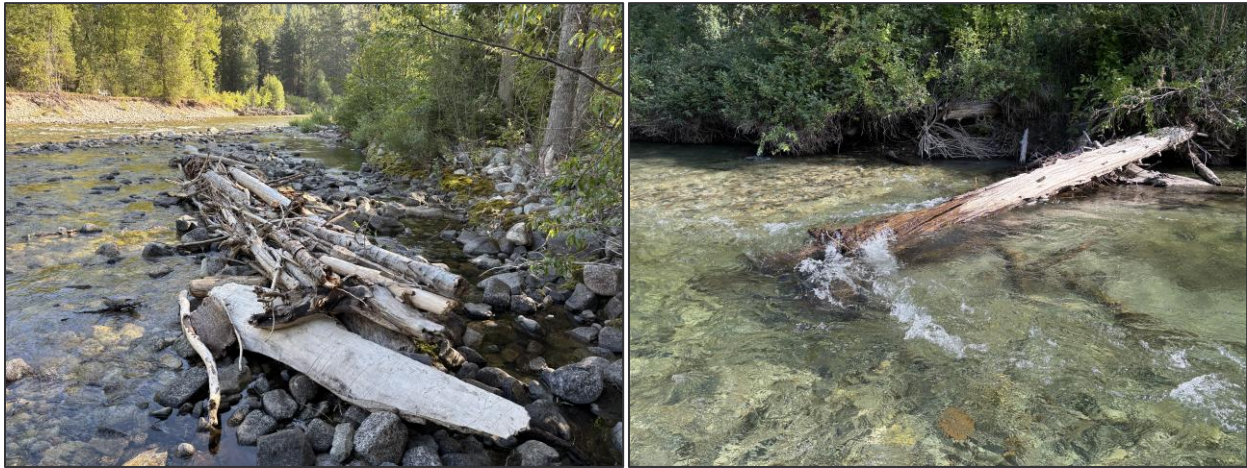
Figure 77. Representative photographs of large wood in Segment 4. Left: Large wood racked on coarse sediments along river right channel margin downstream of RM 26.5. Right: Downed tree extending from river left floodplain into the Entiat River channel near RM 26.4, generating pool scour and coarse sediment deposition.

Naturally recruited large wood was limited within Segment 4 at the time of the August 2025 geomorphic assessment. The Entiat River watershed was heavily logged during the 19th and 20th centuries, reducing recruitable large wood sources within the watershed, and log drives down the Entiat River channel cleared existing large wood from the channel (CCCD 2004). Key pieces exerting an influence on channel processes were generally greater than 1.5 feet in diameter, although wood pieces were generally restricted to channel margins and their influence did not extend to the entire channel. Effective large wood pieces and accumulations in Segment 4 were responsible for promoting pool scour, sorting sediments ranging from sands to coarse gravels, diverting flows toward the channel center, and providing cover (Figure 77). Recruitable sources of effective large wood were generally limited in Segment 4 due to the lack of large mature trees on adjacent floodplains and hillslopes. Due to the higher energy of Segment 4, large wood pieces were often mobile unless trapped by boulders or standing trees and adjacent banks. Number of pieces of LWM by habitat unit is depicted in Figure 72 (Section 6.4.2). Naturally recruited large wood in Segment 4 is supplemented by additional engineered large wood structures installed during past restoration projects on the Entiat River. These structures are generally larger than existing natural large wood jams and exert a greater influence on geomorphic and habitat processes. The installed large wood structures may provide the additional long-term benefit of increased large wood racking potential as local forests recover, and large wood recruitment sources are replenished, however, racking of

naturally recruited large wood is currently limited. Segment 4 large wood installations are discussed in more detail in Section 6.4.5.

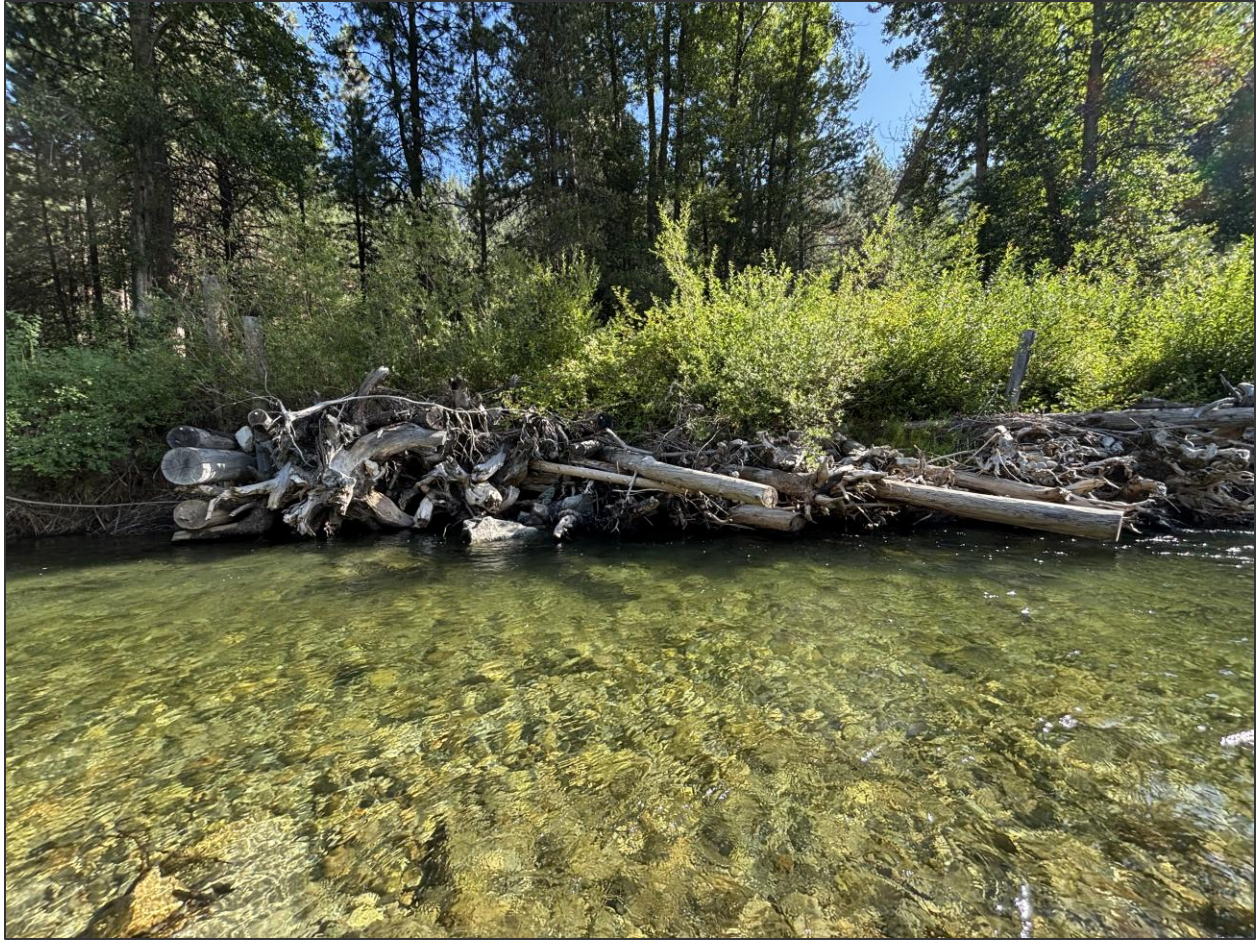
Figure 79. Representative photographs of Entiat 3D restoration project in Segment 4. Top: Large wood structure on river left downstream of RM 26.4. Bottom left: channel with installed large wood for cover, connecting floodplain pond on river right to main channel near RM 26.25. Bottom right: mouth of intermittent river right side channel with added large wood for cover near RM 26.2.
