# Methow River Reach Assessment

## Appendix A | Habitat Assessment

Methow River (RM 40.6 – RM 62.3)

May 2026

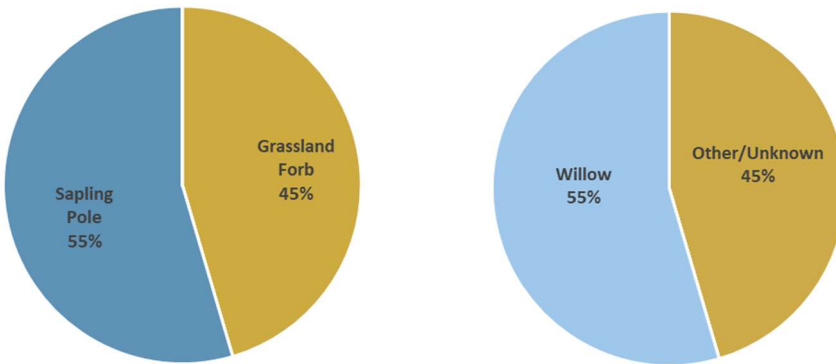
Based on 11 ocular assessments of riparian vegetation in Reach 3, the dominant overstory vegetation was Ponderosa Pine in the Large tree (21.0-31.9- inch dbh) size category. Some riparian vegetation in the Small Tree (9.0-20.9-inch dbh) and Sapling/Pole (5.0-8.9-inch dbh) size classes was observed, as well as units where no riparian vegetation was present. Cottonwood and Quaking Aspen were also recorded in the riparian vegetation zone (Figure 22). Reach 3 understory consisted of Willow species in the Sapling/Pole size class and Grassland/Forb (Figure 23).

**Figure 23. Dominant understory riparian vegetation class and species, based on 11 units surveyed, within 100 feet of the Methow River by ocular estimate.**
