# Icicle Creek Boulder Field Fish Passage Assessment

## Icicle Creek, Chelan County, WA

## FINAL May 2013

# **Geologic Assessment of the Icicle Creek Boulder Field Study Reach**

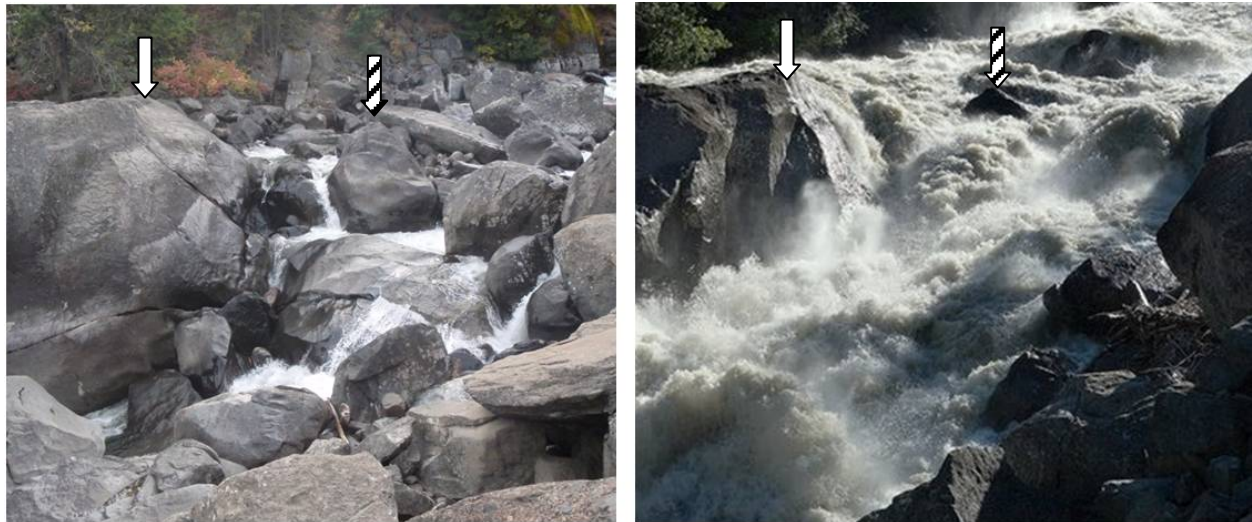
**Photo 1 - Side by side comparison of Anchor Boulder flow chute at 200 cfs (l) and 12,000 cfs (r). The 20,000 cfs 50-yr flood and site constraints of high velocity, large-sized sediment and debris transport limit the in-channel fish passage alternatives. (Arrows provide location reference).**

Icicle Creek experiences a large range of flows on a regular basis. Site visits during low and high water extremes assisted the study team in identifying challenges to the assessment and alternative development (**Photo 1**).

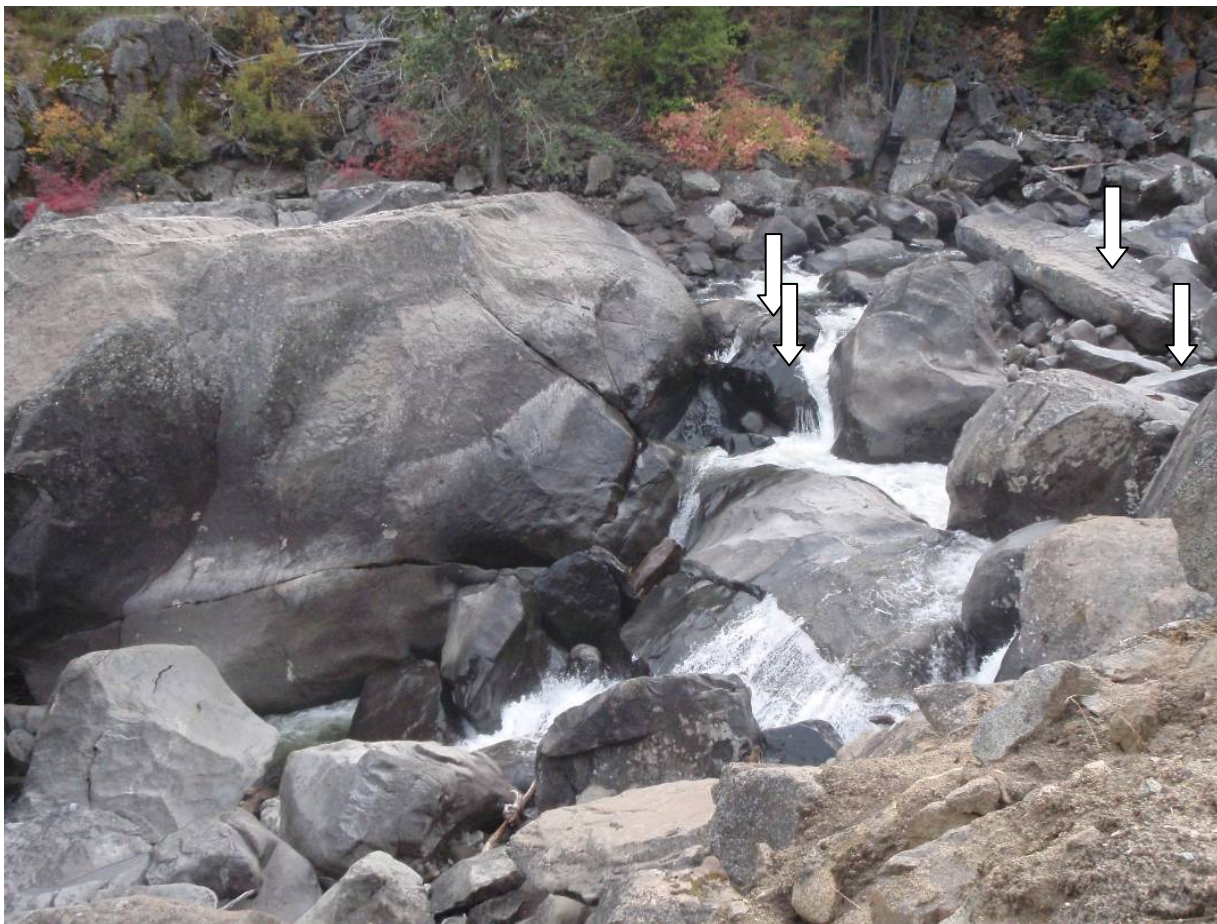
**Photo 6 – Icicle Creek Boulder Field Middle Reach (Anchor Rock) showing 21 foot drop from right to left and the crest blocked by boulders (arrows) that have filled in the openings.**

In another observation, at 200 cfs in the Middle Reach, there appears to be passage opportunities, through the Anchor Boulder segment where there was enough surface flow and pool depth for a potential fish passage route (see **Figure 7** and **Photo 5**). This is a viable route to develop an alternative for two reasons: 1) a velocity or drop could not be measured indicative of a barrier, and 2) while flows under boulders could be concentrated into a fish passage route. This situation was also observed along the right bank next to the Anchor Boulder where there is more direct leaping route within a 21 foot drop, but the crest is blocked by boulders wedged into the clear openings where fish would jump (**Figure 8, Photo 6**).

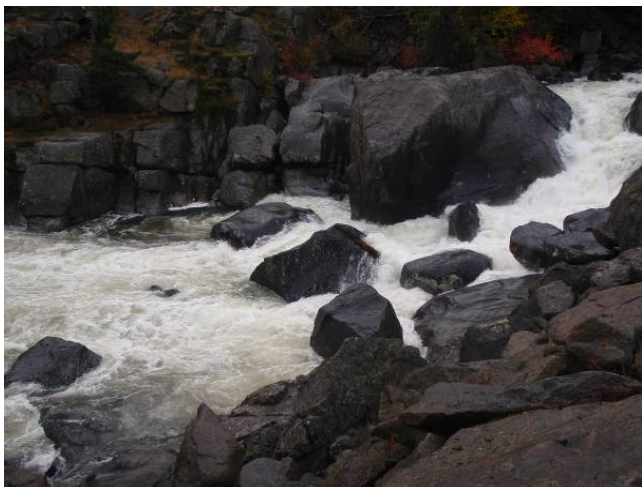
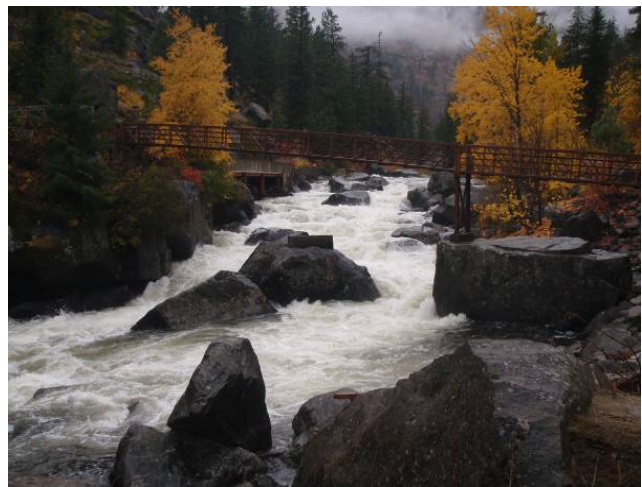
**Photo 7 – Middle Reach at Anchor Boulder (left) and upstream of Anchor Boulder (right) at 1000 cfs.**

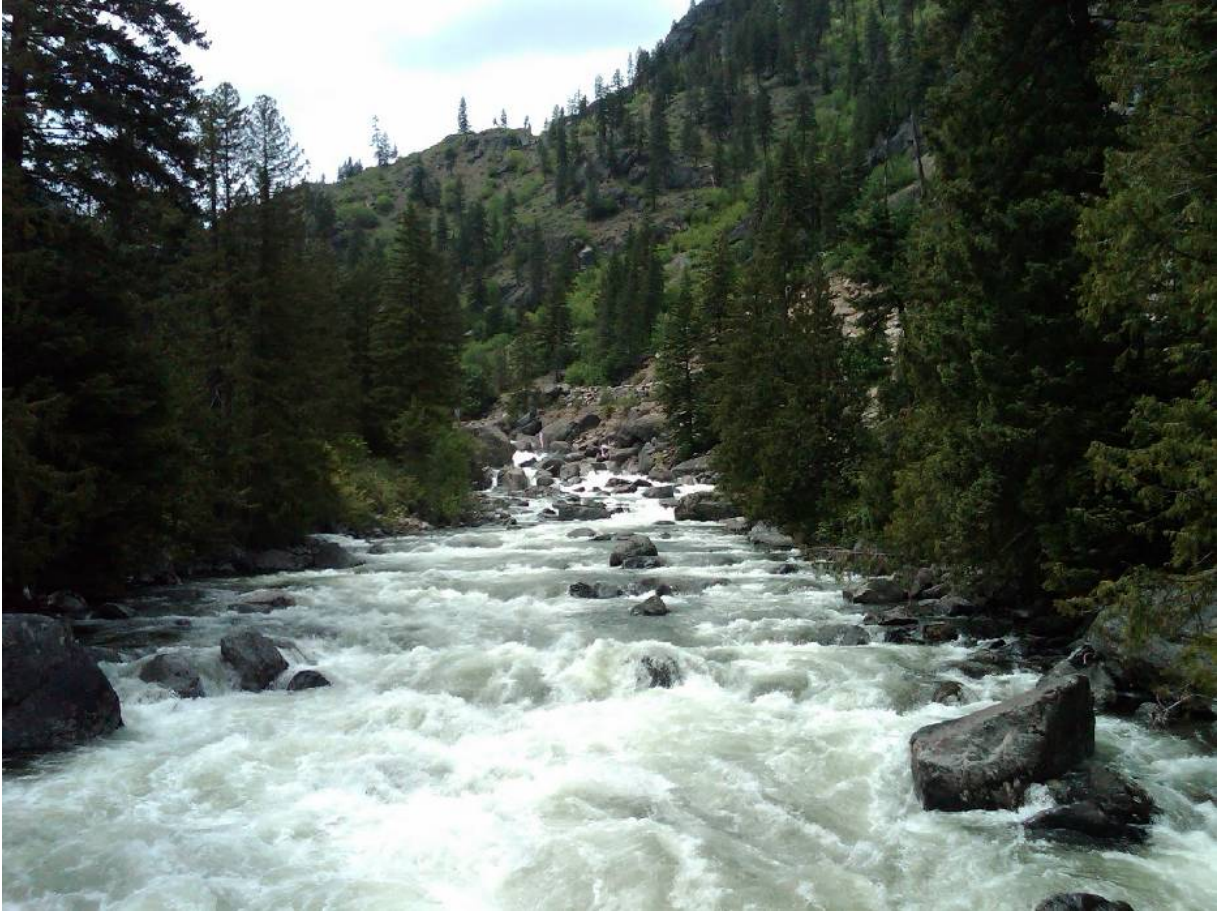
**Photo 8 - View upstream through Lower Reach from Snow Creek Trail bridge, about 1250 cfs. Channel margins and relatively lower gradient compared to Middle Reach in the distance allows fish passage through here.**

The lower reach of the study area, upstream of the Snow Creek trailhead bridge does not have fish passage impediments. Natural flow impediments exist at low flows where surface connectivity is lacking and at high flows above 3,000 cfs although the relatively lower gradient does have channel margin migration corridors most prominently on the left bank (**Photos 8, 9**).

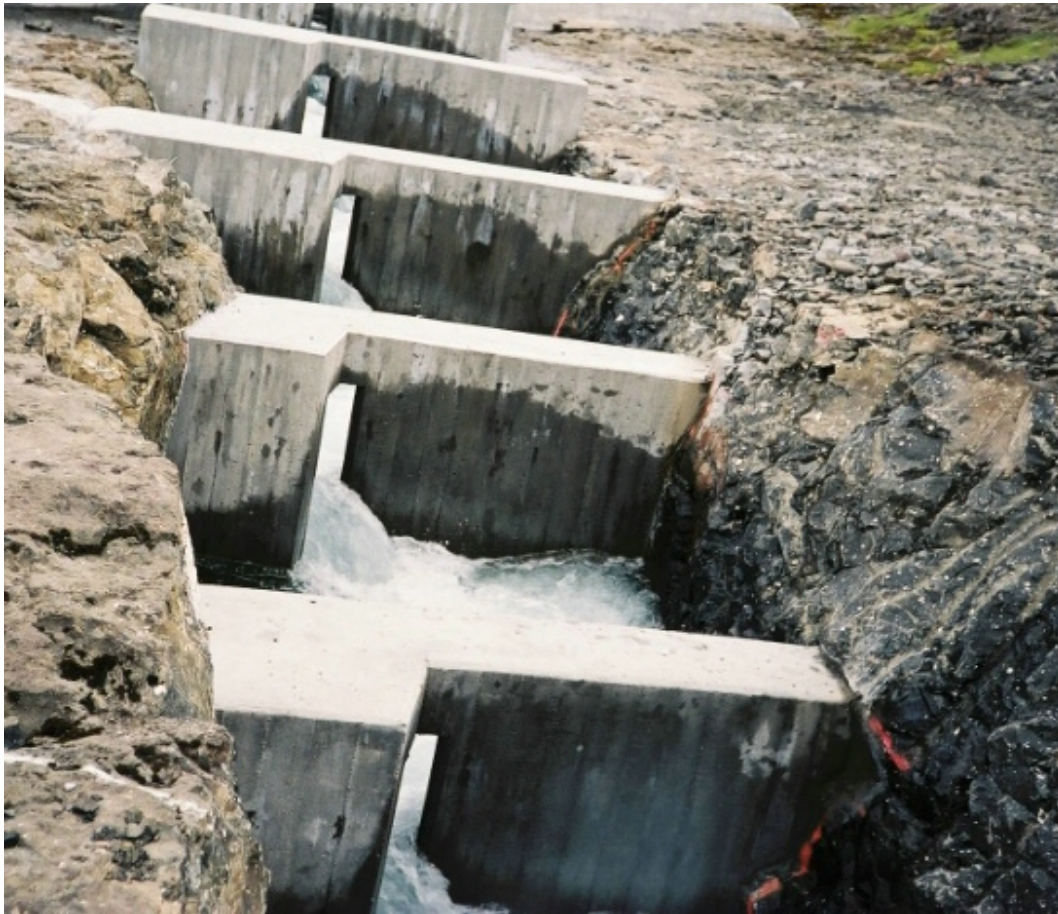
**Photo 11 – Example of vertical slot fishway constructed within a rock trench excavated by blasting.**

This design option (**Photo 11**) would construct a 25 pool vertical slot fishway along the right bank between the Anchor Boulder and bank below the irrigation canal. There is bed rock in this area, so some of the fishway would be blasted into the rock and have rock walls, while other sections would have concrete walls. A detailed survey and geologic assessment is needed to further define the option. The entrance pool located adjacent to the large pool below the Anchor Boulder would be 8 feet wide by 10 feet long. The hydraulic drop through the slots would be one foot. The overall fishway length would be 250 feet. The upstream end (or fish exit) would have a protective wall with bulkhead gate which would be closed during the non-fish migration windows to reduce the potential for damage to the fishway and maintenance.

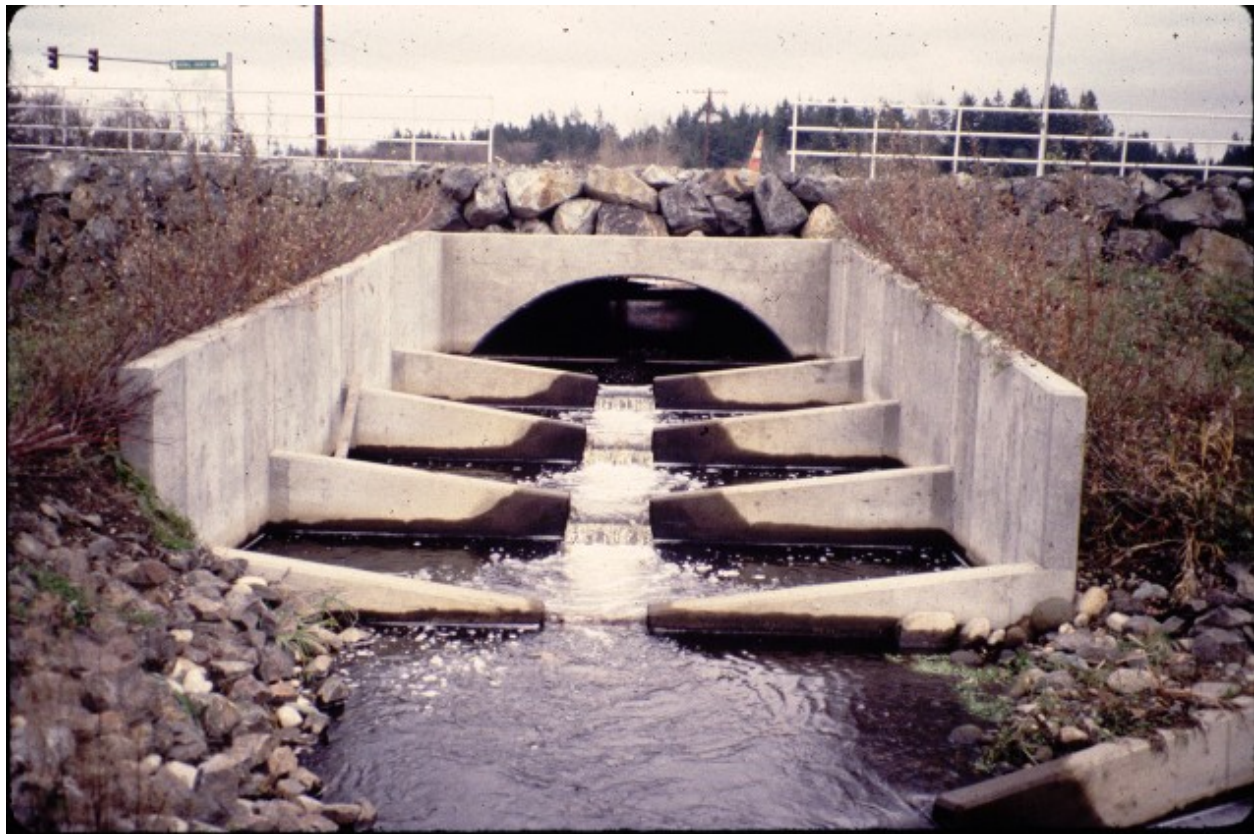
**Photo 12 – Pool and Chute Fishway at low flow (Silver Creek, Washington).**

This design option would remove a section of the existing dam and construct a concrete pool and chute fishway. The fishway would be 24 feet wide and have a high design flow of 120 cfs. Flows greater than 120 cfs would either pass over the existing dam with the use of stoplogs or divert through the irrigation diversion. An appropriate solution for a low head dam with a passage problem is a pool and chute fishway. Up to 100 cfs, all the flow would be in the fishway and there would not be false attraction. The fishway pool length would be 12 feet, with a vertical drop per weir of 0.8 feet and a slope of 6.7%. The fishway slope would be 6.7 percent. Design details of pool and chute fishway is provided in (Powers, 2007). At low flow the fishway would function as a pool and weir fishway and at high flow the water streams down the center of the fishway. An example of a 16 foot wide pool and chute fishway is shown in **Photo 12**.

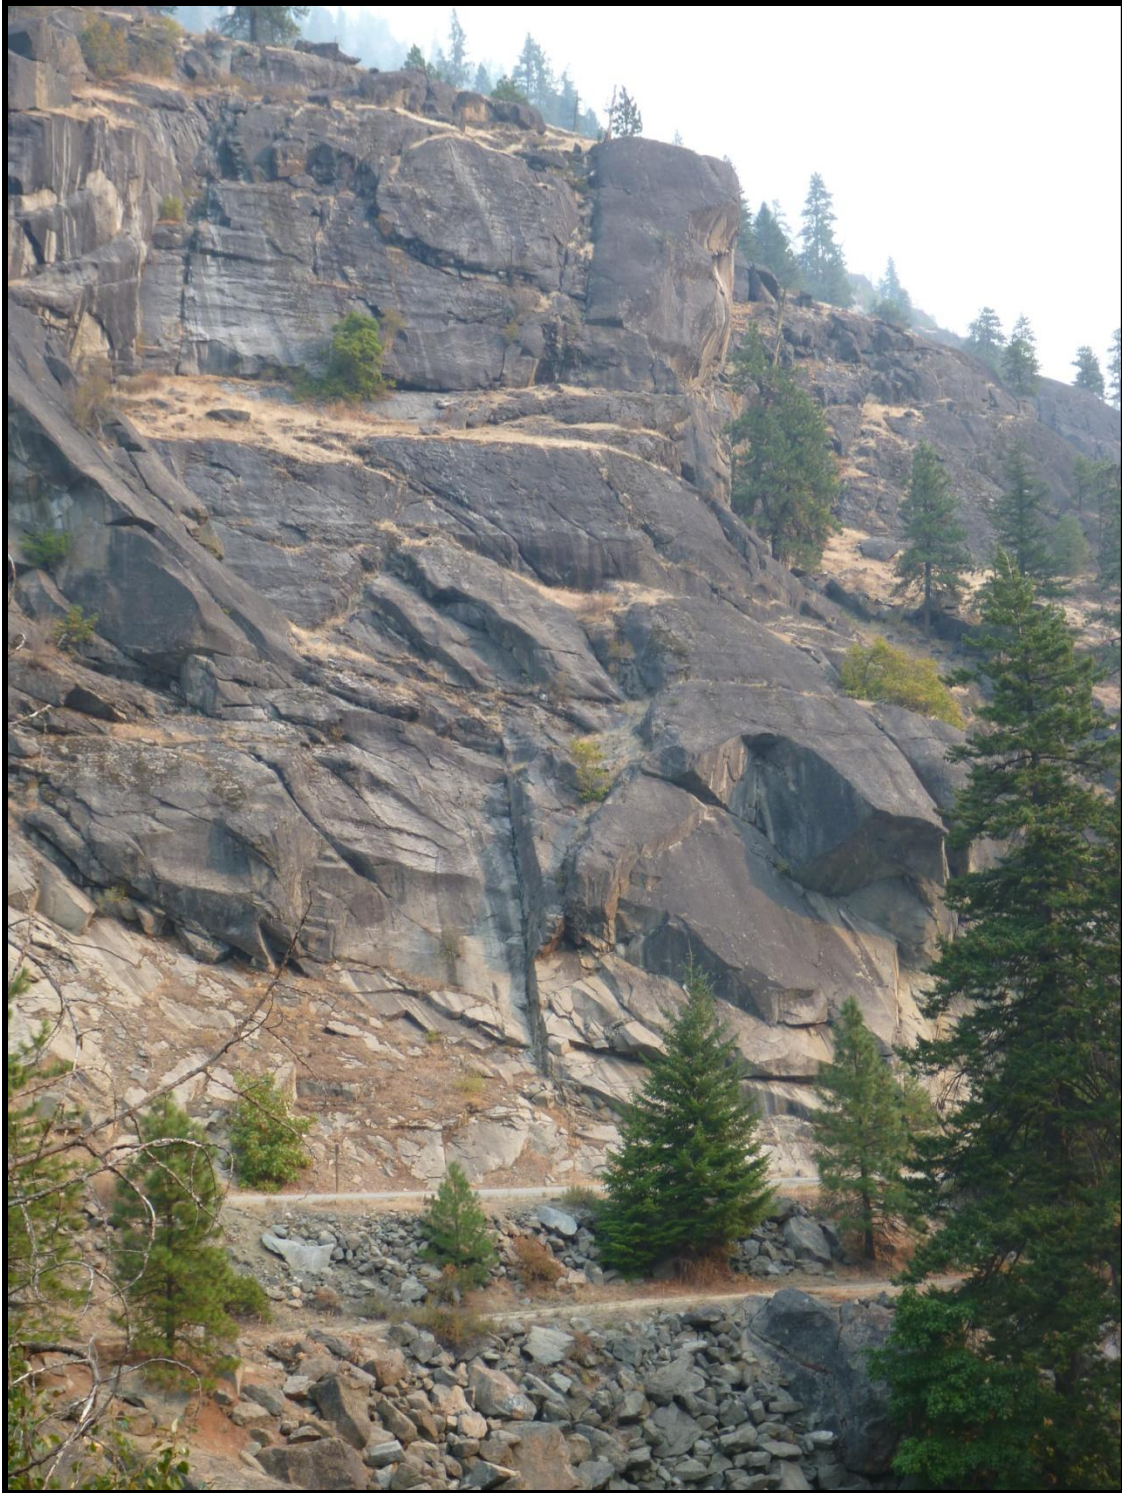
**Figure 4.**      Glaciated north valley wall of diorite and gabbro above Icicle Creek.

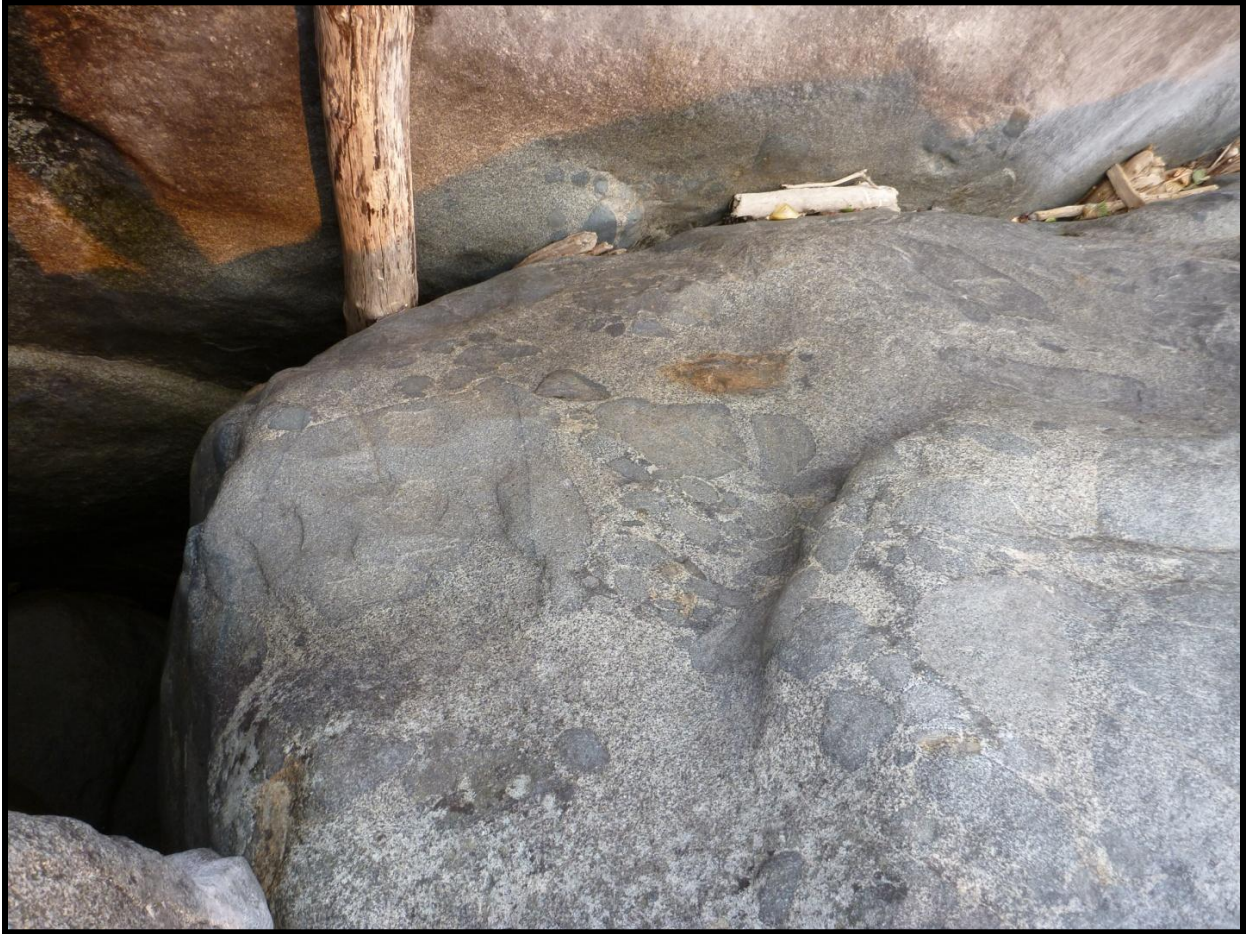
**Figure 10.** Gray inclusions in the bedrock on the right bank of Icicle Creek and in the Anchor Boulder.

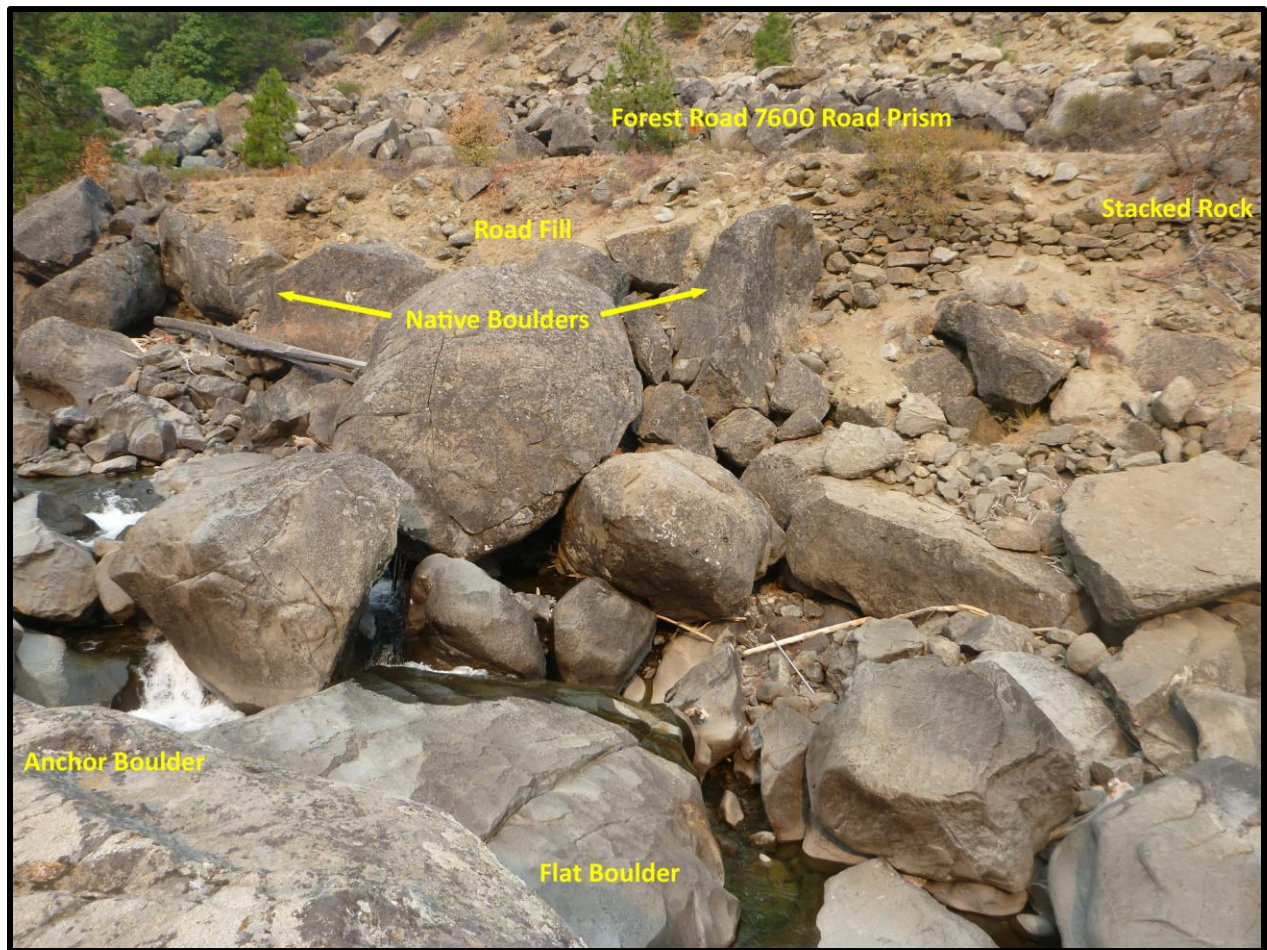
**Figure 12.** Large native boulders and anthropogenic rocks on the left bank of Icicle Creek across from the Anchor Boulder.

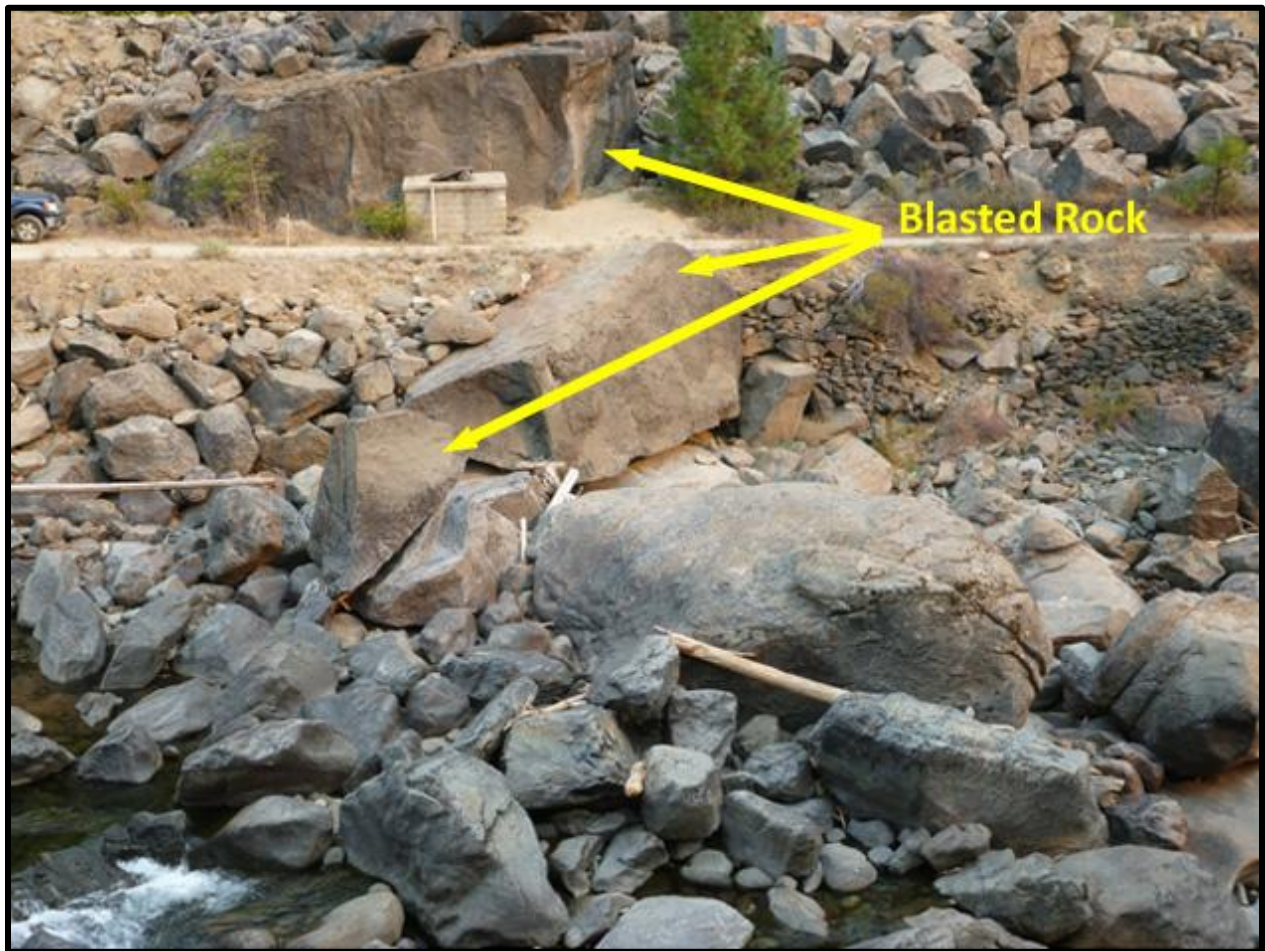
**Figure 14.** Large boulder blasted into three parts during original Icicle Creek road construction.

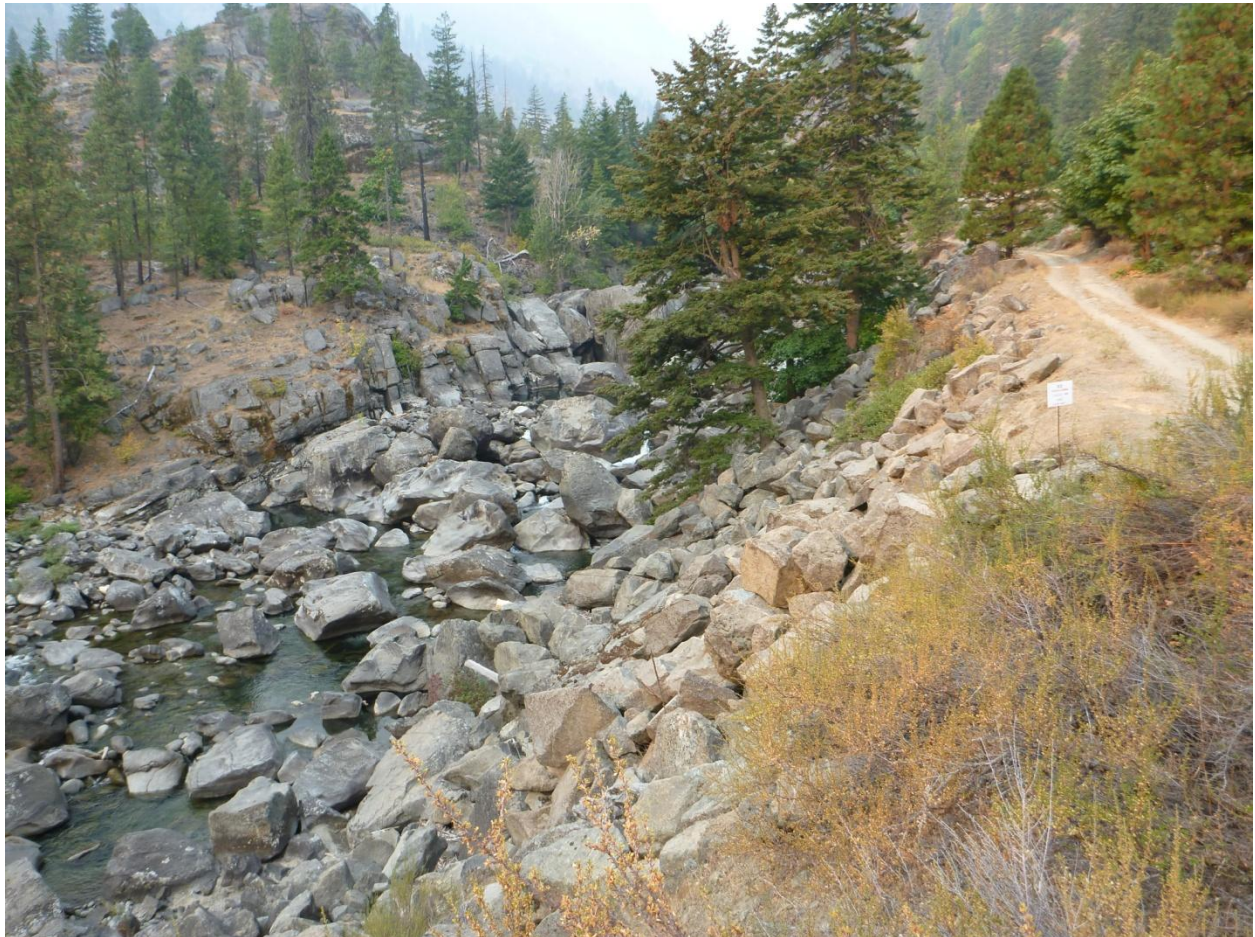
Figure A-1. Lower Reach of Icicle Creek study area below Anchor Boulder showing bedrock outcrop on the right bank and old Icicle Creek Road on left bank.

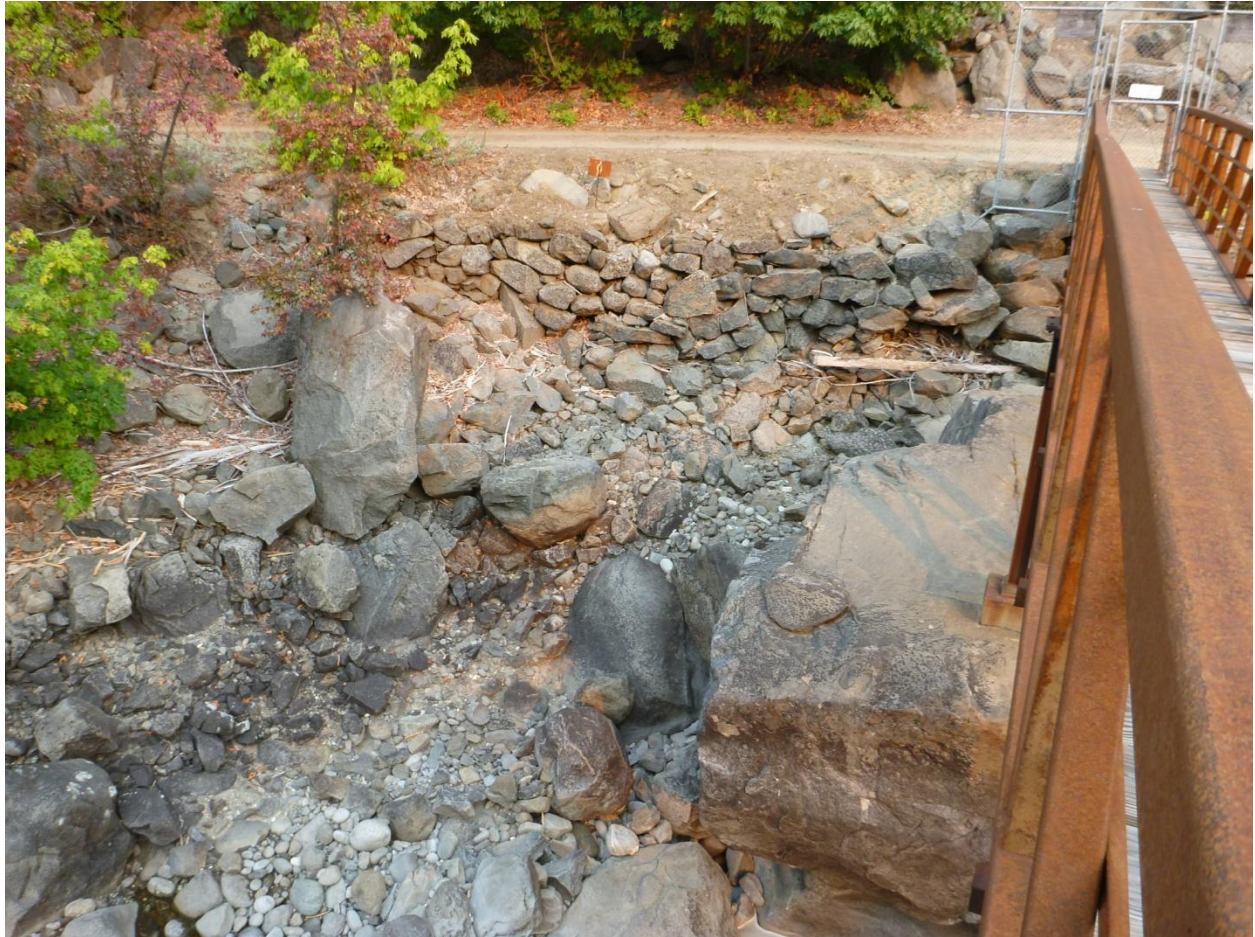
Figure A-2. Stacked rocks for old Icicle Creek Road prism on the left bank at the irrigation district bridge.

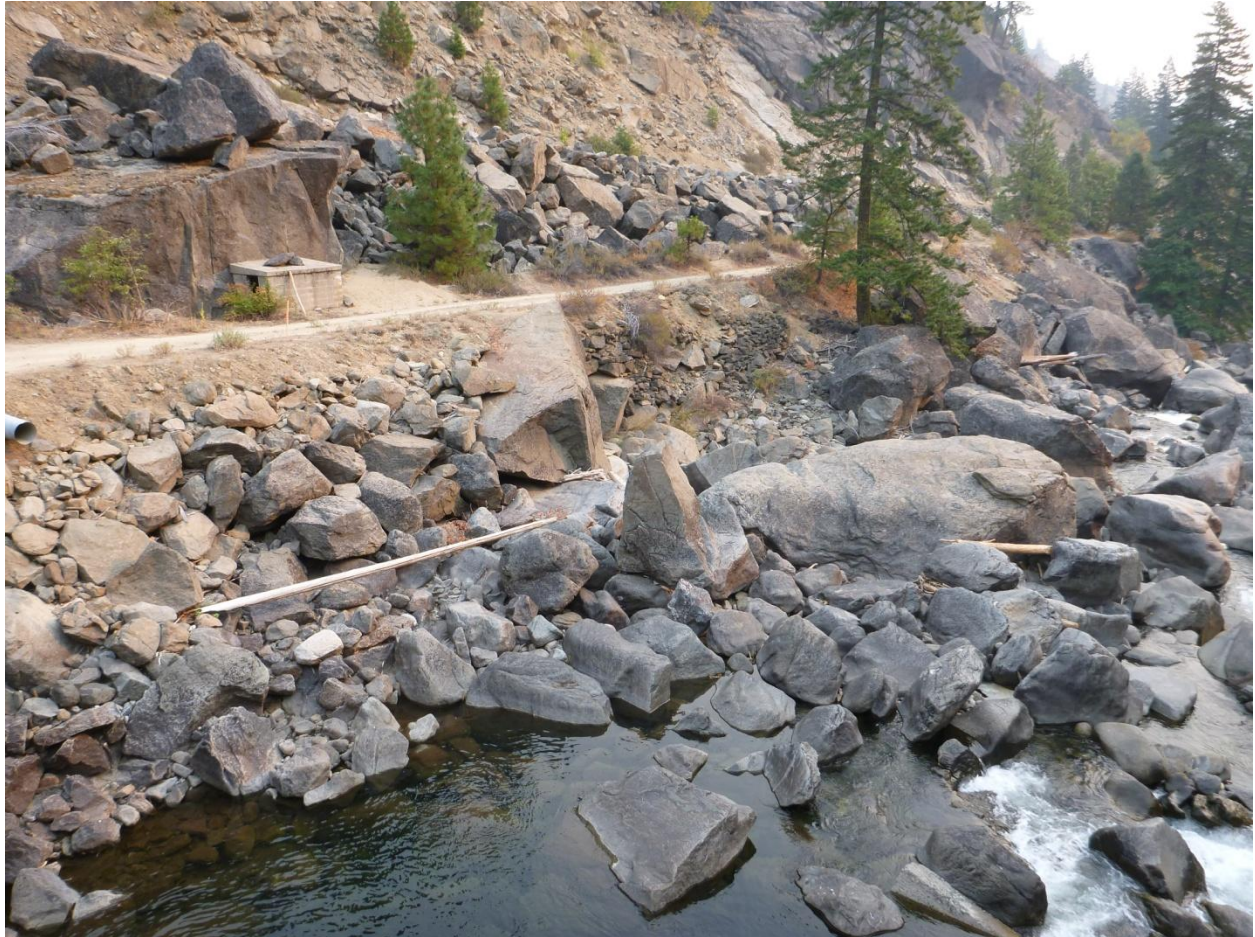
Figure A-3. Looking downstream in middle reach of Icicle Creek study area above Anchor Boulder showing left bank rocks and historical Icicle Creek Road.

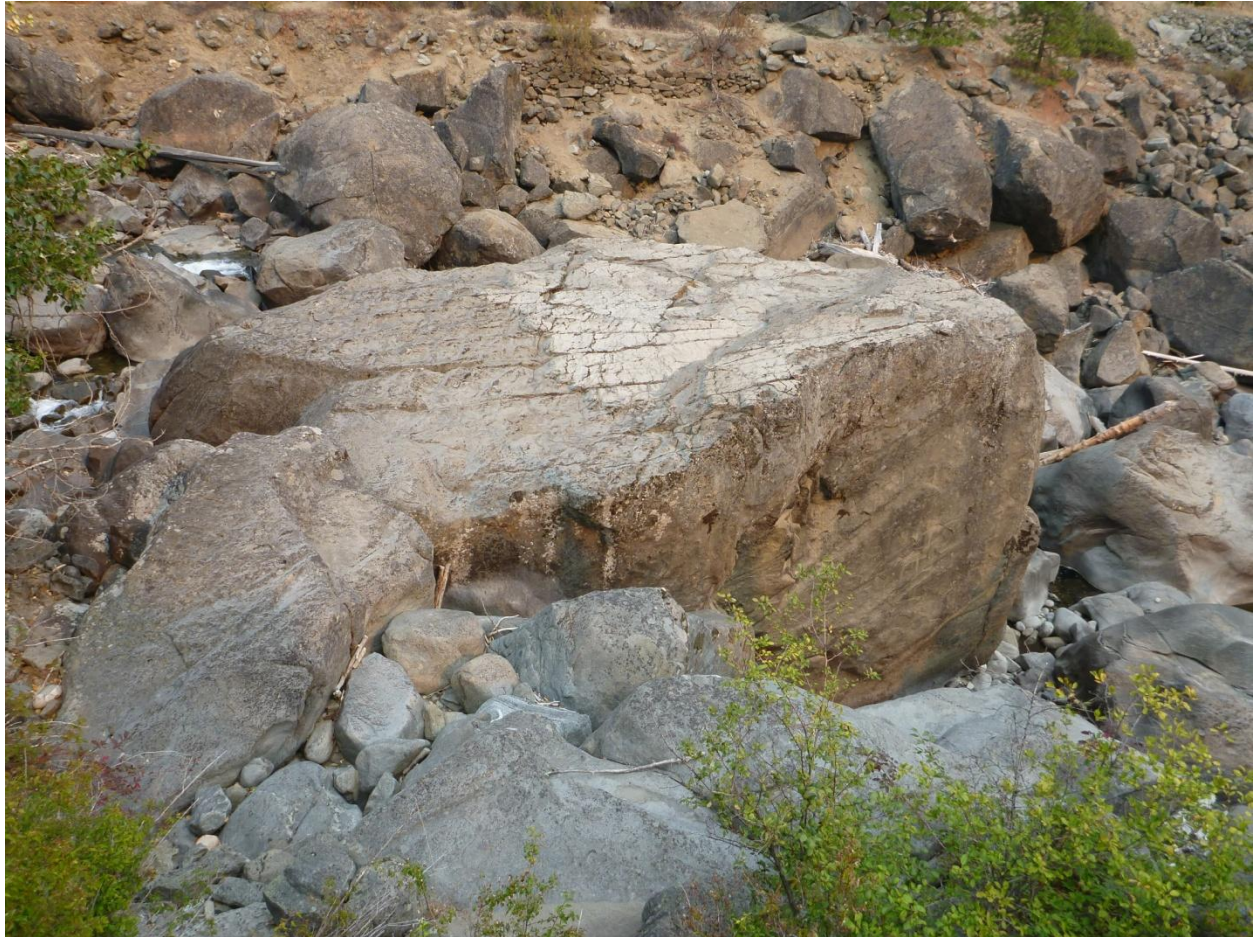
Figure A-4. Glacially polished top surface of the Anchor Boulder and adjacent gray bedrock on the right bank of Icicle Creek.

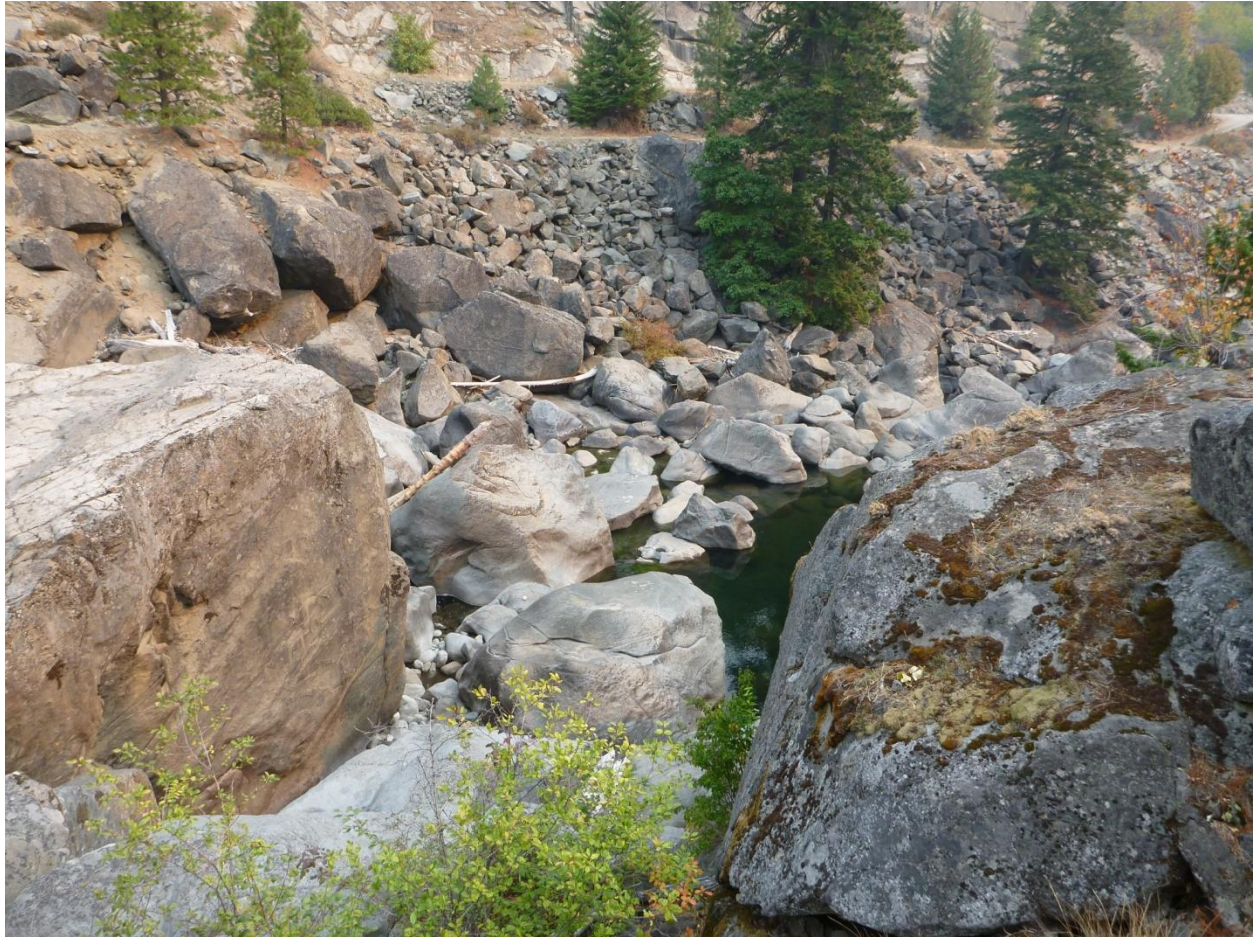
Figure A-5. Fluvial erosion of notch in bedrock at the Anchor Boulder on the right bank of Icicle Creek.

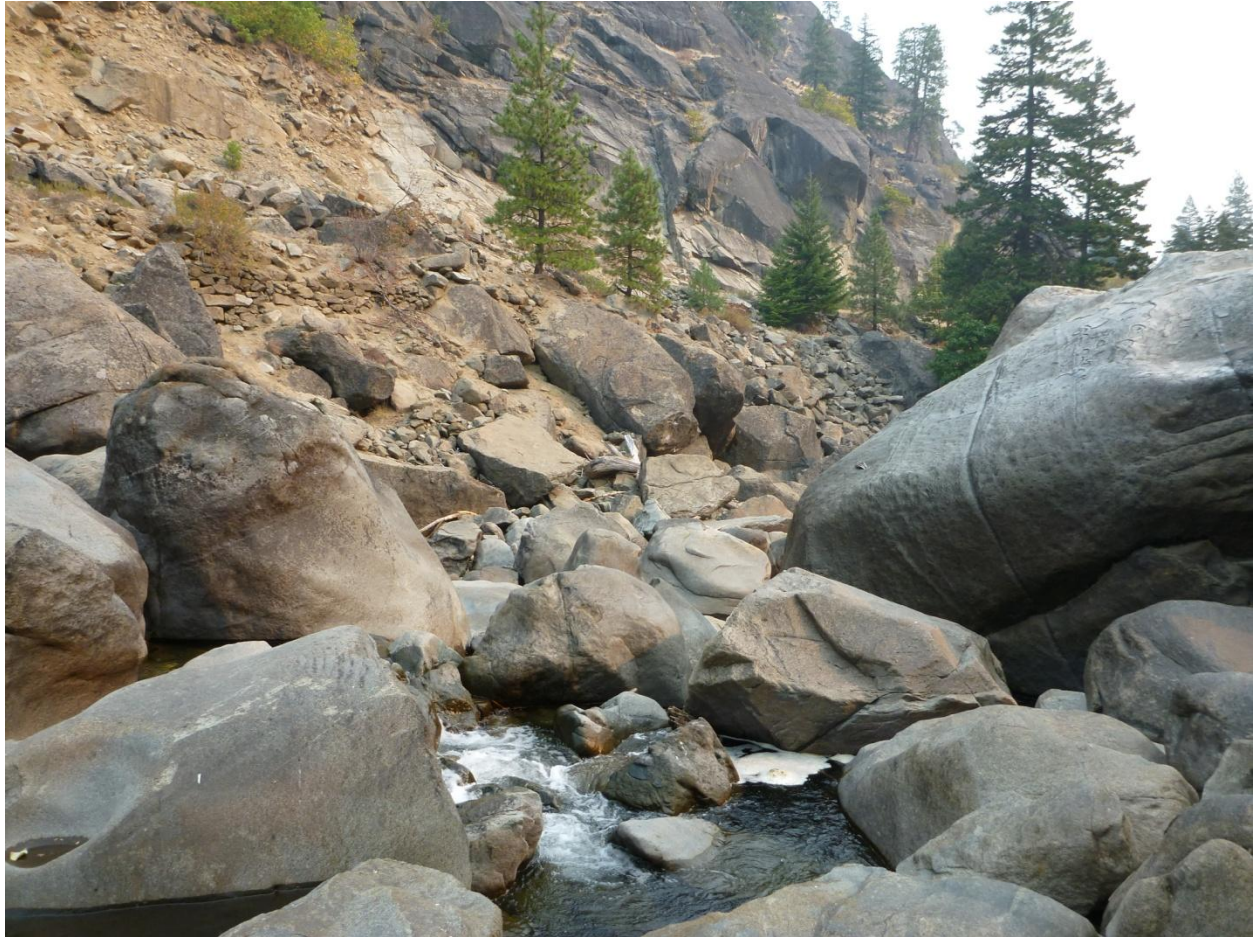
Figure A-6. Looking downstream in the middle reach of the Icicle Creek study area at the boulder field associated with the Anchor Boulder (*large gray rock with vertical groove on the right side of photograph*).

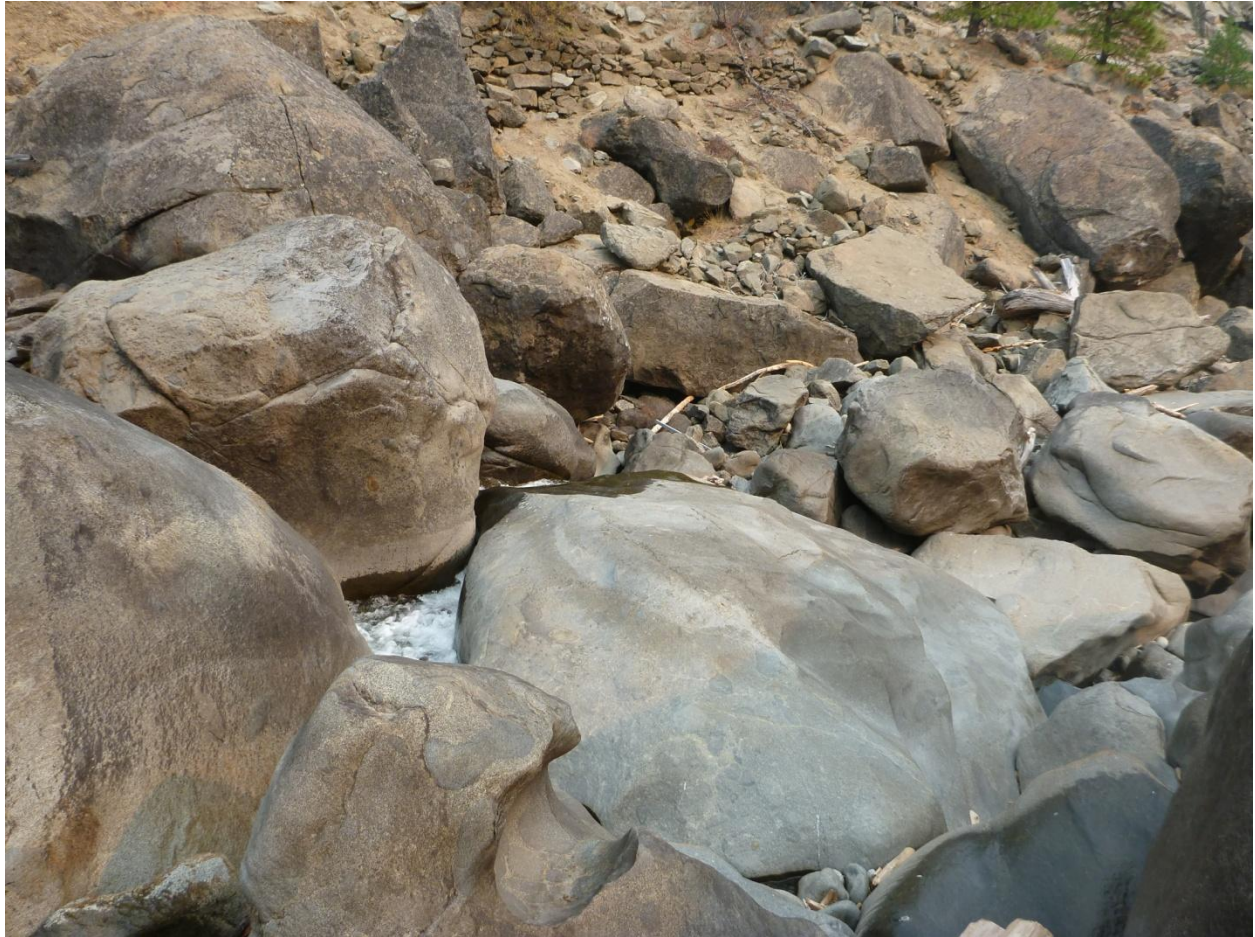
Figure A-7. Fluvially sculpted, flat boulder within Icicle Creek on the north side of the Anchor Boulder.

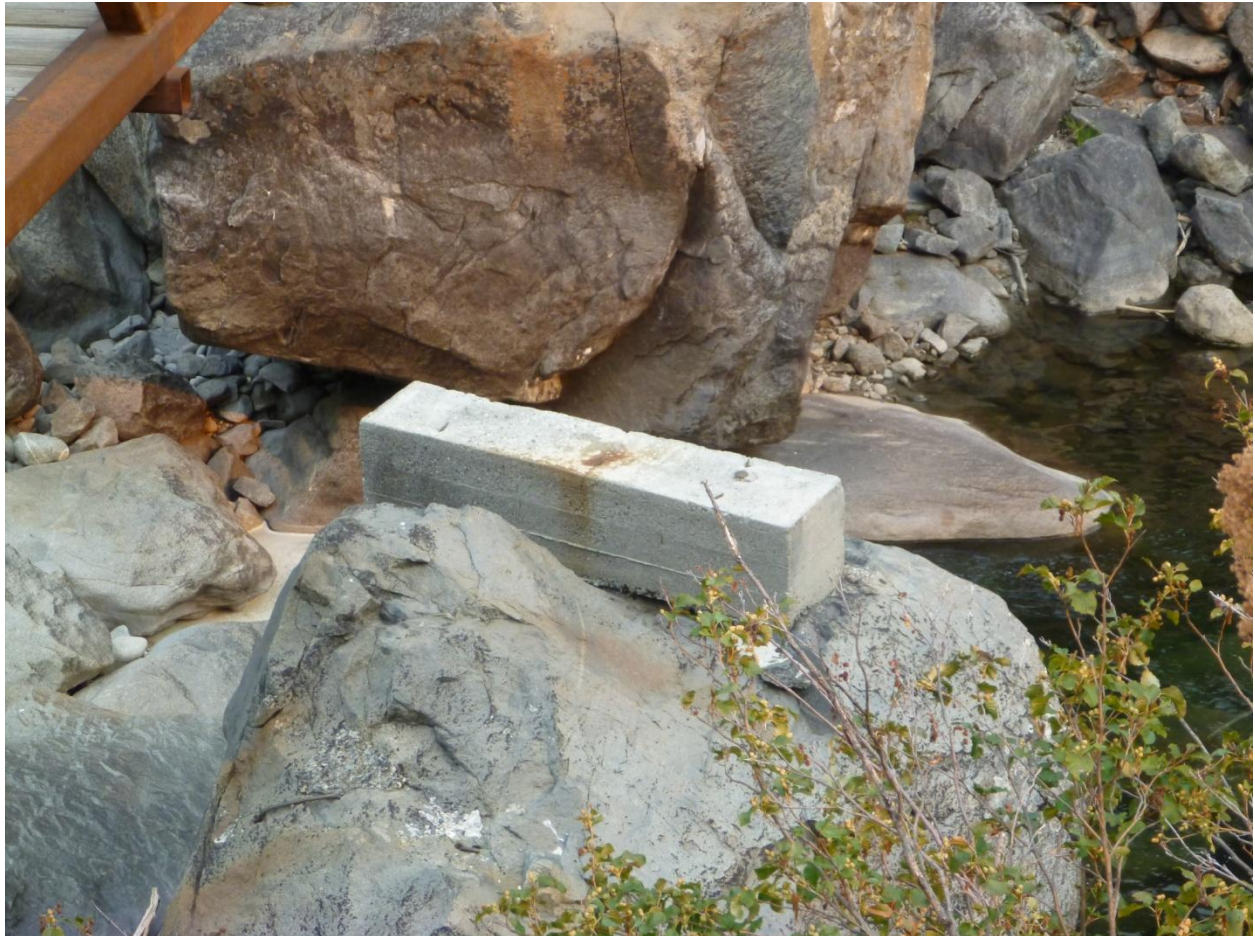
Figure A-8. Concrete block on boulder within Icicle Creek channel at the irrigation district bridge.

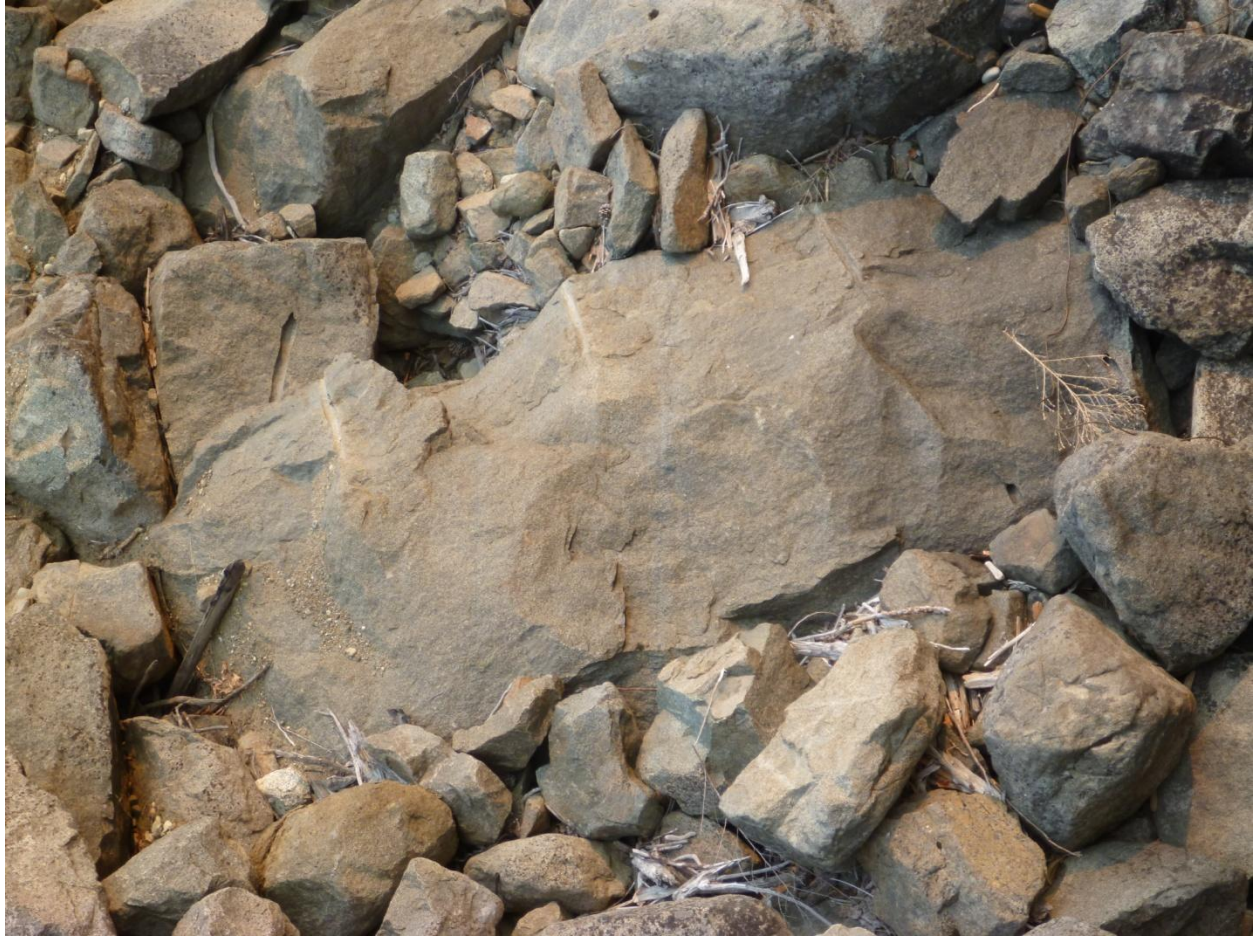
Figure A-9. Drill holes and grooves from blasted rock fragments in road prism along left bank of Icicle Creek.
