# Icicle Creek Boulder Field Fish Passage Assessment

## Icicle Creek, Chelan County, WA

## FINAL May 2013

# **Geologic Assessment of the Icicle Creek Boulder Field Study Reach**

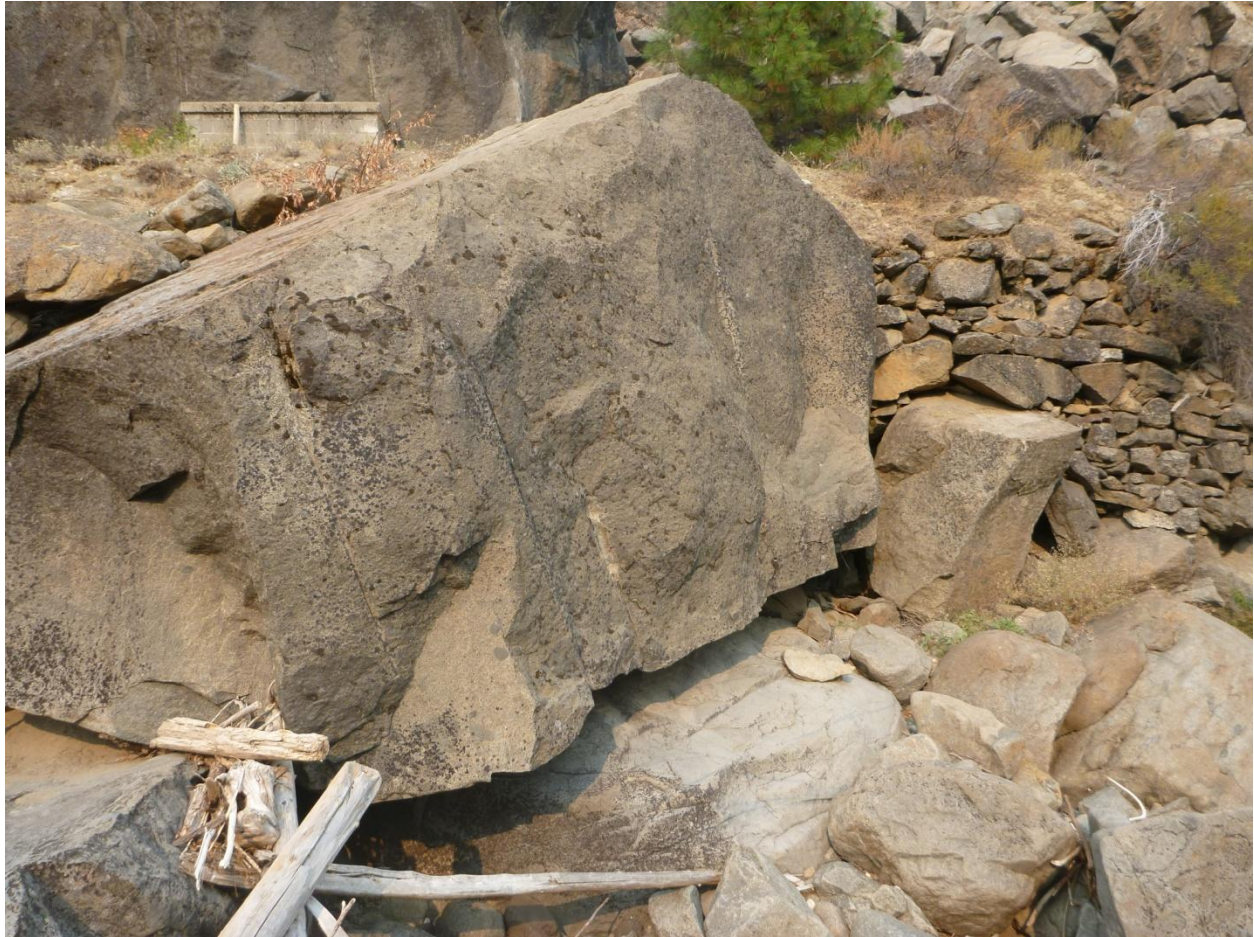
Figure A-10. Drill hole grooves in blasted boulder from road prism along left bank of Icicle Creek.

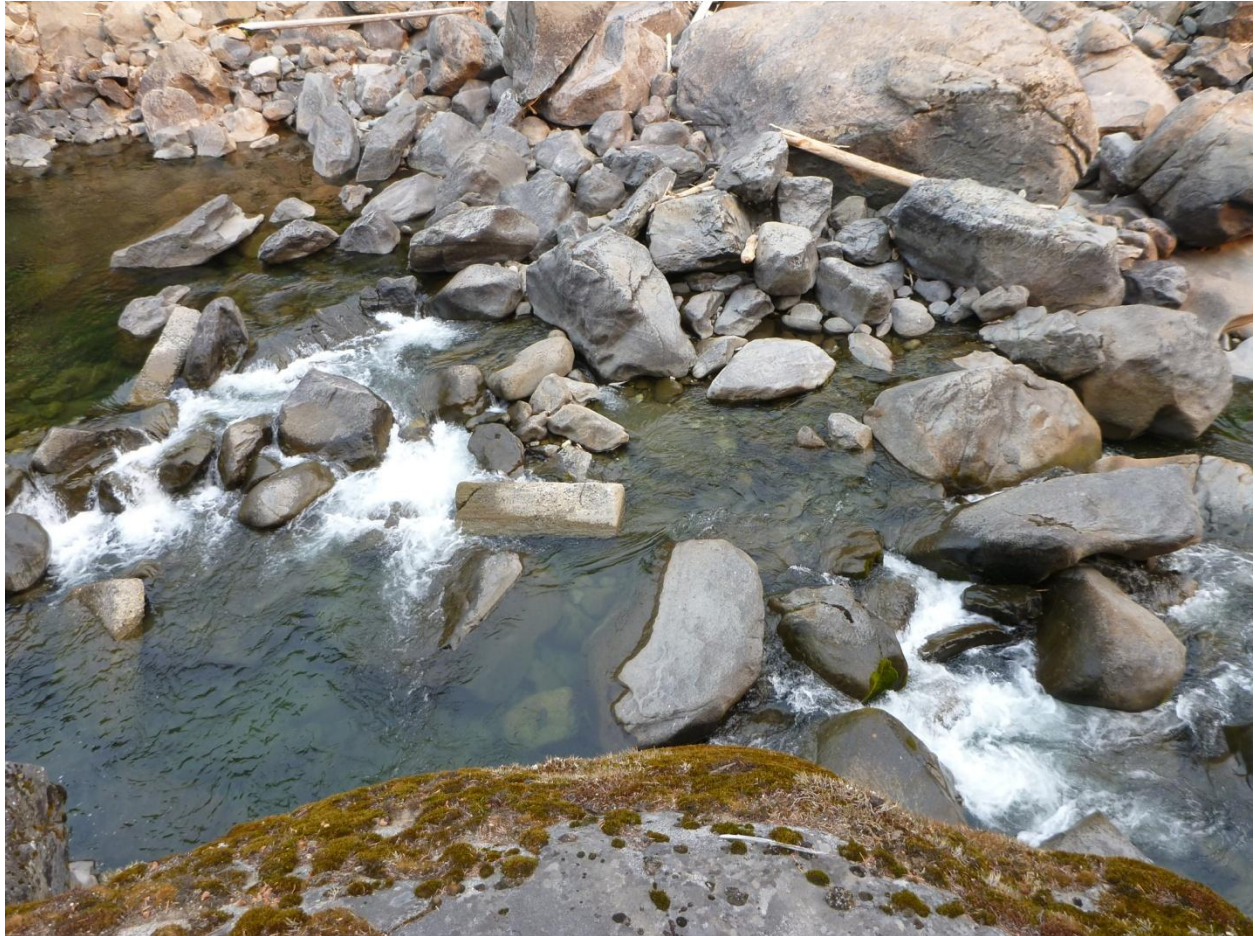
Figure A-11. Concrete blocks in middle reach of Icicle Creek study area.

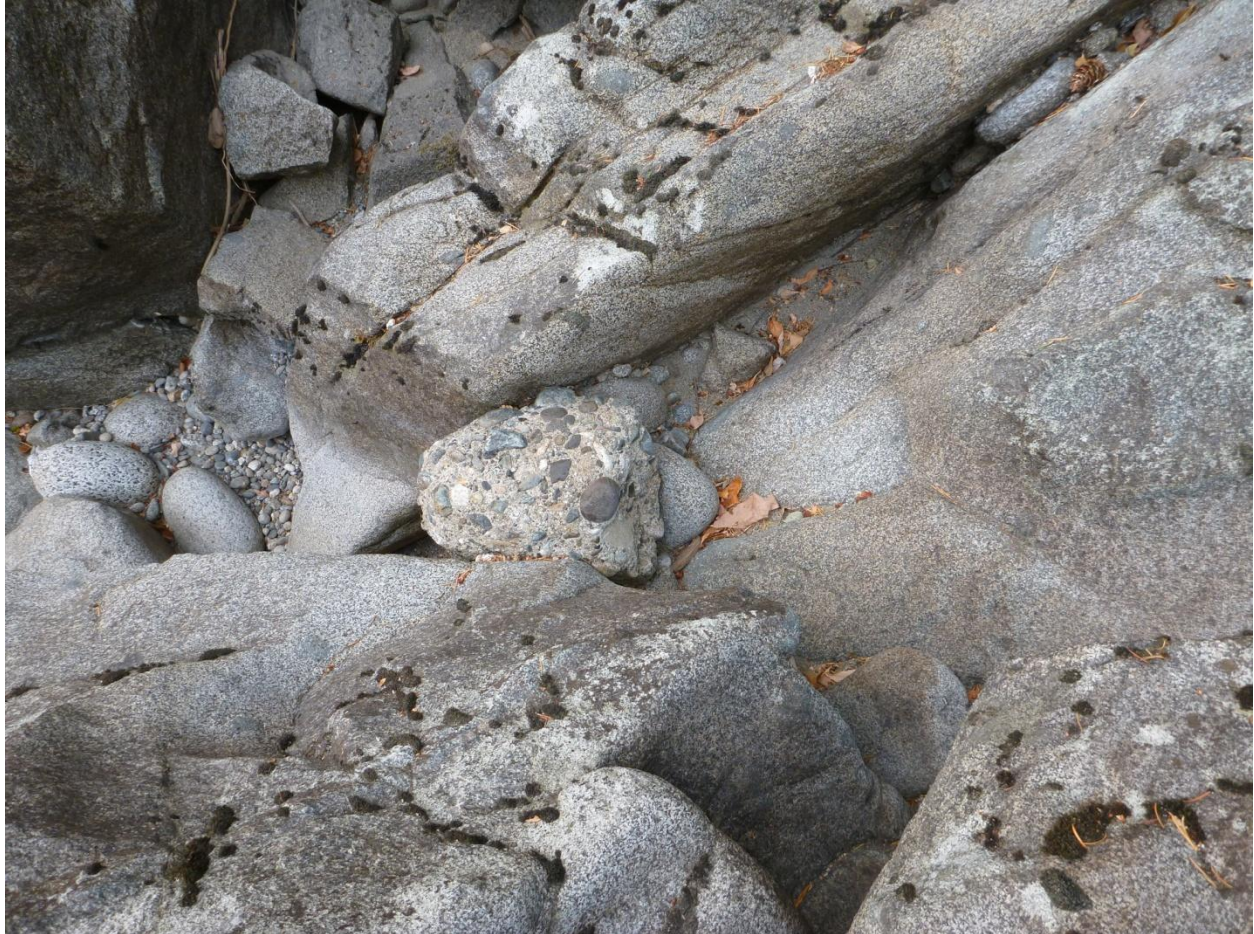
Figure A-12. Concrete block wedged between rocks on right bank of Icicle Creek.

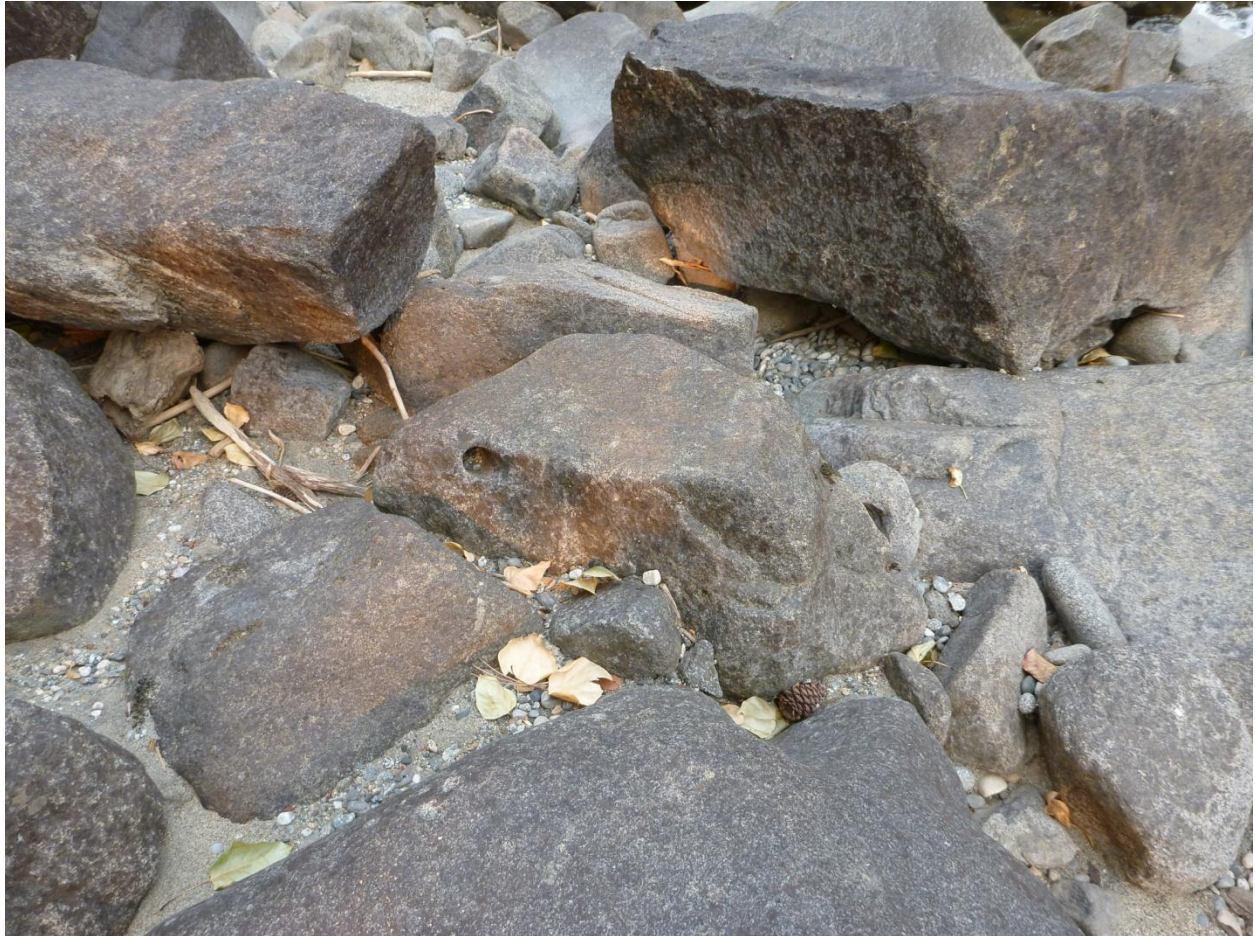
Figure A-13. Drilled rock in the Icicle Creek channel near the right bank upstream of the Anchor Boulder.

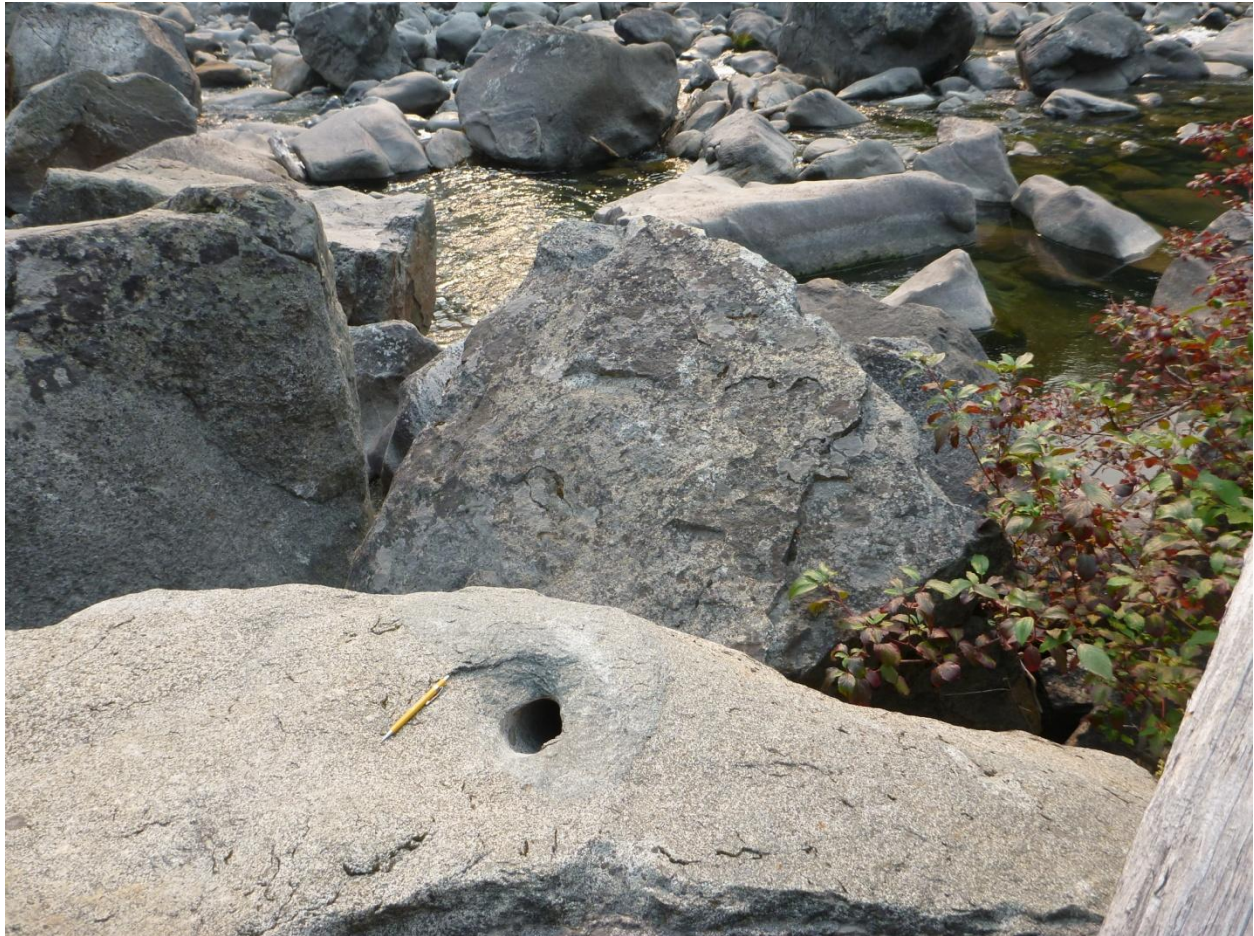
Figure A-14. Drilled rock on Left bank of Icicle Creek above the irrigation district bridge.

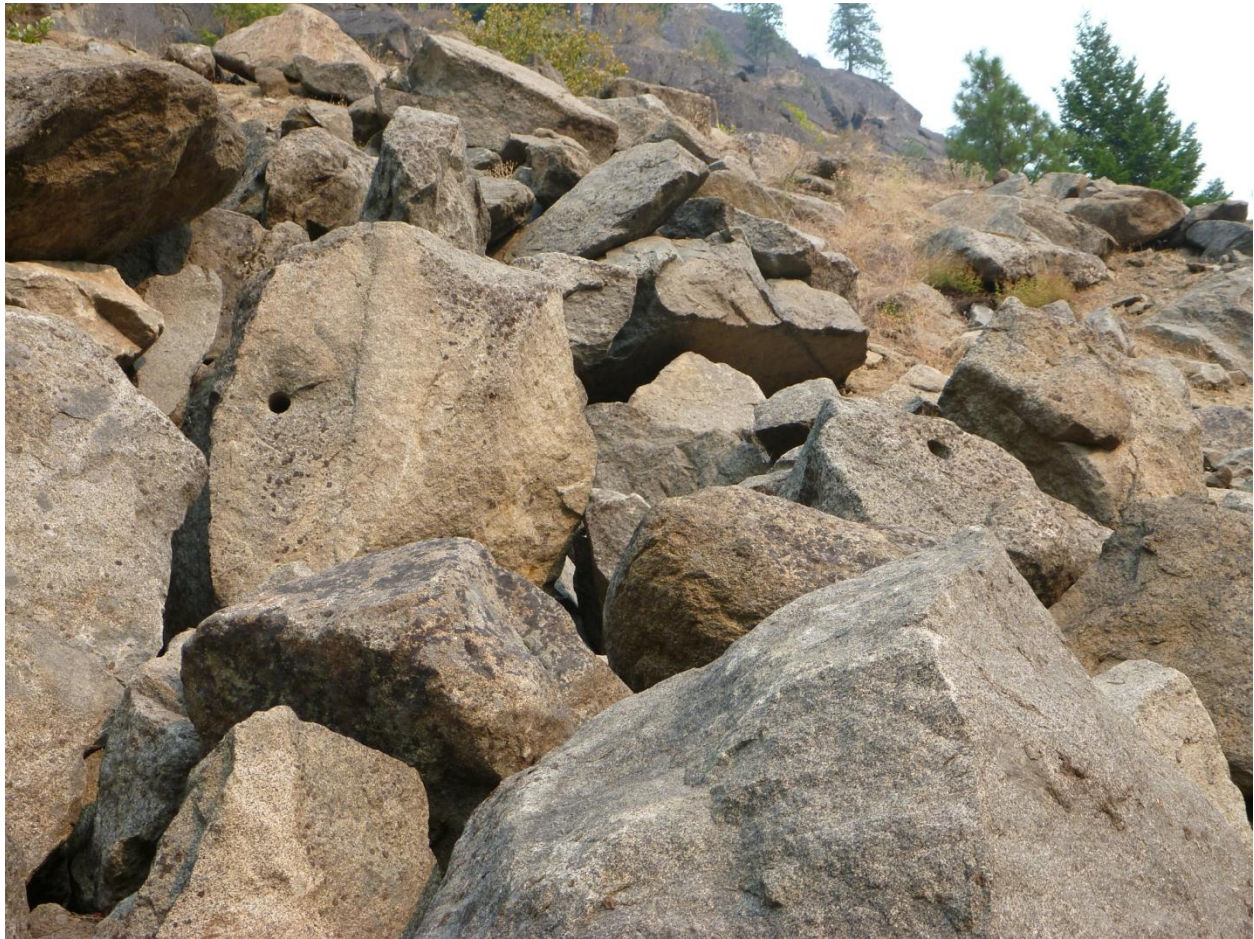
Figure A-15. Drill holes in rock sidecast along the old Icicle Creek Road in the lower reach of the Icicle Creek study area.

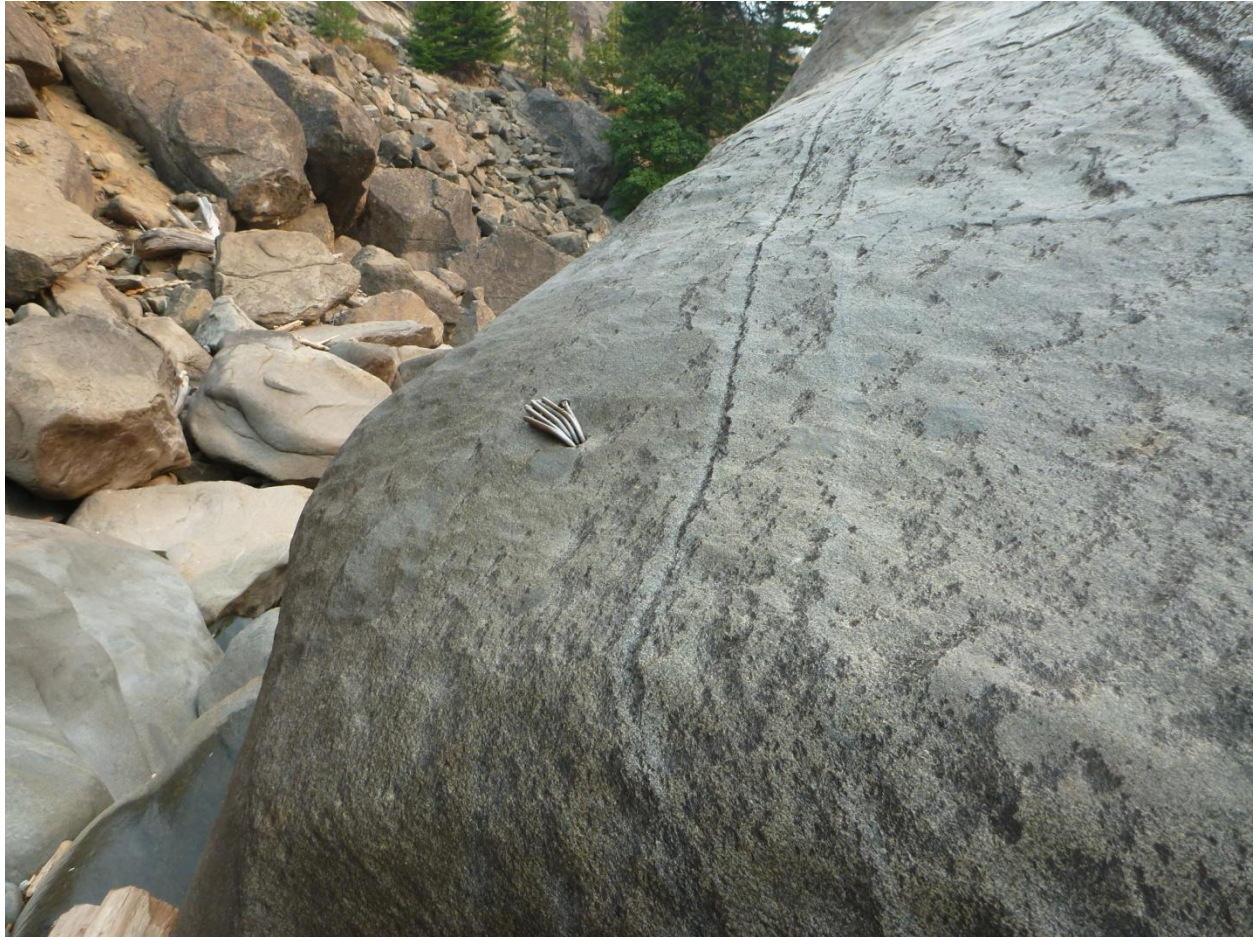
Figure A-17. Bent steel rods jammed into a drill hole on the north end of the Anchor Boulder.
