Appendix C
BEAVER CREEK CORRECTION ANALYSIS FORM

Project Name: **Beaver Creek Culvert Replacement**

Date: **March 31, 2021**

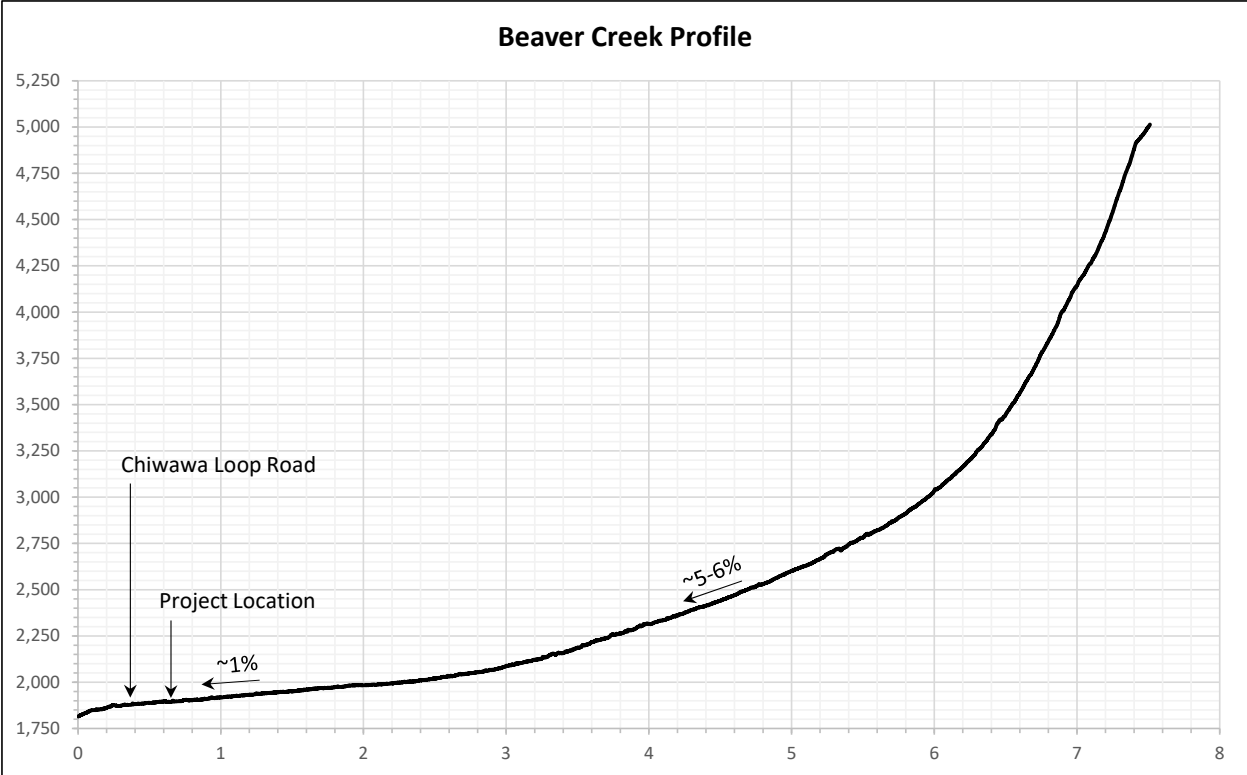
Figure 1. Longitudinal profile of Beaver Creek indicating typical slopes and project location.

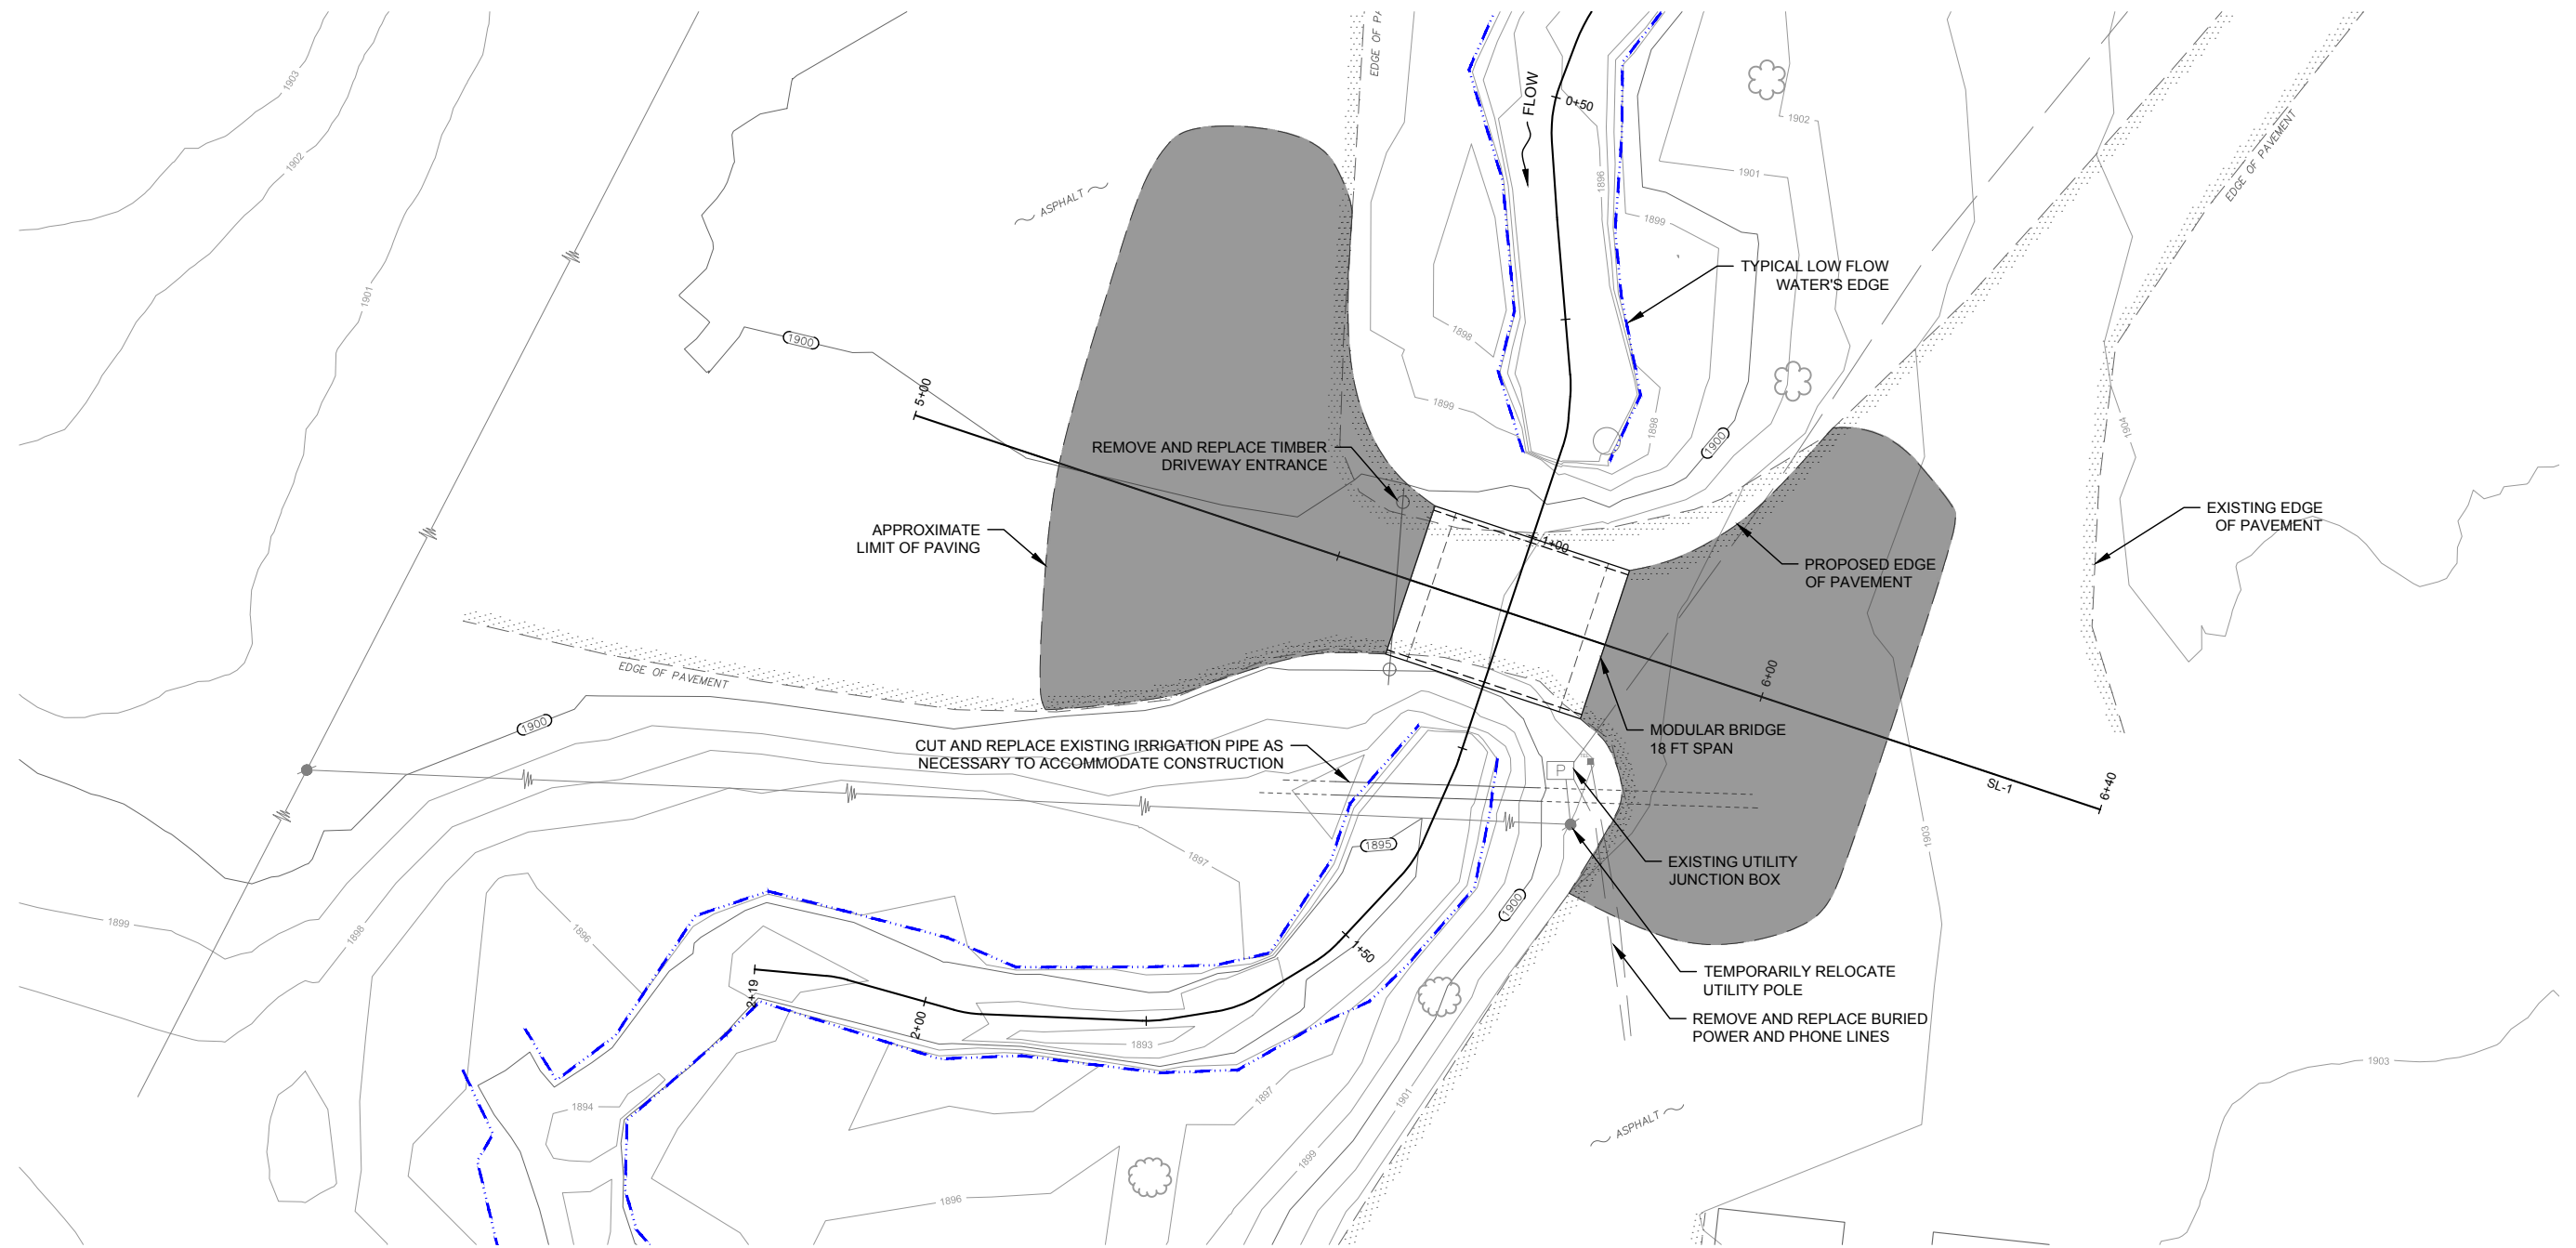
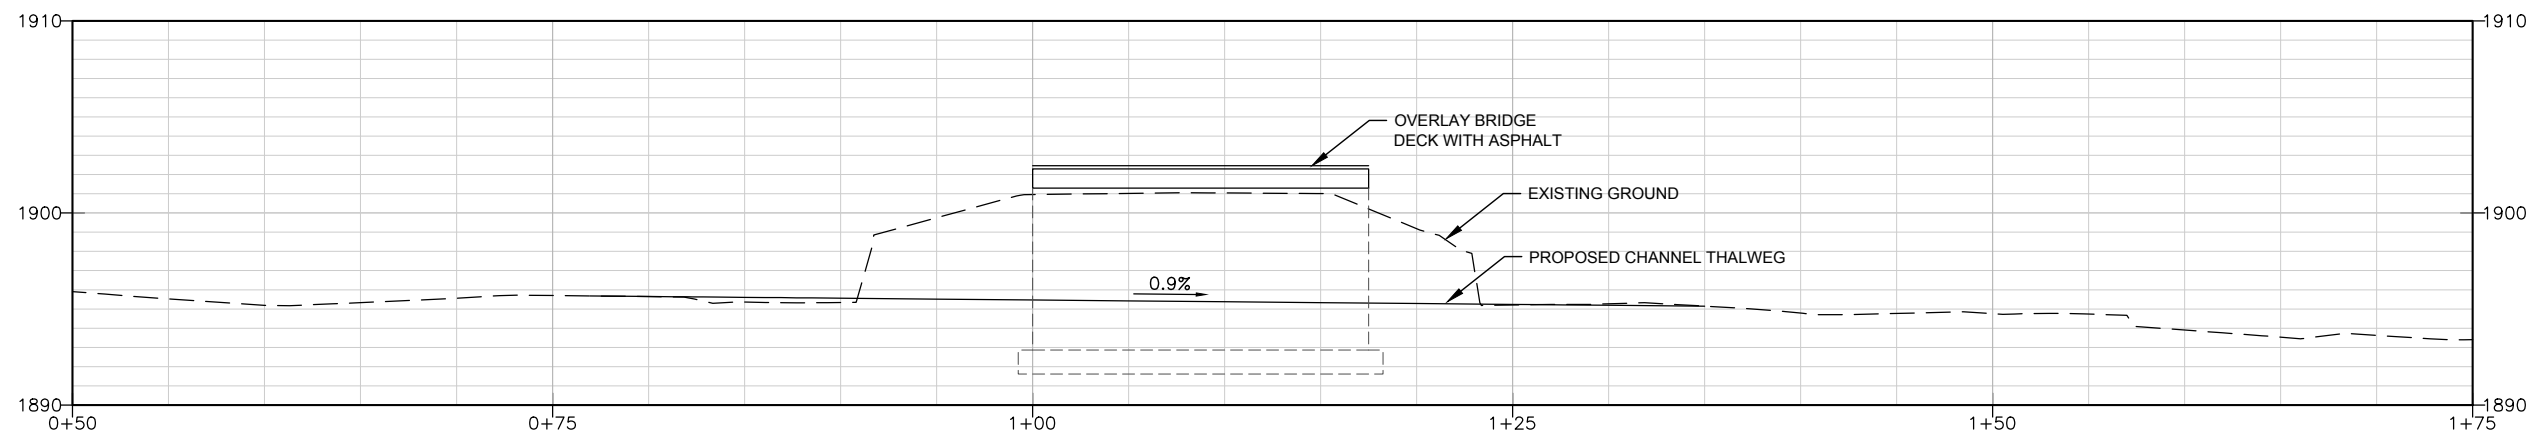
FIGURE 2. PLAN AND PROFILE VIEW OF PROPOSED CONDITIONS FOR PREFERRED ALTERNATIVE

DESIGN OPTION 1: MODULAR BRIDGE OPTION 18 FT SPAN

Preferred Alternative - Provide a 1- or 2-paragraph Recommendation for this Site. Include any Site-Specific Concerns that Will Need to be Addressed During Design and Construction: **The preferred alternative for this project is a modular concrete bridge used to replace the existing undersized culvert. The Stream Simulation design approach outlined in the Washington Department of Fish and Wildlife (WDFW) Water Crossing Design Guidelines (WCDG) was used to develop this design option. The replacement structure is sized based upon the minimum opening size for the field verified and agreed upon bankfull width of 12.9 ft using the standard 1.2 x Bankfull width plus an additional 2 ft which gives 17.5 ft and is rounded up to the next whole foot. Site constraints, particularly the longitudinal slope across the culvert, as well as estimated construction cost played a role in determining the preferred alternative. Chelan County Code requirements for freeboard will require some raising of the existing drivable surface. The landowner has expressed their desire to minimize the profile adjustment of the road to the extent practicable. That being said, both Options 1 and Options 2 provide similar improvements hydraulically and geomorphically while minimizing the vertical adjustment to the driving surface necessary to accommodate minimum freeboard requirements and the structure itself. The modular bridge option is anticipated to cost less (approximately 11%) than the precast split box culvert and is therefore considered the preferred alternative. Plan and profile drawings of the preferred alternative are provided in Figure 2. It is important to note that a geotechnical investigation has been scoped for this effort, but has not yet been conducted. If weak soils are discovered it is likely that design option 1 would become infeasible and design option 2 would become the preferred alternative. At this time the working assumption of the design is that soils will be adequate to allow for independent footings (i.e. a modular bridge is feasible) and therefore design option 1 remains the preferred alternative until the results of the geotechnical analysis are available.**

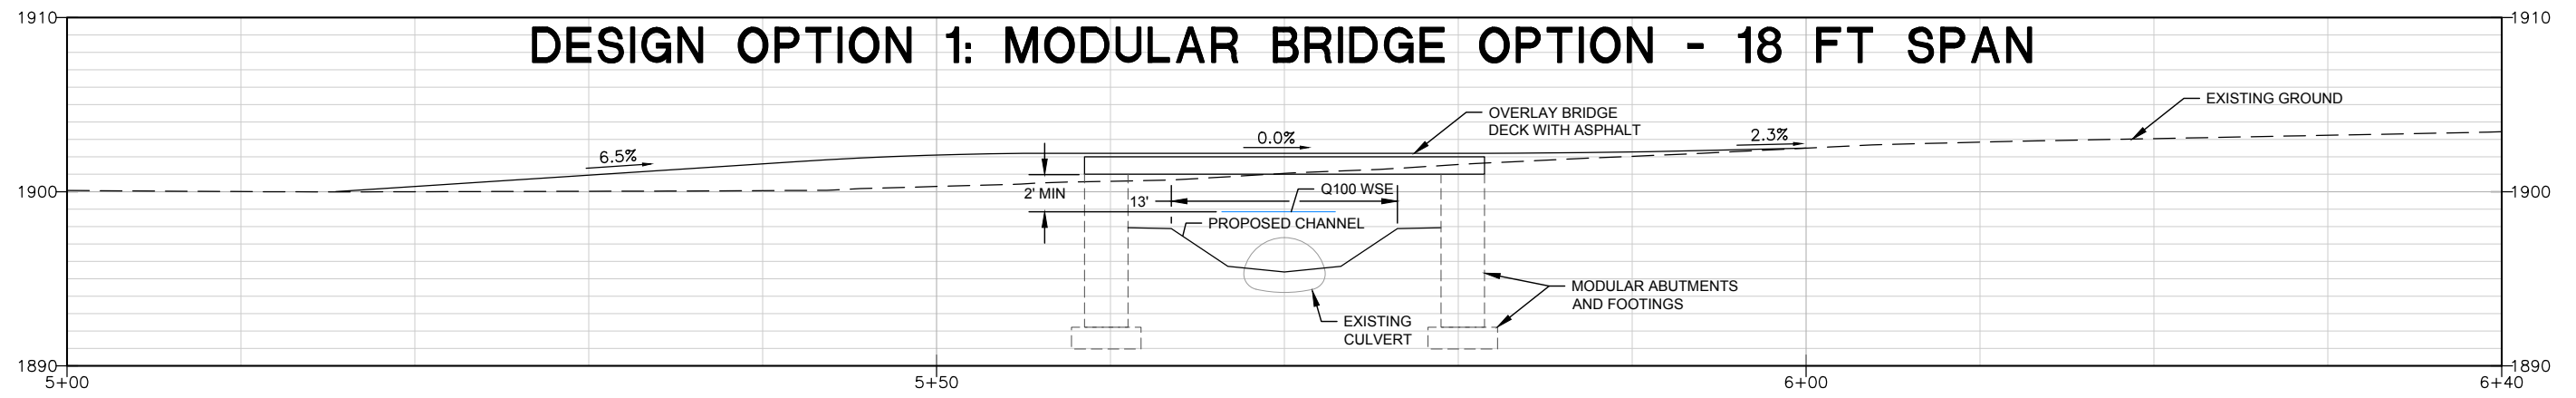
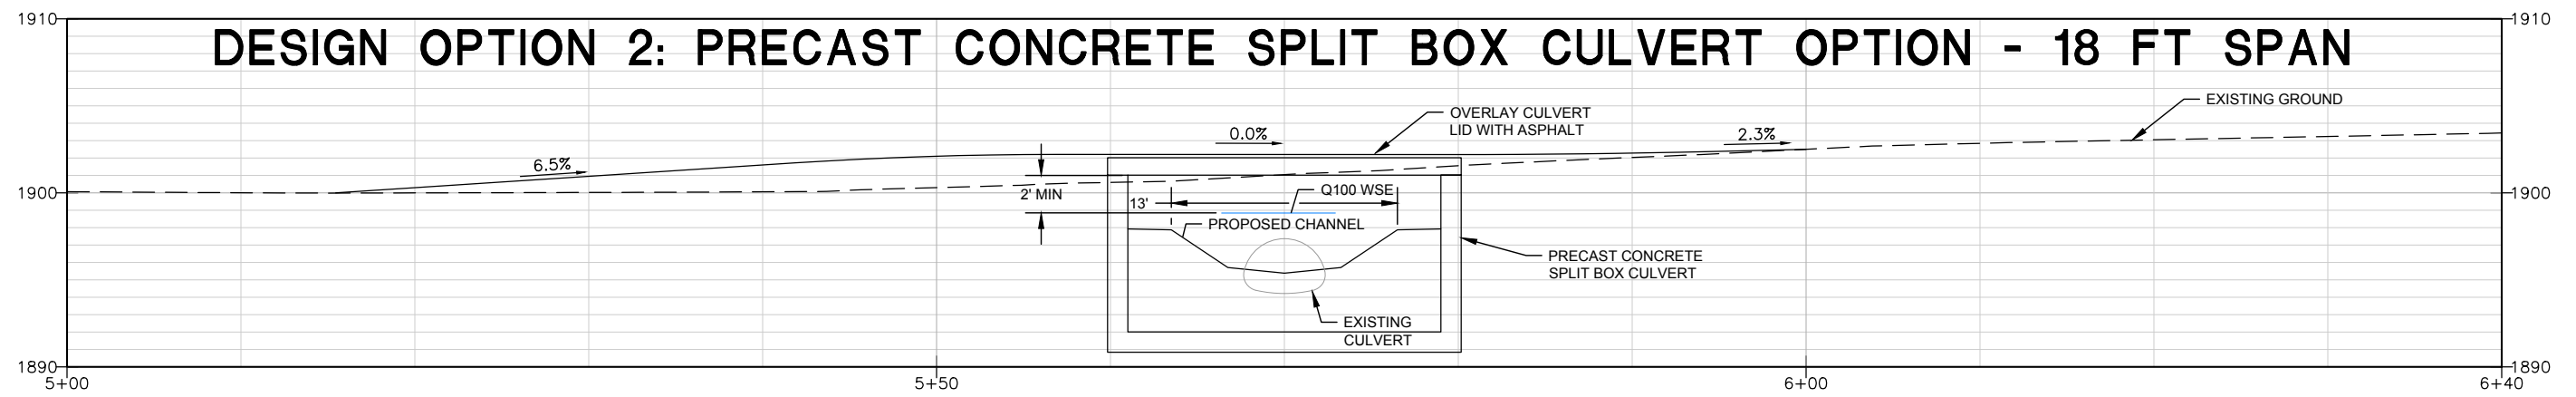
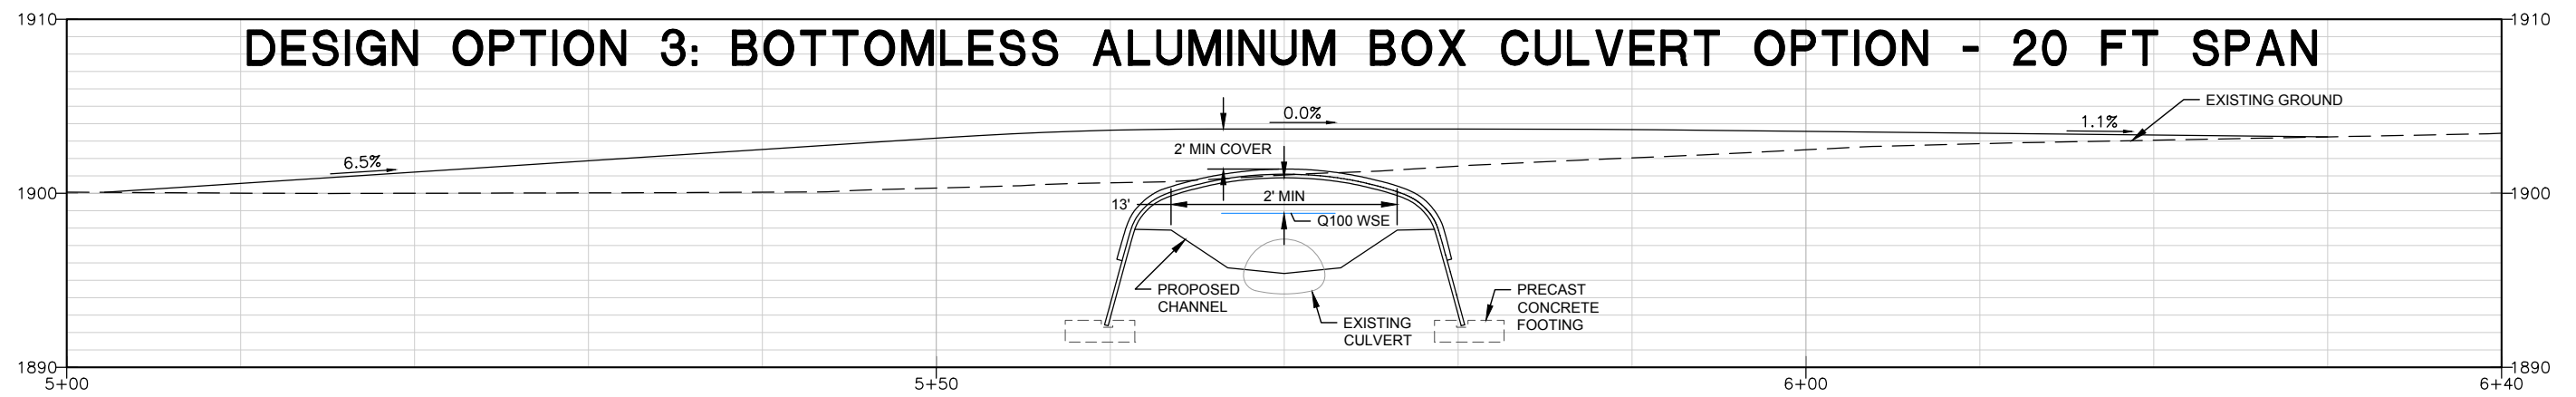
FIGURE 3. TYPICAL SECTION VIEWS FOR DESIGN OPTIONS CONSIDERED

A bottomless aluminum box culvert meeting the minimum span requirements was briefly considered as a third option. Due to the minimum fill required over the aluminum box culvert, the vertical profile adjustment necessary to accommodate this type of structure is simply too severe to be considered a viable option. This option was included on Figure 3 for illustrative purposes only.
