Lower & Middle Nason Creek Reach Assessment & Restoration Strategy Update *Final Report*

JANUARY 2026

PREPARED FOR
Yakama Nation Fisheries

PREPARED BY
Inter-Fluve

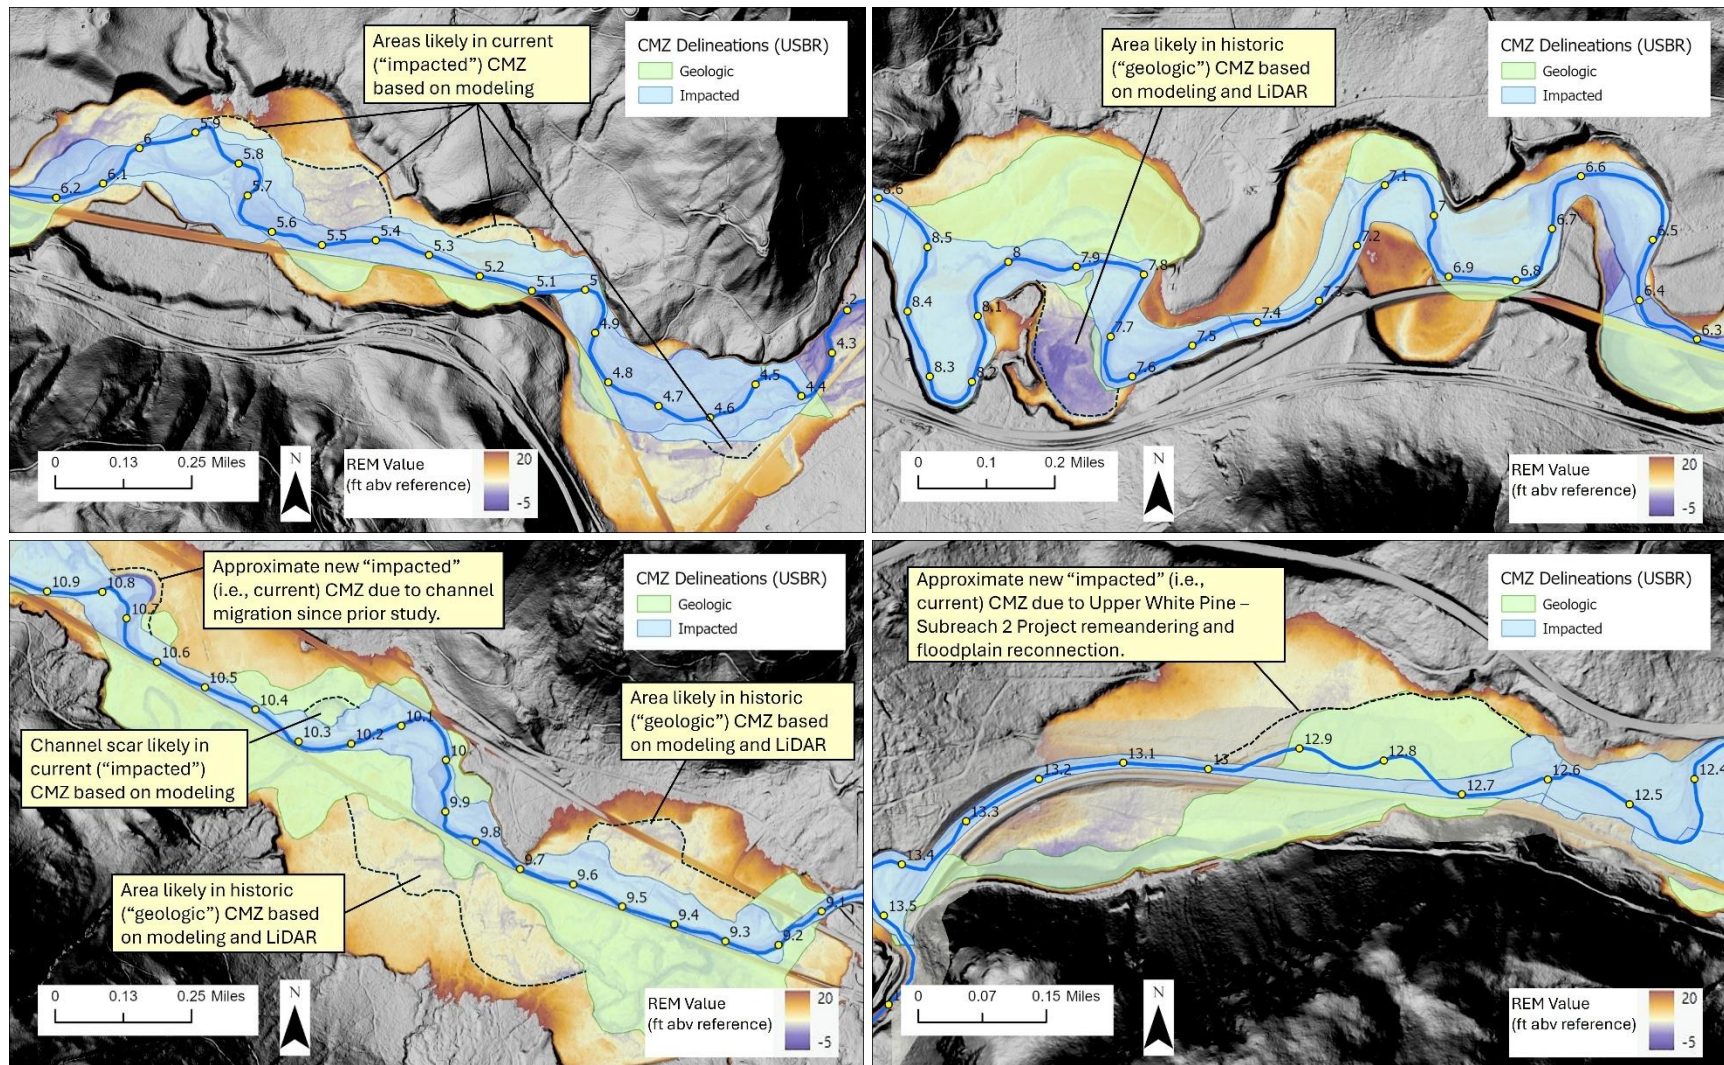
For the upstream portion of the assessment area (RM 4.4 to 13.5), the 2008 Tributary Assessment delineated the Historical Channel Migration Zone (HCMZ), defined as the “areas that have evidence of channel migration for a period of at least the last 100 years and probably several hundred years” (USBR 2008). USBR performed this analysis using LiDAR, field observations, and historical maps and aerial photos. The GIS data of the HCMZ from the Tributary Assessment matches the extents of the “Geologic” and “Impacted” zones included in the maps below, with the “Geologic” zones representing those areas of the HCMZ that have been disconnected from the current CMZ due to anthropogenic changes. In most cases, the HCMZ data appear to match the field observations and modeling performed as part of this reach assessment. A few areas where conditions have changed, or where our assessment suggests different boundaries, are included in the figures below (Figure 12).

Figure 12. Notes of potential changes in channel migration zone delineations (from those delineated in USBR Tributary Assessment 2008) due to: 1) channel adjustments since the previous study or 2) from new data (e.g. newer LiDAR), new hydraulic modeling, and field observations performed as part of this reach assessment.

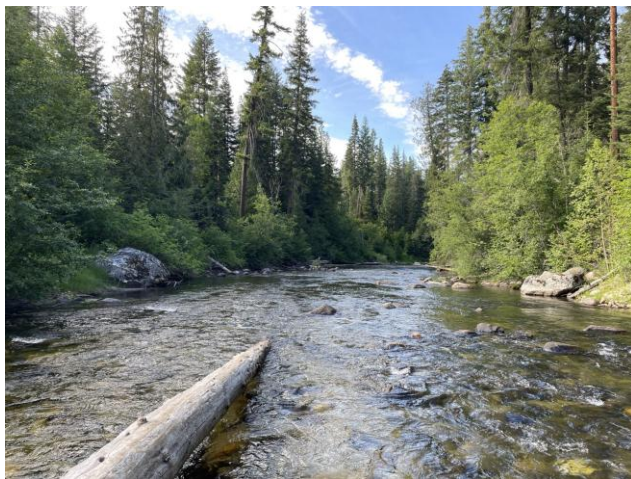
Figure 18. View upstream near RM 1.4 of confined segment in Reach 2.

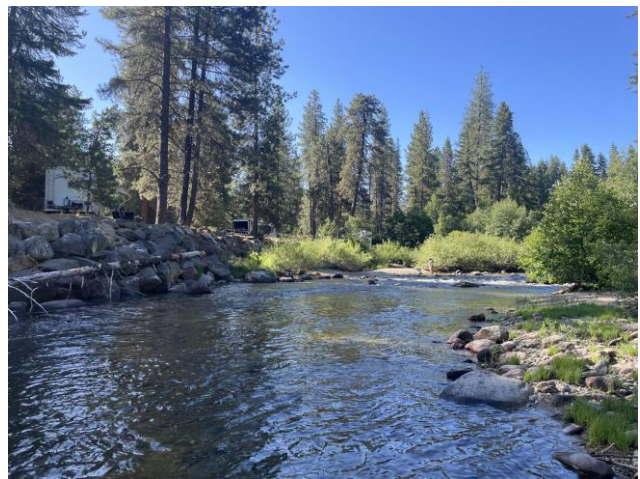
Figure 19. View upstream near RM 1.0 with campground and hard armoring on river-right.

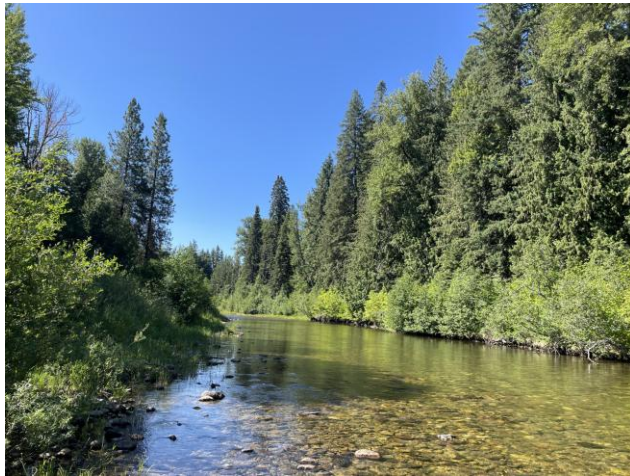
Figure 20. View upstream at highly simplified channel near RM 0.3.

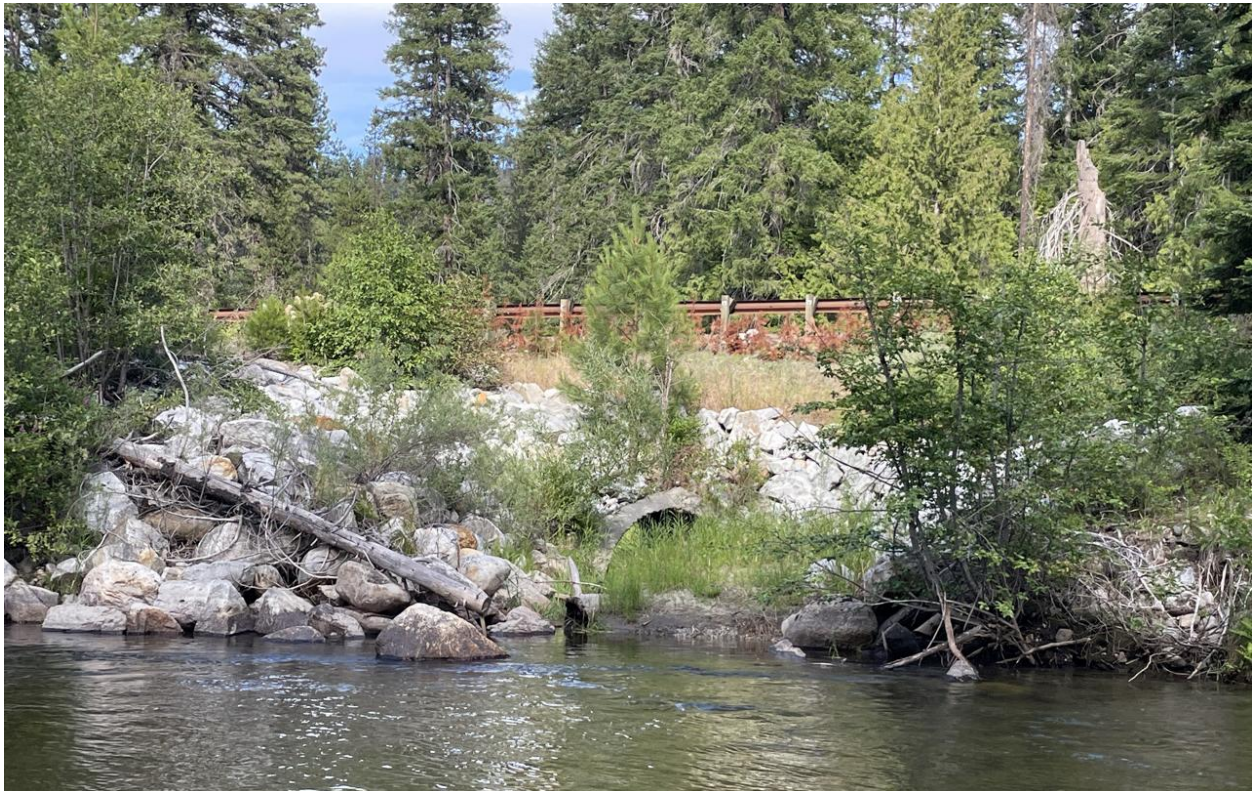
Segment 1 has been heavily impacted by past and ongoing human alterations including road construction, residential and commercial development, and recreation infrastructure. One of the most significant influences on channel and floodplain function is State Route 207, which has cut off at least three former main channel segments and portions of floodplain. These include an approximately 900-ft section from RM 1.1 to 1.3, a >3,000-ft section from RM 0.5 to 0.9, and an approximately 1,200-ft section from RM 0.3 to 0.4. These can be seen in the Relative Elevation Map (REM) in Figure 28. Portions of the channel are now armored with riprap where they abut the highway embankment. The cut off section in Reach 2 is connected as a side-channel via culverts at both ends designed for fish passage (Figure 24). The other cutoff segments only have drainage culverts.

Figure 24. View of river-right bank near RM 1.3 at historical channel cutoff point that is now connected via a culvert under State Route 207.

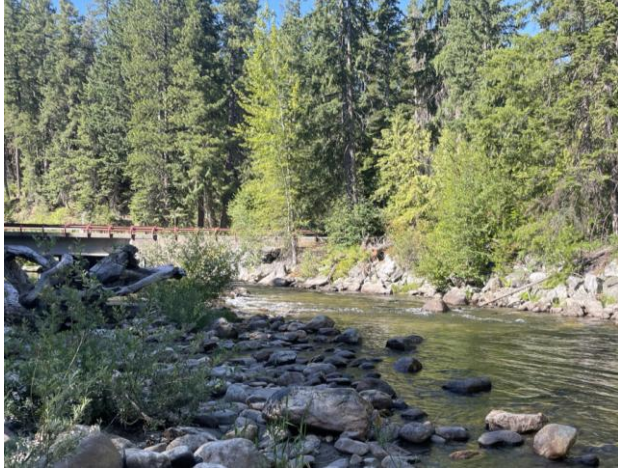
The Nason Creek Campground and Cedar Brae Road and bridge provide other major sources of impairment to channel and floodplain processes. The bridge and bank armoring along the campground has locked the channel in place and prevents channel migration (Figure 25). Approximately 2,500 feet of channel through the campground is armored. There has also likely been floodplain fill associated with the campground, but the specific extent is unknown and so it was not mapped as part of this effort. Downstream of the campground, there are a few areas of bank armoring on river-right (Figure 26) and also areas of fill associated with development to the east of the confluence area.

Figure 25. View upstream near RM 0.7 at river-left riprap and Cedar Brae Rd bridge in background.

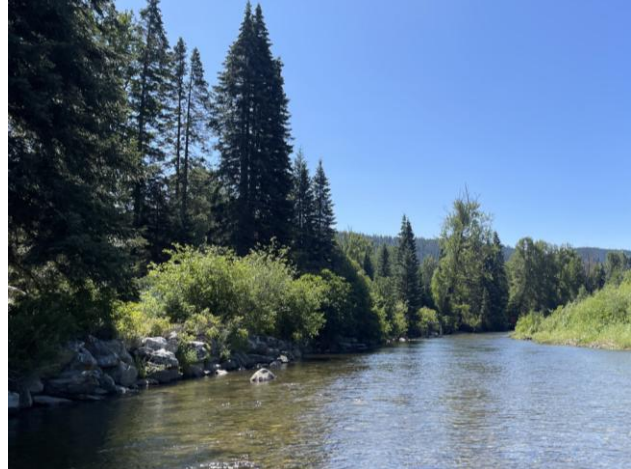
Figure 26. View upstream near RM 0.2 at simplified channel and bank armor on the river-right bank.

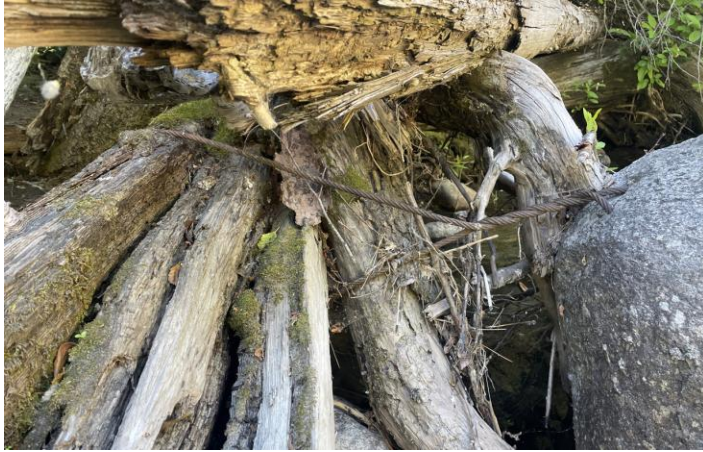
Figure 32. Log cabled to a boulder near RM 0.75.

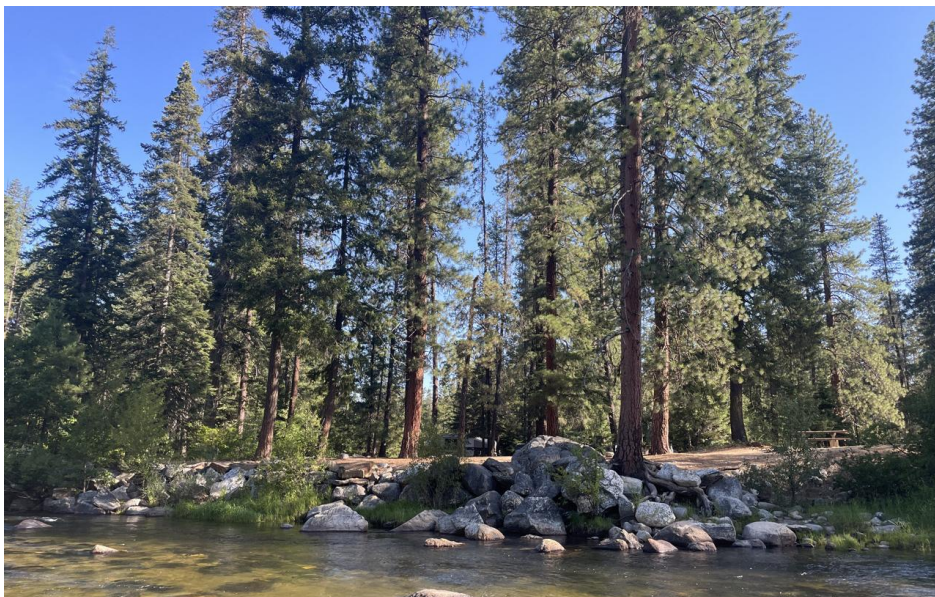
The abundance of riprap, channel confinement, and denuded or young riparian vegetation severely limits large wood recruitment potential (e.g. Figure 33). Furthermore, when wood is recruited, the wood size and the high energy confined channel makes it difficult for wood to be retained in the channel. The only area where channel migration processes are intact is at the confluence, where wood recruitment would most likely result in the wood readily moving out of Nason Creek. Due to constraints on lateral migration, tree recruitment primarily happens only via natural tree fall (i.e. not bank erosion), which occurs seldomly due to the relatively young riparian stands or narrow or non-existent buffers. The few areas where there are large trees include atop the river-left terrace near RM 1 (fig), the downstream river-left floodplain (up to RM 0.7), and in portions of the campground. Tree fall from the campground would likely be prevented or trees would be readily removed from the river. Tree fall from the river-left RM 1 terrace may also be removed as they could provide a hazard for campground users. The mature stand of trees in the downstream river-left floodplain do provide a potential source for recruitment, if the river could be re-located or induced to scroll into that area.

Figure 33. Tree recruitment potential halted by bank armor at campground near RM 1.1.

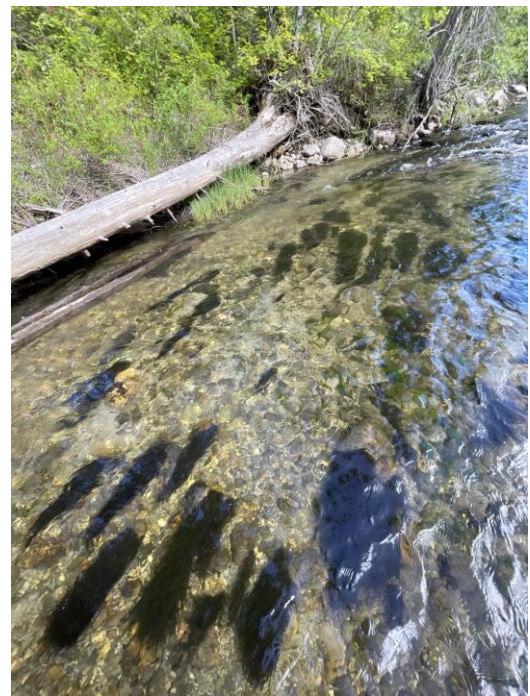
Vegetation in Segment 1 consists of riparian areas and lower floodplain surfaces dominated by cottonwood, dogwood, alder, willow, cedar, and reed canary grass. The higher floodplain and terrace surfaces are dominated by ponderosa pine and fir. At the confluence, there is sparse and mostly young riparian vegetation. In the river-left floodplain between the confluence and RM 0.7, there is a mature forest with some trees over 150 tall. There is also an aspen stand in the river-left floodplain at the confluence area. Most of the remaining overstory is dominated by mixed-age cottonwoods, with young cottonwoods, willows, dogwoods, and alder in the understory and along the channel banks in most locations. Overall, the vegetation in Segment 1 is highly disturbed, with few larger mature trees, low canopy cover, and low large wood recruitment potential for the reasons described previously in the Large Wood Material section. Past timber harvest, plus on-going impacts including the campground, State Route 207, a powerline corridor crossing, and the golf course all contribute to impaired riparian vegetation conditions. The highway and the golf course, in particular, result in persistent narrow riparian buffers, or no buffer at all in some locations. Invasive reed canary grass dominates most of the channel bars and banks and low surfaces. Abundant filamentous algae was observed in the channel in Reach 2, possibly due to the south-facing exposure of the channel and large substrate (Figure 36). A vegetation height map is included for reference in Figure 37.

Figure 36. Algae in channel near RM 1.4.

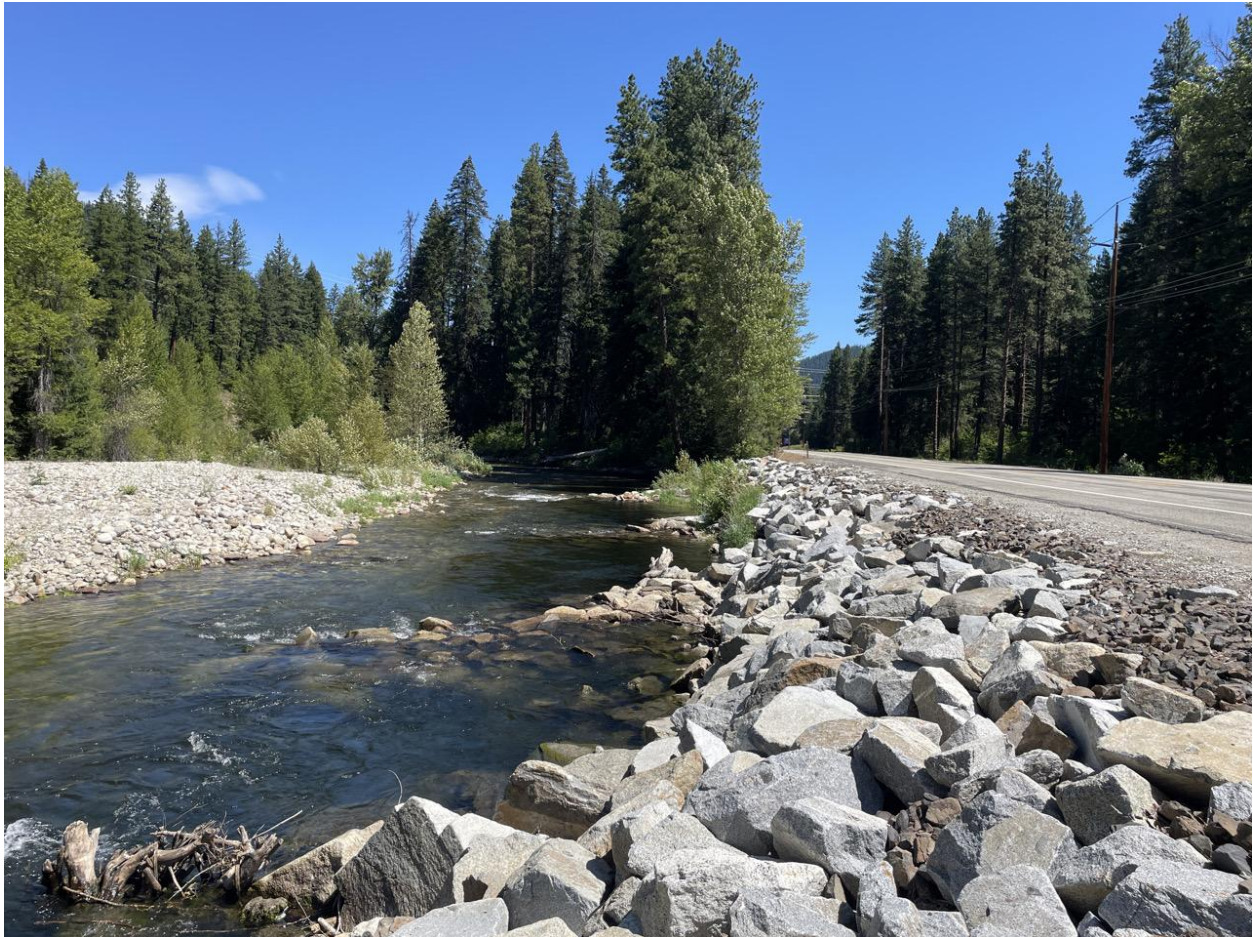
There have been significant impacts to channel and floodplain processes in this segment, primarily in the upstream portion of the segment in Reach 4. The primary impacts are channel and floodplain disconnections that occurred with the construction of State Route 207 on the east side of the valley. This includes an approximately 2,000 ft section of channel between RM 4.2 and 4.4, and a 4,400 ft section of channel between RM 3.3 and 4.0. Analysis performed as part of Reclamation's Lower Nason Assessment (USBR 2011) showed that in the lower 4.6 miles of Nason Creek, channel cutoffs due to the highway reduced sinuosity from ~1.45 to ~1.2 and increased channel slope from ~0.30% to ~0.37%. Although disconnections in Segment 1 also contribute to these changes, the most disconnection has occurred in Segment 2. Past restoration efforts have reconnected a portion of the historical channel as a side-channel connected via culverts through the highway. Bank armoring is located in a few locations where the channel abuts State Route 207 (Figure 48). There is a total of approximately 1,100 feet of riprap. There are some areas of likely floodplain fill midway through the segment in the river-right floodplain near RM 2.5 associated with private residential development. These were not mapped as fill as the specific locations and extents could not be readily verified due to private lands.

Figure 48. View downstream at bank armor along State Route 207 near RM 4.4 (Inter-Fluve photo July 2005).

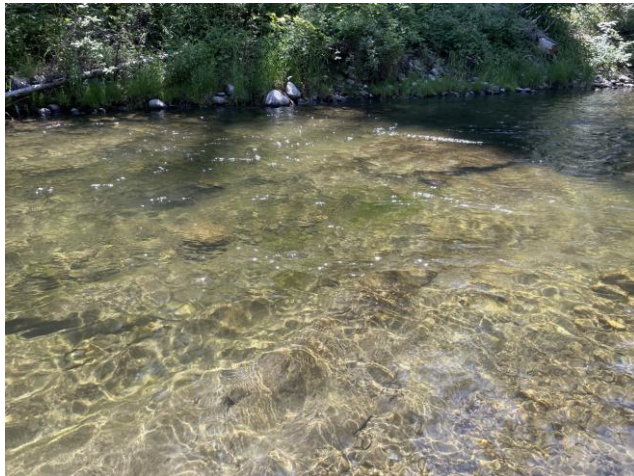
Bed substrate is dominated by gravels, with some cobble-dominated sections in the upstream portion of the segment. Bedrock was observed extending across the channel bed during the field surveys at RM 3.97, 4.03, 4.24, and 4.27 (Figure 49). Bed material sourcing primarily occurs from lateral erosion into modern floodplain deposits and also from erosion into alluvial fan deposits and outcrops of the Chumstick Formation, both of which occur primarily where the channel abuts the west valley wall (Figure 50). Bed material sourcing has been affected by channel cutoffs that have reduced sinuosity, lateral erosion potential, and contacts with the east valley wall sediments at the upstream end of the segment.

Figure 49. Bedrock in the channel bed near RM 4.

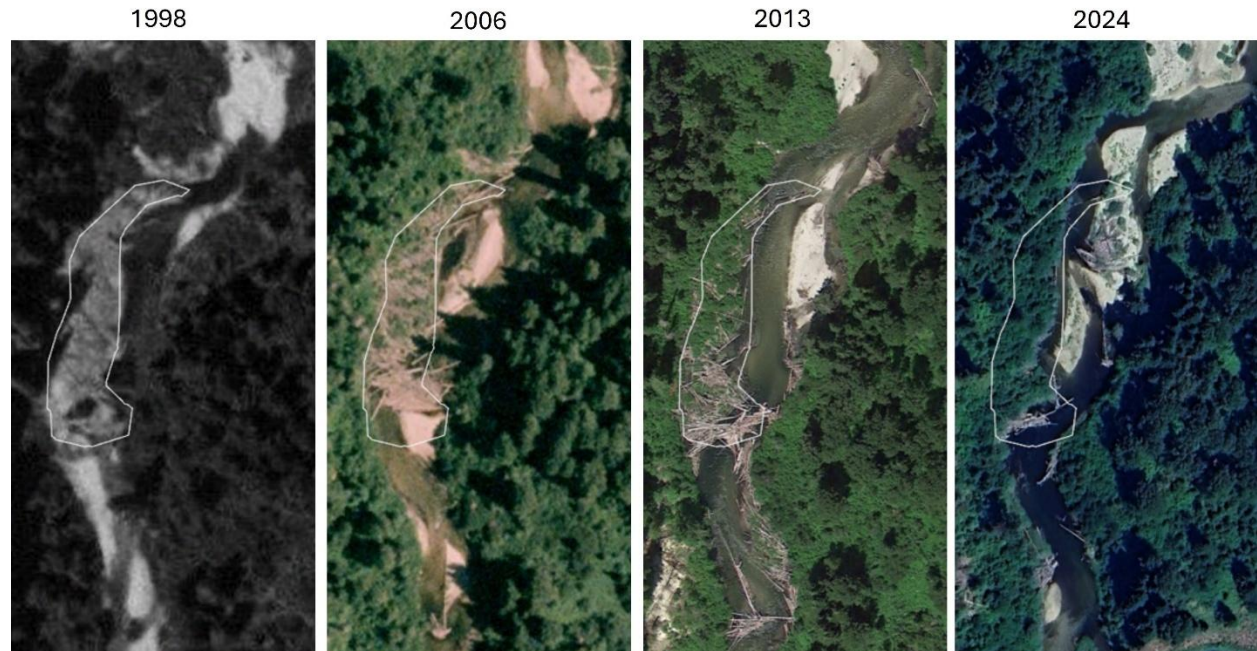
The most complex area of Reach 3, however, is from RM 1.9 to 2.3. The highly complex section with abundant large wood was the location of a prior channel-spanning log jam that was documented in the 2011 Lower Nason Reach Assessment (USBR 2011). Based on the reach assessment and older aerial photos, the channel-spanning jam was likely present from at least 1998 to 2013. Much of the wood from the jam on river-left has been colonized by vegetation and has essentially been incorporated into the left-bank as the channel has shifted right over the years (Figure 55). This demonstrates an important function that large wood can provide in the system; not only providing instream habitat complexity but also serving as substrate for new vegetation growth and comprising

Figure 55. Evolution of channel-spanning log jam near RM 2. Photos series obtained from Google Earth imagery.

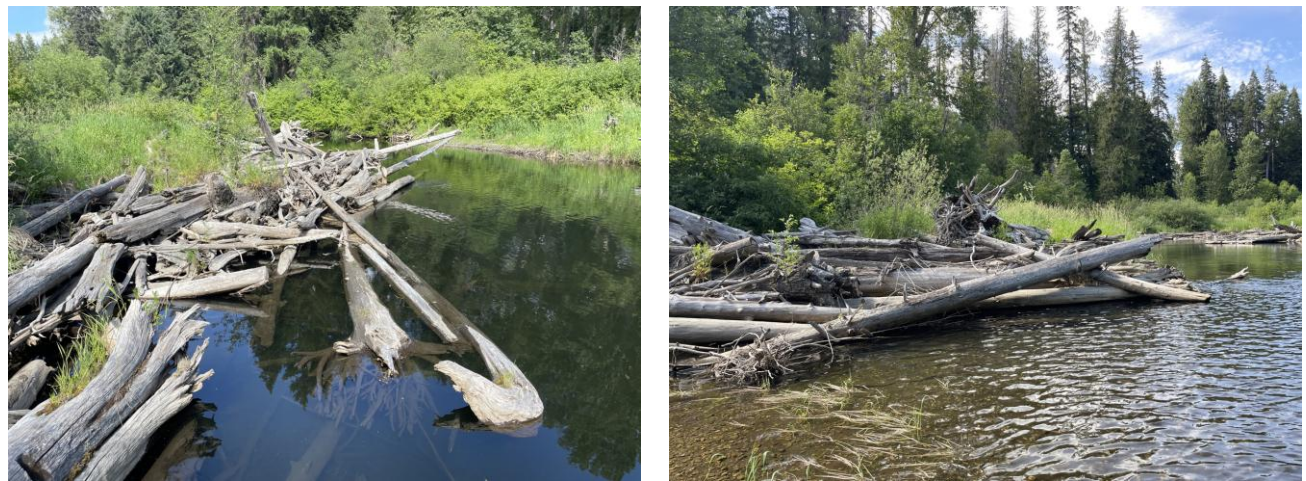
a portion of the streambank and floodplain structure. Photos of the remnants of the jam from the early July 2025 field survey are included in Figure 56 and Figure 57.

Figure 56. Jam on left-bank near RM 2.05 at location of older channel-spanning jam. **Figure 57. Large wood jam at RM 2.1.**

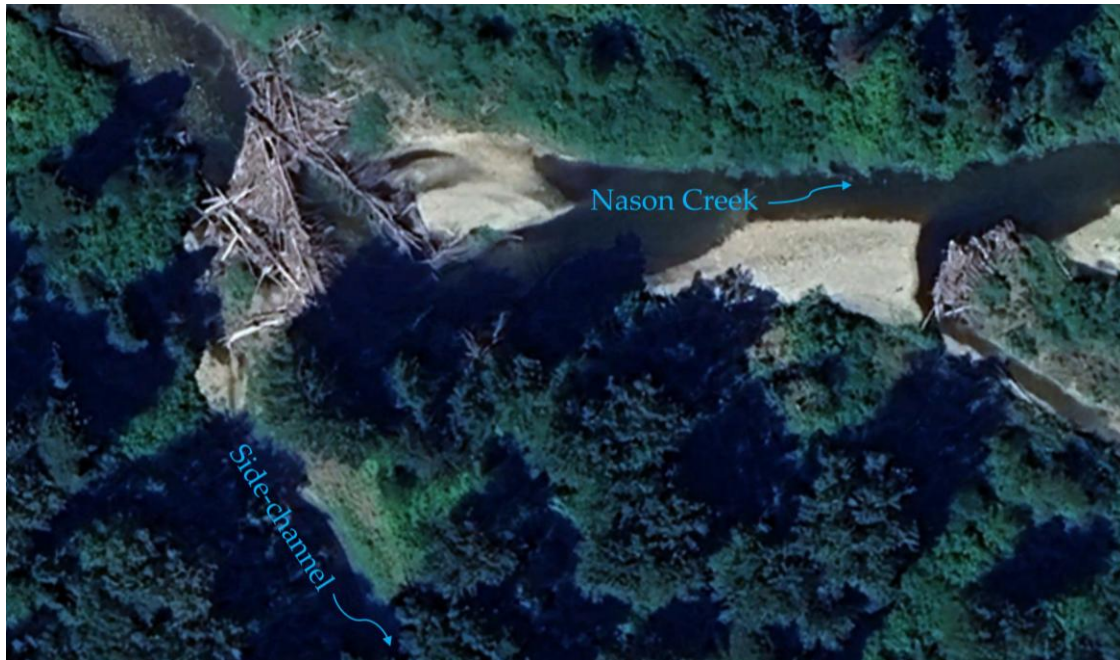
Just upstream of this, at RM 2.25, there was a channel-spanning jam at the time of the early July 2025 survey (Figure 58, and photo of jam in Figure 65). A river-left jam was constructed here as part of the 2018 side-channel project, which then collected more wood to become channel-spanning. It is now providing significant influence on the channel and is helping to maintain activation of the constructed/enhanced river-right side-channel. This jam, combined with another constructed jam just downstream, constitutes a significant portion of the total wood count for this reach.

Figure 58. Channel-spanning jam (partly constructed) at RM 2.25 and constructed apex jam downstream. Spanning jam is helping to keep the river-right side-channel active (Google Earth 2024 image).

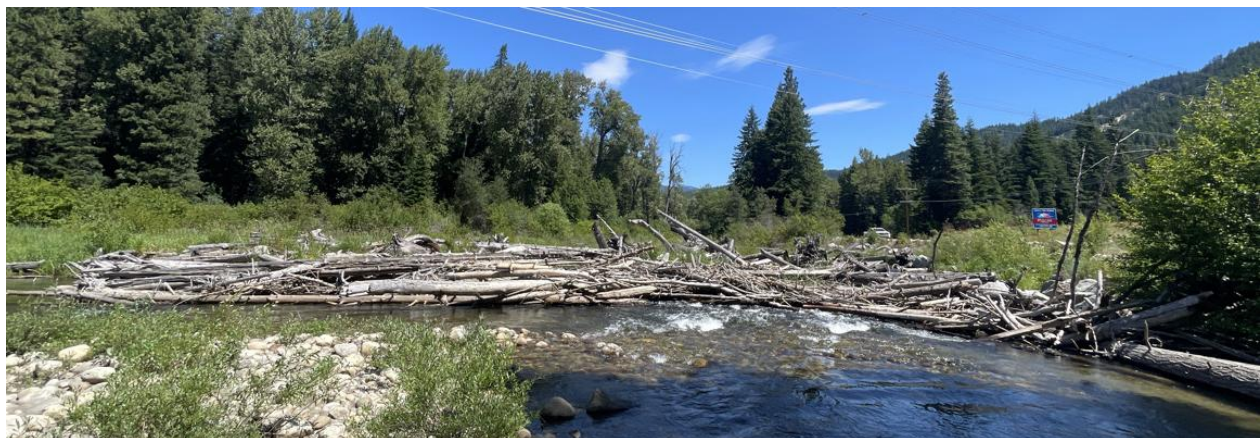
The other area of high wood complexity is in Reach 4 at the top end of the river-right side-channel near RM 4.1 (Figure 59). Abundant wood carries through the top half of this side-channel (Figure 60). Apart from these and some other localized areas with wood, most of Segment 2 is lacking in large wood, and where it does exist, it is not providing significant geomorphic influence on the channel. In addition, recruitment processes are impaired in Reach 4 due to the channel cutoffs and bank armoring described previously. One of the largest stands of mature trees is located in the cutoff portion of floodplain east of the highway near RM 3.5 (see Vegetation section below and Figure 63). The riparian vegetation is also very young or absent in many locations, so even if recruitment processes (e.g. lateral migration) are intact, there are not trees of adequate size to serve as key pieces in the main channel. Young or absent woody riparian vegetation is especially concentrated in sections abutting the highway and within private lands.

Figure 59. Log jam at entrance to river-right side-channel complex near RM 4.1.

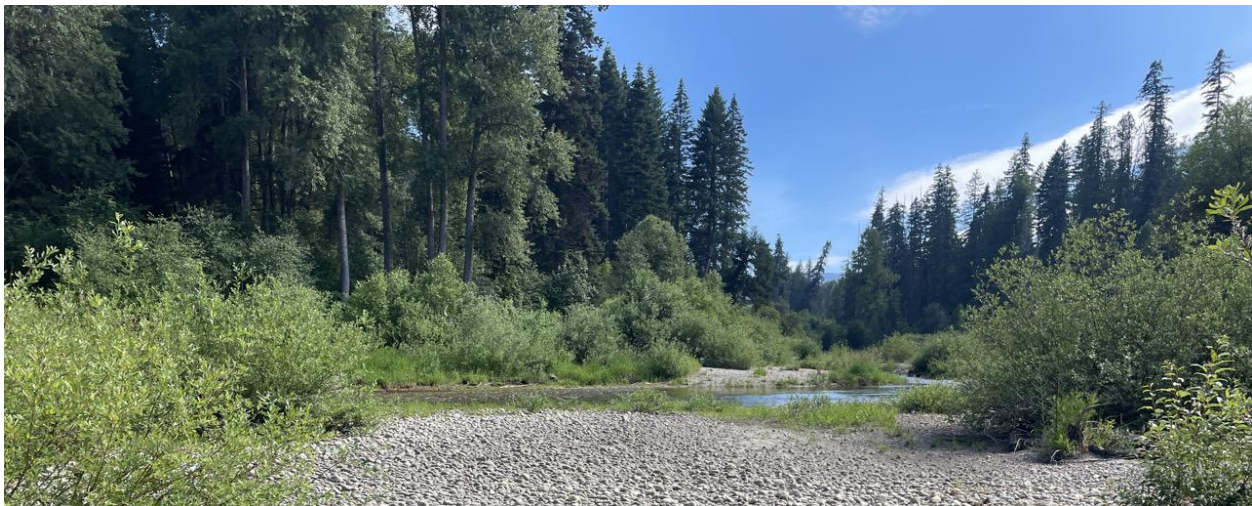
Vegetation types in Segment 2 are similar to Segment 1, with cottonwood, fir, and cedar in the overstory and cottonwood, dogwood, alder, and willow dominating the understory (Figure 61). Understory areas along channel banks also have lesser amounts of spirea, rose, and hawthorn. There is abundant reed canary grass on low surfaces within and just above the active channel margin. Knapweed was observed on gravel bars in a few locations. Vegetation is frequently young in a narrow band along the channel, with a variety of forest types and ages deeper into the floodplain (Figure 63). There are stands with trees over 150 feet tall in a few locations, including at the downstream end of Reach 3 from RM 1.5 to 2.1, in the river-left floodplain from RM 3.1 to 3.4, and in a few other scattered locations upstream. One of the largest stands of large trees is located in the disconnected floodplain across the highway at RM 3.5. Many locations along the left-bank (west side) have experienced timber harvest with sometimes narrow riparian buffers. These areas are also where the stream abuts the steeper west hillslope (Chumstick Formation bedrock), where the vegetation tends to be comprised of drier, more upland species with the overstory dominated by ponderosa pine (Figure 62). In these areas, the left bank of the channel is dominated by shrubs and is less vegetated than the right bank. There are a few other areas where riparian and floodplain clearing has occurred, including along private properties on river-right from RM 2.4 to 3 and within the BPA powerline crossing at RM 4.1, where a 300+-ft swath of riparian zone is routinely cleared.

Figure 61. This photo captures the typical variety of riparian vegetation in the lower end of Reach 3 and in other areas of the segment. This photo is a view upstream near RM 1.9.

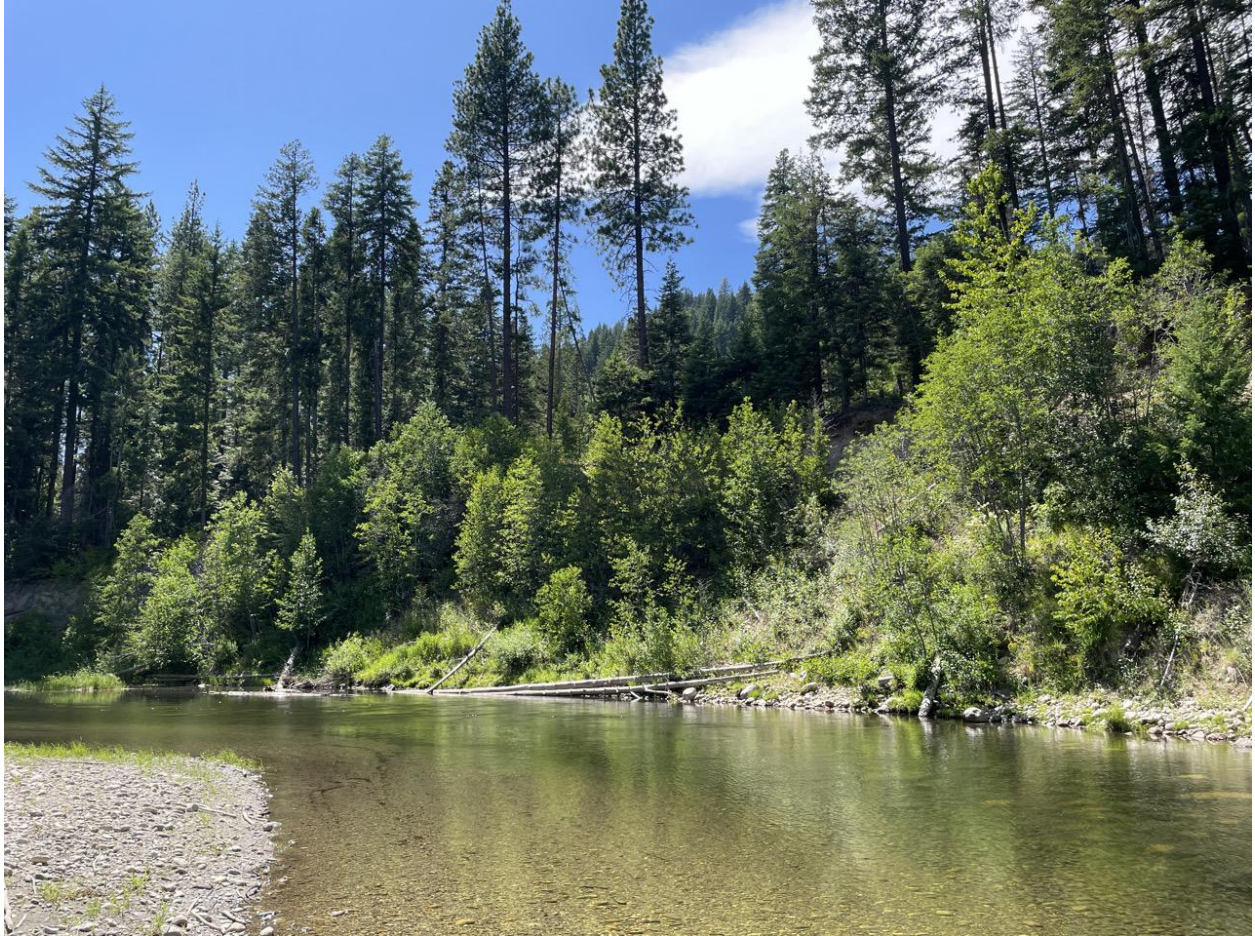
Figure 62. View upstream at RM 2.8 of drier, more upland forest affected by past harvest.

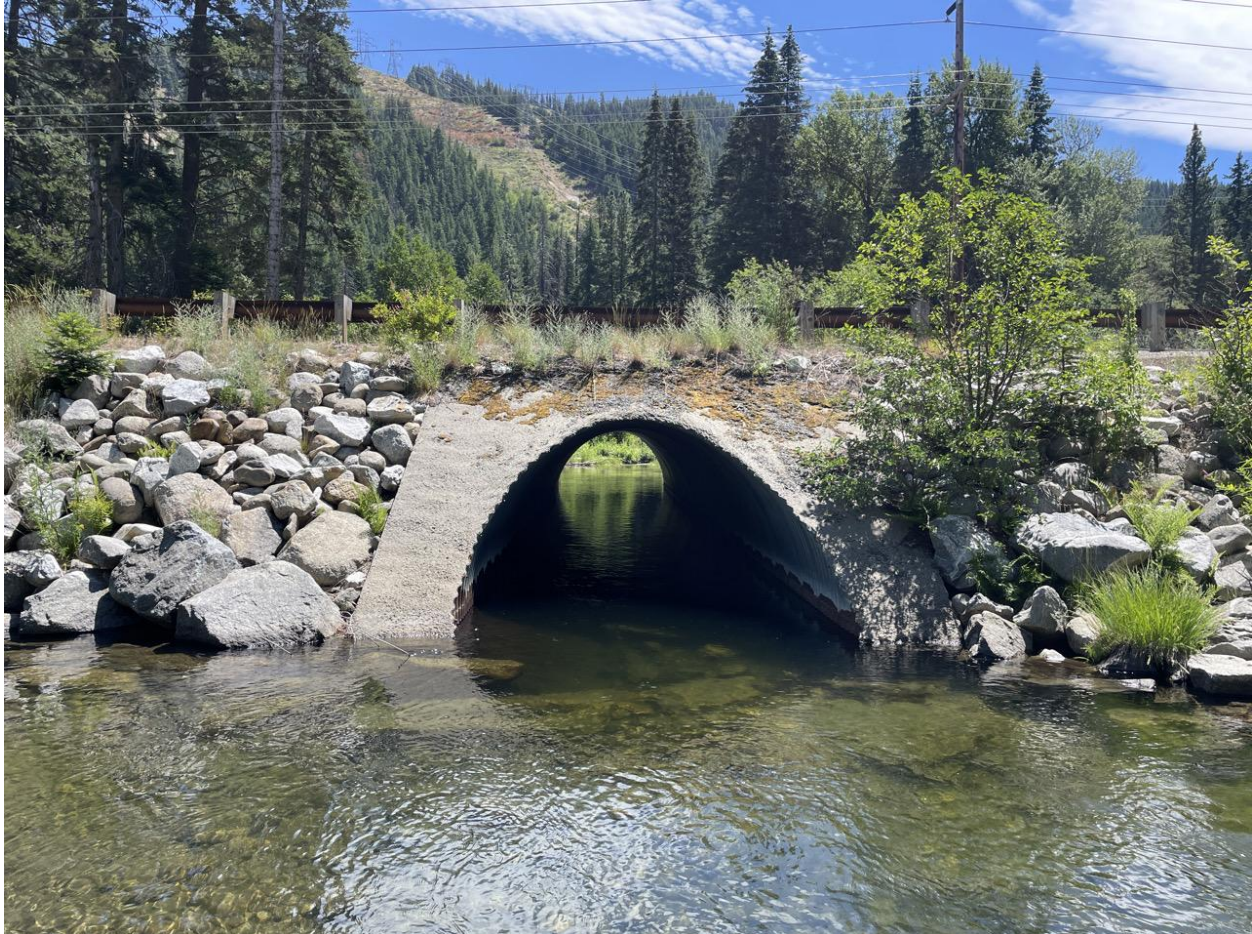
In 2008, the Nason Oxbow Reconnection Project (Chelan County) was constructed from RM 3.4 to 3.7 and included improvement of fish access to the historical “oxbow” channel via culverts through State Route 207 and placement of large wood habitat (Figure 64). At the time of the early July 2025 field survey, there was good connectivity through the culvert connections.

Figure 64. View of culvert under State Route 207 near RM 3.75 (inlet to reconnected ‘oxbow’ side-channel).

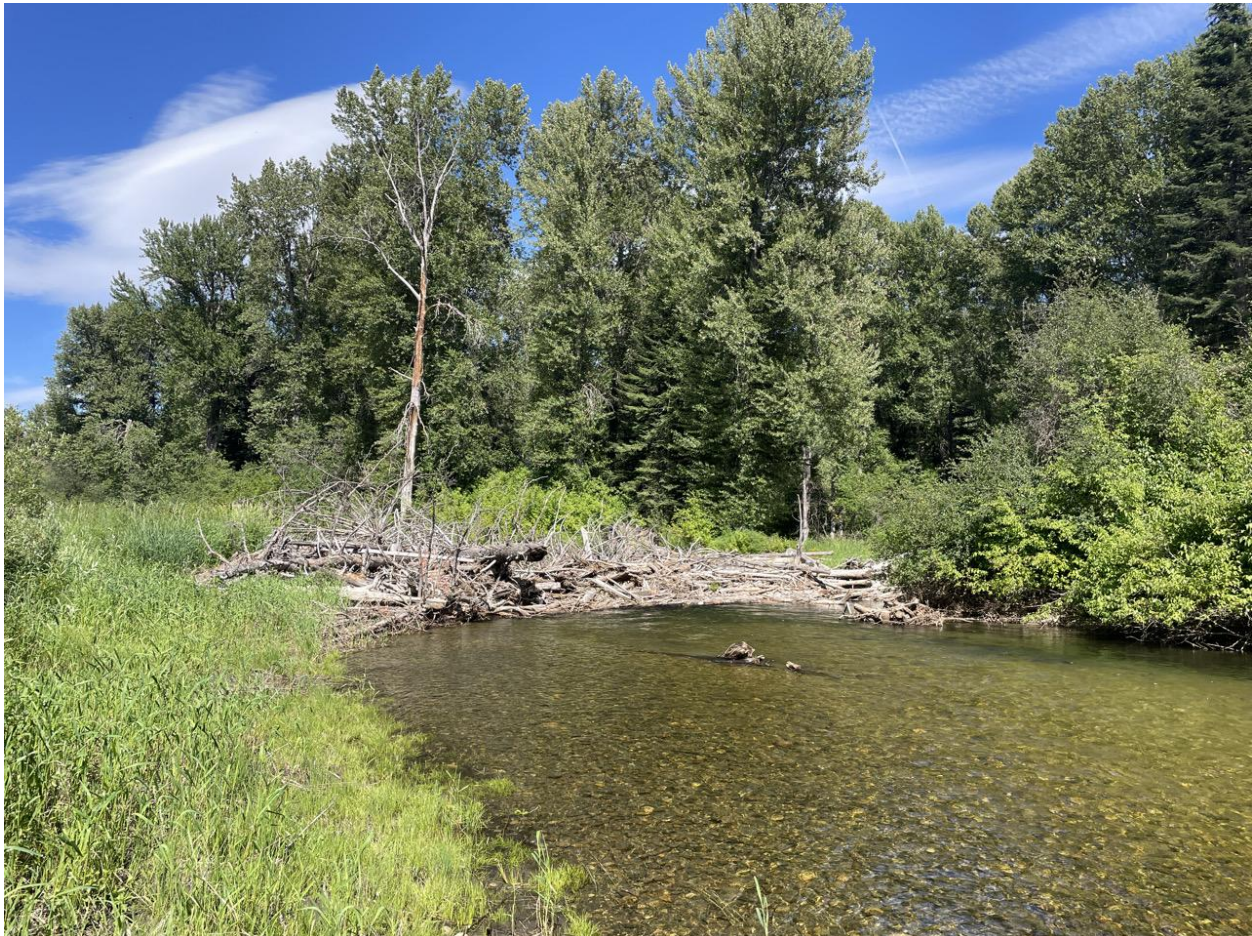
across from the side-channel inlet and subsequently racked wood and at the time of the early July 2025 field survey was a channel-spanning jam helping to keep the side-channel open, creating a deep and complex mainstem pool, and providing gravel sorting. This is currently a highly complex section of channel (Figure 65).

Figure 65. Channel-spanning jam at RM 2.25. Aerial photos suggest that this Jam was originally constructed as a left-bank jam that collected additional wood and became channel-spanning. The jam is very effective at keeping the right-bank side-channel active. The inlet is at the right side of the jam in the photo (Inter-Fluve photo July 2025).

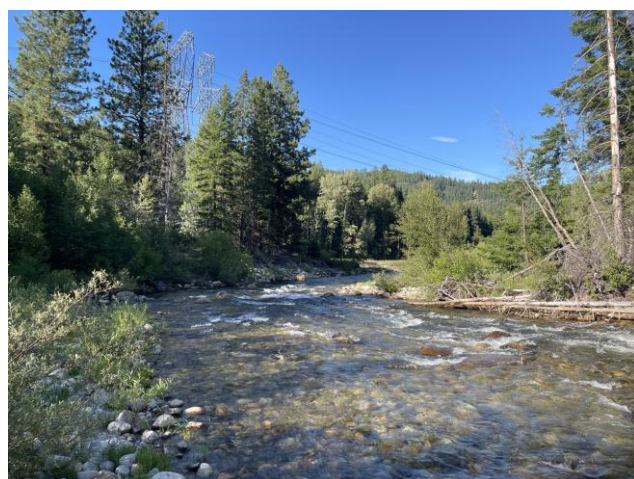
Figure 67. View downstream approaching bend with powerline crossing near RM 6 (Inter-Fluve photo July 2025).

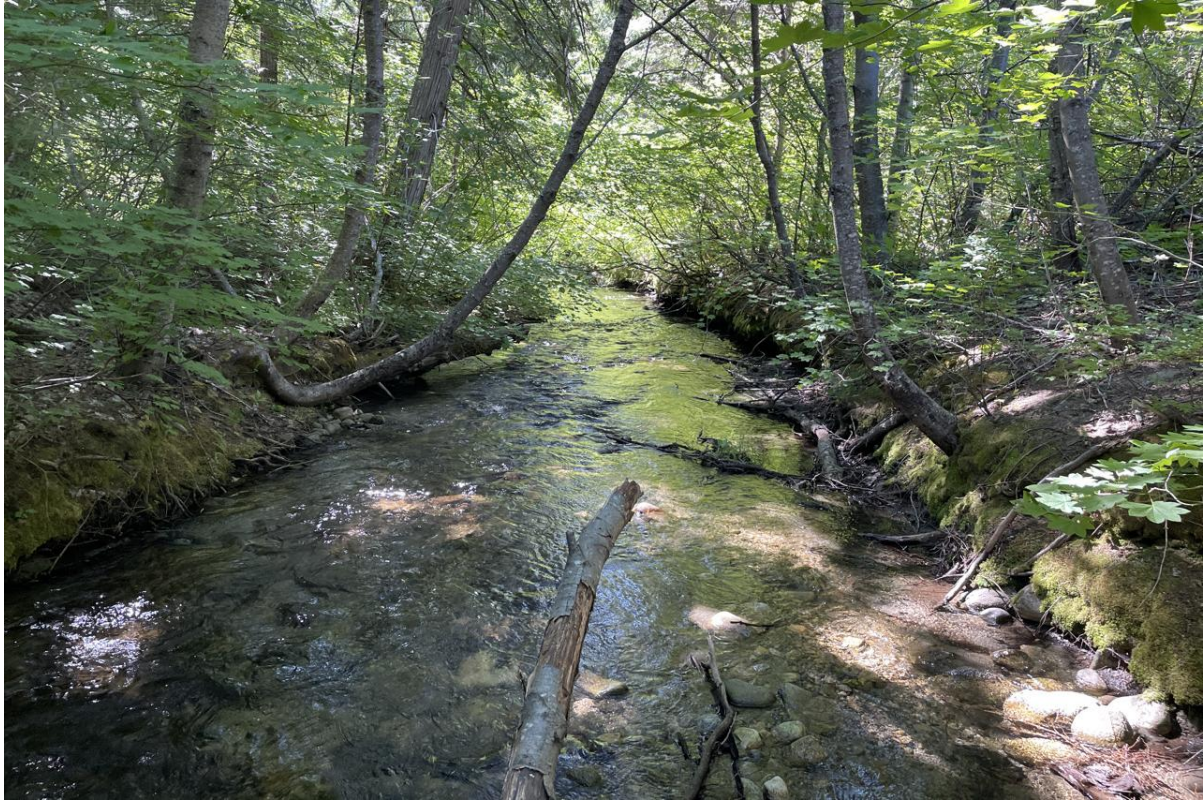
Figure 69. Upstream end of river-left side-channel in Reach 5 near RM 4.9 (Inter-Fluve photo July 2005).

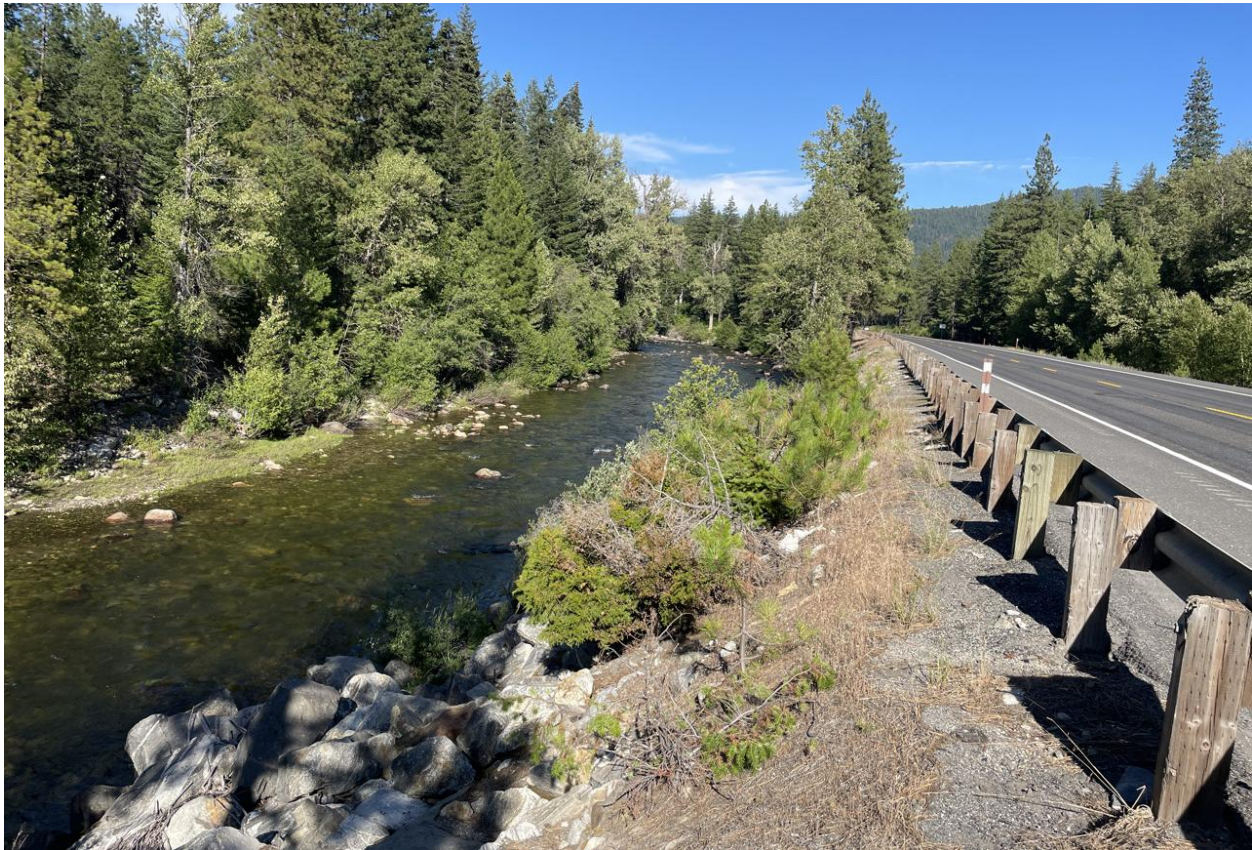
Figure 72. View downstream near RM 6.3.

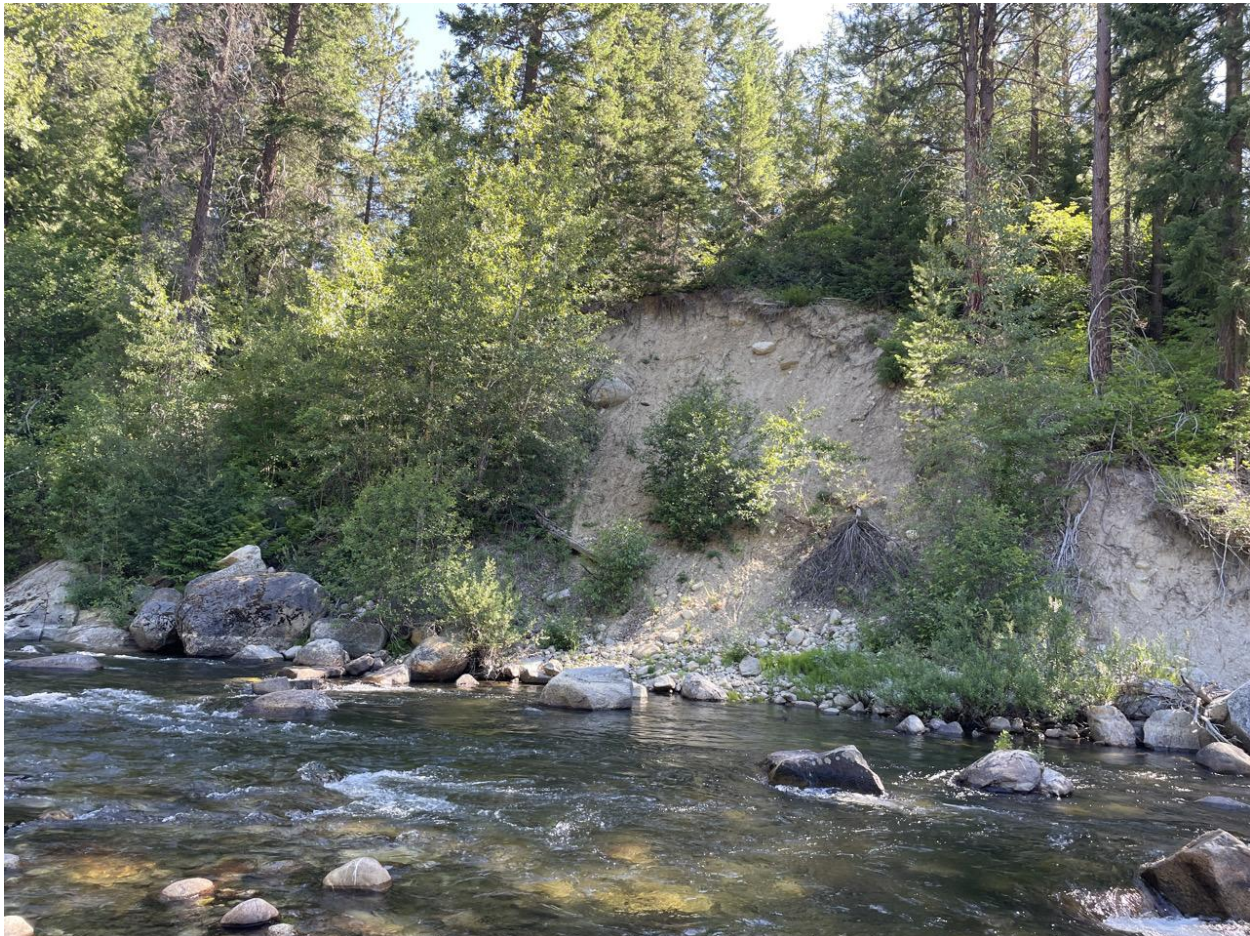
Figure 75. View of river-left bank near RM 5.0 where the channel is eroding into glacial deposits (Inter-Fluve photo July 2025).
