Lower & Middle Nason Creek Reach Assessment & Restoration Strategy Update *Final Report*

JANUARY 2026

PREPARED FOR
Yakama Nation Fisheries

PREPARED BY
Inter-Fluve

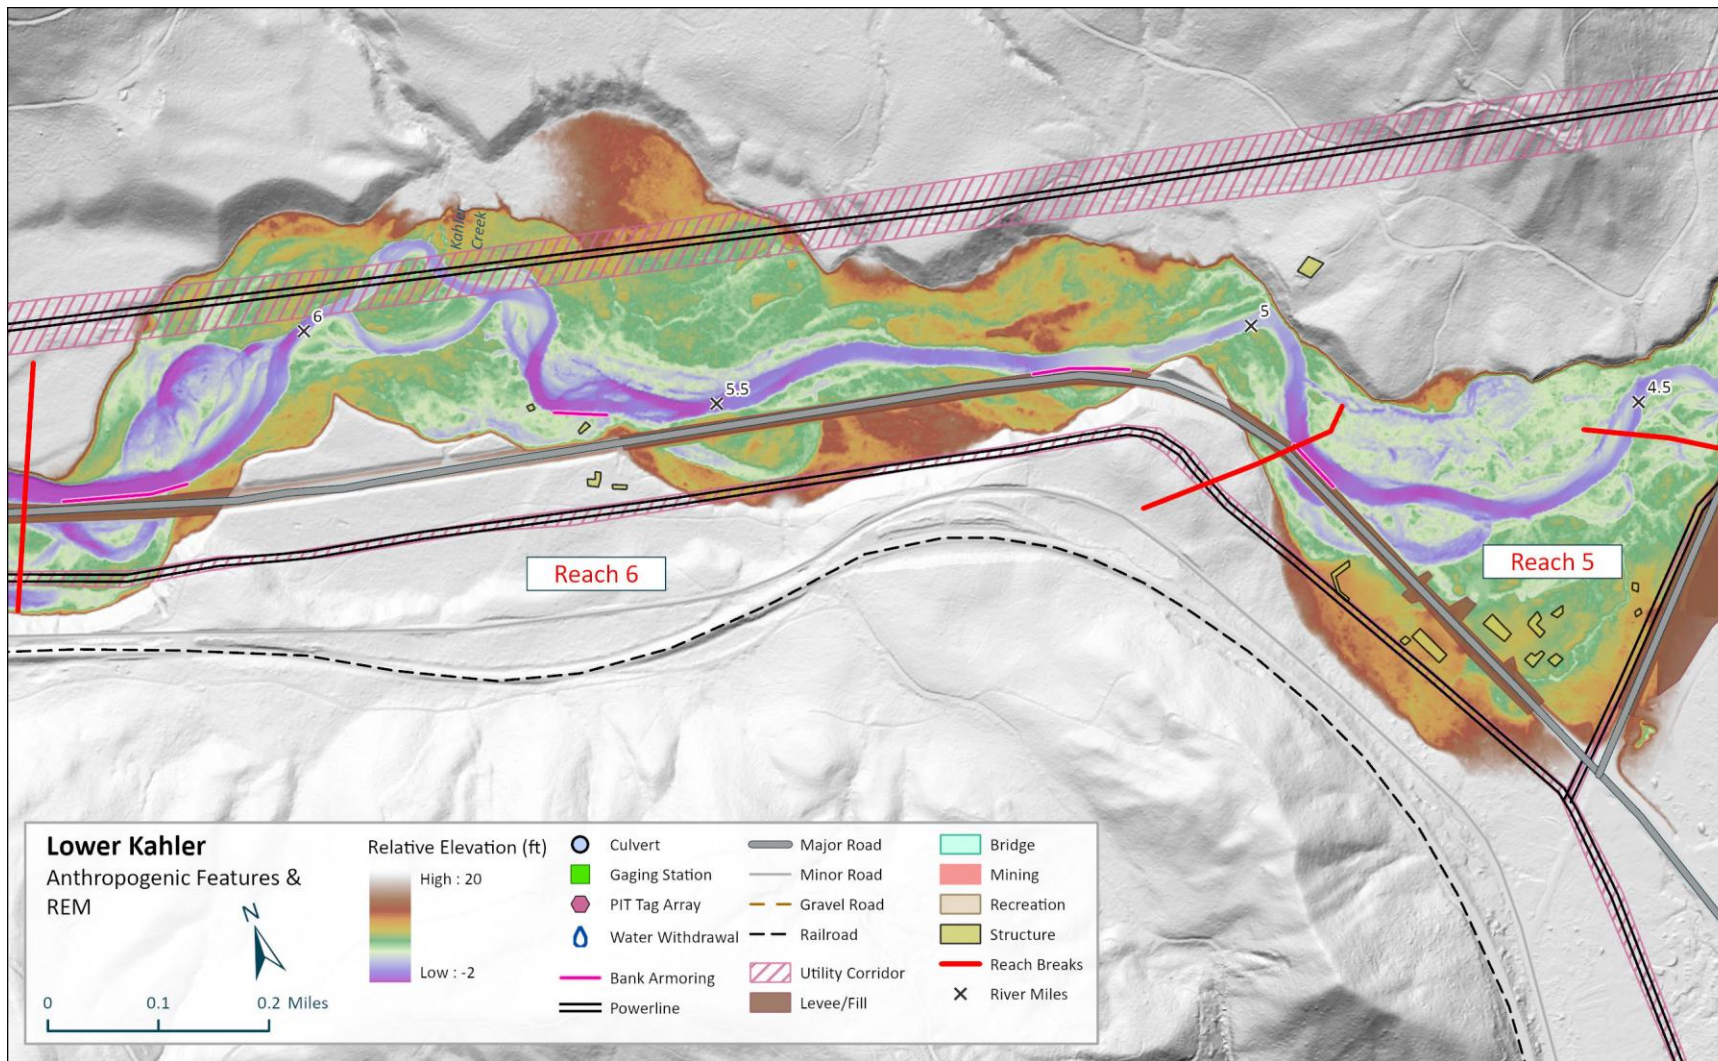
areas. The greatest disconnected zone is at the upstream end of the segment in Reach 6, where an approximately 1,000 ft section of channel (spanning reaches 6 and 7) was cut off (Figure 76). This relocation resulted in the current channel being artificially confined between the highway embankment and a glacial terrace to the north. This has resulted in confinement of the channel to essentially one channel-width wide. The bed of the channel also appears to be significantly lower than the historical channel. LiDAR analysis indicates that the current channel could be greater than 5 feet lower than the historical channel, which may have occurred at the time of highway construction and/or from channel incision over time in what is now a very high energy section of channel (Figure 78). Other points of disconnection due to the highway occurred at RMs 5.5, 5.2, and 4.8. These sections now lie adjacent to the highway embankment, with riprap armoring (Figure 72). The BPA powerline corridor crossing also has an impact on floodplain and channel migration zone connectivity, with transmission towers located within the river-left floodplain near RM 5.95 and RM 5.85 (see Figure 83). The other major impact has been the development and fill around Coles Corner, which has disconnected a portion of the south floodplain in Reach 5. There are also other areas of floodplain fill of unknown origin. Several of these are scattered in the river-left and river-right floodplain near RM 4.7 in Reach 5 (Figure 73). These are now forested and on National Forest land. Modeling shows that the disconnections due to Highway 2 have the largest reductions in floodplain inundation, followed by fill at Coles Corner and then what is likely incision related to highway disconnections (Figure 77 and Figure 78).

Figure 76. Mapped anthropogenic features and relative elevation map for Segment 3.

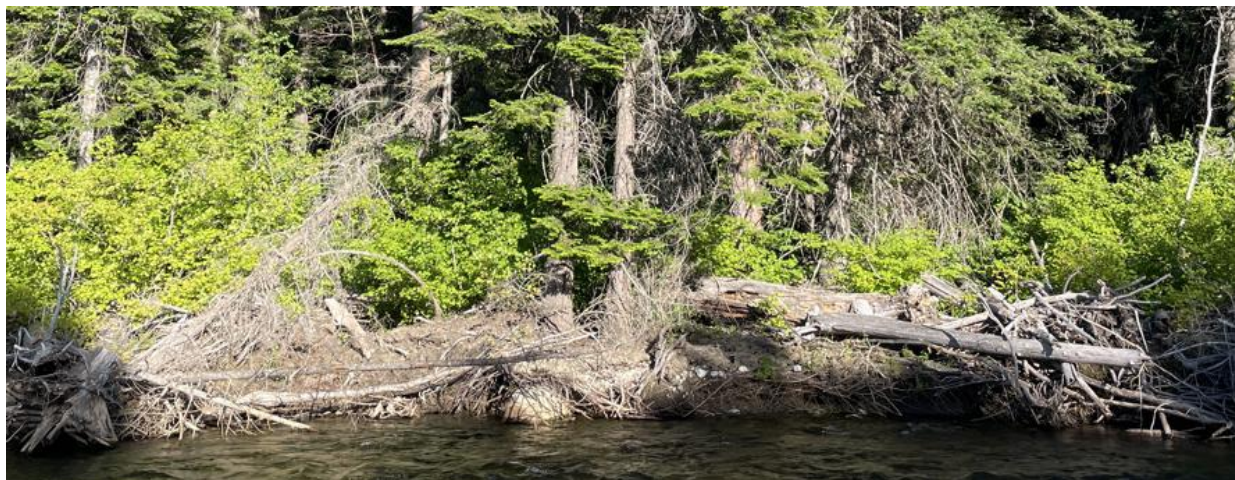
Large wood processes are impaired in this segment. Piece numbers are very low and do not meet standards (see REI, Section 5). Recruitment and retention processes are also impaired due to past channel manipulations and young or absent woody vegetation. There is very little wood in Reach 5 and none of it is providing any significant geomorphic influence on the channel. Much of the wood in this reach is associated with the river-left side-channel that runs through most of this reach. Reach 6 has slightly more wood than Reach 5 but still very little, and the wood that does exist is not proving much geomorphic function. It often consists of single pieces or small jams that are along the banks, outside of the active channel, or located in off-channel areas (Figure 79 and Figure 80).

Figure 79. Small log jams tight against bank on river-left near RM 5.8.

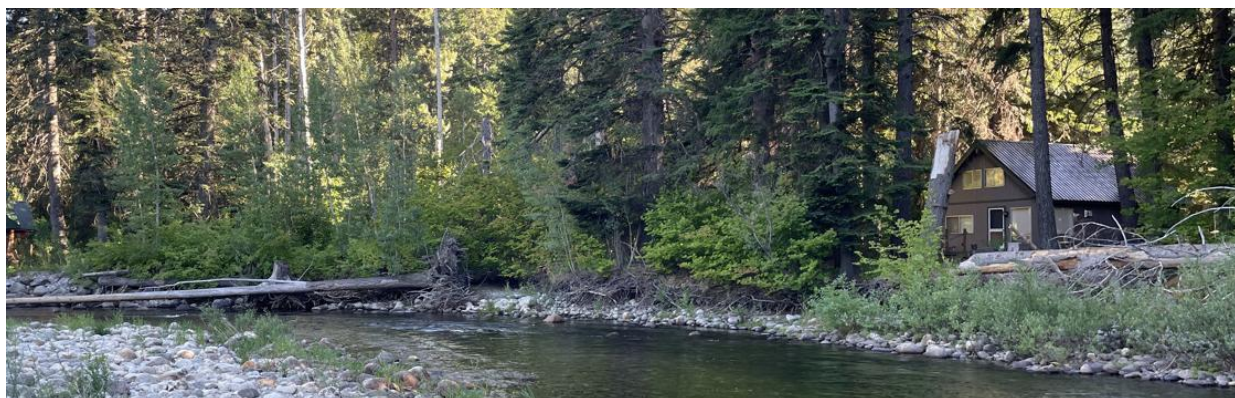
Figure 80. View downstream near RM 5.65. Single large wood pieces can be seen downstream along bank and one piece on the right extending above the channel.

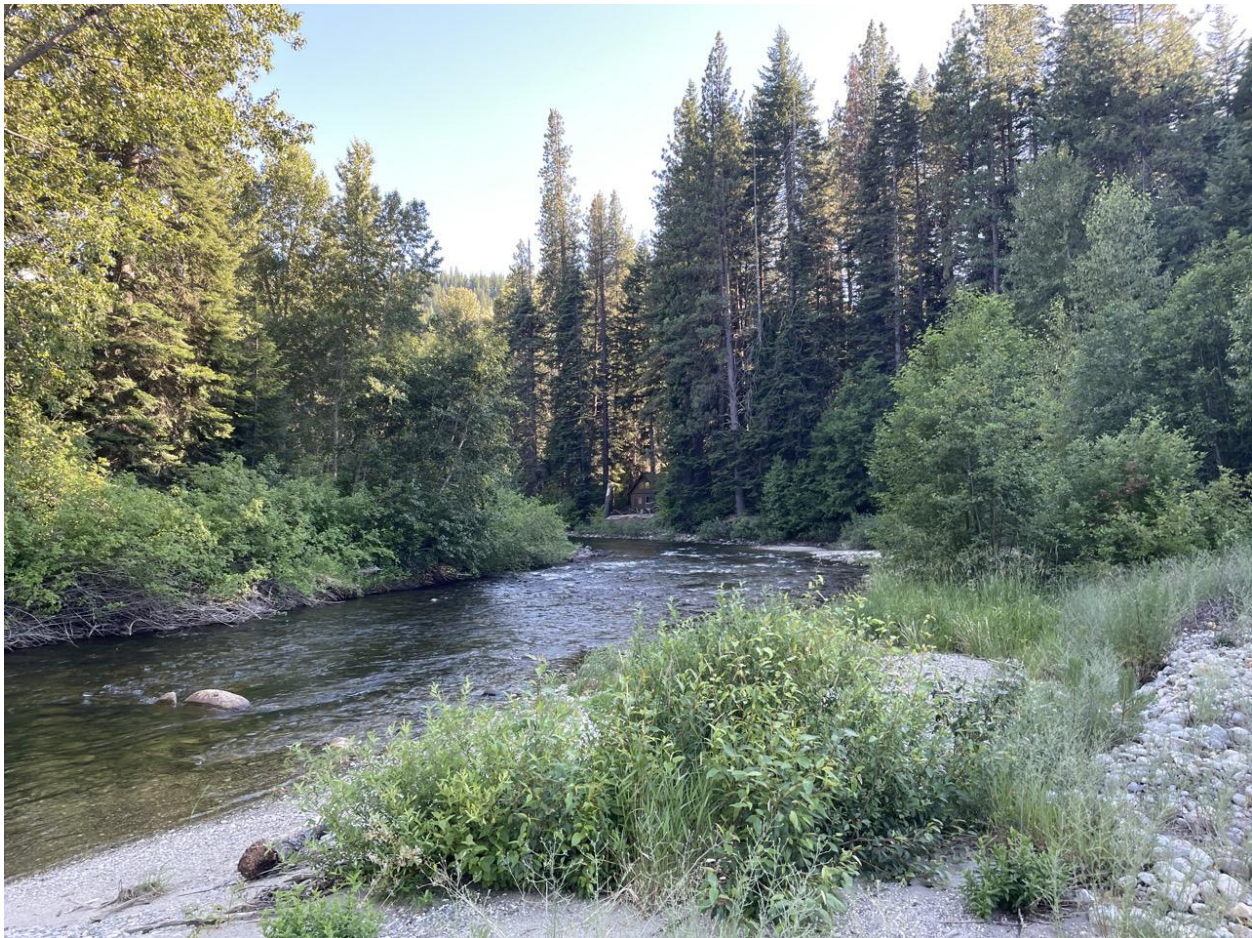
Figure 82. Large pine and fir on river-right. View is looking downstream from RM 5.7.

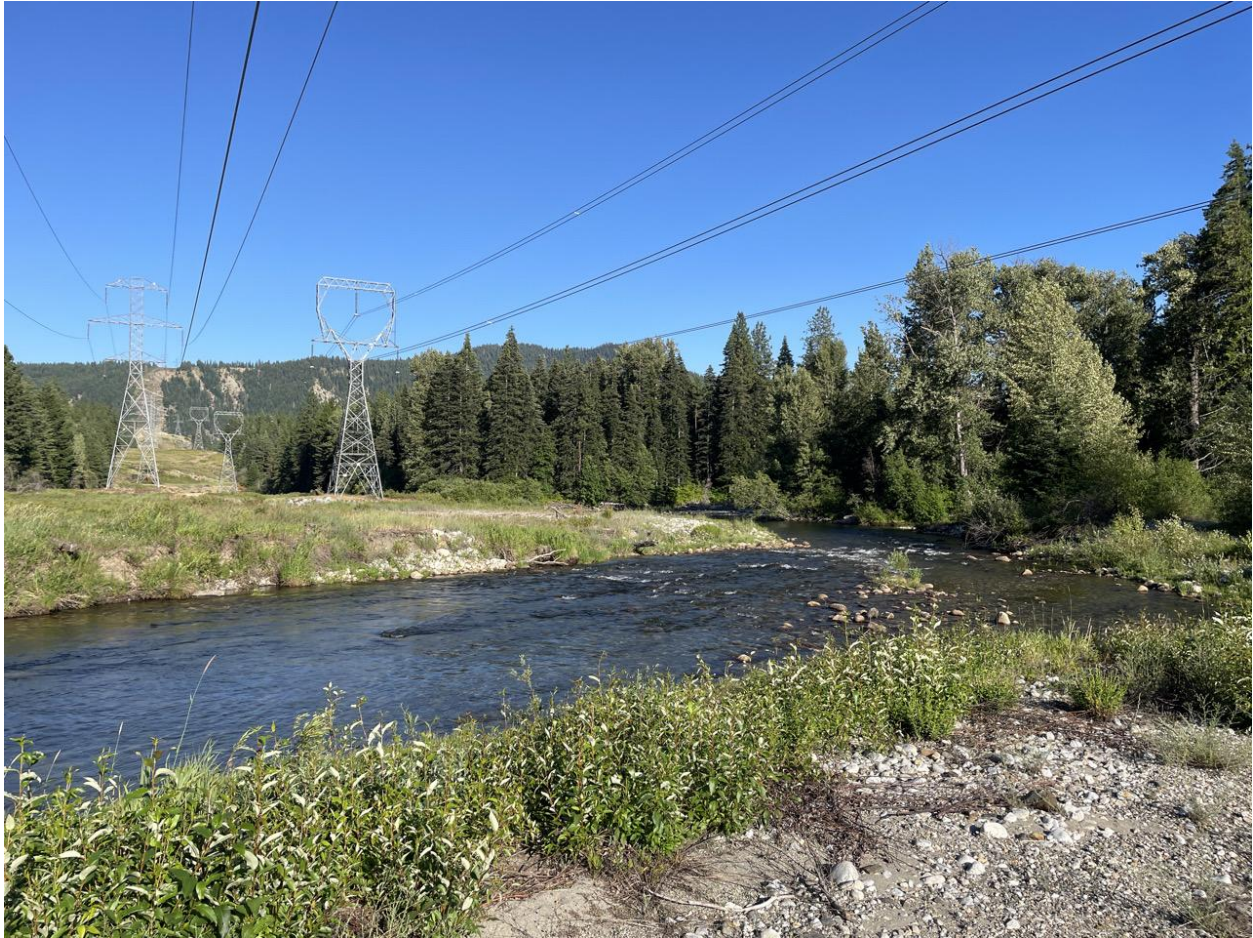
Figure 83. View looking downstream near RM 5.9 at area of channel with denuded riparian vegetation within the BPA powerline corridor (Inter-Fluve photo July 2025).

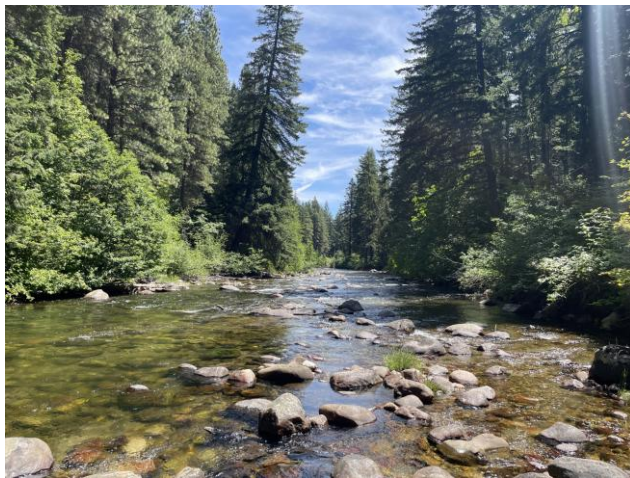
Figure 86. View downstream near RM 8.7 (Reach 9) where the channel is naturally confined, steeper than up- and downstream reaches, and boulder-bed (Inter-Fluve photo July 2025).

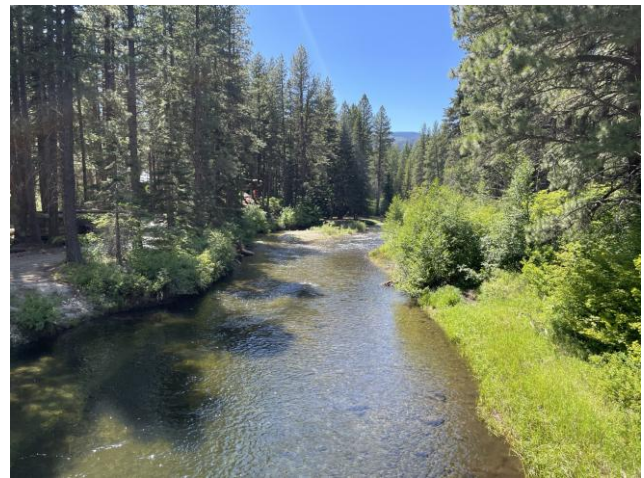
Figure 87. View upstream from the Butcher Creek Rd bridge at RM 7.9. Residential impacts can be seen to the left. Low surfaces are dominated by reed canary grass (Inter-Fluve photo July 2025).

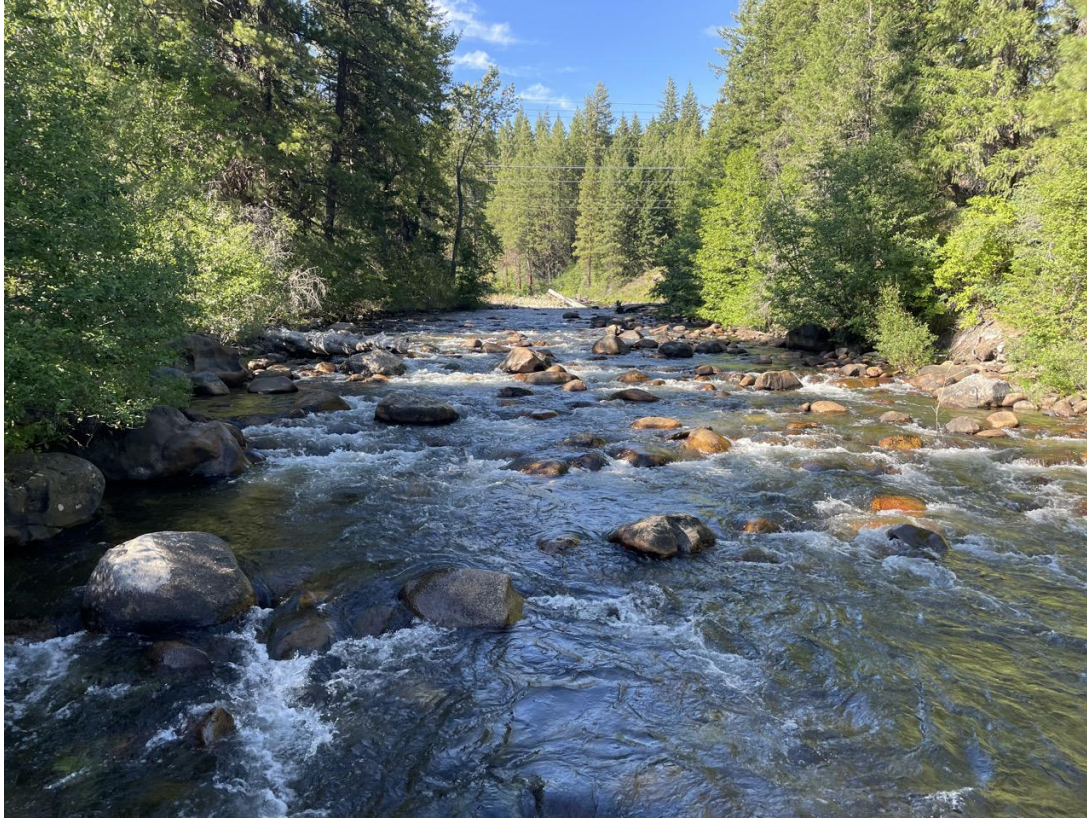
Figure 88. View upstream at steep boulder-bed channel looking upstream toward powerline crossing at RM 6.5 (Inter-Fluve photo July 2025).

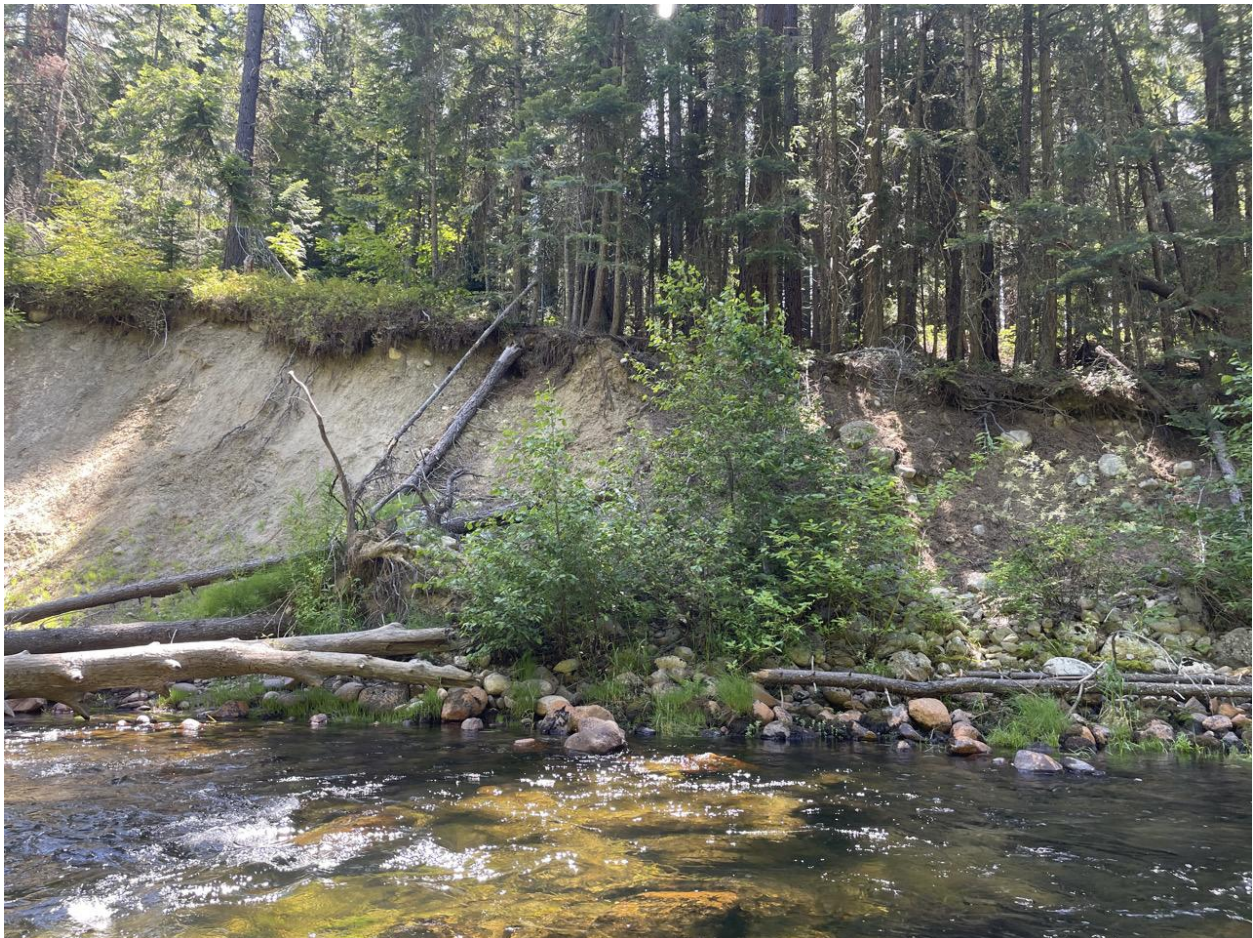
Figure 92. Boulders sourced from river-right bank near RM 8.8.

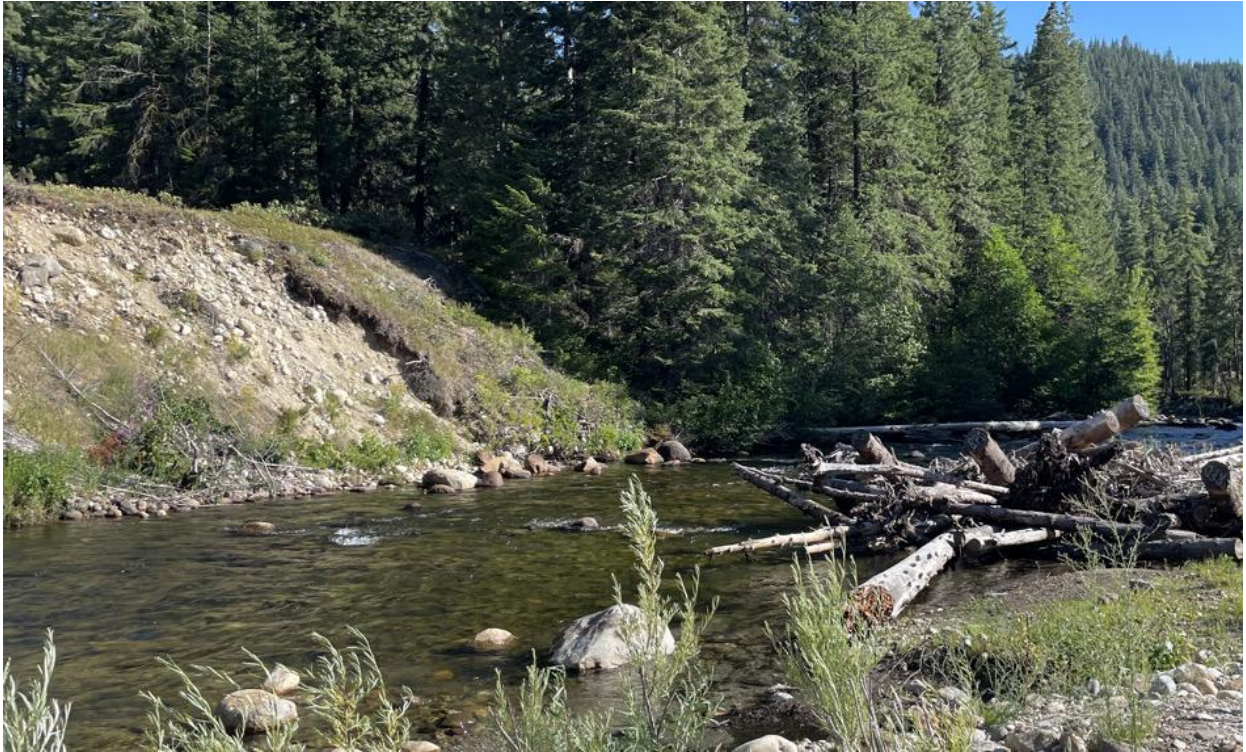
Figure 93. View downstream near RM 6.5 where the river is eroding into glacial deposits on the river-left bank.

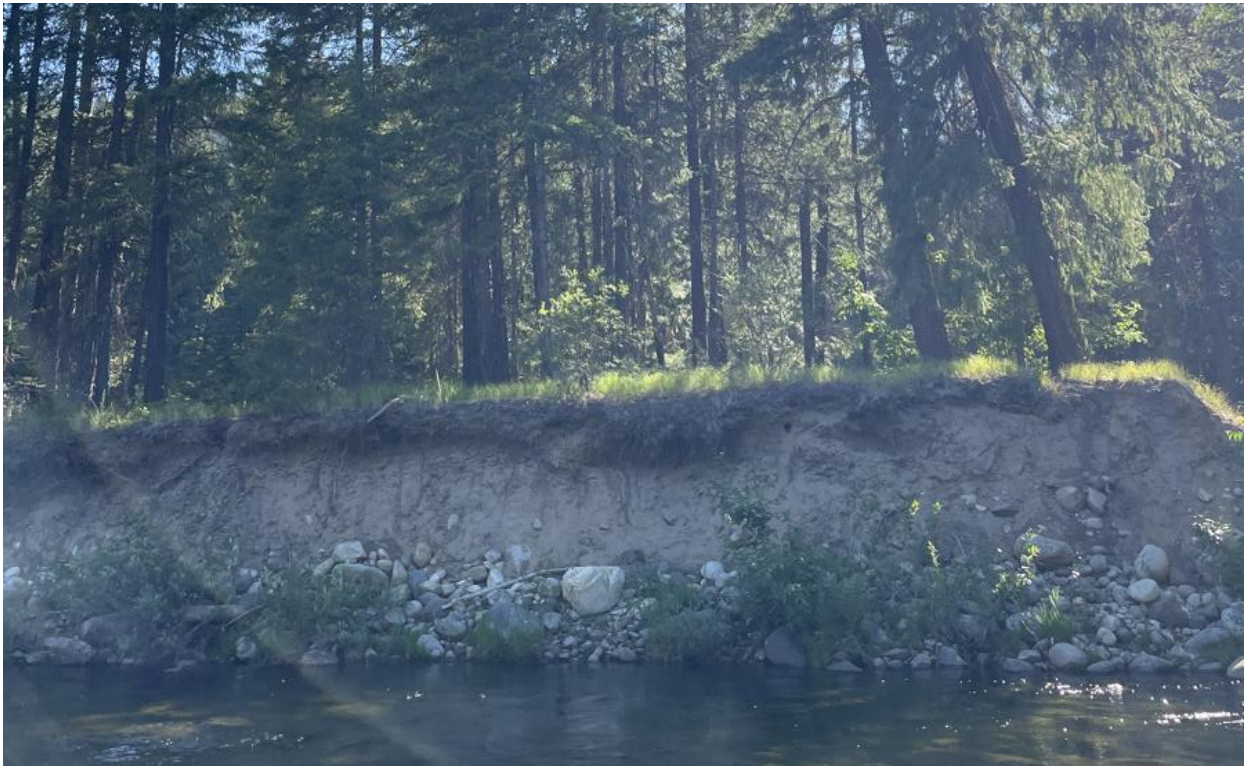
Figure 94. Bank material being recruited on river-right bank near RM 6.4.

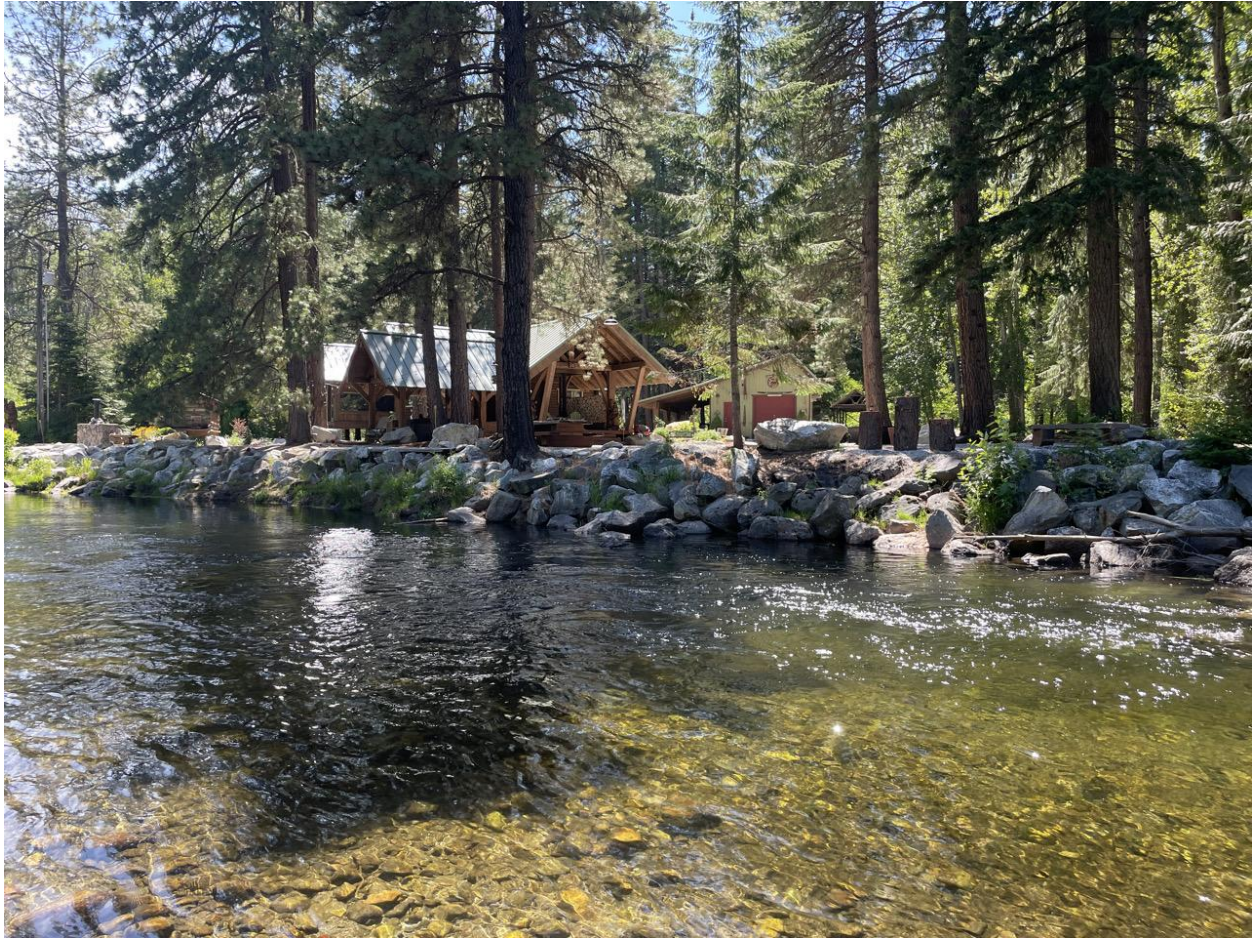
Figure 95. Bank armoring on river-right bank near RM 7.65.

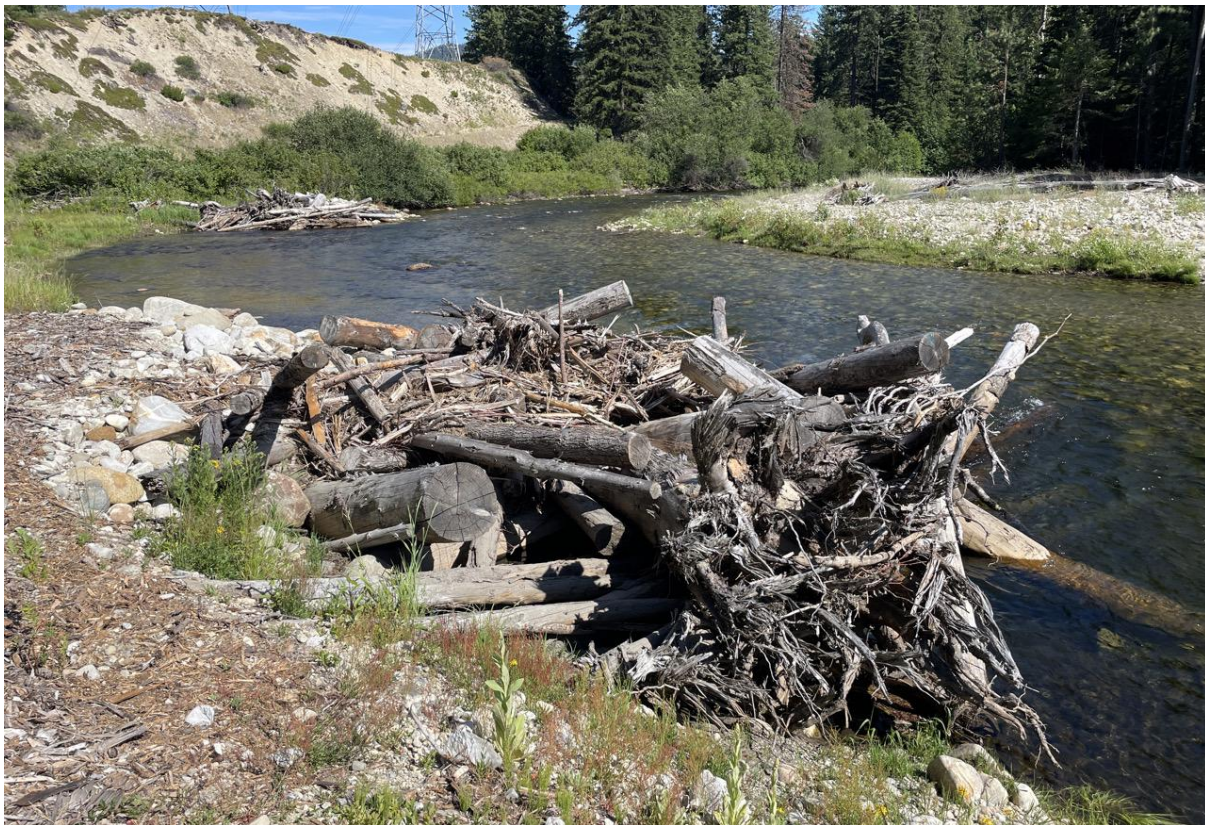
Most of the wood in Reach 7 is located from RM 6.4 – 7.2 and is concentrated in jams placed as part of restoration project work (Figure 99). These jams are relatively new and are providing some geomorphic functions including flow-splitting, pool scour, and sediment sorting/capture. Other, non-placed, wood is fairly scarce in the reach and is not providing any significant geomorphic influence. The total piece count for medium and large pieces in Reach 7 is 244; however, without the placed wood, there would only be 36 pieces, well below the standard of 67 pieces per mile. In Reach 8, nearly all the wood is placed wood, with only 10 of the 73 medium or large pieces being natural, and none of these are providing any significant geomorphic influence on the channel. Reach 9 has low wood overall. The wood that does exist is not providing strong geomorphic influence on the channel and is mostly along the banks (Figure 100) or in backbar channels.

Figure 99. Constructed large wood structures near RM 7.1.

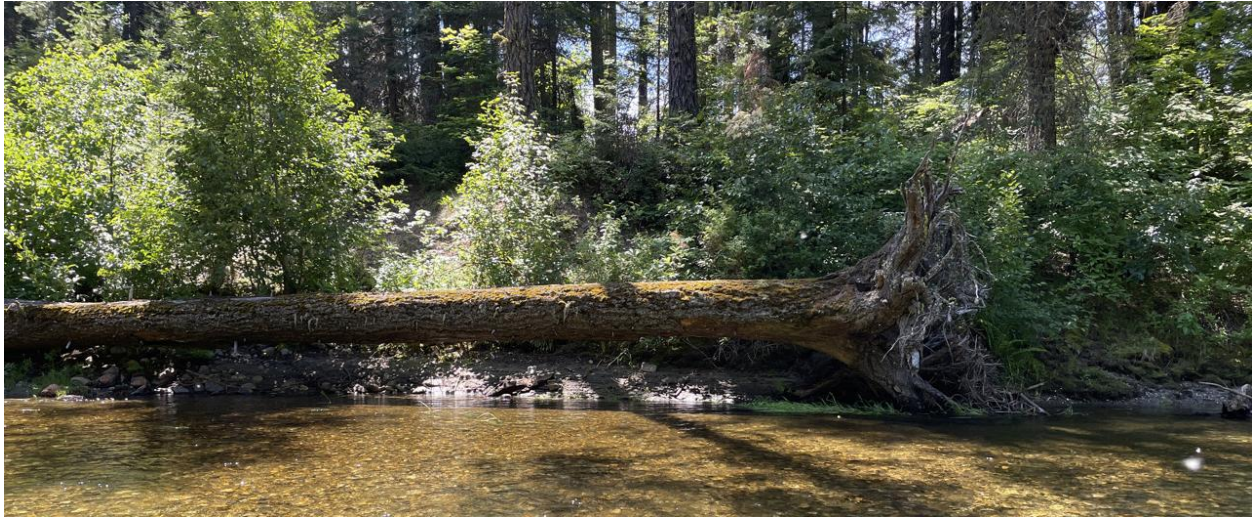
Figure 100. Wood along bank near RM 8.9.

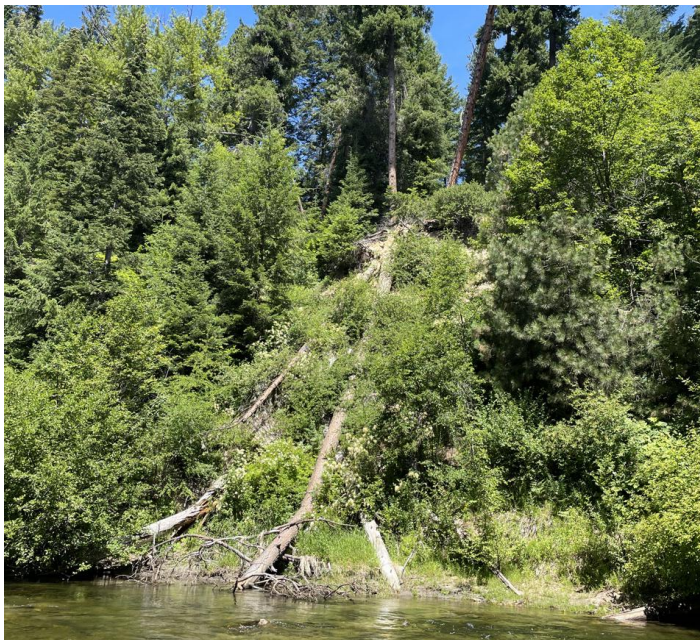
Figure 101. View of left bank near RM 8.7. Wood recruitment from mass wasting.

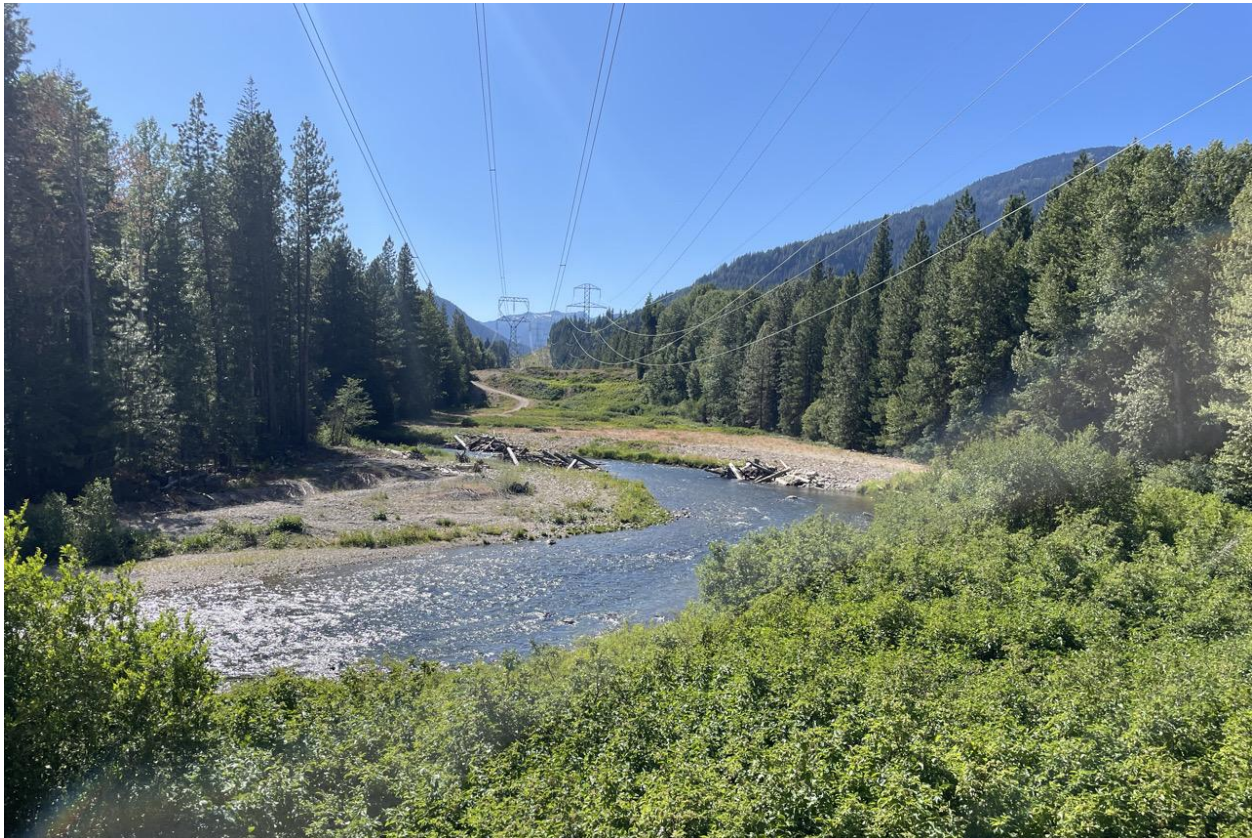
Vegetation in Segment 4 is similar to Segment 3, especially given the similar impacts from the powerline crossing (Figure 103). However, there are fewer areas of large trees >150 ft tall and more areas of riparian clearing, possibly due to more private landownership. As in downstream areas, the overstory tends to be dominated by a combination of cottonwood, fir, and ponderosa pine, but there is less cedar in this segment. The understory is typically comprised of young cottonwood, alder, willow, maple, and dogwood, with lesser amounts of hawthorn, spirea, Pacific ninebark, rose, Oregon grape, and possibly cascara. The entire segment has been impacted by past harvest of riparian and floodplain trees. Apart from the highway and powerlines, recent riparian clearing has occurred in a few locations related to residential uses and other forest management. Clearing has occurred associated with homes from RM 7.5 to 8.5. The floodplain across the bend on river-left between RM 6.8 to 6.9 is sparsely vegetated, with widely-spaced pines (Figure 104). This is common in a few other areas, and may be related to drier conditions on higher glacial outwash surfaces that are not that well-connected to flood flows. Overall, as described previously in the Large Wood Material section, large wood recruitment processes have been disrupted. There is recruitment happening but it is mainly of young or medium-aged trees. There is also relatively little shade being provided by the canopy. A vegetation height map is included for reference in Figure 105.

Figure 103. View from terrace looking upstream near RM 7 at section of denuded riparian vegetation within the BPA powerline corridor (Inter-Fluve photo July 2005).

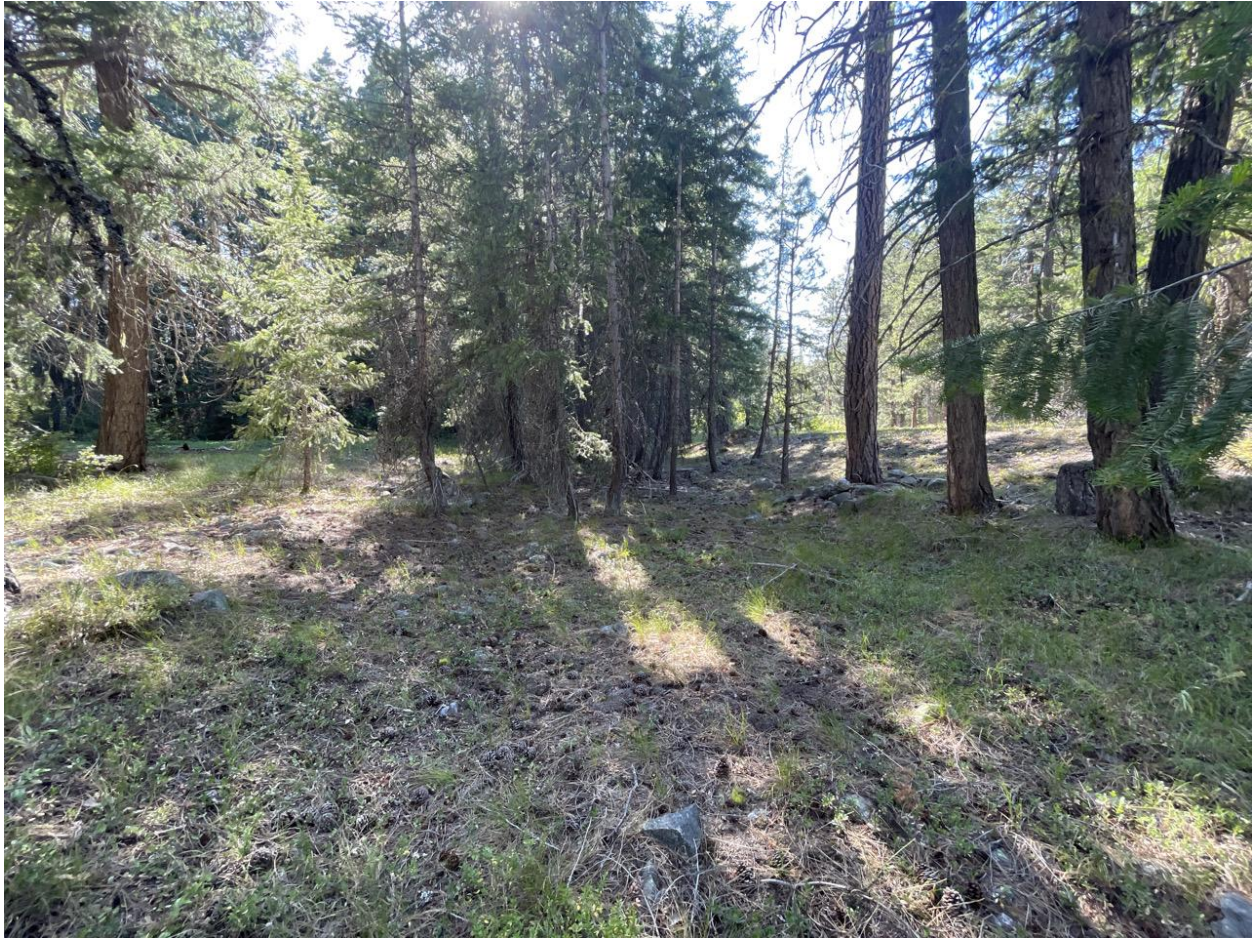
Figure 104. Sparsely vegetated floodplain river-left at RM 6.85.

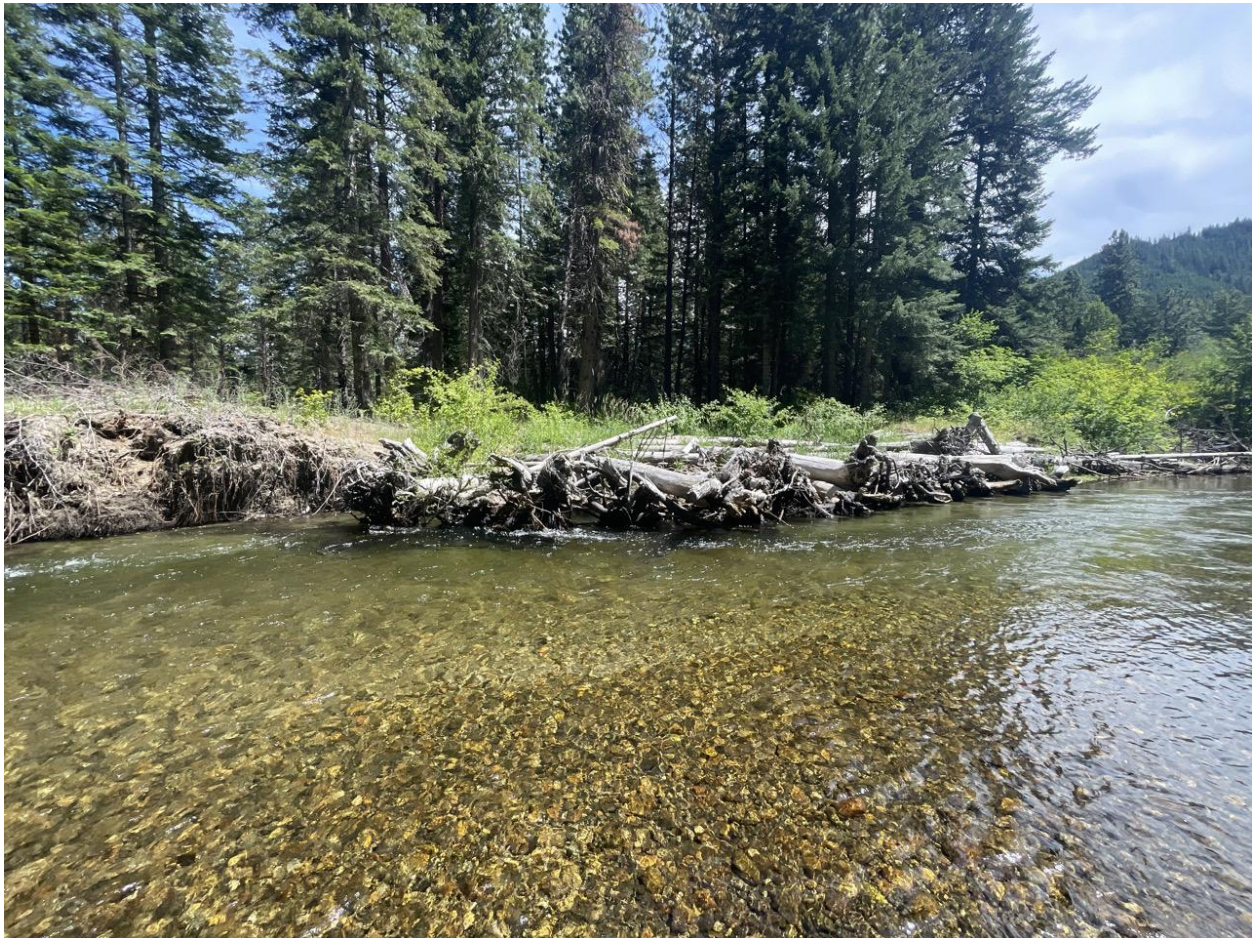
Figure 106. Nason Kahler project constructed log jam near RM 8.35.

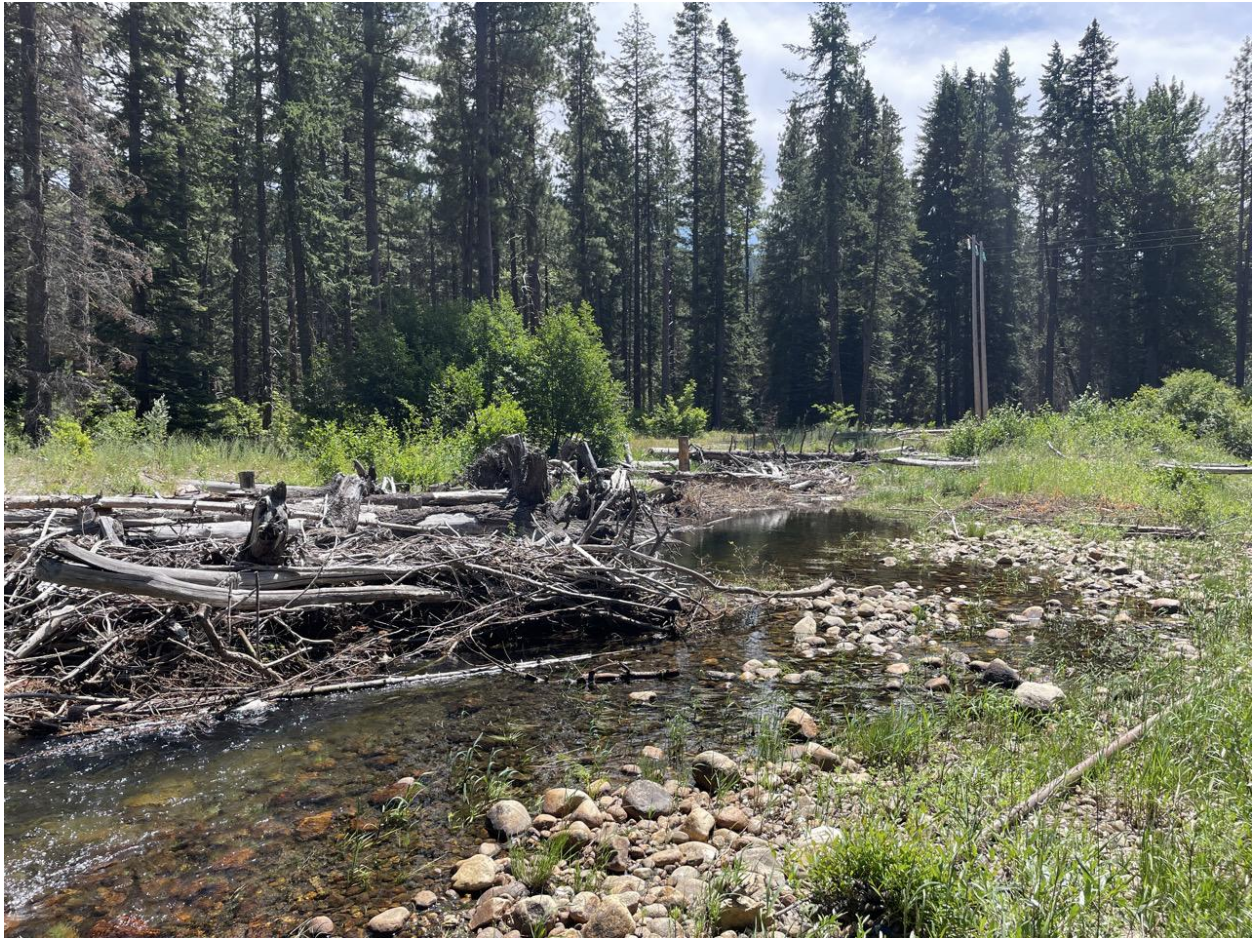
Figure 107. Enhanced side-channel with large wood complexity on river-left near RM 8.5.

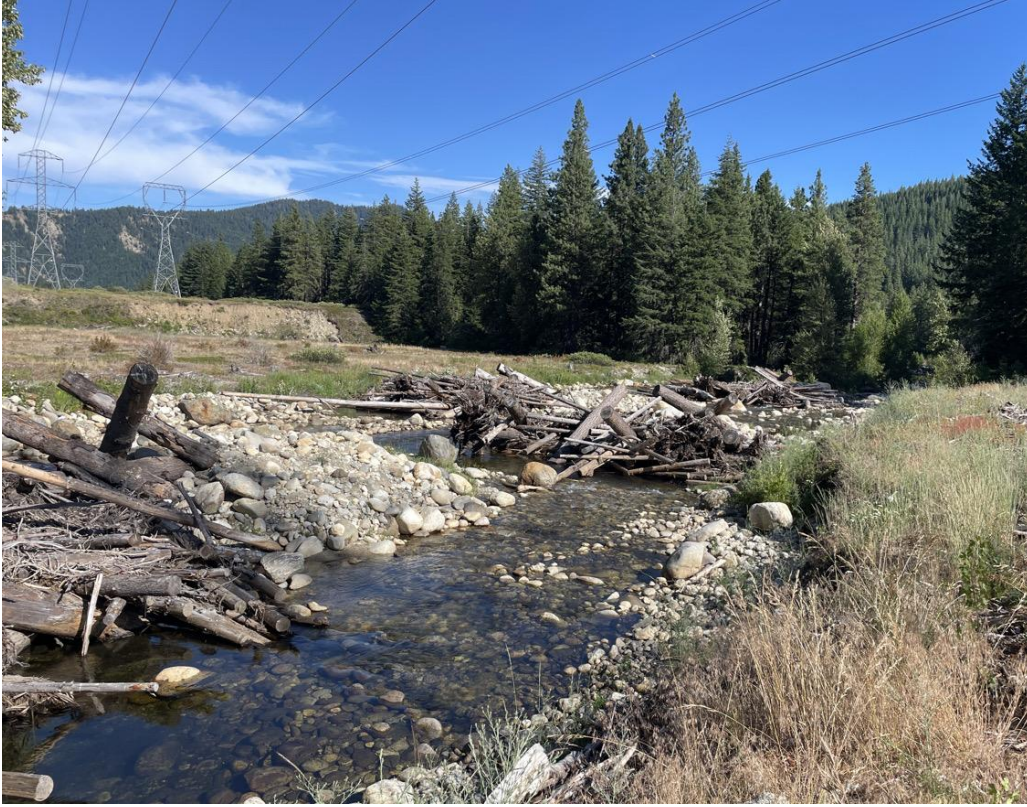
Figure 108. Constructed large wood structures in river-right side-channel near RM 6.6.

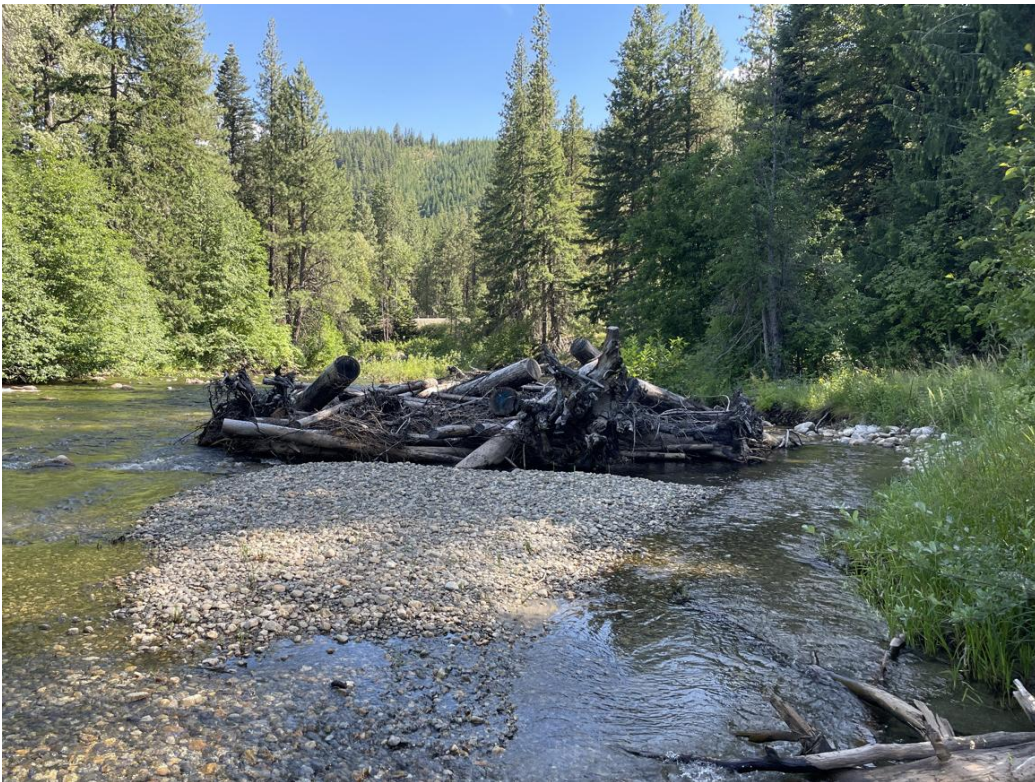
Figure 109. Constructed jam splitting flow along river-right bank near RM 7.0.
