Lower & Middle Nason Creek Reach Assessment & Restoration Strategy Update *Final Report*

JANUARY 2026

PREPARED FOR
Yakama Nation Fisheries

PREPARED BY
Inter-Fluve

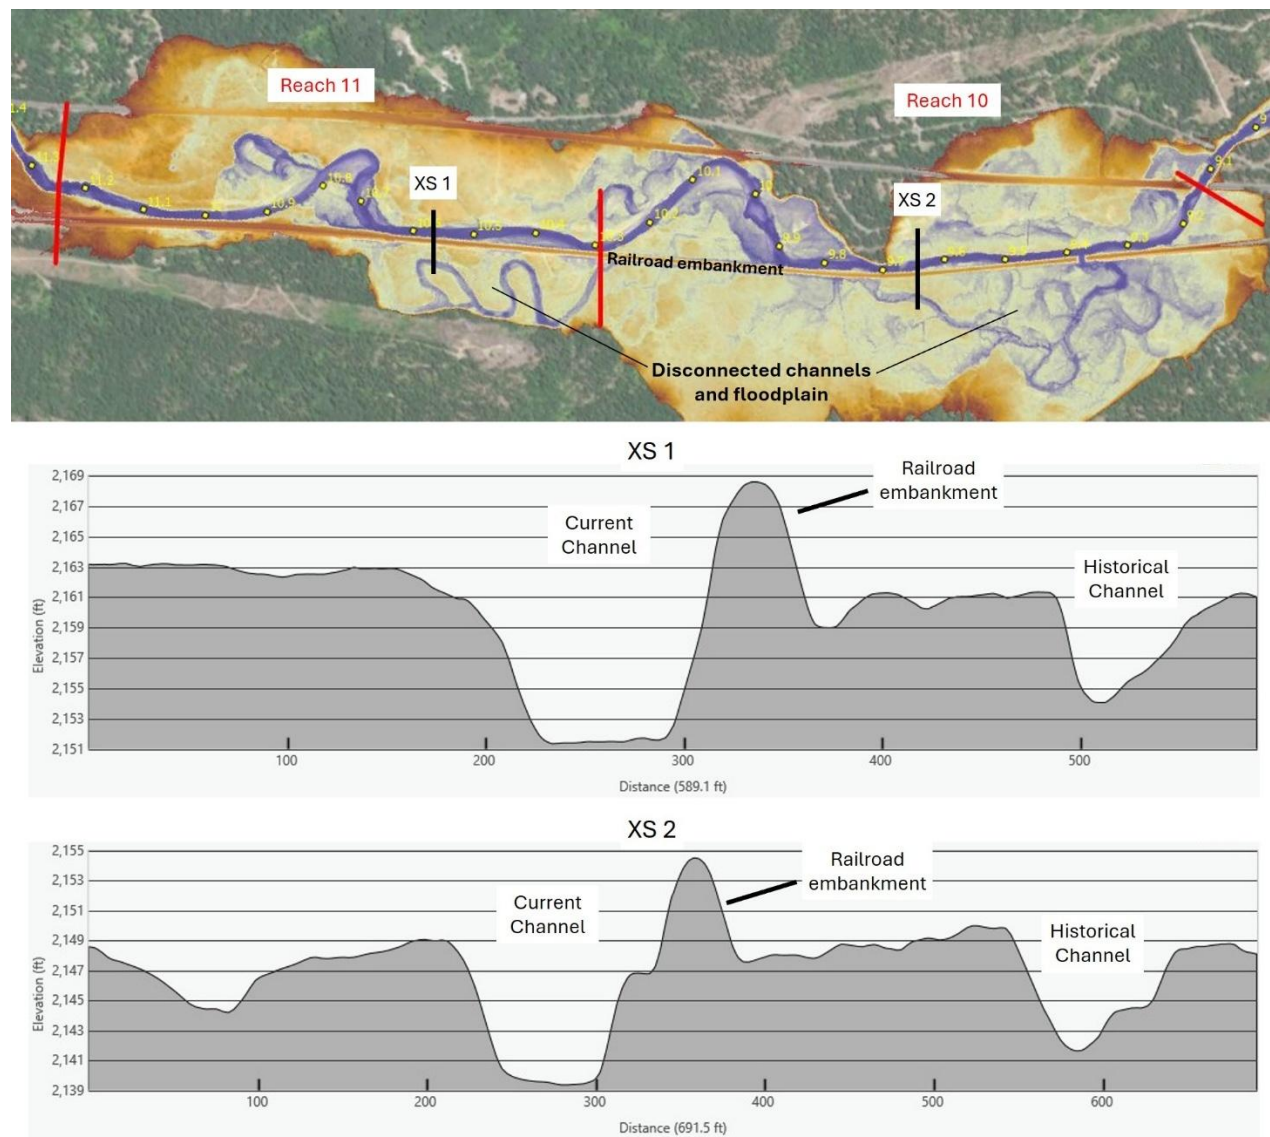
The relocation and straightening of the former channel has resulted in an incised and over-widened channel that has a lower base elevation than the former channel (Figure 116). The elevation difference is at least 3 feet based on analysis of LiDAR data. This has also been documented in past assessments, including the analysis to support the Nason Creek Lower White Pine Habitat Reconnection Project (perforation through railroad embankment near RM 9.4) in 2012 (ICF International 2012b). The confinement, incision, and widening, along with some areas of floodplain fill, have disconnected the channel from accessing its historical floodplain and channel migration zone. Modeling indicates that the 100-year flood continues to inundate a significant portion of the valley bottom in the disconnected area (Figure 120 and Figure 121); however, this is due to tributary inflows into the disconnected zone and not from connectivity to Nason Creek. In the model, this flow backs up as it enters Nason Creek through the reconnection point near RM 9.4. We recognize there are culverts under the railroad embankment (U.S. Bureau of Reclamation 2008) that would limit the extent of inundation in the disconnected zone, but these are not represented in the model, which is based on LiDAR data. Despite the broad inundation shown in the modeling, the natural exchange and flow of water between the floodplain and Nason Creek is severed and channel migration into this zone is prevented.

Figure 116. Cross-sections showing differences in channel elevation and geometry between historical cut-off channel segments and current channel segments in reaches 10 and 11.

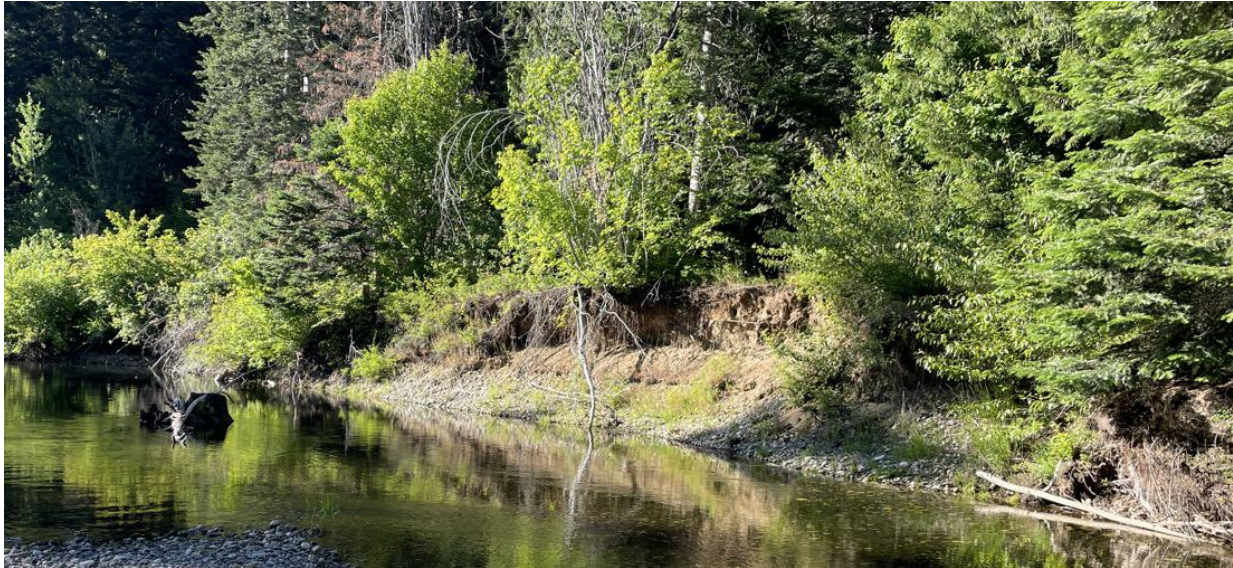
The historical sediment transport processes in this segment have been severely disrupted, with less opportunity for bank material recruitment than would have occurred historically via lateral scrolling; and high energy and scour of bed sediments due to confinement. Bed and bank sediments in the segment overall are dominated by gravels, with small cobble subdominant and a considerable contribution of boulders due to the extensive riprap making up the banks and portions of the bed along the railroad. Sediment sources within the reach are highly impacted by confinement and the abundance of bank armoring, which limits lateral processes of cut and fill alluviation. There are only three areas where lateral processes are still occurring to any meaningful degree, at RM 11.2, at the 'First Bend' site near RM 10.8, and at the 'Second Bend' site near RM 10.0. On river-left at RM 11.2, the approximately 8-ft tall bank has eroded 30+ feet since 2006, based on aerial photo analysis and conversations with the landowner during the field survey (Figure 117).

Figure 117. View upstream at eroding river-left bank near RM 11.2 (Inter-Fluve photo June 2025).

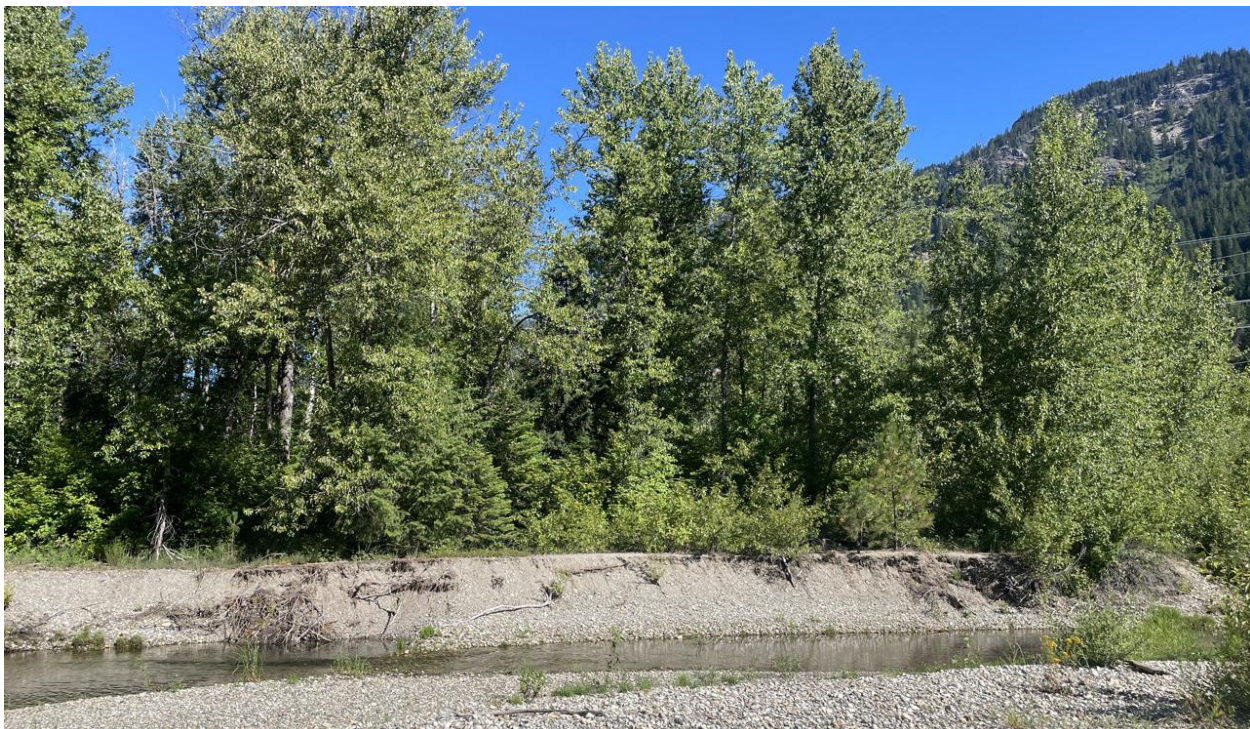
At the First Bend site, prior to restoration work in 2013, the outside bend was rapidly eroding due to a lack of riparian forest. The controlled meander cut-off, wood placements, and riparian reforestation work (2013 and 2022 projects) have reduced rapid scrolling, but this area nevertheless remains a source of material through localized bank erosion and scour of bar features. There are also lateral dynamics, including bank erosion, bar scouring, and bedload deposition occurring at Second Bend (Figure 118).

Figure 118. View toward river-right bank near RM 10 showing area of gravel recruitment from bank (Inter-Fluve photo July 2025).

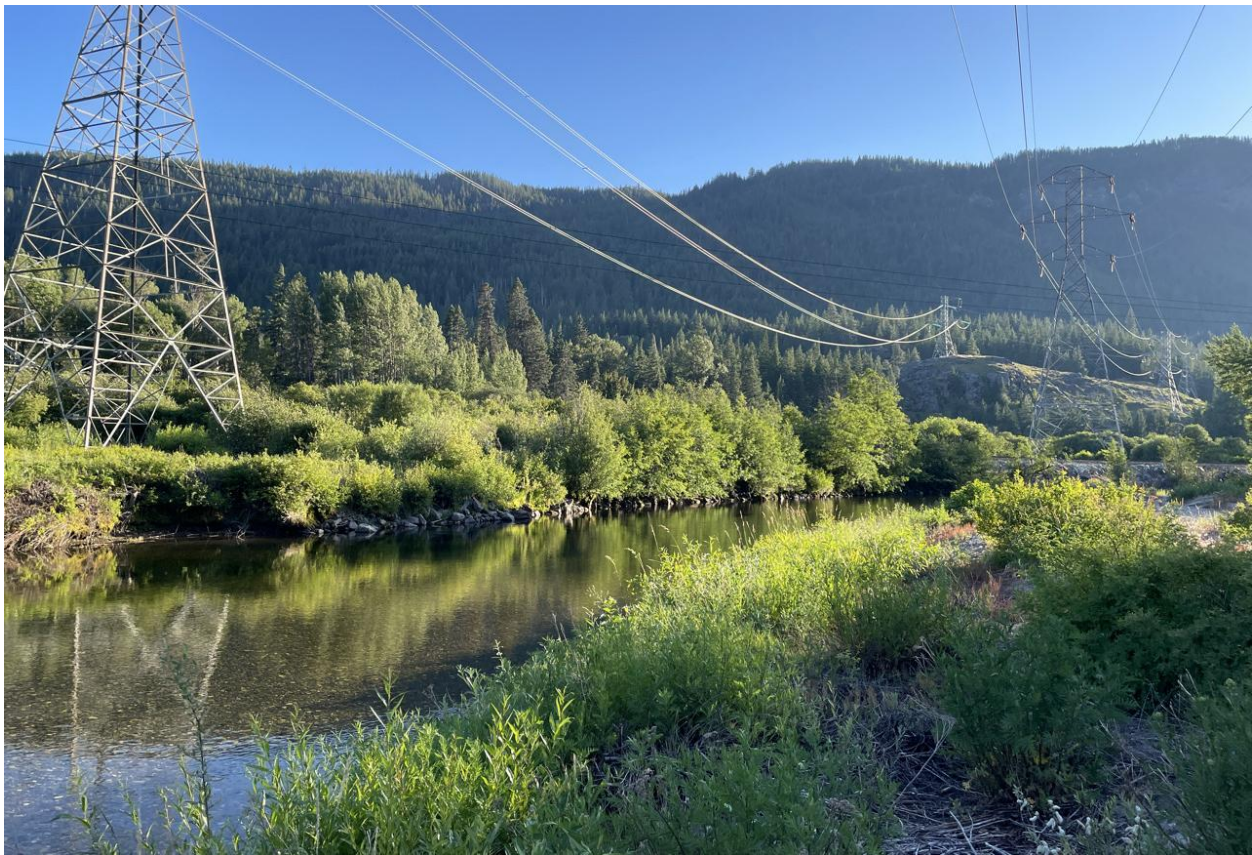
Figure 122. Example of complete loss of large wood recruitment potential due to bank armoring and clearing under the BPA powerlines. View upstream near RM 10.2.

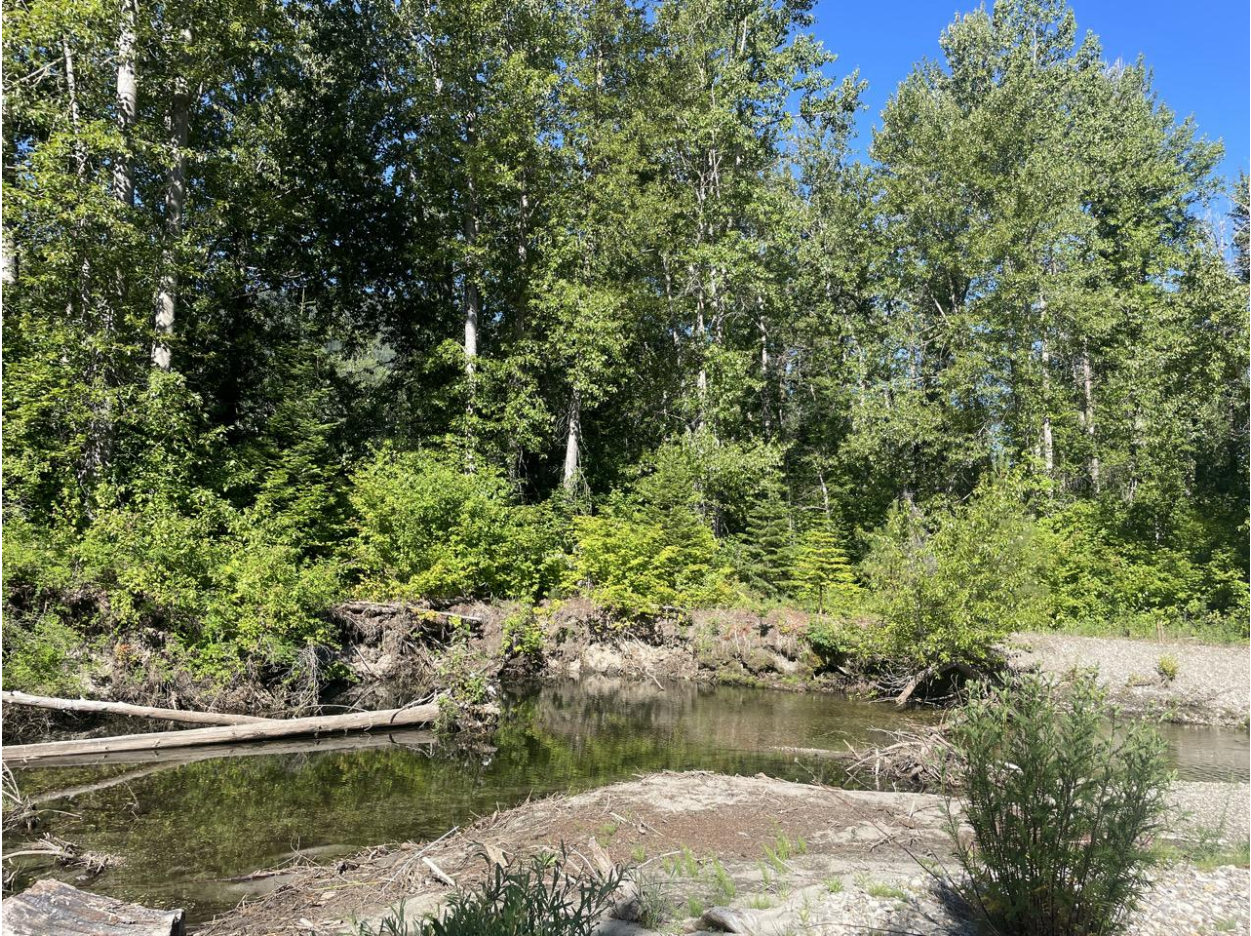
Figure 123. Bank erosion and recruitment occurring into a young and medium-aged stand of cottonwoods at flow-split near RM 10.0. View of river-right bank (Inter-Fluve photo July 2025).

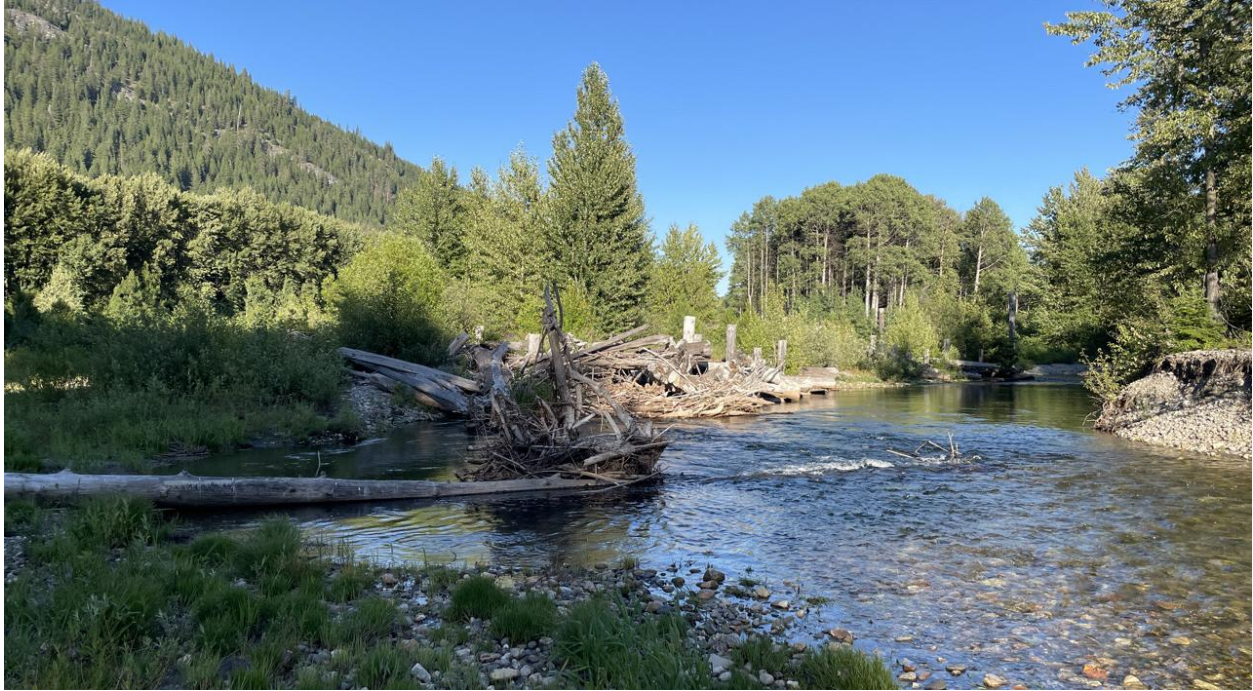
There have been at least five past projects in this segment (Figure 133). The First Bend project (Yakama Nation) was constructed in 2013 and included a controlled meander cut-off and other treatments (Figure 126). The controlled cut-off was to avert an impending avulsion across the inside of the river-right bar (where an advancing headcut was located), which would have resulted in a straightened channel along the railroad embankment, loss of the existing complexity at the bend, and contributing even further to the straightened and armored condition of the greater reach. The controlled cut-off ‘dialed back the clock’, so to speak, on the evolutionary trajectory of the bend, maintaining complexity and promoting the evolution of the abandoned channel section into an off-channel wetland complex. Project implementation in 2013 included the following: construction of a pilot channel across the bend; large wood structures along the pilot channel; layback, large wood placement, and planting of the vertical bank at the outside of the bend; large wood placement downstream in the mainstem; placement of vertical members to help retain an existing log jam; and riparian reforestation (Inter-Fluve 2013). The pilot channel was successful in ‘capturing’ the main channel after 3-4 years, and over the past 12 years the abandoned channel has slowly been filling with sediments and converting to high quality off-channel habitat (Figure 127). This channel, however, remains active as a split-flow condition during high flows each year.

Figure 126. View downstream into cut-off channel at First Bend project site. Photo taken from RM 10.8 (Inter-Fluve photo June 2025).

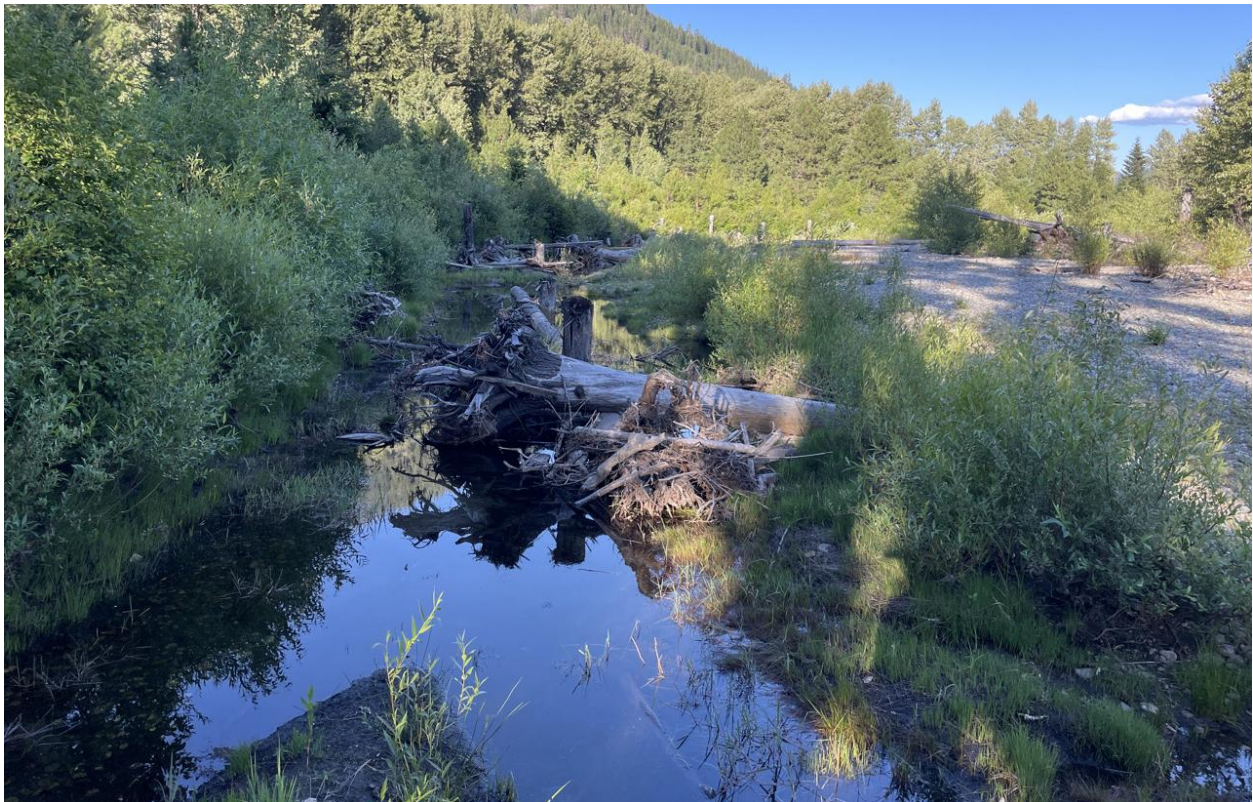
Figure 127. Upstream end of abandoned channel at First Bend project showing wetland development and good riparian regrowth on river-left (Inter-Fluve photo June 2025).

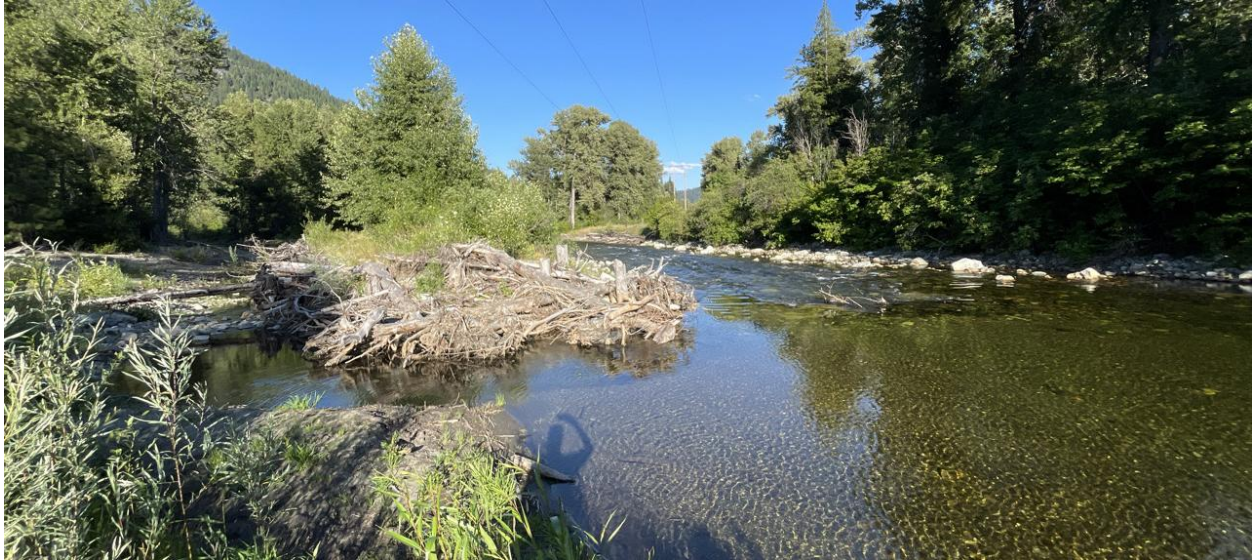
In 2022, the Nason Merritt Oxbow Reconnection Project (Cascade Fisheries) occurred just upstream and partially within the First Bend project site. This project involved the following: construction of a river-left side-channel that connects into floodplain wetlands and the abandoned First Bend channel downstream; construction of a log jam on the upstream river-right bank; construction of a roughened channel (constructed riffle) in the mainstem; and riparian revegetation (RIO Applied Science and Engineering 2022). The roughened channel (constructed riffle) prevents channel headcutting from continuing upstream from the cut-off channel, and thereby helps to keep the left-bank side-channel active (Figure 128). These features complement the First Bend project elements. At the time of the late June 2025 field survey, the side-channel had a small amount of flowing water, but is possibly not active at lowest base flows. Planted revegetation along the sides of the side-channel appeared to have mixed success, with some significant mortality.

Figure 128. View downstream near RM 10.9 of constructed side-channel inlet (river-left) and constructed riffle (in main channel) at the Merritt Oxbow Reconnection Project (Inter-Fluve photo June 2025).

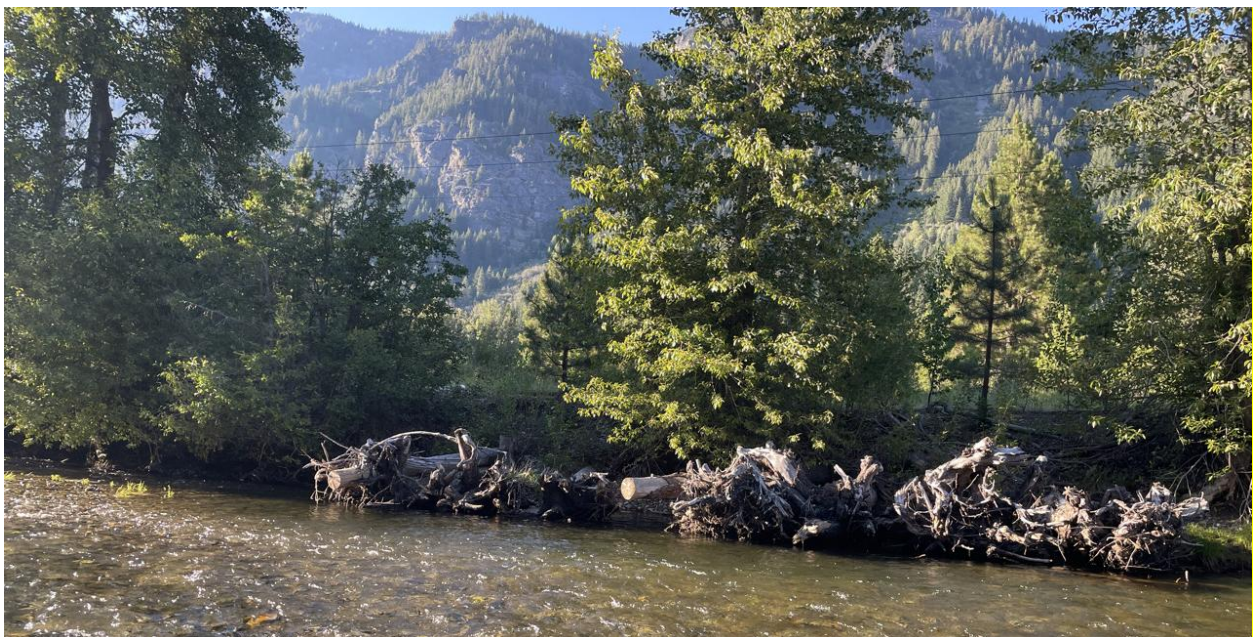
The LWP Groups 2 & 3 Project (Yakama Nation) occurred in 2016 between RM 10.1 and 10.45 and included large wood placements in the mainstem, backwater channel and alcove creation with large wood, reconnection of a floodplain wetland pond complex, and riparian revegetation. During the late June 2025 field survey, the mainstem log jams were observed to be tightly tucked to the bank and not interacting much with flow. The alcove/backwater complex had high quality habitat (wetted, highly complex), but it was not connected via surface flow with the mainstem, possibly due to beaver activity, with the alcove water surface approximately 1 foot higher than the mainstem water surface.

Figure 129. Large wood structure installed on river-left bank as part of LWP Groups 2&3 Project near RM 10.45 (Inter-Fluve photo June 2025).

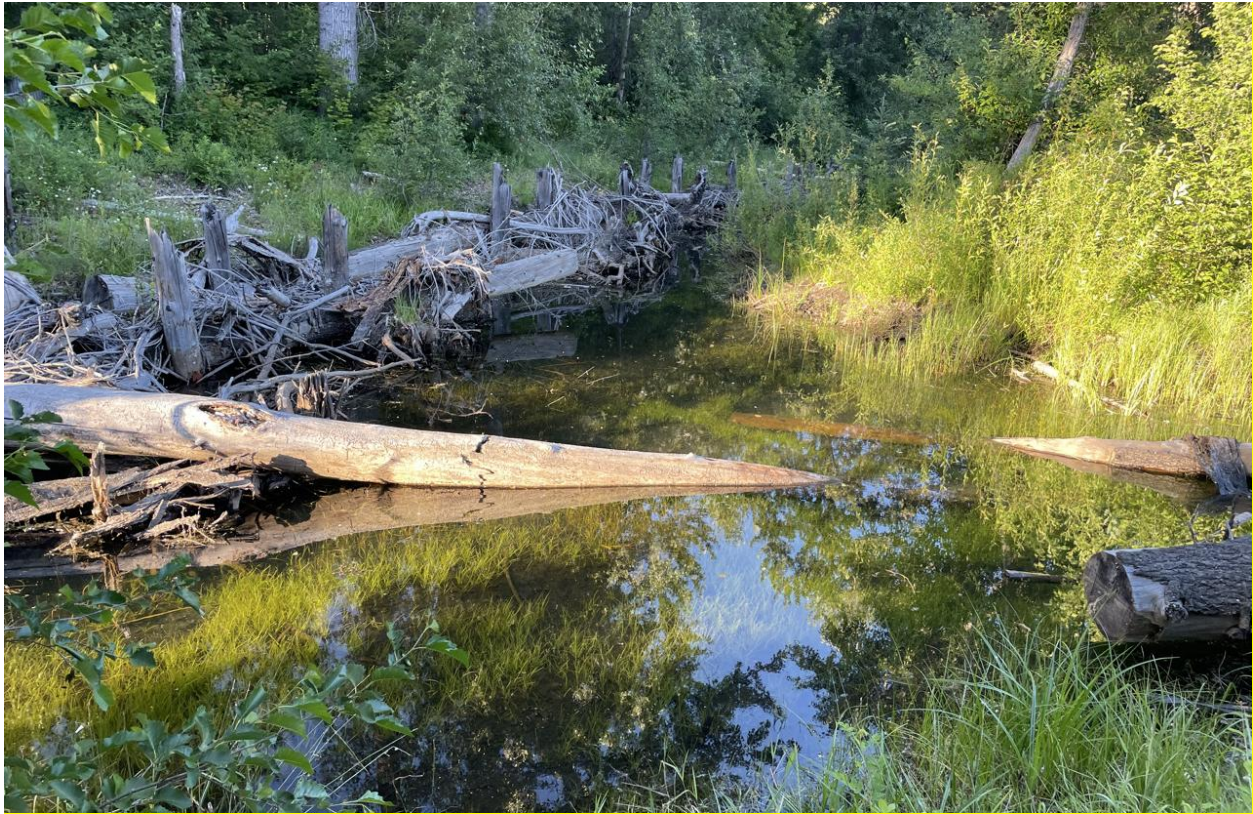
Figure 130. Constructed backwater alcove in river-left floodplain as part of LWP Groups 2&3 Project near RM 10.15 (Inter-Fluve photo June 2025).

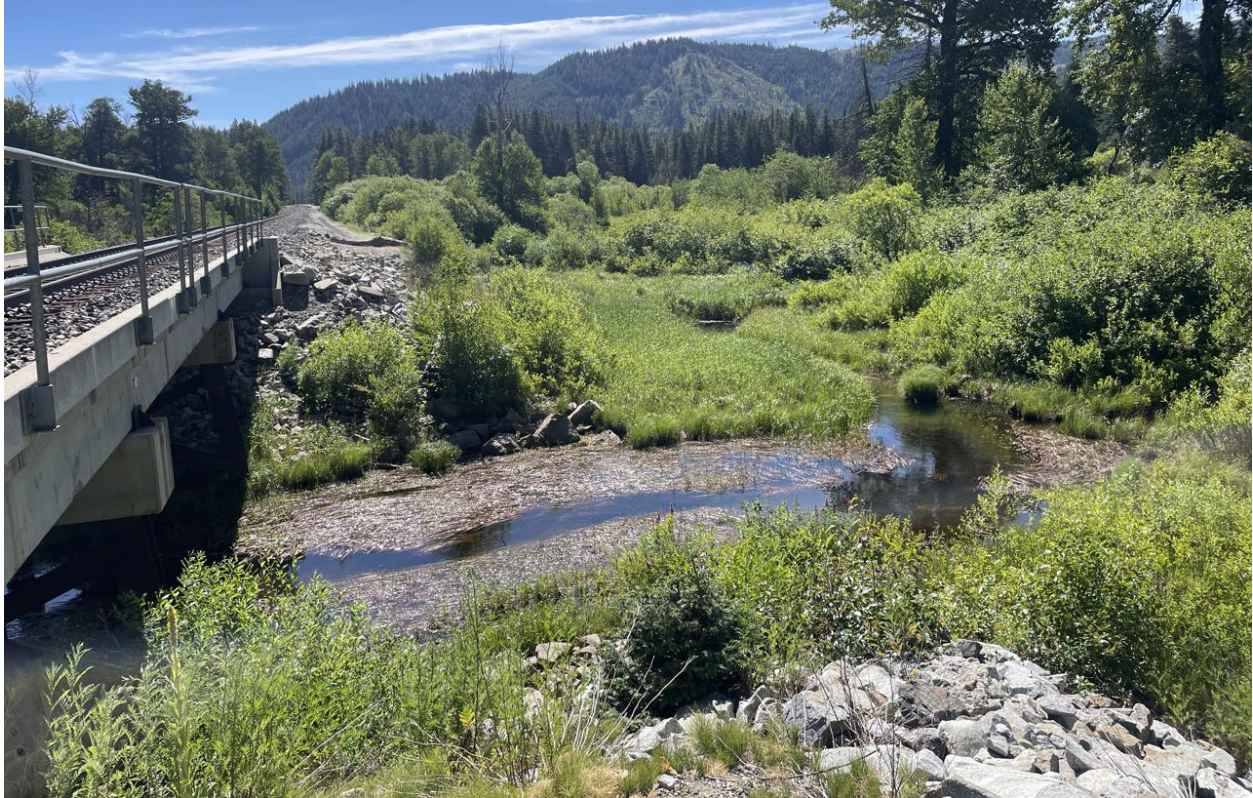
The Nason Creek Lower White Pine Habitat Reconnection Project (Chelan County) was constructed in 2012 and included a breach, via a bridge, through the railroad embankment to connect Nason Creek to the large disconnected historical channel segment to the south of the railroad. Site observations during the early July 2025 field survey showed continued good connectivity through the breach between Nason Creek and the downstream end of the disconnected channel across the railroad (Figure 131).

Figure 131. View from opposite side of the railroad at the historical channel reconnection near RM 9 (Inter-Fluve photo July 2025).

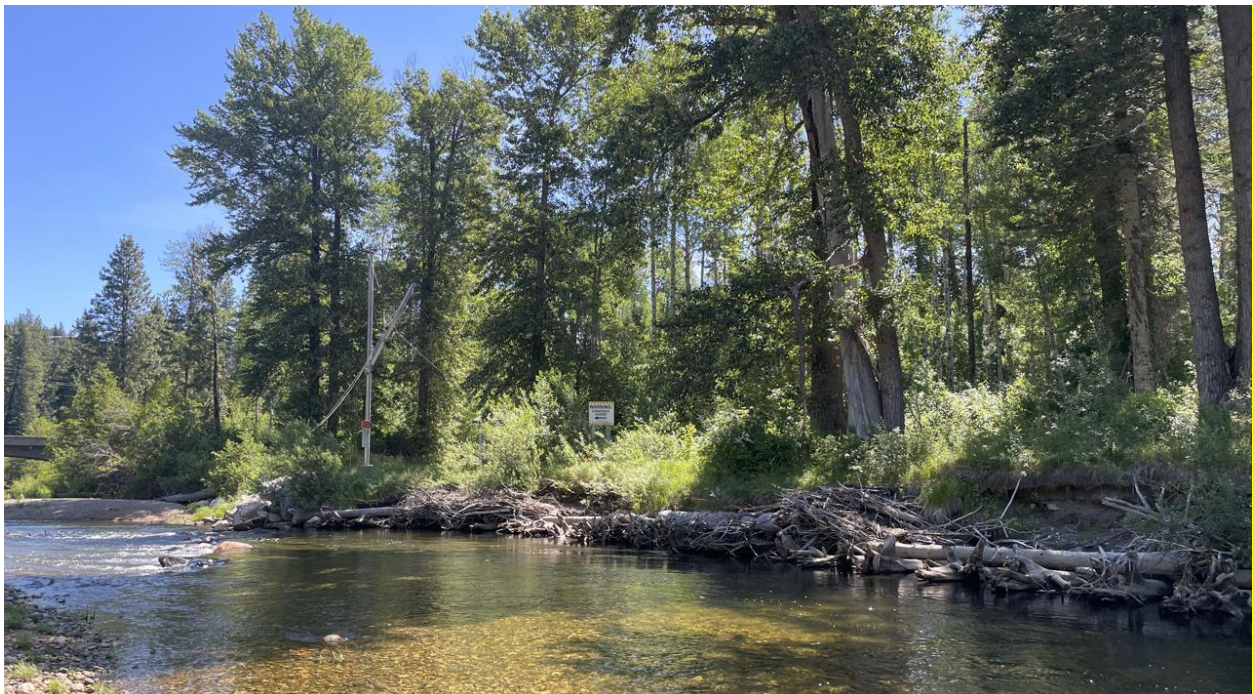
There is a large wood bank revetment on river-right at the bend at RM 9.2. This was presumably placed to protect the Grant PUD hatchery facility (Figure 132). Observations during the field survey indicated that erosion of the upper portion of this bank is potentially putting the structure at risk of failure.

Figure 132. Large wood bank revetment on the river-right bank at RM 9.2 (Inter-Fluve photo July 2025).

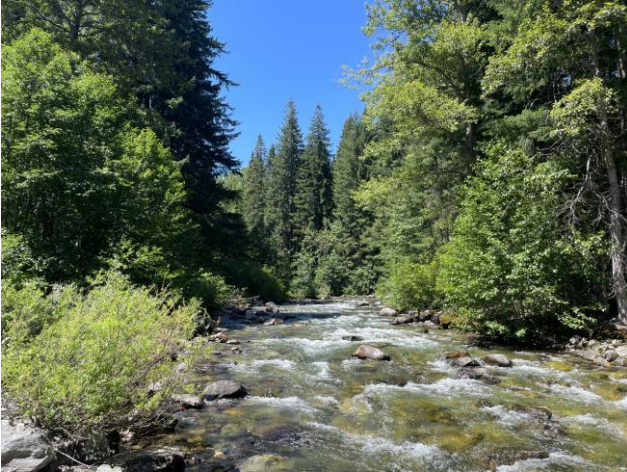
Figure 134. Steep boulder-bed channel at upstream end of segment near RM 13.4 (Inter-Fluve photo June 2025).

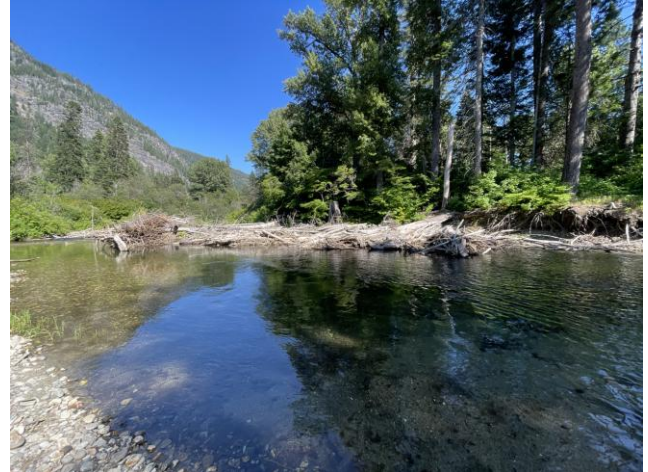
Figure 135. Area of relative complexity (large wood, channel migration) near RM 11.8 (Inter-Fluve photo June 2025).

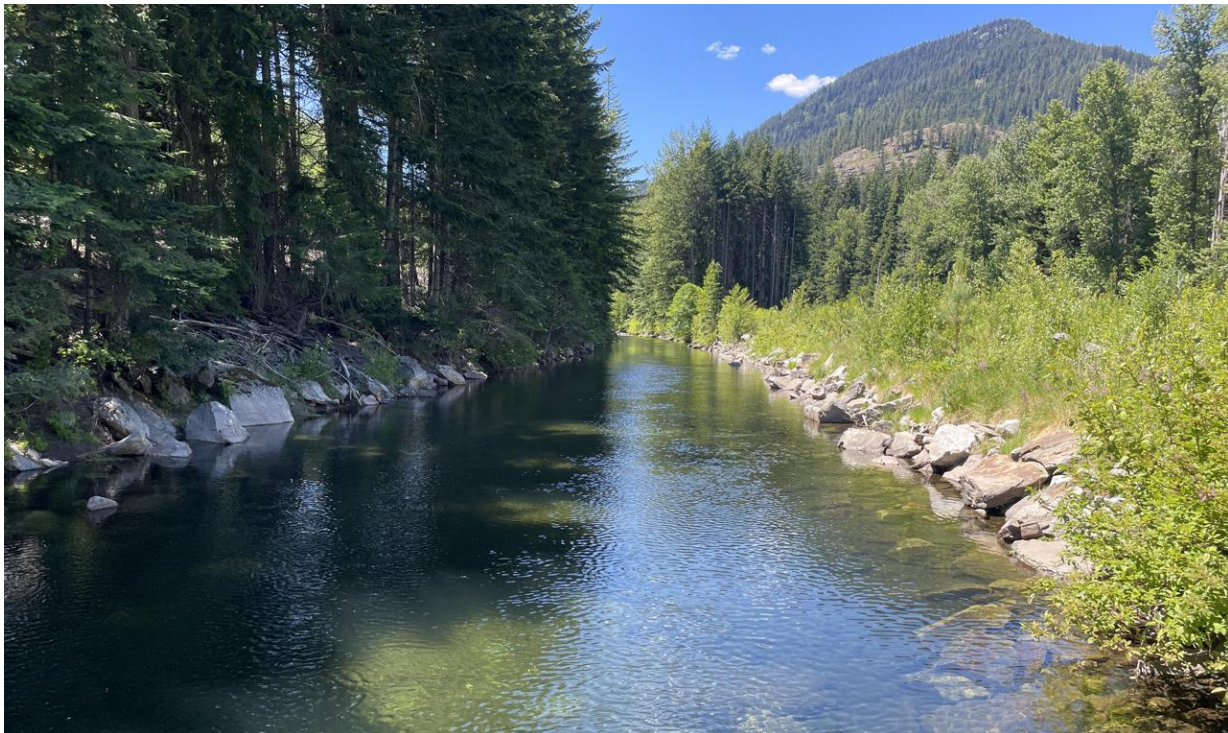
Figure 136. View looking upstream near RM 13 showing riprap along both sides of the channel. This is the historically relocated and ditched channel segment. The railroad is on the left. The right side is just upstream of the prior UWP (upper) project where a levee was removed and riparian/floodplain revegetated, but riprap was left in place (Inter-Fluve photo June 2025).

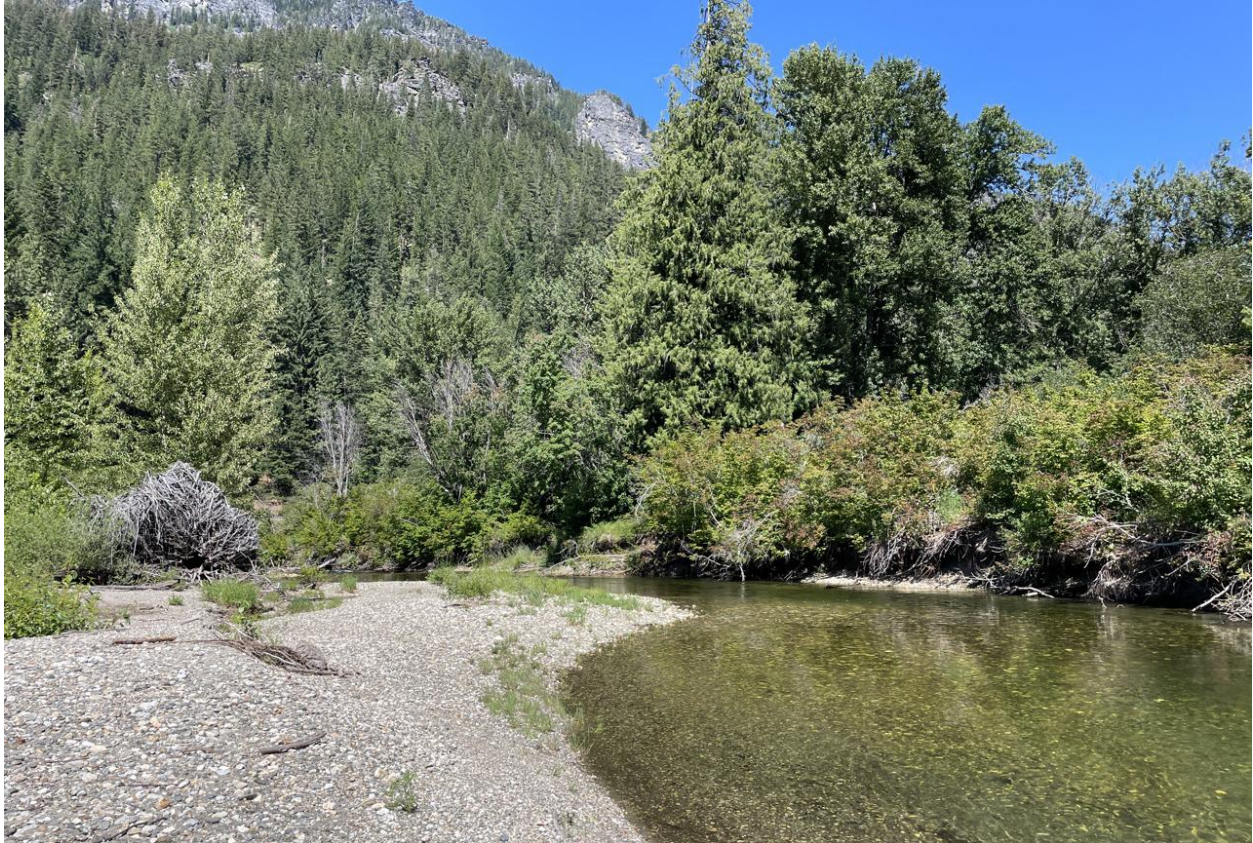
Figure 140. View downstream near RM 12.3 (knife shop bends). Active bank erosion and some large wood recruitment is occurring on river-right (Inter-Fluve photo June 2025).

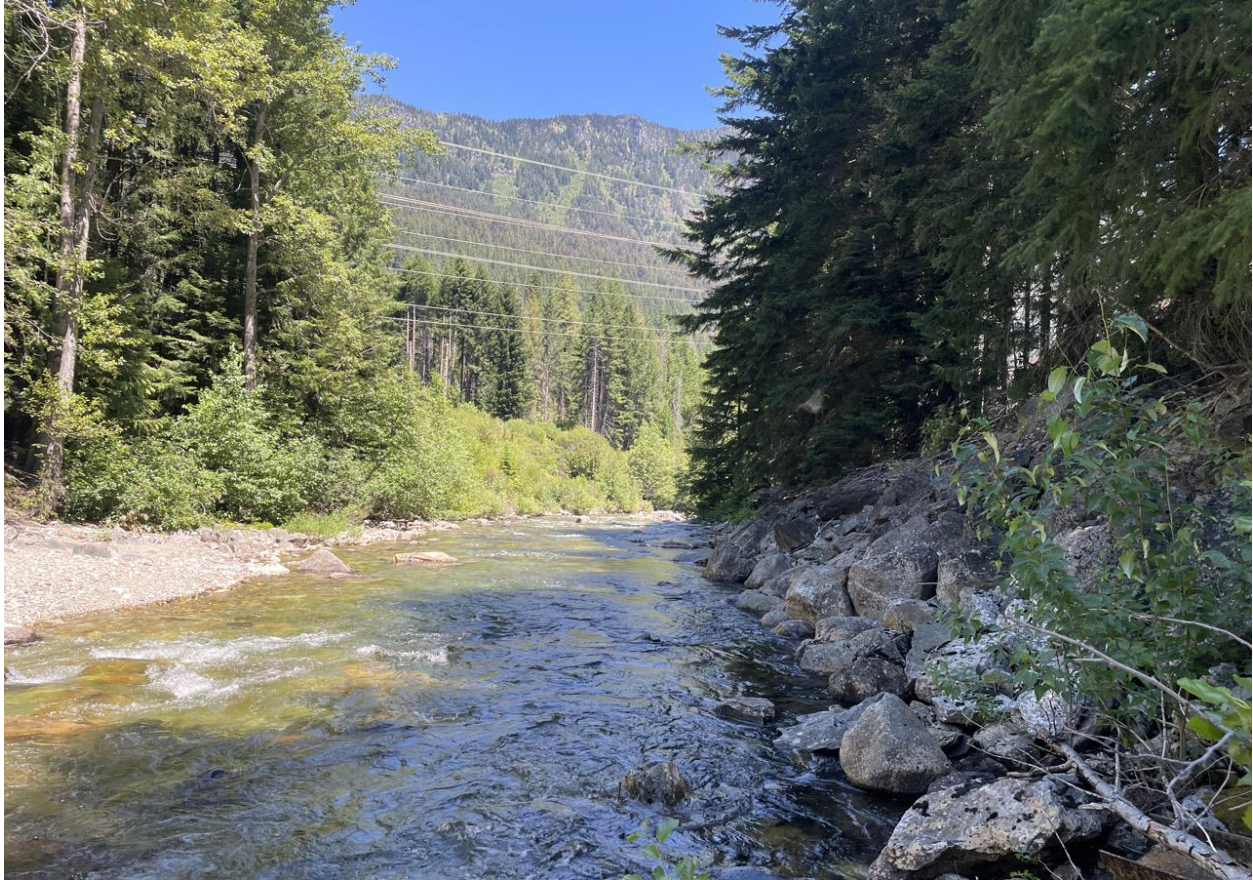
Figure 141. View downstream near RM 13.8. Riprap from the railroad embankment can be seen on river-right and bed material sourced from the Mahar Creek alluvial fan can be seen on river-left. BPA powerline crossing and related vegetation impacts can be seen in the background on river-left.

Vegetation conditions in Segment 6 are highly impacted by past and ongoing uses and infrastructure. The vegetation in Reach 12 is highly affected by the adjacent Highway 2 (Figure 148) and vegetation in Reach 13 is highly affected by the railroad embankment (see Figure 141). These pieces of infrastructure have resulted in considerable lengths of channel with narrow riparian buffers on at least one side of the channel. The CPUD powerlines also affect riparian conditions in a few areas where they cross the channel, including near RM 11.7 and RM 12.55. Residential uses and clearing at Merritt also contribute to impaired riparian vegetation conditions in the downstream portion of the segment. There are very few trees that exceed 150 feet height, and many areas are dominated by shrubs, grass, or are completely devoid of vegetation altogether. The areas with the most mature stands are located in the river-right floodplain from 11.6 to 11.8 and in the river-left floodplain on the inside of the bend from RM 12.4 to 12.6. There are some large cottonwoods, up to 4-5 feet diameter, near RM 11.7. The overstory typically consists of fir, western red cedar, cottonwood, or ponderosa pine. The understory is typically comprised of alder, willow, dogwood, or maple. The overstory is discontinuous and many areas only have shrub-dominated stands with only occasional larger trees. Large wood recruitment potential is described in the previous section and is very low overall. There is moderate stream shading provided by canopy cover in this section. A vegetation height map is included for reference in Figure 149.

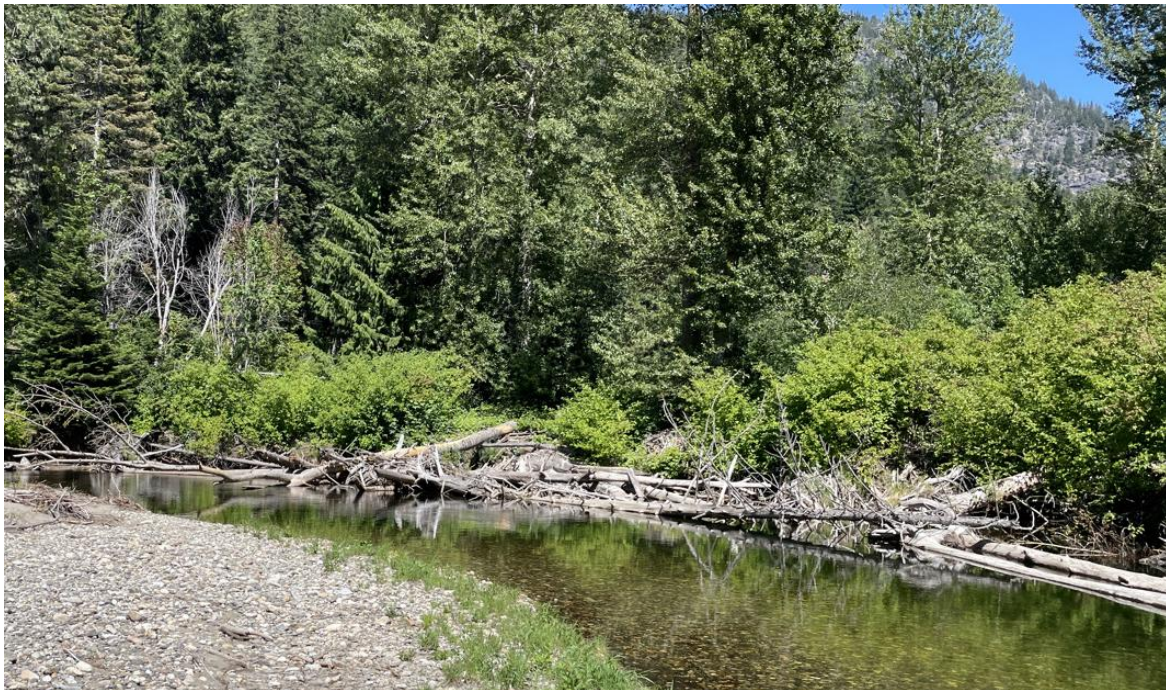
Figure 145. View looking upstream toward river-left bank near RM 12.35 at actively eroding and relatively complex section within the 'knife shop bends' (Inter-Fluve photo June 2025).

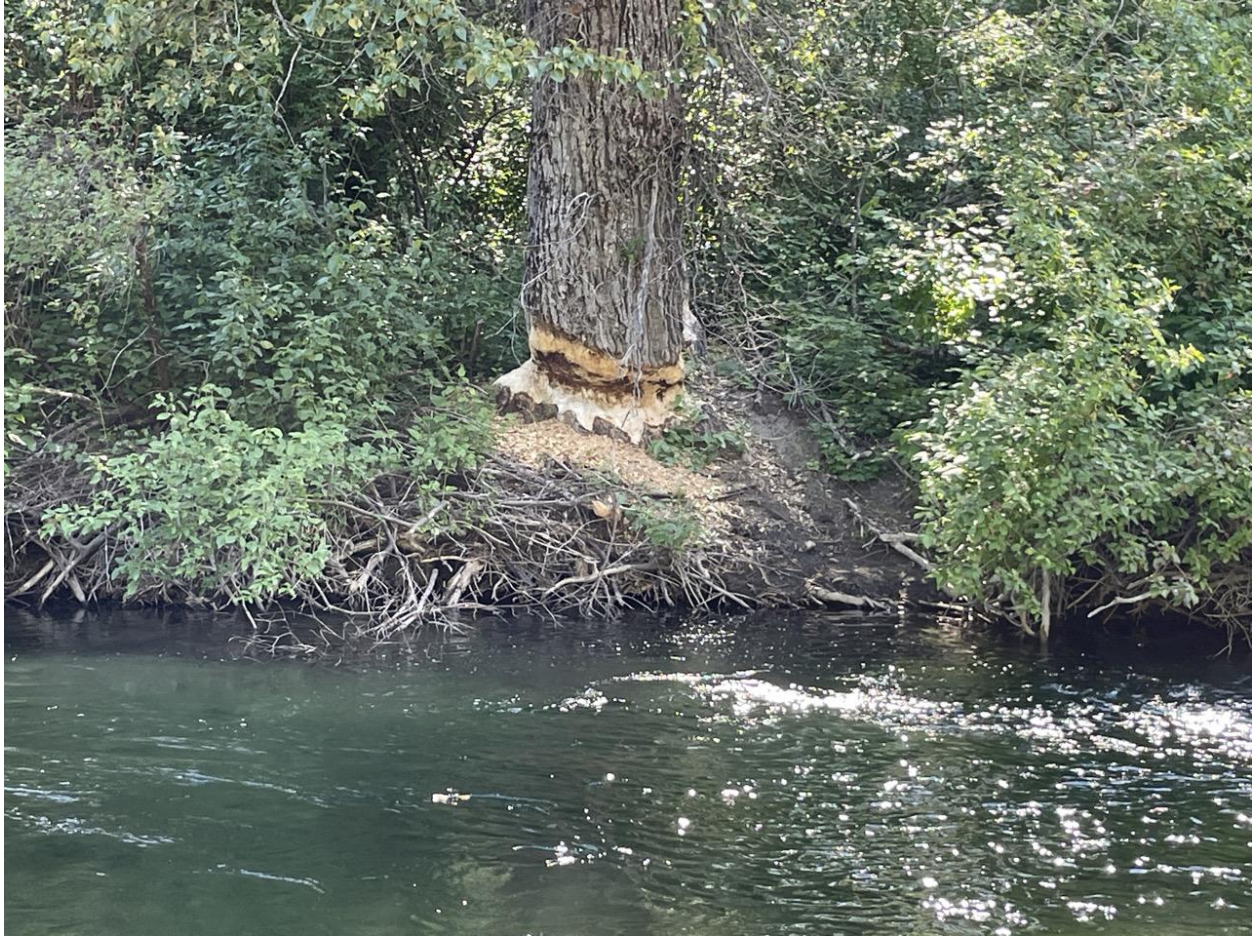
Figure 146. Large cottonwood tree soon to be recruited via a beaver chew near RM 11.7 (Inter-Fluve photo June 2025).

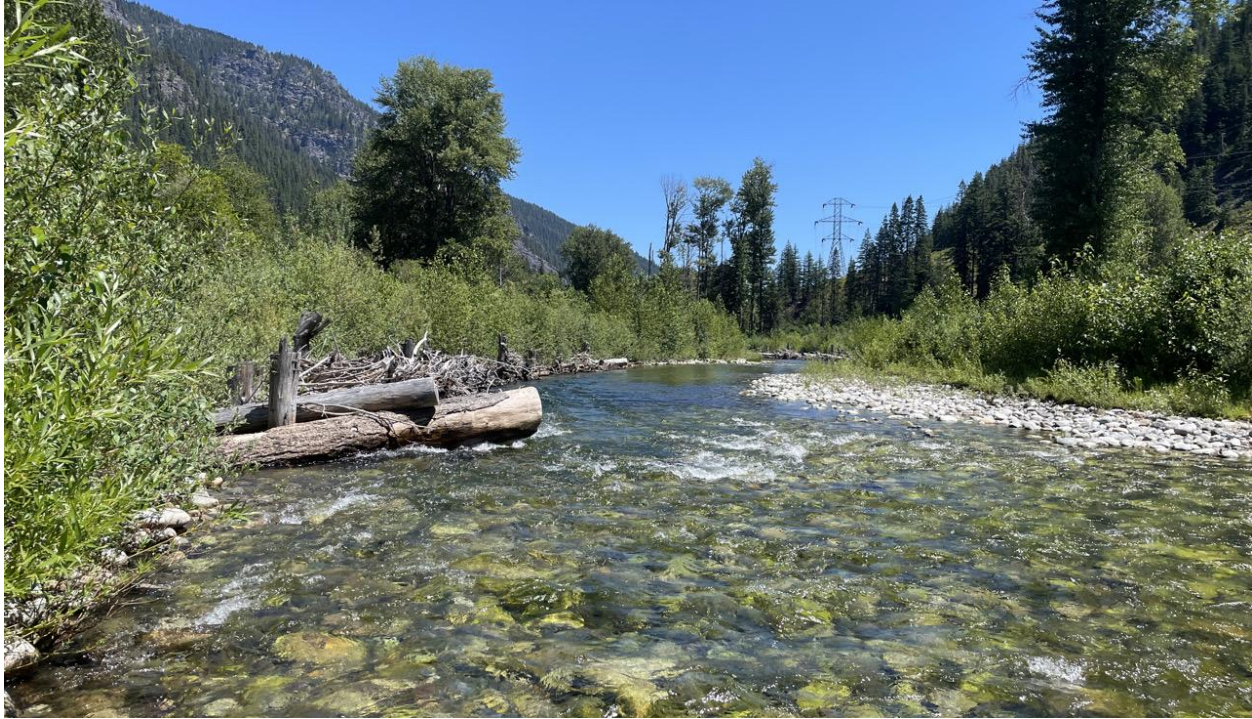
The UWP (upper) project was led by Chelan County and was constructed from 2016 to 2018 in multiple phases (Figure 150). This project included relocation of the CPUD powerlines to the north out of the floodplain, removal of a river-left levee/armoring, lifting and re-meandering of a 1,400-ft long previously ditched portion of the mainstem, creation of connected alcove habitat, addition of large wood, placement of floodplain roughness large wood, and revegetation (Inter-Fluve 2017)(Inter-Fluve 2017)(Inter-Fluve 2017). During the June 2025 field survey, no major changes had appeared to occur since construction, except for significant growth of planted riparian vegetation on the left bank, especially upstream of the re-meander portion. Riparian vegetation on the right bank is still relatively sparse and very young. This area was not planted to the same degree as the left bank due to agreement with the railroad (based on the author's personal knowledge of the project). Vegetation success on the river-left bank along the re-meandered portion is high; however, vegetation growth further back from the bank on the left bank is more sparse. The large wood jams are engaged with the river at low flows and in most cases are maintaining pool scour. There did not appear to be significant changes in substrate conditions (e.g. scour or aggradation) in the re-meandered section. As described previously, the channel upstream of the re-meandered portion is backwatered. There appeared to be some sign of gravel and sand deposition on the bed at the upstream end of the backwatered section.

Figure 150. View downstream near RM 12.9 of UWP (upper) project, within the re-meandered section (Inter-Fluve photo June 2025).
