Lower & Middle Nason Creek Reach Assessment & Restoration Strategy Update *Final Report*

JANUARY 2026

PREPARED FOR
Yakama Nation Fisheries

PREPARED BY
Inter-Fluve

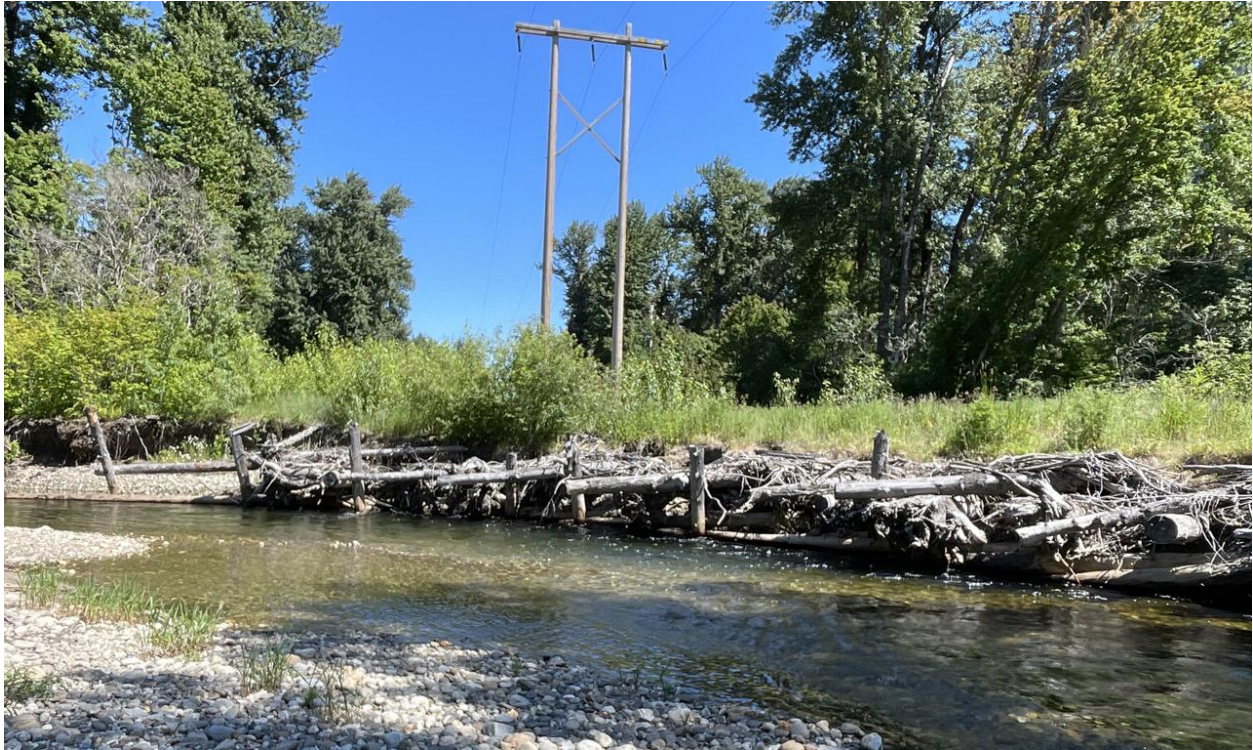
The UWP (lower) project was led by Yakama Nation and was constructed in 2015 (Figure 151 and Figure 152). This project included mainstem bank-buried jams, construction of an extensive alcove complex with large wood, and riparian revegetation (Inter-Fluve 2014)(Inter-Fluve 2014)(Inter-Fluve 2014). The mainstem jams extended from RM 12.1 to 12.6 and consisted of approximately 12 jams. The largest jam is located at the ‘powerline bend’ on river-right at RM 12.45. This jam was intended to provide habitat complexity to an area of rapidly eroding streambank within the CPUD powerline corridor where riparian vegetation clearing (powerline corridor maintenance) had prevented mature riparian forests from being able to provide natural bank stability. During the June 2025 field surveys, this jam was observed to have some deterioration, including some erosion and possibly loss of large wood members at the downstream end and erosion of the upper bank in some locations. Much of the planted shrub vegetation was no longer present, and may have been cleared by poweline maintenance. Some of the other smaller bank-buried jams were providing good margin complexity and maintaining pool scour; however, a few of them were tight against the banks and not engaging with flow at the low flows during the field survey, and were not associated with scour pools. The created alcove habitat, which connects to the channel near RM 12.1, had abundant large wood, and likely provides critical salmonid rearing cover as described previously. However, the alcove was not connected to surface flow in the mainstem at the time of the survey, which was also likely related to a beaver dam in the alcove just above the mainstem connection point. The alcove did have standing water, but the alcove did not appear accessible to fish at the low flows during the survey. Planted vegetation along the alcove looked to be robust and thriving.

Figure 151. View downstream of 'powerline bend' jam at RM 12.45. Some erosion can be seen at the downstream portion of the jam (Inter-Fluve photo June 2025).

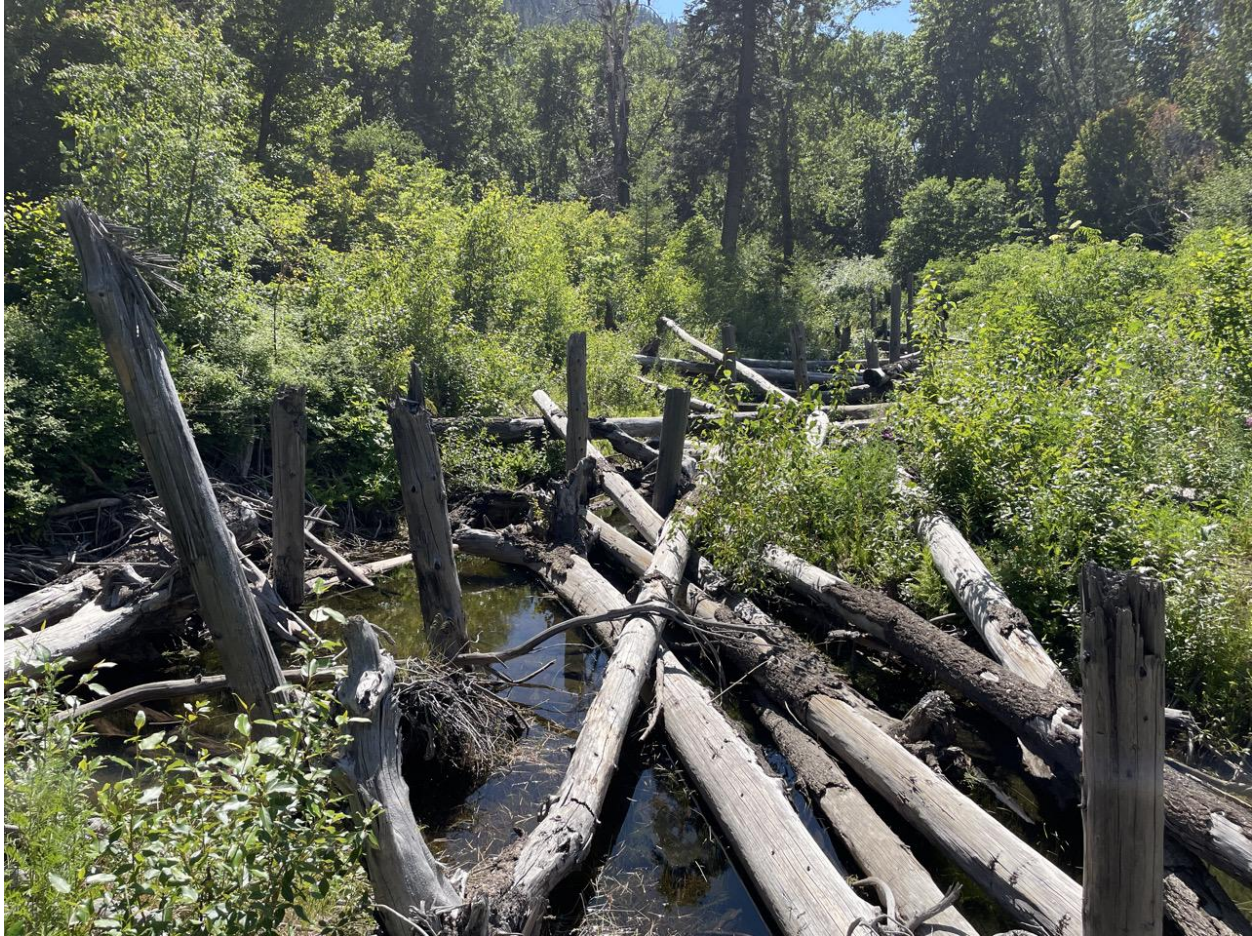
Figure 152. Constructed alcove with large wood placements near RM 12.1 (Inter-Fluve photo June 2025).
