MEMORANDUM

From: Mike Brunfelt, LG and Mike McAllister PE – Interfluve

Date: December 31, 2022

Re: Cub Creek 2 Fire: Chewuch River Watershed and Fish Habitat Impact Summary

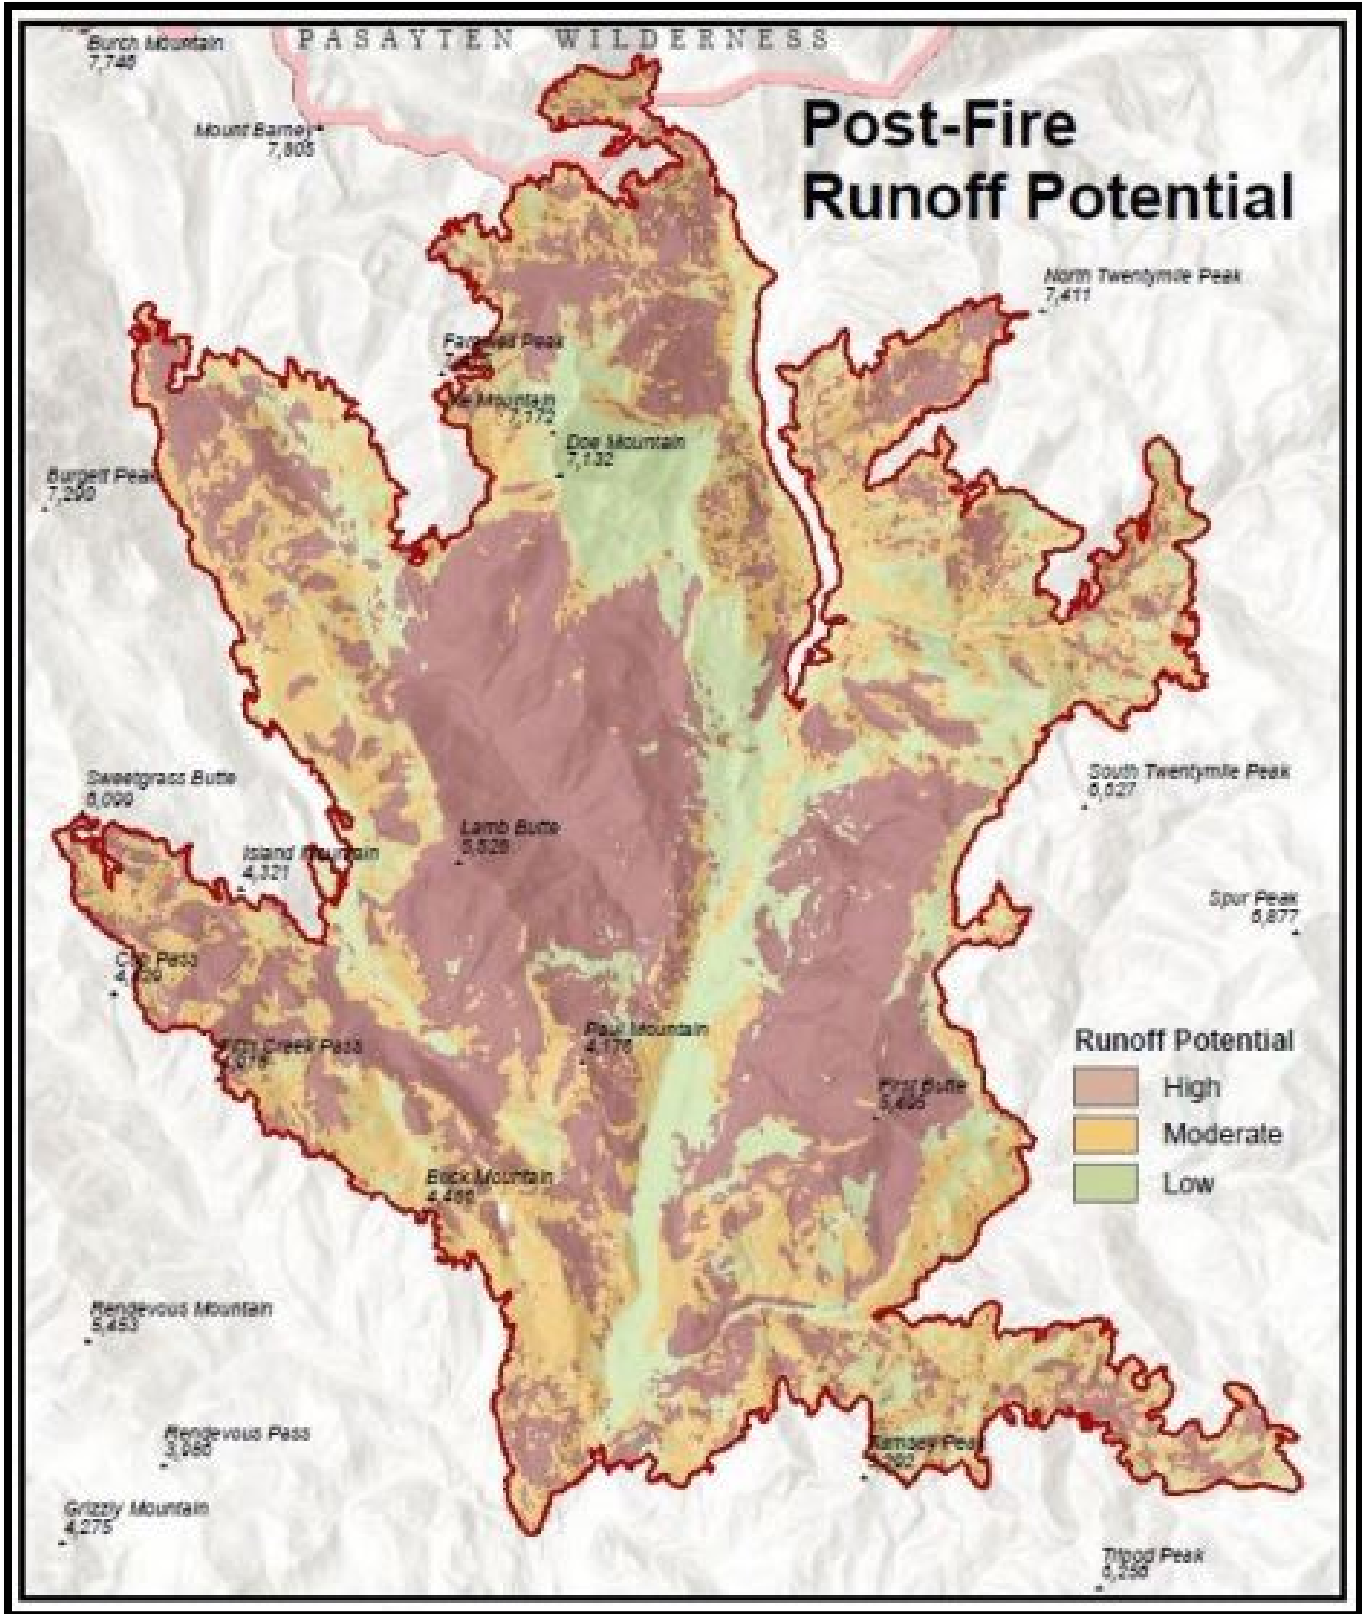
The USFS produced a Cub Creek 2 post-fire hydrologic model to estimate runoff over much of the burned area. The model indicated flows in smaller drainages resulting from the 5-yr 1-hour rainstorm (20% probability of occurrence in the first year following the fire, about 50% probability in years 1-3) are predicted to increase flows 50 to 200 times greater than pre-fire flow levels (Figure 1).

Figure 1. Map showing post fire runoff potential (USFS 2021).

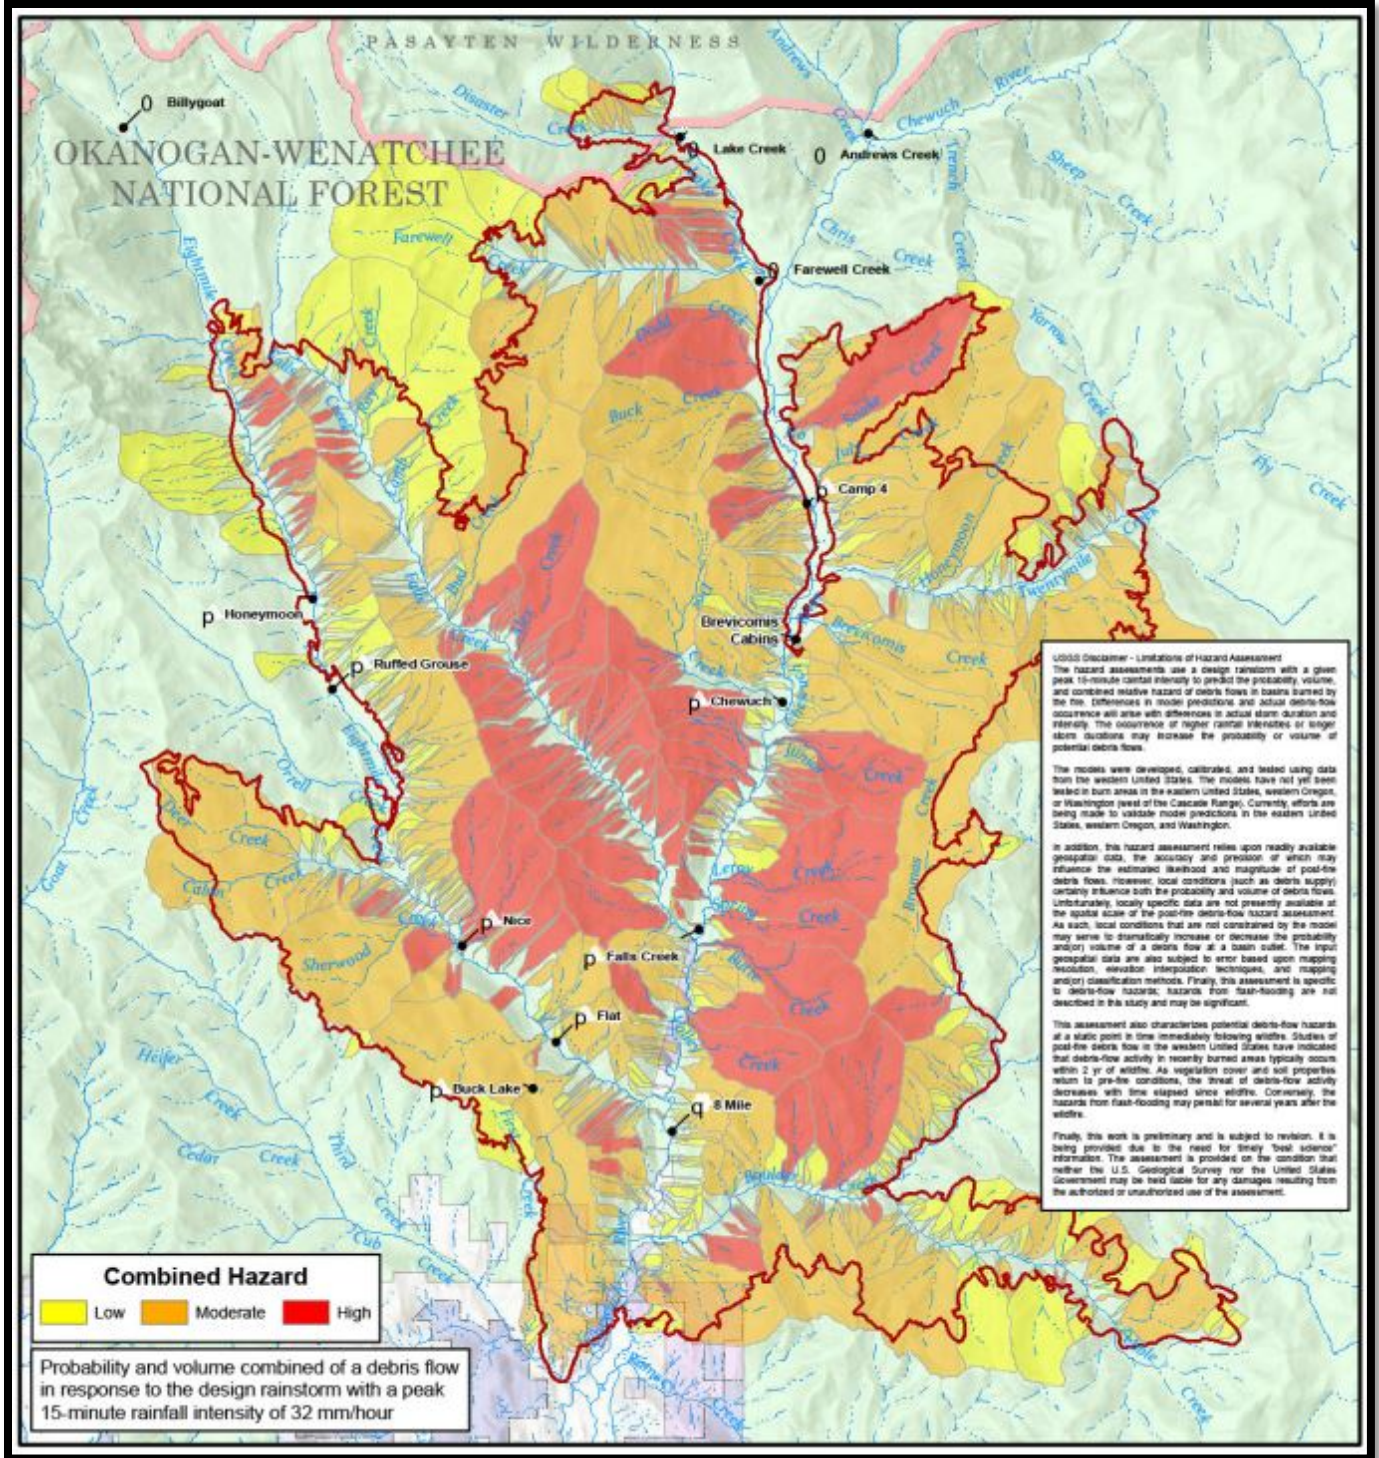
Due to the USFS post-fire survey of watershed soil conditions, hydrologic model results, steep tributary channels and clear evidence of past debris torrents, the USFS also estimated post-fire debris torrent risk using United States Geological Survey (USGS) debris flow risk models. The models estimated a moderate to high level of debris flow hazard in large segments of the watershed area burned in the fire. Sub watersheds in the center of the burn area were found to have high (60-80%) to very high (>80%) probability of debris flow occurrence if the modelled hydrologic precipitation event occurred in those areas (Figure 2). Doe Creek, Falls Creek, Eight Mile Creek, and the Chewuch River were areas where debris flow risk was the highest (USFS 2021).

Figure 2. Map showing debris flow hazards based on USGS model run results (USFS 2021).
