## Appendix A | Stream Habitat Assessment

Habitat Inventory Survey: *August 1st – September 1st, 2024*

White River RM 0 - RM 16.17

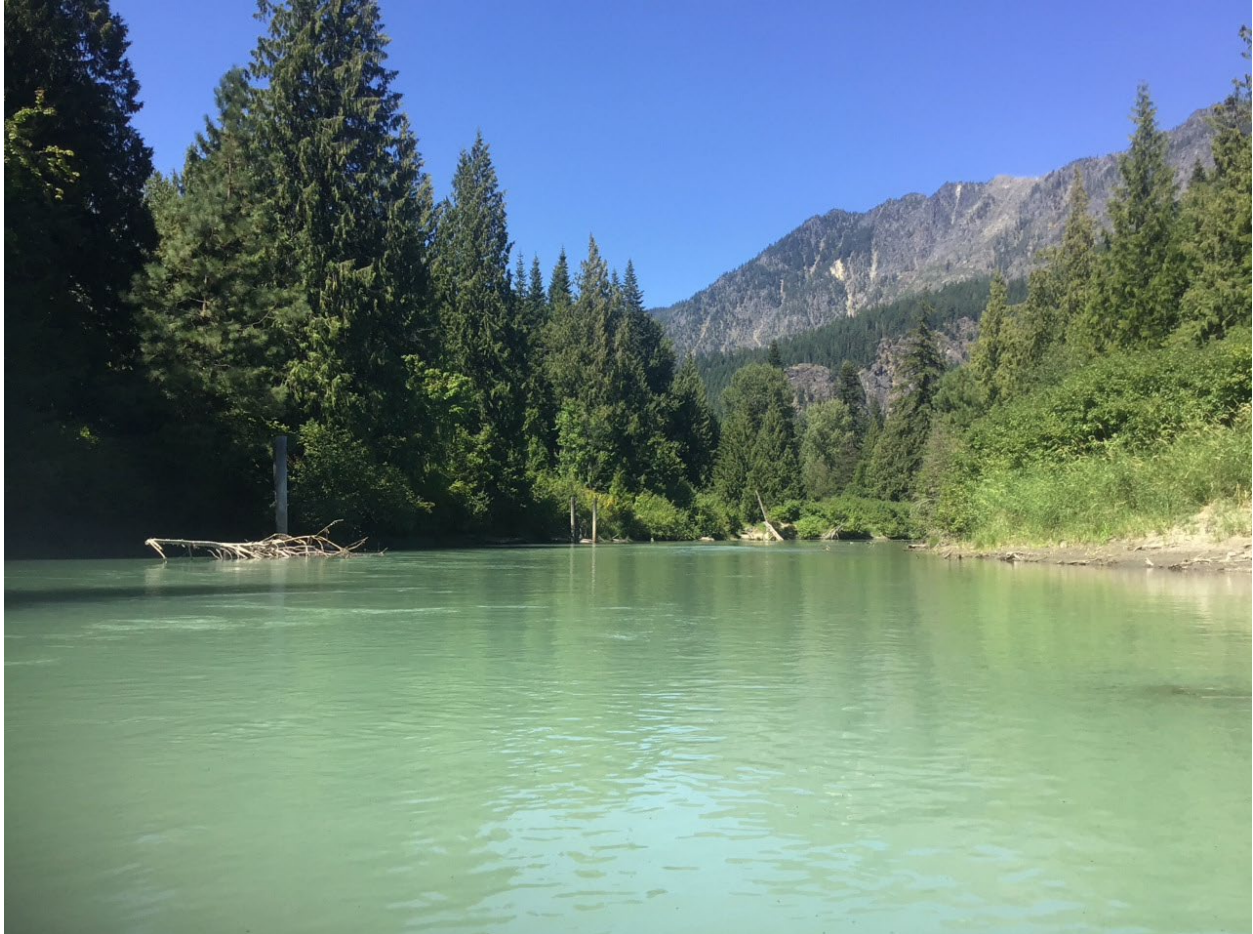
**Figure 23. Representative photo of Reach 2. Habitat is dominated by pool units.**

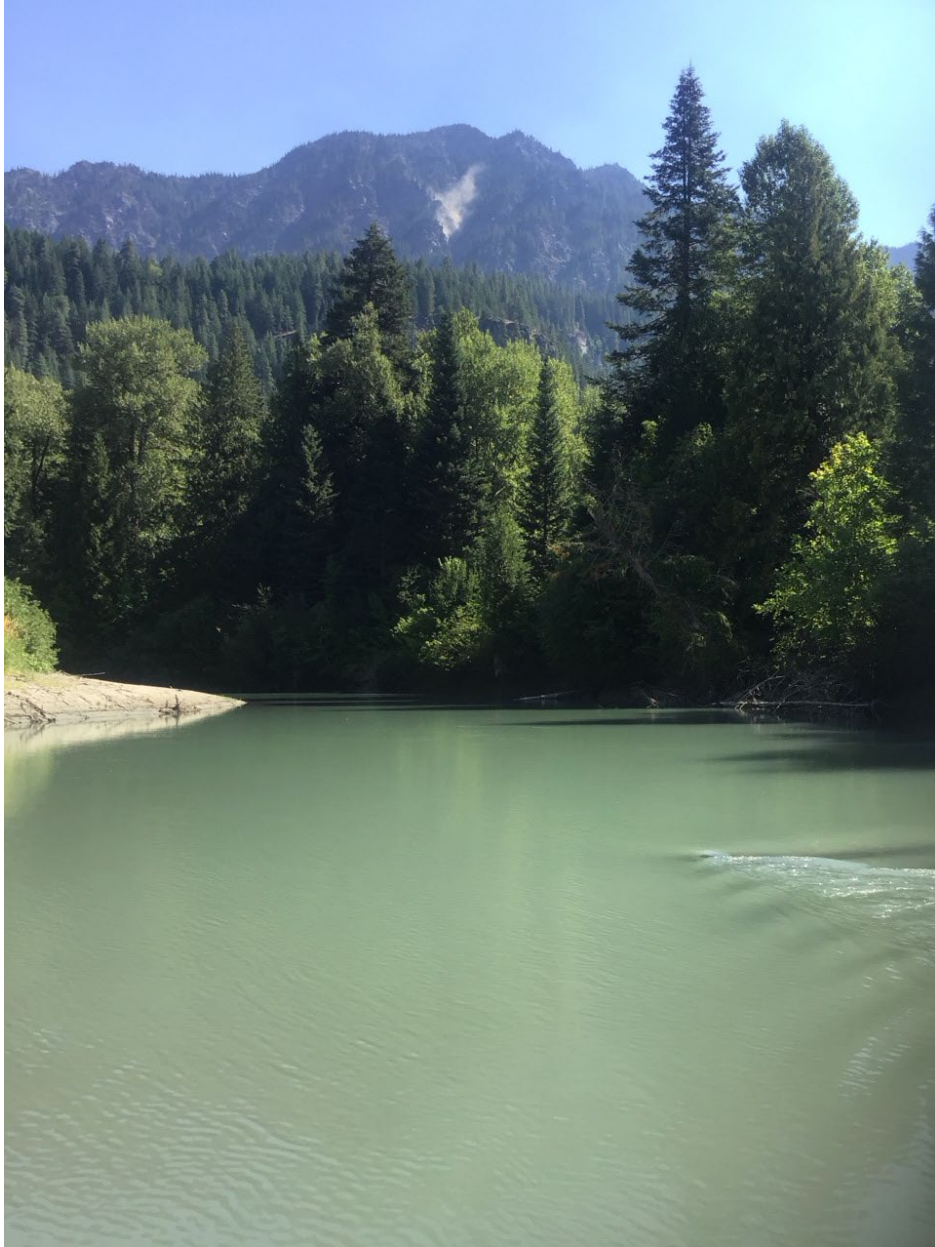
**Figure 31.** Representative photo of Reach 3. Habitat is dominated by pool units.

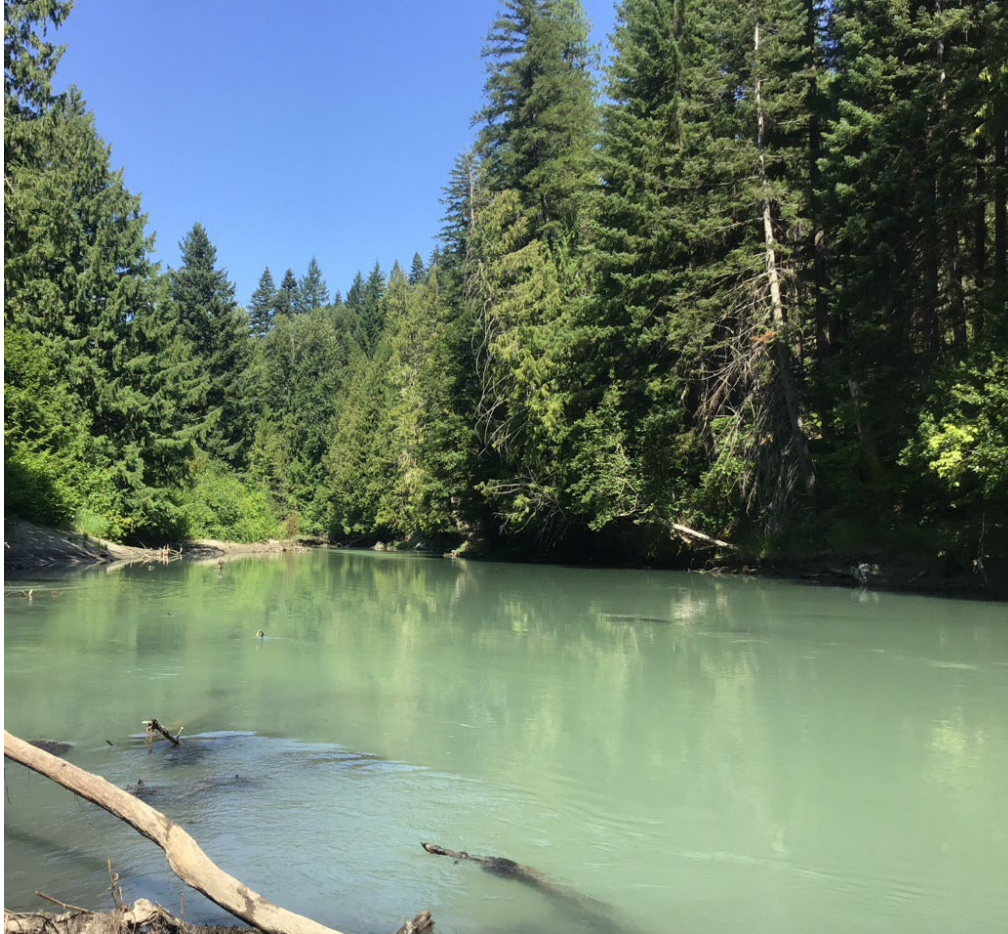
**Figure 39.** *Representative photo of Reach 4. Habitat is dominated by pool units.*

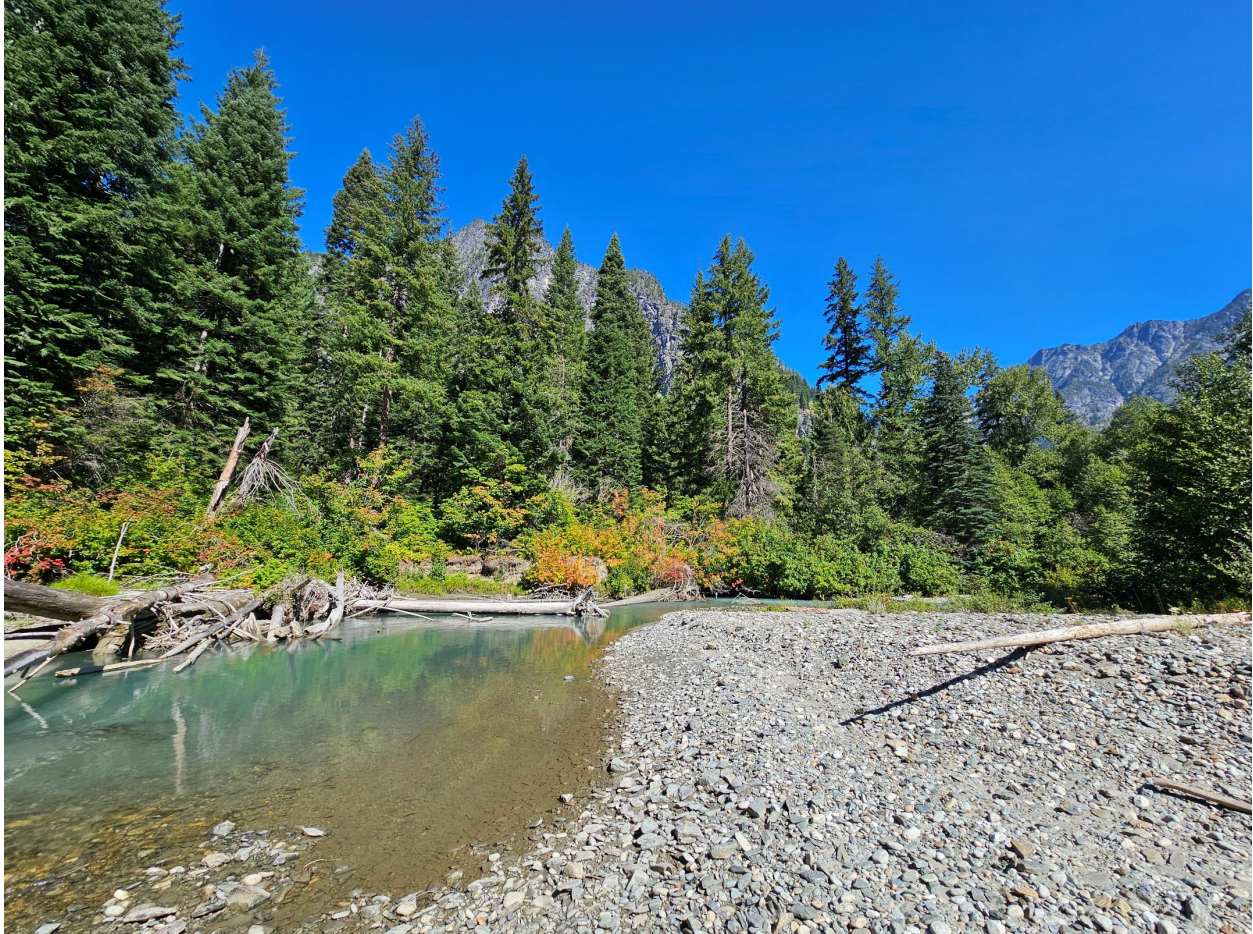
**Figure 95. Representative photo of the Napeequa River Reach 1. The habitat type is dominated by pool units, with an increasing amount of fast water units moving upstream.**

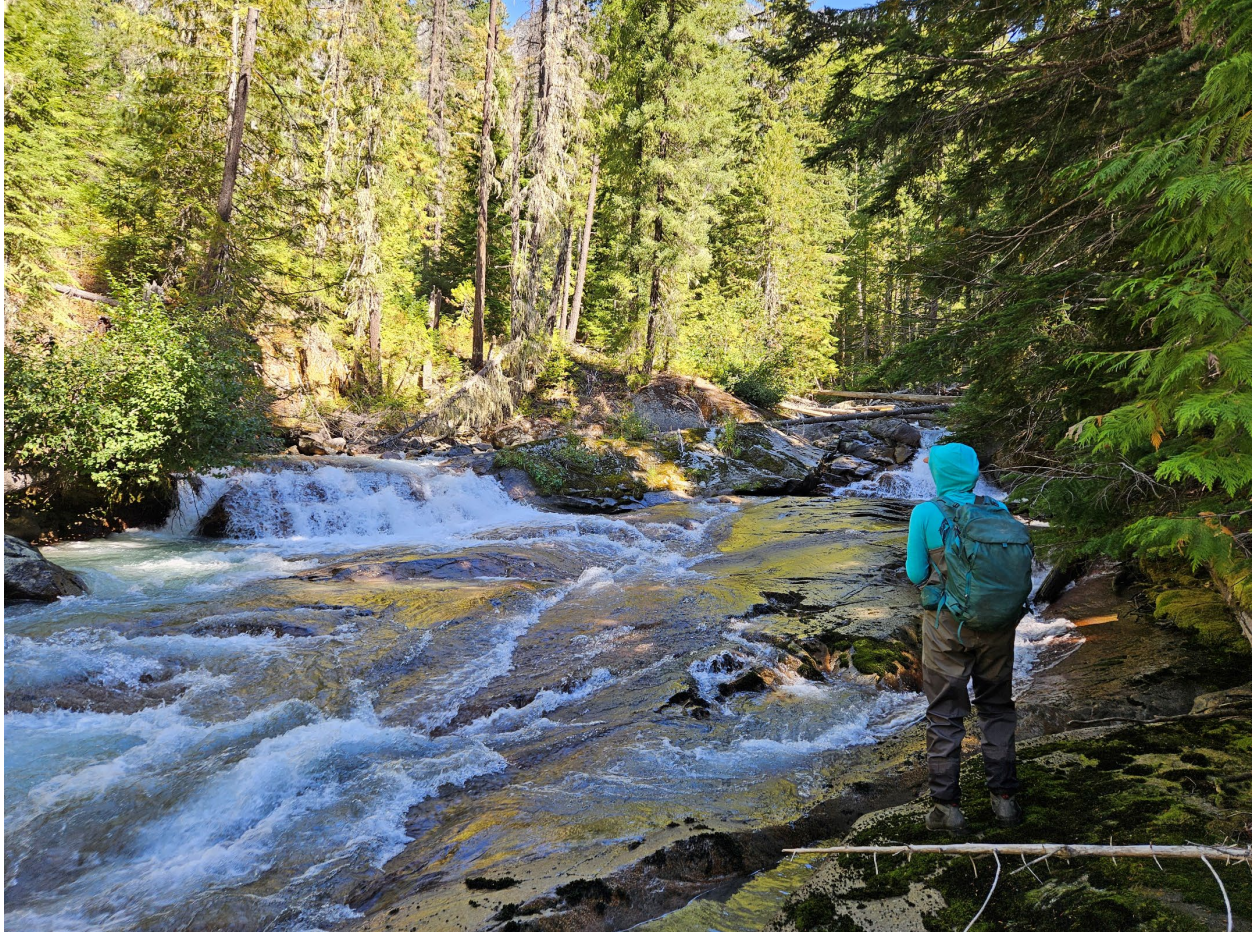
**Figure 103.** Representative photo of the Napeequa River Reach 2. The habitat was dominated by riffle. This photo shows the cascade section in Side 8.

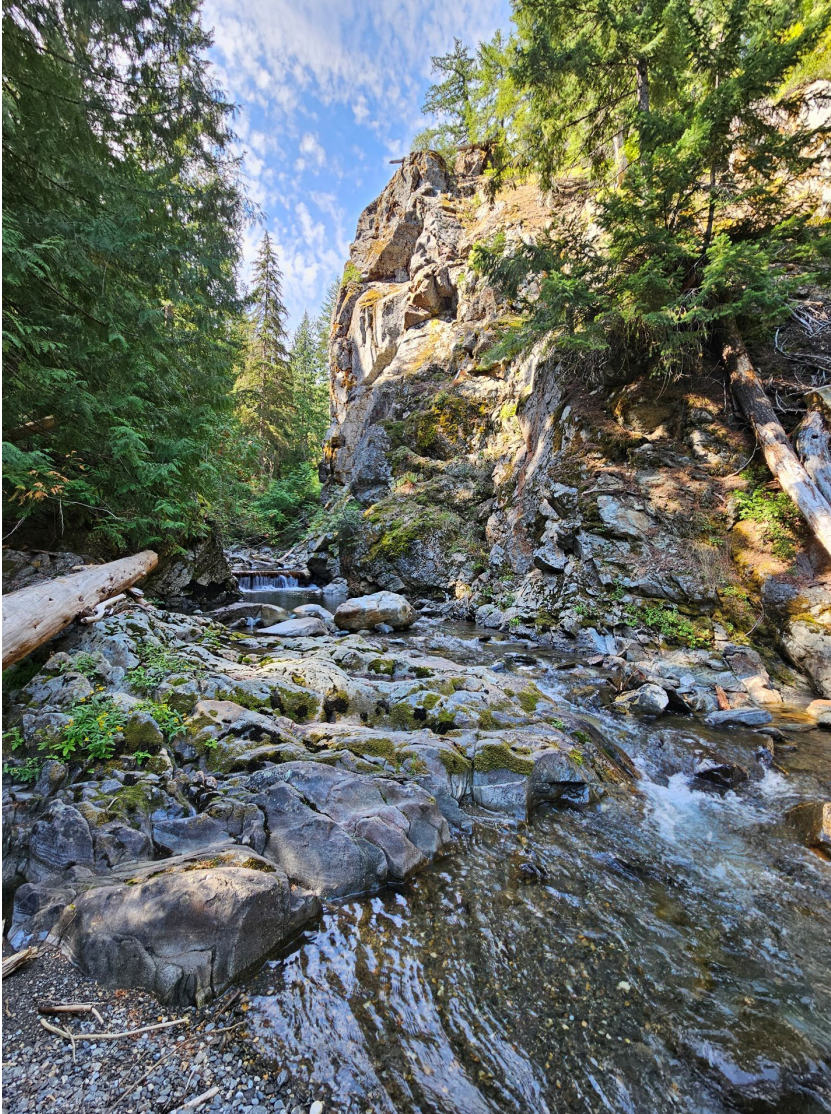
**Figure 108.** Representative photo of the Panther Creek Reach. The primary habitat type recorded was riffle. This photo shows the steep narrow gorge in which Panther Creek flows out of as well as the channel spanning log forming a plunge pool.
