Appendix C | Restoration Strategy

MIDDLE ENTIAT RIVER REACH ASSESSMENT UPDATE

February 2026

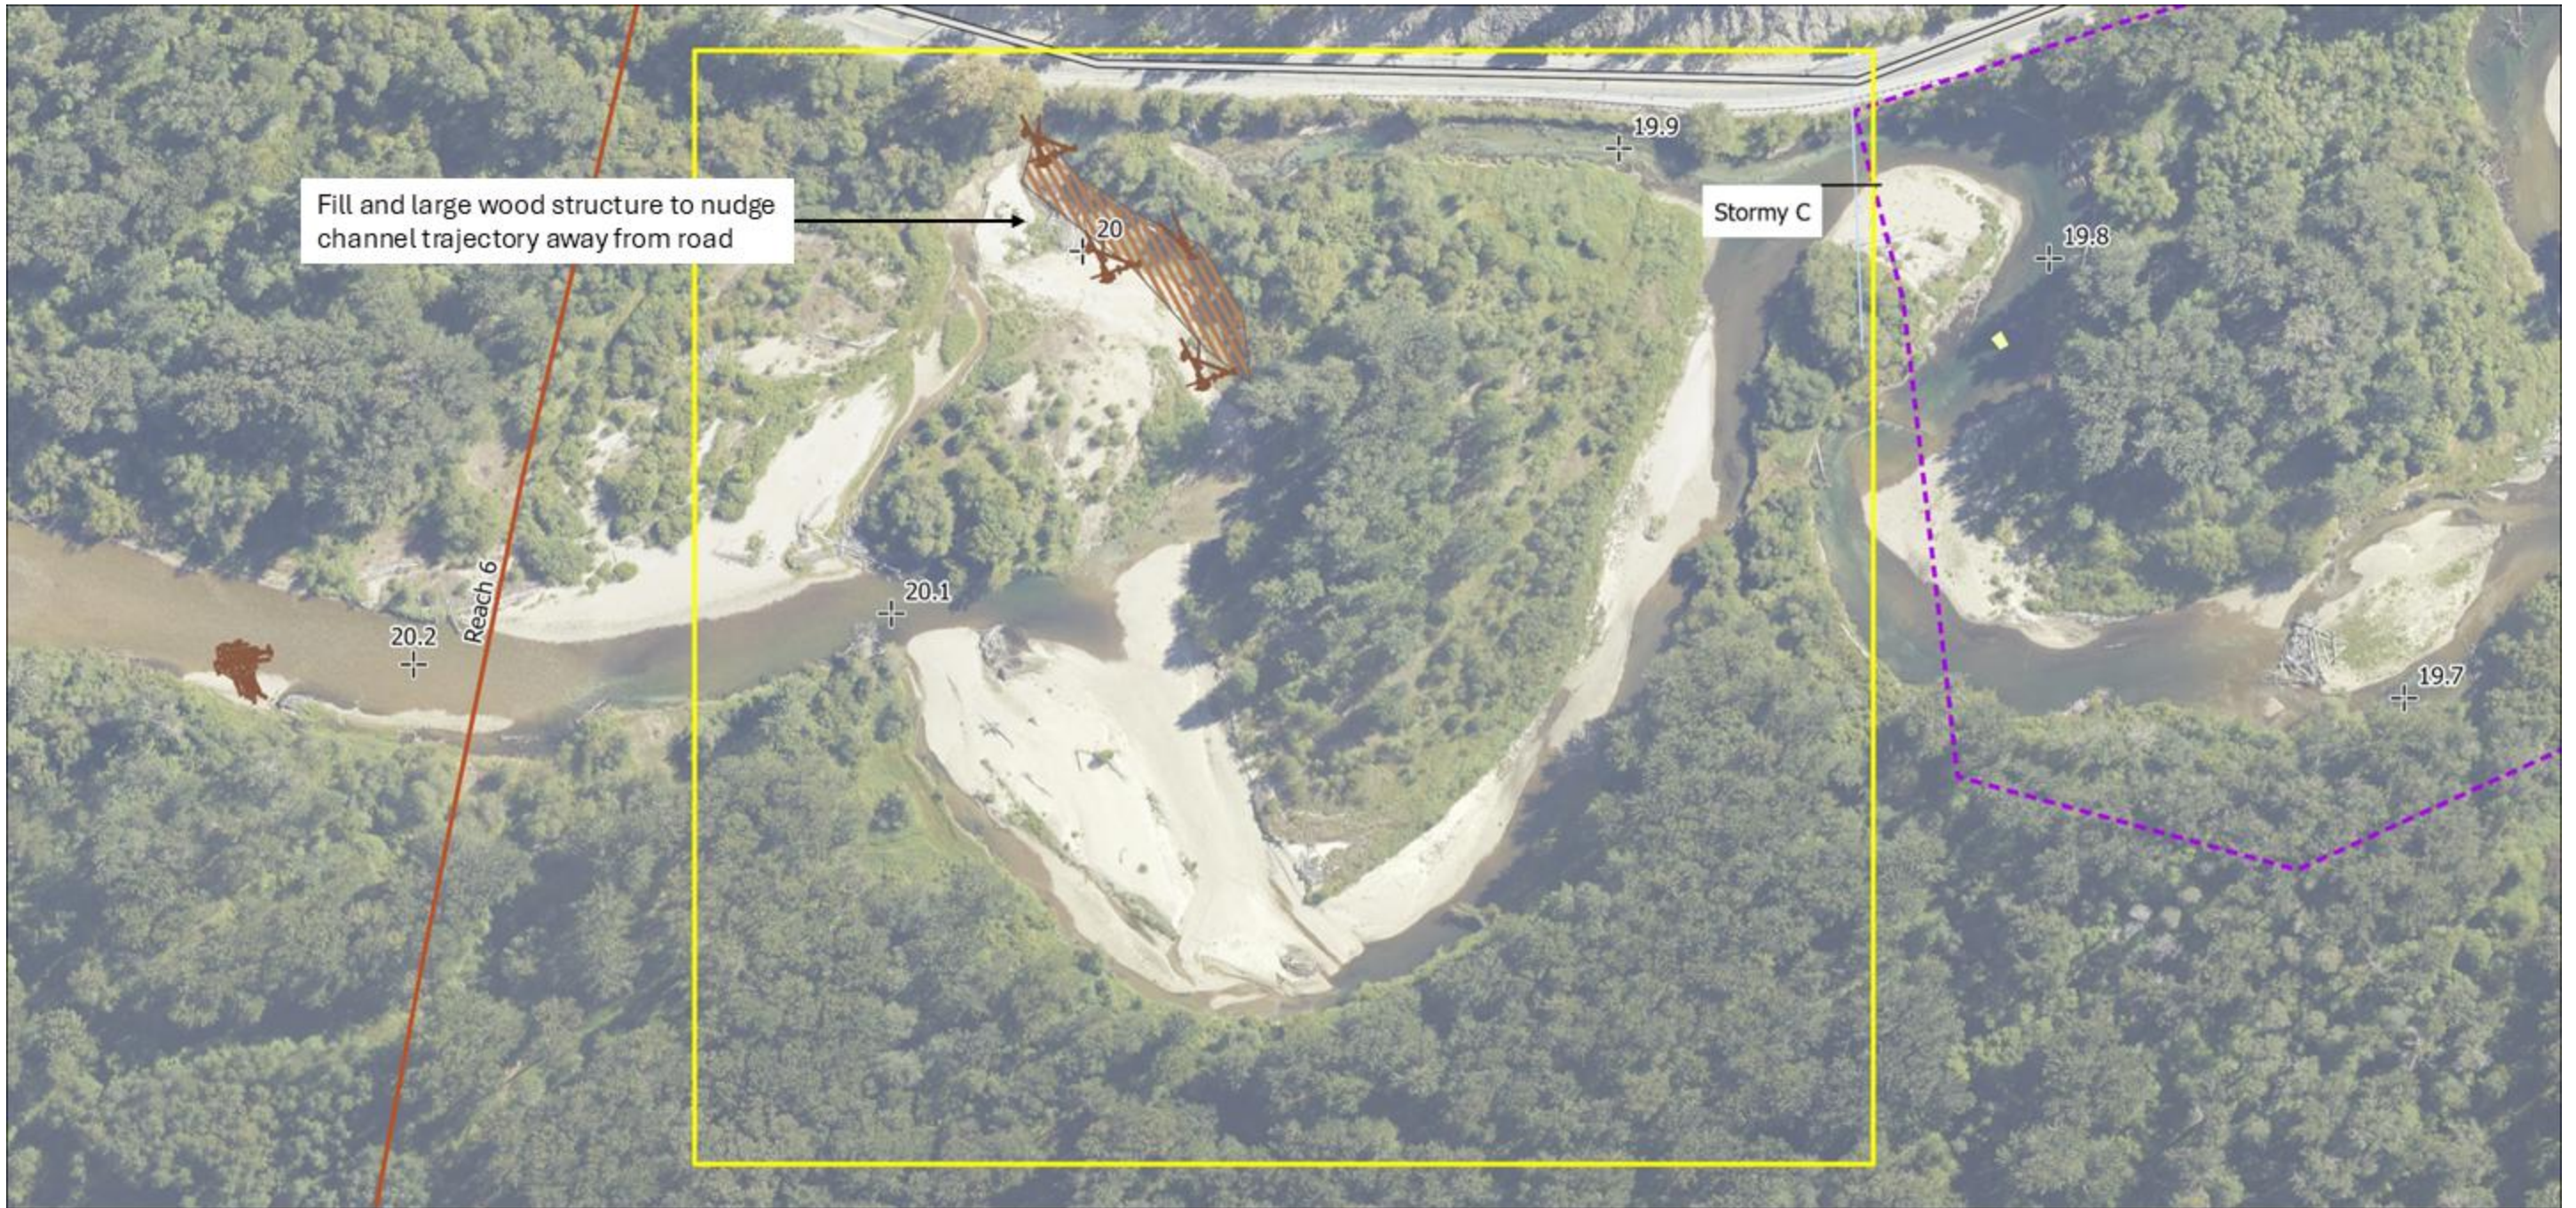
Entiat River Reach Assessment
Project Opportunities
Stormy Avulsion

- Project Elements**
- Log & log with rootwad
 - 2, 3, & 4 log structures
 - Small & large whole tree
 - Small & large apex jams
 - Sm, med & lrg bank jams
 - Side Channel Excavation
 - Side Channel Enhancement
 - Revegetation
 - Remove/Replace Armoring
 - Regrade
 - Reach Breaks
 - Segments
