# Washington Department of Fish and Wildlife

## Site Description Report

**WDFW Fish Passage and Diversion Screening Inventory Database**  
**Dam Assessment Report**

**WDFW Fish Passage and Diversion Screening Inventory Database  
Surface Water Diversion Assessment Report**

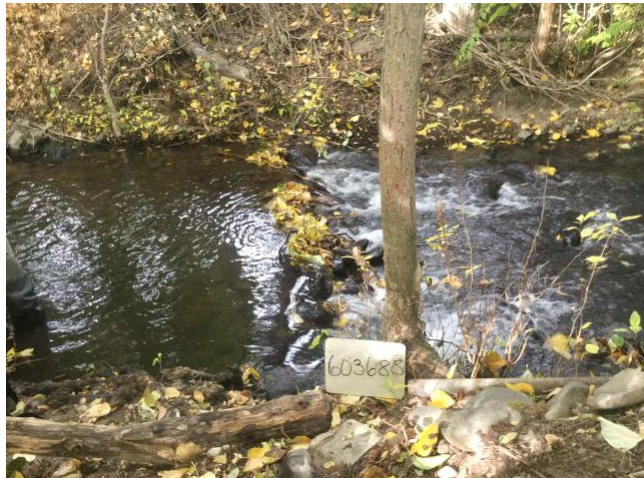
Dam Name:		Type:	Rock Fill	Operated:	Year Round
Reservoir Name:		Span:	Full	Fishway Present:	No
Primary Purpose:	Irrigation	Outlet:	Spillway

Length (m):	4.6
Height (m):	0.50
Water Surface Difference (m):	0.32
Plunge Pool Depth (m):	0.20

Barrier:	Yes
Reason:	WS Drop
Passability (%):	67
Recheck:

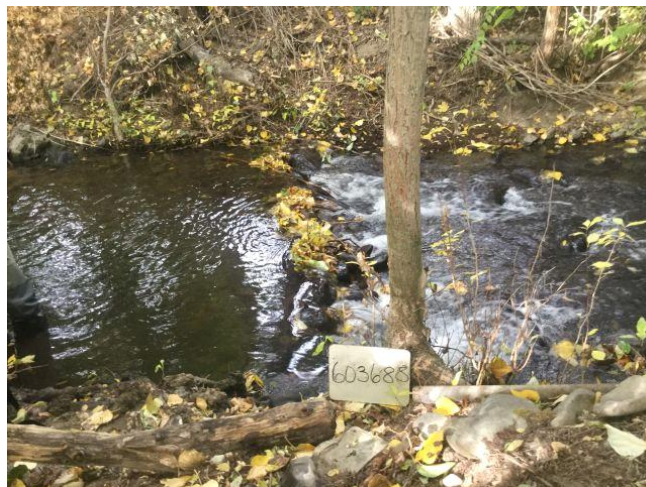
Type:	Pump	Point of Diversion:	RB	Diversion Dam:	Yes
Access By:	Foot	Location:	River Bank	Headgate:	No
Fish Bypass:		Fish Bypass Functioning:			
Fish Bypass Enclosure Status:

Pump disassembled for winter or may no longer be in use.
--

Screen Type:	
Screen Material:	Perforated Plate
Mesh Size (in):	0.0625
Diameter (ft):	4.00
Height (ft):	0.67
Length (ft):	-99.99
Area (sq ft):	-999.99
Condition:	OK
Compliant (WDFW Criteria):	
Under Operation:	
Active Cleaning:
