Fish Passage & Diversion Screening Inventory Database Report Cover Sheet

Site Description Report

WDFW Fish Passage and Diversion Screening Inventory Database
Dam Assessment Report

**WDFW Fish Passage and Diversion Screening Inventory Database
Surface Water Diversion Assessment Report**

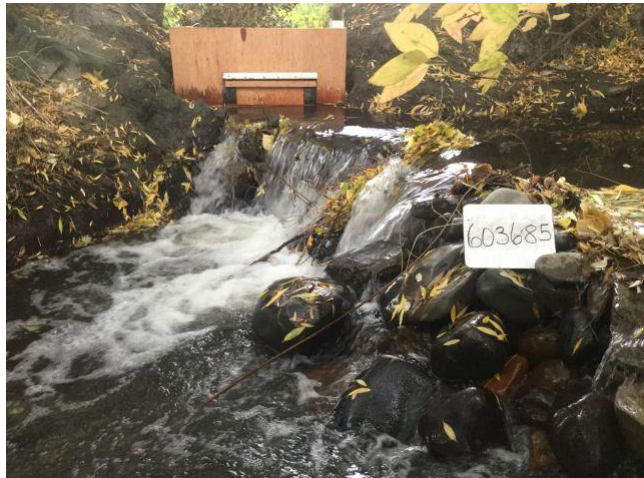
Dam Name: <input type="text"/>	Type: <input type="text" value="Rock Fill"/>	Operated: <input type="text" value="Year Round"/>
Reservoir Name: <input type="text"/>	Span: <input type="text" value="Full"/>	Fishway Present: <input type="text" value="No"/>
Primary Purpose: <input type="text" value="Irrigation"/>	Outlet: <input type="text" value="Spillway"/>

Length (m):	<input type="text" value="5.3"/>
Height (m):	<input type="text" value="0.85"/>
Water Surface Difference (m):	<input type="text" value="0.55"/>
Plunge Pool Depth (m):	<input type="text" value="-99.99"/>

Barrier:	<input type="text" value="Yes"/>
Reason:	<input type="text" value="WS Drop"/>
Passability (%):	<input type="text" value="33"/>
Recheck:	<input type="text"/>

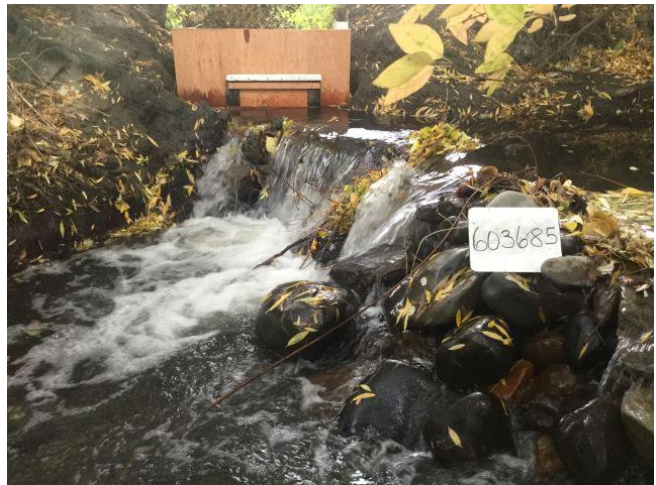
Type:	Pump	Point of Diversion:	RB	Diversion Dam:	Yes
Access By:	Foot	Location:	River Bank	Headgate:	Yes
Fish Bypass:		Fish Bypass Functioning:			
Fish Bypass Enclosure Status:

Could not see intake screen in diversion pond.
--
